**MINERALS PROGRAM INSPECTION REPORT**  
**PHONE: (303) 866-3567**

| <b>MINE NAME:</b><br>Robinson Sons Gravel Pit No. 1 | <b>MINE/PROSPECTING ID#:</b><br>M-2008-076 | <b>MINERAL:</b><br>Sand and gravel and | <b>COUNTY:</b><br>Las Animas |
| <b>INSPECTION TYPE:</b><br>Monitoring | <b>WEATHER:</b><br>Clear | <b>INSP. DATE:</b><br>March 26, 2024 | <b>INSP. TIME:</b><br>12:47 |
| <b>OPERATOR:</b><br>Robinson Sons Inc. | <b>OPERATOR REPRESENTATIVE:</b><br>Daniel Robinson | <b>TYPE OF OPERATION:</b><br>112c - Construction Regular Operation | |

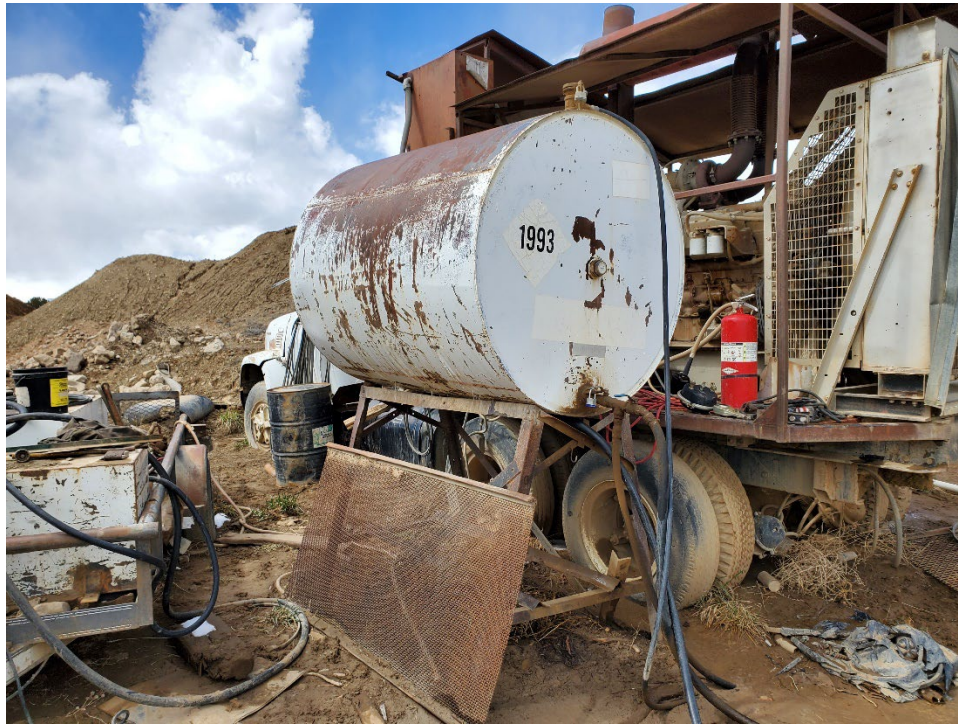
**PROBLEM:** Improper storage and containment of fuels and/or other hazardous materials was present on site.

A fuel tank was observed in the equipment lay-down area in Area 1. The tank was not double walled, to the Operator's knowledge, and did not have a form of secondary containment (Photo 1). This has been **cited as a problem above**. The Operator stated that they would place a stock tank underneath the tank to serve as secondary containment. The Operator shall submit a photo of the stock tank around the fuel tank, or other instillation of an approved form of secondary containment, to the Division by the corrective action date.

**Photo 1:** Fuel tank in Area 1 requiring secondary containment.

**CORRECTIVE ACTIONS:** All storage tanks, petroleum and any hazardous materials on site for any period of time shall have appropriate secondary containment. The site will also have to comply with all applicable SPCC requirements. Please supply photo documentation that any fuel or hazardous materials containers are stored properly - including applicable secondary containment structures by the corrective action date. Note that secondary containment structures shall consist of an impermeable containment which could contain all contents of the tanks and various containers (when full) plus 10% of the total capacity. The Operator may also provide photo documentation that all containers have been removed from the site on or before the corrective action date.

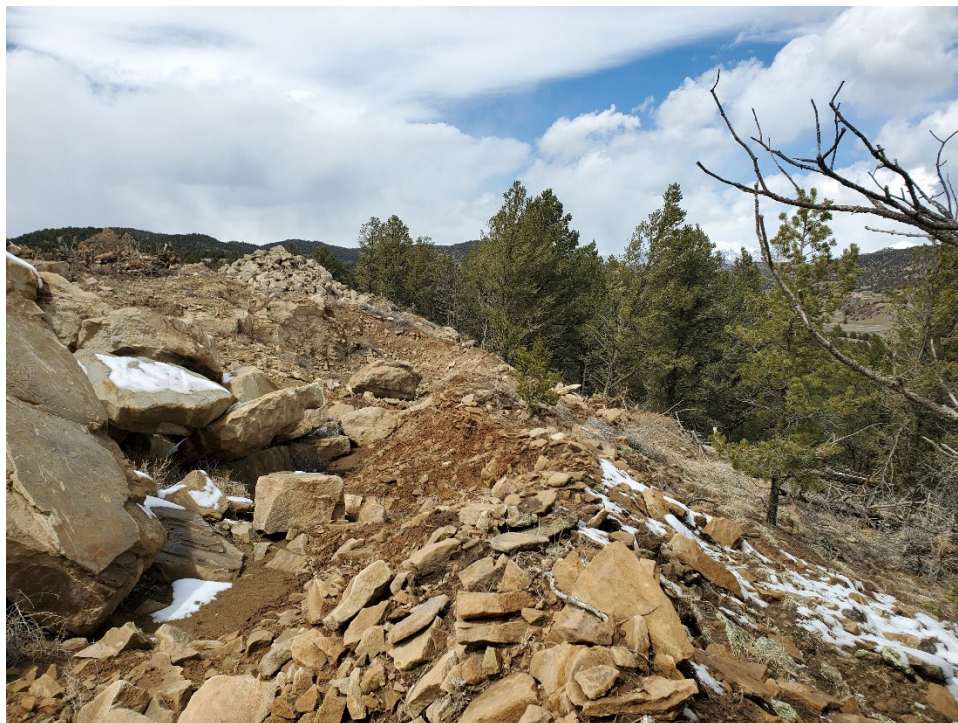
**Photo 2:** Berms surrounding perimeter of the disturbance in Area 2.

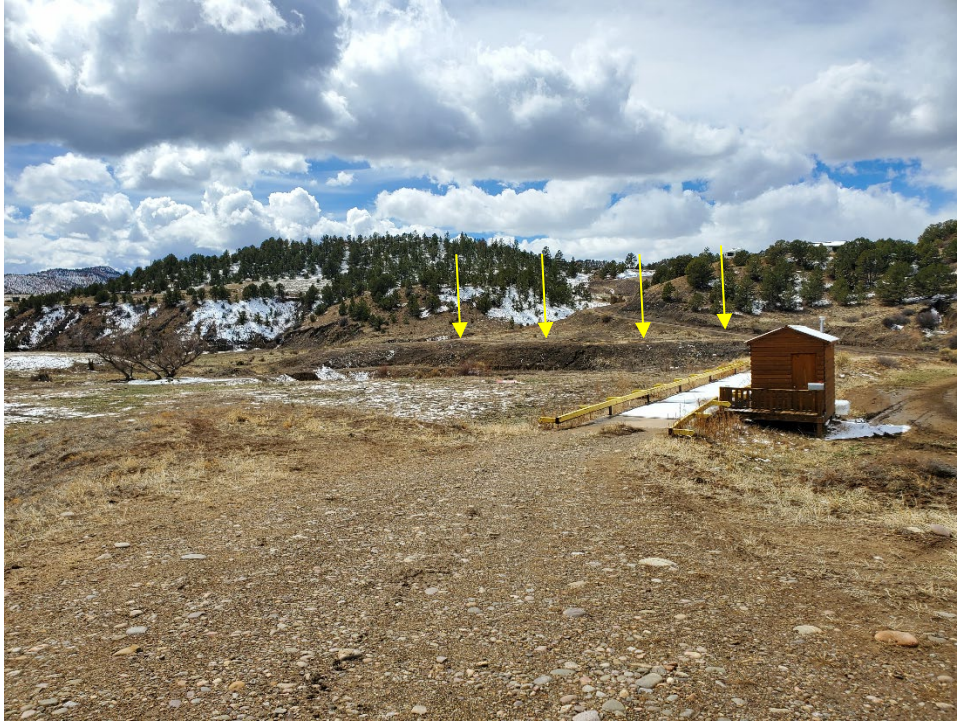
- *Reclamation-Only Area*
  - No recent disturbance was observed within the creek (Photo 3), or the actual designated 'Reclamation-Only Area'. The Operator stated that there has been no activity in the creek since it was reclaimed at least three years ago.

**Photo 3:** Arrows point to the 'Reclamation Only' area within the creek bed. This area has not been re-disturbed since it was reclaimed.

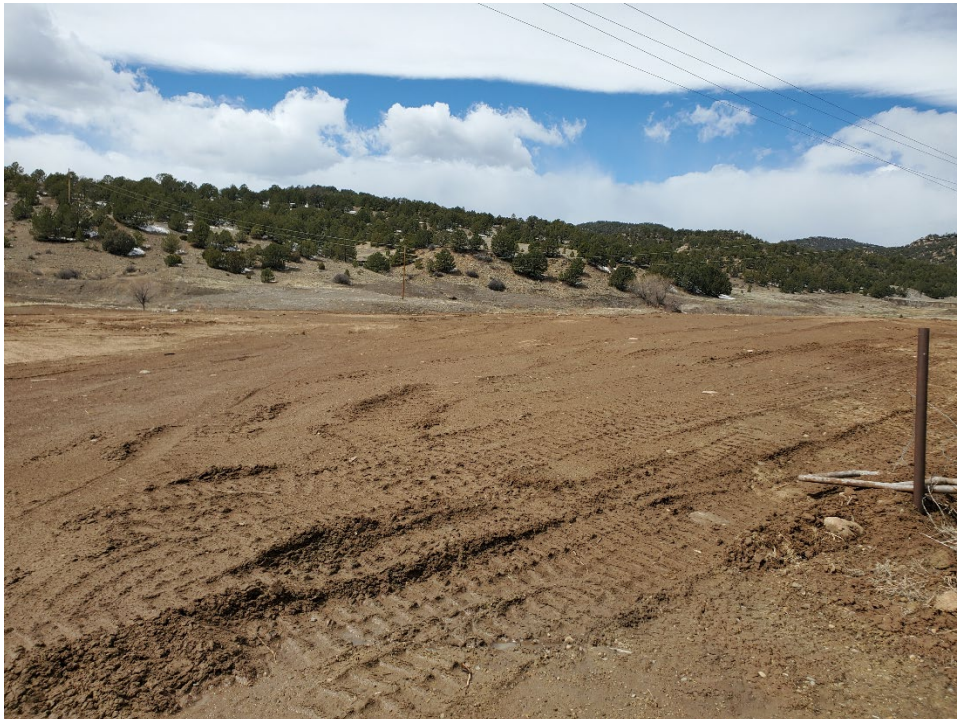
- The area to the north of the entrance road, and east of the 'Reclamation-Only Area' has been widened (Photos 4-6; Maps 1 & 3). The Operator stated that there had been a drop-off on the north side of the road, so they used their surplus of backfill material on-site to level the area out to make it safer for maneuvering haul trucks. Although the entire permitted area is approved to be affected, there is not currently an approved reclamation plan for this area. **This has been cited as a problem above.** The Operator shall submit a Technical Revision to update the reclamation plan narrative, and the reclamation plan map, to indicate and illustrate how this area will be reclaimed, by the corrective action date.

**Photo 4:** Standing at the north side of the entrance road, looking north-west at the widened embankment on the north-portion of the entrance road.

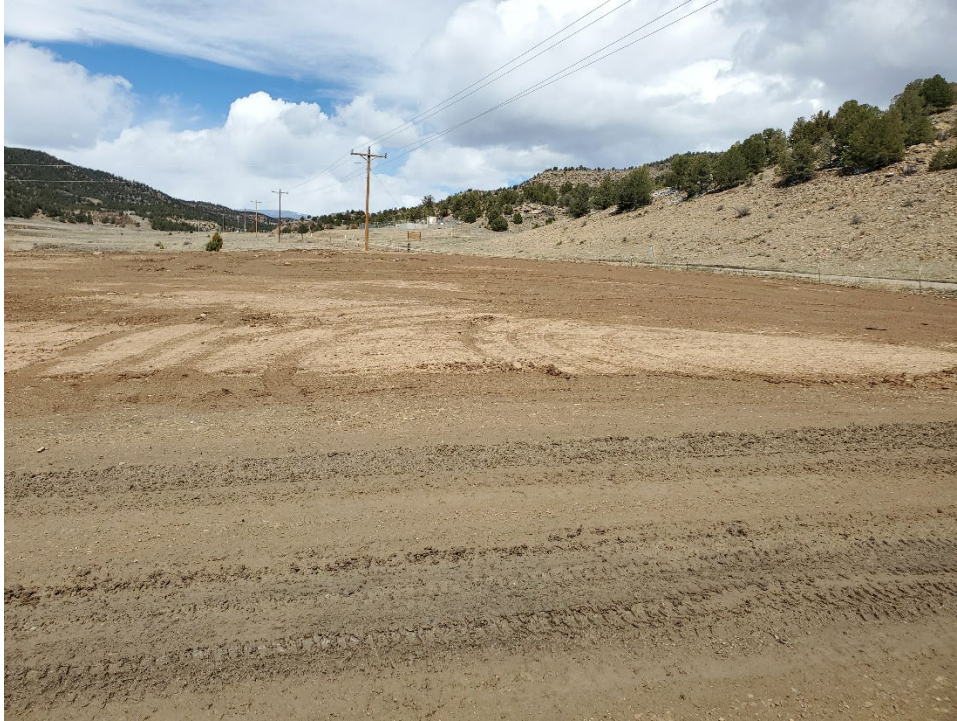
**Photo 5:** Looking north across the widened embankment on the north-portion of the entrance road.

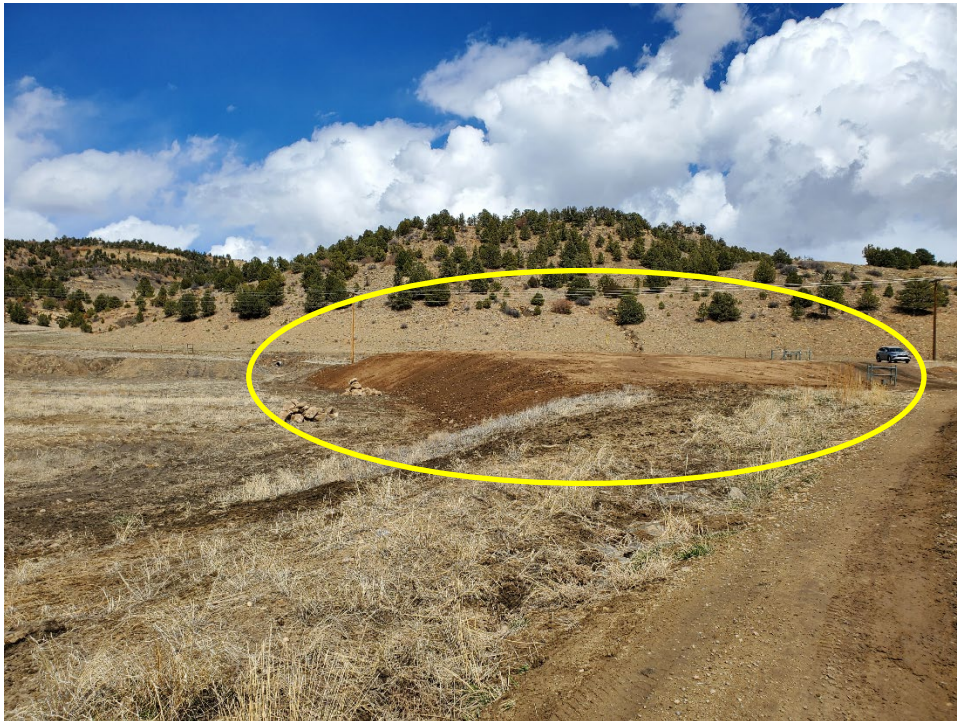
**Photo 6:** Looking east at the widened embankment on the north-portion of the entrance road (circled).

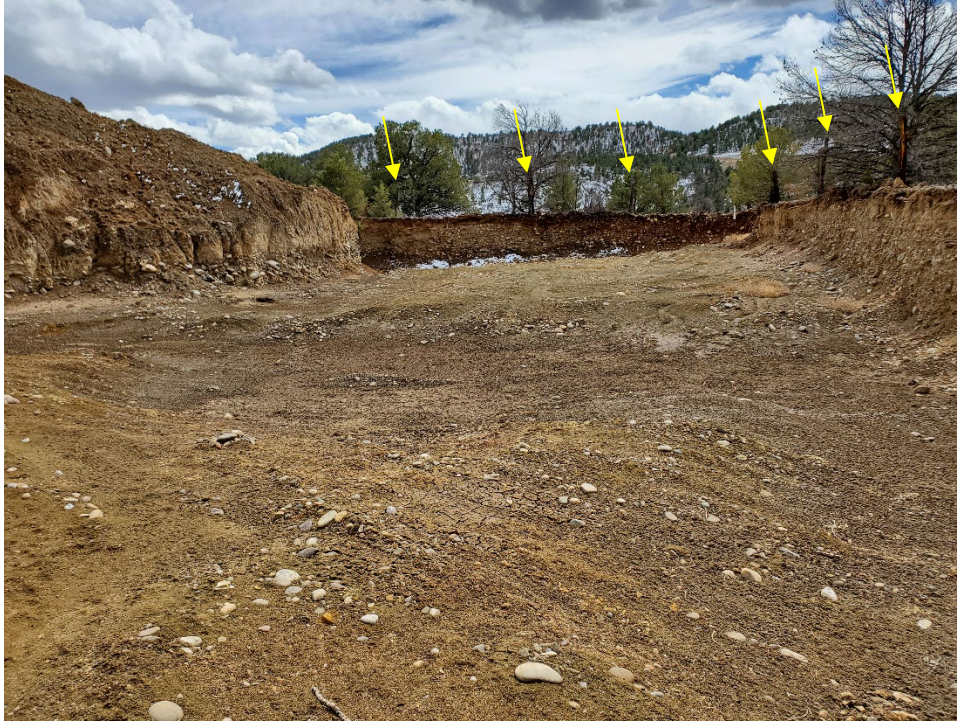
- *Area 1*
  - Active mining in Area 1 consists of:
    - Two pit areas (south and north) with highwalls (Photos 7-10).
      - The highwalls remaining along the southern border (southern pit area) follow the fence along the south-west corner of the site.

**Photo 7:** Looking south at the southern-west corner of Area 1. The arrows point to fence posts along the top of the highwalls.

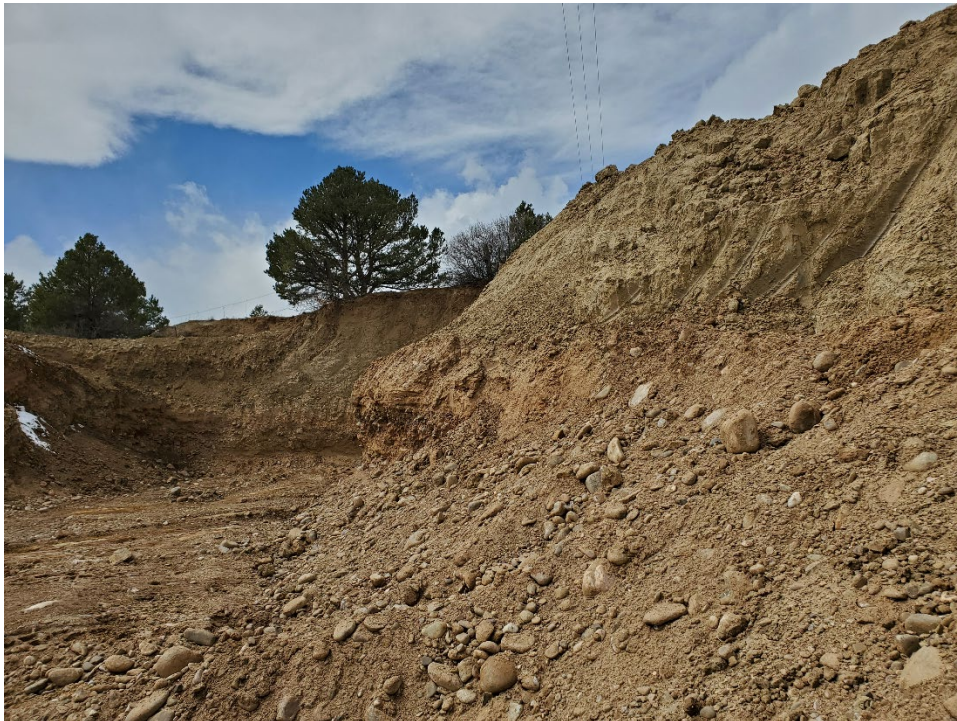
**Photo 8:** Looking west along the highwalls in the northern border of the northern pit area in Area 1.

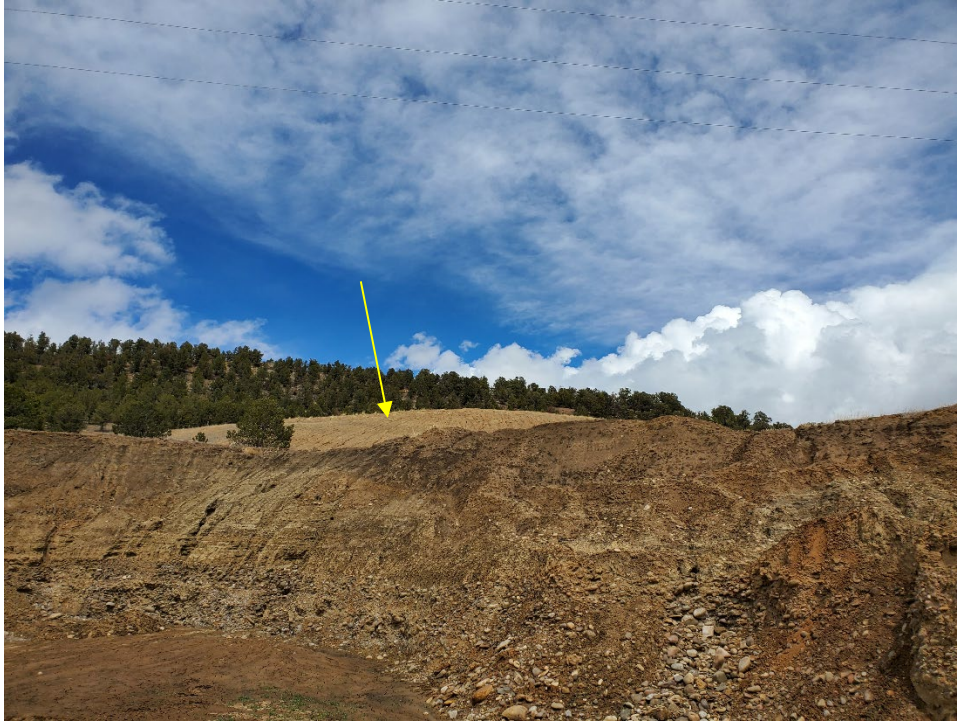
**Photo 9:** Looking north at the northern extent of the north pit in Area 1. The arrow points to a reclaimed slope that consists of more topsoil if needed.

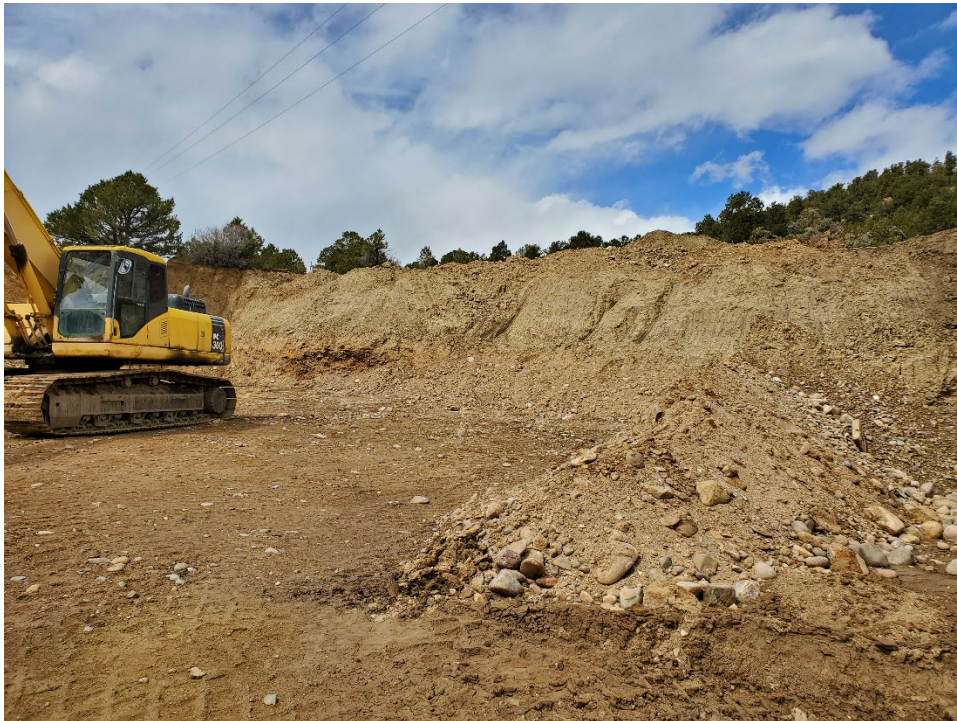
**Photo 10:** Looking north-west at the start of the highwall on the east side of the northern pit of Area 1.

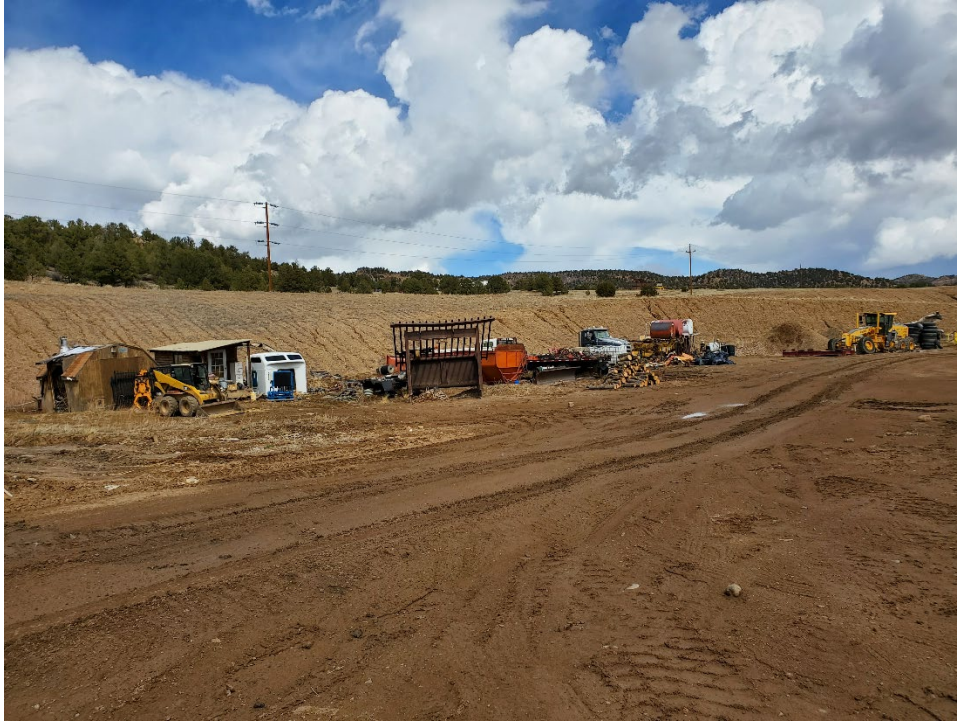
- A mined out pit floor, currently being used for equipment and stockpile storage (Photos 11-13).
  - A pile of broken-up asphalt was observed in the south-east corner of Area 1 (Photo 14). The Operator stated that this material was salvaged from a bridge demolition. The Division reminds the Operator that they may crush this material and incorporate it with their product, but they are not approved to backfill with this material without an approved Technical Revision to their mining plan that complies with the requirements of Rule 3.1.5(9). The following is a statement from the currently approved plan regarding imported fill:

**Photo 11:** Looking north-east along the reclaimed slopes, and some of the equipment stored, in Area 1.

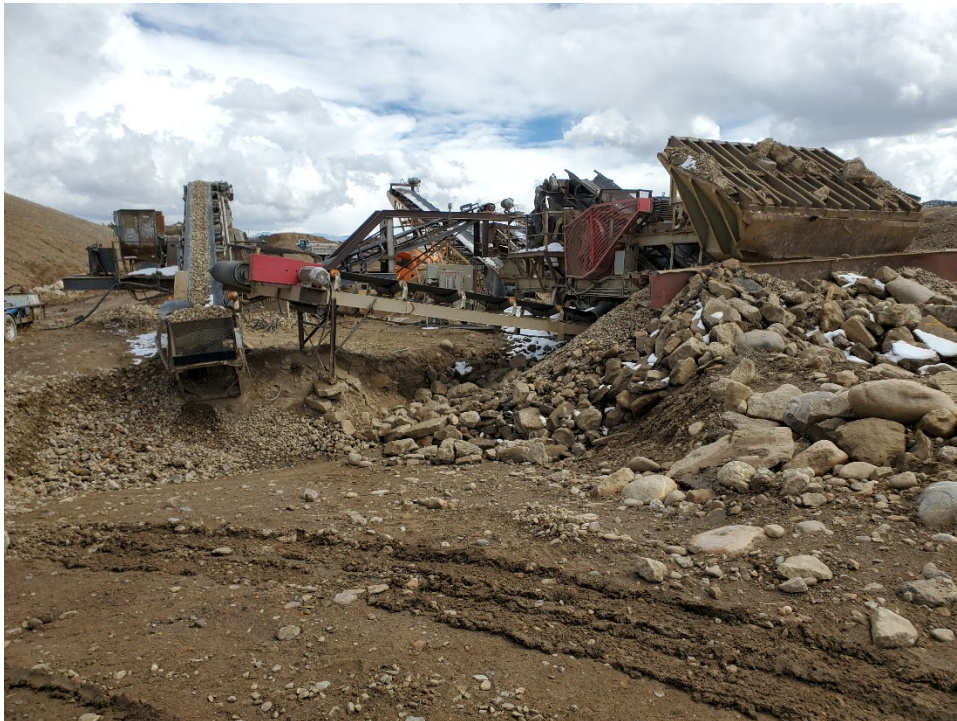
**Photo 12:** Looking east at the processing area in Area 1.

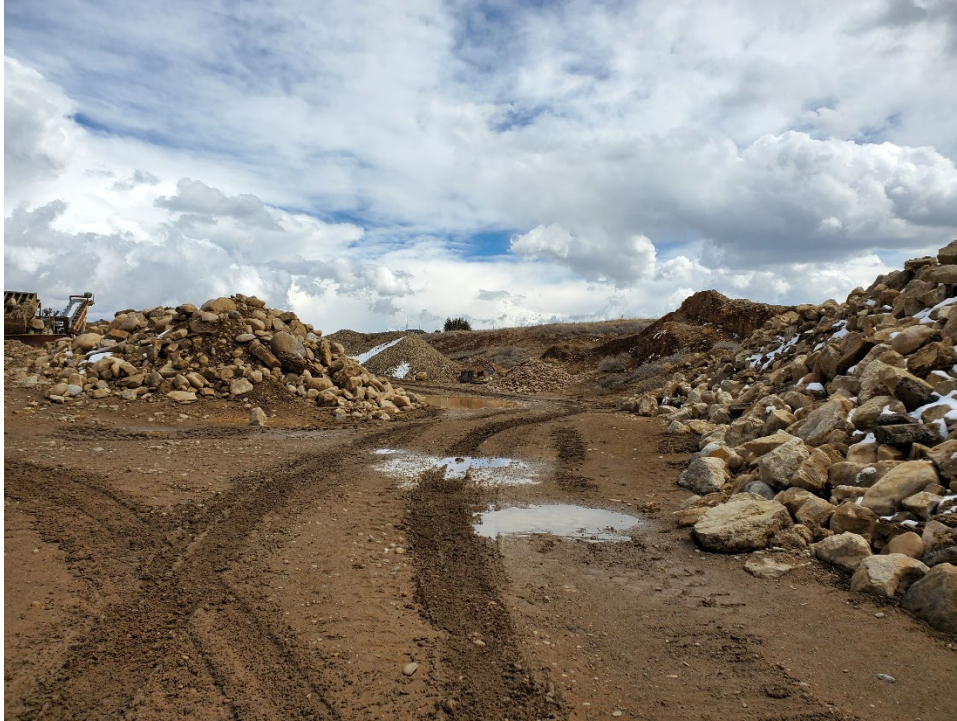
**Photo 13:** Looking south-east at some product stockpiles stored in the mined out area in Area 1.

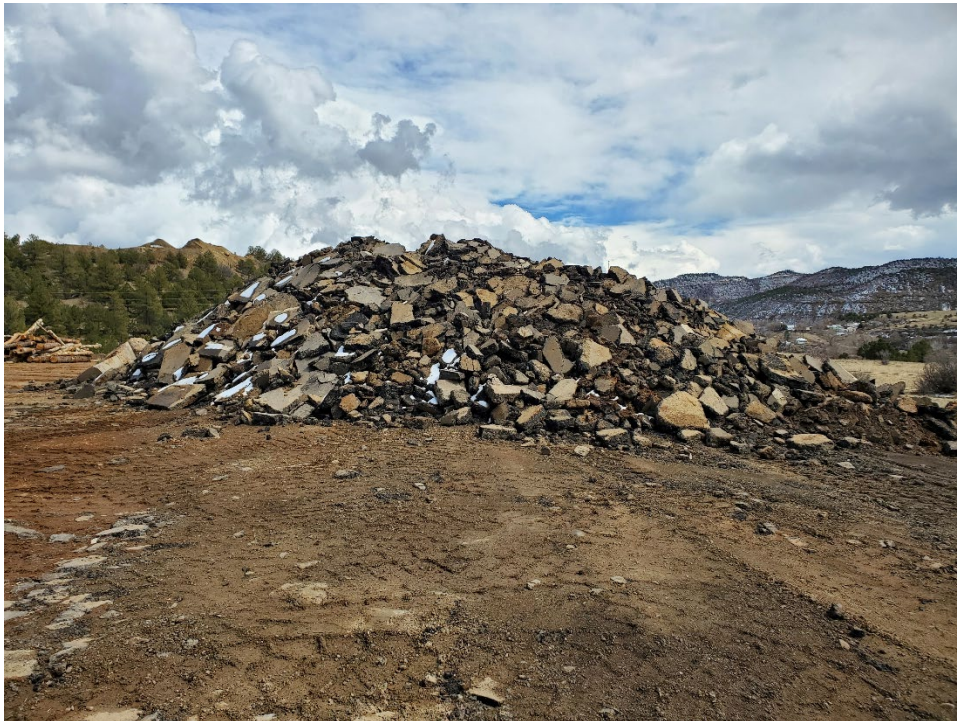
**Photo 14:** A pile of broken up asphalt from a bridge demolition, brought into the pit to be crushed and combined with product.

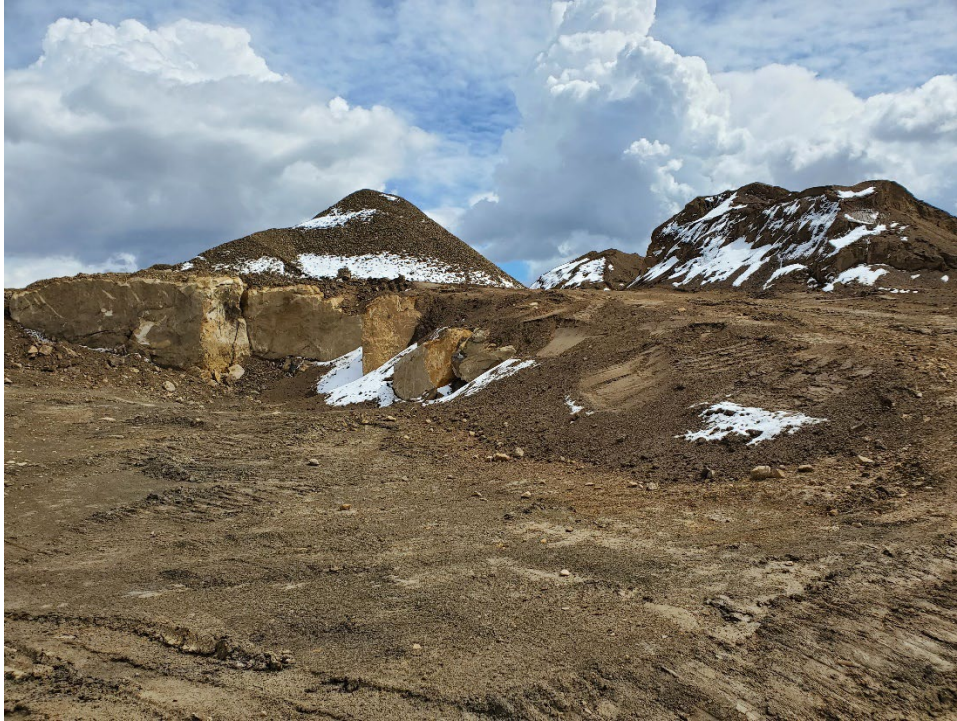
- *Area 2*
  - Excavating has finished in Area 2. Product stockpiles, and some overburden piles, and a small length of highwall remain (Photos 15-17).
  - The rest of the material in Area 2 is too massive to excavate without blasting, so the exposed highwall will be backfilled and reclaimed.

**Photo 15:** Looking south-east at the remaining portion of highwall, a graded slope, and some overburden stockpiles in Area 2.

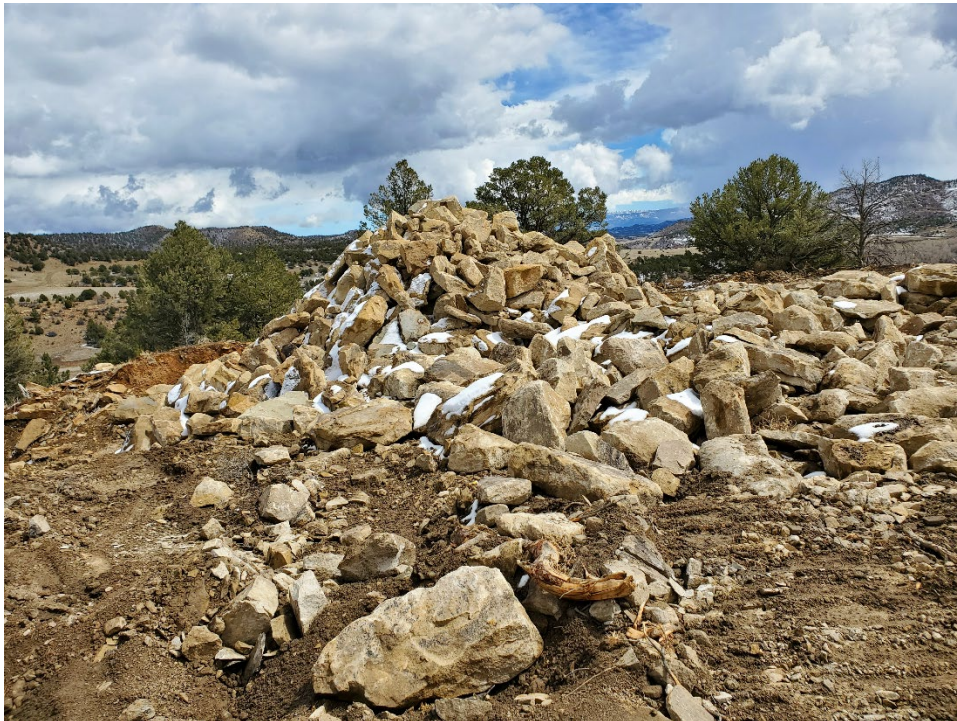
**Photo 16:** Product stockpile in Area 2 to be hauled to Area 1 soon.

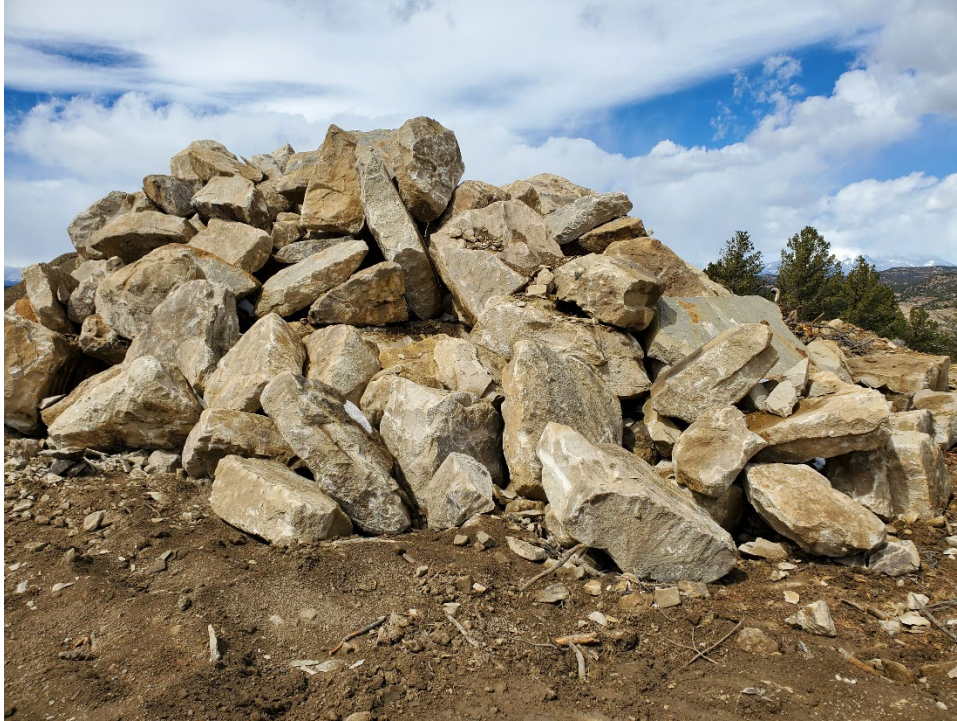
**Photo 17:** Product in Area 2 to be hauled to Area 1 to be crushed, or to be used as larger rip-rap material.

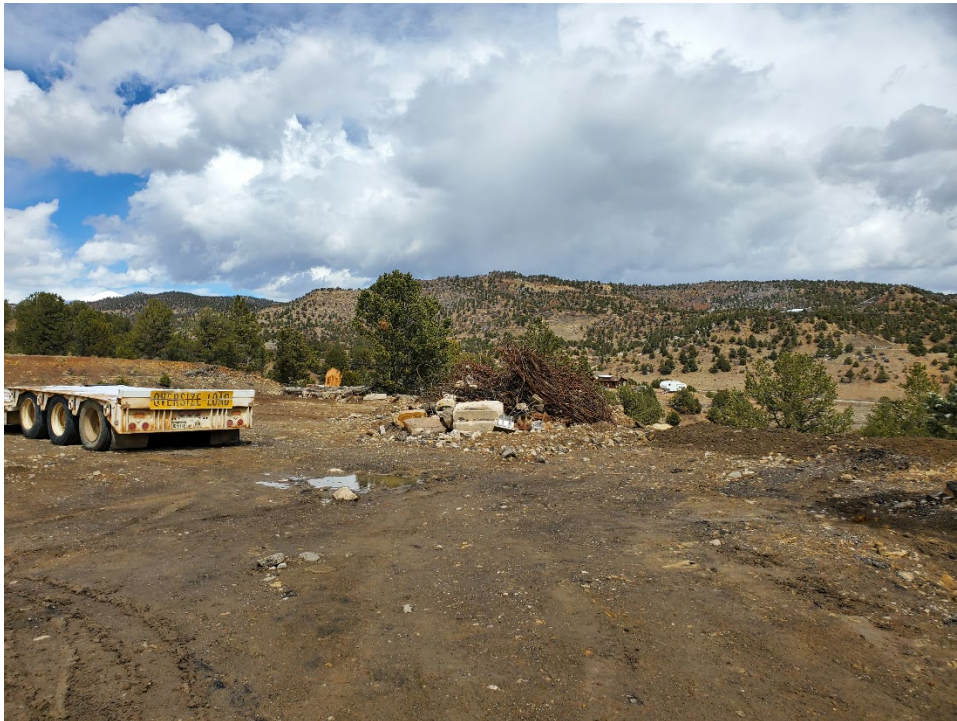
- The stockpiled product in this area consists of varying sizes of rip-rap material.
  - A pile of scrap metal and rebar was observed along the east portion of the road into Area 2 (Photo 18). The Operator stated that this was also salvaged from the bridge demolition and is temporarily being stored in Area 2, but will soon be hauled off-site.

**Photo 18:** Facing north-east, looking at a pile of rebar/scrap metal salvaged from a bridge demolition. Pile is being stored until it can be hauled off-site.

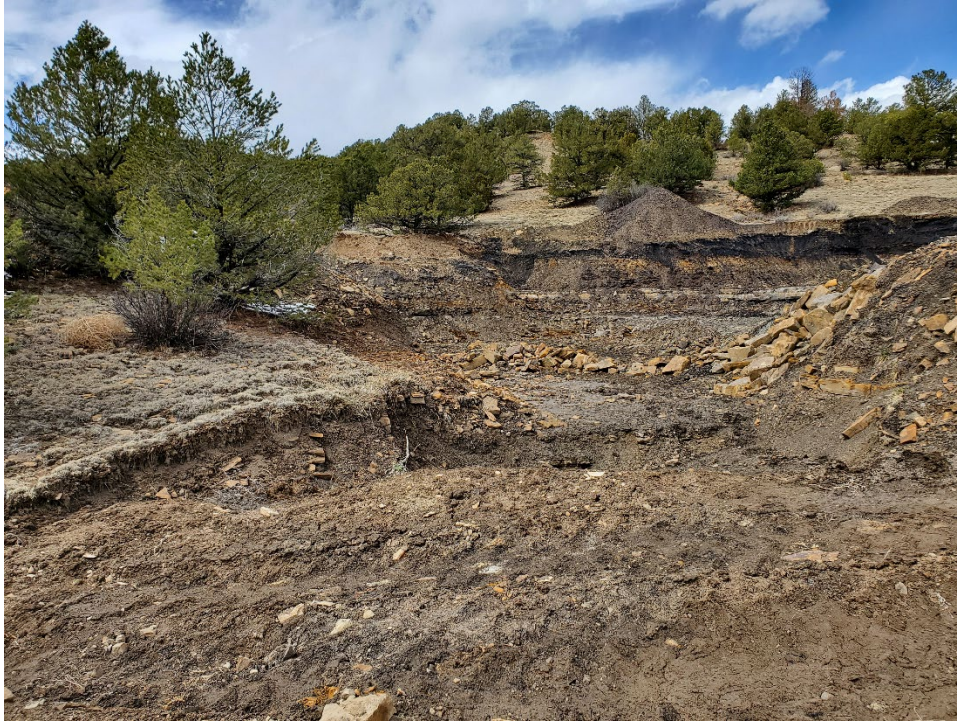
- *Area 3*
  - On the Operator's 2023 annual report map (see Map 2 within this report) an area within Area 3 was proposed for mining during 2024. During the inspection, the Division observed a small pit excavated within the area indicated on the map (Photos 19-21). The Operator stated that they may mine deeper within this pit if they can acquire a crusher strong enough to break up the material. If not, they'll haul the material that they have already excavated and use it as more rip-rap product.

**Photo 19:** Looking north-west into the pit area in Area 3.

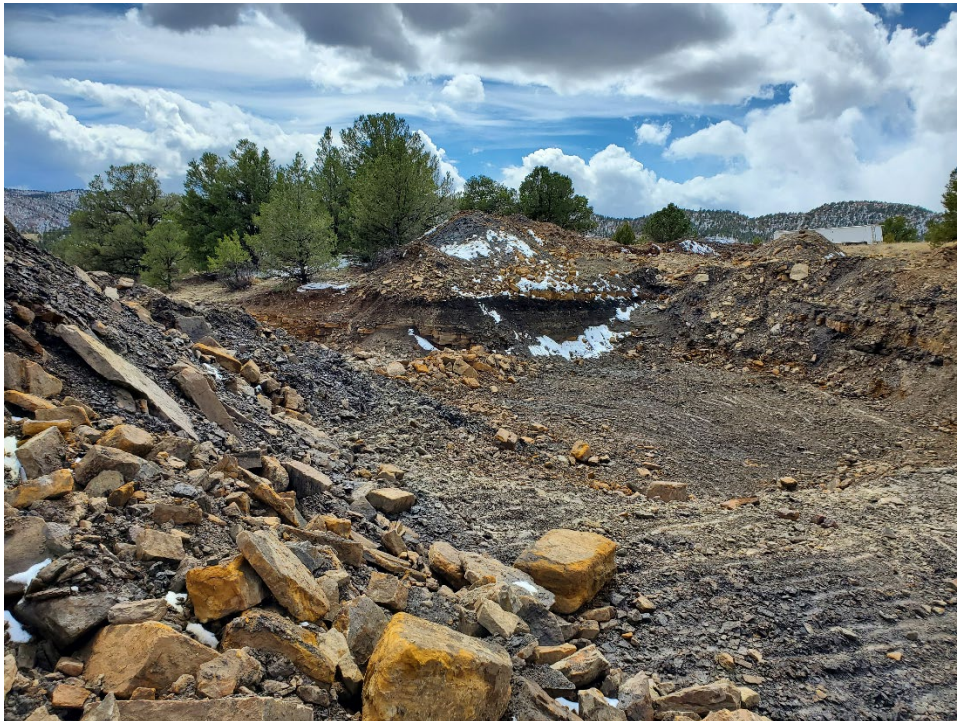
**Photo 20:** Looking west across the pit area in Area 3.

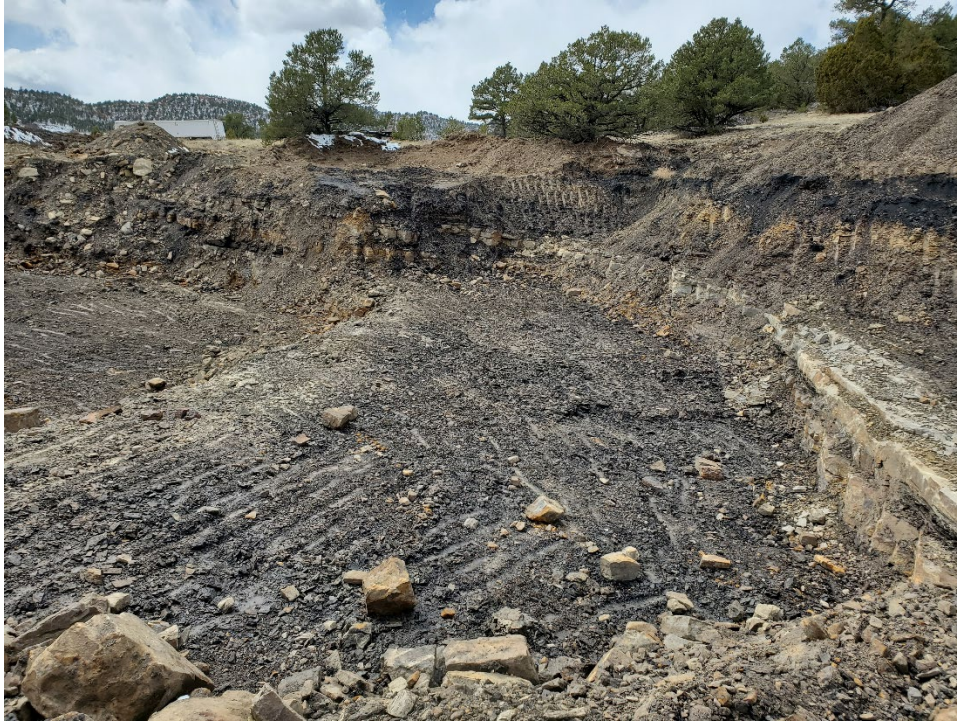
**Photo 21:** Looking south-west from the northern border of the highwall in Area 3.

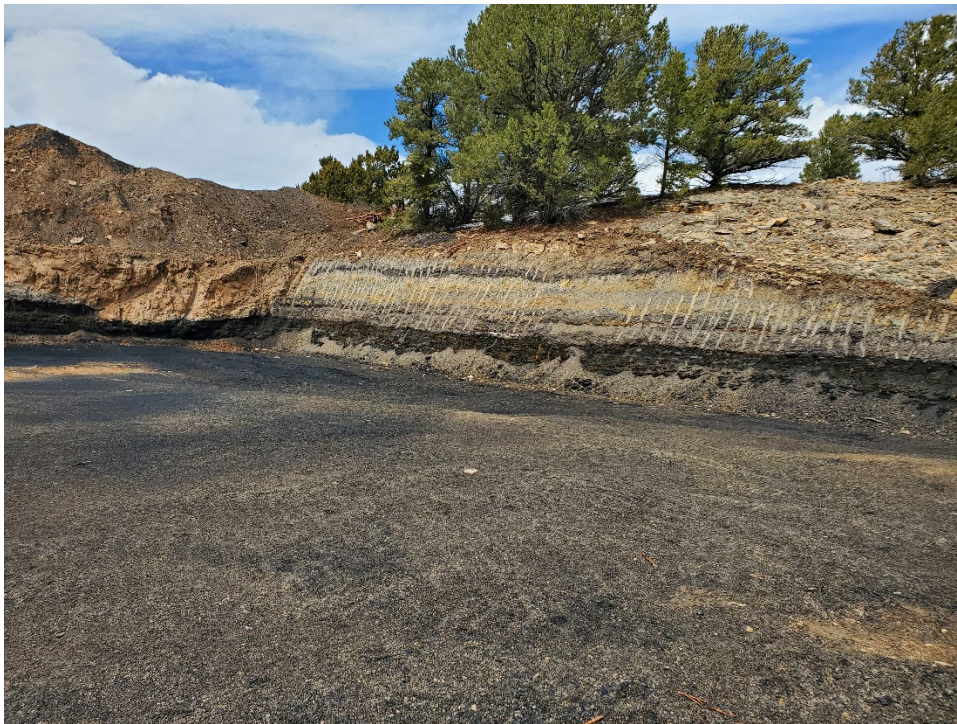
- *Area 4*
  - The Division observed an approximately 0.3 acre area excavated within Area 4 (Photos 22). The Operator stated that they are not mining within this area, nor do they have any intention to mine within Area 4. The disturbance observed is for the construction of a personal garage on the property. The approved post-mining land use for this operation is both pastureland and residential, therefore the instillation of a residential garage is in compliance with the approved post-mining land-use.

**Photo 22:** Looking north-east into the area cleared for the construction of a garage in Area 4.

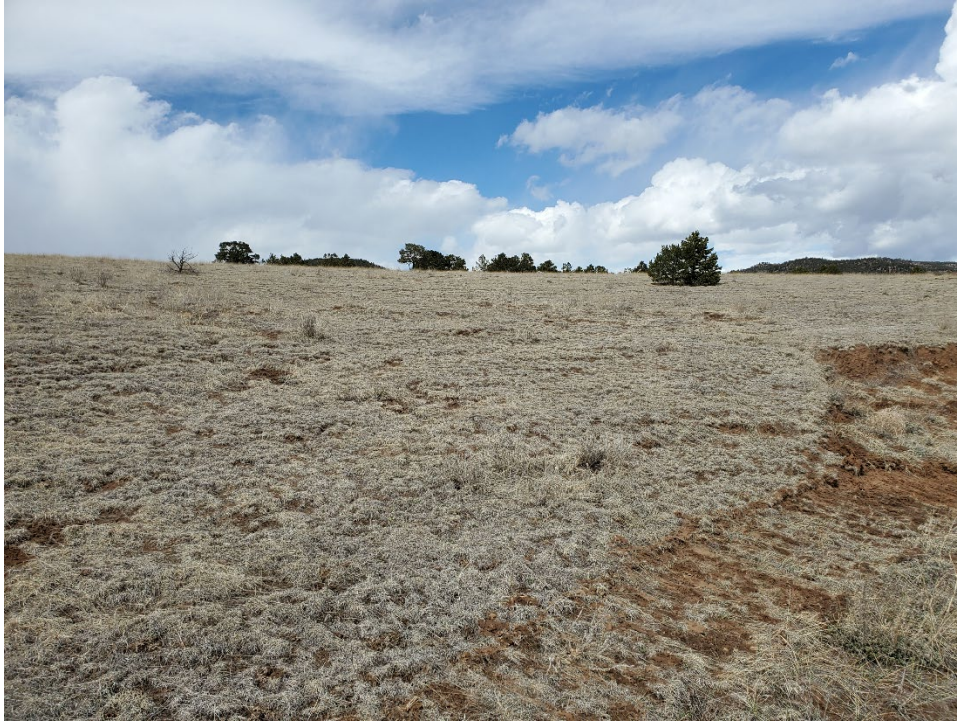
- The rest of Area 4 appears to be undisturbed (Photo 23).

**Photo 23:** Looking north from the northern border of the disturbance in Area 4 at the undisturbed land.

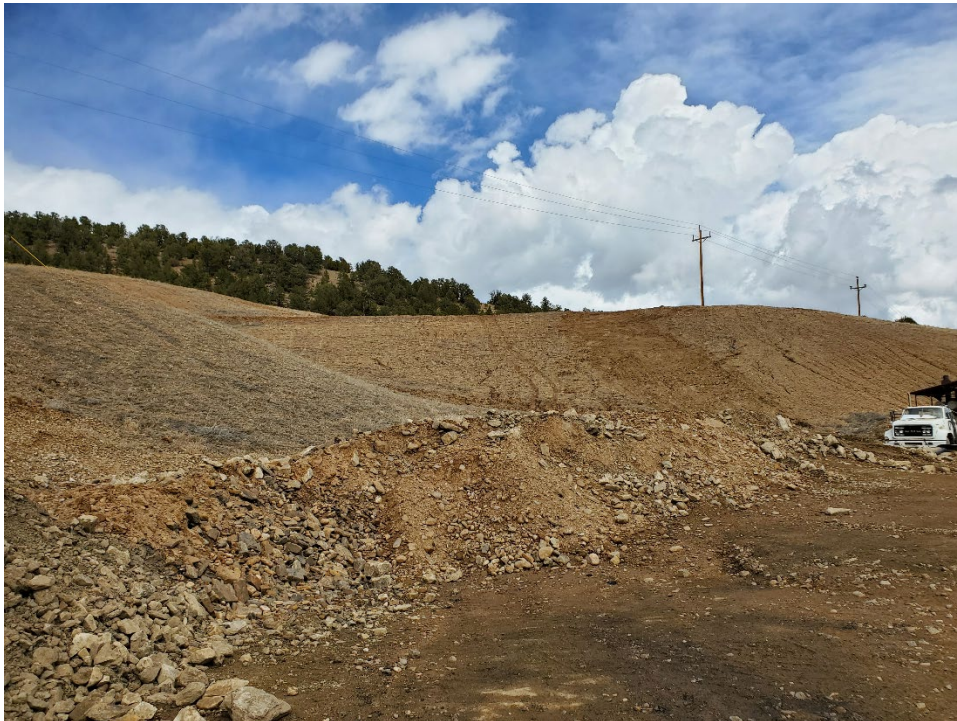
**PROBLEM:** Erosion gullies and ruts were observed on-site. This is a problem at this time for failure to protect the affected land from erosion pursuant to C.R.S. 34-32.5-116 (4) (j).

Some rills have formed on the re-vegetated slopes in Area 1 (see photos corresponding with the Reclamation Success section below in Area 1). **This has been cited as a problem above.** The Operator stated that they will

**Photo 24:** Looking north-east along some reclaimed slopes in Area 1. Some rilling is seen along the slopes that will need to be addressed.

**CORRECTIVE ACTIONS:** The Operator shall provide photo documentation to the Division verifying erosion gullies and ruts have been repaired, and that the site has have been reconstructed and stabilized to prevent erosion damage by the corrective action date.

stabilize these areas and may cut horizontal paths along them to help reduce the speed of the run-off over the slopes. The Operator shall submit photo evidence, indicating that the slopes have been stabilized, to the Division by the corrective action date.

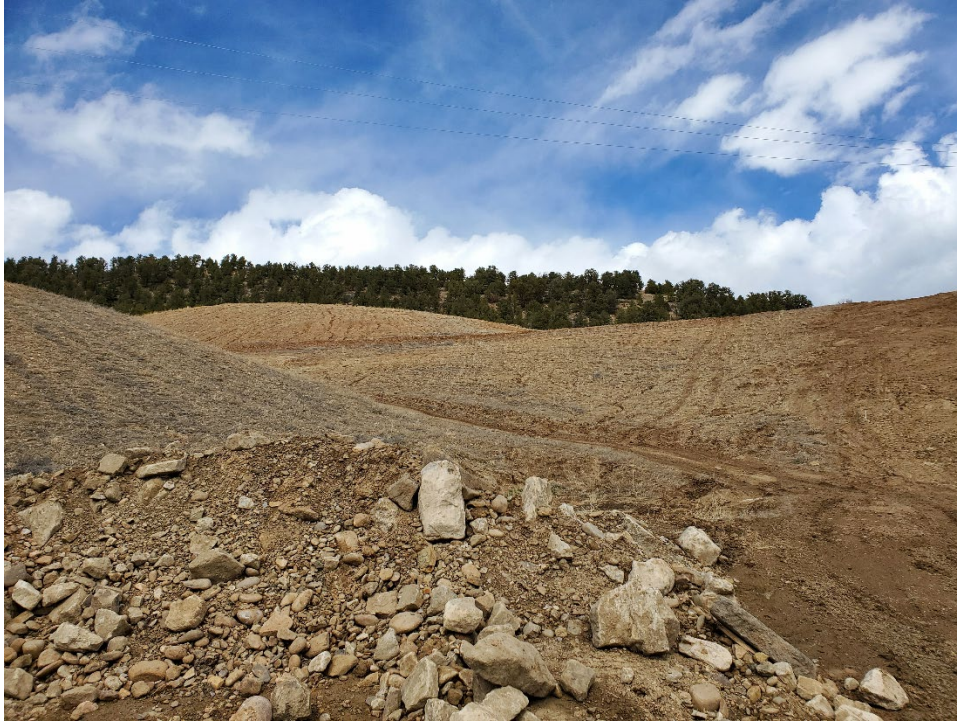
**Photo 25:** Looking north-west at some reclaimed slopes. Some rilling is seen on the slopes.

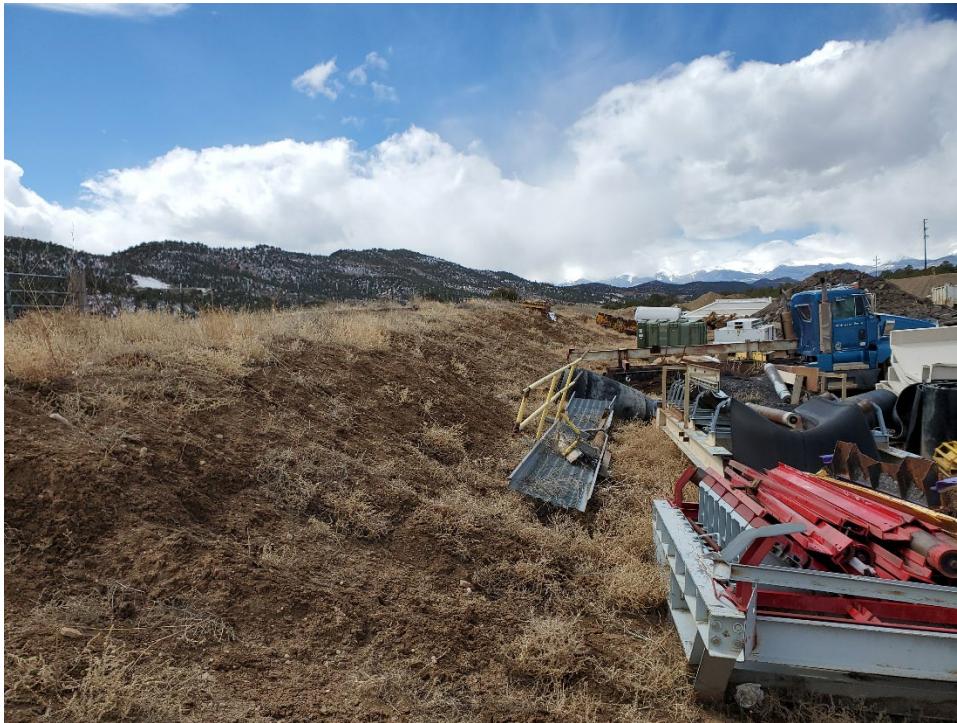
**Photo 26:** Looking west along the north-face of the reclaimed southern highwall.
