**MINERALS PROGRAM INSPECTION REPORT**  
**PHONE: (303) 866-3567**

| <b>MINE NAME:</b><br>Robinson Sons Gravel Pit No. 1 | <b>MINE/PROSPECTING ID#:</b><br>M-2008-076 | <b>MINERAL:</b><br>Sand and gravel and | <b>COUNTY:</b><br>Las Animas |
| <b>INSPECTION TYPE:</b><br>Monitoring | <b>WEATHER:</b><br>Clear | <b>INSP. DATE:</b><br>March 26, 2024 | <b>INSP. TIME:</b><br>12:47 |
| <b>OPERATOR:</b><br>Robinson Sons Inc. | <b>OPERATOR REPRESENTATIVE:</b><br>Daniel Robinson | <b>TYPE OF OPERATION:</b><br>112c - Construction Regular Operation | |

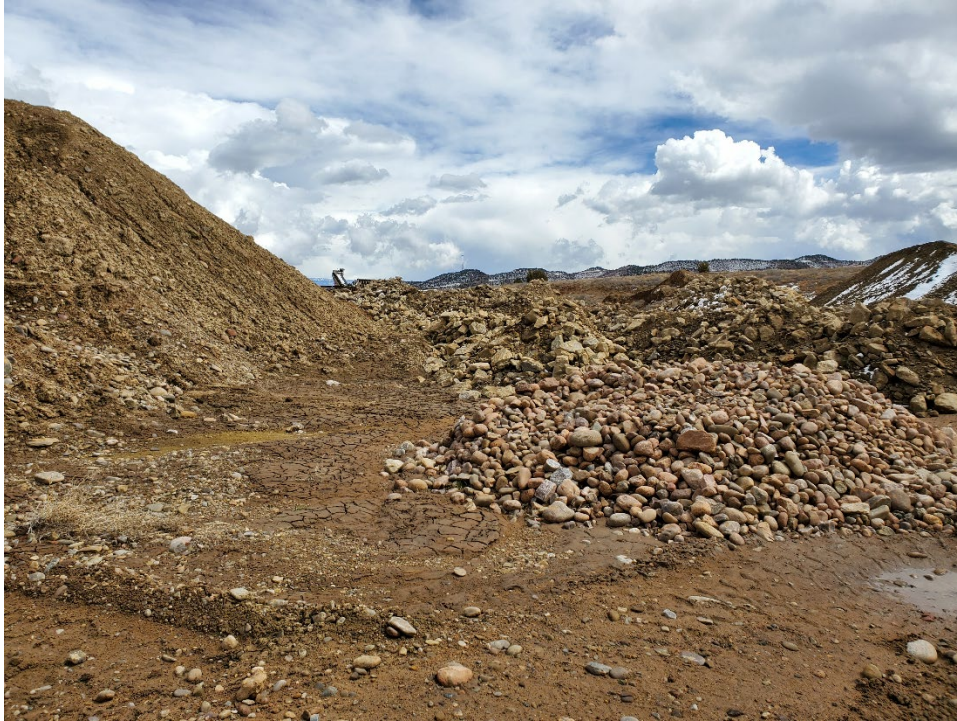
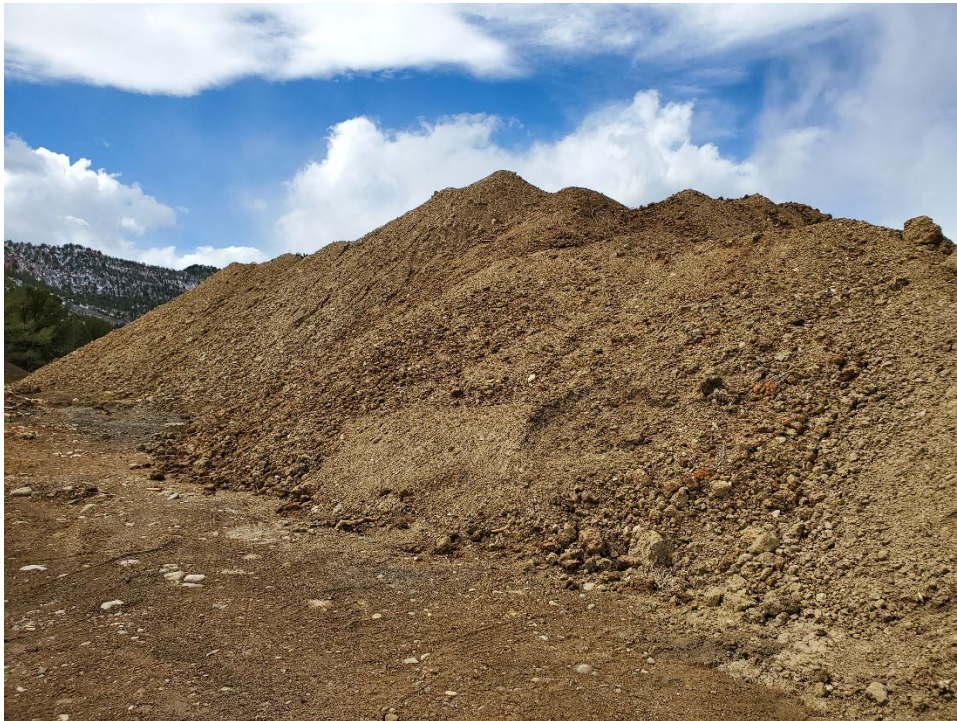
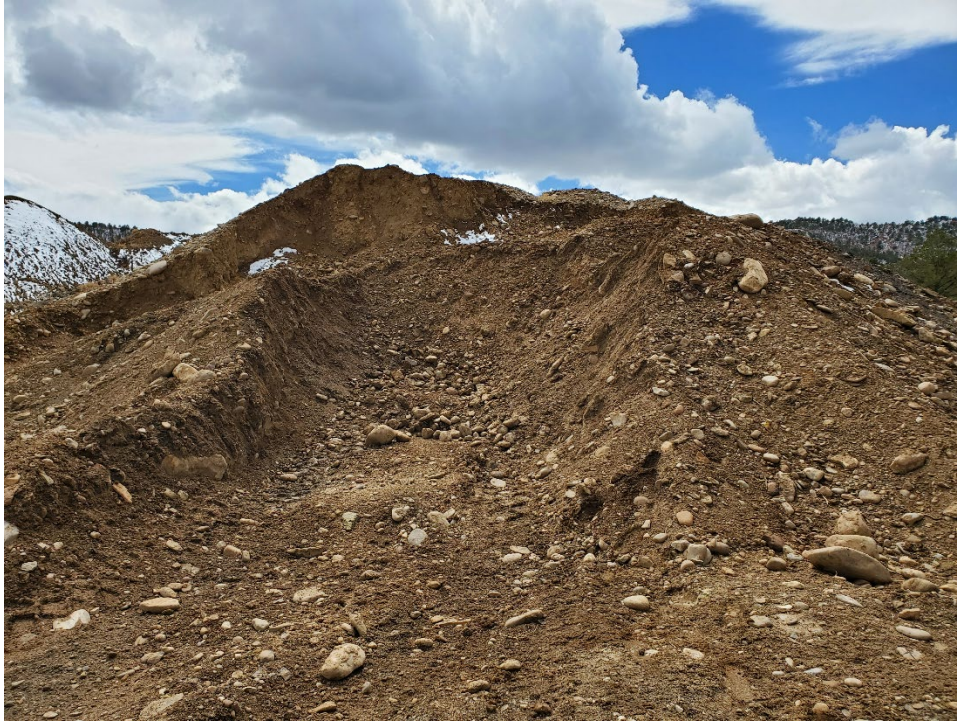
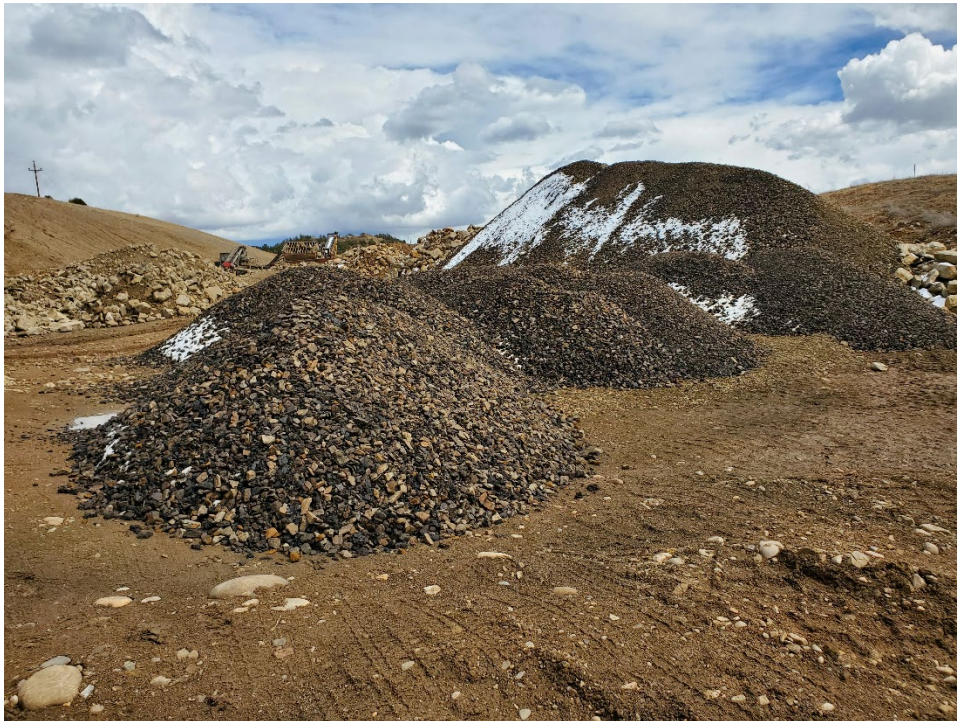
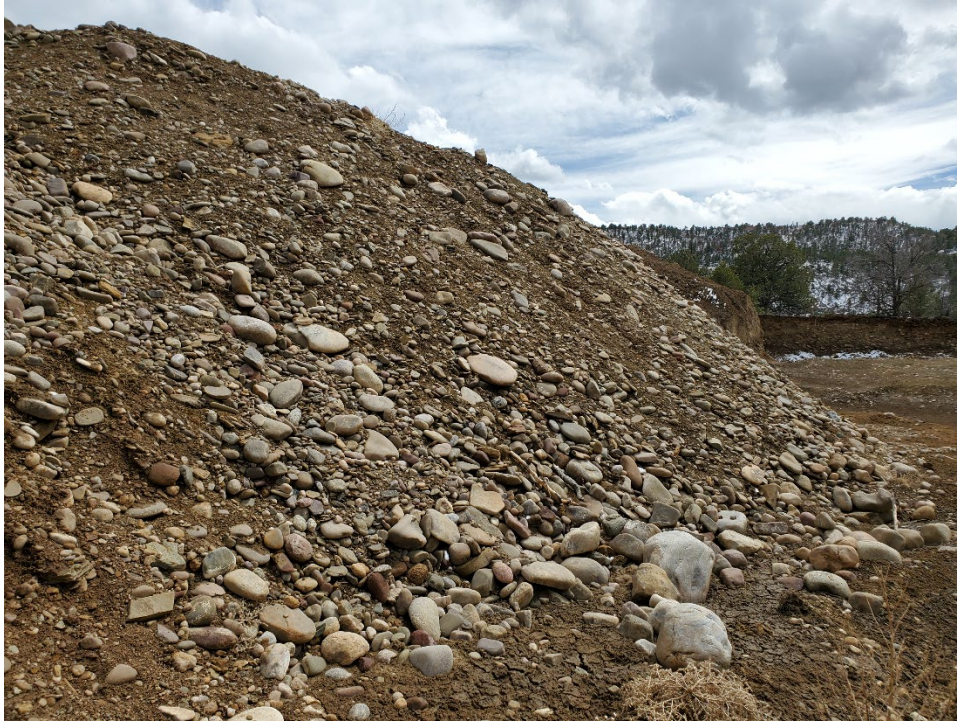
- There is plenty of overburden material to be used for backfilling areas throughout the site, stored in Area 1 (Photos 27-31), as well as above the highwalls in Areas 2 and 3.

**Photo 27:** Overburden piles to be used in reclamation in Area 1 (and a product stockpile in the foreground).

**Photo 28:** Overburden/backfill material along the south side of the northern pit in Area 1.

**Photo 29:** Overburden/backfill material located between the south and north pits in Area 1.

**Photo 30:** Overburden/product stockpiles in Area 1.

**Photo 31:** Overburden pile in Area 1 that may be screened for additional product, or used for backfill.

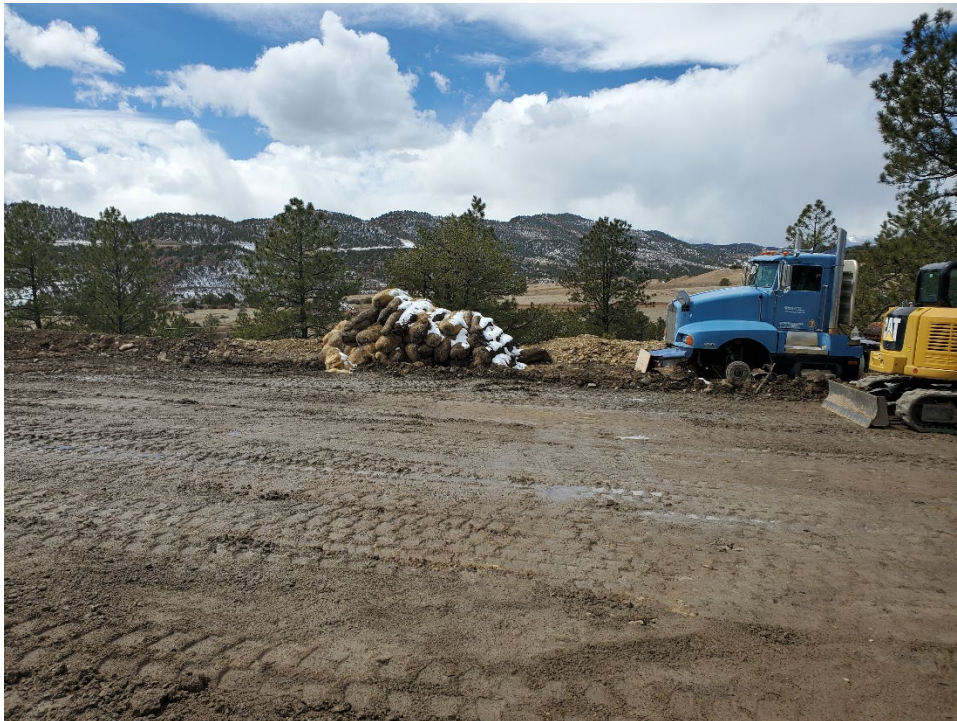
- *Area 2*
  - Some equipment is stored along the east side of the access road, as well as straw waddles in preparation for backfilling the remaining highwall, grading the disturbance, and seeding the area this summer (Photo 32).

**Photo 32:** Straw waddles stored along the east side of the entrance into Area 2.

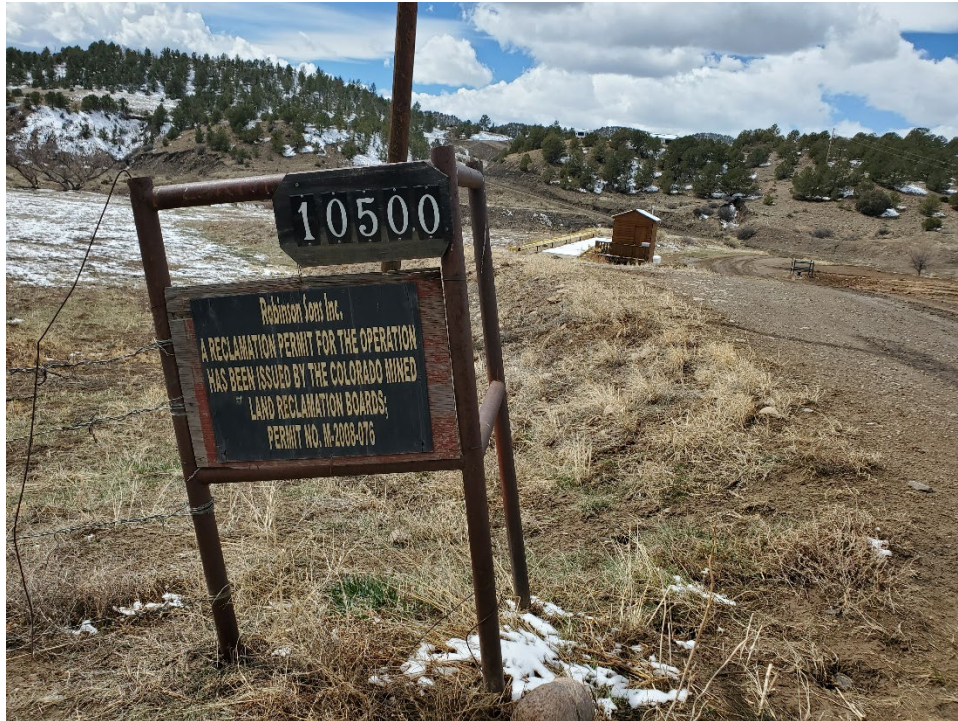
A permit sign, posted in compliance with Rule 3.1.12(1) was observed at the entrance to the site (Photo 33). Affected area markers were also observed during the inspection, and appear to be in compliance with Rule 3.1.12(2). Additionally, the gas line is clearly marked in the field, and the operator appears to be maintaining the 30 foot setbacks from the gas lines, and the 10 foot setbacks from the power poles.

**Photo 33:** Mine sign posted at the entrance to the site.

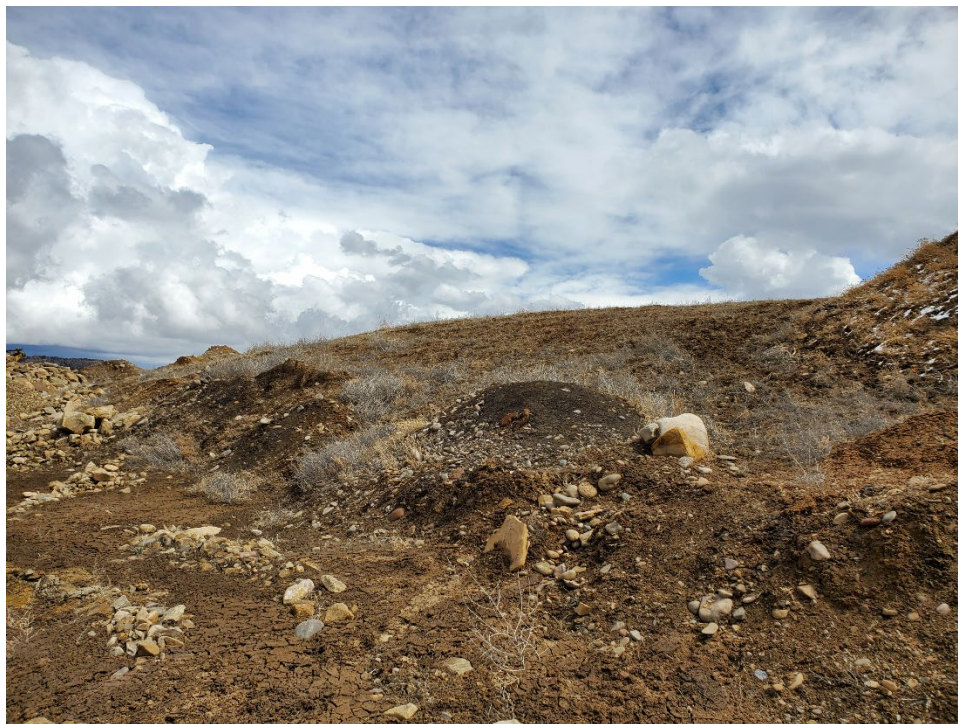
Multiple piles of topsoil were observed onsite. Some topsoil has been recently salvaged with excavation (Photo 34), some had been stabilized but recently used for reclamation (Photo 35), and some was observed in Area 2 in preparation of upcoming reclamation in that area. Additionally, one of the reclaimed slopes to the north of the northern pit in Area 1 also has plenty of topsoil material available if needed (see slope in the background of Photo 9). The topsoil piles appear to be stable at this time.

**Photo 34:** Vegetated topsoil pile in Area 1.

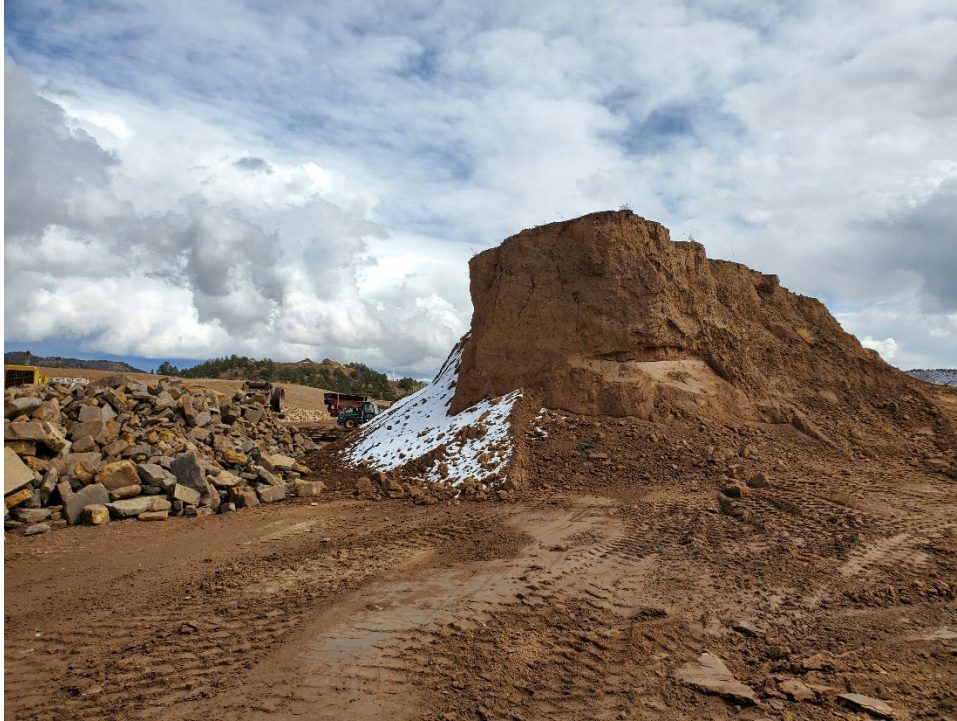
**Photo 35:** Topsoil pile that has been used recently for some reclamation. The other side is stabilized with vegetation.
