Inspection Report, Lorencito Canyon Mine, C-1996-084

Attached for your records is a copy of the Division's Inspection Report for the April 10, 2024 partial inspection of the Lorencito Canyon Mine, C-1996-084.

PERMIT INFORMATION

Permit Number: C-1996-084 Mine Name: Lorencito Canyon Mine Operator: New Elk Coal Company, LLC Operator Address: Mr. John Terry 12250 Highway 12 Weston, CO 81091	County: Las Animas Operation Type: Surface Permit Status: Permanent Cessation Ownership: Private
	Operator Representative Present: John Terry
Operator Representative Signature: (Field Issuance Only)

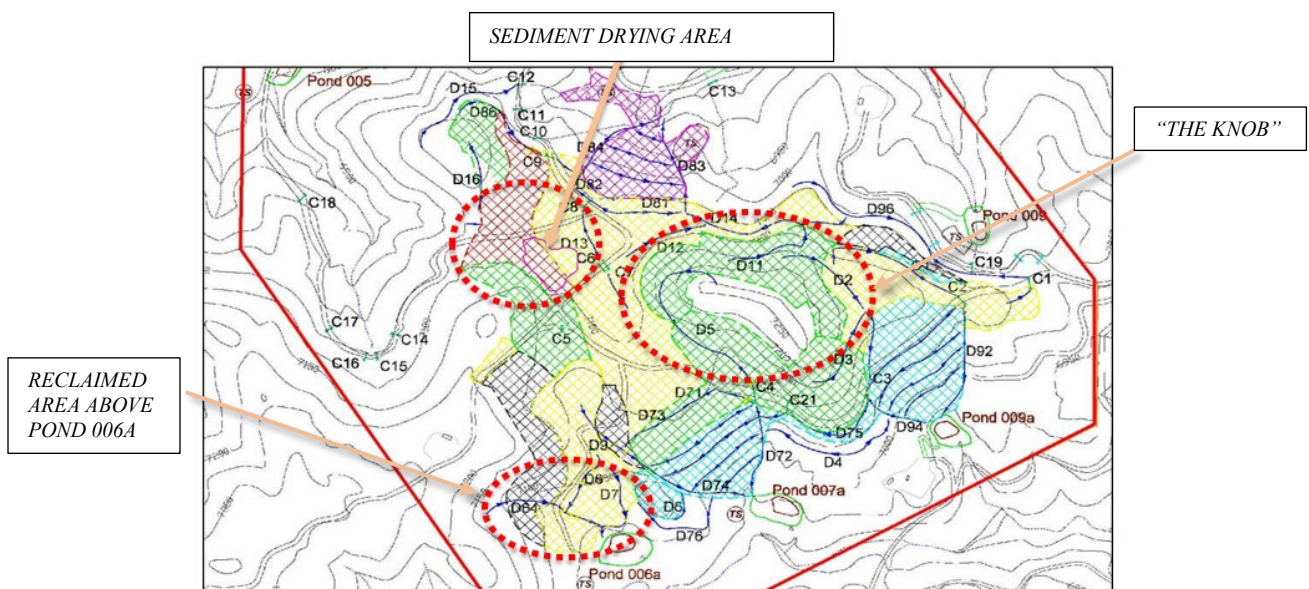
4. The following items pertain to ongoing erosional issues in the areas shown in Figure 1, that pursuant to Rule 4.14.6 need to be addressed. A Technical Revision will be required to expand on the current Rill and Gully plan in the PAP. **The Operator shall submit the technical revision, obtain approval, repair the erosion, and stabilize the slopes pursuant to the approved plan by December 31, 2024.**

FIGURE 1. AREAS WHERE RILLS, GULLIES AND SPARSE VEGETATION HAS BEEN FOUND TO BE A PERSISTENT PROBLEM AT THE SITE ARE WITHIN THE DOTTED CIRCLE AREAS. BACKGROUND IMAGE IS THE 2020 ANNUAL REPORT MAP.

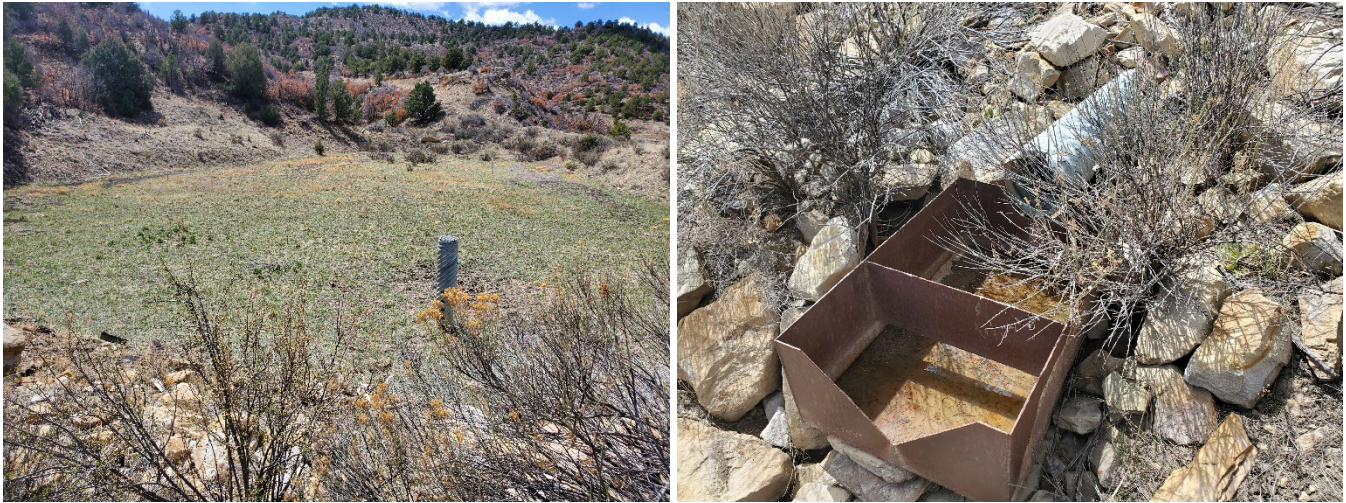
- Pond 005:
 - The pond was dry and was not discharging (Photo 1-left).
 - The pond embankment was stable and vegetated.
 - The primary and emergency spillways appeared clear and functional.

- The flume had some water (Photo 1-right), but was not discharging.

Photo 1: (Left) Pond 005, (Right) Pond 005's flume.

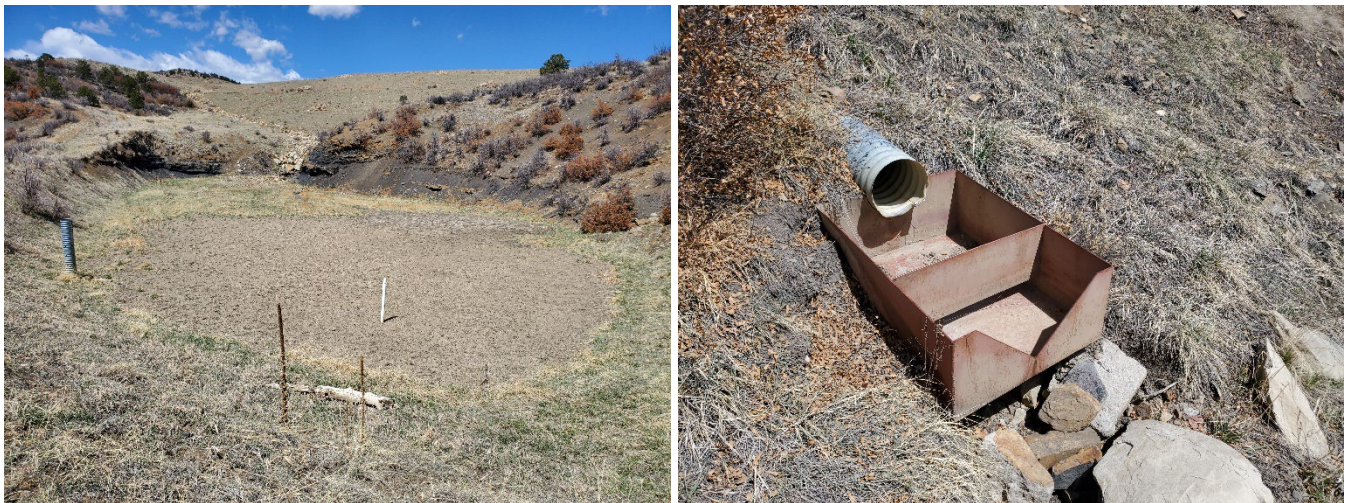
- Pond 007a:
 - The pond was dry and was not discharging (Photo 2 - left).
 - The pond embankment was stable and vegetated.
 - The primary and emergency spillways appeared clear and functional.
 - The flume was dry (Photo 2 - right), and was not discharging.

Photo 2: (Left) Pond 007a, (Right) Pond 007a's flume.

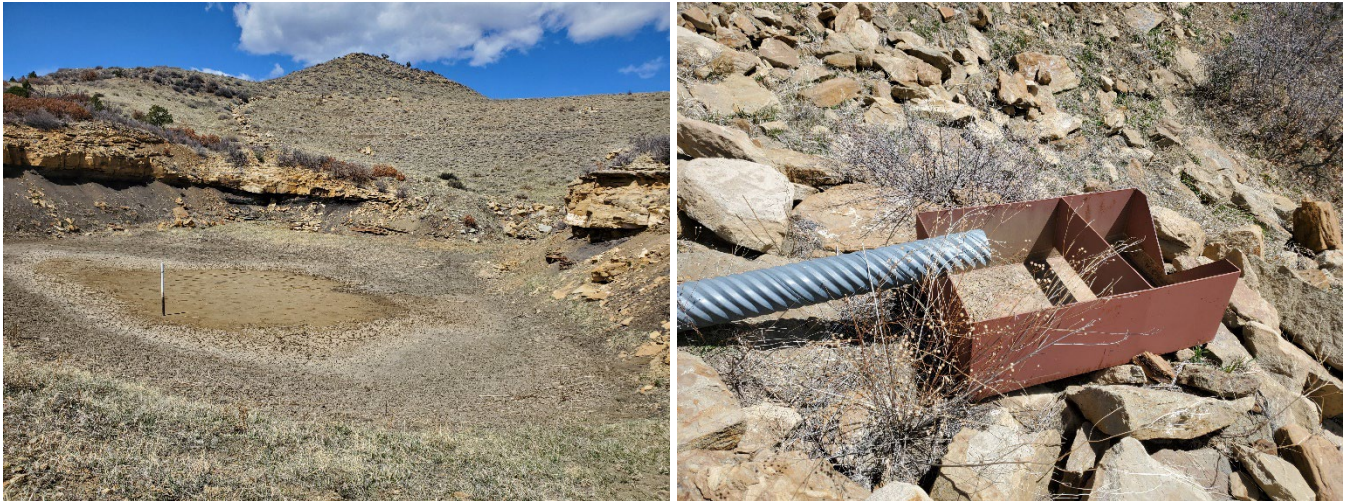
- Pond 009a:
 - The pond had a small amount of standing water, but was not discharging (Photo 3 - left).
 - The pond embankment was stable and vegetated.
 - The primary and emergency spillways appeared clear and functional.

- The flume was dry (Photo 3 - right), and was not discharging.

Photo 3: (Left) Pond 009a, (Right) Pond 009a's flume.

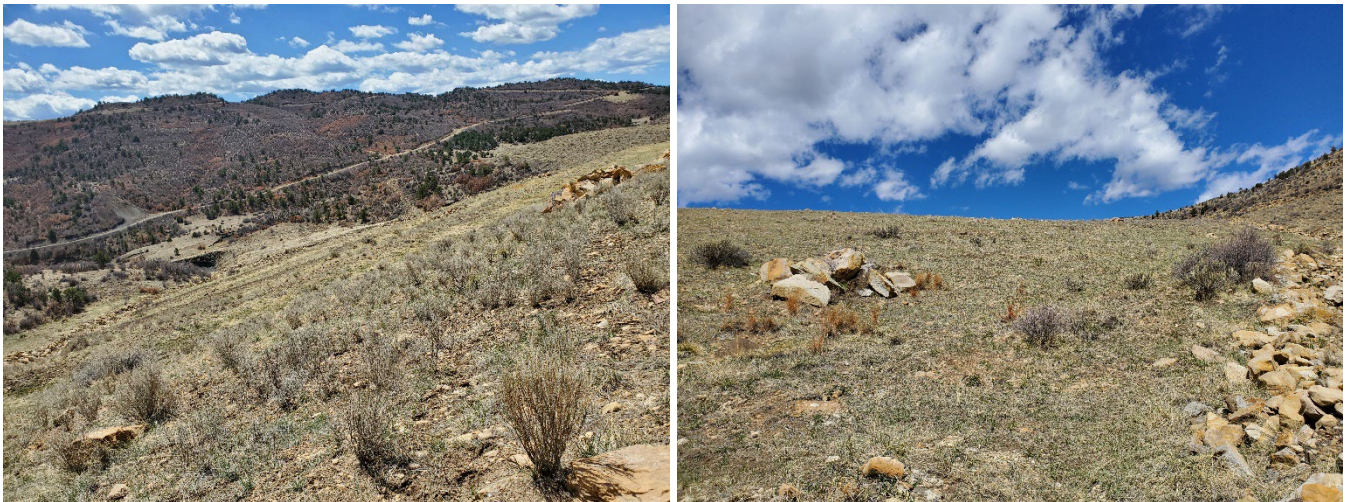
- To reach Pond 007, the Division walked down Fill 007 and met the Operator on the other side of the Pond. Fill 007 was well vegetated and appeared stable (Photo 4). The channel on the east side was clear of obstructions (Photo 5).

Photo 4: (Left) Looking south-west down Fill 007. (Right) Looking north-east up Fill 007.

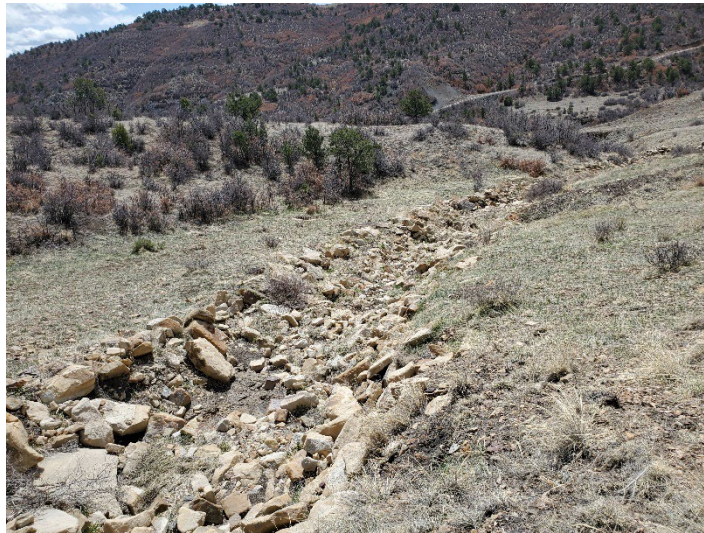
Photo 5: Looking south-east down the eastern channel on Fill 007.

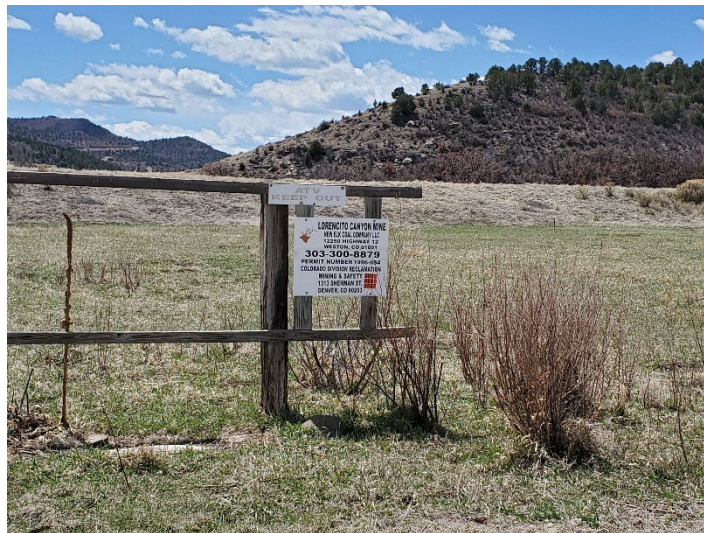
- Mine signs were posted at road entrances (Photo 6) and at the entrance to the permit boundary in compliance with Rule 4.02.

Photo 6: Mine sign posted near the entrance road.
