Inspection Report, Colowyo, C-1981-019

Permit Number: C-1981-019 Mine Name: Colowyo Coal Mine Operator: Colowyo Coal Company L.P. Operator Address: Mr Tony Tennyson 5731 State Highway 13 Meeker, CO 81641	County: Moffat, Rio Blanco Operation Type: Surface Permit Status: Active Ownership: Private
	Operator Representative Present: Tony Tennyson and Tom Fry
Operator Representative Signature: (Field Issuance Only)

Inspection Start Date: April 9, 2024 Inspection Start Time: 07:30 Inspection End Date: April 9, 2024 Inspection End Time: 14:30		Inspection Type: Coal Partial Inspection Inspection Reason: Normal I&E Program Weather: Clear	
Joint Inspection Agency: None		Joint Inspection Contacts: 	
Post Inspection Agency: None		Post Inspection Contacts: 	
Inspector(s): Hunter Ridley Zach Trujillo	Inspector's Signature: <i>Hunter Ridley</i>		Signature Date: April 18, 2024

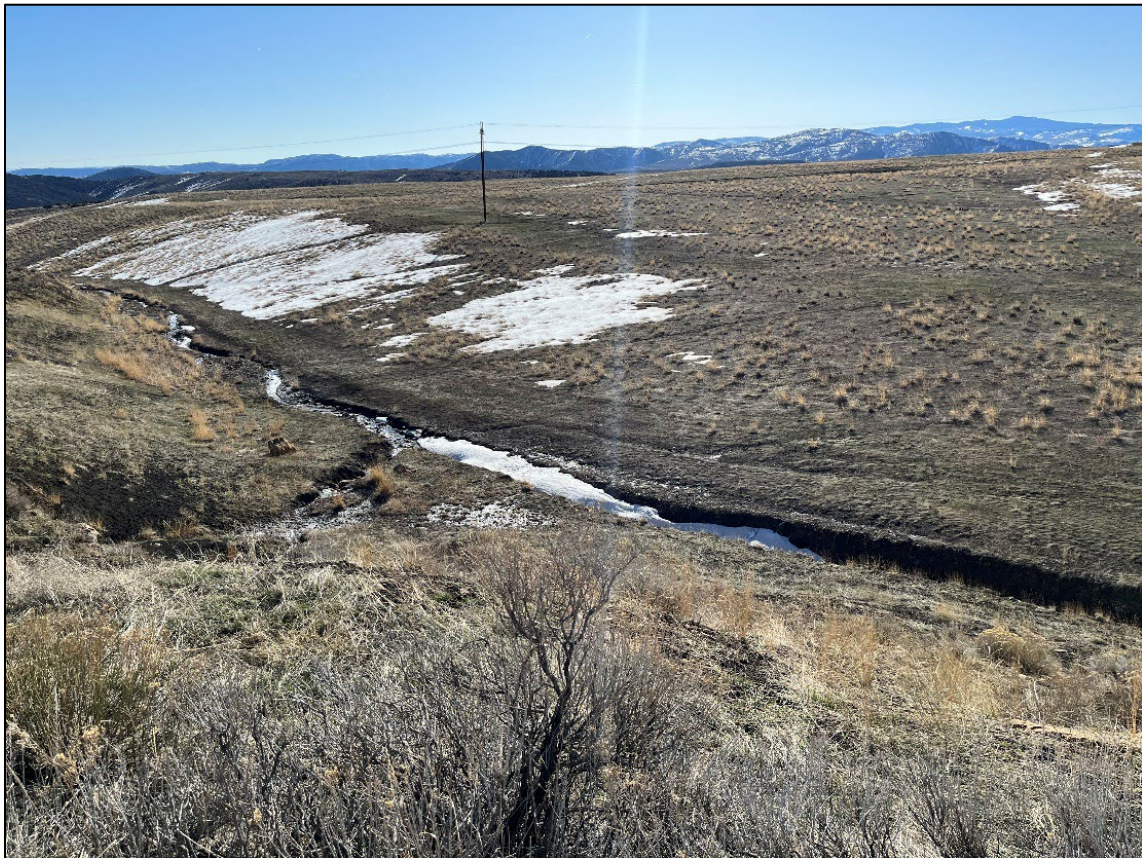
The following ditches in the East Pit were observed during the inspection: Streeter Ditch (Photo 1), Section 15 Ditch (Photo 8), and the Final East Pit Ditch (Photo 9). All ditches were only partially observed from vantage points and will be inspected on foot later in the year when conditions allow. Mid-sized erosional cuts were noted on the southern end of the Streeter Ditch. This issue may be resolved with the construction of the Upper Section 3 Pond and Lower Section 3 Pond set to be built this summer, however repairs may still be necessary. This has been added as a maintenance item. The crest of EP2 was visible from the Final East Pit Ditch observation vantage point. Other surge ponds along this ditch will need to be walked during the spring/summer inspections. Section 15 and Section 16 ponds were inaccessible during this inspection.

Photo 1: View east of Streeter Gulch Ditch.

- Monitor the slump area at Section 26 Pond
- Regrade and seed the topsoil pile in the northern section of Collom Pit when conditions allow
- Monitor Streeter Ditch cuts, repair if necessary
- Monitor the small erosional feature in D4, repairs will be necessary if conditions worsen

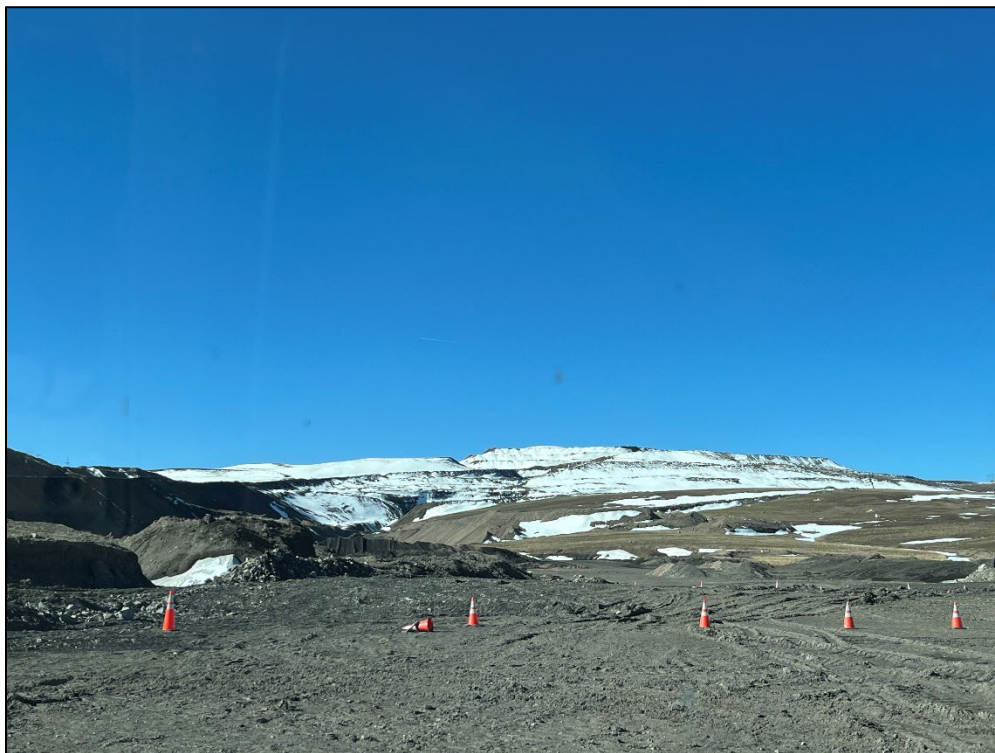
The West Pit was observed to be almost entirely backfilled, with a majority of the pit in final reclamation. There is a small portion of highwall remaining to the south (Photo 2) which will be reclaimed using the nearby internal haul road in final reclamation. An old drag line will need to be removed from the West Pit in final reclamation.

Photo 2: View south into the partially reclaimed west pit.

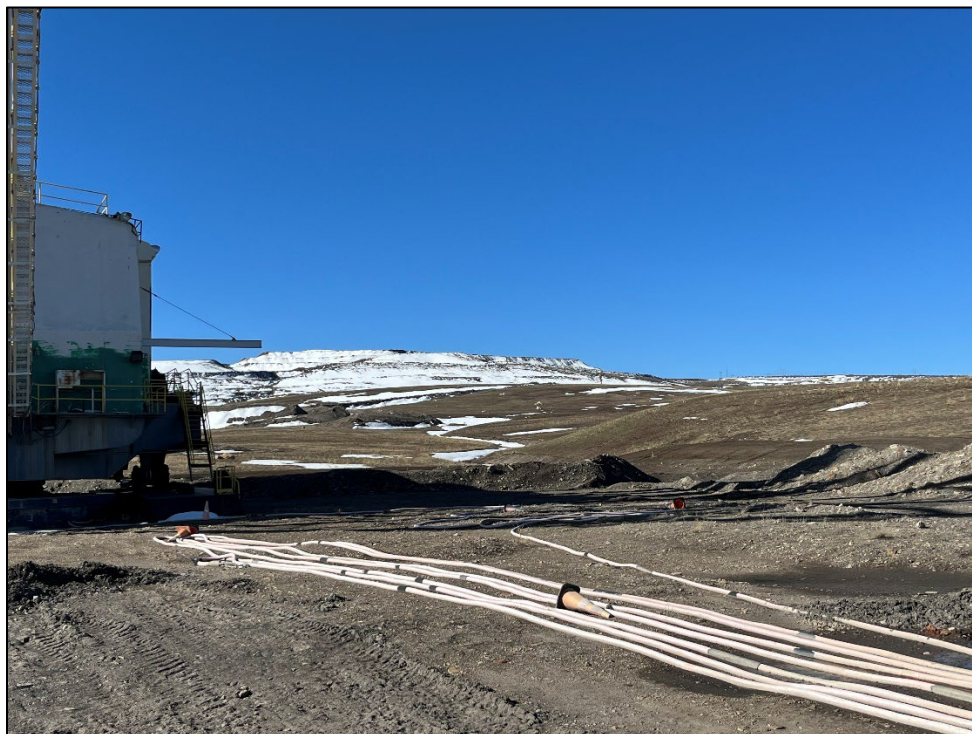
The following ditches in the West Pit area were inspected this month: Buckskin Ditch (Photo 3), East Taylor Ditch (Photo 4 and 7) and Taylor Ditch (Photos 4 and 10). The Taylor Ditch was inspected from above atop a berm along an internal haul road. A surge pond (ETD1) along the East Taylor Ditch was observed to be holding water (Photo 7). No water quality samples are collected at surge ponds across the site. The East Taylor Ditch currently discharges to Taylor Creek. No signs of erosion or cutting were visible along any of the observed West Pit ditches.

Photo 3: Buckskin ditch, to which Streeter Ditch will eventually connect in final reclamation.

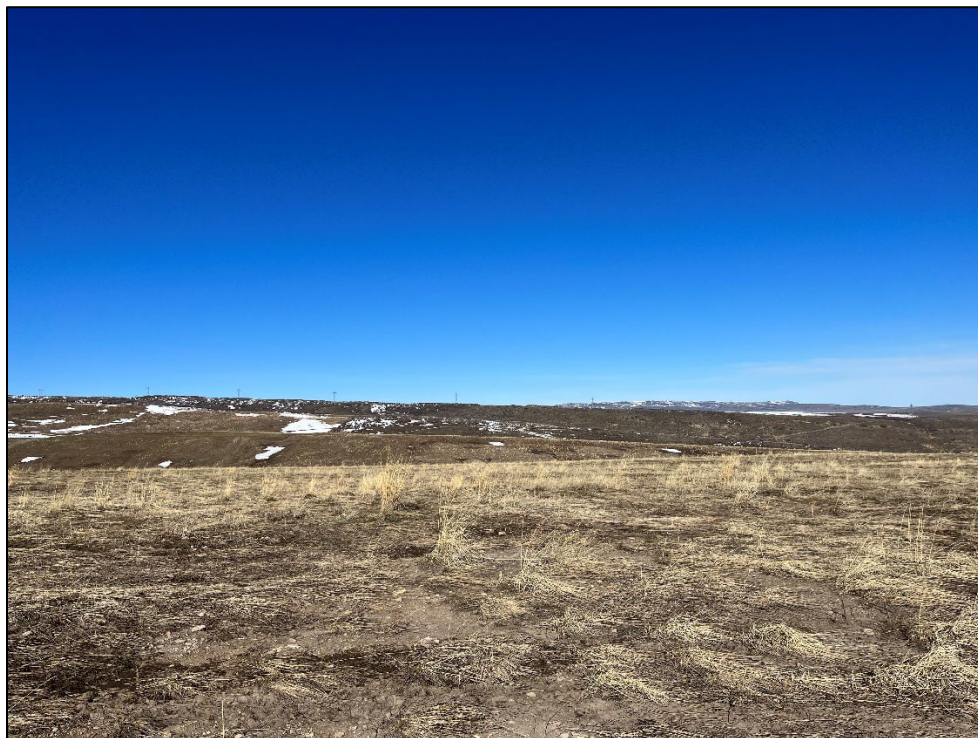
Reclamation parcels along the South Taylor Pit were unable to be inspected due to muddy conditions. Reclamation in the West Pit is nearly complete; a majority of this area has been graded, topsoiled, seeded, and is supporting stable vegetation (Photos 4 – 7). There were no signs of erosion across this area.

Photo 4: View west of the valley where the East Taylor Ditch sits, the Taylor Ditch is located behind the second ridge.

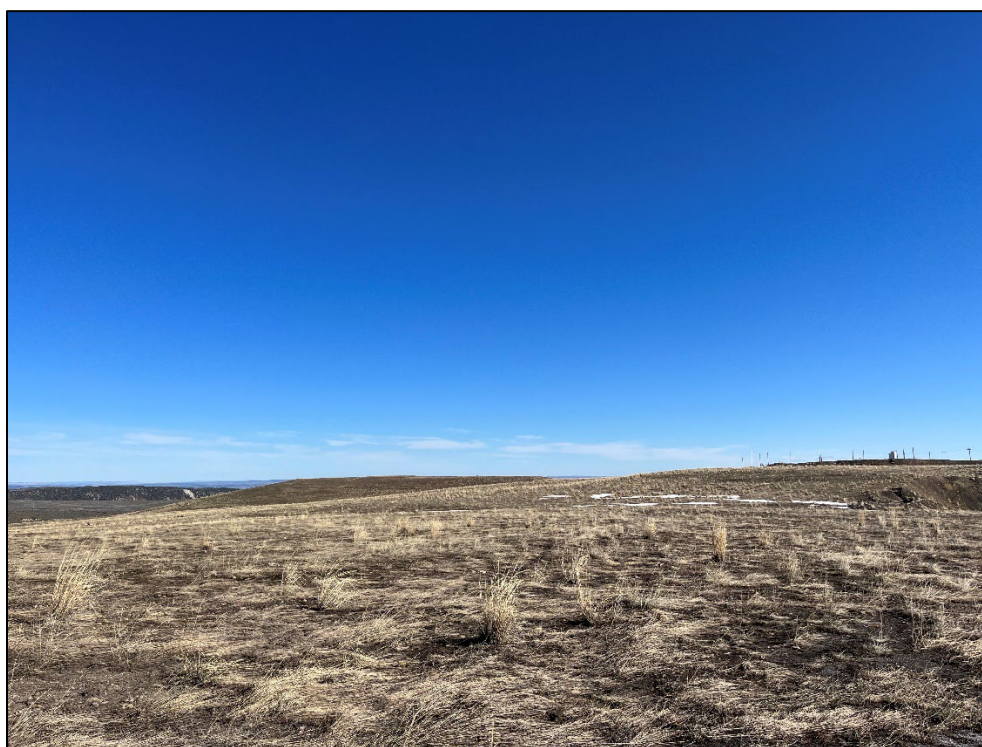
Photo 5: View north of Hinkes Peak, West Pit Pond is located behind this peak and is usually always dry.

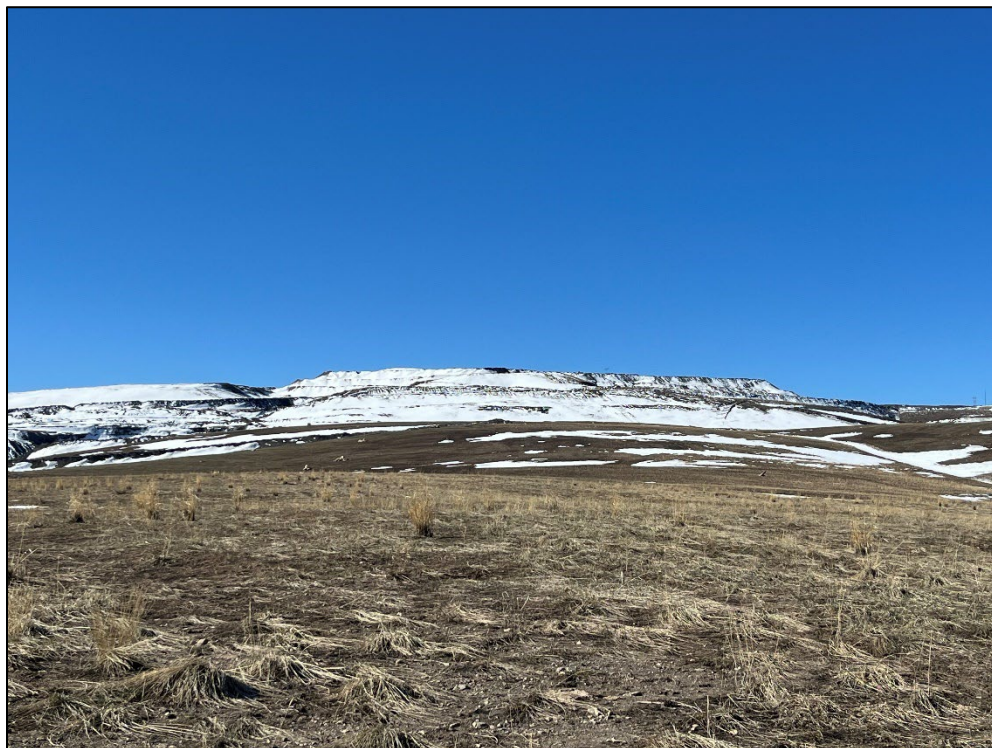
Active backfill operations were noted in the South Taylor Pit during the inspection. Spoil is excavated from a temporary spoil located just north of the pit (Photo 6). At the time of inspection, material was

Photo 6: view south of the crest of the west pit, the second ridge in the background is the temporary spoil pile which is being used to fill the South Taylor Pit.

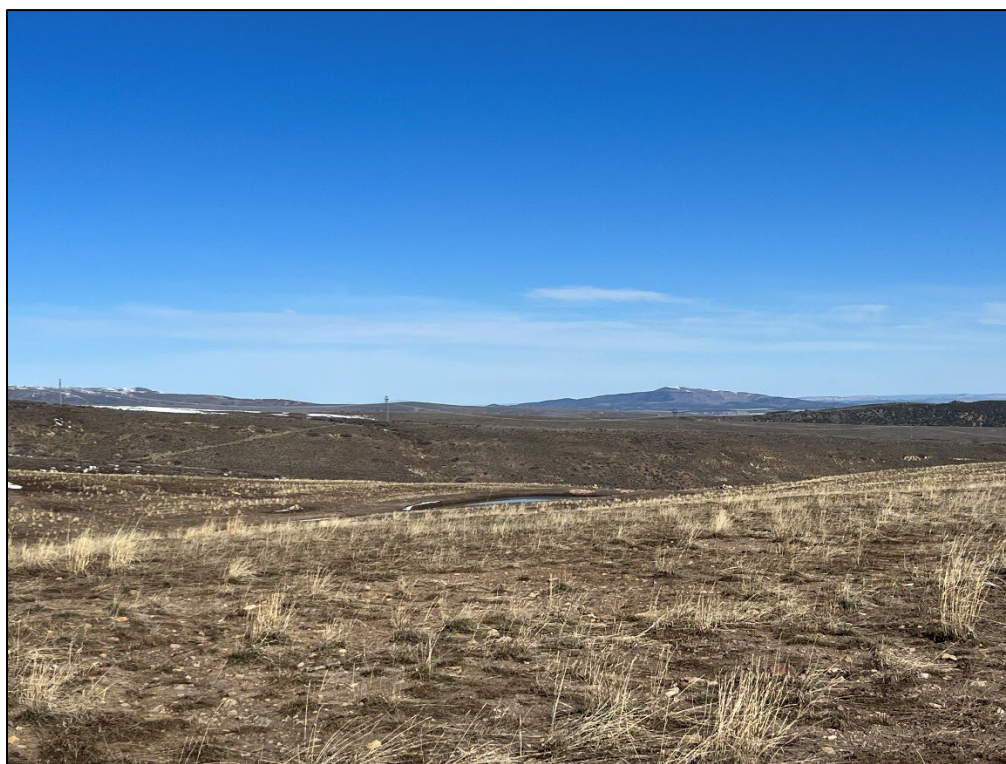
Photo 7: view west of a surge pond (ETD1) along the East Taylor ditch.

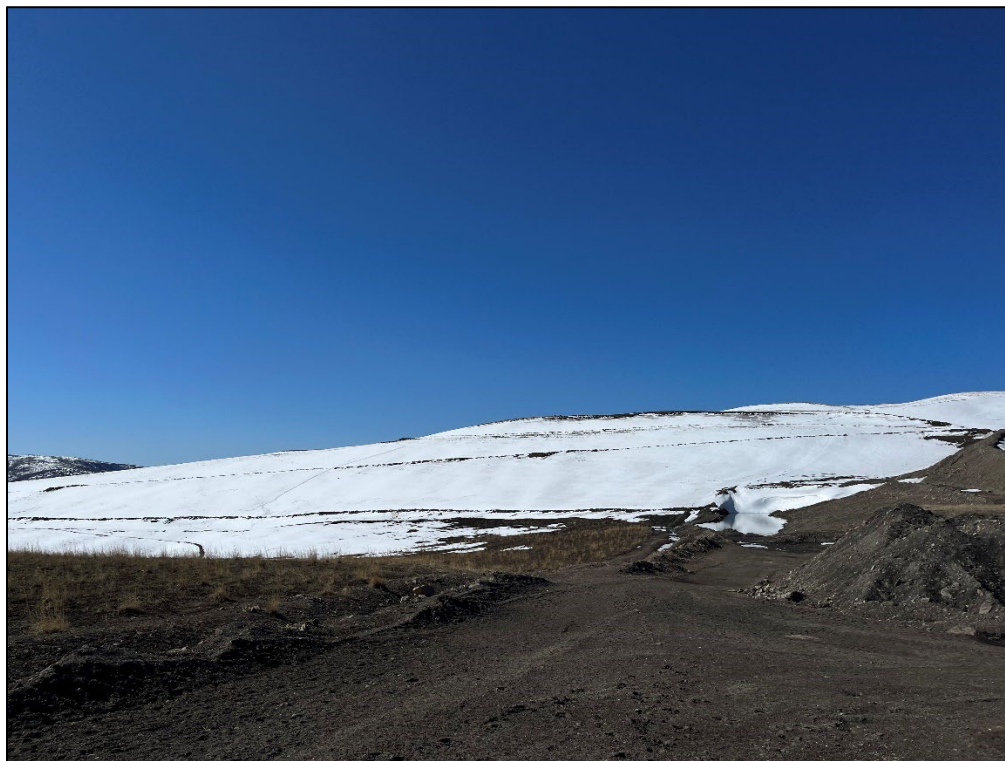
Photo 8: View southeast of Section 15 Ditch, linear feature below is an access road to Section 15 Pond.

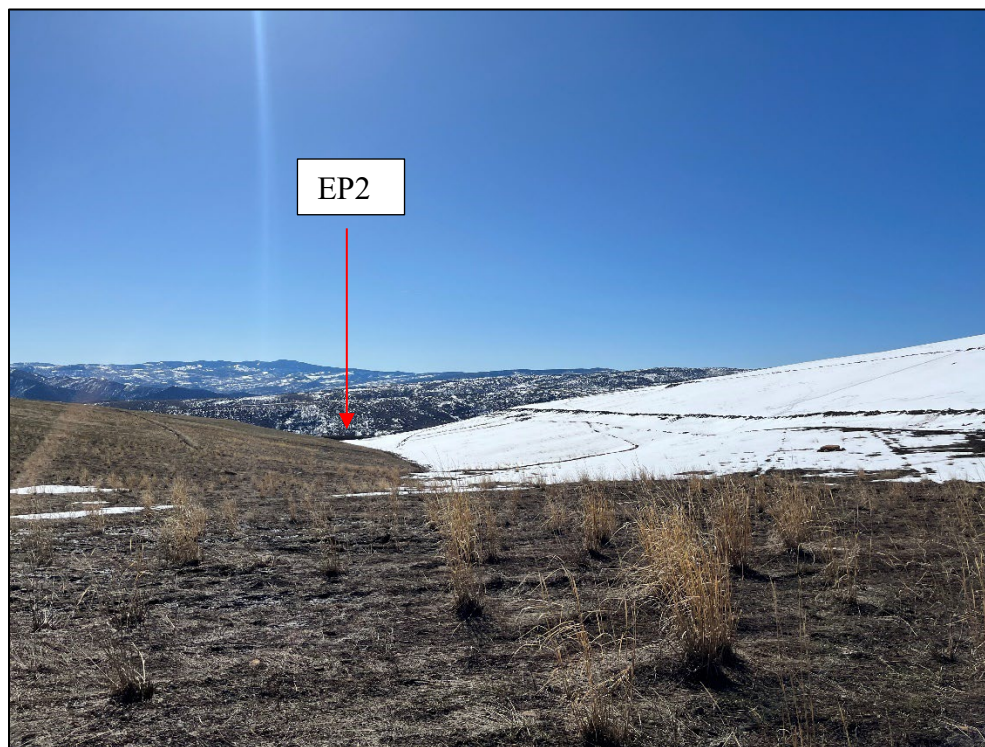
Photo 9: View south / southeast of the Final East Pit Ditch, EP1 and EP3 are located downgradient. The crest of EP2 is just slightly visible in the background.

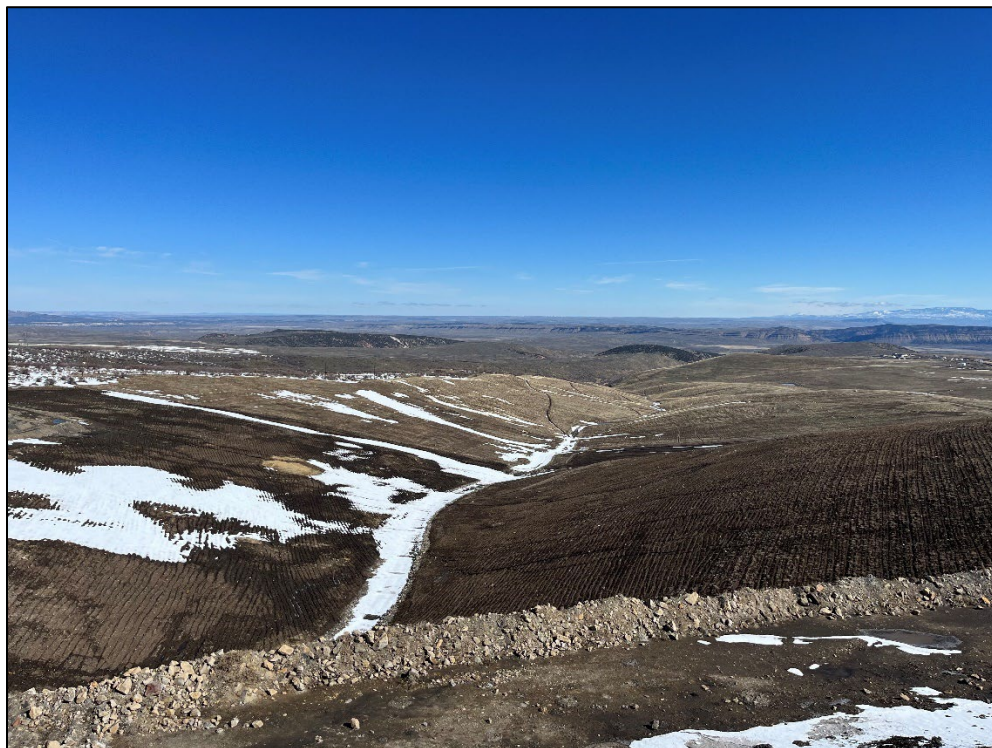
Photo 10: View north of the Taylor Ditch and West Pit, eventually drains to East Taylor Pond.

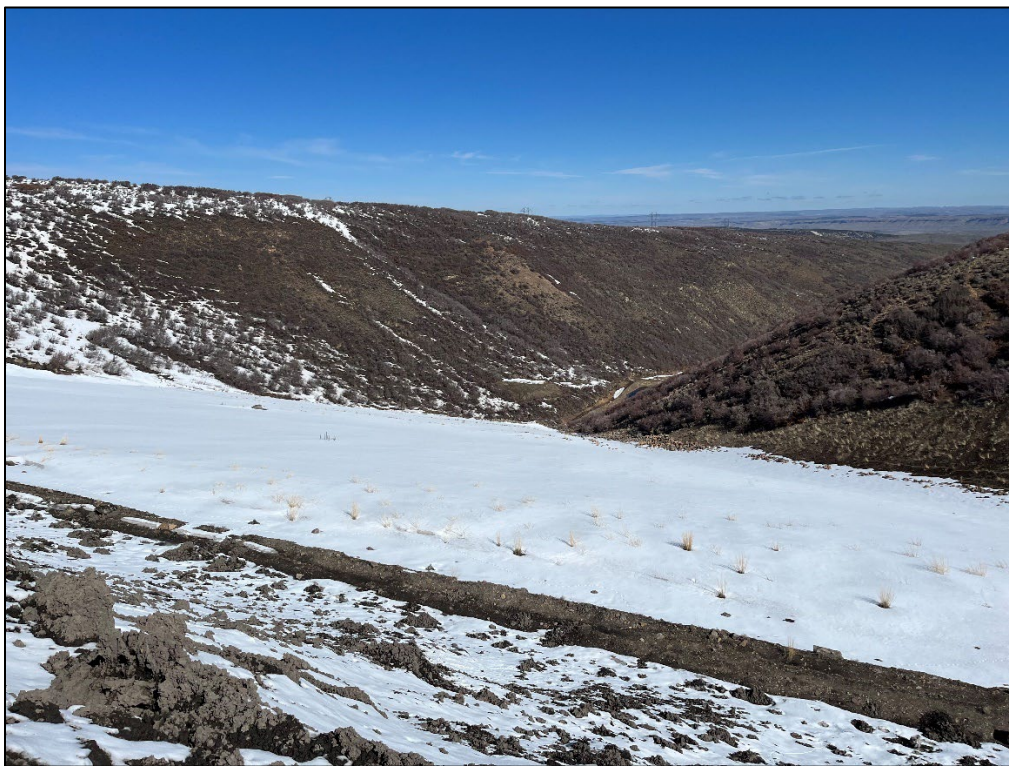
The West Taylor Pond (Photo 11) was inspected in the South Taylor Area. The West Taylor Pond was inspected from above from atop the Taylor valley fill area. The pond was holding water at the time of inspection and appeared stable. Section 28 Pond, just south of the South Taylor Pit, was inaccessible to due muddy road conditions but is usually accessed via a light use road off Hwy 13.

The Taylor Valley Fill area was inspected (Photo 11). The slope face was snow covered at the time of inspection; however, no major signs of erosion or concerns were observed. Water which flows through the fill's undrain eventually flows to the West Taylor Pond.

Photo 11: View north of the valley fill area in the South Taylor Pit, an underdrain pond is located below which eventually flows to the West Taylor Pond.

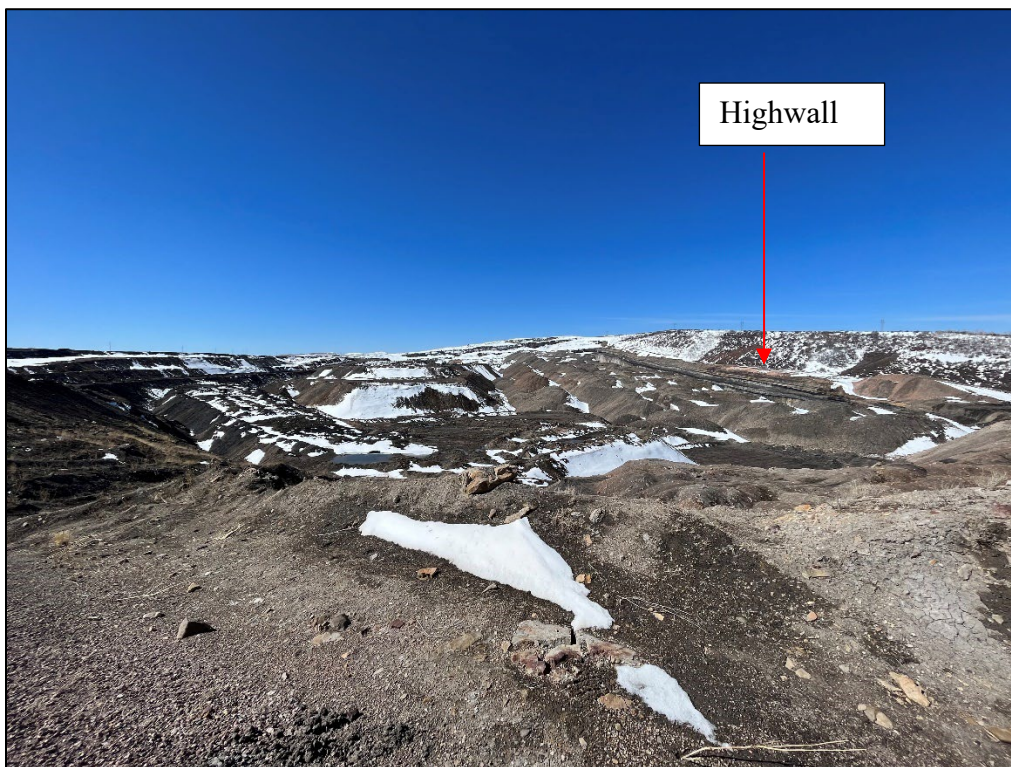
being dumped in the south and western areas of the pit. Material is graded and reworked as needed. An ~400 ft highwall remains to the west for possible future use (Photo 12). An old crusher is present in this area.

Photo 12: View southwest of the South Taylor Pit

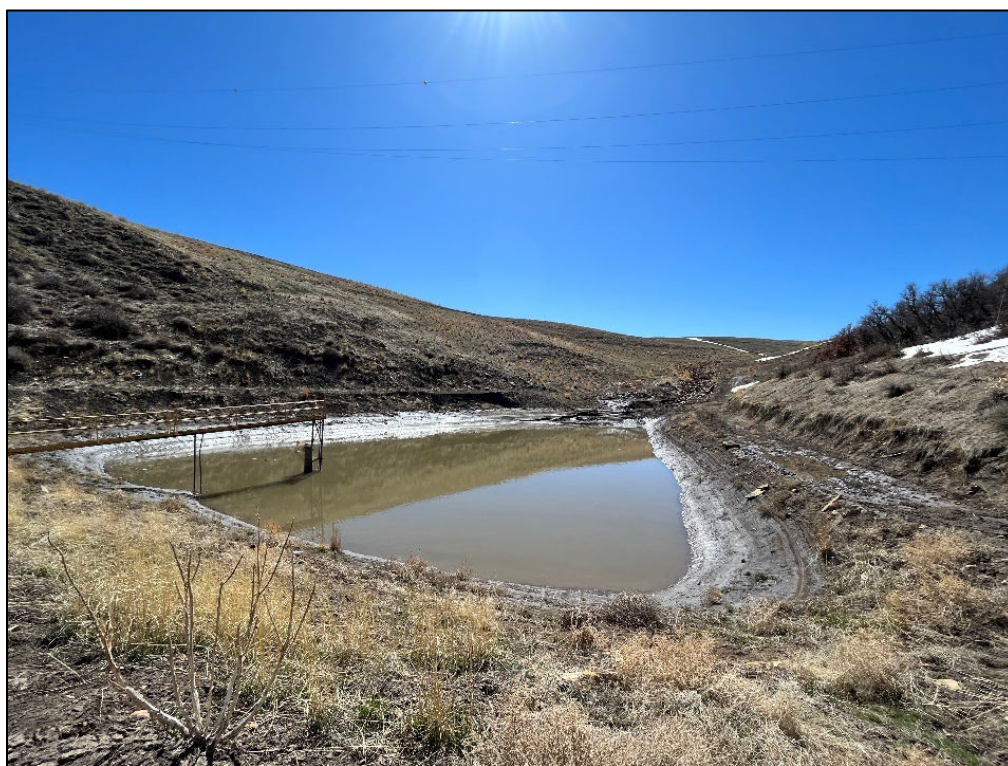
The East Taylor Pond (Photo 13) in the West Pit area was inspected this month. The East Taylor Pond was able to be accessed via a small offroad trail along Taylor Creek. The West Pit Pond was also accessed via this road during the inspection. This pond is usually dry but was holding some water at the time of inspection. The East Taylor Pond currently discharges to Taylor Creek. However, water quality at this pond is low. Colowyo representatives stated that they intend to eventually discharge this water to an underground aquifer via a borehole located outside the permit boundary. While this borehole will not need to be permitted with the Division, any pipeline disturbance associated with the well may need to be permitted through a revision.

Photo 13: View south of the East Taylor Pond.

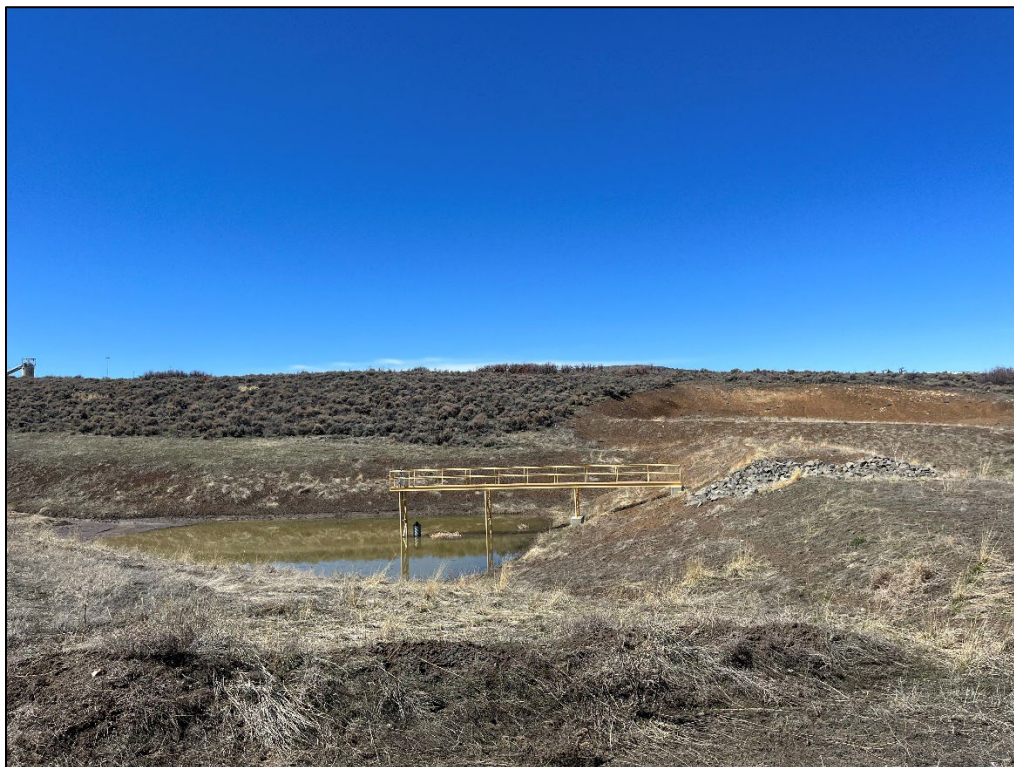
The following Ponds in the Collom Pit area were inspected this month: Section 36 Pond (Photo 16), Sidehill Pond (Photo 20), Middle Pond, and Section 25 Pond (Photo 17), Section 26 Pond (Photo 19). No outstanding problems were noted at any of the ponds, however the slump area at Section 26 Pond will need to continue to be monitored closely for any signs of degradation. Section 25 Pond has had maintenance issue previously, but currently has no signs of erosion or notable items of concern. All ponds were observed to be holding water.

Photo 16: Section 36 Pond.

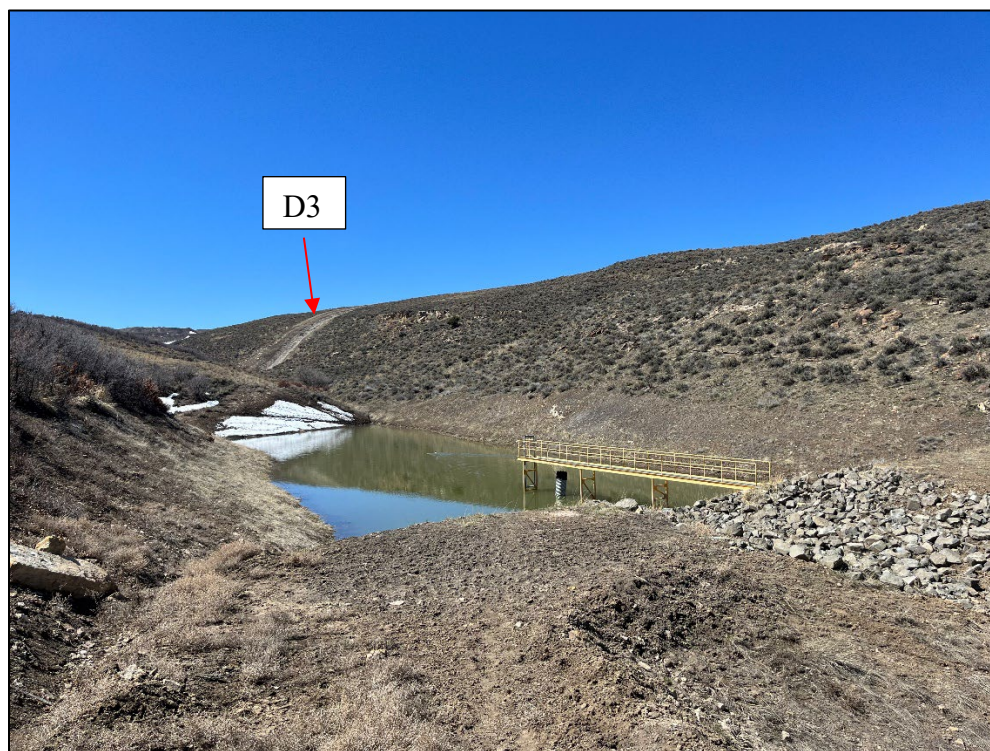
The following ditches in the Collom Pit area were inspected this month: D1, D2, D3 (Photo 17), and D4 (Photo 20). These ditches were observed from along the road and from vantage points near ponds in the area. The southern end of D4 had a small erosion feature within the channel; there is no concern at present, but this area should be monitored for any signs of increasing erosion. All other channels appeared to be stable and functioning properly.

Photo 17: Section 25 Pond.

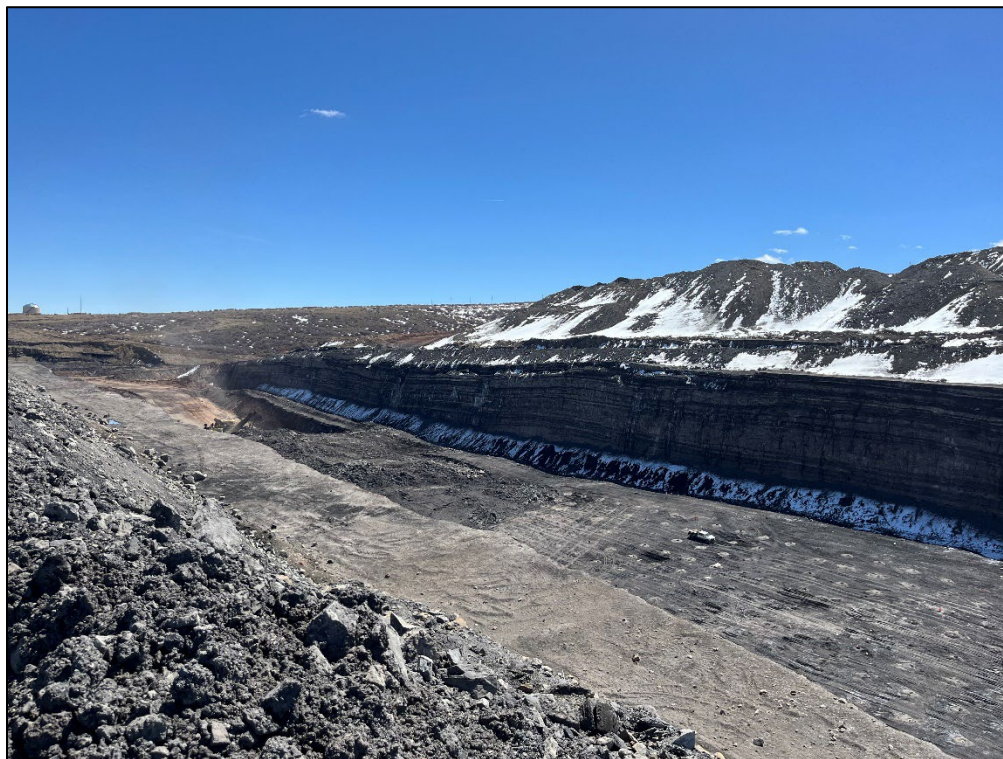
As of the time of the inspection, only four blasts have occurred at the Colowyo Mine in 2024. All blasting is currently occurring in the Collom Pit. Drill holes were being prepped in the active truck and load section of the northern portion of Collom Pit (Photo 18). No blasts were observed during the inspection.

Highwall mining operations continue in the eastern portion of the Collom Pit. The highwall miner was entering in a western direction and moving south. Previous entries have been backfilled as the mining progresses. Tuck teams were noted to be actively excavating and hauling previously blasted material from the western side of the Collom Pit (Photo 18).

Photo 18: View into the active truck and loader excavation area of Collom Pit.

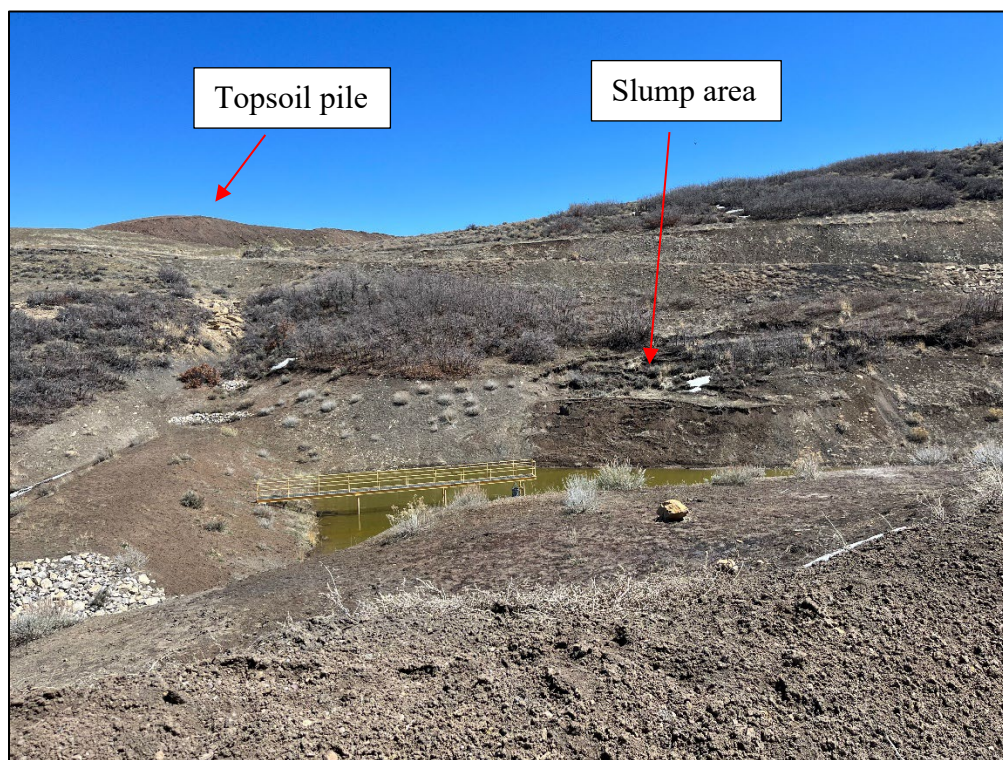
Topsoil piles across the site contained appropriate markers. The topsoil pile behind Section 26 Pond will need to be shaped and seeded when conditions allow (Photo 19).

Photo 19: Section 26 Pond, slump to the east continues to be monitored.

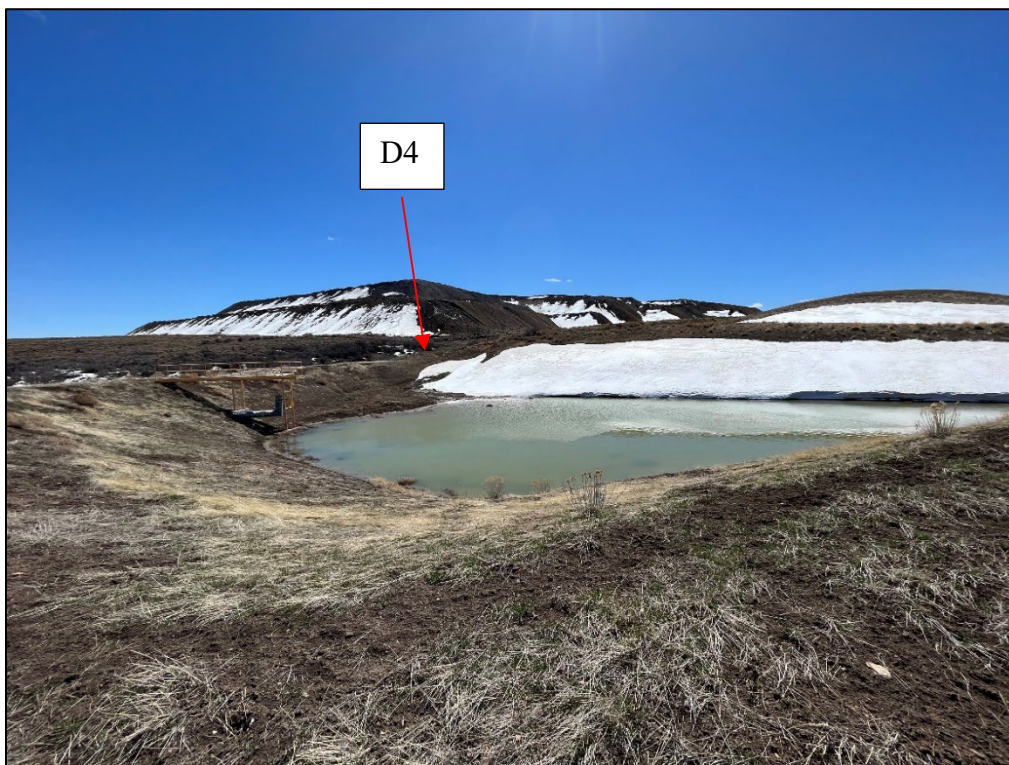
Photo 20: Sidehill Pond.

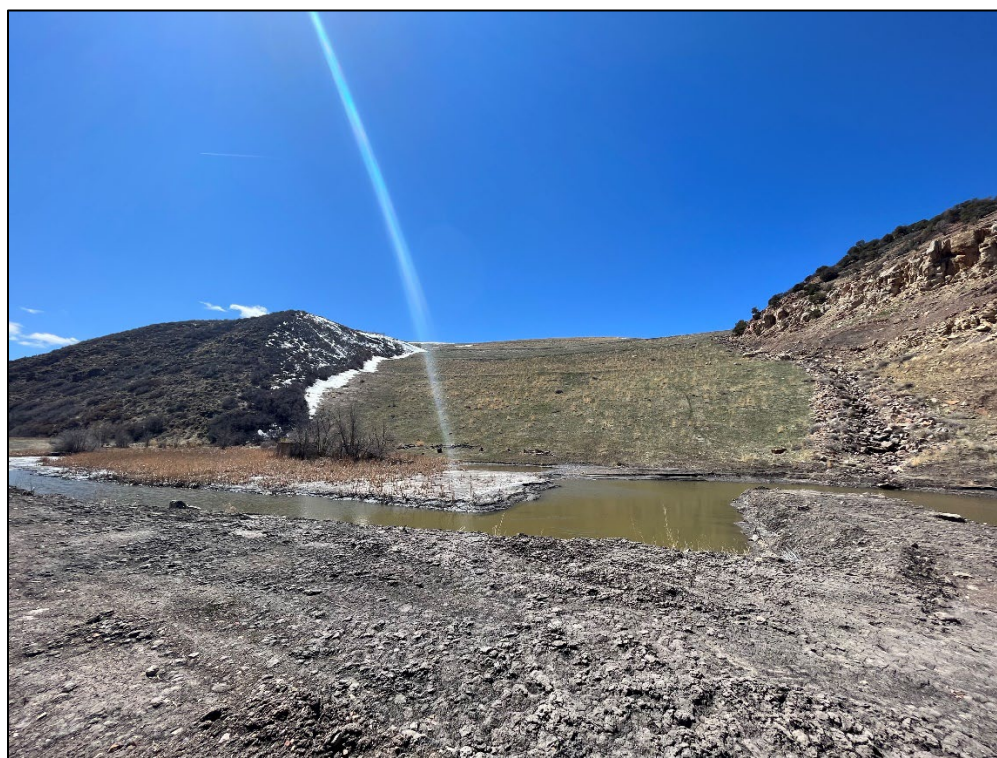
The Streeter Pond (Photo 21) and Prospect Pond (Photo 23), accessible via Hwy 13, were inspected. Both ponds held water at the time of inspection and all embankment appeared to be stable and vegetated (e.g. Photo 22). Some vegetation has not yet regrown where last year's pond cleanout work occurred. No issues were reported.

Photo 21: View west of Streeter Pond and Phase III released valley fill area, ditch to the north has not yet been Phase III released.

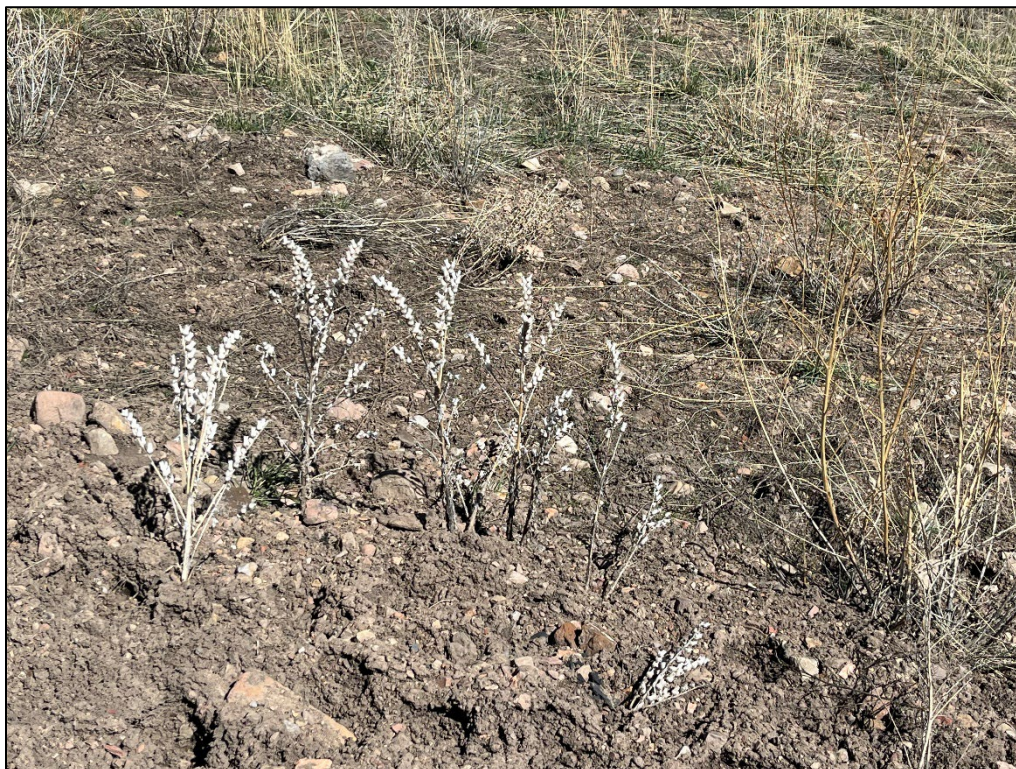
Photo 22: Additional species of penstemon were noted at the Streeter Pond.

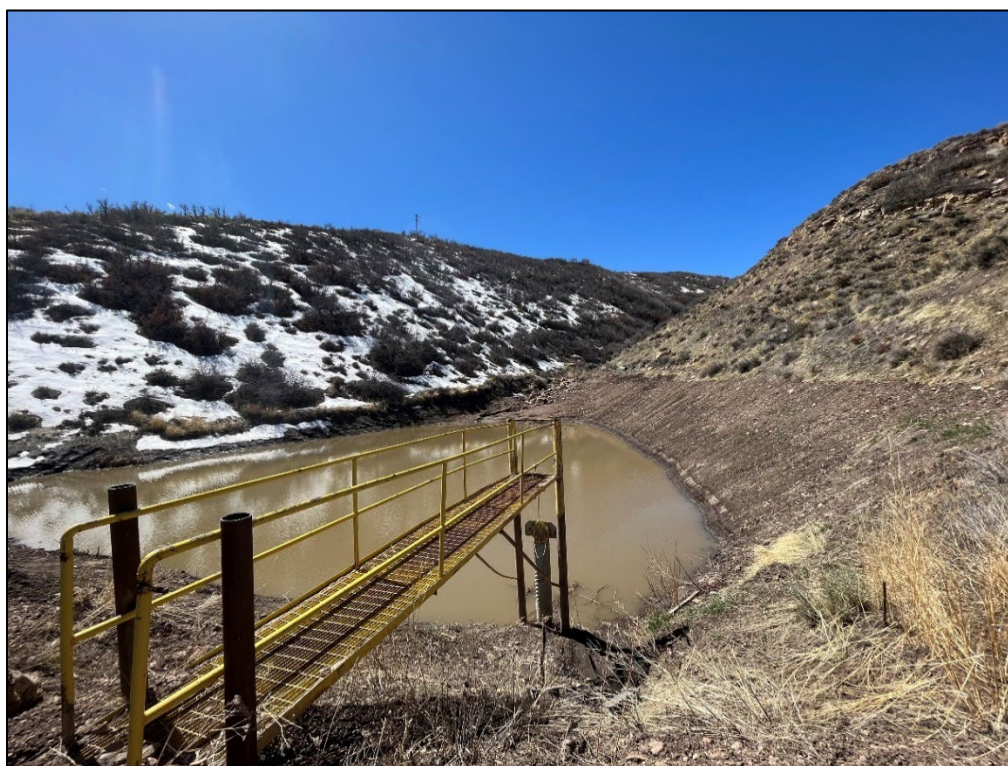
Photo 23: View west of Prospect Pond off Hwy 13.
