COLORADO

MINERALS PROGRAM INSPECTION REPORT

MINE NAME: St. Barbara Sand and Gravel Mine	MINE/PROSPECTING ID#: M-2004-013	MINERAL: Sand and gravel	COUNTY: Pueblo
INSPECTION TYPE: Monitoring	WEATHER: Clear	INSP. DATE: March 19, 2024	INSP. TIME: 12:00
OPERATOR: Pete Lien & Sons, Inc.	OPERATOR REPRESENTATIVE: Duane Pollard	TYPE OF OPERATION: 112c - Construction Regular Operation

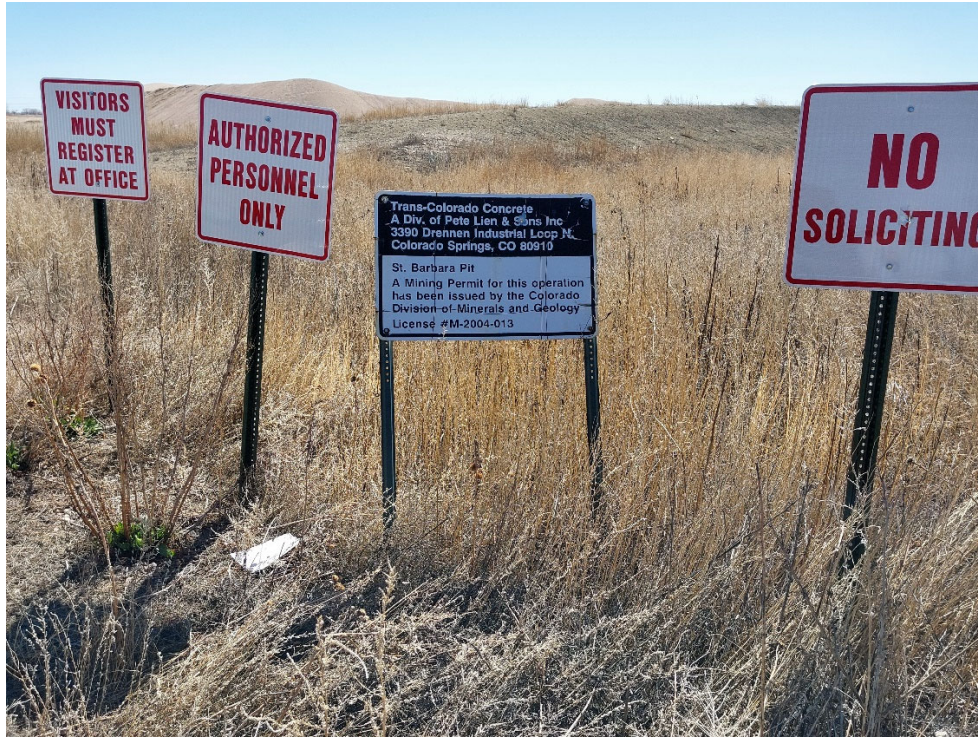
The mine sign viewed at the entrance of the site meets the requirements of Rule 3.2.12(1). The boundary markers were not inspected by the Division during this visit.

Photo #1: Mine sign, in compliance with Rule 3.1.12(1).

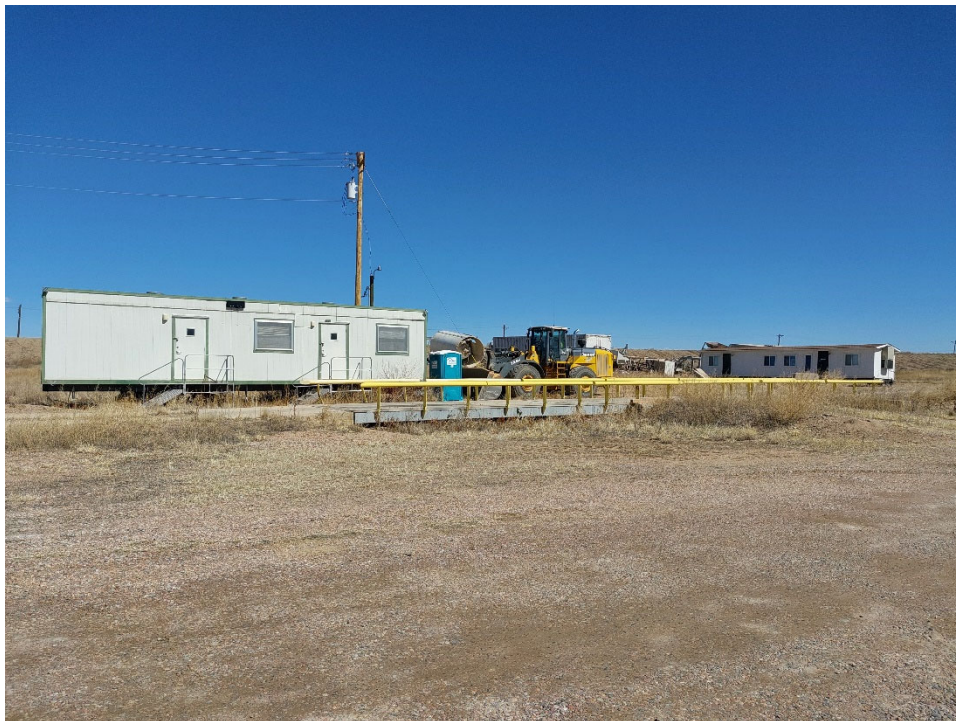
A scale is installed on the site, just to the north of the road and east of the entrance. There are items on site to build a processing facility on the northwest portion of the permit area. At the time of the inspection none of the structures were installed or operable. No processing is occurring on the site at the time of the inspection.

Photo #2: Scale and scale house.

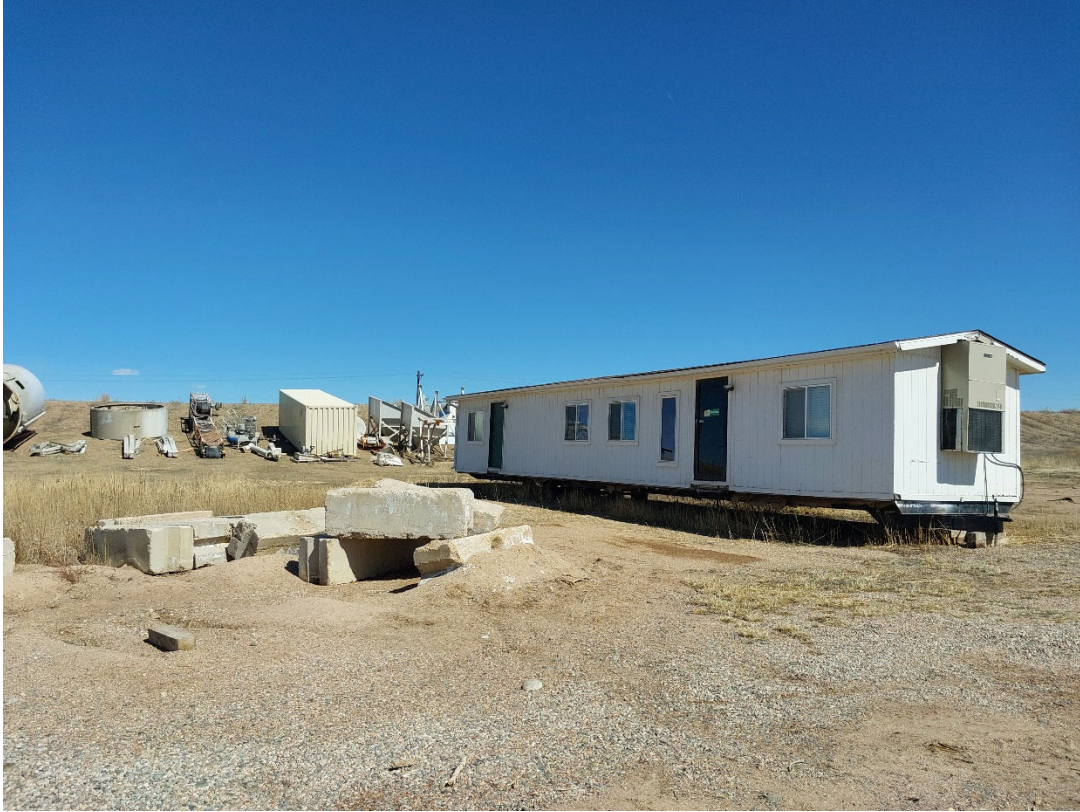
Photo #3: Structures to be installed for on-site processing operations.

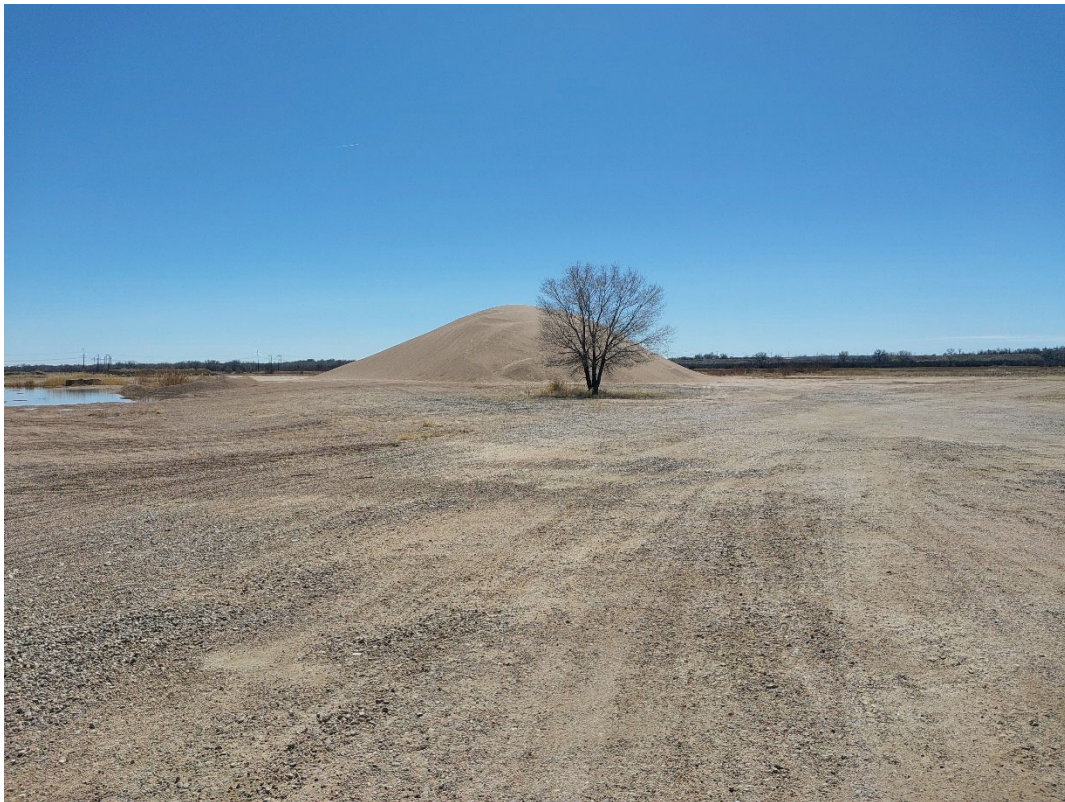
Photo #4: Large product stockpile.

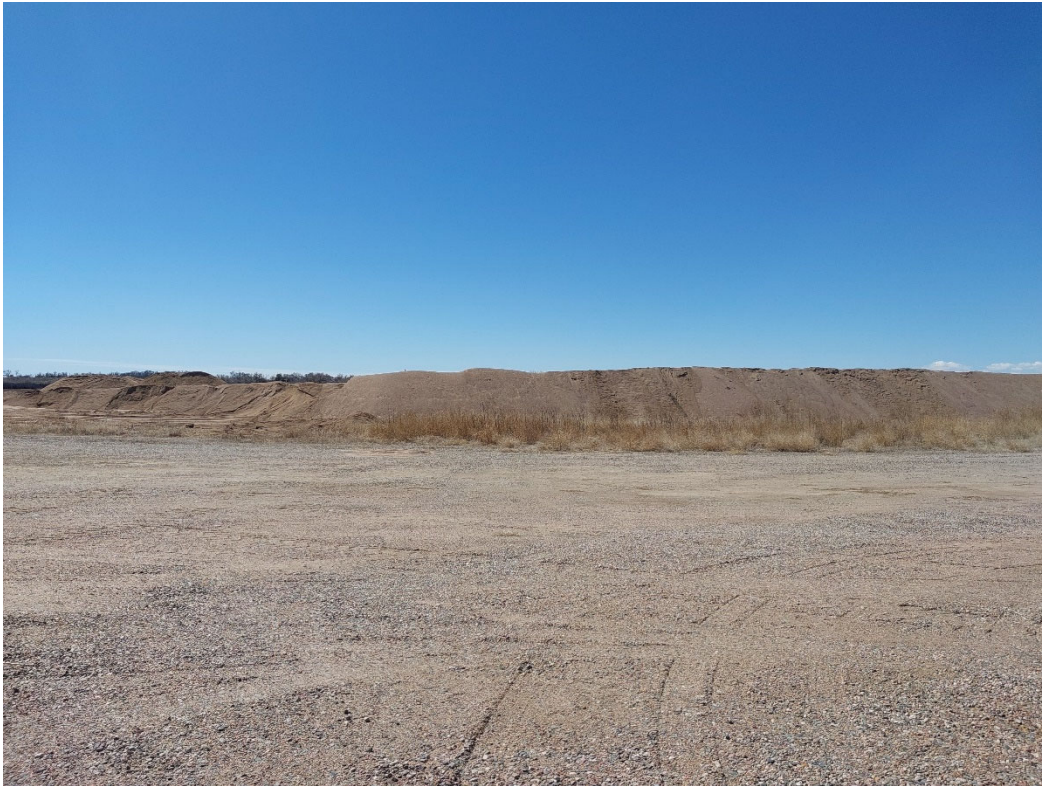
Photo #5: Product stockpile located just south of the entrance; disturbance seen on the left side of the stockpile indicating most recent distribution of the product.

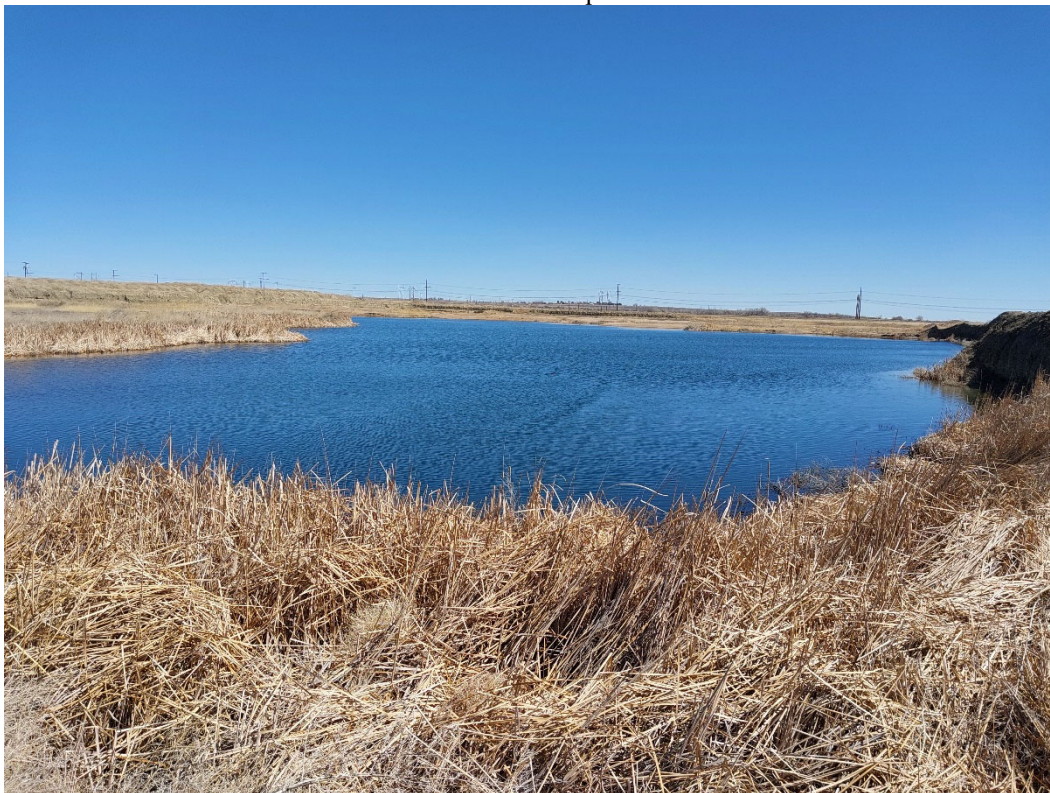
PROBLEM: The Division has no evidence that the operator has a valid substitute water supply plan for the exposed groundwater at the site. This is a problem related to 34-32.5-116(4)(h) of the Colorado Revised Statutes and 3.1.6(1)(a) of the Construction Materials Rules and Regulations governing injury to existing water rights.

Field measurements of the exposed groundwater were obtained during the inspection. There are 4 ponds and one settling pond on the site, there are also ditches that connect the 4 ponds to the settling pond. The four ponds measured to be 6.164 acres, 1.055 acres, 0.811 acres, and 0.682 acres in size at the time of the inspection. The settling pond measured to be 0.507 acres and the ditches were dry at the time of the inspection. The total amount of exposed groundwater appeared to be 9.22 acres. Please see the map provided at the end of this report for more information about the location of each pond and their respective sizes. According to the SWSP on file with the Division, this is less than the allowable 9.76 acres of exposed groundwater. However, as mentioned

Photo #6: Largest pond, located in the north center of the permit area; measures 6.16 acres of surface area.

CORRECTIVE ACTIONS: The operator shall provide the Division with an updated substitute water supply plan that describes the allocated amount of groundwater that the Operator may expose during mining operations.

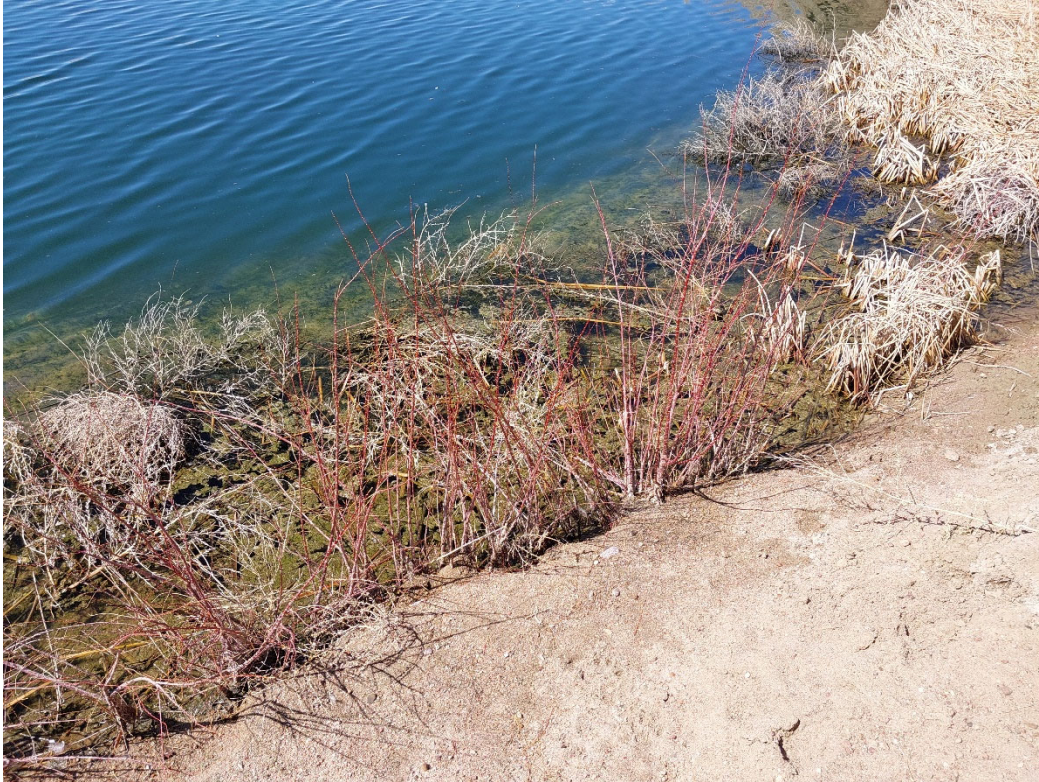
PROBLEM: There are state-listed noxious weeds present on site, tamarisk and Russian Olive trees were observed on site, both list B noxious weeds. This is a problem for failure to employ weed control methods for state listed noxious weed species within the permitted area, and to reduce the spread of weeds to nearby areas as required by Section 3.1.10 (6) of the rule.

Tamarisk, a list B noxious weed, appears to be growing throughout the permit area. There were several areas of note that are marked on the map given below. The noxious weed appeared to be growing around the perimeters of each of the ponds and on the topsoil stockpile.

Photo #7: Tamarisk viewed at the northeast side of the largest pond area.

CORRECTIVE ACTIONS: Implement approved weed control plan and provide photographic proof to the Division that this has been done.

The Operator needs to implement their weed control plan and have these plants removed.

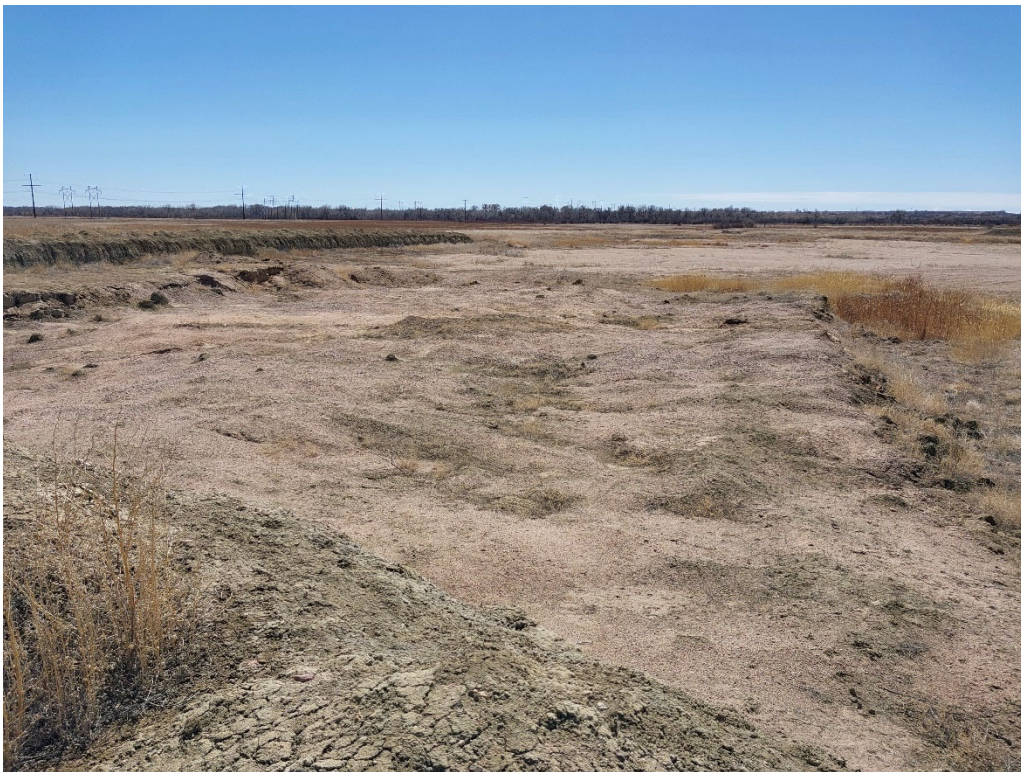
The backfilling and grading that has been performed appeared adequate with no signs of excess erosion.

Photo #8: Backfill and grading done east of the largest pond.

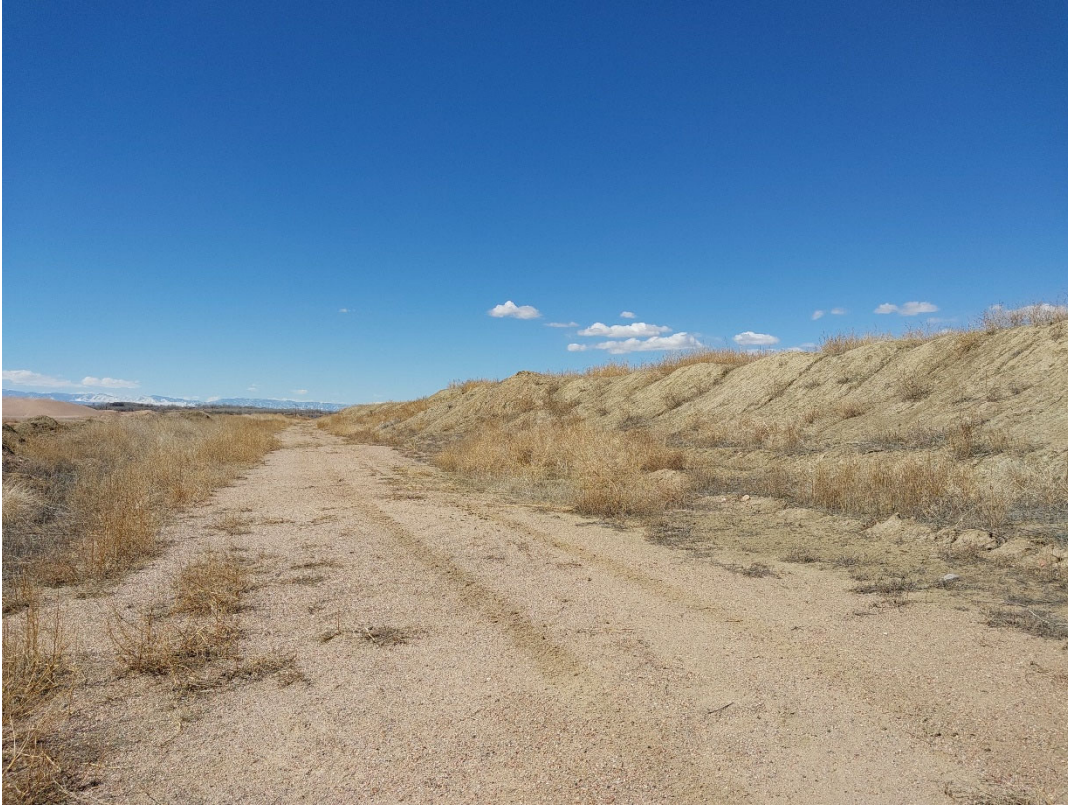
The ditches that route overflow from the ponds to the settling pond act as internal structures for stormwater management. The ditches were dry at the time of the inspection. The berm along the perimeter of the permit boundary appears to be stable with no erosion issues.

Photo #9: Haul road along the north side of the permit boundary, berm to reduce noise and visibility effects and support stormwater management plan on the right side of the road; photo taken looking to the west.

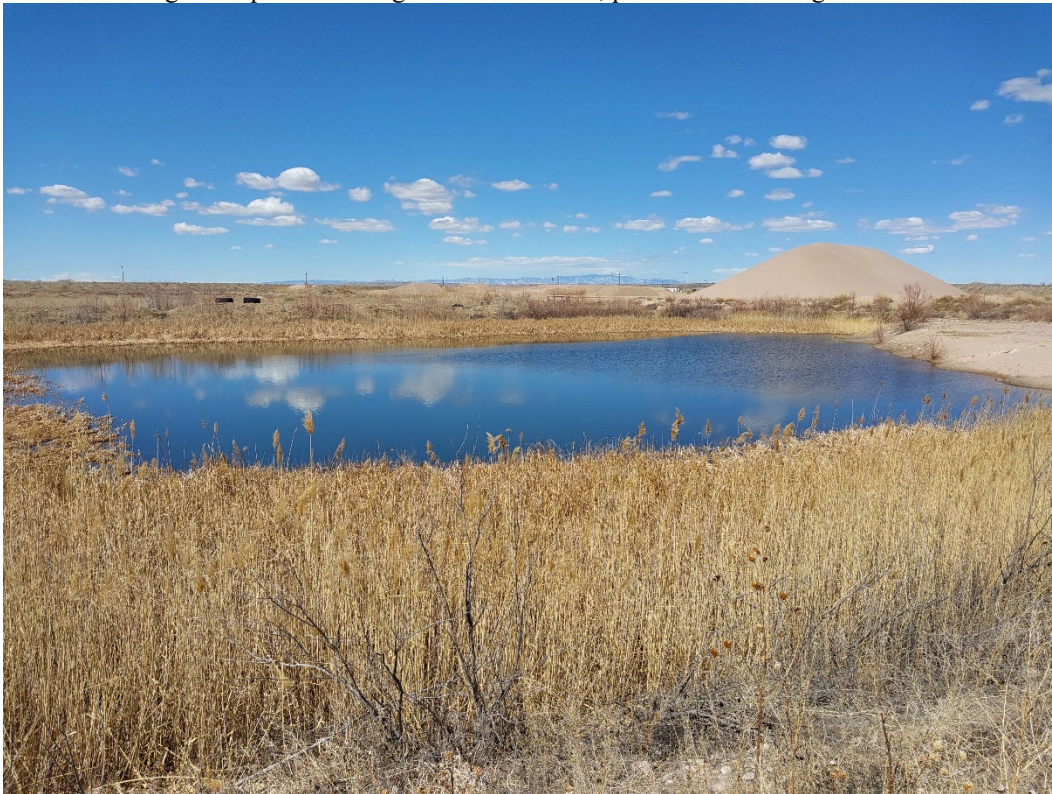
Photo #10: Smaller pond, located south of product stockpile on the east side of the permit boundary; measured area of exposed groundwater is 1.06 acres.

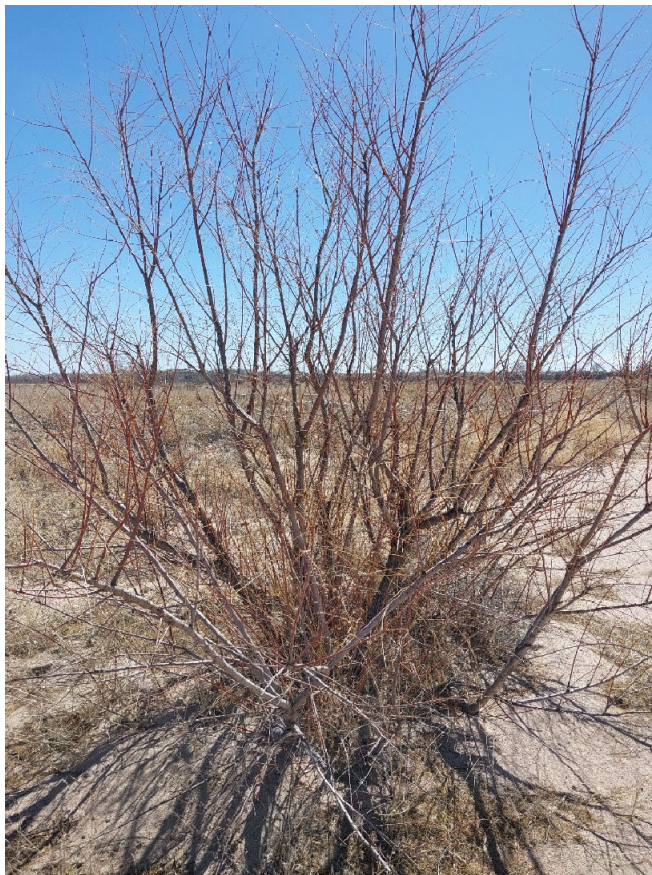
Photo #11: Well developed tamarisk located on the north side of the 1.05 acre pond.

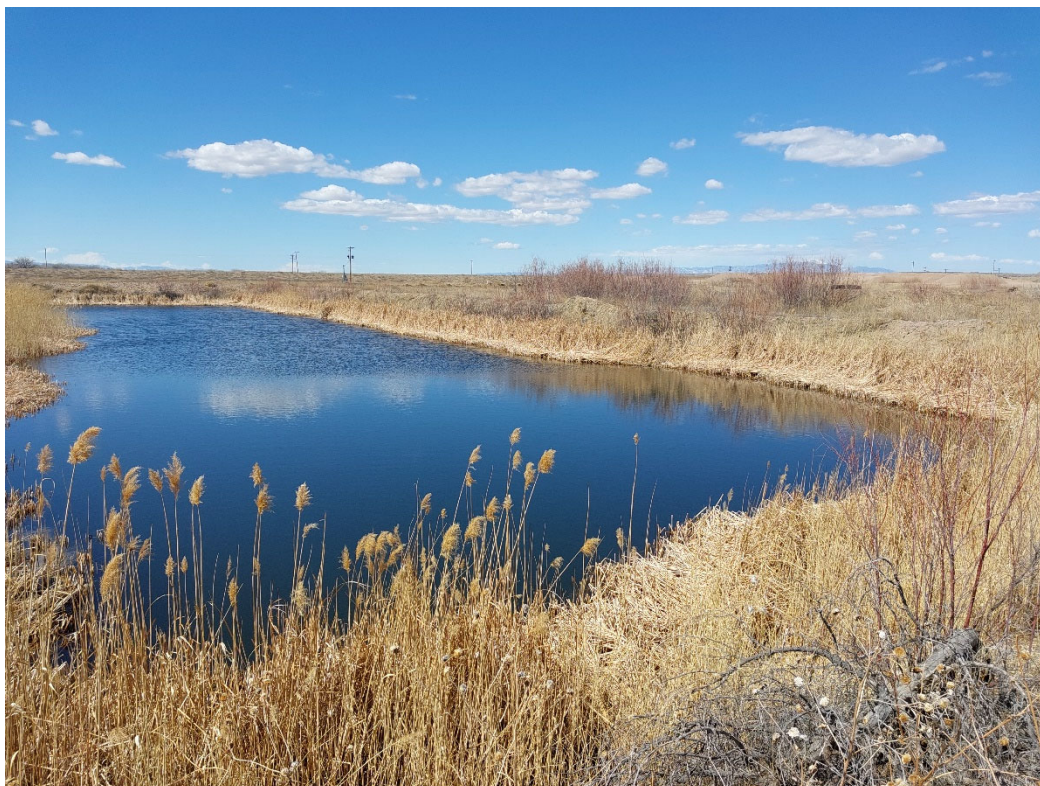
Photo #12: Smaller pond, located south of product stockpile on the east side of the permit boundary; measured area of exposed groundwater is 0.811 acres.

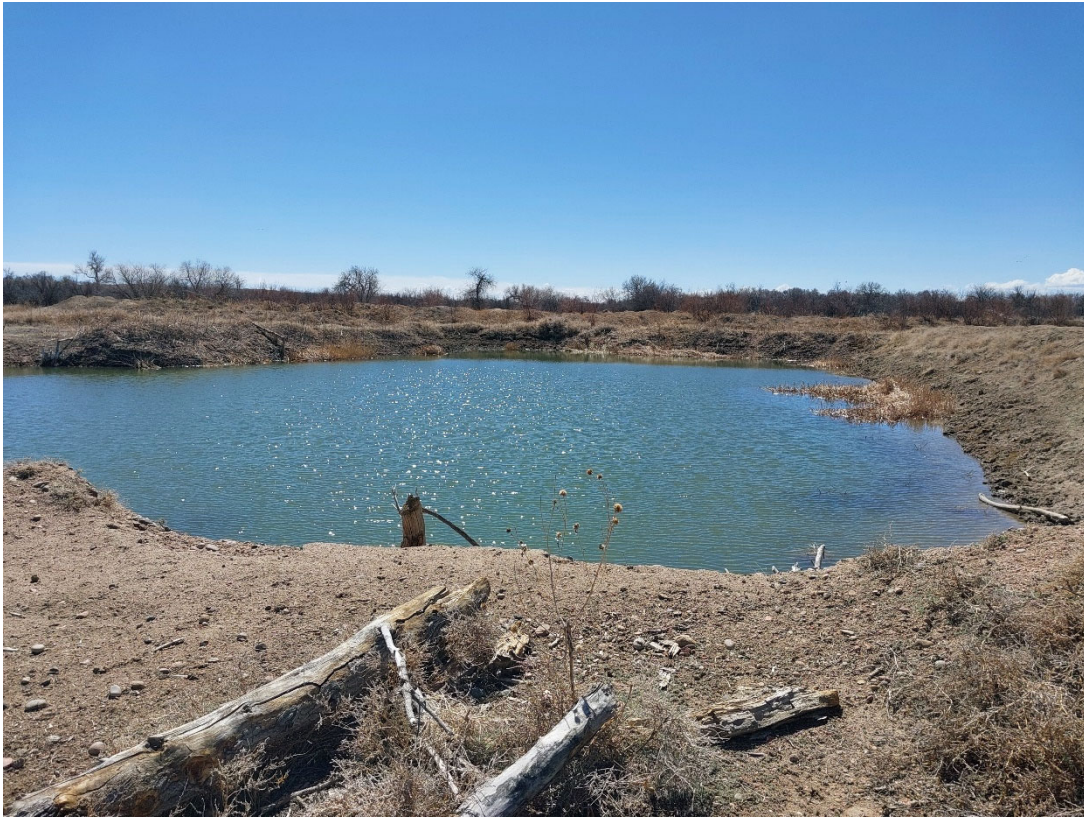
Photo #13: Settling pond, measured area of exposed groundwater is 0.507 acres.

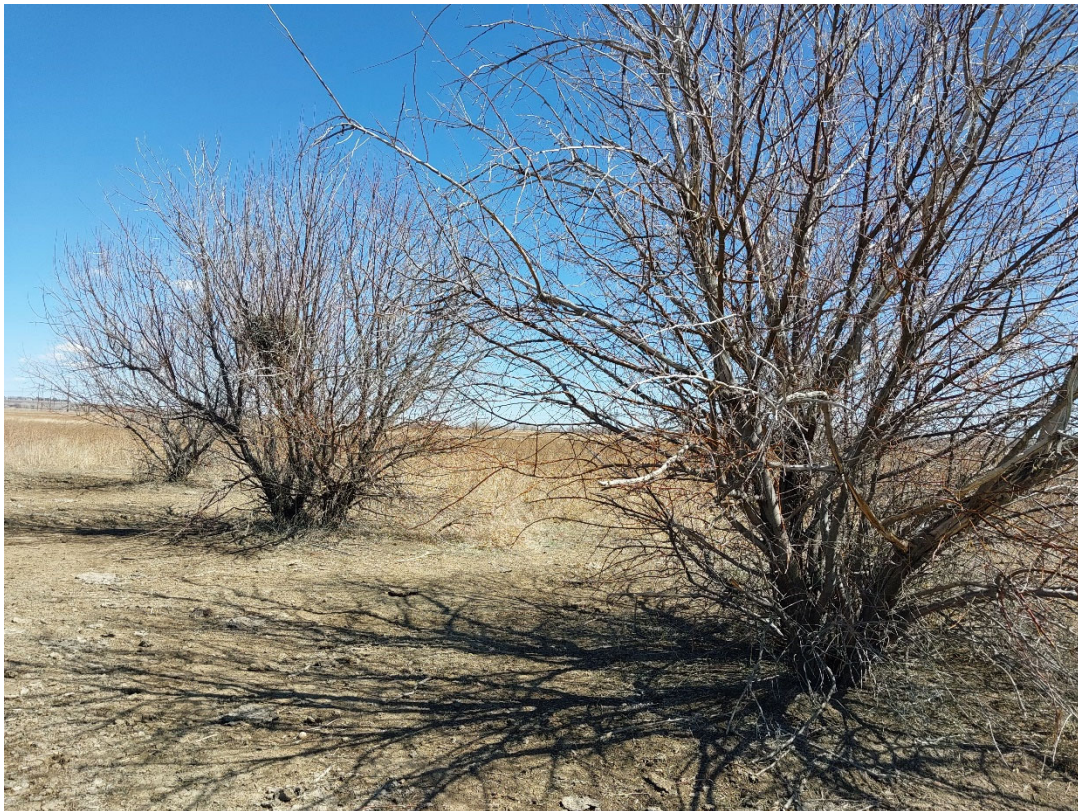
Three Russian Olive trees, another list B noxious weed, were also seen along the haul road, marked on the map given below.

Photo #14: Three Russian Olive trees viewed on site.

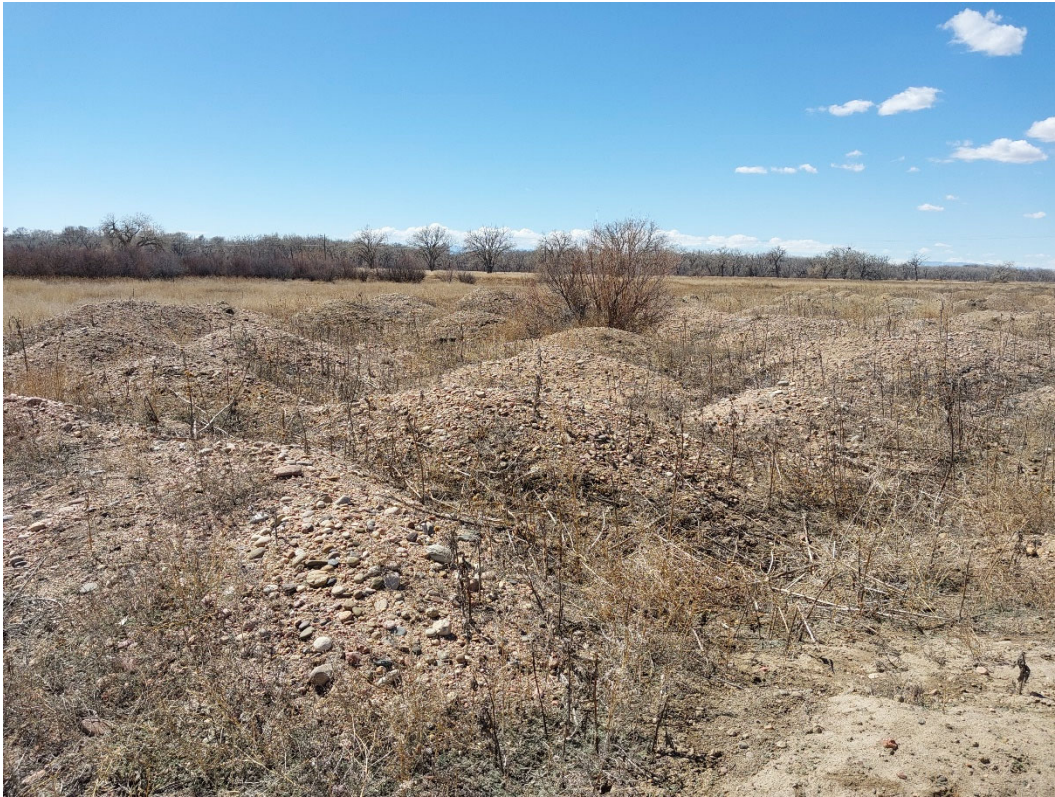
Photo #15: Topsoil/overburden stockpile, tamarisk is seen growing in the middle of the stockpile area.

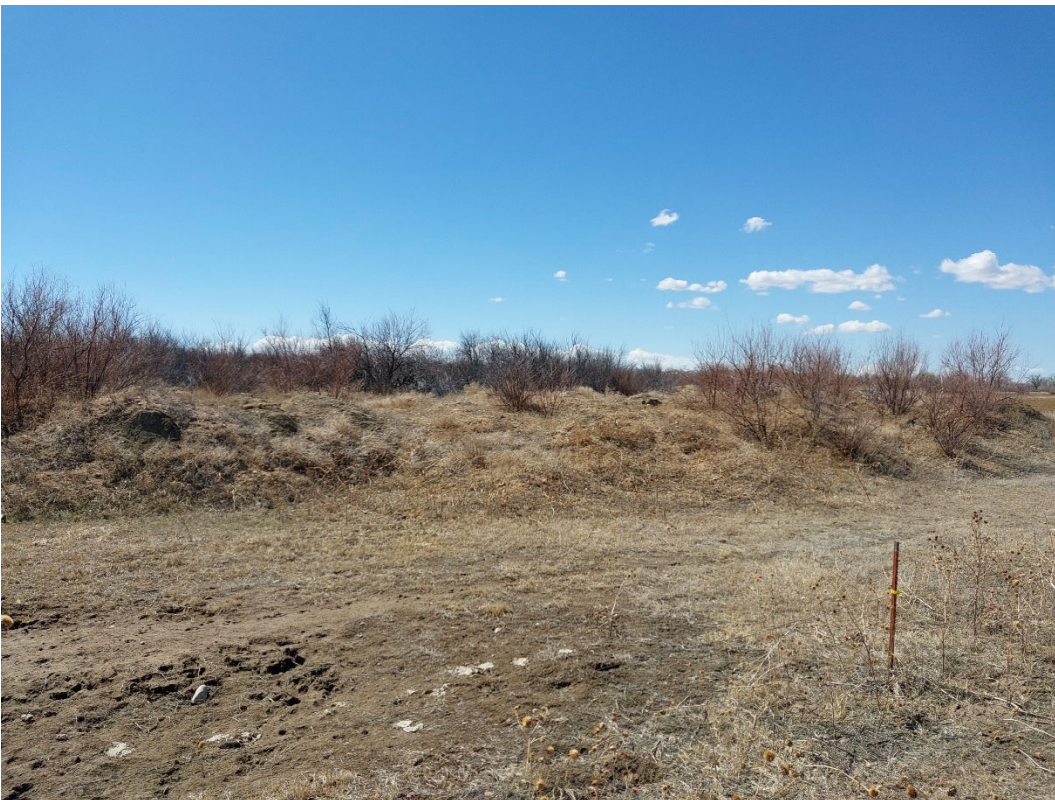
Photo #16: Overburden stockpile located to the west of the settling pond; tamarisk has invaded this stockpiled material.
