STATE OF  
COLORADO

## April Partial Inspection

**PERMIT INFORMATION**

**INSPECTION INFORMATION**

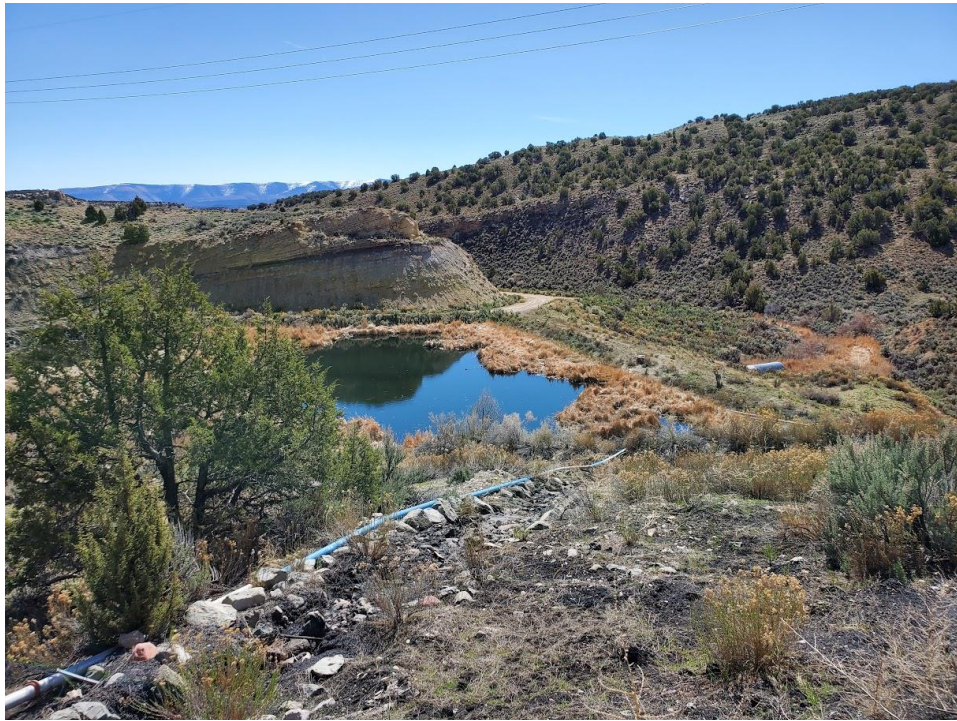
erosional concerns identified. The ditches that convey water from the benches to the pond are in good condition with no maintenance items noted (Photo 1). The PP-1 Pond is located on the middle bench of the facilities area near the prep plant. The pond was below the discharge level. There were no erosion or stability issues identified in the PP-1 Pond. The PP-2 Pond is located on the upper facilities bench. The embankment was stable with no erosional features identified. The outlet structure was in good condition with no vegetation obscuring the outlet (Photo 2). Water diversion ditches throughout the main facilities area were unobstructed and stable.

Photo 1: View to the southeast of Pond DP-1 with conveyance ditch in foreground.

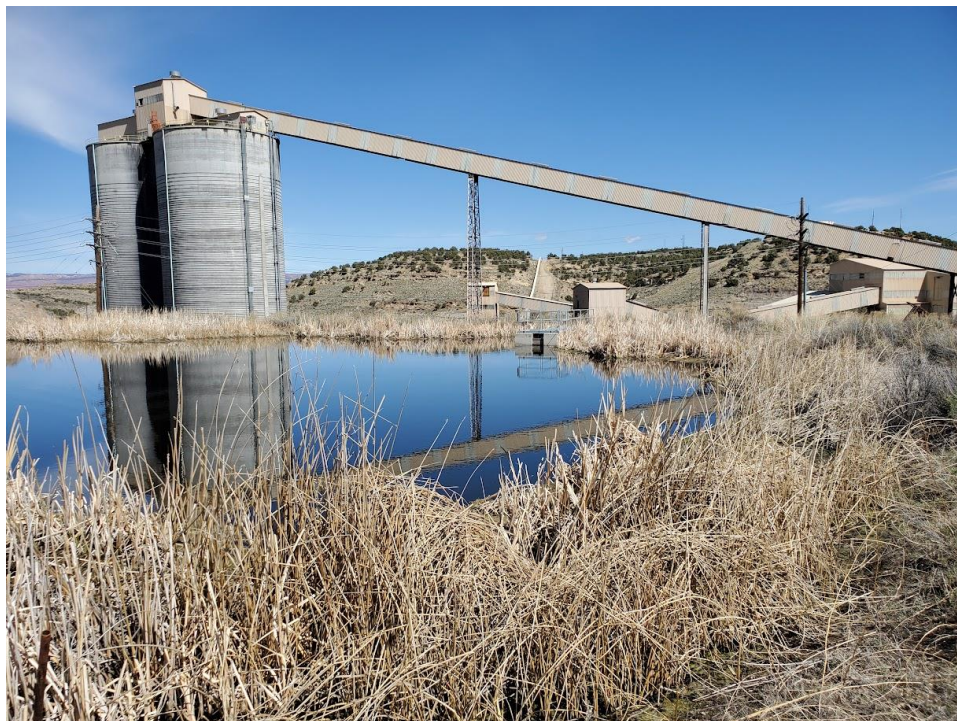
Photo 2: View to the north of Pond PP-2

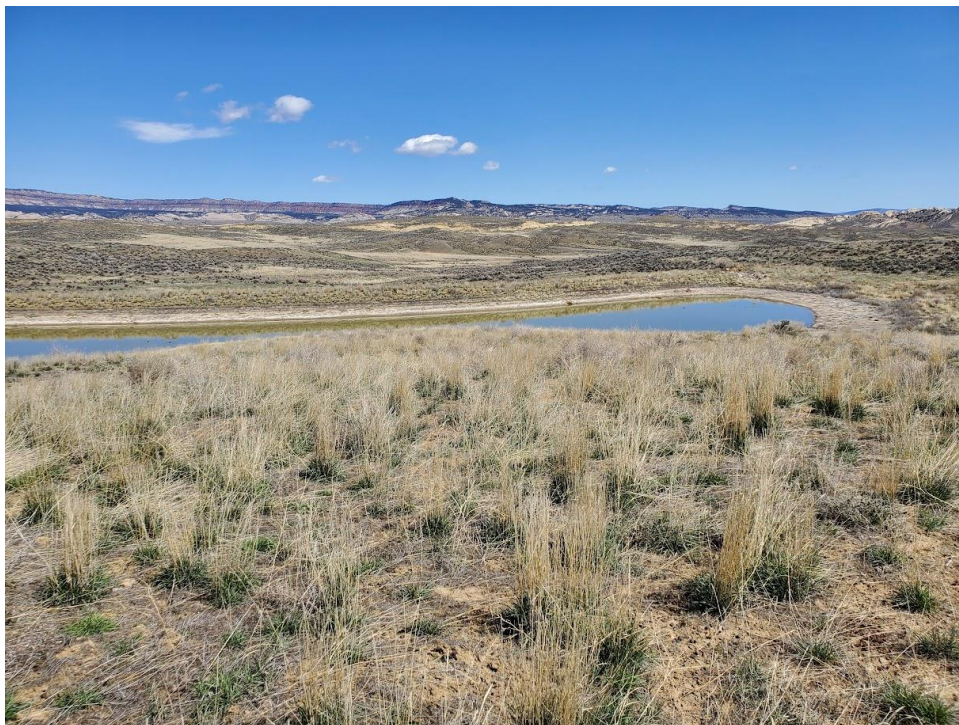
The B Seam Dewatering System No. 2 is located to the east of the Slot Storage. The system was inactive during the inspection. The upper cell had no indications of water being present and the embankments were appeared stable. The main cell was holding a small amount of water below the level of discharge. The outlet appeared clear of debris. The embankments of the pond were stable with no indications of erosion. (Photo 3) The lower cell had no indication of water being present and the embankments appear stable.

Photo 3: View to the north of main cell of B Seam Dewatering System #2

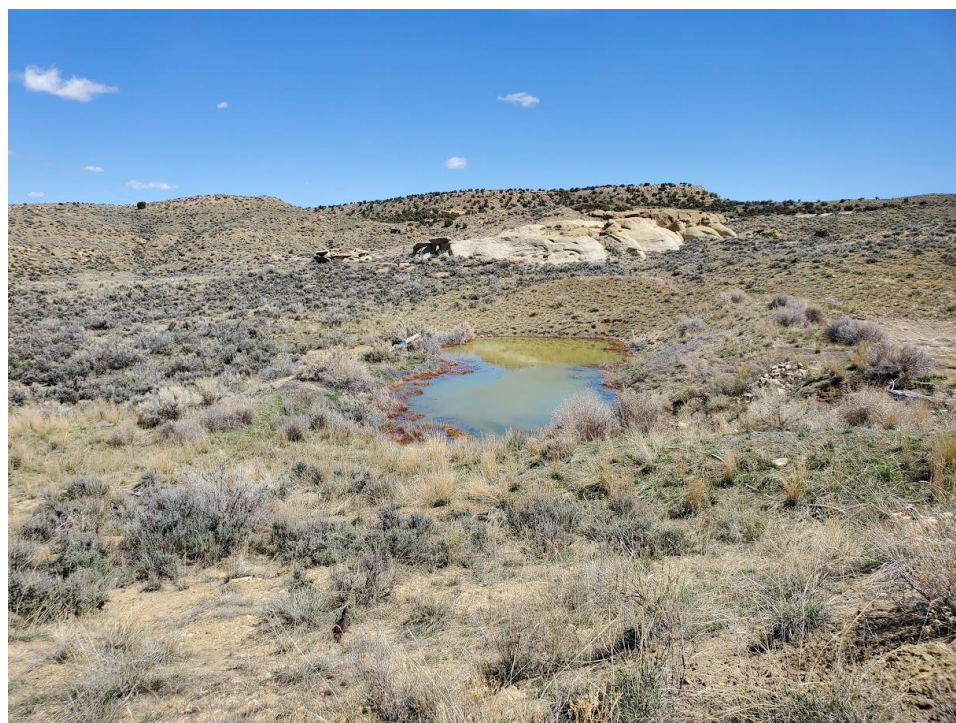
The D-Seam Dewatering System is located toward the eastern permit boundary. The was active at the time of the inspection. Water is being placed in the lower cell of the system (Photo 4) and the upper cells are not in use. Minor amounts of meteoric water were present in the upper cells. The berms of the ponds showed no signs of displacement or erosion. The pad where the pump is located is in good condition with no signs of instability.

Photo 4: View to the east of lower cell on the D Seam Dewatering System

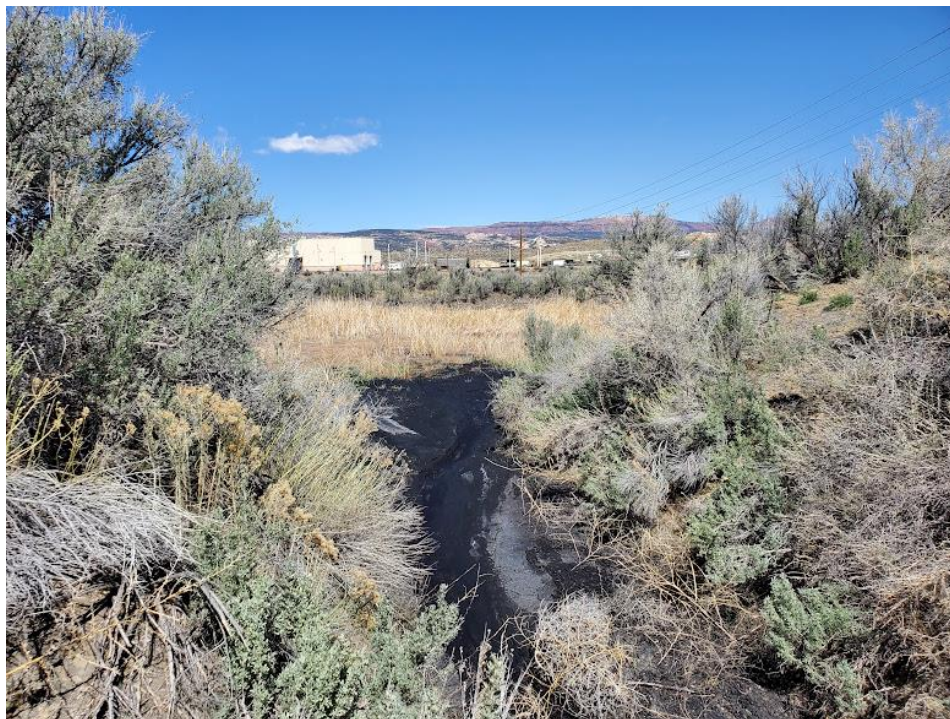
The SS-1 and SS-2 Pond is located just to the north of the Slot Storage Facility. The SS-1 pond is located to the north of the Slot Storage Facility. The pond was dry at the time of the inspection (Photo 5). The embankments of the pond were well vegetated and stable with no indications of erosion. The culvert located at the inlet to the pond was clear. The SS-2 Pond is located at the northwestern base of the Slot Storage. The pond was dry at the time of the inspection.

Photo 5: View to the north of Pond SS-1

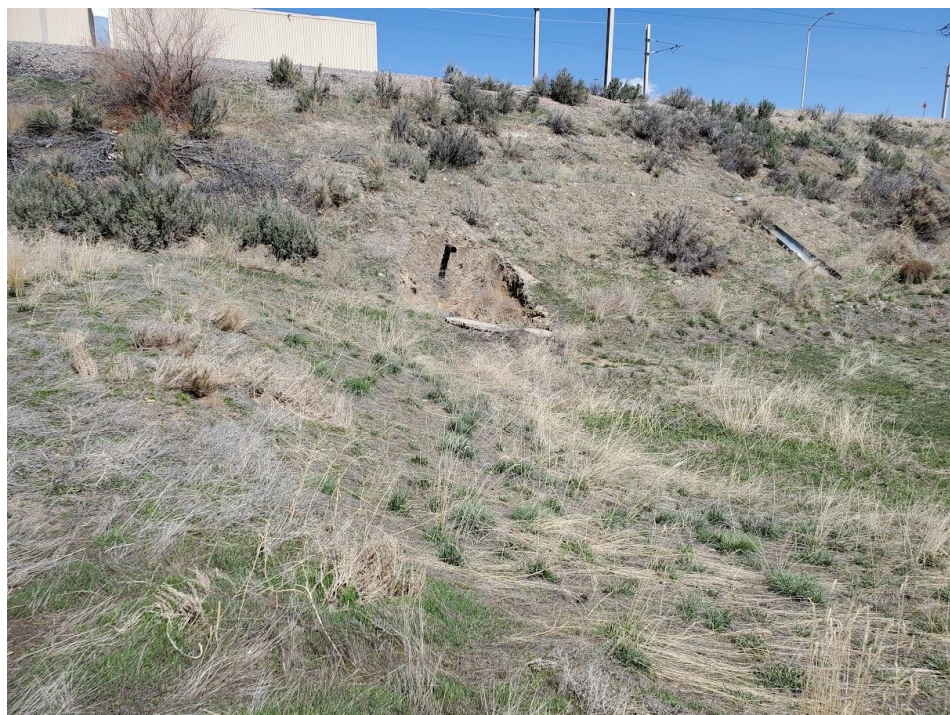
Photo 6: View to the north of erosional scar on Pond RP-1. Does not appear to have enlarged.

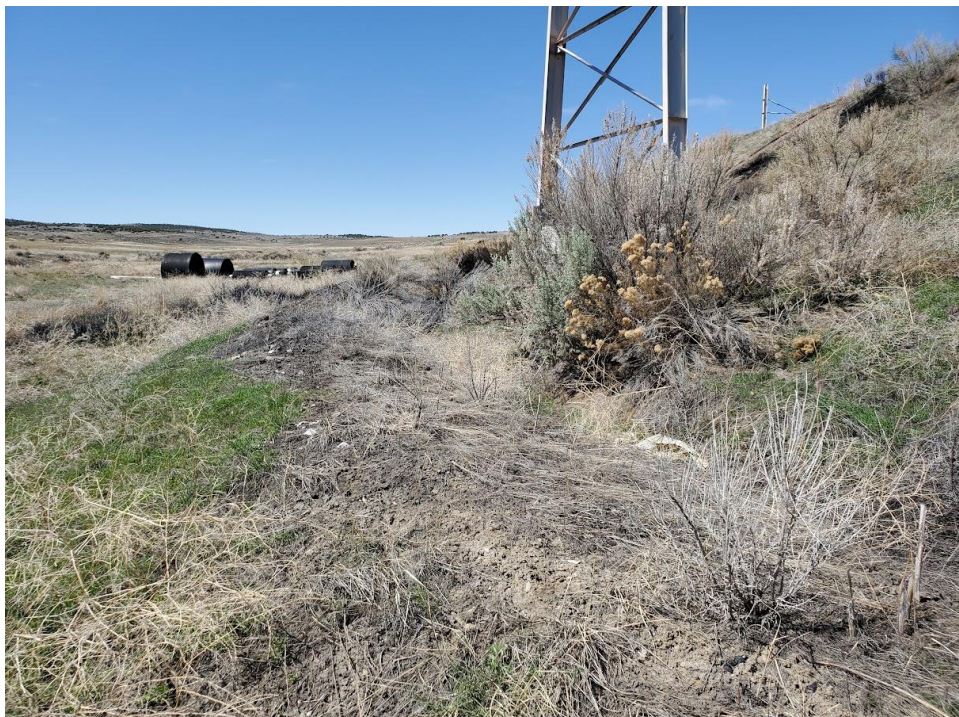
The RS-1 Sump and the RR-1 Pond are located at the south side of the Rail Loadout. The RS-1 Sump was. There were no indications of erosion. The RR-1 Pond was also dry. The embankments of the pond seem stable. The erosion feature on the northern embankment that has been noted in previous inspection reports does not appear to have grown in size. (Photo 6) **The Rail Loadout Storage South Ditch is congested with brush, please remove brush from the ditch. (Photo 7)**

Photo 7: View to the west of congested Rail Loadout Storage South Ditch.

1. Please clean brush from the Rail Loadout Storage South Ditch.
2. Please repair the rills on the embankments to Pond RP-4.

**Please complete brush removal from the Rail Loadout Storage South Ditch no later than May 9, 2024.**

**Please provide the Division with photos of the completed maintenance item by May 9, 2024. Please complete repairing the rills on the embankments of Pond RP-4 when regrading the refuse pile slopes above the pond in the spring.**

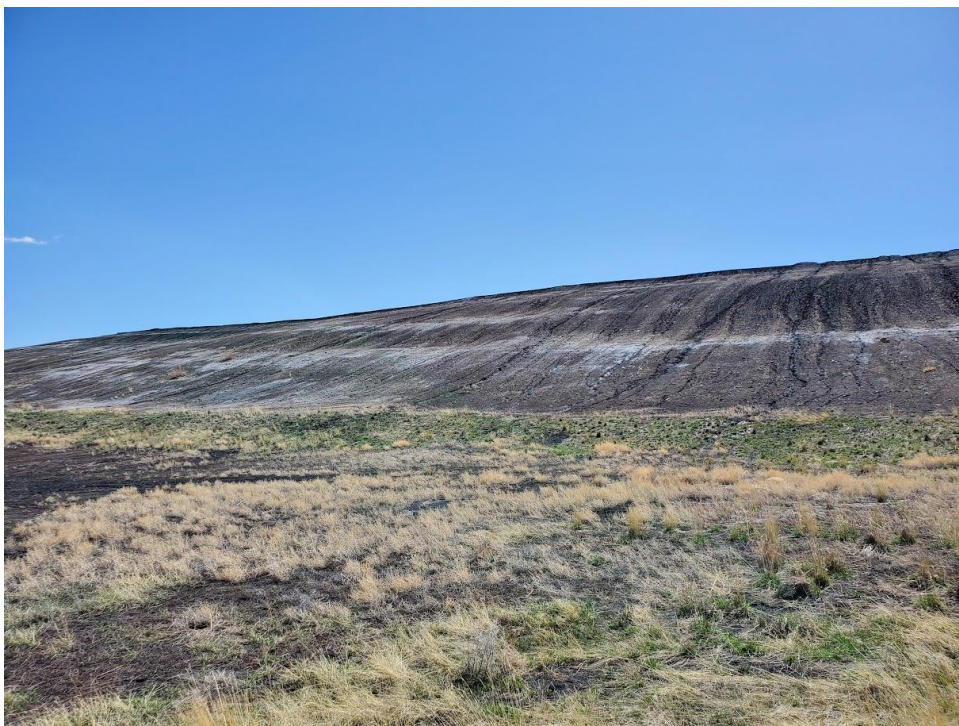
Two ponds are located at the northern base of Refuse Pile RP-2/3/4. The RP -2/3 Pond is located on the pile's northeast corner. The Pond consists of three cells. The east and west cells were holding water, but the main cell was dry. There were no erosional features identified. The channels above the ponds appear clear of debris. No erosional features were noted on the embankments of the conveyance ditches. The trash rack was clear of debris. The RP-4 Pond is located at the northwest base of the pile. The pond was holding minor amounts of water during the inspection. **The southern embankments directly below the stack are beginning to show signs of erosion. The rills that have formed on the embankments of the refuse pile are now cutting into the vegetated embankment. Please repair the rills that have formed on the pond embankment. (Photo 8)** The outlet for the RP-4 Pond is capped with a trash rack. The outlet was clear of debris.

During the inspection refuse material was being placed in windrows on the RP-2/3/4, RP-5a, and RP-A Refuse Pile. The piles were stable. Erosion on the slopes of the pile has been noted in previous Division inspection reports. The rills are beginning to enlarge and will to be filled in once crews are able.

Photo 8: View to the southeast of rills on RP-2/3/4 pile that extend into Pond RP-4

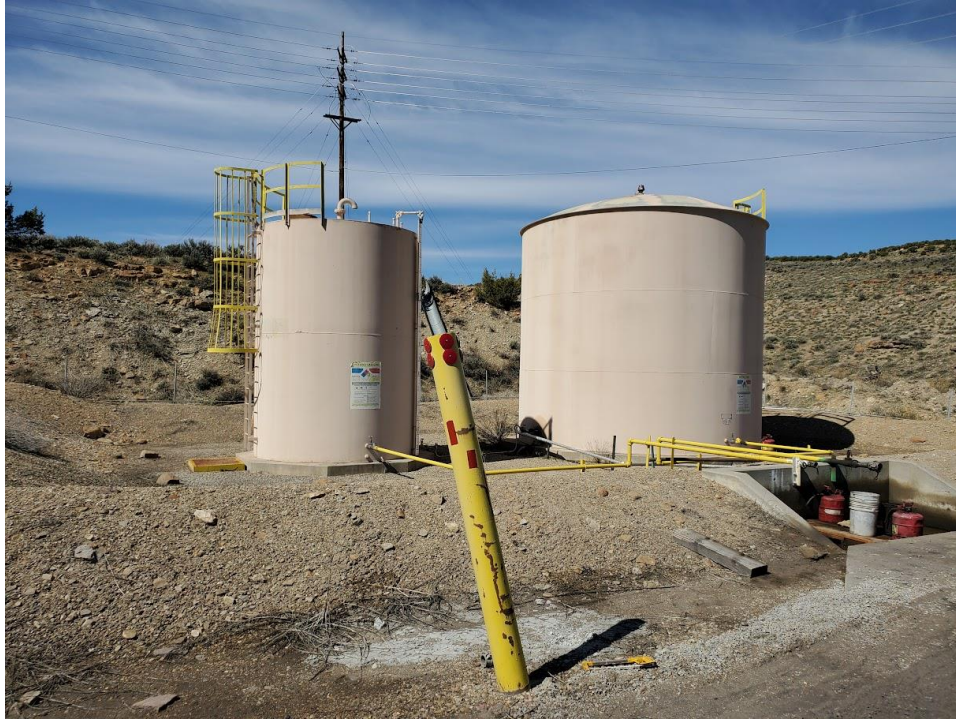
Hydrocarbons are being stored in accordance with best practices. Fuel is stored in double walled tanks near the haul road leaving the facilities area. The double walled tanks are also within a berm. (Photo 9)

Photo 9: View to the east of fuel tanks in secondary containment.

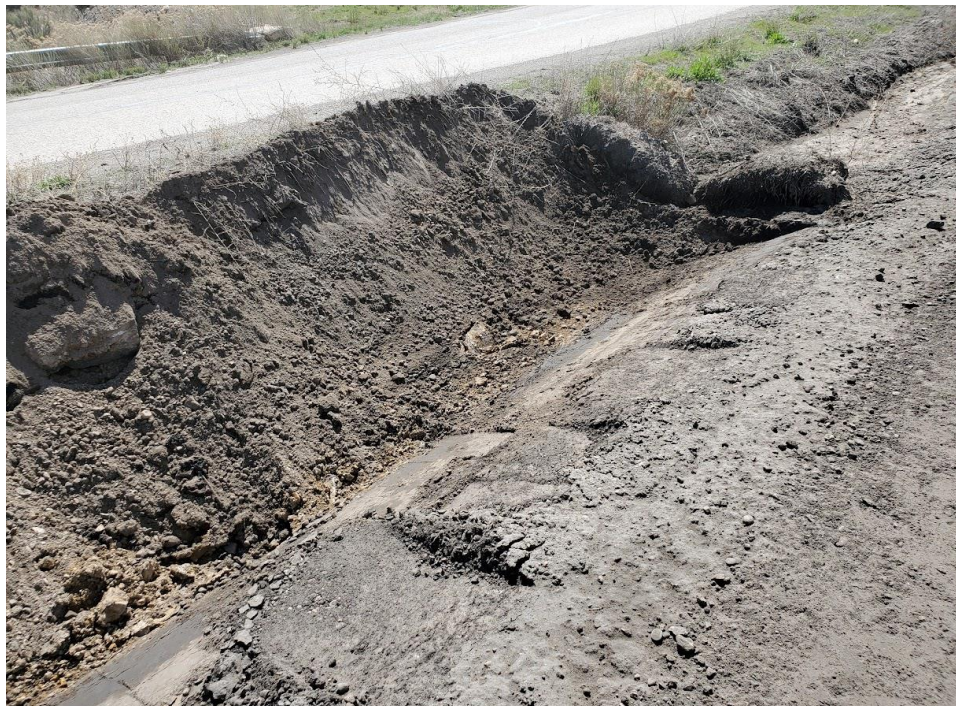
The Haul Road was clear and well maintained. No sections of ruts or other road damage were observed. Surface crews are cleaning the ditches paralleling the haul road (Photo 10). The roads have not yet been treated for dust and a small amount of dust was noticeable behind haul trucks.

Photo 10: View to the southeast of conveyance ditch along haul road. Crews have cleaned sediment from the ditch.
