New Horizon Mine, C-1981-008, SL-27 Inspection Report

**C-008, New Horizon Mine SL-27 Inspection Report_CCW.pdf**

This inspection report documents the Divisions observations and data collected during a bond release inspection (SL-27) of the New Horizon Mine, Permit No. C-1981-008. The inspection was conducted on March 6, 2024 by Clayton Wein and Todd Jesse of the Division. Elk Ridge Mining and Reclamation (ERMR) was represented during the inspection by Tony Tennyson. ERMR is the current landowner of the parcel requested for release. The Office of Surface Mining, Reclamation and Enforcement (OSMRE) was present for the inspection and represented by Andrew Monroy. The weather was mostly clear with a temperature of 60° F. The ground conditions were dry.

The SL-27 Bond Release Application (SL-27) requested the Phase I release of 85.5 acres of land that was backfilled, graded, topsoiled and seeded in 2023. The reclamation parcel is split into an eastern portion and a western portion by the Johnson Access Road. The parcel is located to the northwest of the intersection of BB Road and 2700 Road.

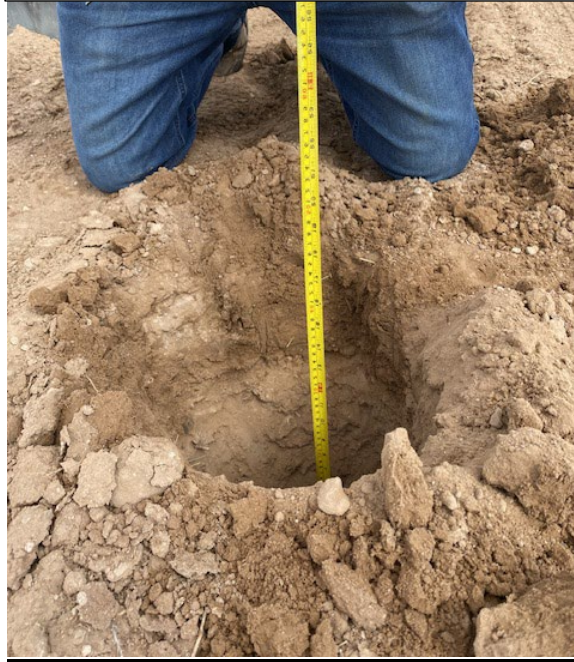
In total 5 topsoil samples were taken during the bond release inspection. Three of which were located in the eastern portion of the reclamation parcel and two were located in the western portion of the reclamation parcel. In the eastern portion of the reclamation parcel sample points 134 and 141 were in the area designated as dryland pasture. Both topsoil samples yielded a depth of 17 inches. Sample point 136 was taken within the area designated prime farmland. Sample point 136 achieved a depth of 24 inches of topsoil. Sample locations 142 and 143 were in the western portion of the reclamation parcel. A depth of 12 inches of topsoil was sampled at point 142 and a depth of 15 inches was sampled at point 143. In general all topsoil samples meet the requirements of the approved depths. Sample point 142 was 12 inches and the permit outlines 12.2 inches. The 0.2 inch difference between the requirement and the sample is likely due to a slight compaction of the soil in that area or is well within a margin of error in the sample recording. Please see the Photographs section of this report to view the photos taken of the topsoil samples collected from the SL-27 Inspection (Photos 1 through 5).

Photo 1: The topsoil ample taken at point 134.

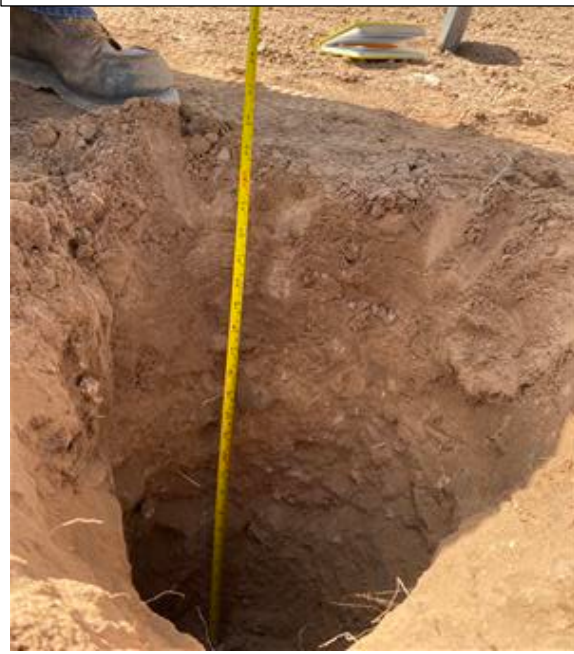
Photo 2: The topsoil sample taken at point 136.

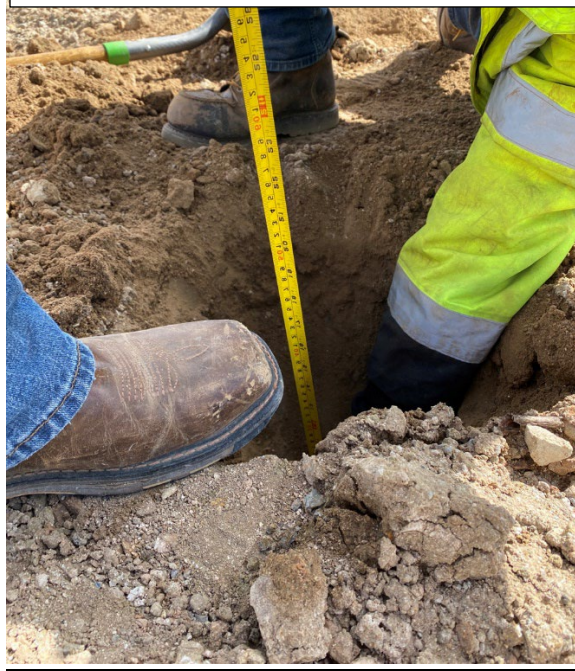
Photo 3: The topsoil sample taken at sample point 141.

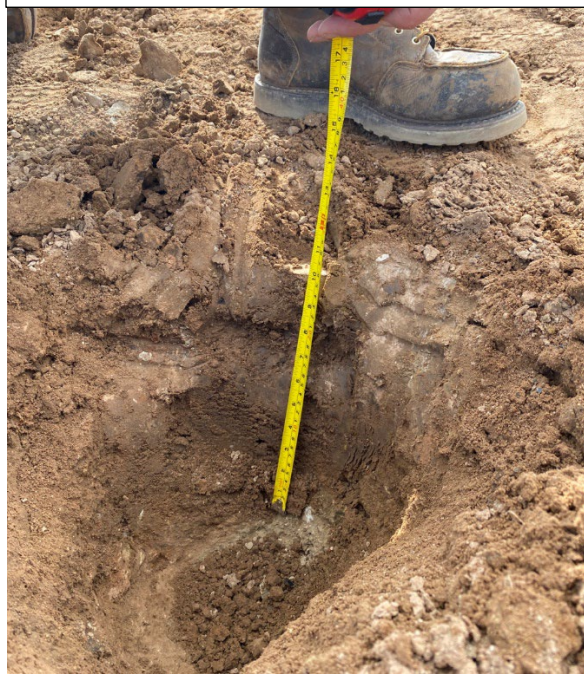
Photo 4: The topsoil sample taken at sample point 142.

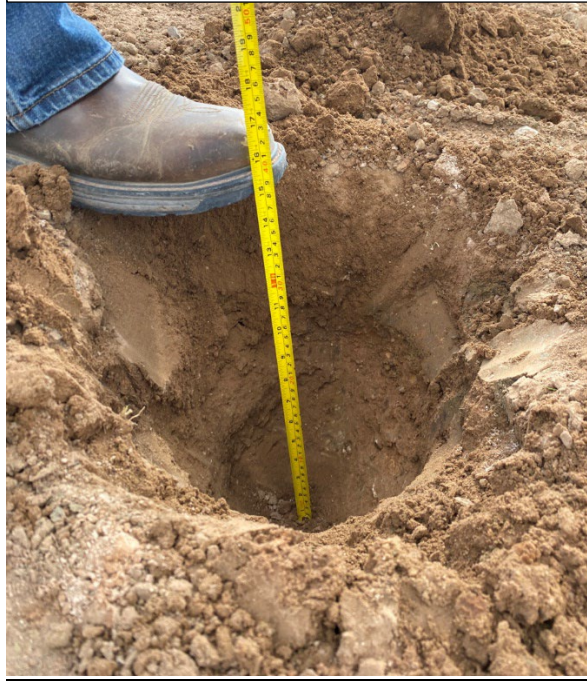
Photo 5: The topsoil sample taken at sample point 143.

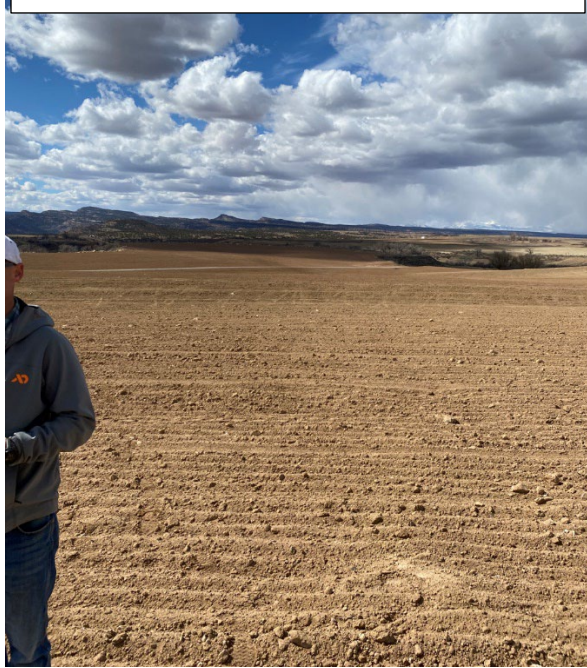
The Division inspected portions of the reclamation other than A-A' and B-B' for the visual accuracy of the topography. The northern and northeastern portions of the reclamation are approved to slope gently to the north. Visual inspections from the Division of these areas confirmed that the reclaimed topography did slope gently to the north. There were no concerns of instability or erosion found in these areas. No indications of differential settling were observed. The southwestern portion of the reclamation parcel is approved to slope to the north in the western portion and to the northeast in the eastern portion of this area. A small section of the southern portion of the southwestern reclamation slopes gently to the south/southwest. This section of the reclamation was observed to slope gently to the north in the western section and then the sloping turns to gently slope to the northeast in the eastern portion. A small section facing southwest of survey point 143 slopes gently to the southwest. The reclamation. This portion of the reclamation was stable and there were no erosional features observed. Additionally, there were no observed signs of differential settling. Please see the Photographs section of this report to view photos taken of the SL-27 reclamation topography (Photos 6 through 8).

Photo 6: SL-27 Reclamation sloping down to the west and then back up in elevation. Photo 6 was taken looking to the west.

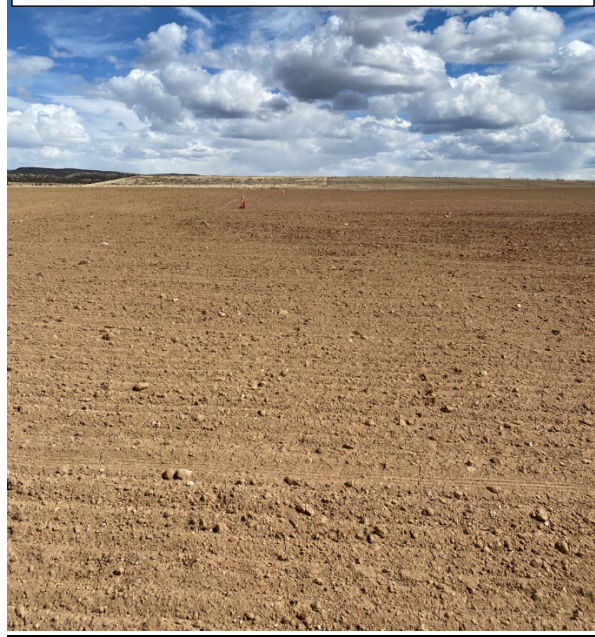
Photo 7: SL-27 reclamation sloping up to the east. Prime farmland is located in the middle of Photo 7. The photo was taken east with the ground sloping down to the west.

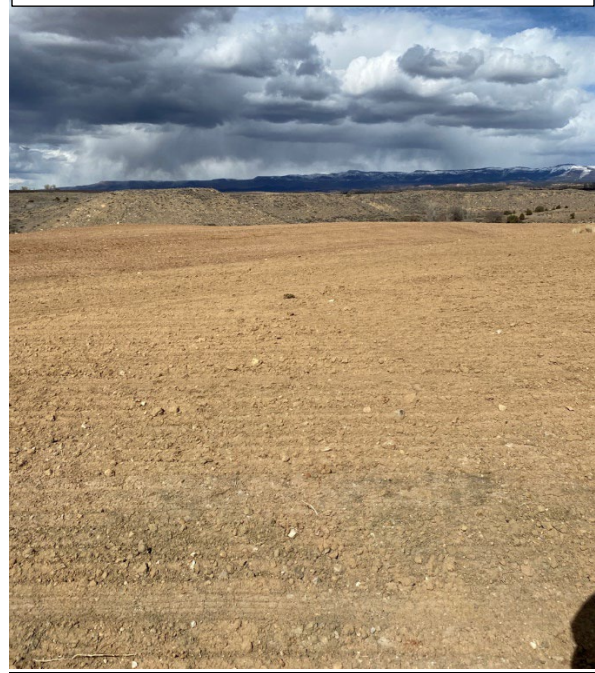
Photo 8: SL-27 reclamation at the eastern section. Photo 8 was taken looking to the north.
