New Horizon North Mine, C-2010-089, SL-4 Inspection Report

C-089, New Horizon North Mine SL-04 Bond Release Inspection Report_CCW.pdf

PERMIT INFORMATION

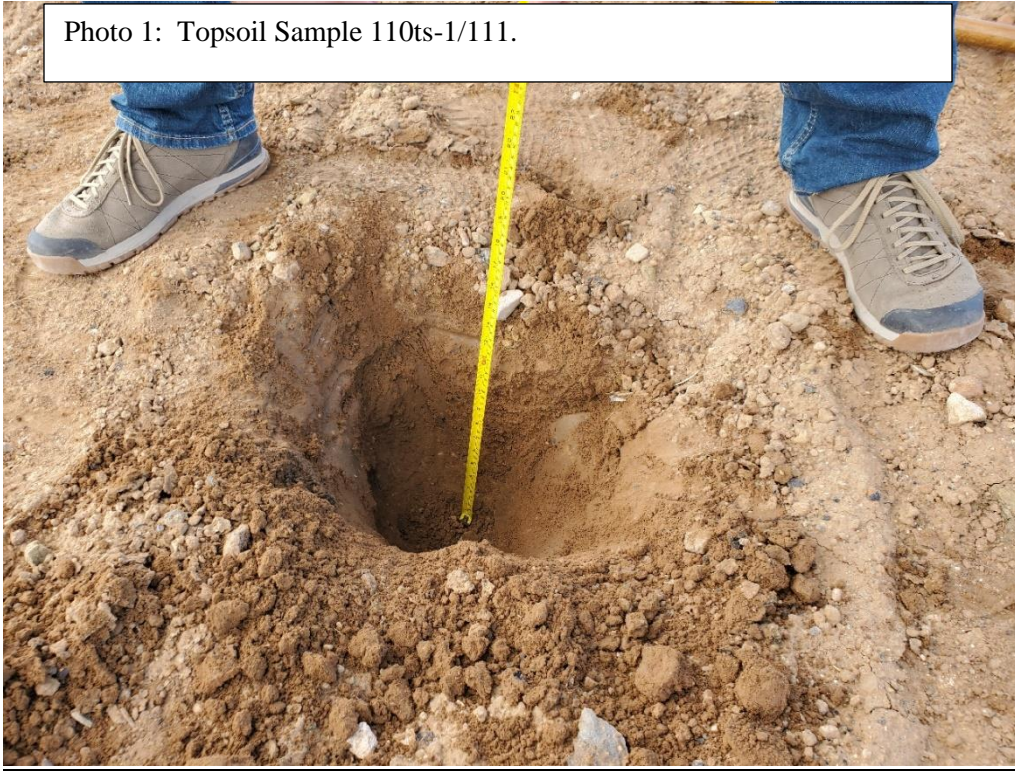
Photo 1: Topsoil Sample 110ts-1/111.

A total of 7 topsoil depth samples were measured in the field. Please not all topsoil sample location data can be found in Table 1 at the end of this report. The Division recorded data points on two devices to ensure that data was collected in an area with little to no cell phone signal. Thus, sample location points have a combined name. Two samples were taken in the southern portion of the requested release area. These were points 110ts-1/111 and 114ts-2/115. Both of these locations yielded a topsoil depth greater that the 1.2 feet required. 110ts-1/111 measured to be 16 inches deep. 110ts-1/111 was measured in the southern permit area. 114ts-2/115 measured to be 15.5 inches deep. 114ts-2/115 was measured in a portion of the reclaimed area of Pond 001. Sample locations 119ts-3/120, 121ts-4/122 were taken within the area of the reclaimed west ditch. Sample location 119ts-3/120 yielded a result of 12 inches. This sample was below the required topsoil depth of 14.4 inches. Discussions at this location with the landowners and ERMR indicated that this location was in the middle of the reclamation work and was used by the reclamation workers to travers back and forth across the reclamation. The workers likely compacted the topsoil by traveling on it frequently. The landowners expressed that they were not concerned about the depth of this topsoil in this location and were pleased with the work that ERMR had completed. Sample location 121ts-4/122 yielded a depth of 17 inches of topsoil. This location exceeded the required topsoil depth. Sample point 123/124ts-5 was taken in the location of the reclaimed pond 002. The topsoil depth at this location was measured to be 16 inches, exceeding the minimum topsoil depth requirement. Sample locations 127/128ts-6 and 131ts-7/133 were taken on the eastern portion of the reclamation in and adjacent to the reclaimed east ditch. Both locations recorded a topsoil depth of 15 inches. Surpassing the minimum topsoil depth requirement. In total 6 of the 7 locations sampled exceeded the minimum topsoil depth requirement and one location reached 83.3% of

the required amount. Discussions with the landowners indicated that they were pleased with the topsoil depths. The Landowners stated that they were not concerned about the depth of the topsoil at 119ts-3/120 and were ok with the amount of topsoil presently on the ground. Please see the Photographs section of this report for images of the topsoil samples taken during the inspection (Photos 1 through 7).

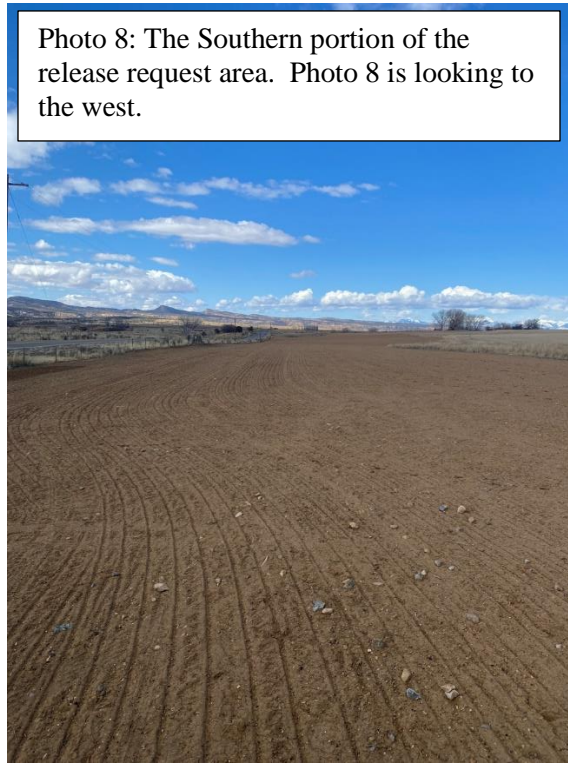
Post mining topography is approved to slope gently to the north, west, south and east from a highpoint located in the central eastern portion of the permit area. The southern portion of the permit area was observed to be sloping gently to the south. The slope was consistent and there were no sections with erosional features. The upper portions of the reclamation blended smoothly with the existing reclaimed dryland pasture to the north. There were no sections with differential settling. Pond 001 was located in the southwest corner of the permit area. The pond was reclaimed reducing it to the size of a stock pond at the request of the Landowners. The topography surrounding the stock pond slope to the south. The edges of the reclamation blended smoothly with the embankments of the pond. There were no rills or other erosional concerns identified on the reclaimed slopes. There were no observed sections of differential settling in that area. The west ditch extended from Pond 001 north to a saddle and then down gradient north from the saddle to Pond 002. The reclamation from the stock pond to the saddle gently sloped to the west and south. The reclamation was stable with no erosional features. The reclamation blended smoothly with the dryland pasture to the east. No areas with differential settling were observed. The remaining reclamation from the saddle north to the reclaimed Pond 002 sloped gently to the west and mostly to the north. The reclaimed area was free of erosion and stable. No indications of differential settling were identified. The reclamation blended well with the dryland pasture to the north. The area where pond 002 and a topsoil stockpile to the east of the pond were reclaimed to slope to the west and north. The reclamation sloped gently to the west and north with no erosional features. The site was stable with no differential settling observed. The reclamation blended well with the dryland pasture to the east and south. The east ditch was approved to slope gently to the south and slightly to the east. The reclamation was stable and had no areas with differential settling. No erosional features were observed. The reclamation sloped gently to the south and ever so slightly to the east. The reclamation blended well at the boundary with the dryland pasture to the west.. The reclamation at the southeast corner bends from the eastern permit boundary to the southern permit boundary. The reclamation in this area was approved to slope primarily to the south and slightly to the southeast. The reclamation followed the approved plans and sloped mostly to the south and the southeast portion sloped gently to the southeast. The section of reclamation had no erosion and was stable. No differential settling had occurred. The northwest section of this reclamation blended well with the adjacent dryland pasture. In general the topography observed during the inspection closely resembled that of the approved post mining topography (Map 2.05.4-1. The Division discussed with the Landowners the contours of the reclamation. They indicated to the Division that they were pleased with the outcome of the reclamation work. They further stated that they had no concerns regarding the reclamation being applied for under the SL-4 Bond Release Application. Please see the Photographs section of this report for the observations of the reclamation taken during the inspection (Photos 8 through 15).

Photo 8: The Southern portion of the release request area. Photo 8 is looking to the west.

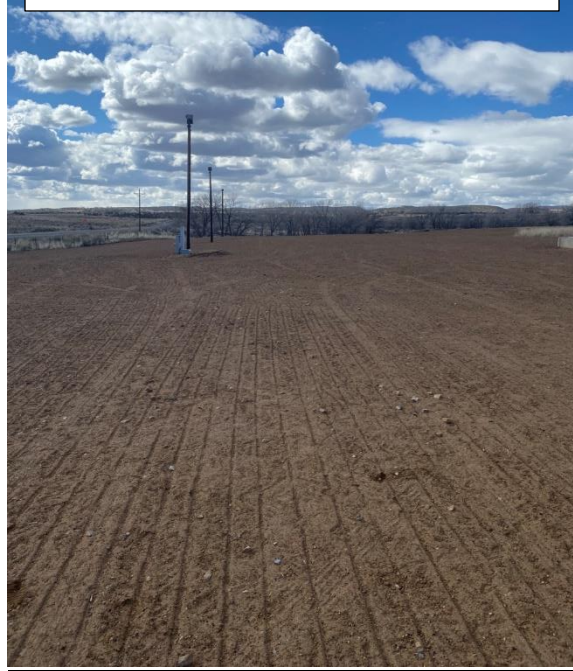
Photo 9: The southern release request area. Photo 9 is looking to the east.

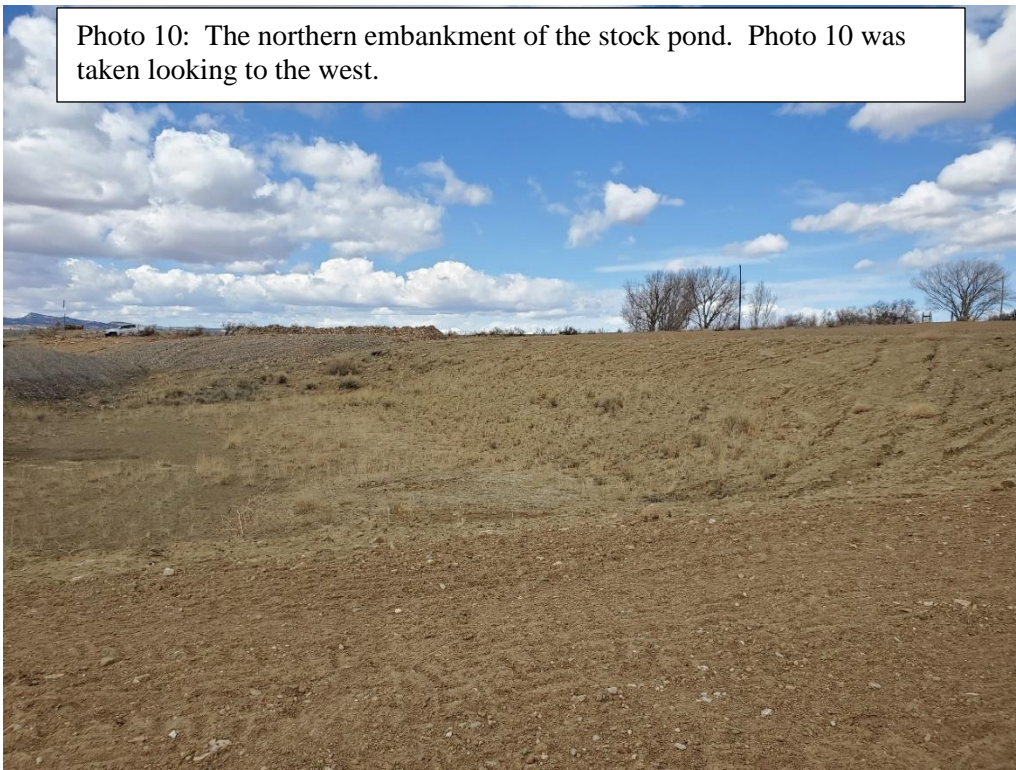
request of the landowners. The pond is located at the southwestern corner of the permit area. The pond was stable with no major erosional concerns. There are minor rills on the pond's embankments. Some vegetation was on the pond embankments to help stabilize the embankments. Rills on the embankments of stock ponds is common and none of the rills observed indicated a potential to create damage to the pond. Discussions with the Garveys indicated that they were not concerned with the rills and that they were happy with the reclamation of the pond. The reclamation work performed at Pond 001 was included in the Phase I release request for SL-4.

Photo 10: The northern embankment of the stock pond. Photo 10 was taken looking to the west.

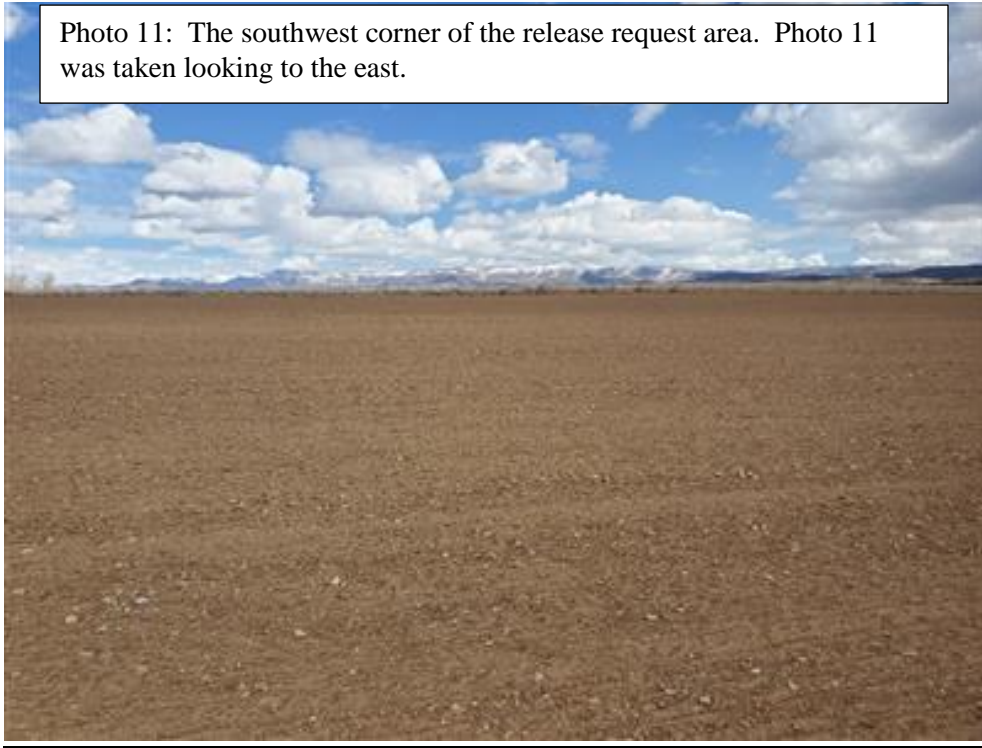
Photo 11: The southwest corner of the release request area. Photo 11 was taken looking to the east.

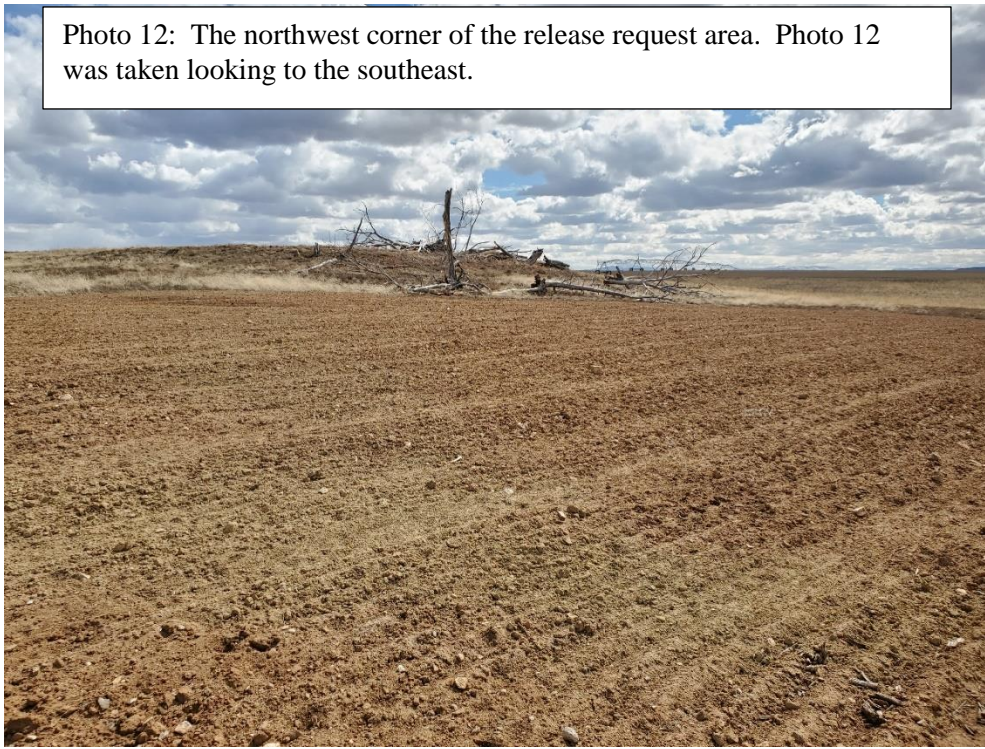
Photo 12: The northwest corner of the release request area. Photo 12 was taken looking to the southeast.

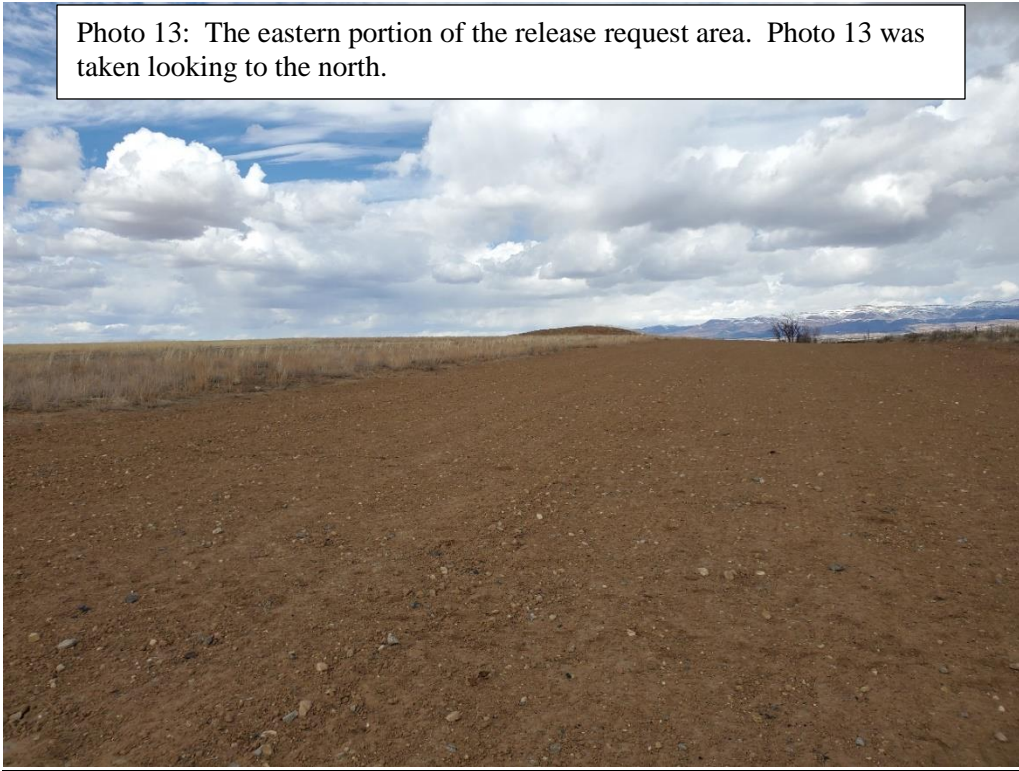
Photo 13: The eastern portion of the release request area. Photo 13 was taken looking to the north.

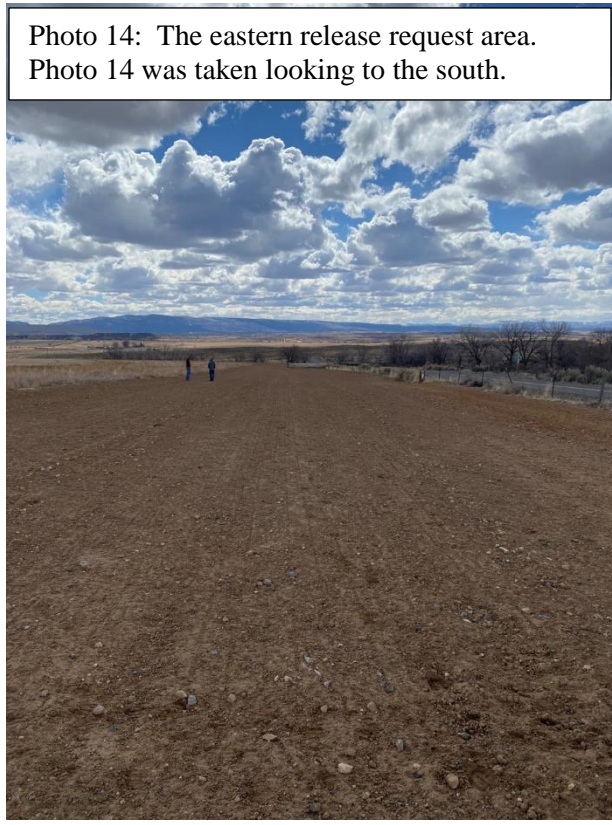
Photo 14: The eastern release request area. Photo 14 was taken looking to the south.

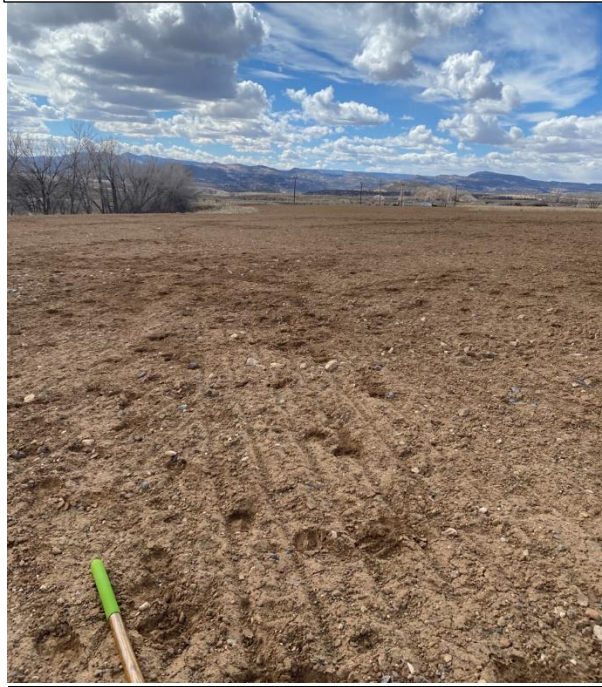
Photo 15: The southeast corner of the release request area. Photo 15 was taken looking to the southwest.

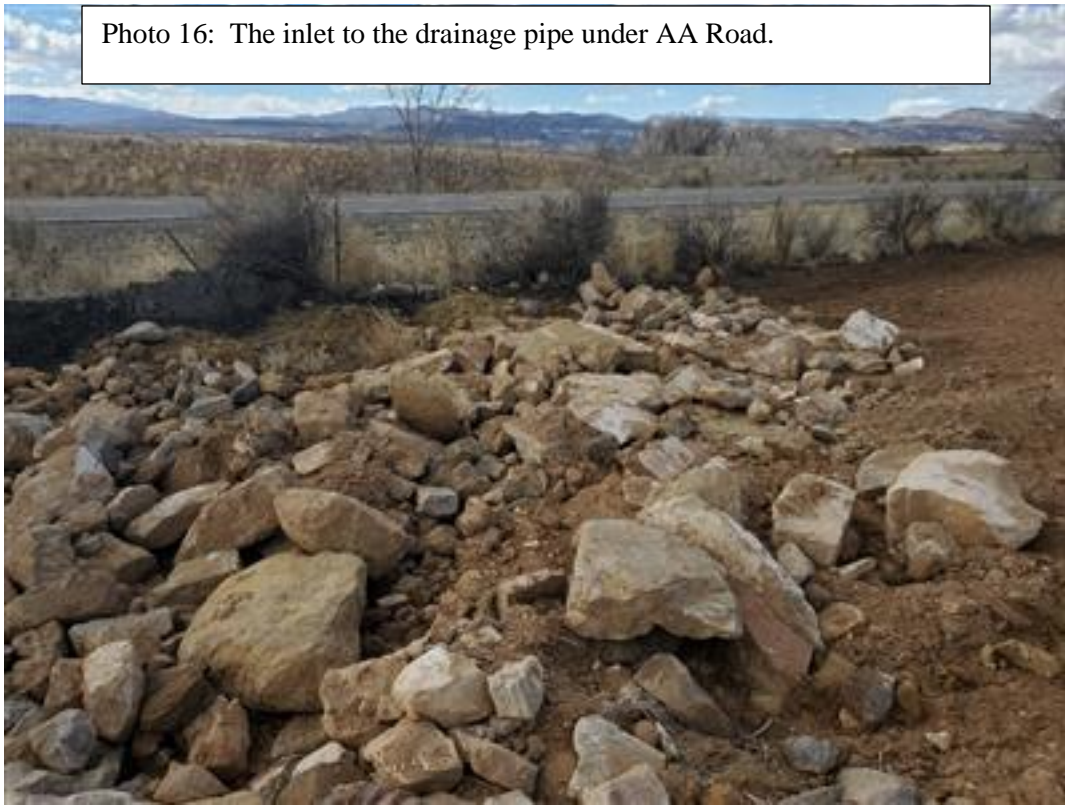
Both structures have been approved to remain as permanent post-mining features as requested by the landowner, ERM. The two structures will remain in their current configuration. The Discharge pipe under AA Road was in good condition and clear of obstructions. The inlet to the pipe is lined with riprap. The riprap was in good condition and no erosion was observed. The inlet to the pipe was stable. The outlet from the pipe was also lined with riprap. The outlet was stable and there were no indications of erosion. The riprap liner was in good repair. The access road leads south from AA road and continues to the south to a stock pond. The road was stable with no erosional concerns. There were no off-site impacts observed. For visuals of the Access road and the supporting drainage pipe please see the Photographs section of this report (Photos 16 through 18).

Photo 16: The inlet to the drainage pipe under AA Road.

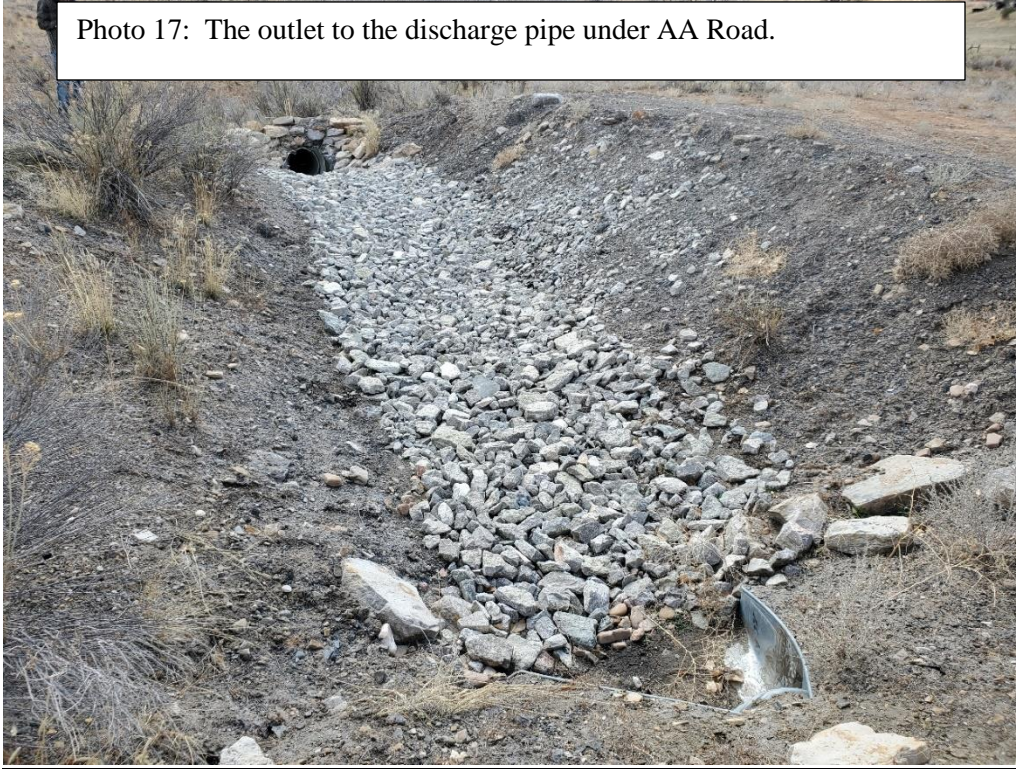
Photo 17: The outlet to the discharge pipe under AA Road.

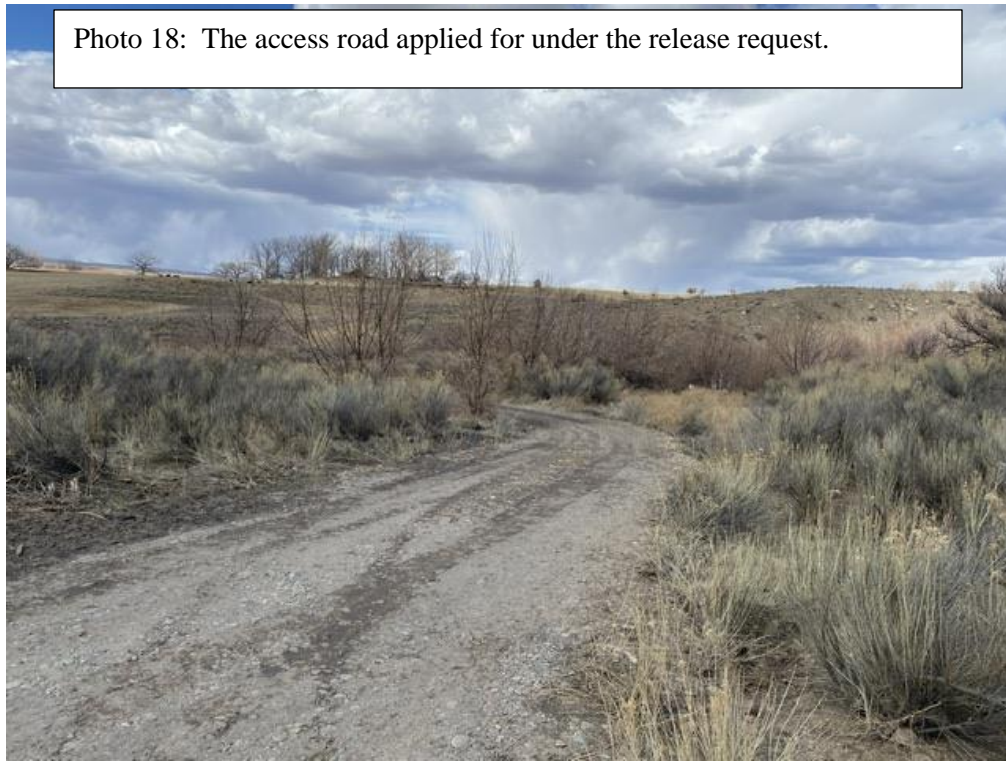
Photo 18: The access road applied for under the release request.
