Inspection Report, New Elk Mine, April 10, 2024 Inspection

Attached for your records is a copy of the Division's inspection report for the partial inspection of the New Elk Mine, C-1981-012, conducted on April 10, 2024.

Permit Number: C-1981-012 Mine Name: New Elk Mine Operator: New Elk Coal Company, LLC Operator Address: Mr. John Terry 12250 Highway 12 Weston, CO 81091	County: Las Animas Operation Type: Underground Permit Status: Active Ownership: Private
	Operator Representative Present: John Terry
Operator Representative Signature: (Field Issuance Only)

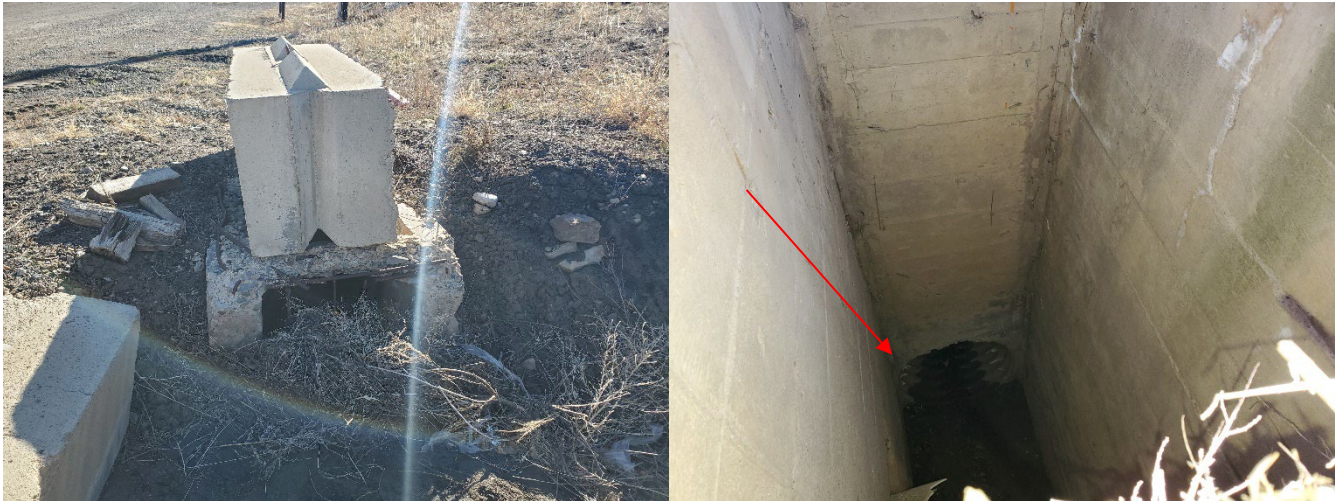
- During the previous inspection, the Division attempted to collect a measurement of culvert C11, and found that it was unreachable (Photo 1). During the April 2024 inspection, the Division was able to measure the outlet side of C11 (Photo 2). C11 at the outlet side is metal, and has a one foot diameter.

Photo 1: Photos from the Division's previous inspection. (Left) concrete cover over C11. (Right) Arrow points to C11.

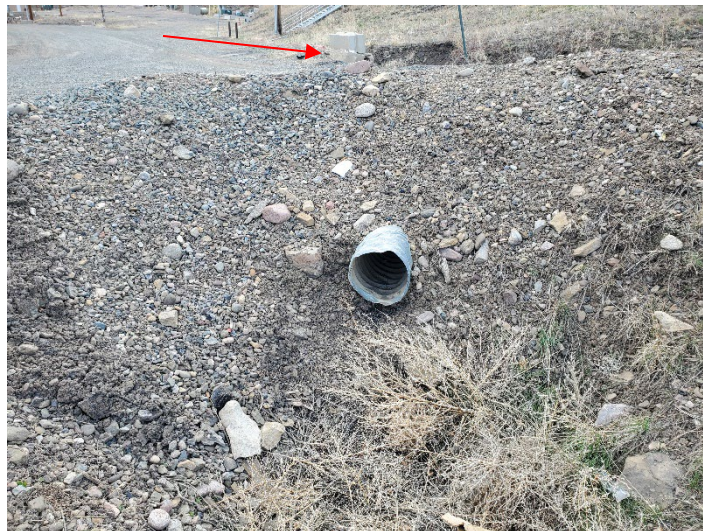
Photo 2: C11 (Arrow points to other side of C11 shown in Photo 1).

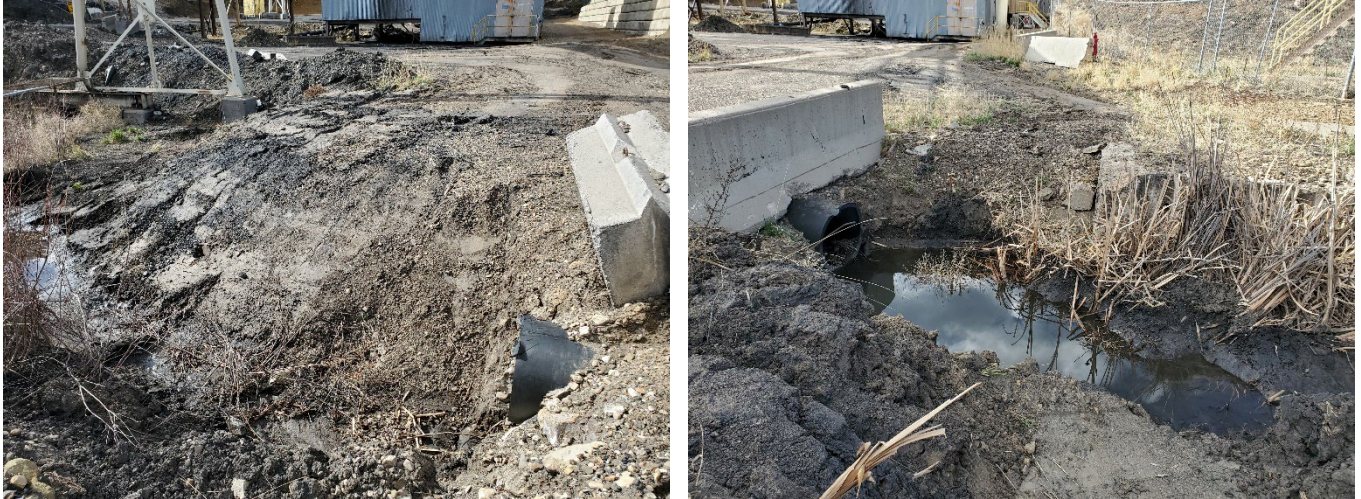
- Erosion was observed on the road area above and to the side of Culvert C16D during the February 2024 inspection. This bank area has been repaired and stabilized, and the ditch on C16D's west inlet has been cleaned also (Photo 3).

Photo 3: (Left) Stabilized bank around C16D. (Right) Cleared out west side of C16D.

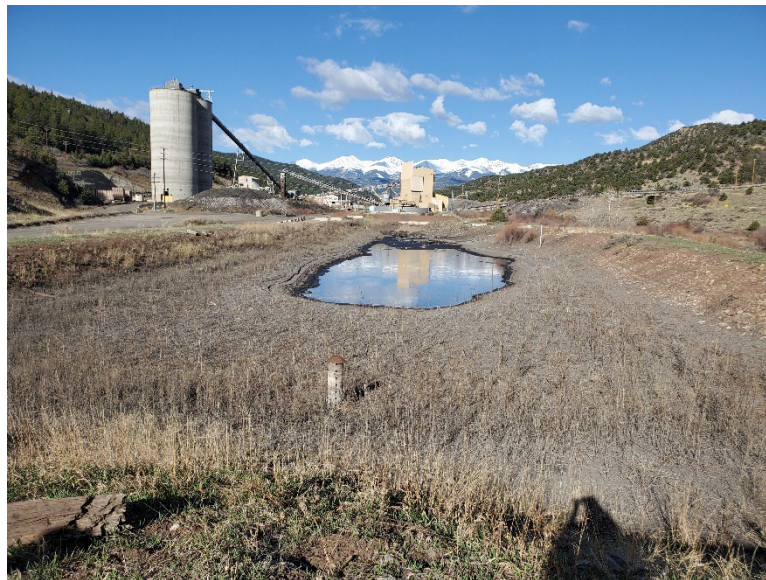
Photo 4: Pond 007A

- During the previous inspection, Containment #5 was observed. The Division informed the Operator that Containment #5 would require some maintenance, such as cleaning some of the sediment accumulation, before operations begin. The Operator stated during the April 2024 inspection that Containment Area #5 was expected to be cleaned within the following week.
- Pond 007A contained a small amount of water but was not discharging (Photo 4). The emergency spillway was free of obstructions and the embankment appeared to be stable. Pond 007A had recently been pumped to Pond 004.

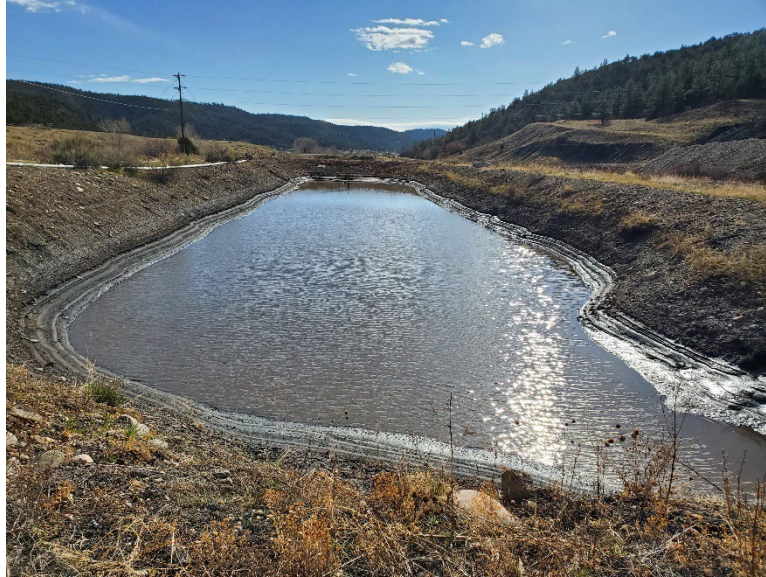
Photo 5: Pond 006A.

- Pond 006A contained some water that was being pumped to Pond 004 during the inspection (Photo 5). The banks around Pond 006A appeared to be stable.

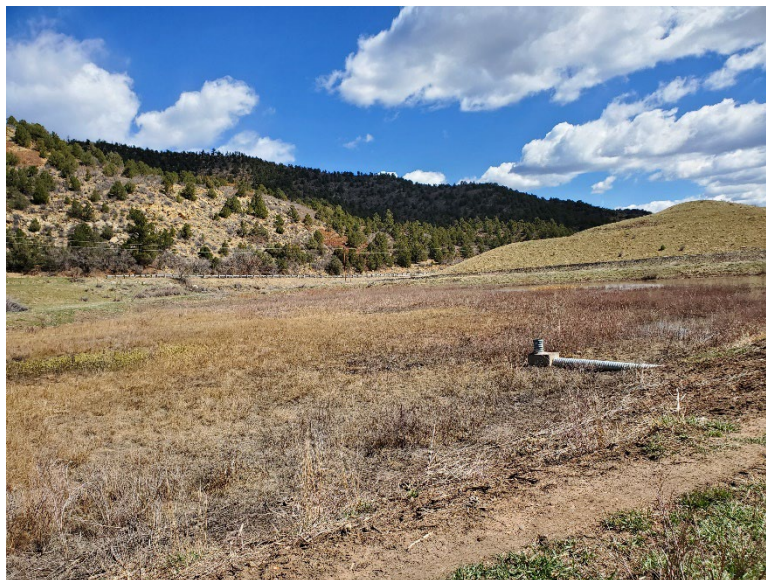
Photo 6: Pond 004.

- Pond 004 contained some water, primarily from the water that had been pumped from Pond 007A and was being pumped from Pond 006A (Photo 6). Ditch D2 is used to pump water from Ponds 006A, 007A, and 08. Ditch D2 contained water being pumped from Pond 006A during the inspection (Photo 7). Pond 004 was not discharging.

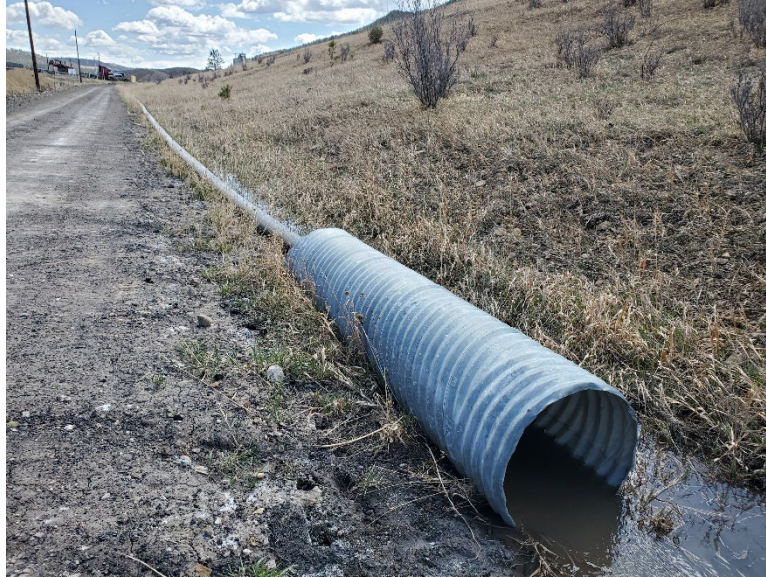
Photo 7: Ditch D2 being used to pump water from Pond 006A to Pond 004.

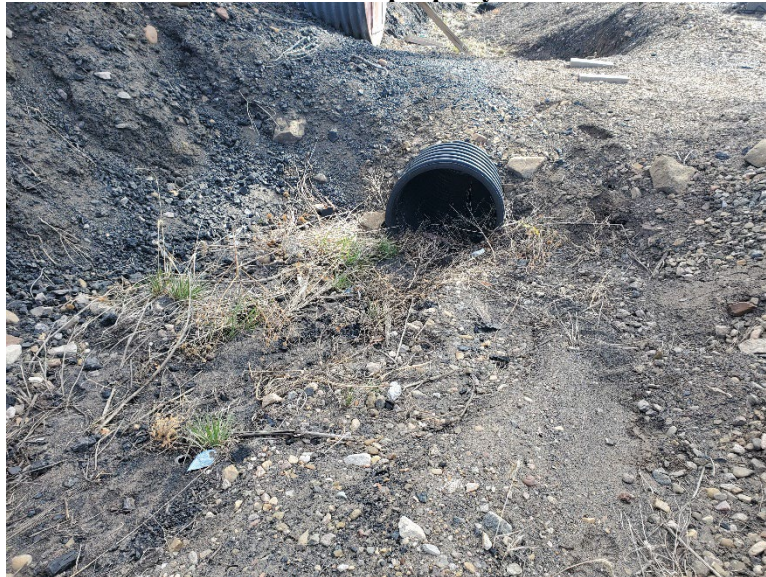
- Culvert C17A contains an accumulation of sediment (Photo 8). **The Operator shall clean the culvert to remove the sediment to ensure it can function properly.**

Photo 8: C17A has accumulated excess sediment.

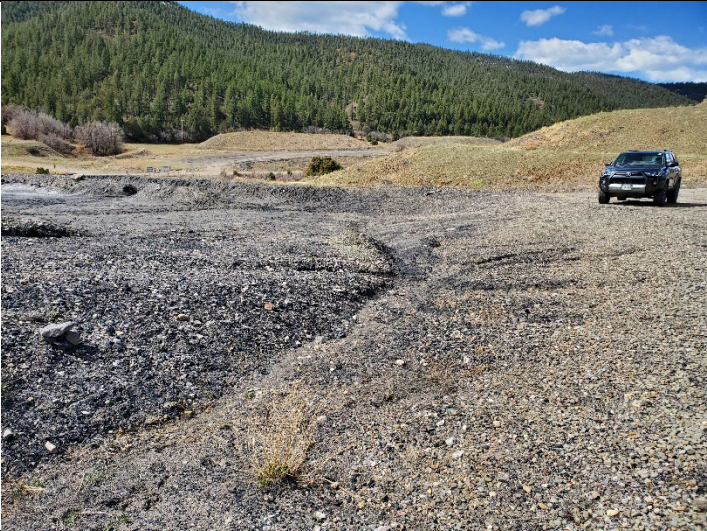
12	0.95 x 4.3	Trap.	N/A	Trap.

-No longer a ditch, slopes down to the west side, and into D14
13	0.59 x 2.93	V	3.5 x 10	V

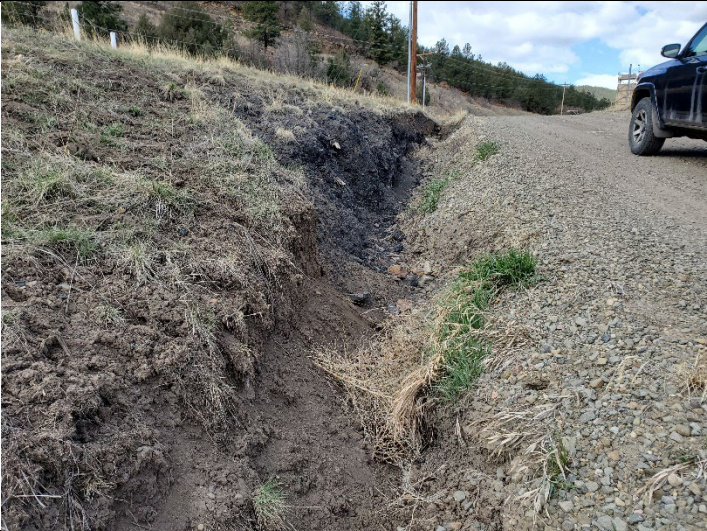
17B	0.92 x 4.59	V	0-4 x 5	V

-Ranges from about 4' at the top of the slope, down to 0' at the bottom of the road.
18	2.5 x 13.8	V	2.41 x 10'	Trap.

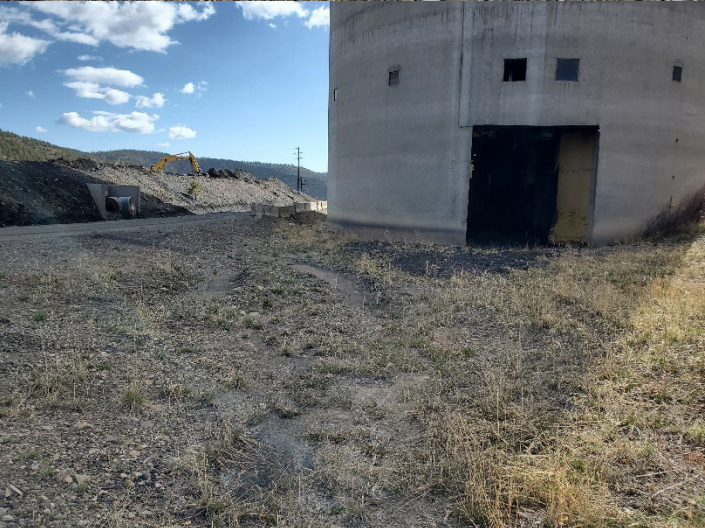
24D	0.86 x 4.28	V	0.16-0.25 x 10	Trap.

-Not a really a ditch, more of a depression/path on the side of the road.

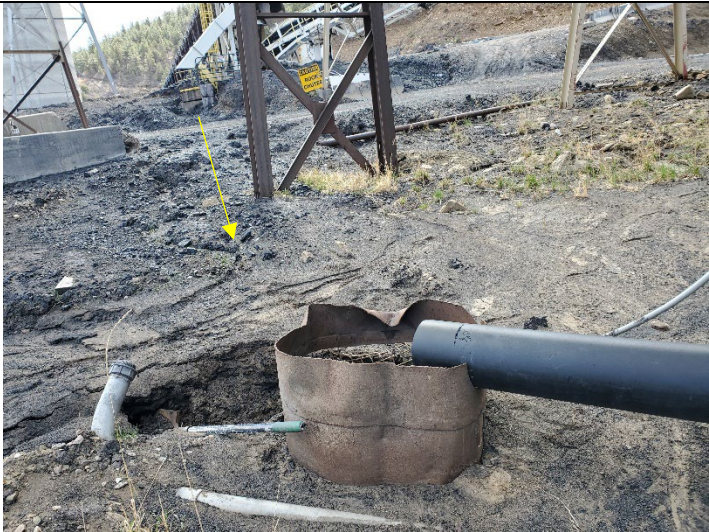
25	1.5 x 7.5	V	2 x 8.75	N/A

-Not a ditch anymore. The Operator believes that it was at one point, but now the water runs over a slope that runs down the road into culvert C31.
26	1.44 x 10.61	V	2 x 19	Trap.

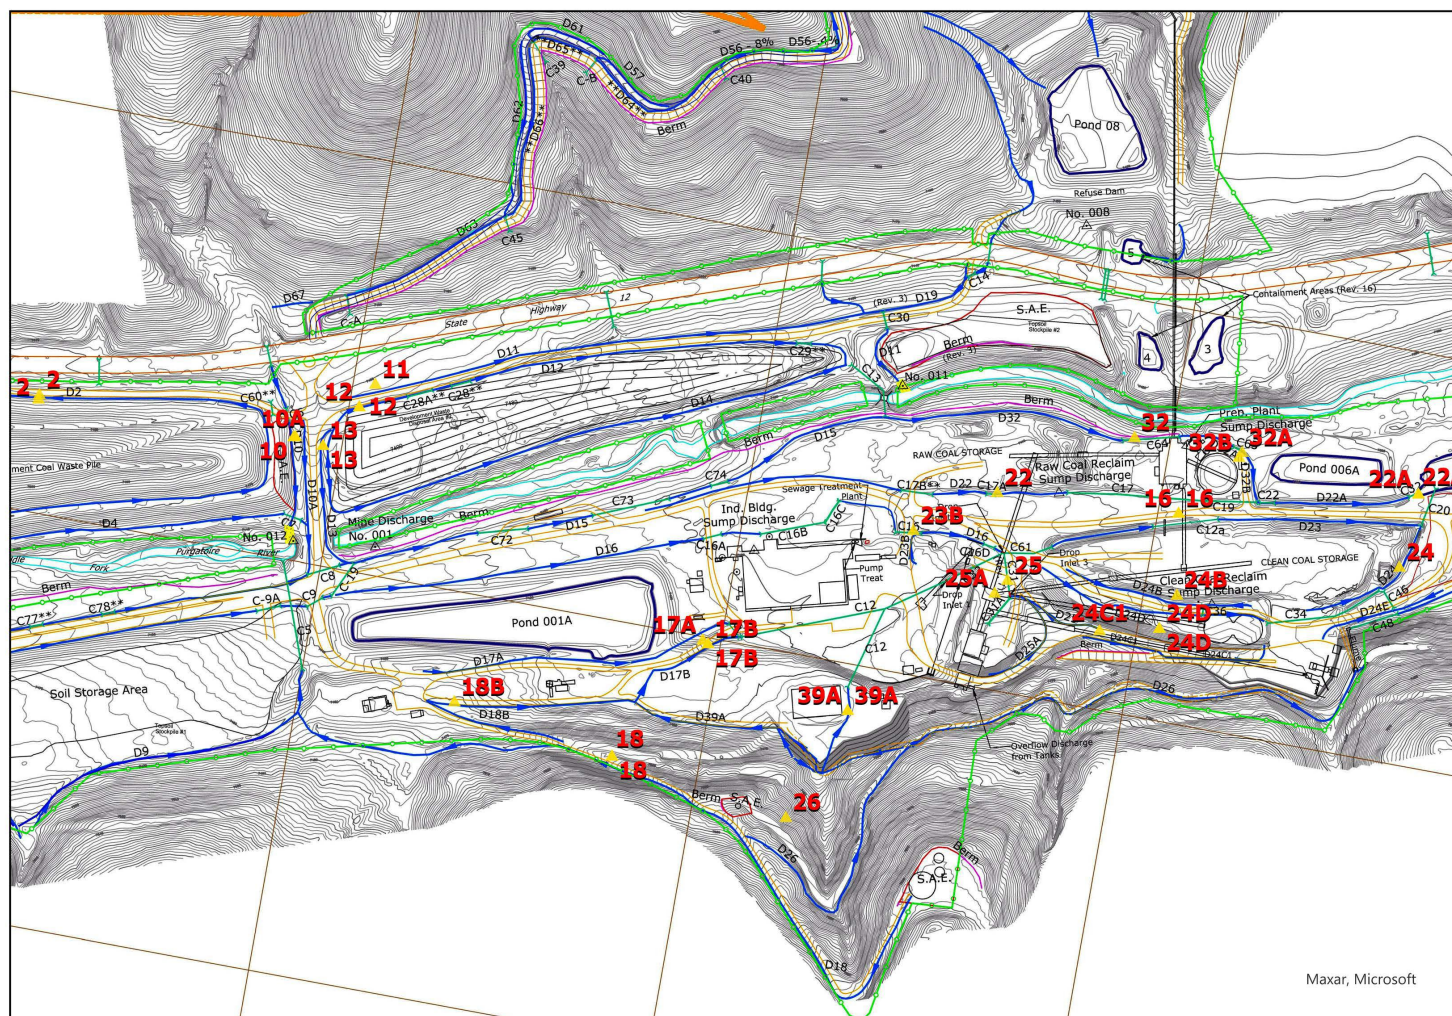
Figure 1: Figure indicating the approximate locations where photos and measurements were taken for each ditch in Table 1, overlain onto the *Map 13: East Portal Sediment and Surface Water Control Plan* map from the PAP. *There is some error in the photo locations in relation to the locations indicated on the map.
