PERMIT INFORMATION

Permit Number: C-1981-019 Mine Name: Colowyo Coal Mine Operator: Colowyo Coal Company L.P. Operator Address: Mr Tony Tennyson 5731 State Highway 13 Meeker, CO 81641	County: Moffat, Rio Blanco Operation Type: Surface Permit Status: Active Ownership: Private
	Operator Representative Present: Tony Tennyson and Tom Fry
Operator Representative Signature: (Field Issuance Only)

This was a partial inspection of the Colowyo Coal Mine; DRMS Permit No. C-1981-019, operated by Colowyo Coal Company (Colowyo). The inspection was conducted by Hunter Ridley and Zach Trujillo with the Colorado Division of Reclamation, Mining, and Safety (Division). Tony Tennyson, representing Colowyo was present at the mine office and Tom Fry of Colowyo accompanied the inspection. Weather during the inspection was clear with temperatures around 40° F. Muddy conditions prohibited access to more remote areas of the site.

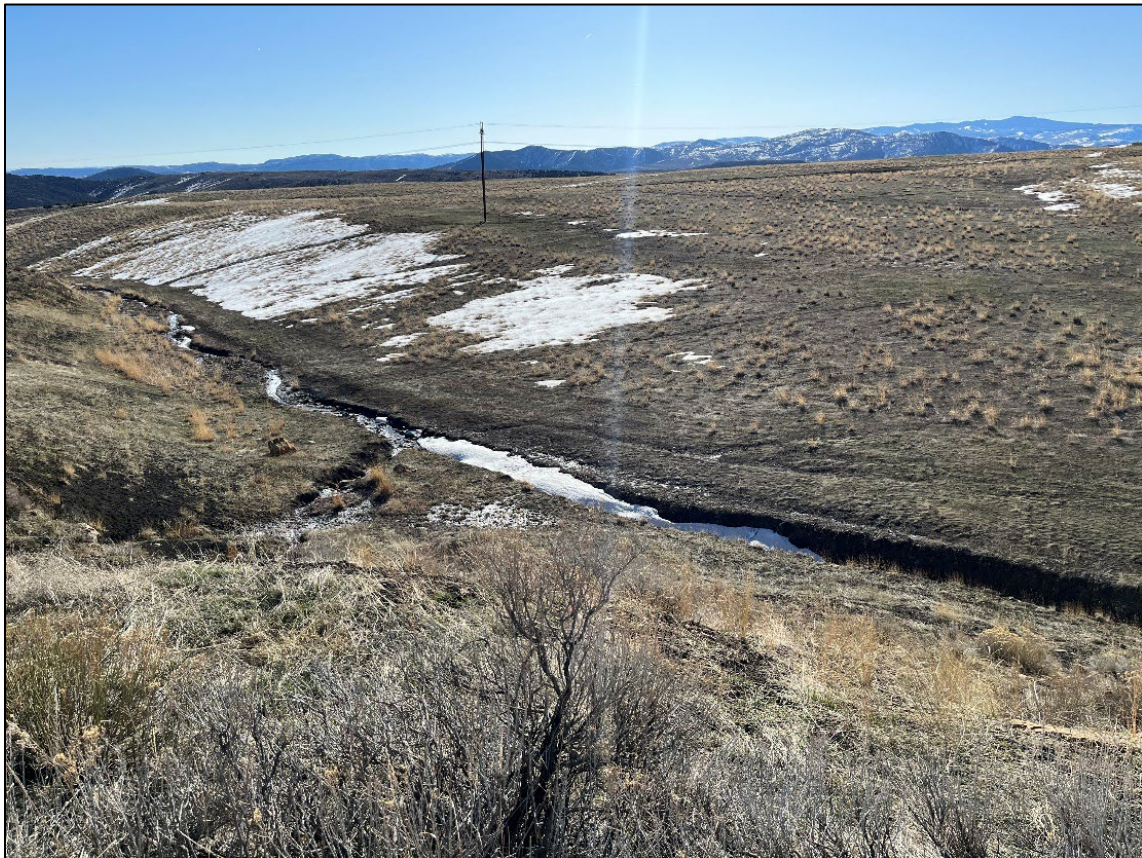
The following ditches in the East Pit were observed during the inspection: Streeter Ditch (Photo 1), Section 15 Ditch (Photo 8), and the Final East Pit Ditch (Photo 9). All ditches were only partially observed from vantage points and will be inspected on foot later in the year when conditions allow. Mid-sized erosional cuts were noted on the southern end of the Streeter Ditch. This issue may be resolved with the construction of the Upper Section 3 Pond and Lower Section 3 Pond set to be built this summer, however repairs may still be necessary. This has been added as a maintenance item. The crest of EP2 was visible from the Final East Pit Ditch observation vantage point. Other stock ponds along this ditch will need to be walked during the spring/summer inspections. Section 15 pond was inaccessible during this inspection.

Photo 1: View east of Streeter Gulch Ditch.

- Monitor the slump area at Section 26 Pond
- Regrade and seed the topsoil pile in the northern section of Collom Pit when conditions allow
- Monitor Streeter Ditch cuts, repair if necessary
- Monitor the small erosional feature in D4, repairs will be necessary if conditions worsen

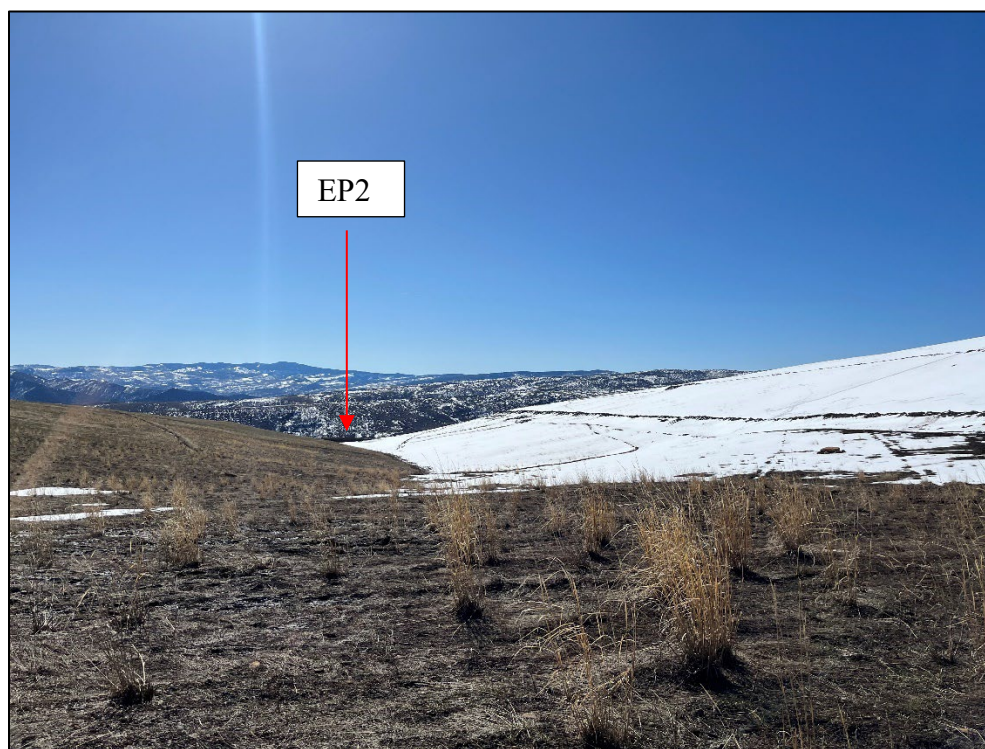
Photo 9: View south / southeast of the Final East Pit Ditch, EP1 and EP3 are located downgradient. The crest of EP2 is just slightly visible in the background.

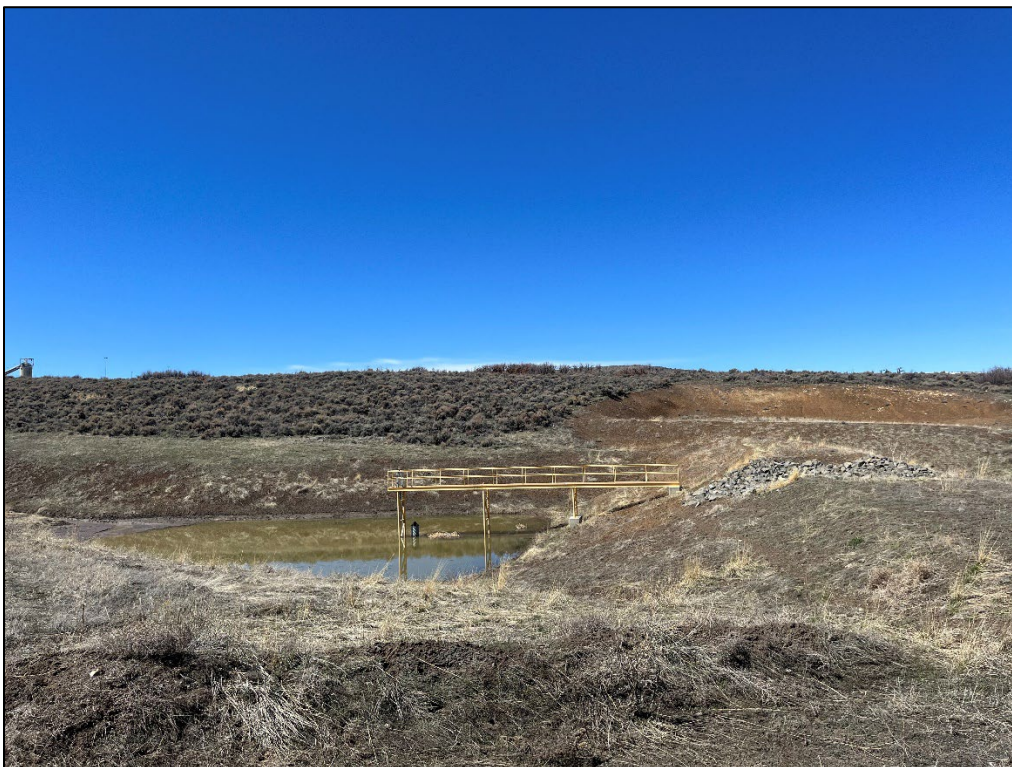
The following Ponds in the Collom Pit area were inspected this month: Section 36 Pond (Photo 16), Sidehill Pond (Photo 20), Middle Pond, and Section 25 Pond (Photo 17), Section 26 Pond (Photo 19). No outstanding problems were noted at any of the ponds, however the slump area at Section 26 Pond will need to continue to be monitored closely for any signs of degradation. Section 25 Pond has had maintenance issue previously, but currently has no signs of erosion or notable items of concern. All ponds were observed to be holding water.

Photo 16: Section 36 Pond.

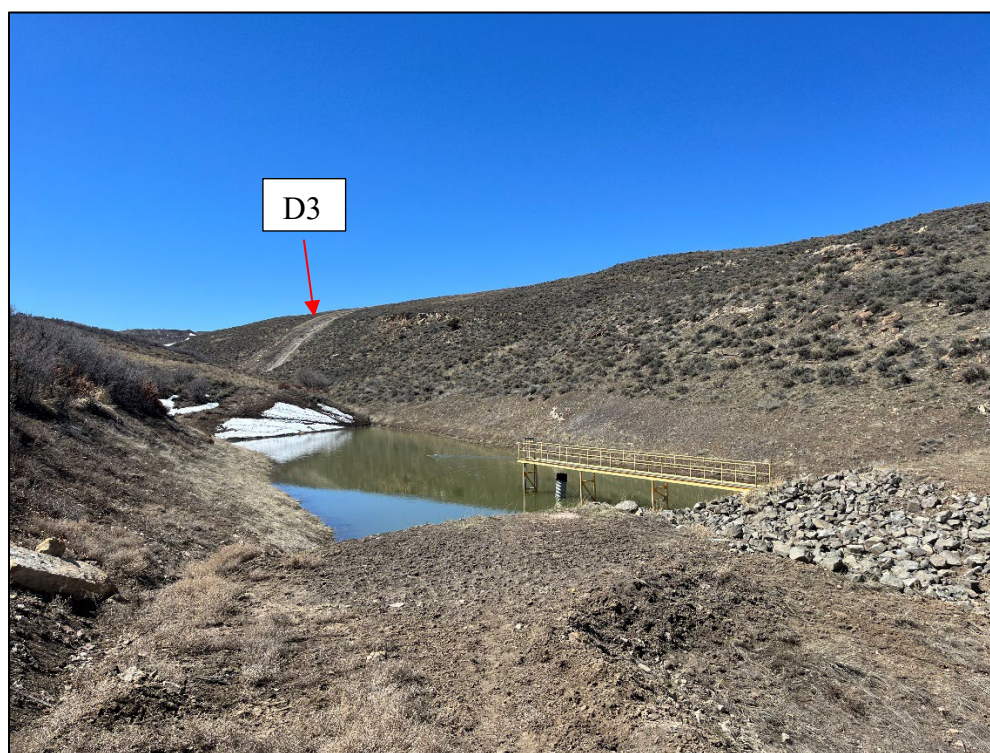
The following ditches in the Collom Pit area were inspected this month: D1, D2, D3 (Photo 17), and D4 (Photo 20). These ditches were observed from along the road and from vantage points near ponds in the area. The southern end of D4 had a small erosion feature within the channel; there is no concern at present, but this area should be monitored for any signs of increasing erosion. All other channels appeared to be stable and functioning properly.

Photo 17: Section 25 Pond.

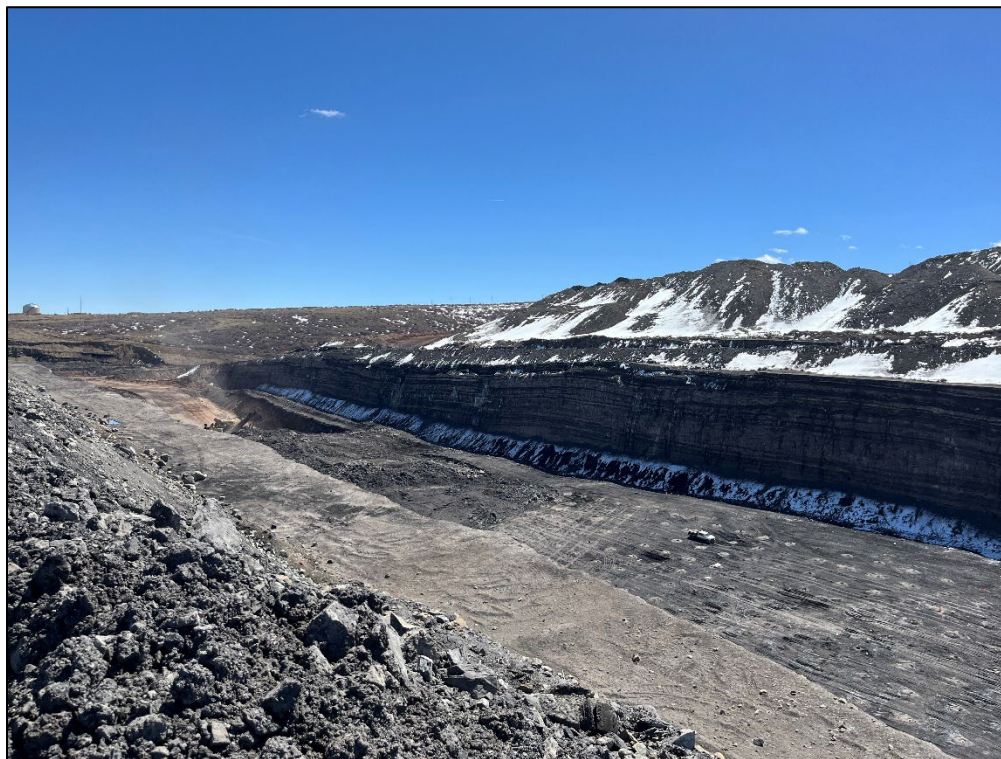
As of the time of the inspection, only five blasts have occurred at the Colowyo Mine in 2024. All blasting is currently occurring in the Collom Pit. Drill holes were being prepped in the active truck and load section of the northern portion of Collom Pit (Photo 18). No blasts were observed during the inspection.

Highwall mining operations continue in the eastern portion of the Collom Pit. The highwall miner was entering in a western direction and moving south. Previous entries have been backfilled as the mining progresses. Tuck teams were noted to be actively excavating and hauling previously blasted material from the western side of the Collom Pit (Photo 18).

Photo 18: View into the active truck and loader excavation area of Collom Pit.

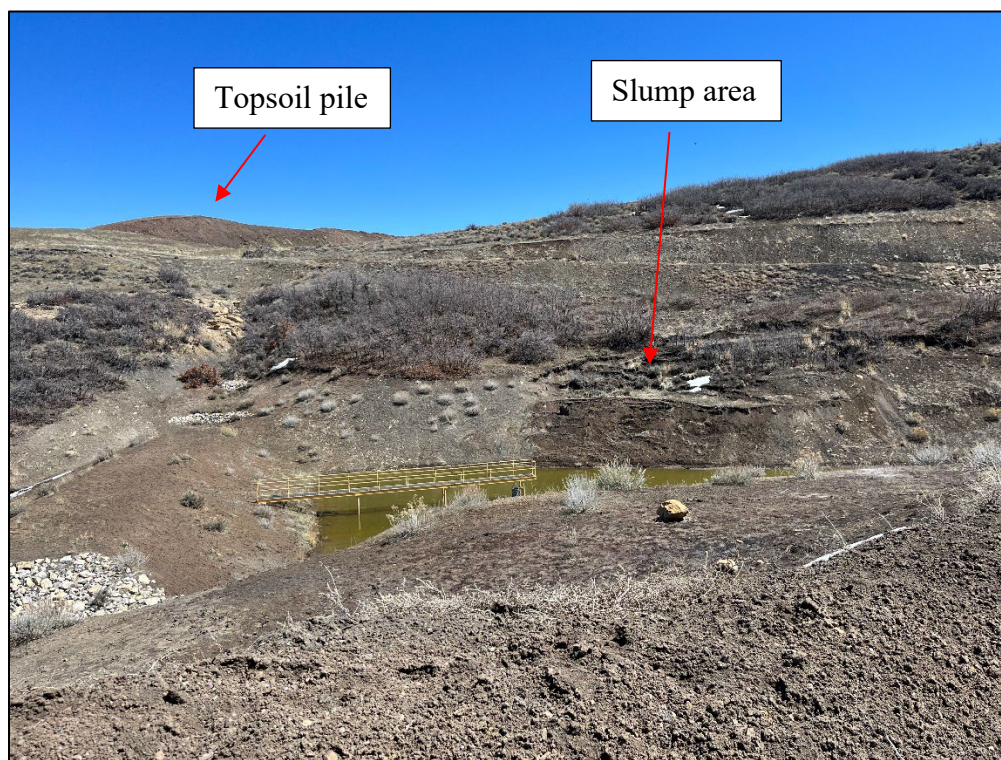
Topsoil piles across the site contained appropriate markers. The topsoil pile behind Section 26 Pond will need to be shaped and seeded when conditions allow (Photo 19).

Photo 19: Section 26 Pond, slump to the east continues to be monitored.

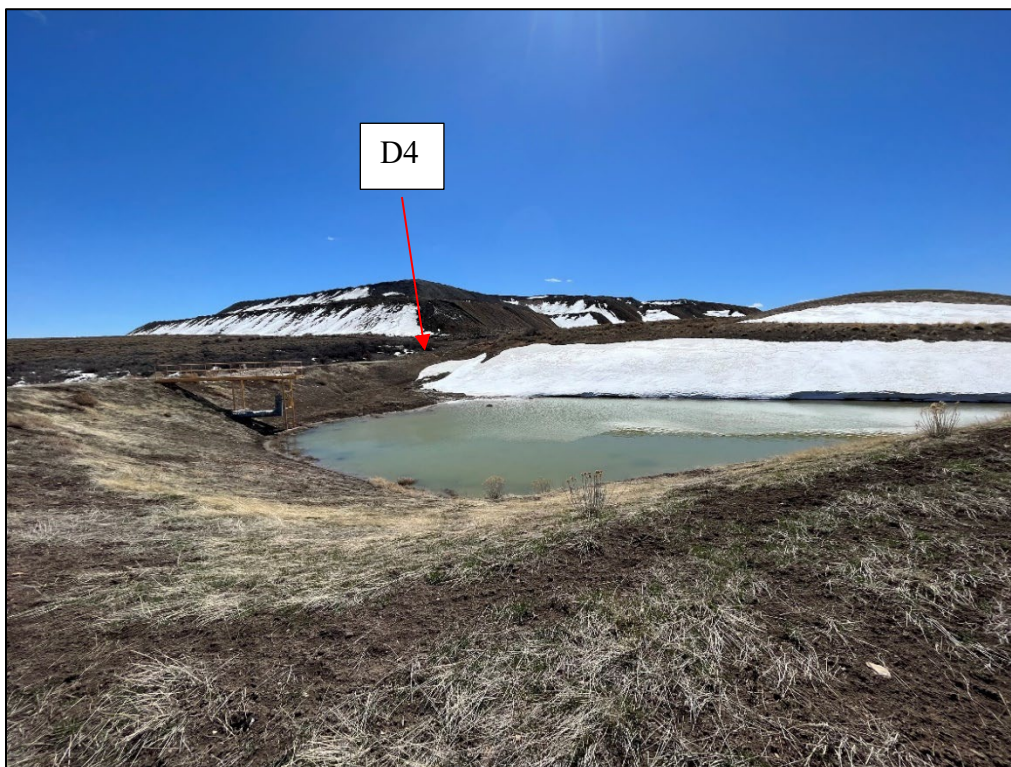
Photo 20: Sidehill Pond.
