MINERALS PROGRAM INSPECTION REPORT

MINE NAME: St. Barbara Sand and Gravel Mine	MINE/PROSPECTING ID#: M-2004-013	MINERAL: Sand and gravel	COUNTY: Pueblo
INSPECTION TYPE: Monitoring	WEATHER: Clear	INSP. DATE: March 19, 2024	INSP. TIME: 12:00
OPERATOR: Pete Lien & Sons, Inc.	OPERATOR REPRESENTATIVE: Duane Pollard	TYPE OF OPERATION: 112c - Construction Regular Operation

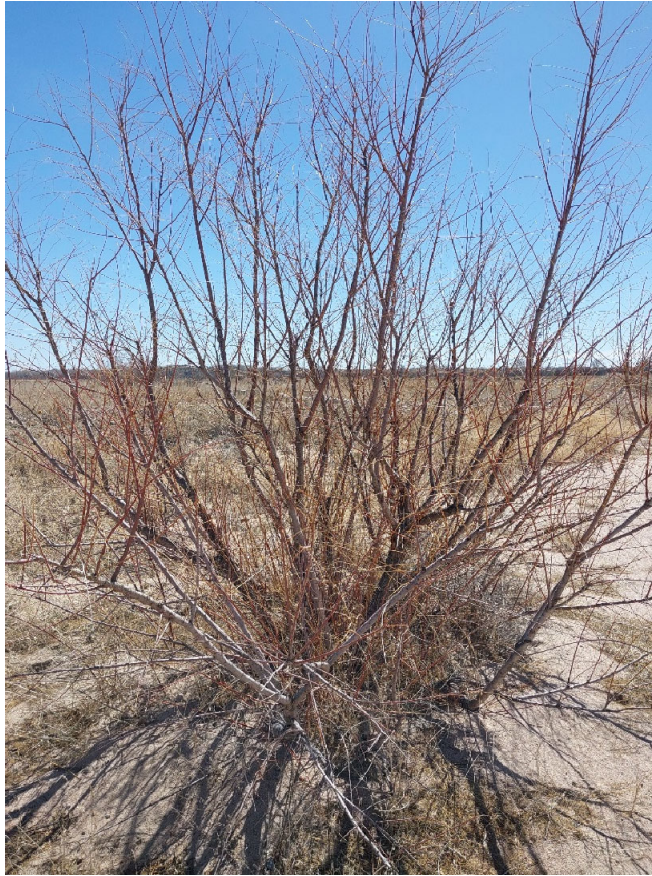
Tamarisk, a list B noxious weed, appears to be growing throughout the permit area. There were several areas of note that are marked on the map given below. The noxious weed appeared to be growing around the perimeters of each of the ponds and on the topsoil stockpile.

Photo #11: Well developed tamarisk located on the north side of the 1.05 acre pond.

CORRECTIVE ACTIONS: Implement approved weed control plan and provide photographic proof to the Division that this has been done.

The Operator needs to implement their weed control plan and have these plants removed.

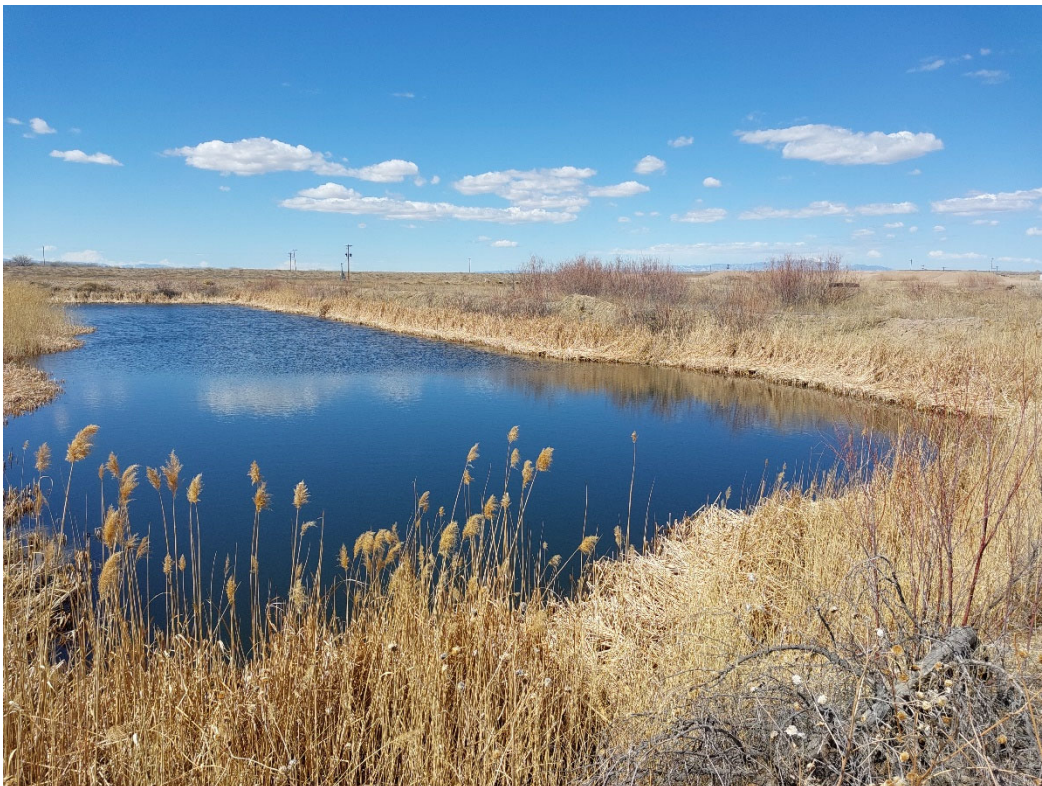
Photo #12: Smaller pond, located south of product stockpile on the east side of the permit boundary; measured area of exposed groundwater is 0.811 acres.
