MINERALS PROGRAM INSPECTION REPORT
PHONE: (303) 866-3567

MINE NAME: Lindsey Pit	MINE/PROSPECTING ID#: M-2013-015	MINERAL: Gravel	COUNTY: Phillips
INSPECTION TYPE: Monitoring	WEATHER: Cloudy	INSP. DATE: April 10, 2024	INSP. TIME: 12:00
OPERATOR: Mike L. Koellner dba L&L Ready Mix	OPERATOR REPRESENTATIVE: NA	TYPE OF OPERATION: 110c - Construction Limited Impact	
REASON FOR INSPECTION: Normal I&E Program	BOND CALCULATION TYPE: None	BOND AMOUNT: \$30,137.39	
DATE OF COMPLAINT: NA	POST INSP. CONTACTS: None	JOINT INSP. AGENCY: None	
INSPECTOR(S): Jocelyn Carter Jared Ebert	INSPECTOR'S SIGNATURE:

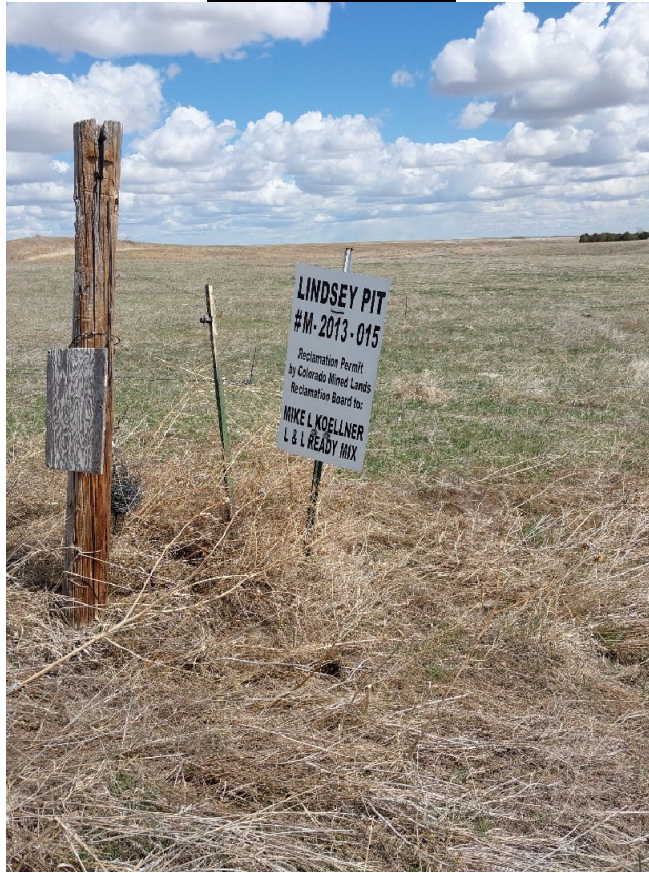
There is a sign at the entrance of the mine site in accordance with Rule 3.1.12(1) and the permit boundary markers are in place in accordance with Rule 3.1.12(2).

Photo #1: Mine sign at entrance off County Road 7, in accordance with Rule 3.2.12(1).

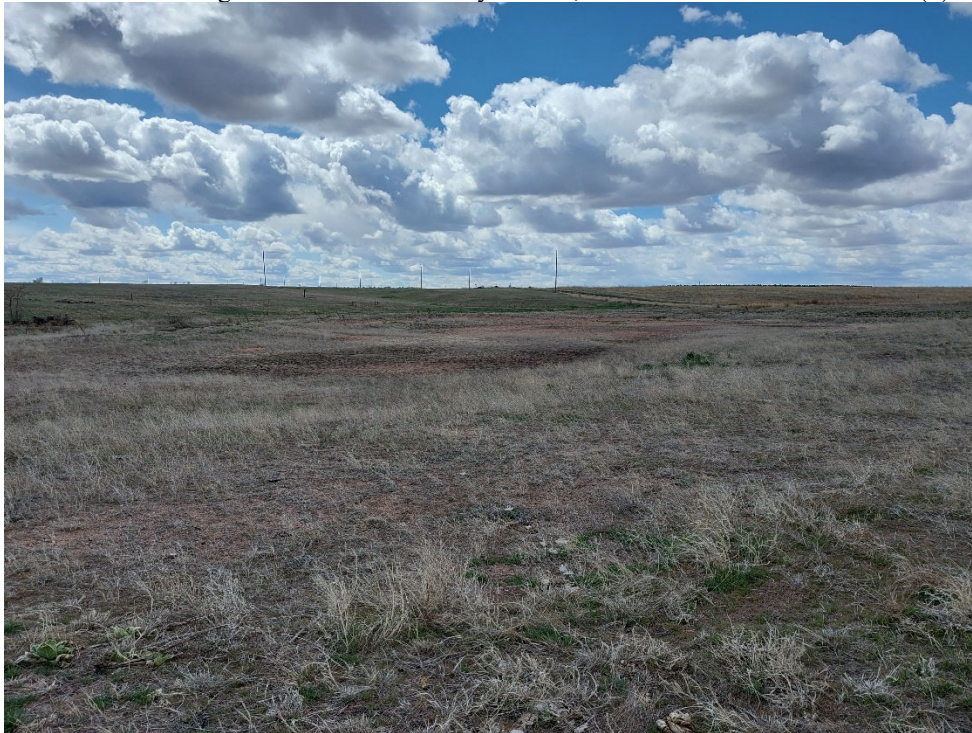
Photo #2: View of the South Fork Frenchman Creek on the east side of the permit area. Looking south southwest from the south side of the access/haul road, east side of the permit area.

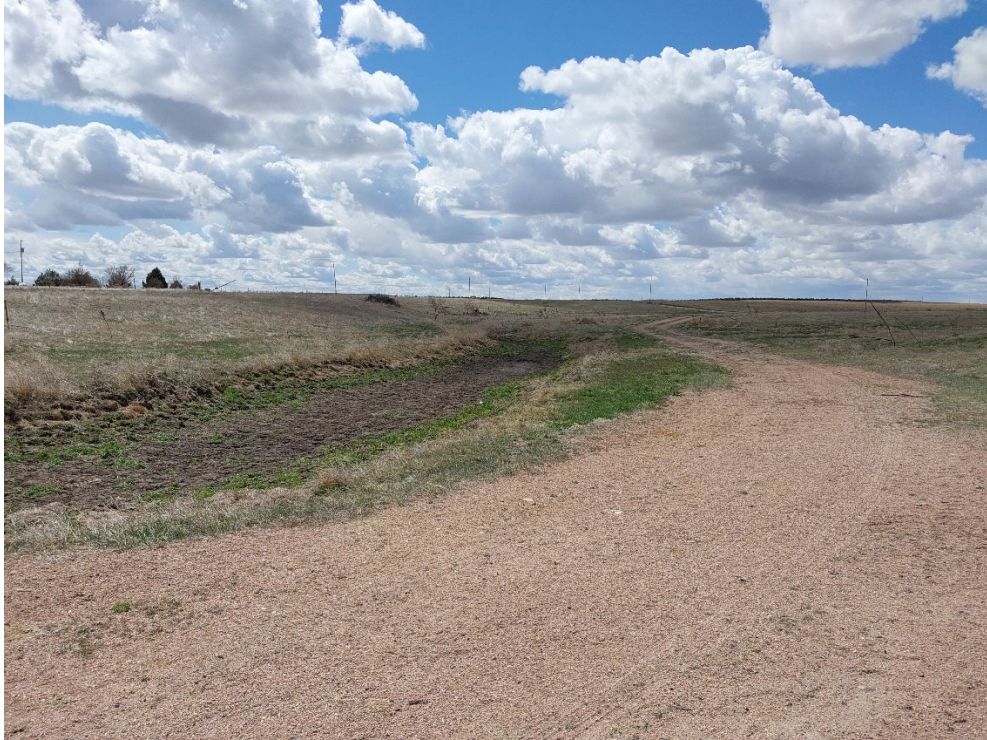
The access road that is routed along the north side of the permit area appeared to be stable and was within the prescribed size of no wider than 20 feet throughout the mine site.

Photo #3: Access/haul road following the north side of the creek. Looking southwest from the northside of the road in the east central portion of the permit area.

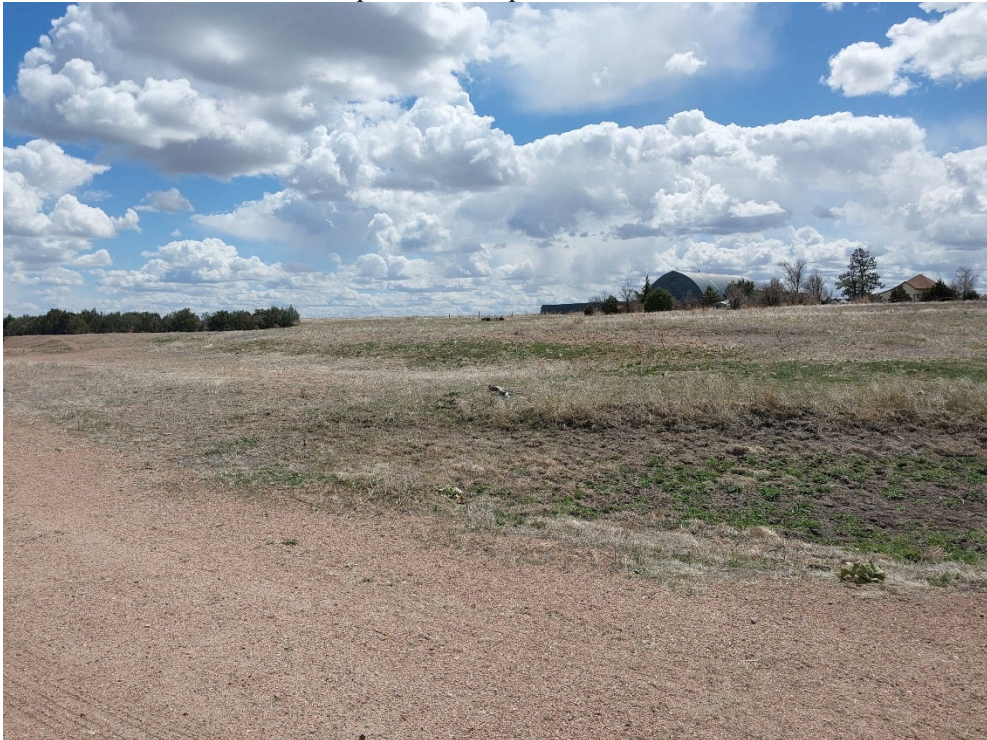
Photo #4: Graded and revegetated area to the south of the access/haul road. Looking southwest from the north side of the road in the east central portion of the permit area.

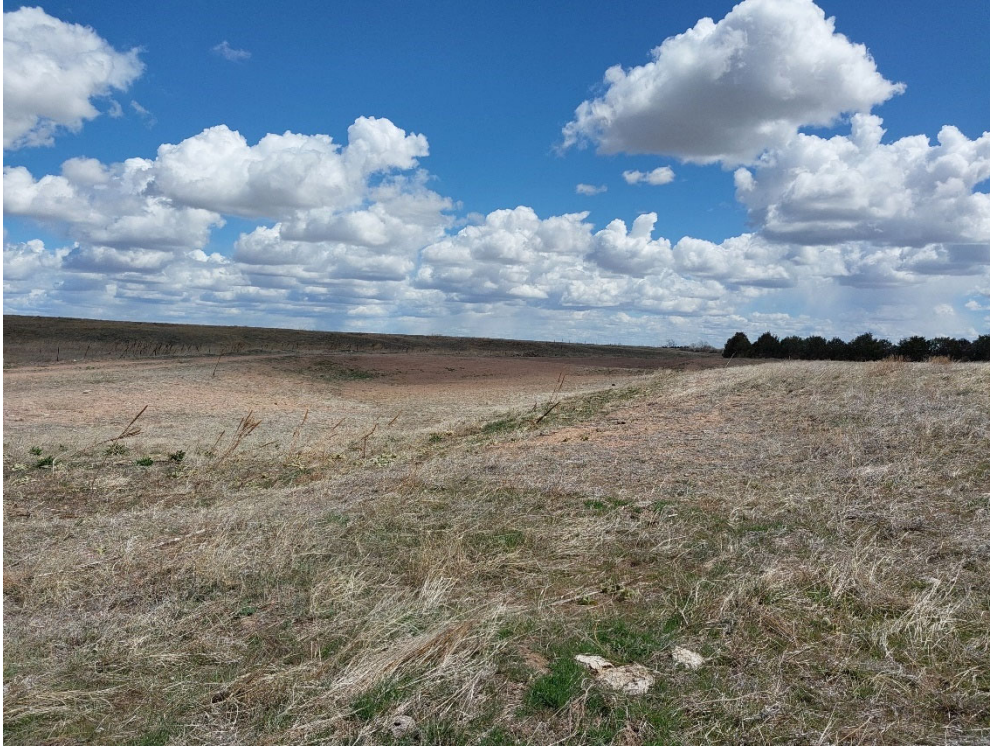
Photo #5: View of the eastern permit area, looking east from the south side of the creek in the central portion of the permit area.

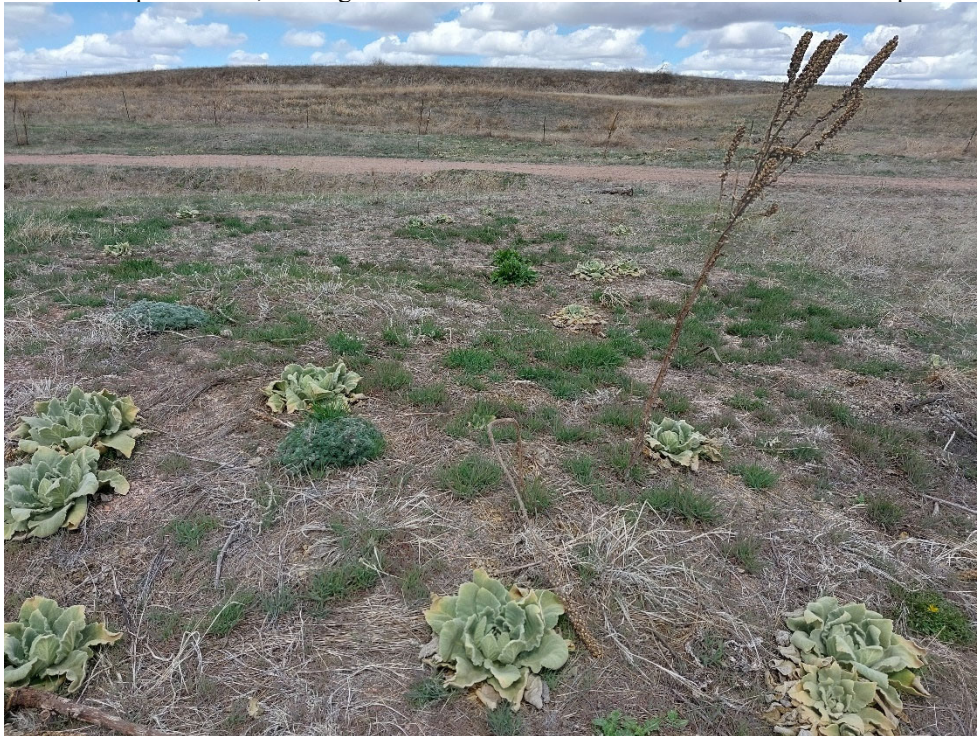
Vegetation has not yet been re-established in much of the affected area. Seeding rows could be seen on the graded surfaces. Common mullein was observed throughout the site, this is a list C noxious weed. The Operator should follow their weed control plan and/or consult with the Soil Conservation District on the best weed control methods to implement at the site. If the approved weed control plan needs to be revised, this can be done through a Technical Revision to the permit.

Photo #6: Common mullein viewed on the south side of the creek, the access/haul road can be seen in the background, looking north in the central portion of the permit area.

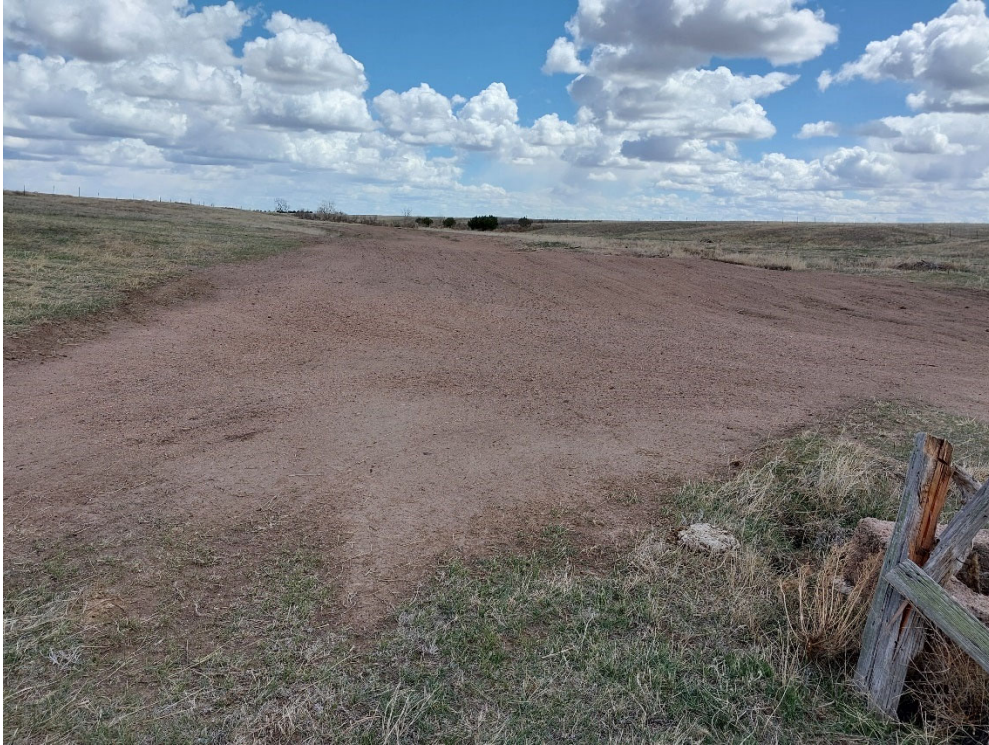
Photo #7: Recently graded portion of the permit area, looking east, taken from the west edge of the graded area.

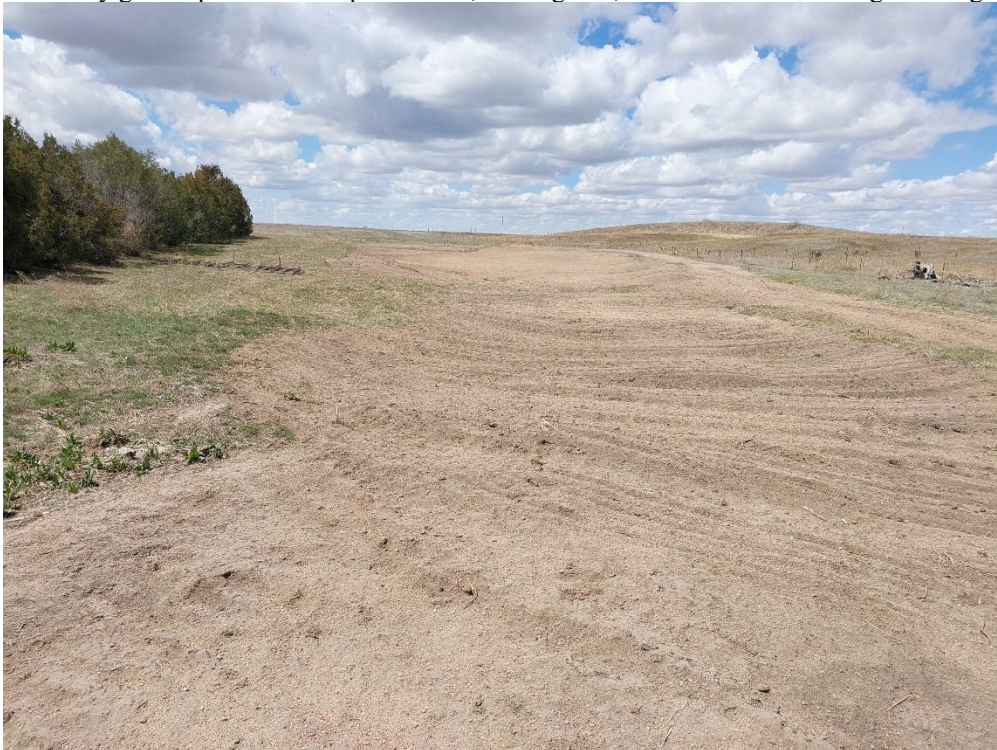
Photo #8: Recently graded portion of the permit area, looking west, taken from the east edge of the graded area.

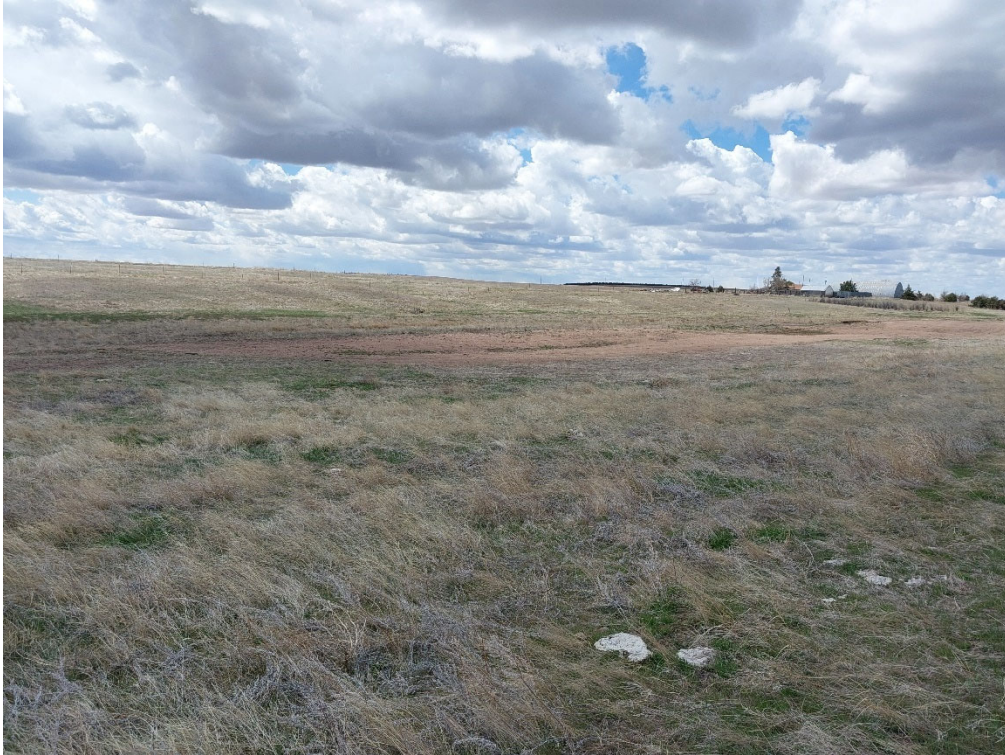
Photo #9: Permit area viewed from the northeast permit boundary marker, looking southwest, recently graded area can be seen in the center of the photo.

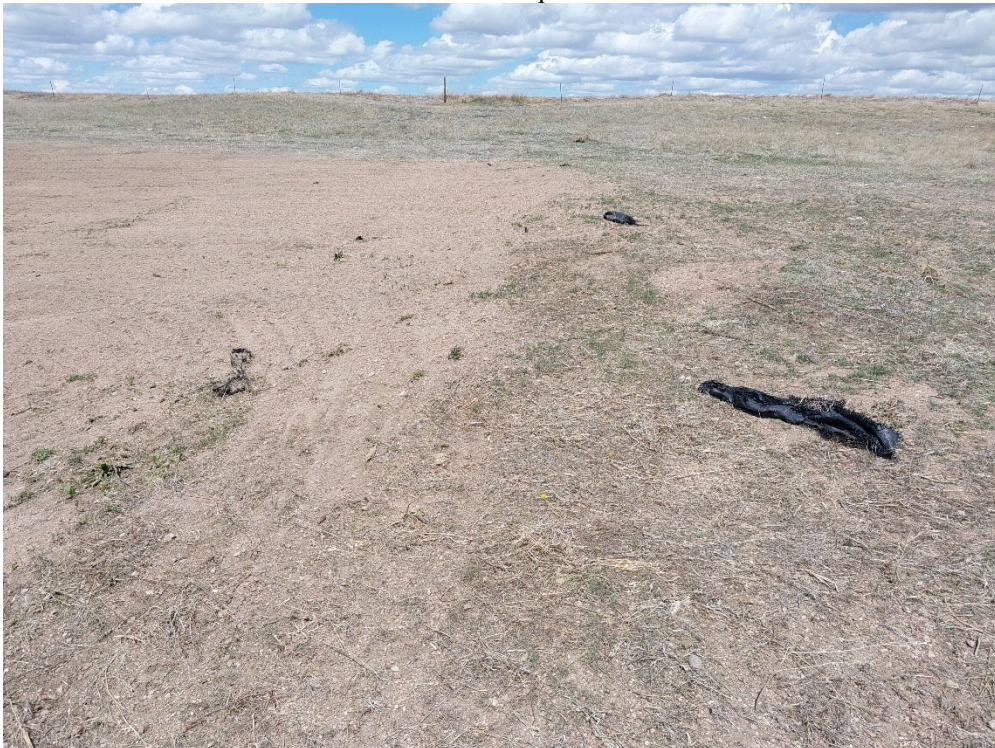
There are torn up silt fencing scraps on the east side of the affected area that need to be cleaned up by the Operator.

Photo #10: Silt fence scraps viewed on the east end of the recently graded area, taken from the south side of the creek, looking north, see map below.

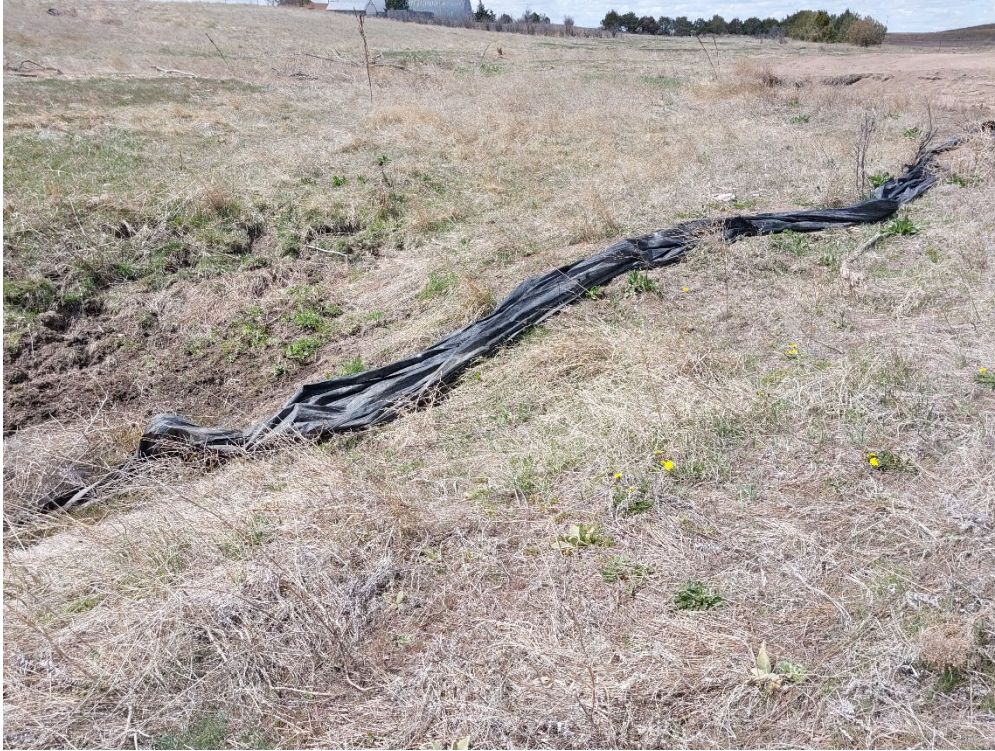
Photo #11: Silt fence scraps viewed on the south side of the recently graded area, looking west, see map below.

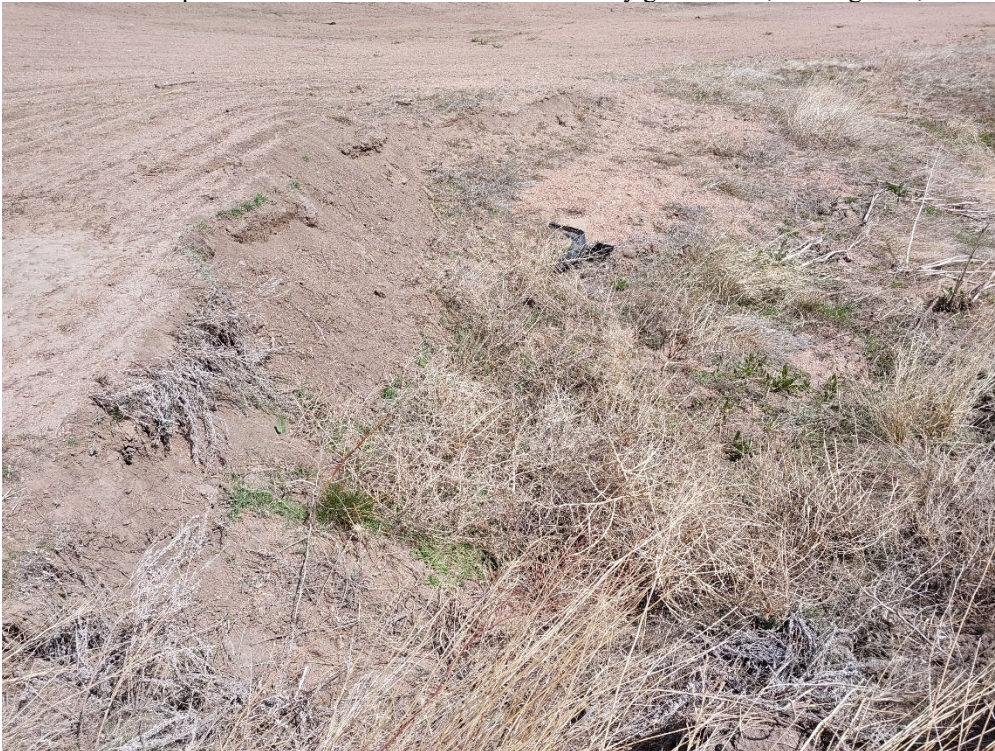
There appeared to be one area that had a high spot, or pitch point, with a sudden drop in the creek bed at the outside of a banking curve in the creek. The spot is in the eastern portion of the permit area and is marked on the map below. The operator should regrade this area to avoid a drainage issue that may develop as a result of the feature.

Photo #12: Pitch point/high spot on the south side of the creek and recently graded area, looking northeast, see map below.
