MINERALS PROGRAM INSPECTION REPORT
PHONE: (303) 866-3567

MINE NAME: Everitt Pit	MINE/PROSPECTING ID#: M-2004-037	MINERAL: Gravel	COUNTY: Phillips
INSPECTION TYPE: Monitoring	WEATHER: Cloudy	INSP. DATE: April 10, 2024	INSP. TIME: 11:00
OPERATOR: John M. Everitt	OPERATOR REPRESENTATIVE: Janice Everitt	TYPE OF OPERATION: 110c - Construction Limited Impact	
REASON FOR INSPECTION: Normal I&E Program	BOND CALCULATION TYPE: None	BOND AMOUNT: \$27,085.00	
DATE OF COMPLAINT: NA	POST INSP. CONTACTS: None	JOINT INSP. AGENCY: None	
INSPECTOR(S): Jocelyn Carter Jared Ebert	INSPECTOR'S SIGNATURE:

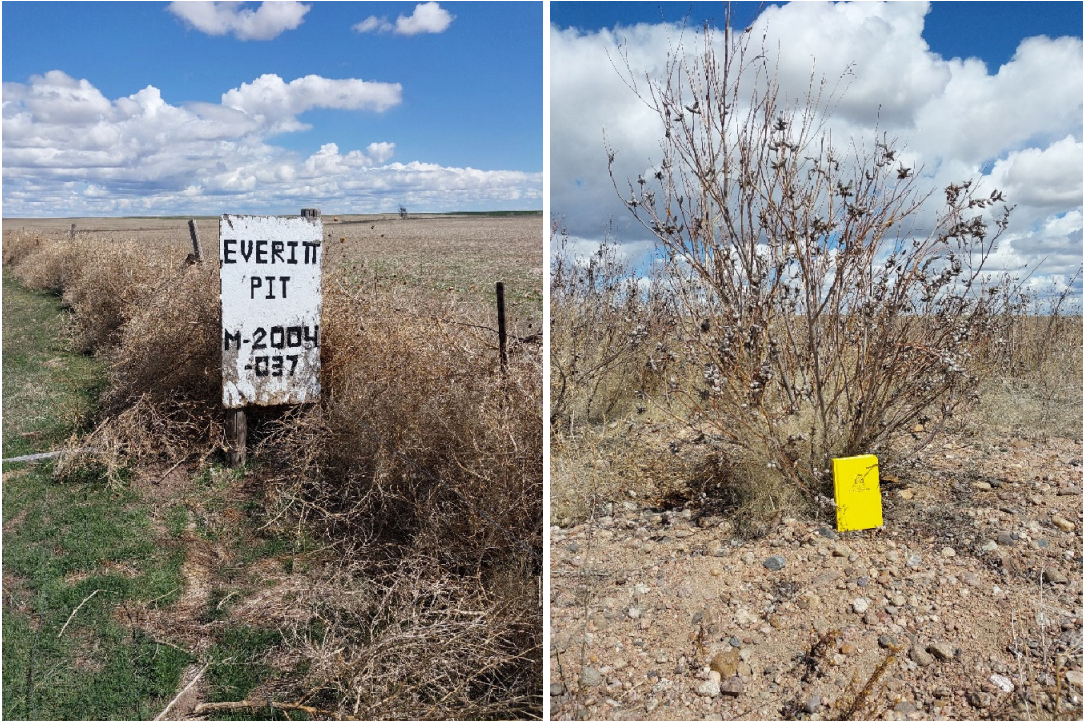
There is a sign posted at the entrance on County Road 16 that is in accordance with Rule 3.1.12(1). There are no permit boundary markers posted at the site. Rule 3.1.12(2) states that the permit boundary needs to be marked by easily identifiable markers or monuments.

Photo #1 (left): Mine sign at the entrance on County Road 7. Photo #2 (right): Representative photo of vegetation success, yellow field notebook for scale, 5.875" x 7.5".

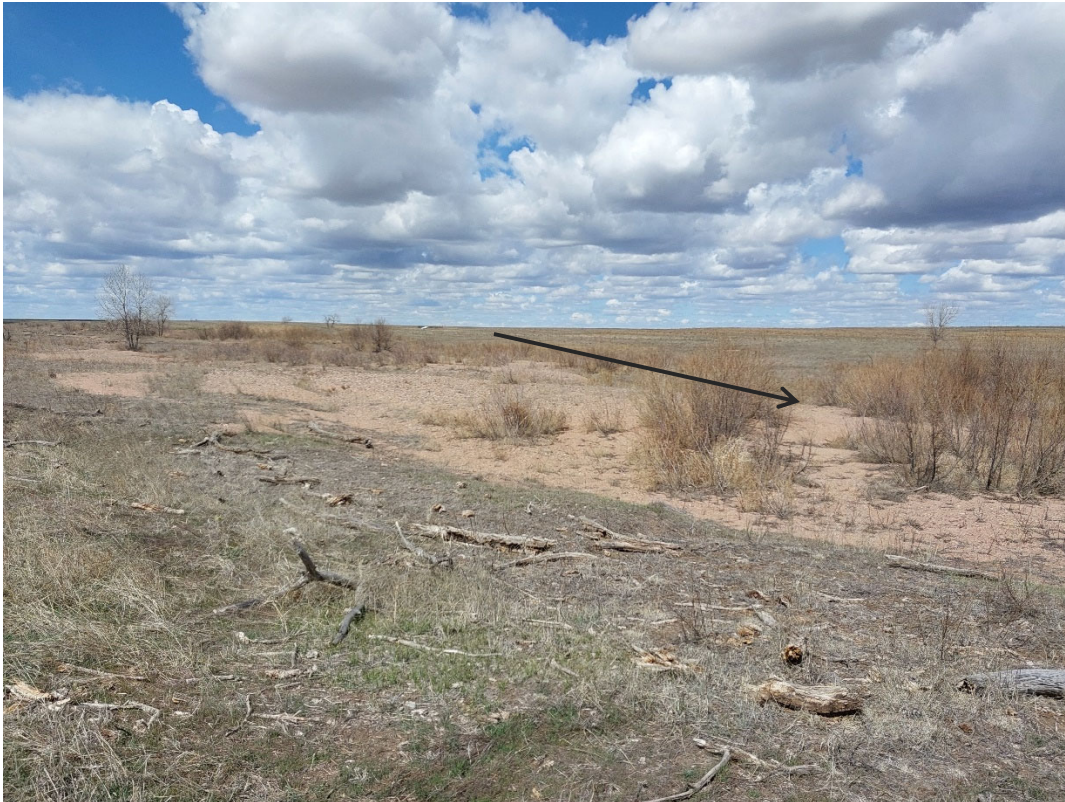
Photo #3: Permit area, Sandy Creek can be seen, the flow direction of the creek is shown with the arrow; taken from the southeast portion of the permit area, looking northwest.

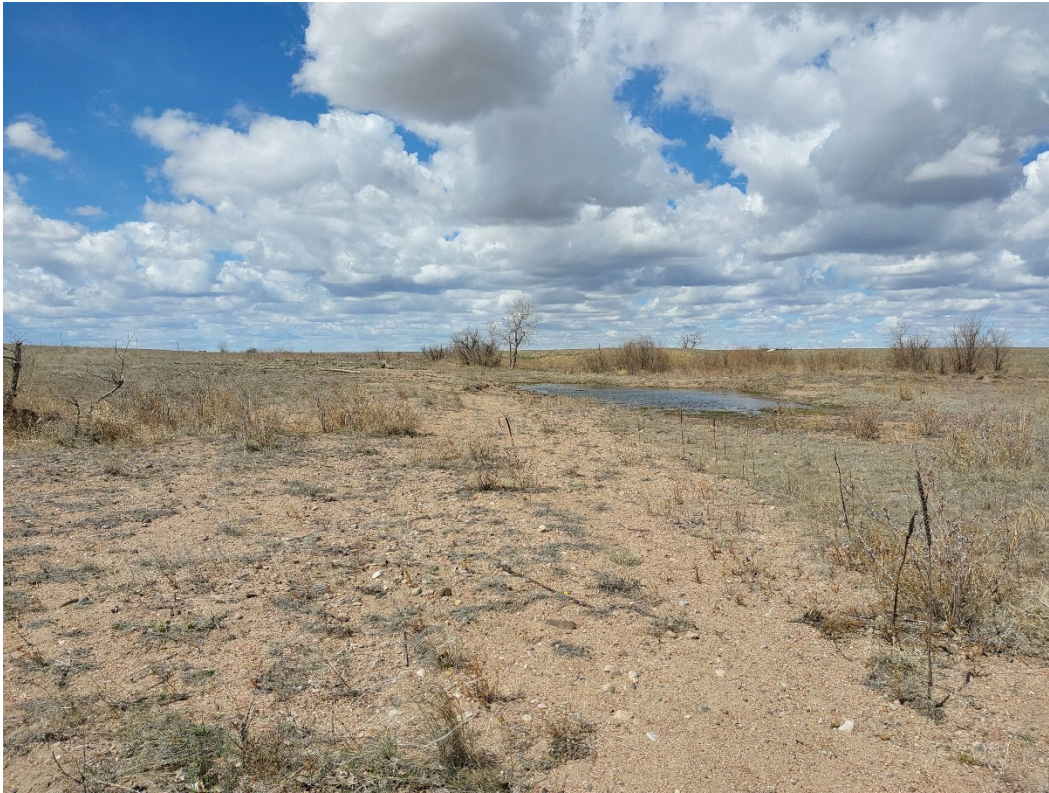
There was some water in the creek bed observed at the time of the inspection. There does not appear to be any disruption to the hydrologic balance in the affected area or the surrounding area.

Photo #4: Retained water in the creek, taken from the east portion of the permit area looking west.

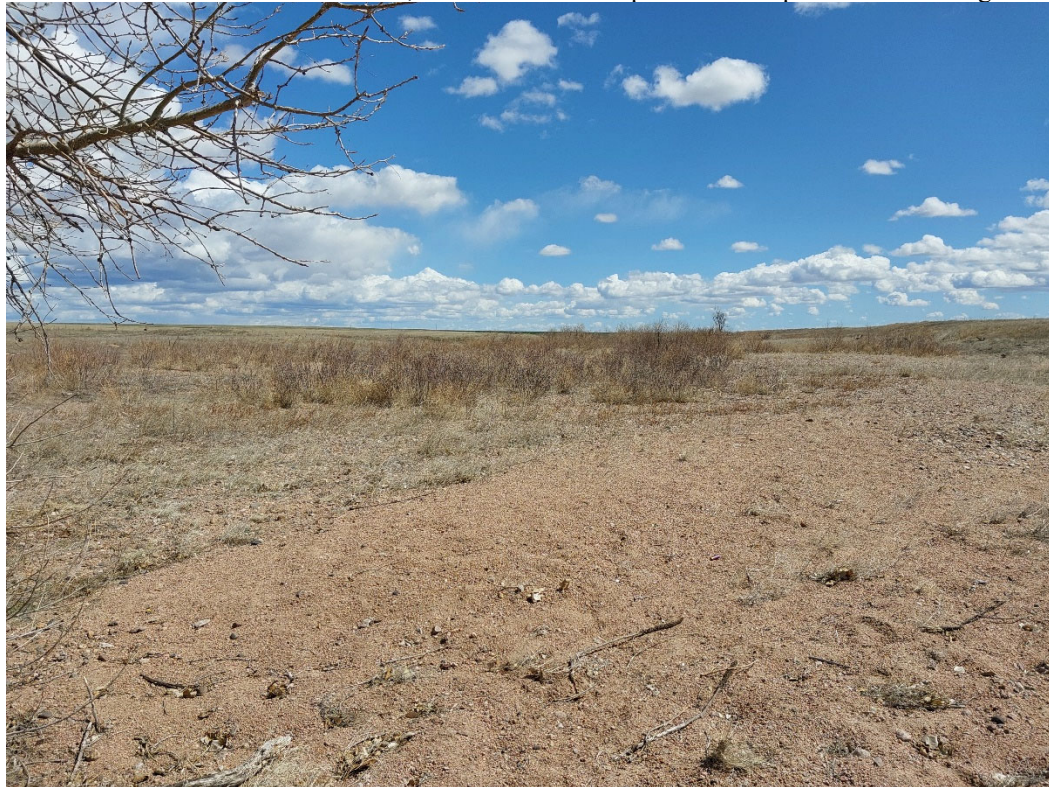
Photo #5: Photo of the approximate western portion of the permit area, looking west from within the creek bed.

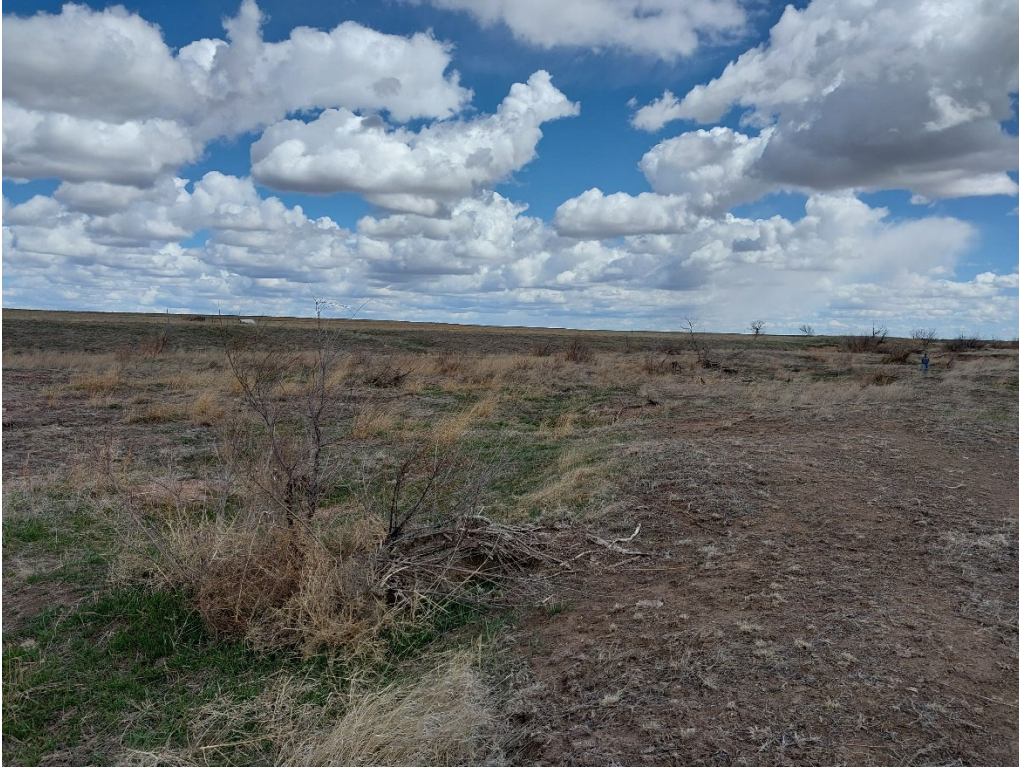
Photo #6: Looking east from the approximate western portion of the permit area, taken from the south side of the creek.

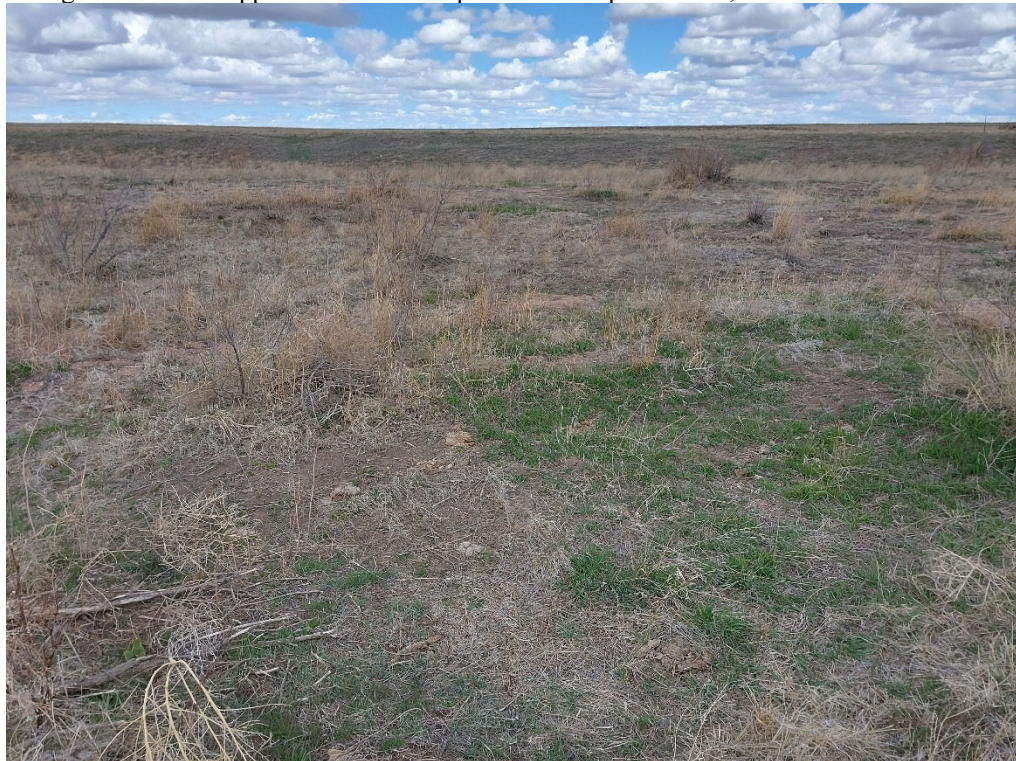
Photo #7: The revegetated river creek channel, taken from the approximate center of the permit area and the south side of Sandy Creek looking north.
