MINERALS PROGRAM INSPECTION REPORT
PHONE: (303) 866-3567

MINE NAME: Shot Rock Pit	MINE/PROSPECTING ID#: M-2012-023	MINERAL: Crushed stone material	COUNTY: Las Animas
INSPECTION TYPE: Surety-Related Inspection	WEATHER: Clear	INSP. DATE: April 9, 2024	INSP. TIME: 13:05
OPERATOR: Tamrock Gravel LLC	OPERATOR REPRESENTATIVE: Brent and Tami Tamburelli	TYPE OF OPERATION: 112c - Construction Regular Operation	
REASON FOR INSPECTION: Surety Related	BOND CALCULATION TYPE: Complete Bond	BOND AMOUNT: \$22,800.00	
DATE OF COMPLAINT: NA	POST INSP. CONTACTS: None	JOINT INSP. AGENCY: None	
INSPECTOR(S): Amber Gibson	INSPECTOR'S SIGNATURE:

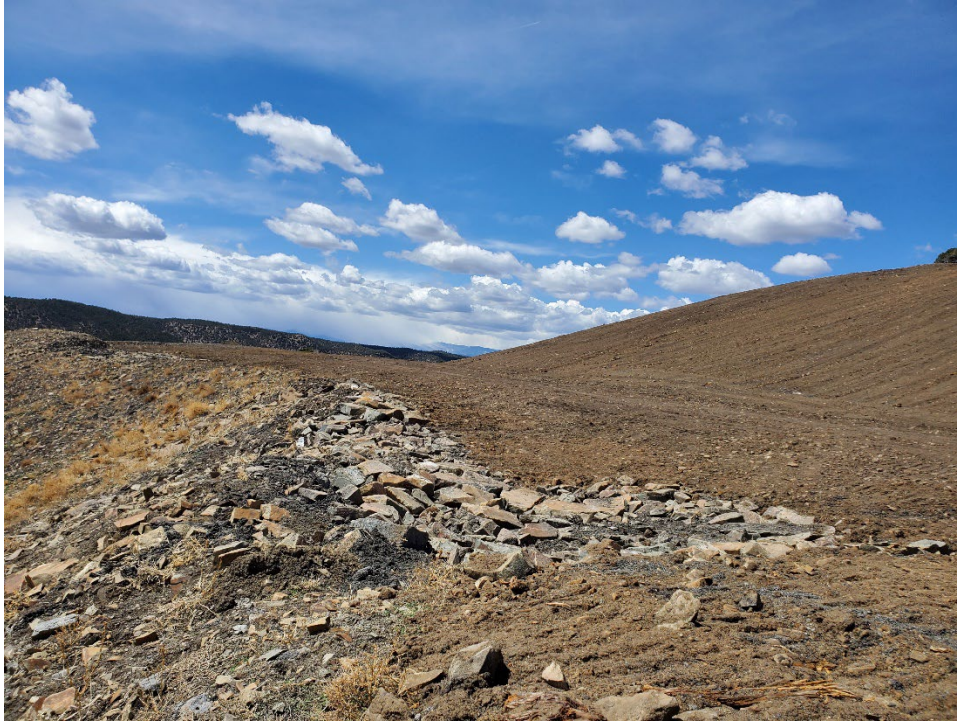
The Operators have observed where water tends to pool and/or drain-to in the previously mined areas. In response, the Operators have installed armored drainage channels, using the rip-rap stockpiles they had on-site, to control run-off and prevent erosion from affecting off-site areas (Photos 1-3). No standing water was observed at the time of the inspection.

Photo 1: Looking east at an armored drainage along the southern side of the mined area.

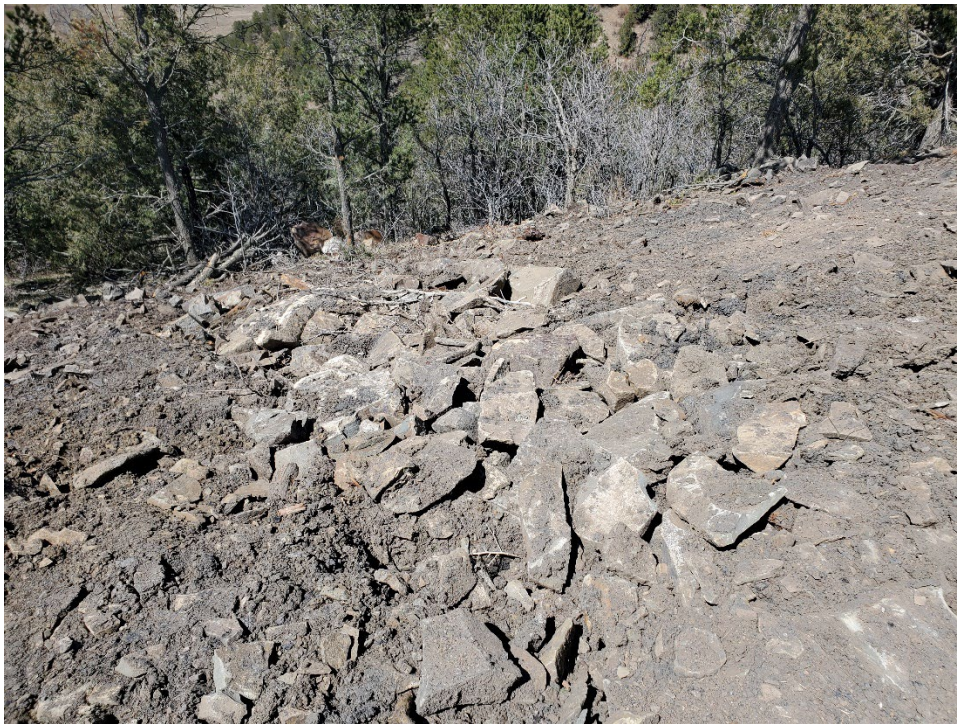
Photo 2: Looking downslope from the top of an armored drainage.

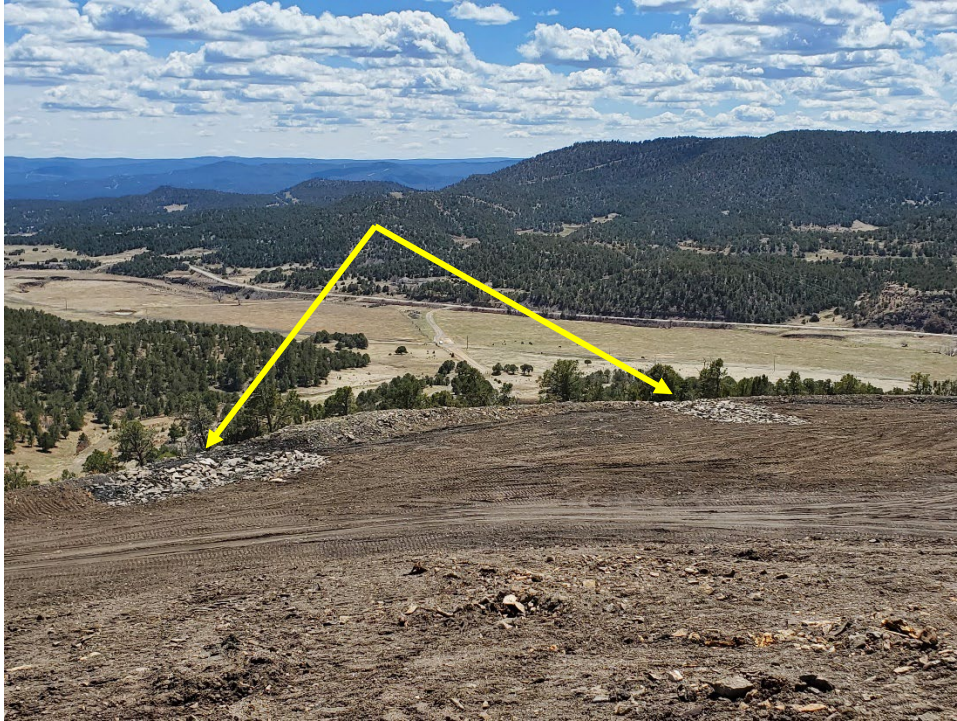
Photo 3: Looking south at two armored drainages.

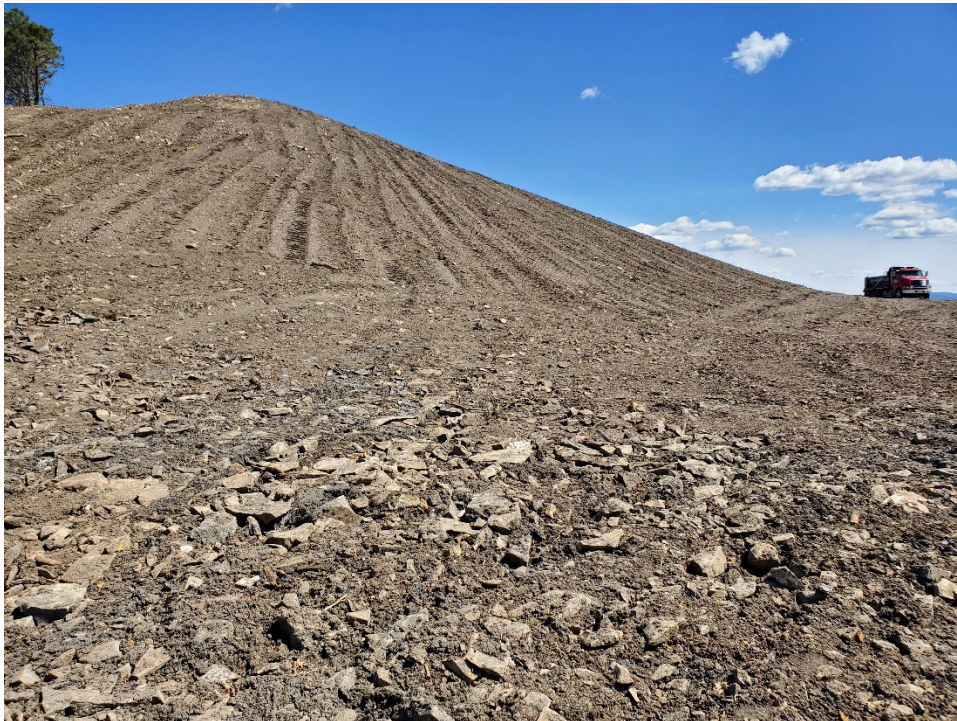
Since the previous inspection, the Operator has conducted the majority of the reclamation in the mined area. The Operator had used the overburden piles that were stored onsite, to backfill and grade the slopes observed at the Division's November 2023 inspection, to 3H:1V slopes or shallower (Photos 4-6). The slopes, processing areas, and equipment storage areas within the mined area have all been topsoiled--using all of the stockpiled topsoil material at the site. At the time of the April 2024 inspection, the Division collected an approximately 1.33 acre measurement (using the Esri's Field Maps application) of a test-plot area. This area is in the east side of the permit (Photos 7-8) where the equipment storage had been. The Operator had recently seeded the area to help determine which method of seeding will work best. The steeper slopes are planned to be seeded using a hydro-seeding approach. The amount of reclamation accomplished at the site has helped to greatly reduce the reclamation liability, and was considered in the Division's bond re-evaluation for SR1 and AM1.

Photo 4: Looking north-east at the western-most graded slope.

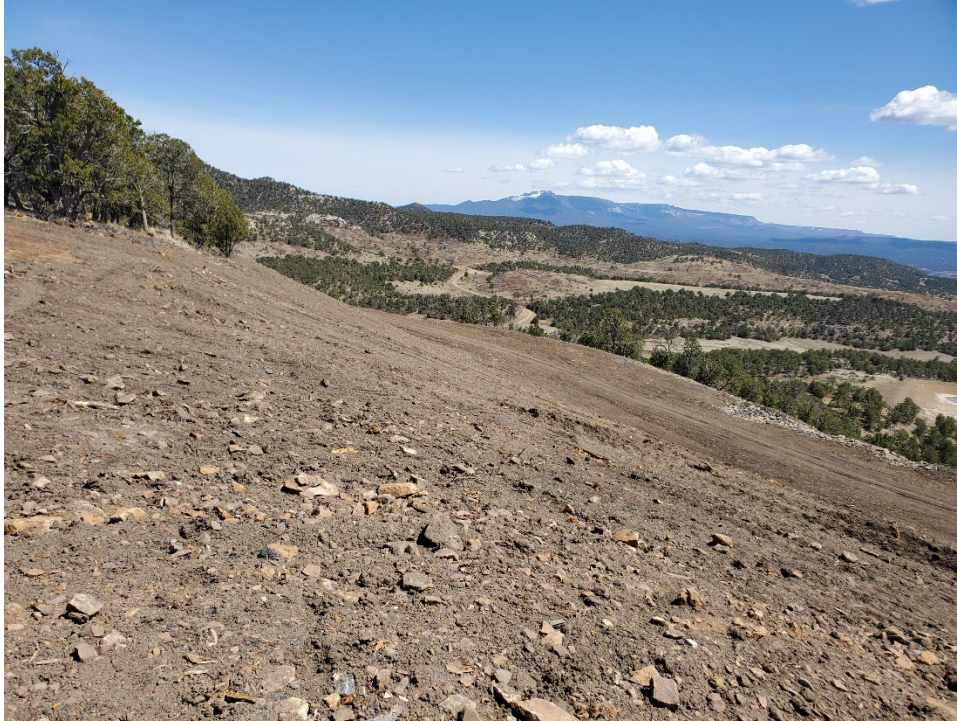
Photo 5: Looking south-east from the top of a graded slope.

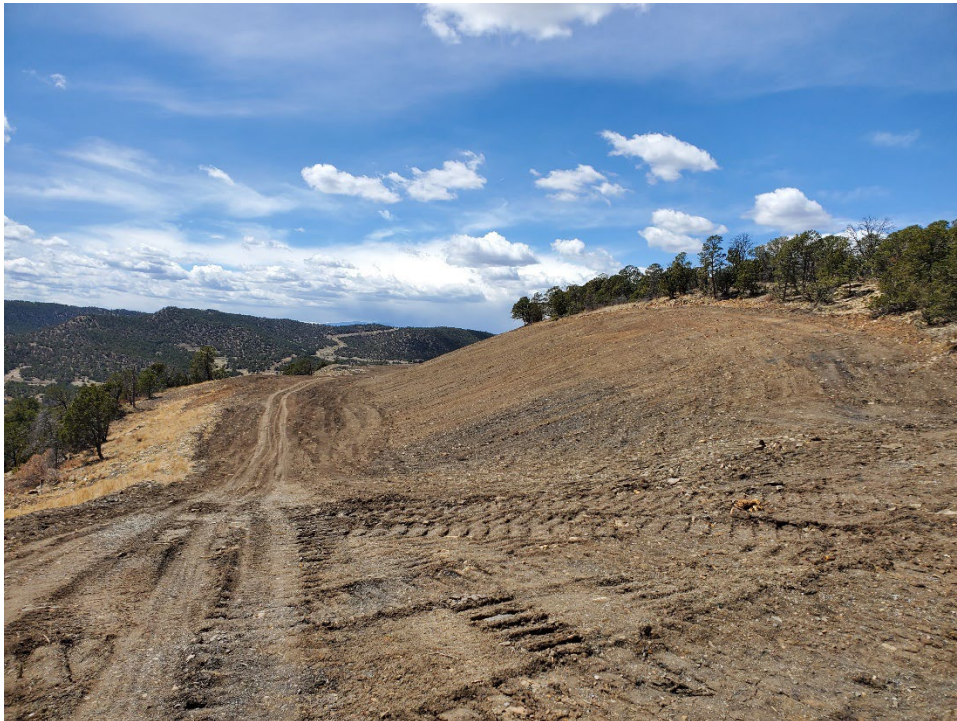
Photo 6: Looking west across the backfilled and graded slope.

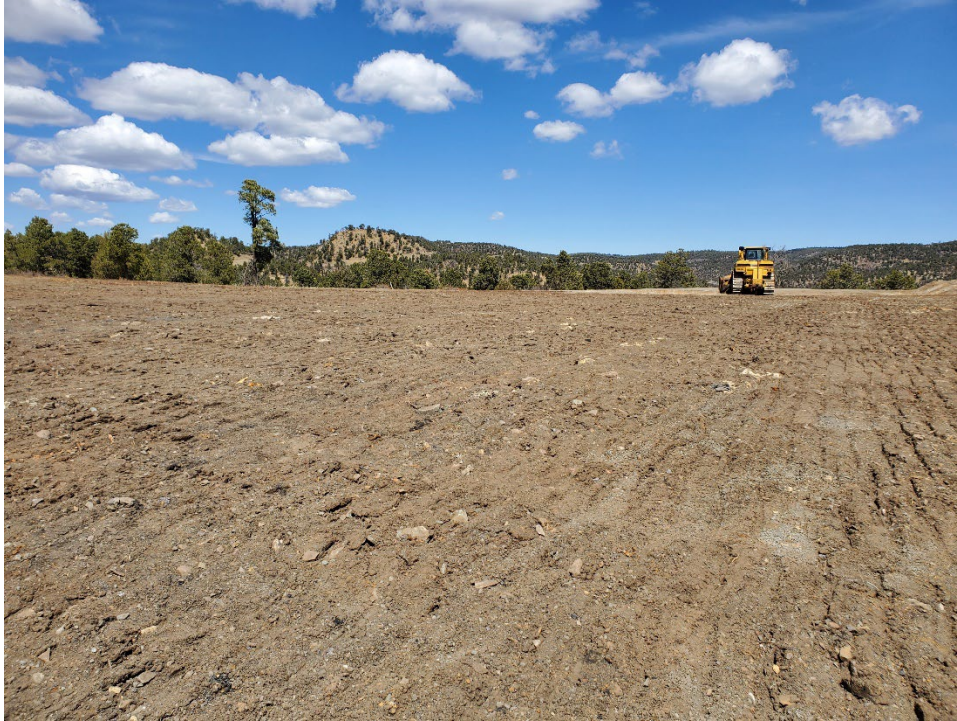
Photo 7: Test-plot area that had recently been seeded.

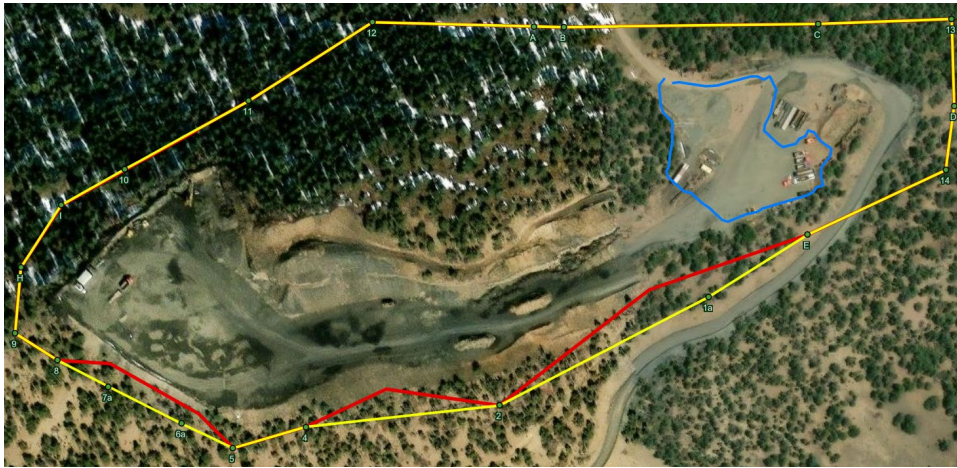
Photo 8: Figure indicating the approximate location of the newly proposed boundary (yellow polygon), the currently approved boundary (red polygon), and the 'test-plot' area that had been recently seeded at the time of the inspection (blue polygon).

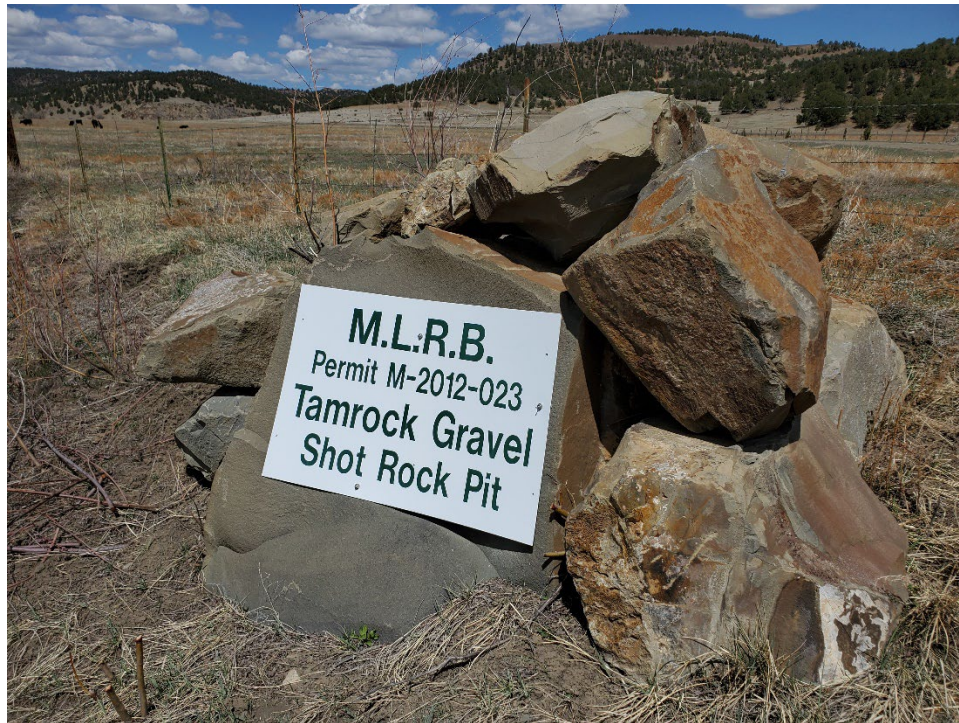
A mine sign was posted in compliance with Rule 3.1.12(1) at the entrance of the site (Photo 9). Additionally, a notice for the AM1 application, in compliance with Rule 1.6.2(b), was also posted at the entrance (Photo 10).

Photo 9: Mine permit sign posted at the entrance to the site.

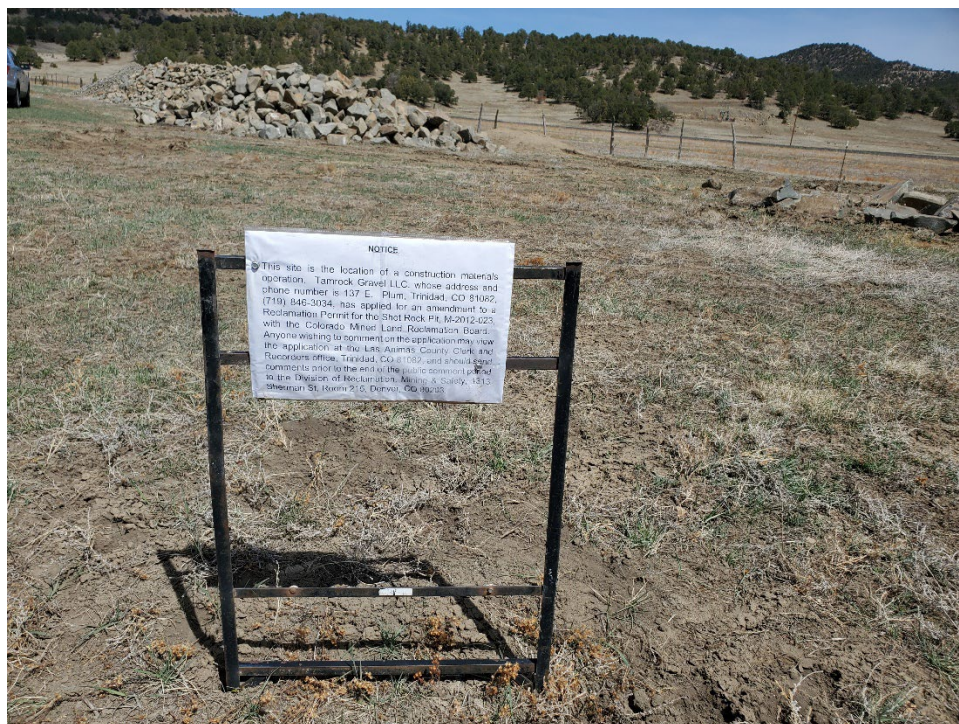
Photo 10: Notice sign posted in compliance with Rule 1.6.2.

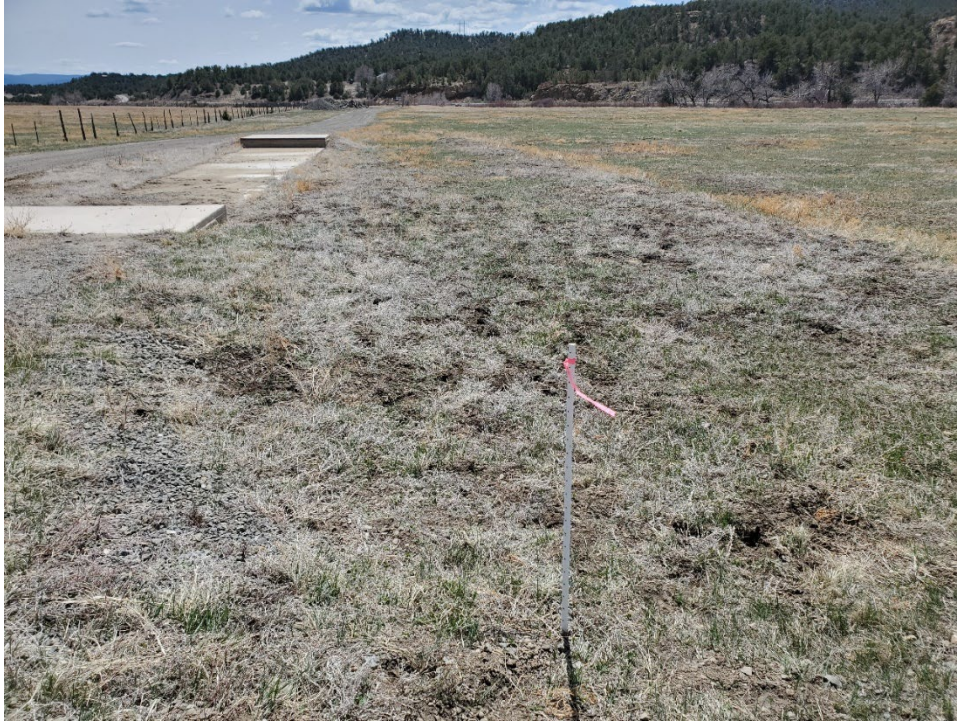
Permit boundary markers were observed around the affected area, and appeared to be in compliance with Rule 3.1.12(2). White poles with pink flags serving as boundary markers (as well as a fence acting as the eastern boundary) were observed alongside the newly incorporated 'road area' (Photo 11). The Operator had installed white fence posts and/or pink flags on the existing permit boundary t-posts around the mined area. Newly installed rock monuments, with pink flags, indicate the new location of the proposed re-located AM1 boundary markers (Photos 12-13). Additionally, the Division observed that the wire fence that begins in the north-west boundary and extends along the northern boundary to the eastern boundary around the mined area, remains in-tact and still serves as the north-west to north-east boundary (Photo 14). The Operator stated that they had gathered the coordinates in the field for the amended marker locations, and sent them to their consultant, who then made the AM1 maps.

Photo 11: White marker pole with pink ribbon alongside the proposed 'road area'.

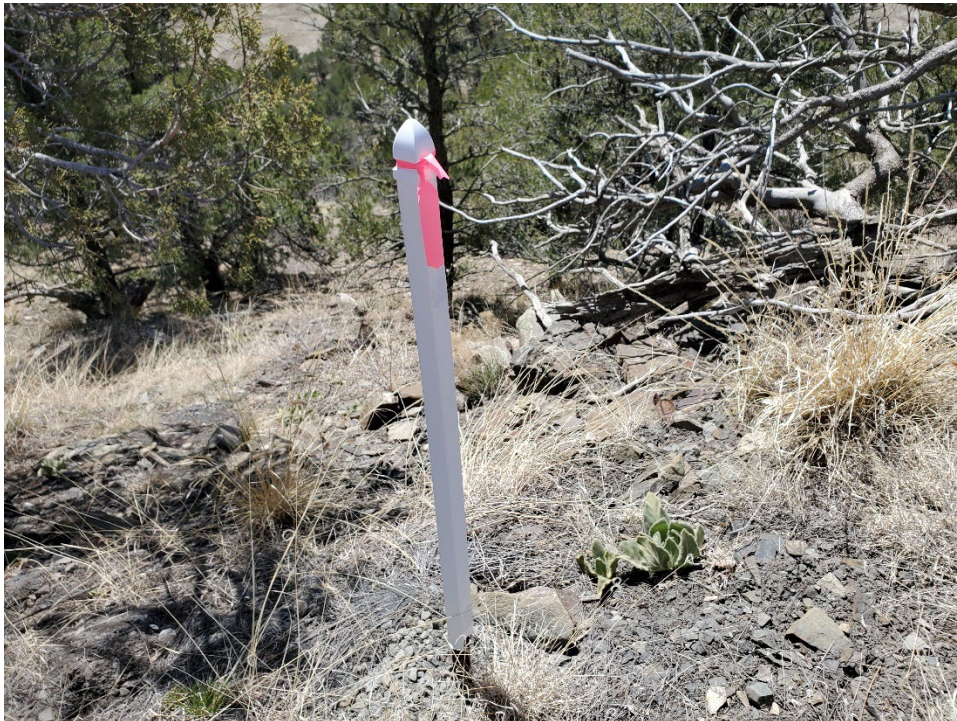
Photo 12: Original permit boundary marker t-post with white fence covering and pink ribbon.

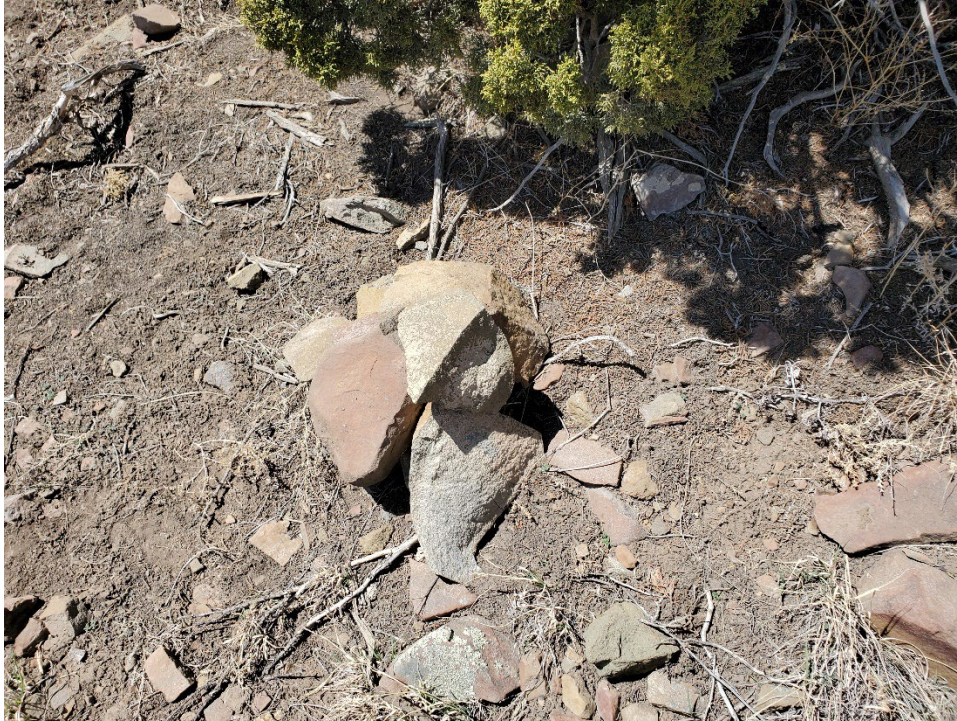
Photo 13: Rock monument indicating a new proposed boundary marker location.

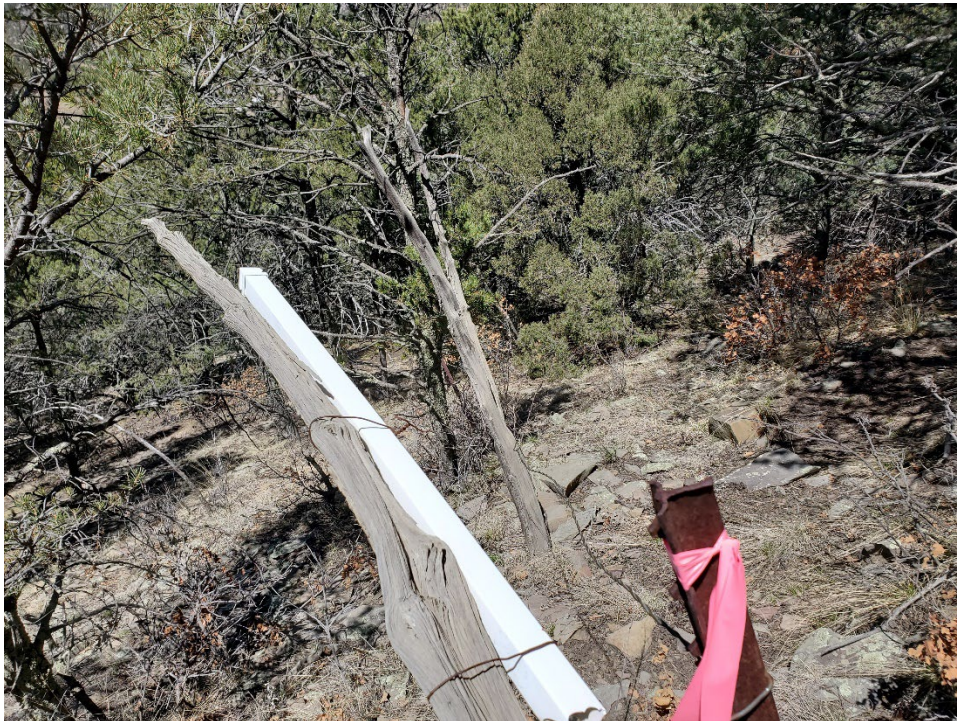
Photo 14: Looking east along the northern fence from the north-western corner boundary marker on the fence line.
