**LORENCITO CANYON MINE**  
**Permit No. C-1996-084**

**INSPECTION OF EXCESS SPOIL-FILLS 7, 8, & 9**  
**March 26, 2024**

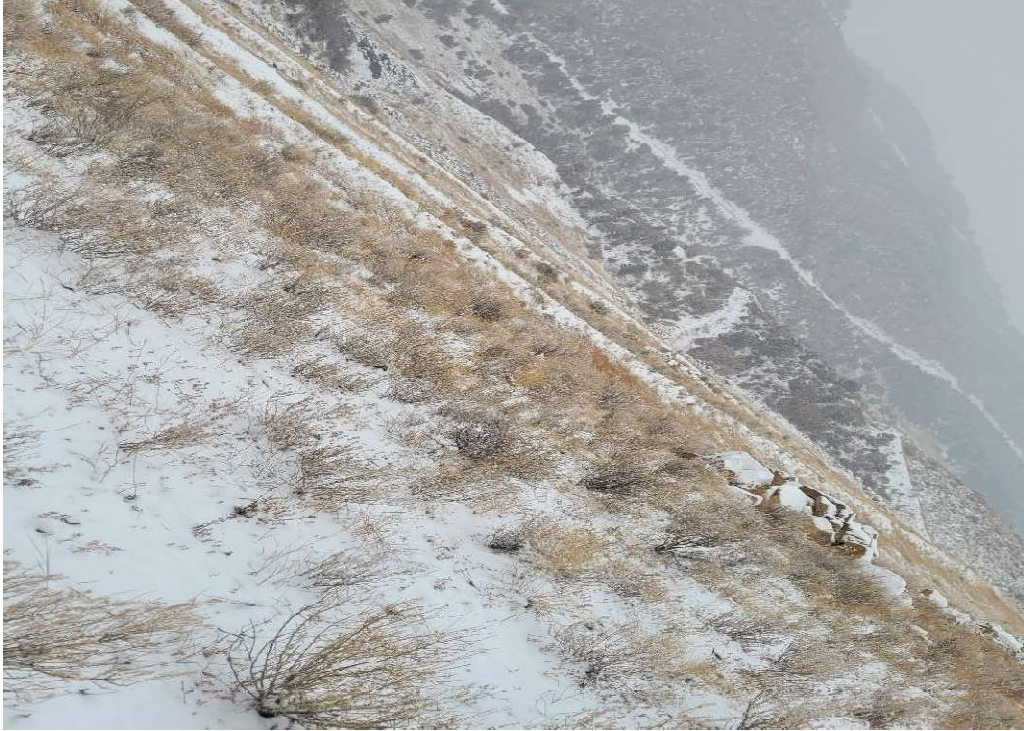
**Fill #7**

East armored down drain needs to be monitored and might need a spot that is washed out to be re-armored. All else looks good.

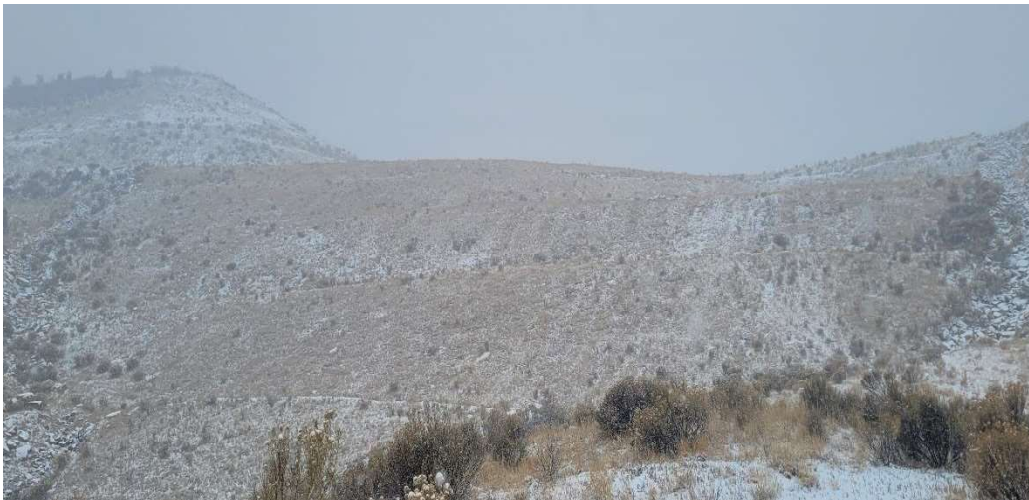
**Fill #8**

Lower portion of East down drain needs to be monitored and may need additional rock in bare spots. All else is in good condition.

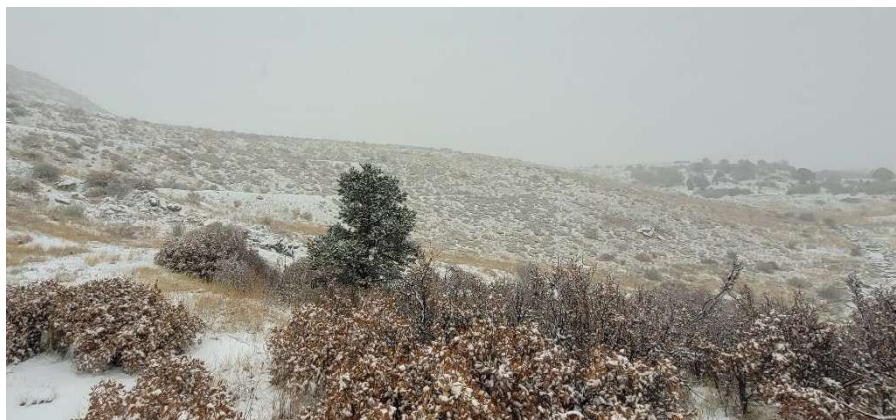
**Fill #9**

Overall the site is in good condition.
