**NEW ELK MINE**  
**Permit No. C-1981-012**

**QUARTERLY COAL WASTE BANK INSPECTION REPORT**  
**March 26, 2024**

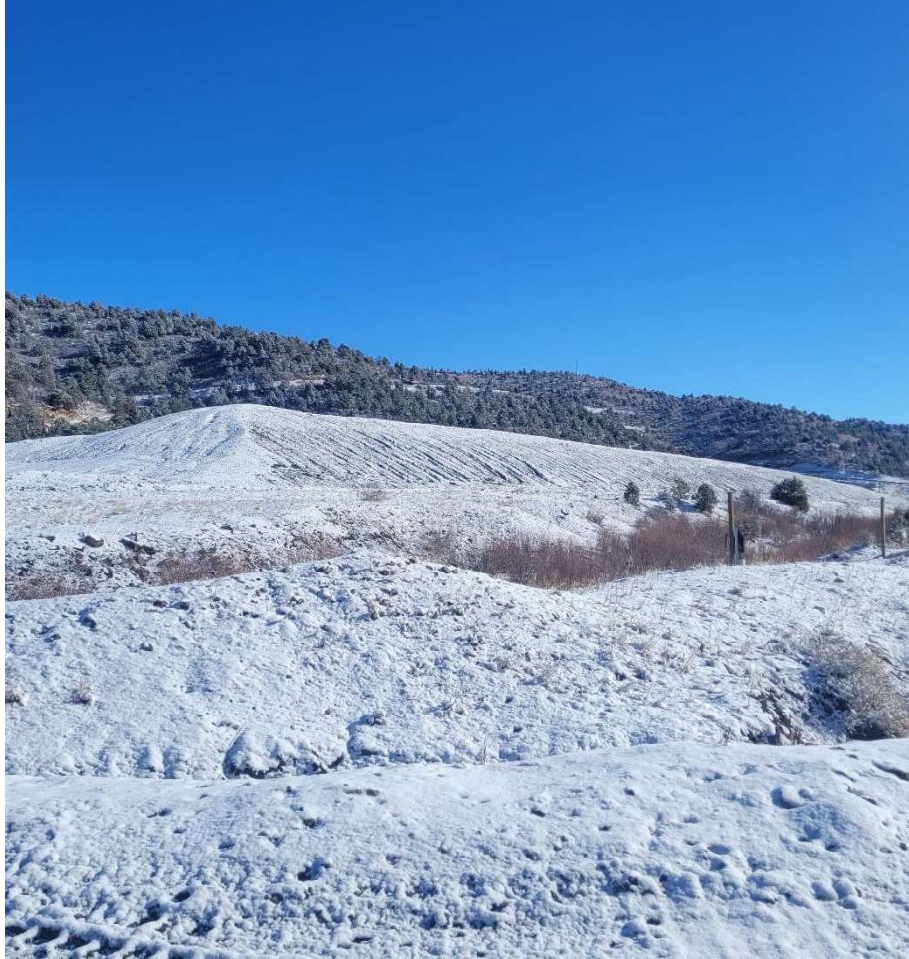
**DWDA #1 South Face**

Surface and out slopes of the pile were inspected for visible signs of potential failure or instability. None were observed.

Overall the disposal area is in good condition.

Ditch along base of DWDA 1 has been cleaned from the South West Corner around the western face to allow for positive drainage around the area and into Pond 4.

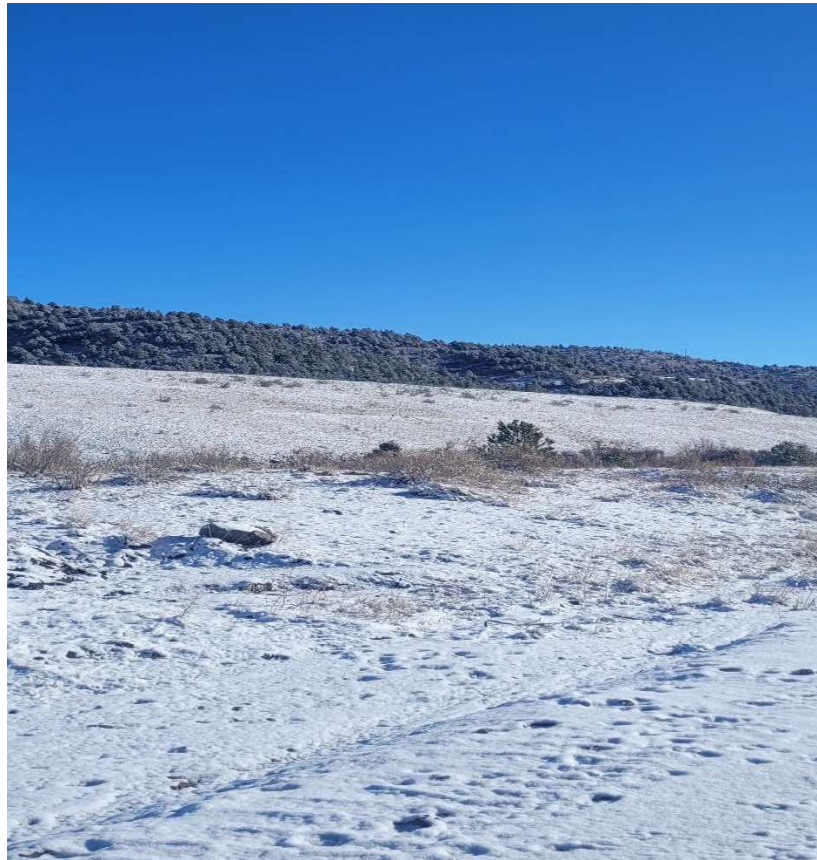
**DWDA #2 South Face**

Surface and out slopes of the pile were inspected for visible signs of potential failure or instability. There was some surface erosion but not enough to make the area unstable. In all no signs of failure or instability were observed.

Overall the disposal area is in good condition. The ditch around the southern and western toe was cleaned and the banks between the pile and the river buffer area was cleaned and had standard maintenance done to keep water flowing to the sediment pond on the eastern end of pile.

The Rills are being monitored and have not gotten any bigger and there is no sediment loading. Operator is evaluating either reclamation of the area or permitting alternative uses of the land north of the Purgatoire River and south of Highway 12. The ditch along the southern face has been cleaned and the berm between DWDA #2 and the river has been reinforced to prevent any run off to reach the river.

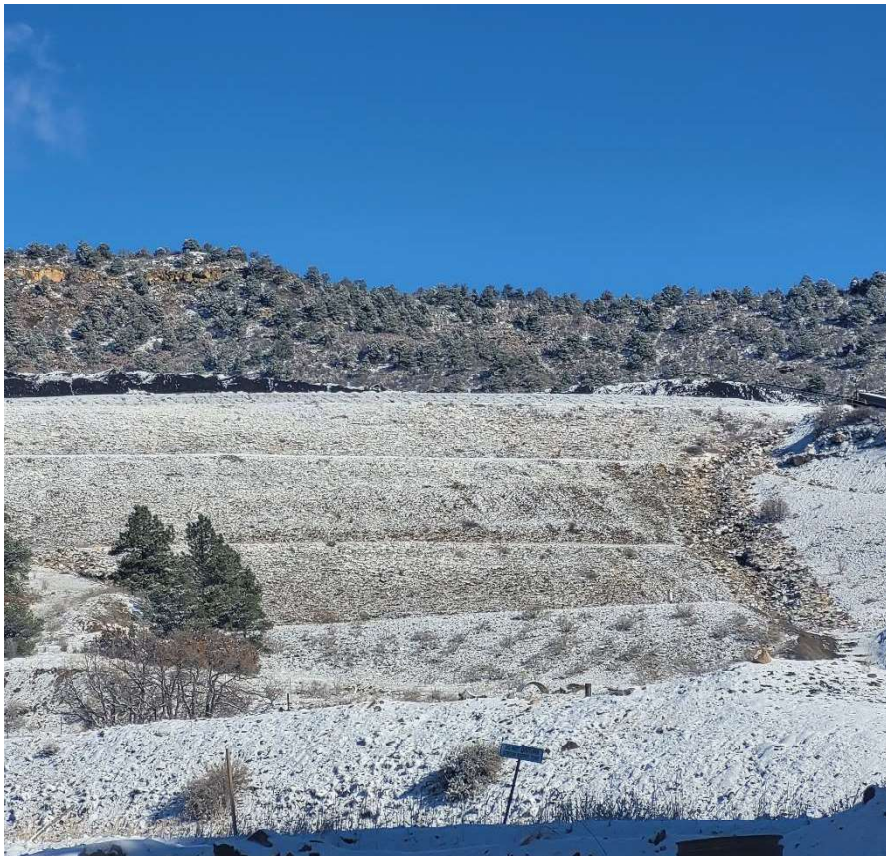
**Face of Refuse Disposal Area**

None observed.

Overall the site is in good condition.

Work on the Clean Water Ditch above the RDA Area was finished. Cleaning of the ditch, was to help prevent the clean water from flowing on the RDA Area.
