**MINERALS PROGRAM INSPECTION REPORT**  
**PHONE: (303) 866-3567**

<b>MINE NAME:</b> Climax Mine	<b>MINE/PROSPECTING ID#:</b> M-1977-493	<b>MINERAL:</b> Molybdenum	<b>COUNTY:</b> Lake, Summit
<b>INSPECTION TYPE:</b> Monitoring	<b>WEATHER:</b> Clear	<b>INSP. DATE:</b> April 18, 2024	<b>INSP. TIME:</b> 10:00
<b>OPERATOR:</b> Climax Molybdenum Company	<b>OPERATOR REPRESENTATIVE:</b> Alex Ungers	<b>TYPE OF OPERATION:</b> 112d-3 - Designated Mining Operation	
<b>REASON FOR INSPECTION:</b> Normal I&E Program	<b>BOND CALCULATION TYPE:</b> None	<b>BOND AMOUNT:</b> \$91,011,850.00	
<b>DATE OF COMPLAINT:</b> NA	<b>POST INSP. CONTACTS:</b> DRMS	<b>JOINT INSP. AGENCY:</b> None	
<b>INSPECTOR(S):</b> Amy Yeldell	<b>INSPECTOR'S SIGNATURE:</b>

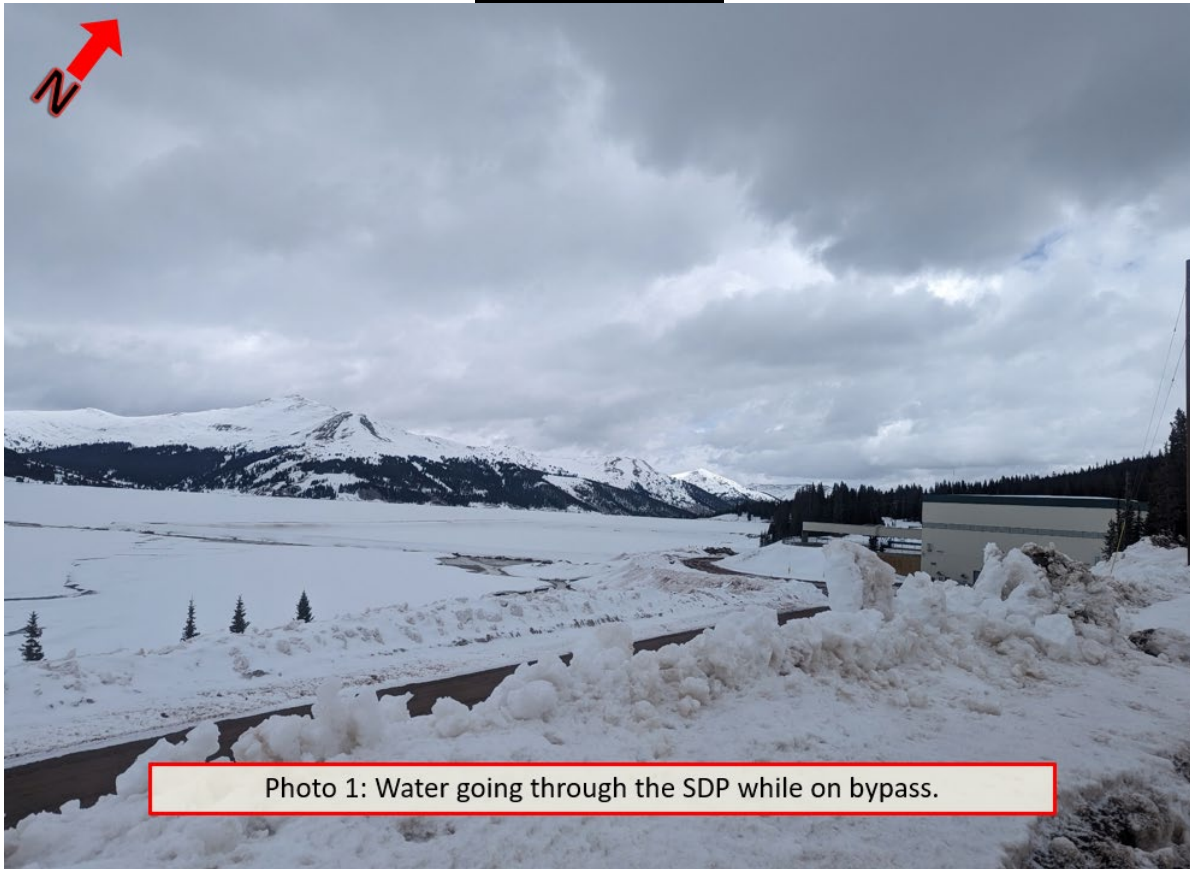
The SPD is currently on by-pass and all water is being treated at Mayflower. Climax is finding that not treating water at the SDP, resulting in better coprecipitation of Ferric Molybdenum. By not removing the iron at the SDP the pH going into the PDWTP is at a lower pH which is resulting in more Molybdenum removal during water treatment and is overall better for water chemistry. Climax will continue to test various treatments for best efficiency and overall water quality. All water will continue to be properly treated prior to discharging into Tenmile Creek.

Photo 1: Water going through the SDP while on bypass.

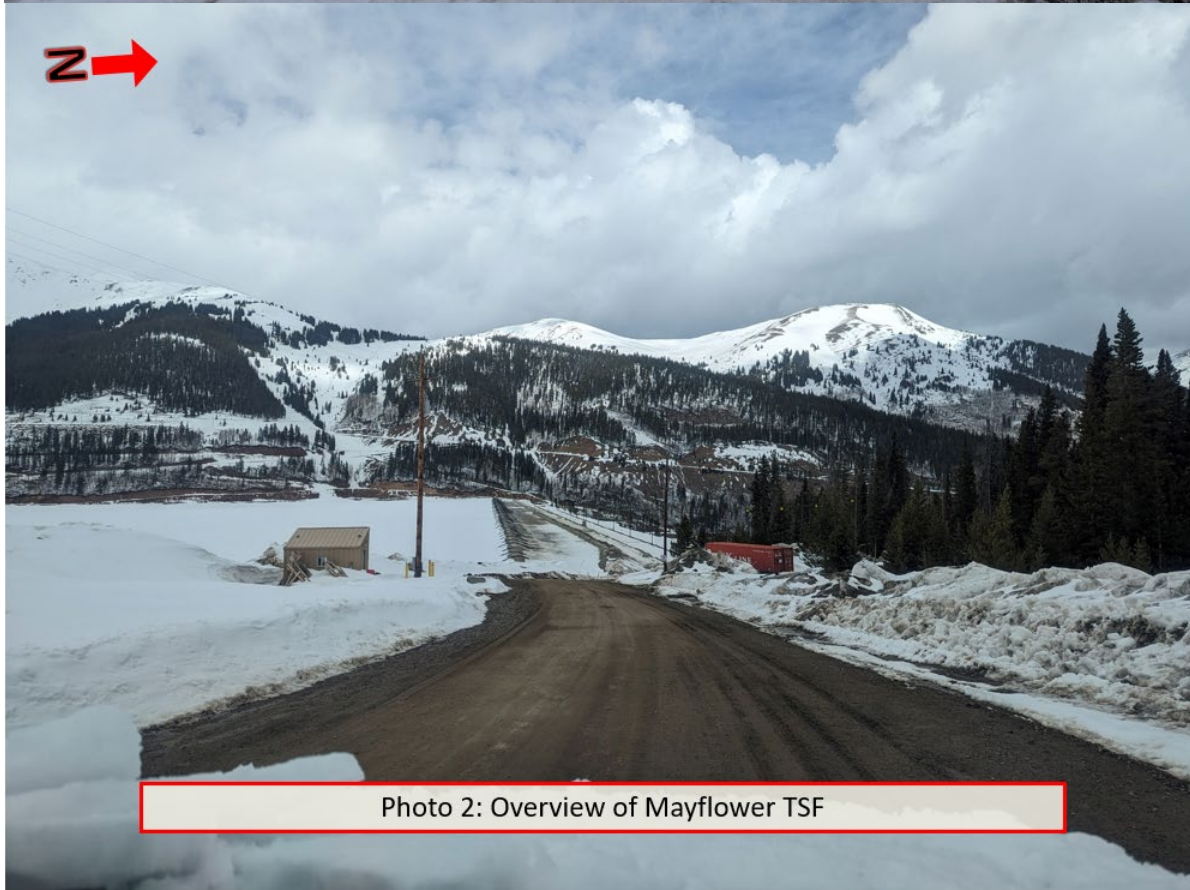
Photo 2: Overview of Mayflower TSF
