C1980007, West Elk Mine, April Inspection Report

PERMIT INFORMATION

Permit Number: C-1980-007 Mine Name: West Elk Mine Operator: Mountain Coal Company, LLC Operator Address: Jessica Wilczek 5174 Highway 133 Somerset, CO 81434	County: Delta, Gunnison Operation Type: Underground Permit Status: Active Ownership: Private
	Operator Representative Present: Rodger Polson, Ed Ogrodny, Michael Aire
Operator Representative Signature: (Field Issuance Only)

Inspection Start Date: April 18, 2024 Inspection Start Time: 10:00 Inspection End Date: Inspection End Time:	Inspection Type: Coal Complete Inspection Inspection Reason: Normal I&E Program Weather: Cloudy
Joint Inspection Agency: None	Joint Inspection Contacts:
Post Inspection Agency: None	Post Inspection Contacts:
Inspector(s): Leigh Simmons	Inspector's Signature:

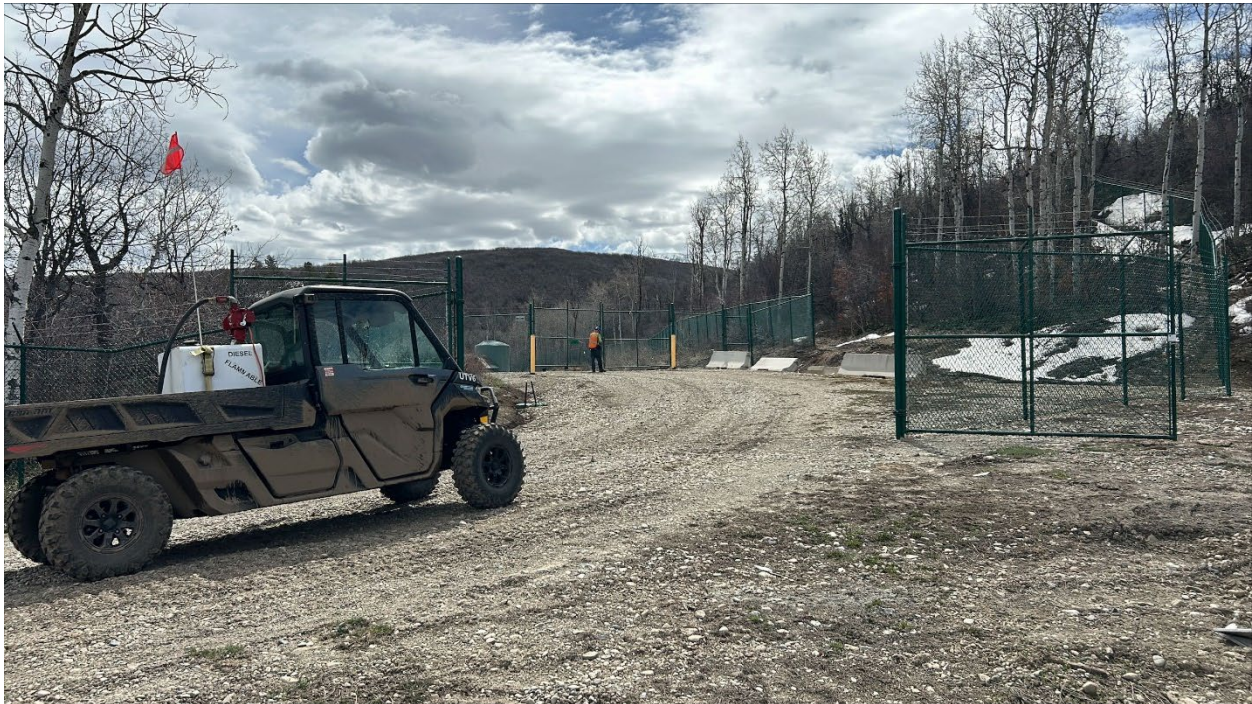
No recent activity had occurred at the Deer Creek vent shaft. The facility was secured by two fences, each with a locked gate. A third fence secured the perimeter of the actual shaft itself. The site was clean and tidy, the pad was well graveled, with no ponded water. The drainage ditch around the outside of the pad was clear and protected with straw bales to control sediment leaving the facility.

Figure 1: Access to the Deer Creek Vent Shaft facility

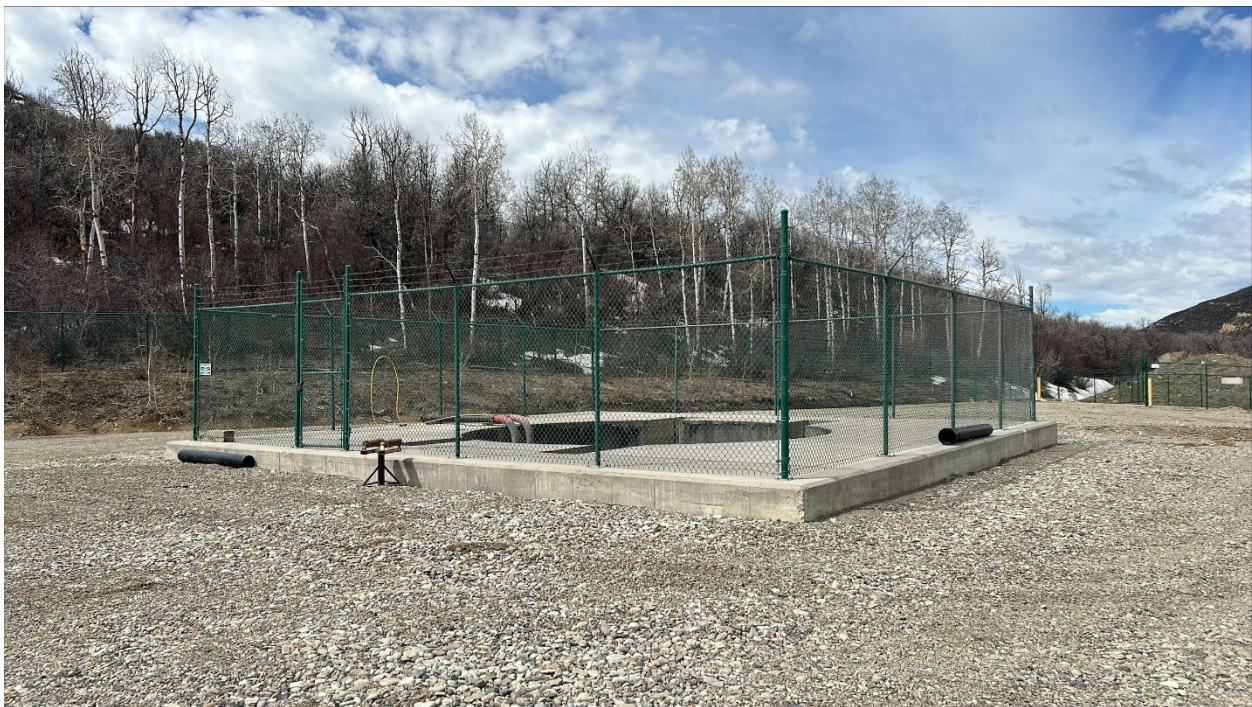
Figure 2: Deer Creek Vent Shaft

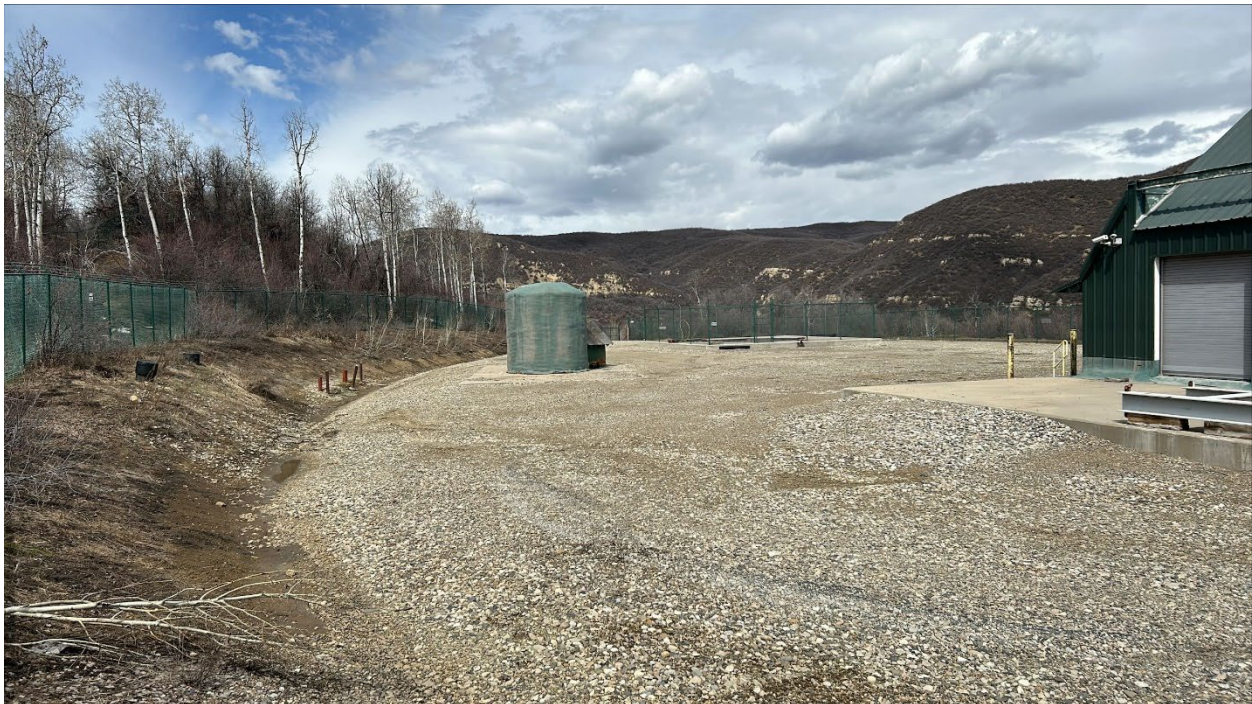
Figure 4: Graveled pad with positive drainage and sediment control

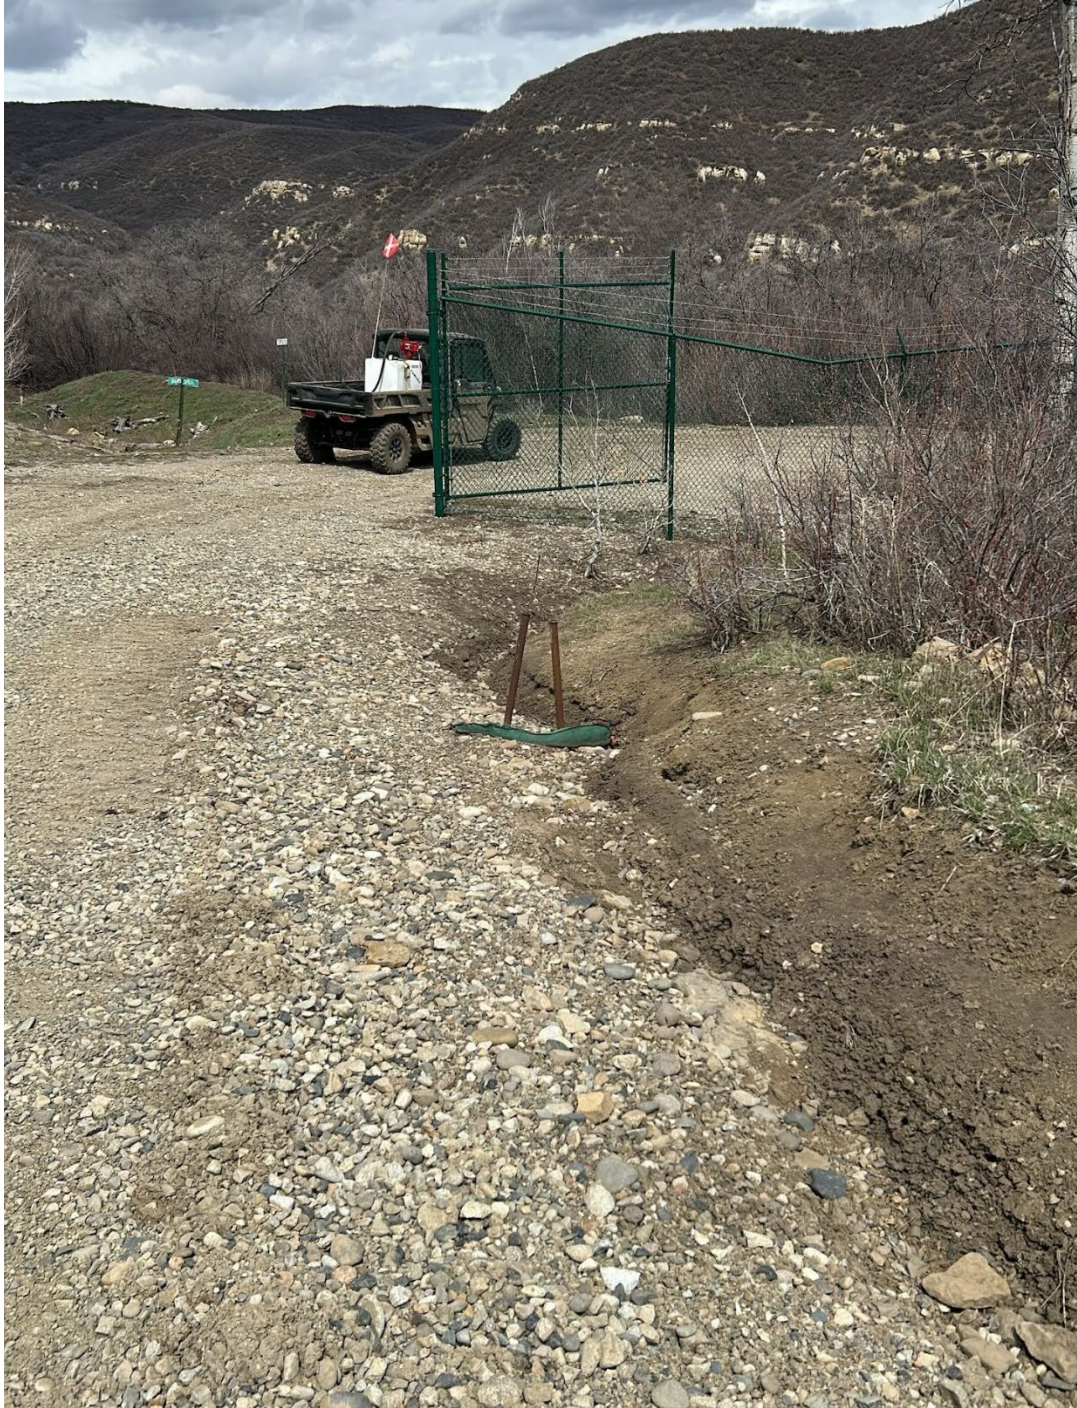
Figure 5: Sediment control

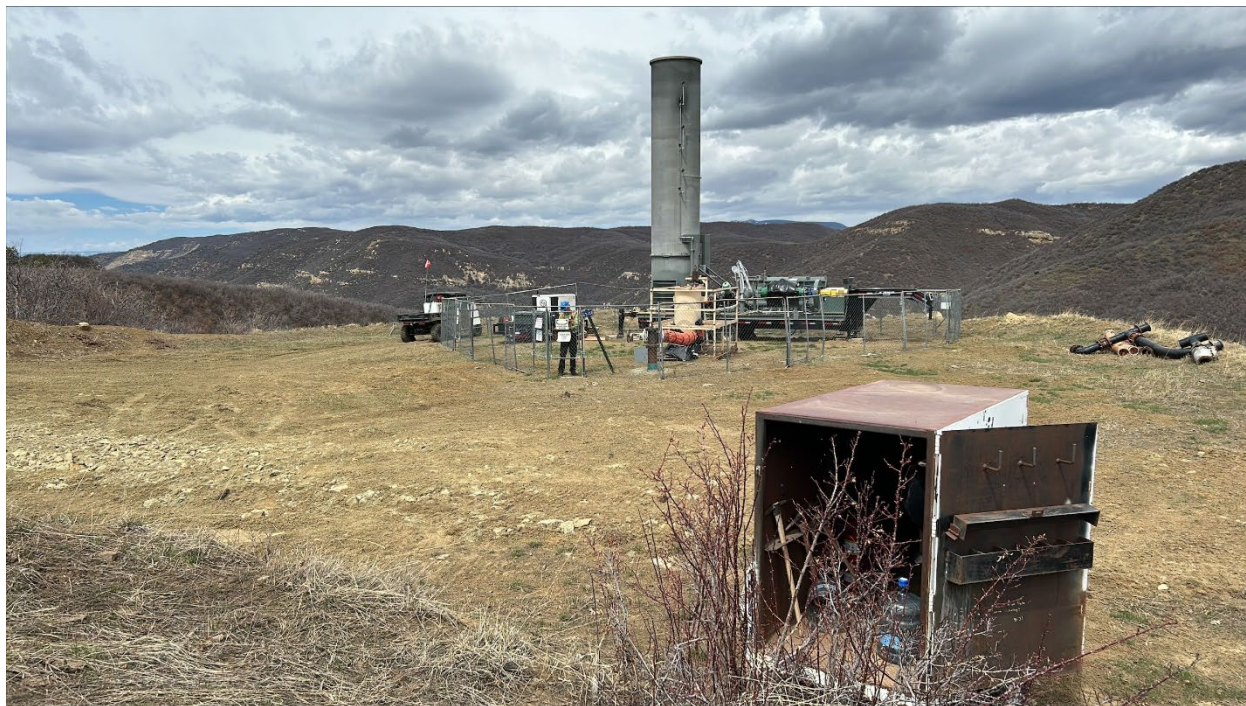
The mobile flare was installed on the E3-6 MVB pad. The flare was running at the time of the inspection and had been running all through the winter. Mr. Polson completed the regular maintenance check of the equipment and collected a sample of the gas coming from the mine during the inspection. The maintenance procedures begin by checking the emergency stop function. With the flare off, water is drained from the separator and the generator is topped up with diesel (Mr. Polson estimated that it uses 15-20 gallons of fuel per day). The flare is re-started following an automated procedure, which involves pre-heating the burner using propane from a tank.

Figure 6: Mobile flare on E3-6 MVB pad

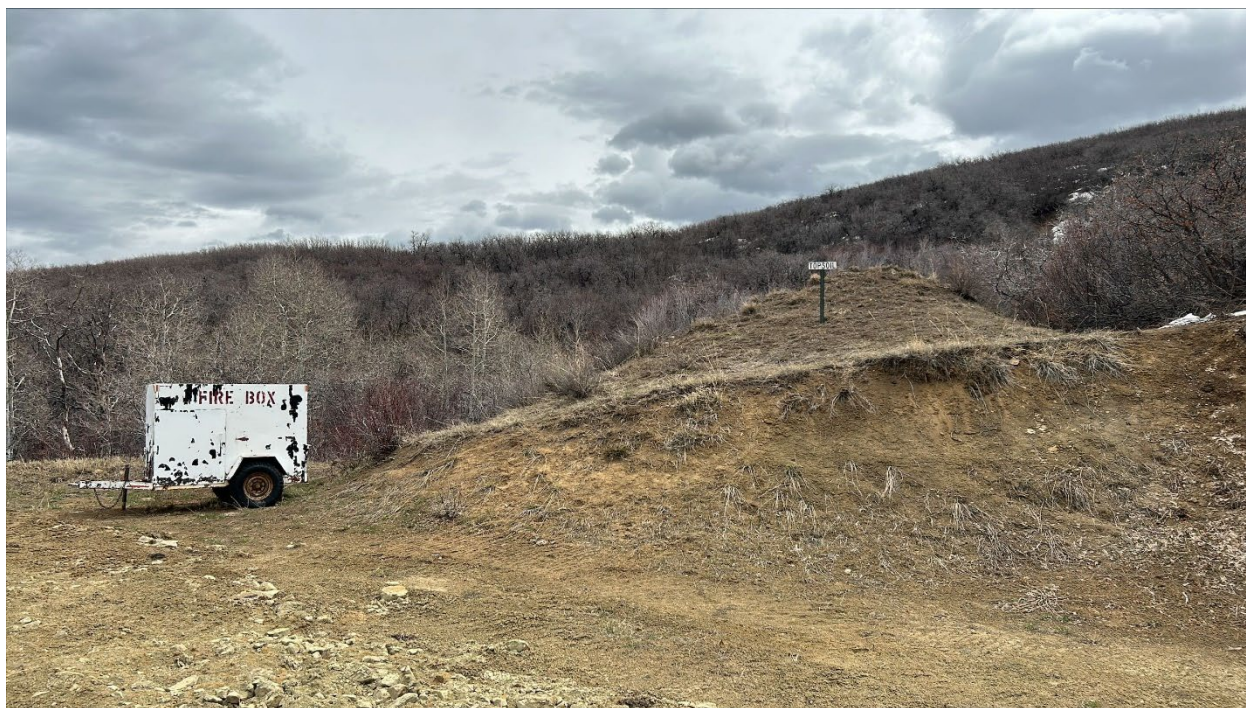
The E3-6 pad itself was stable and compact, with no sign of ponded water. Topsoil was stockpiled and clearly marked. Straw bales had been placed to control sediment on many of the MVB pads and access roads and had been protected from grazing by wildlife and cattle using short sections of fencing.

Figure 7: Fire box and topsoil pile

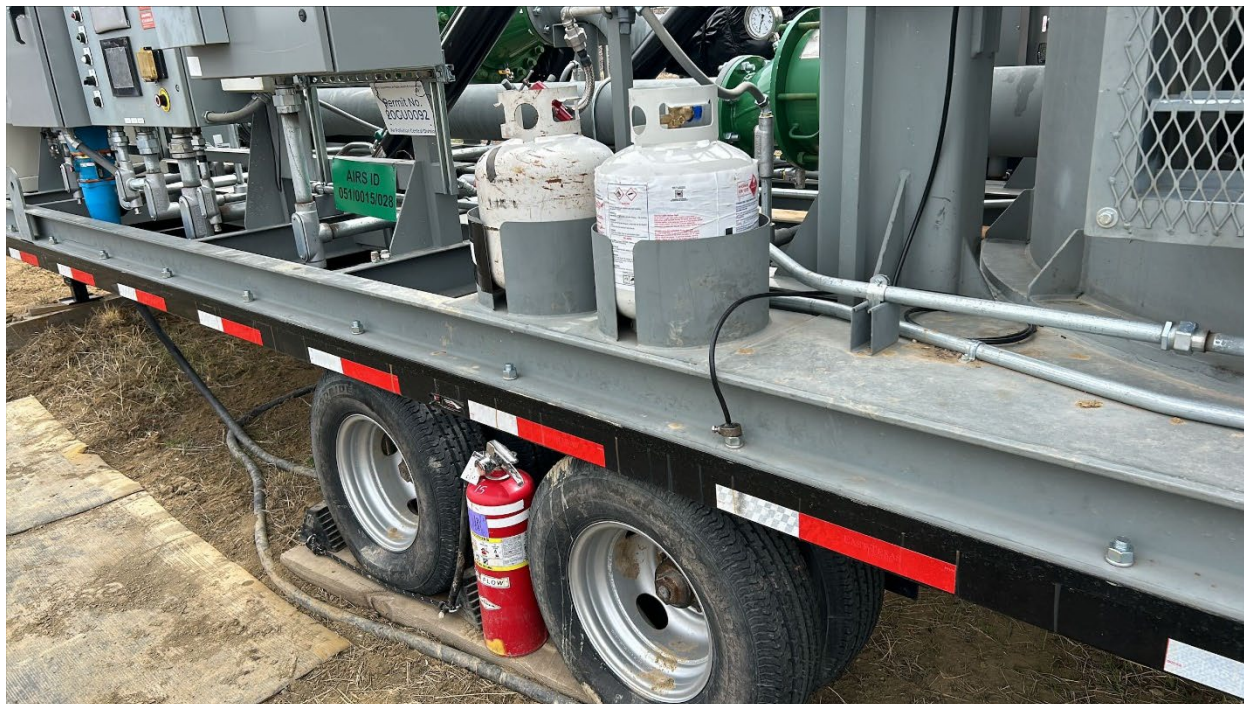
Figure 13: Propane for pre-heating flare

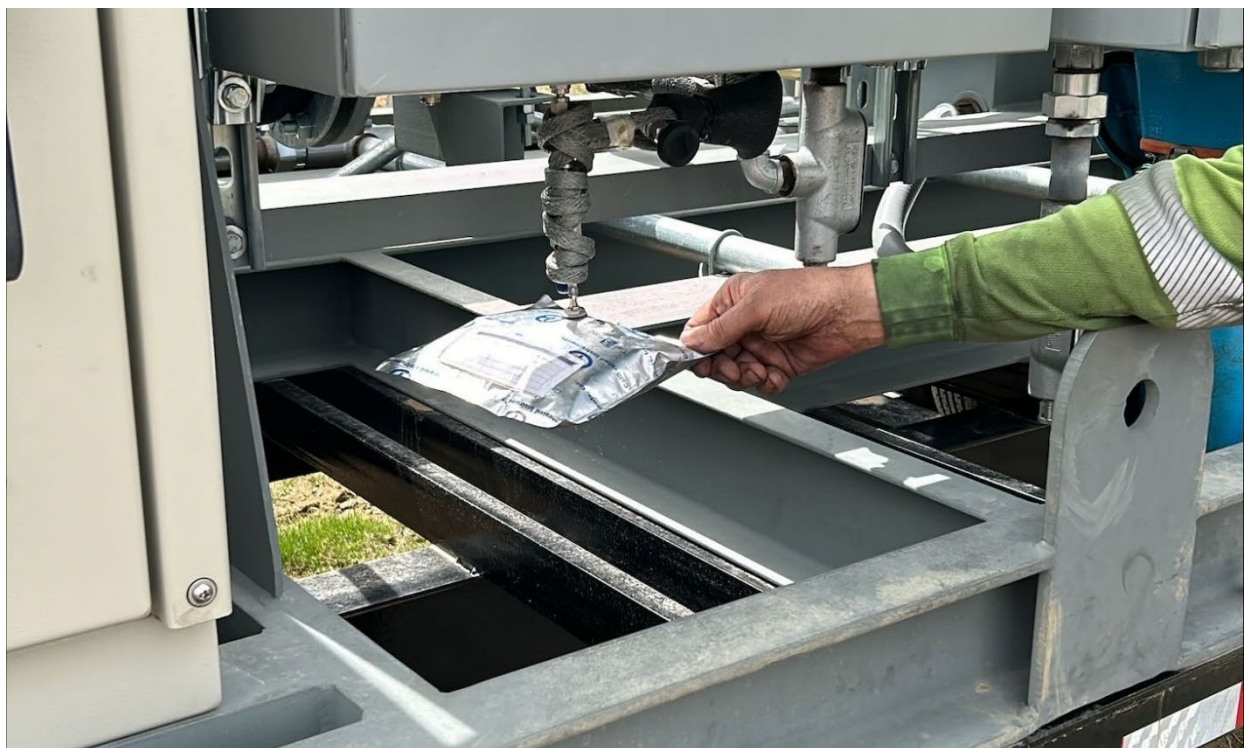
A bag sample of the influent gas was collected, following a standard procedure: The bag is attached to a small nipple near the control panel. A ball valve is opened to allow gas to flow through the nipple. The bag is flushed three times before the sample is collected. The bag is taken for analysis by gas chromatography at the lab next to wash plant. The bag sample is used to validate the in-line monitoring of the gas composition. Mr. Polson said that the gas has been consistent all winter. The in-line monitoring display showed 67.4% methane, 0% oxygen at the time of the inspection. The flare and all associated equipment were secure behind a chain-link fence. Outside of the fence, on the edge of the pad was a trailer marked “Fire Box”, containing water, fire extinguishers and hand tools.

Figure 14: Bag sample collection

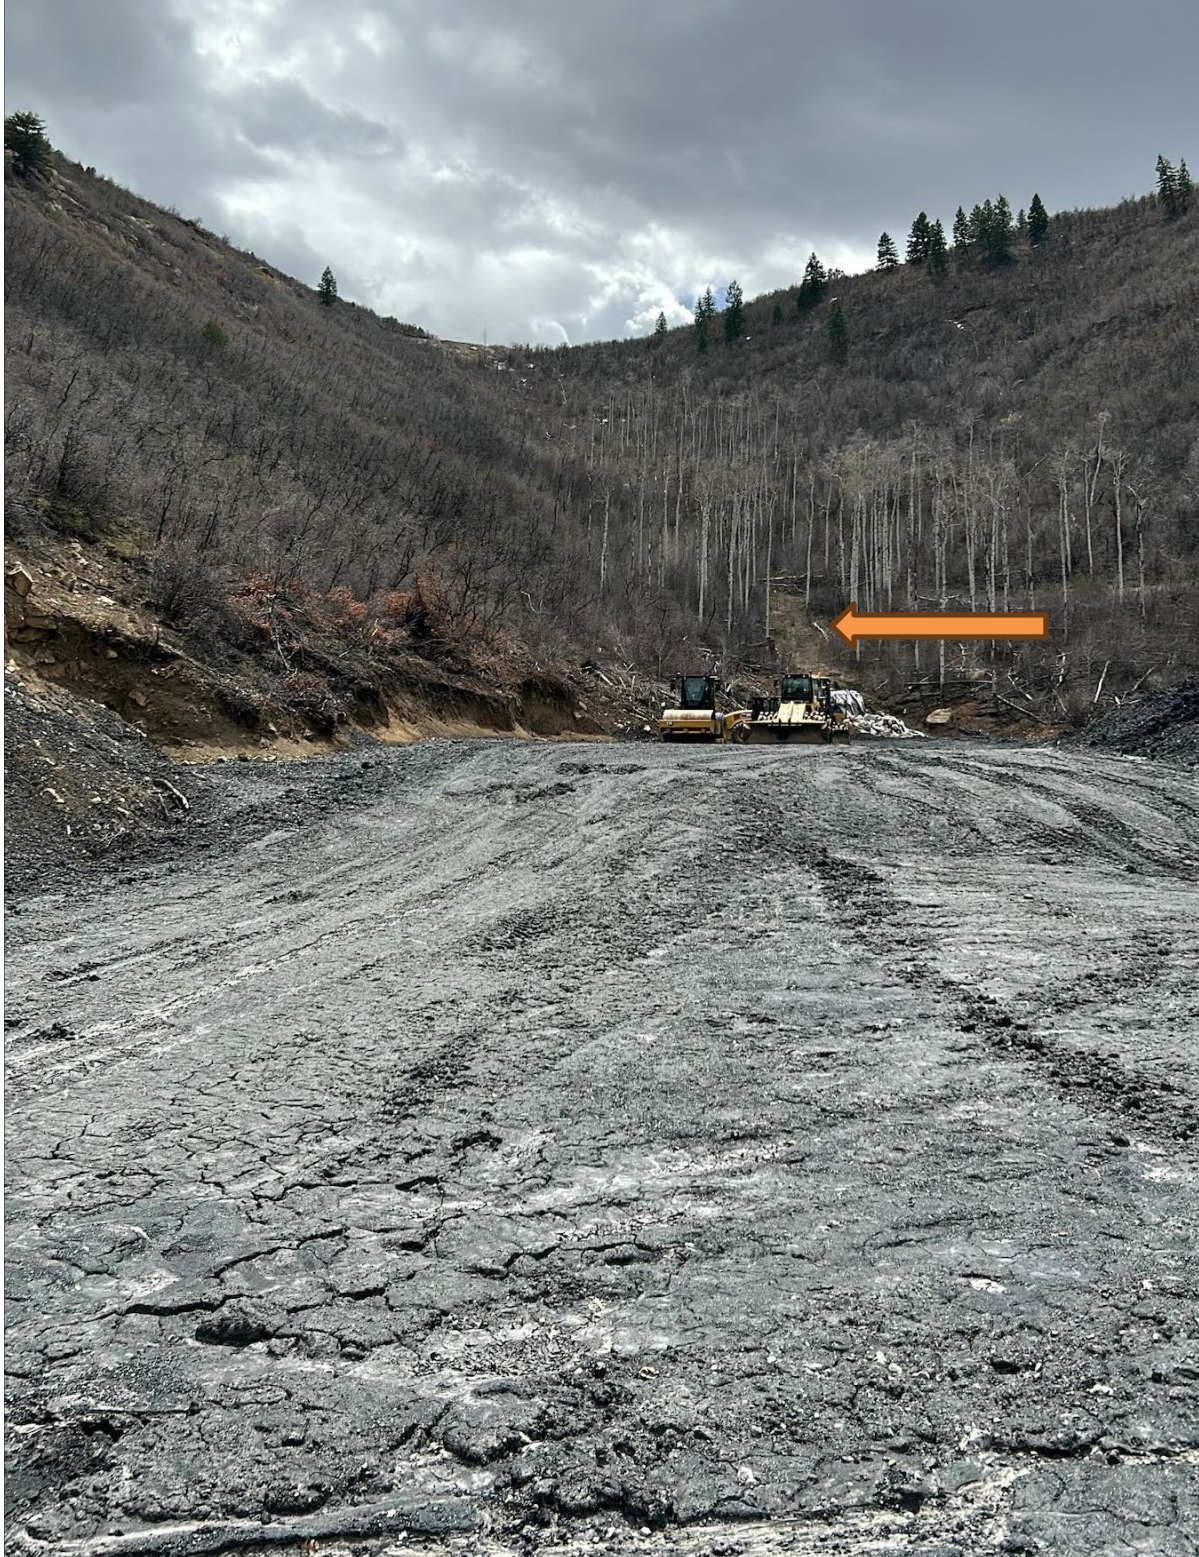
Figure 15: RPEE. Topsoil stripping to approximately level of arrow is anticipated

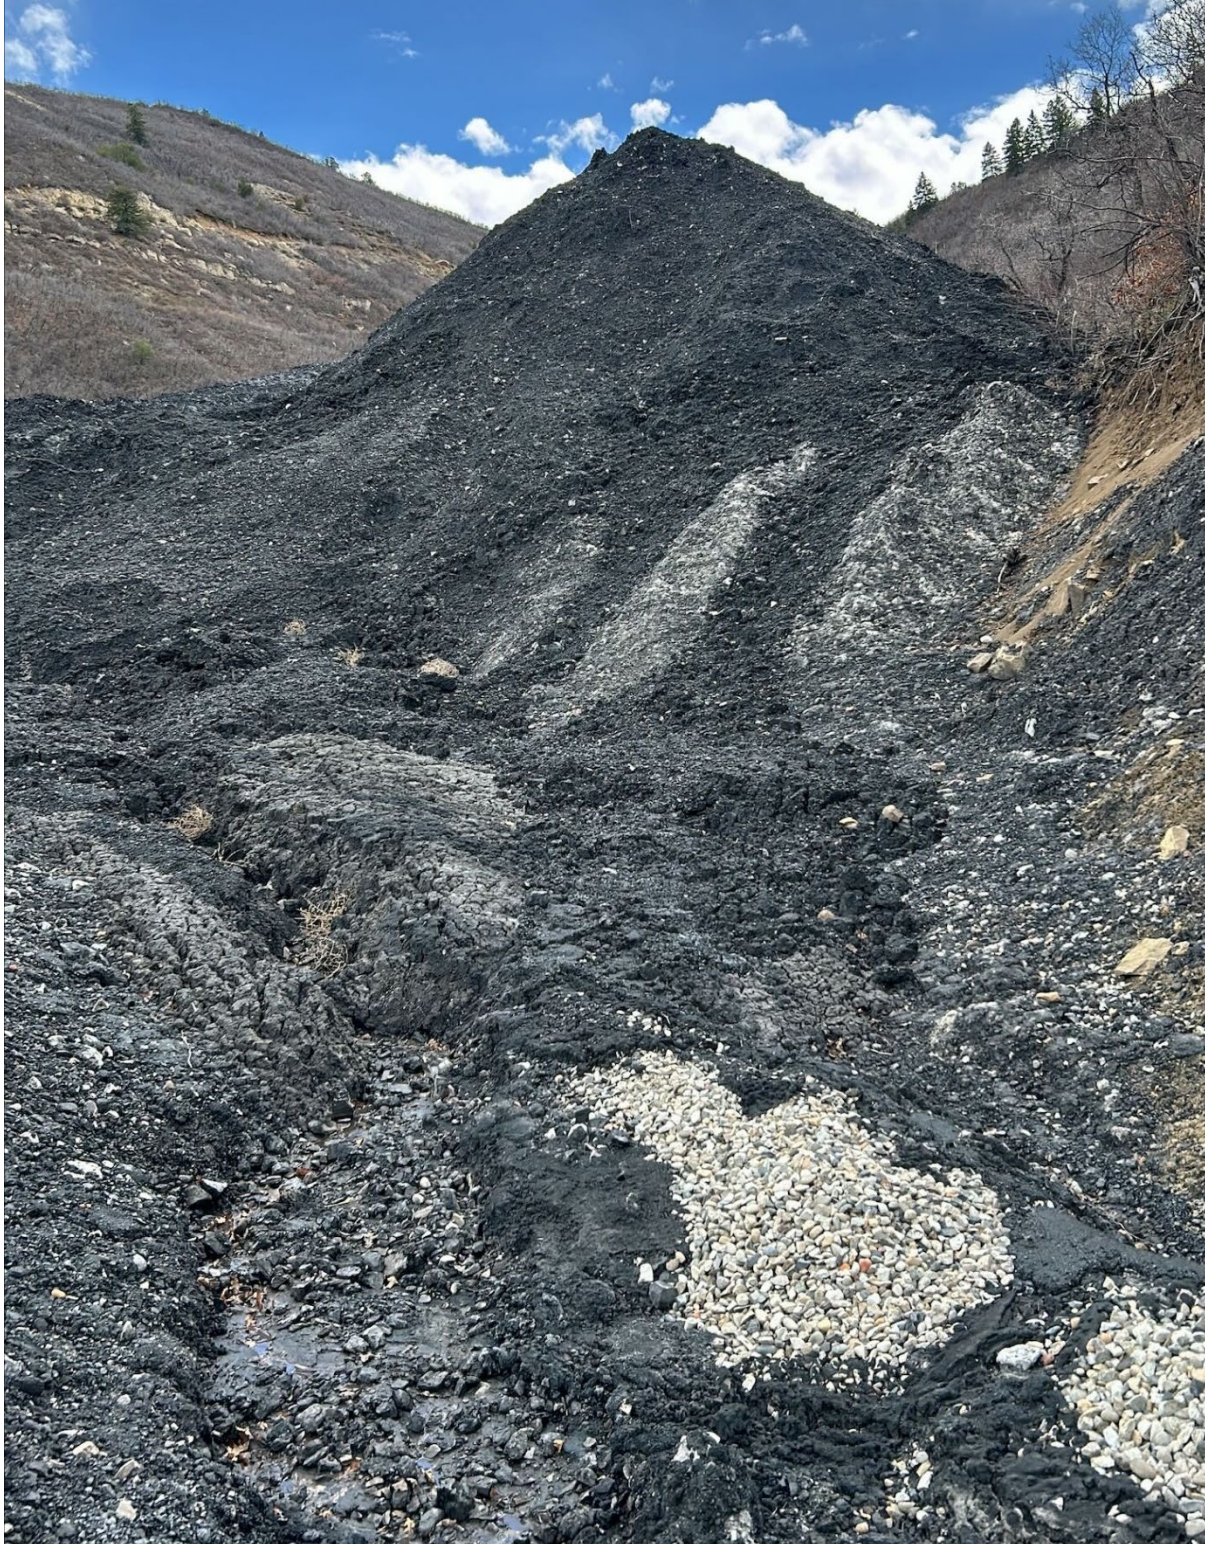
An estimated 100,000 tons of uncompacted waste was piled on the west side of the top of the RPEE. Water continued to drain from the material. It was anticipated that contractors with Wells would begin to work on the pile in May.

Figure 16: Uncompacted refuse on west side of pile, continuing to drain

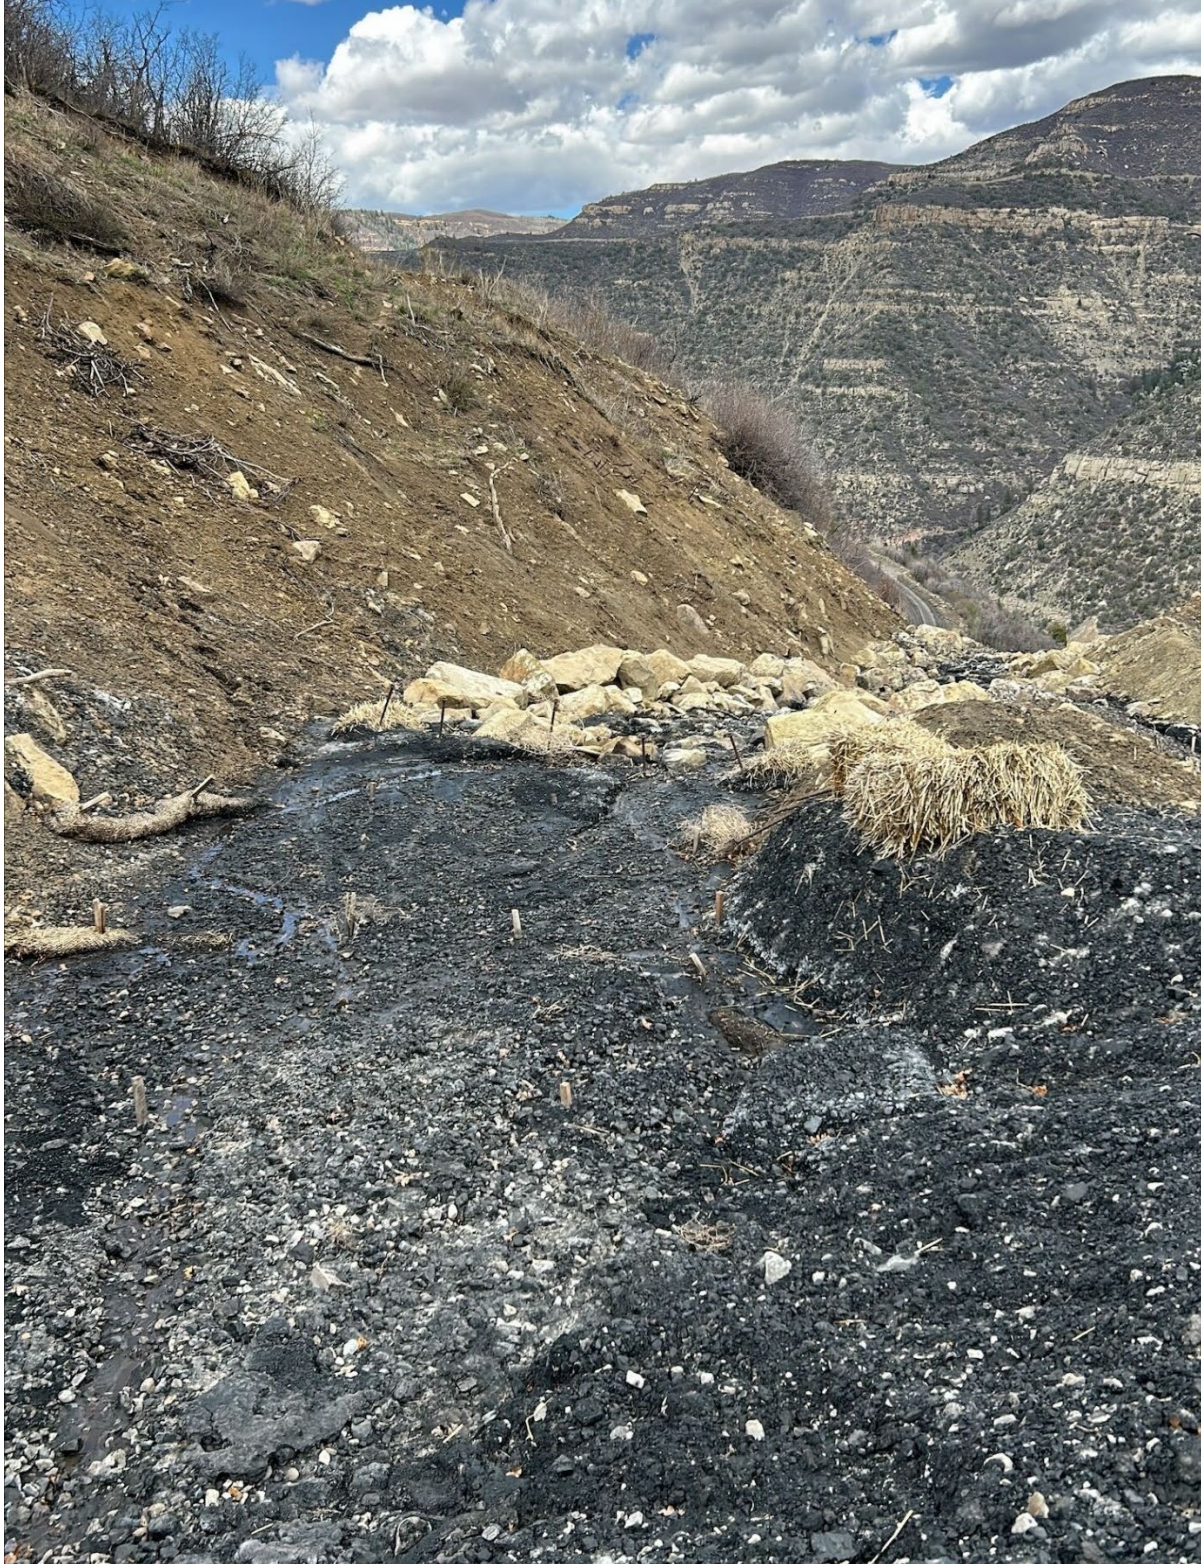
Figure 17: Drain on west side of pile

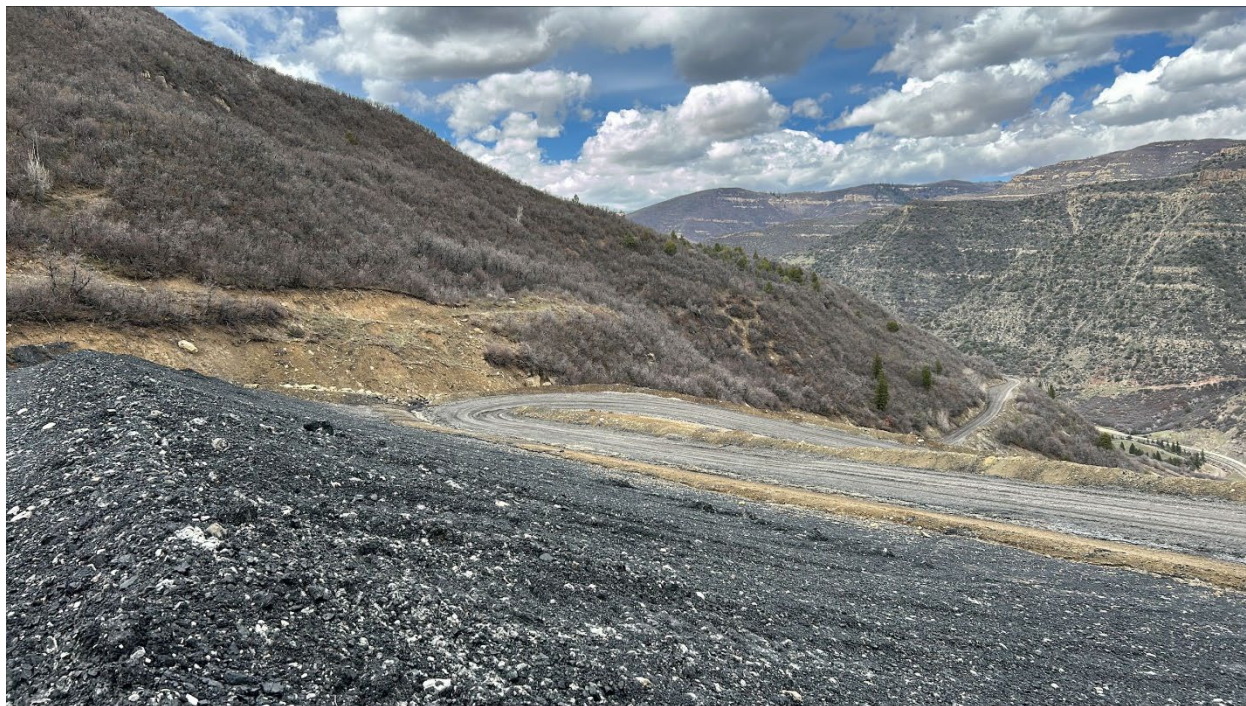
The RPEE haul road was in excellent condition for the time of year, which is testament to the preparation work that Wells Excavating did to clean the ditch, grade the surface, and install water bars before the winter, as well as the fact that no attempt was made to travel the road in haul trucks through the winter.

Figure 18: Compacted face of RPEE, with top of haul road

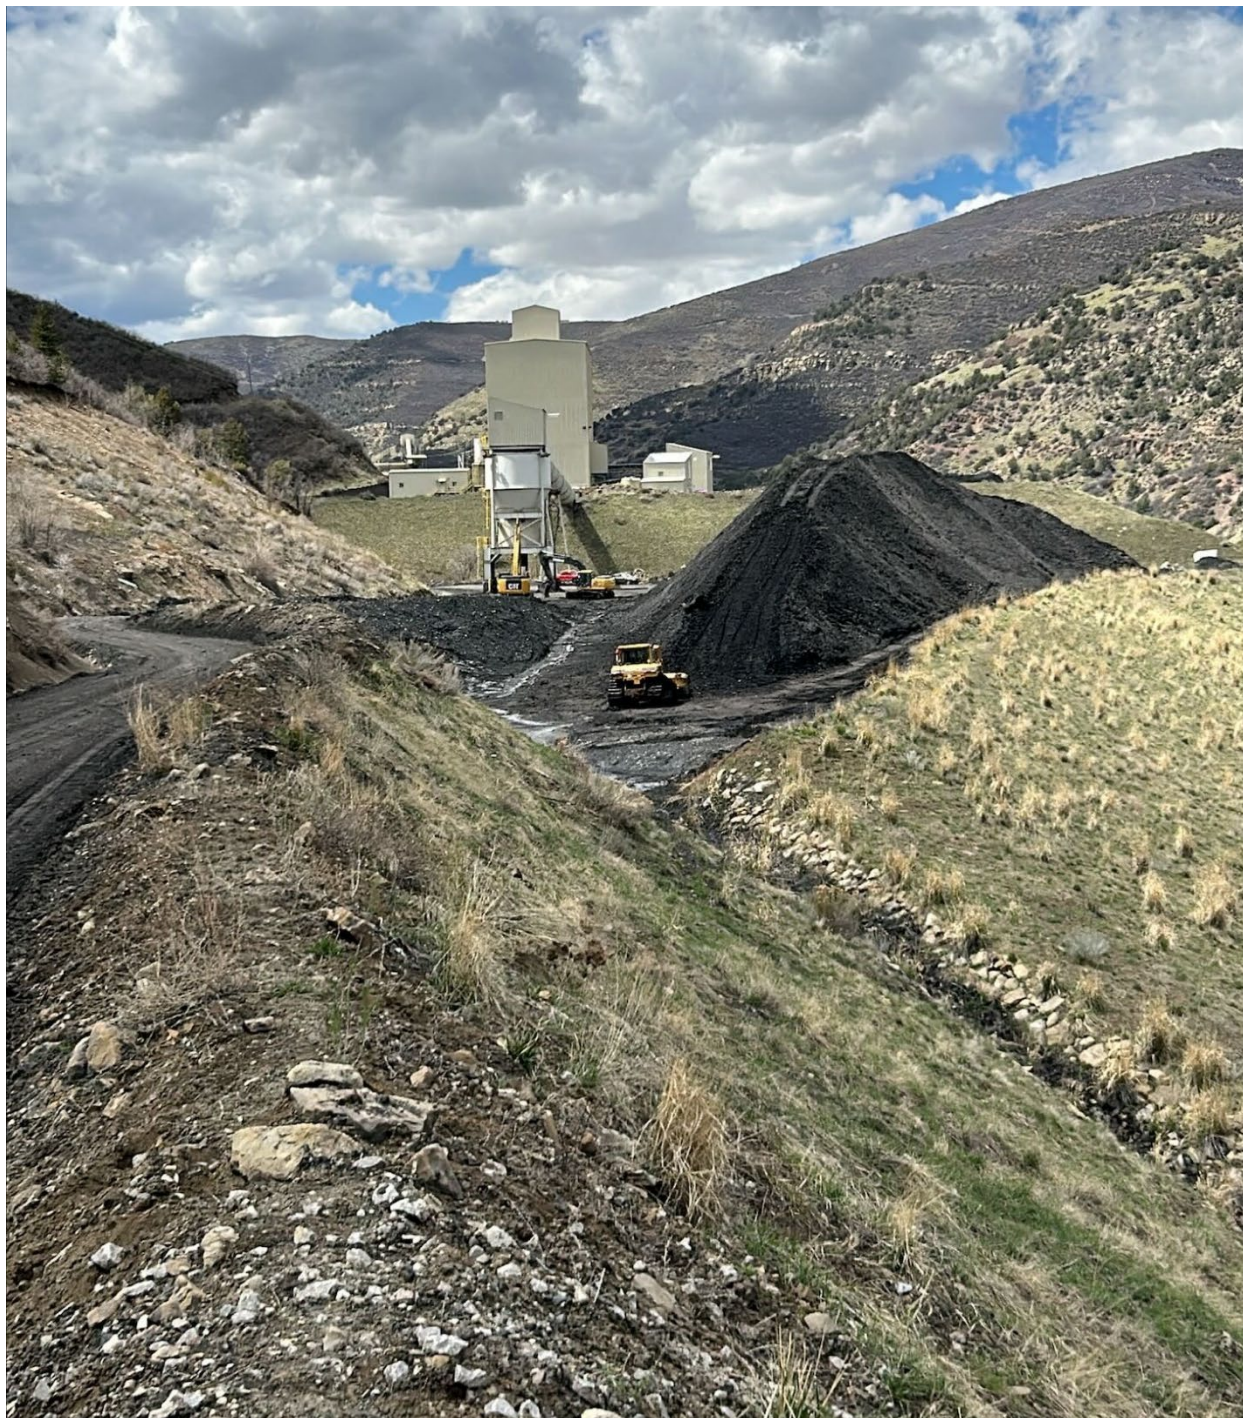
Newly generated processing waste had been temporarily stockpiled on the RPE. An estimated 30,000 tons of material was in the pile. A wide roadway had been left around the edge of the pile.

Figure 20: Processing waste temporarily stockpiled on RPE

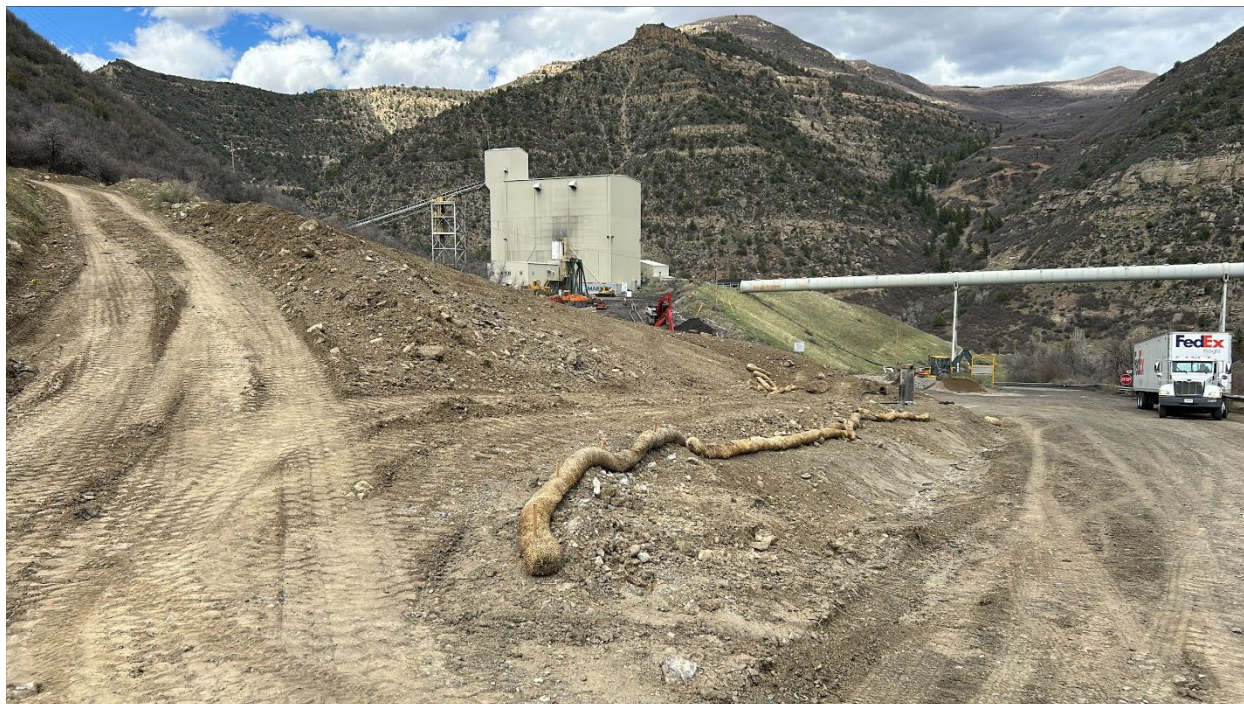
Equipment had been demobilized from the Box Canyon North well pad, the mud pit had been filled in and the earth work to regrade the pad and restore the roadside ditch had been completed. The concrete pad and pumphouse had not yet been constructed. At the time of the inspection work was in progress to install the pipeline from the well across the road.

Figure 21: Site of Box Canyon North Well, showing regraded pad and restored road ditch

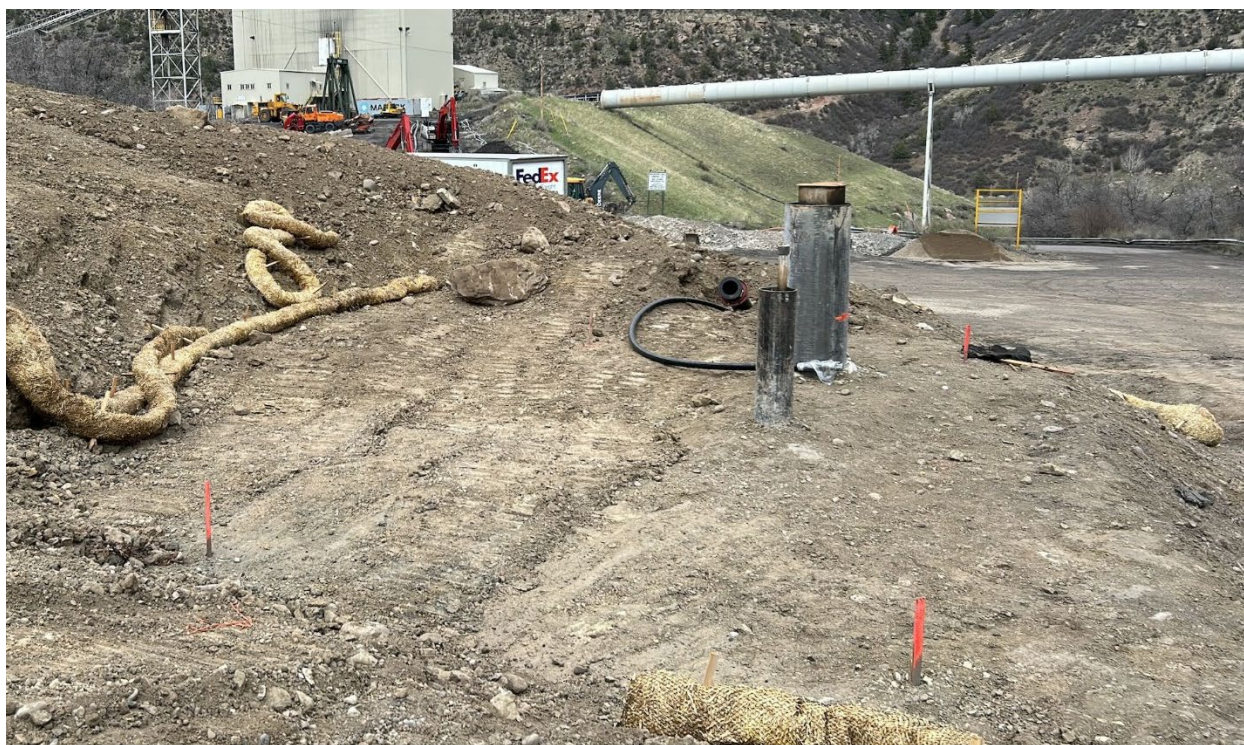
Figure 22: Cased borehole and stakes for concrete pad

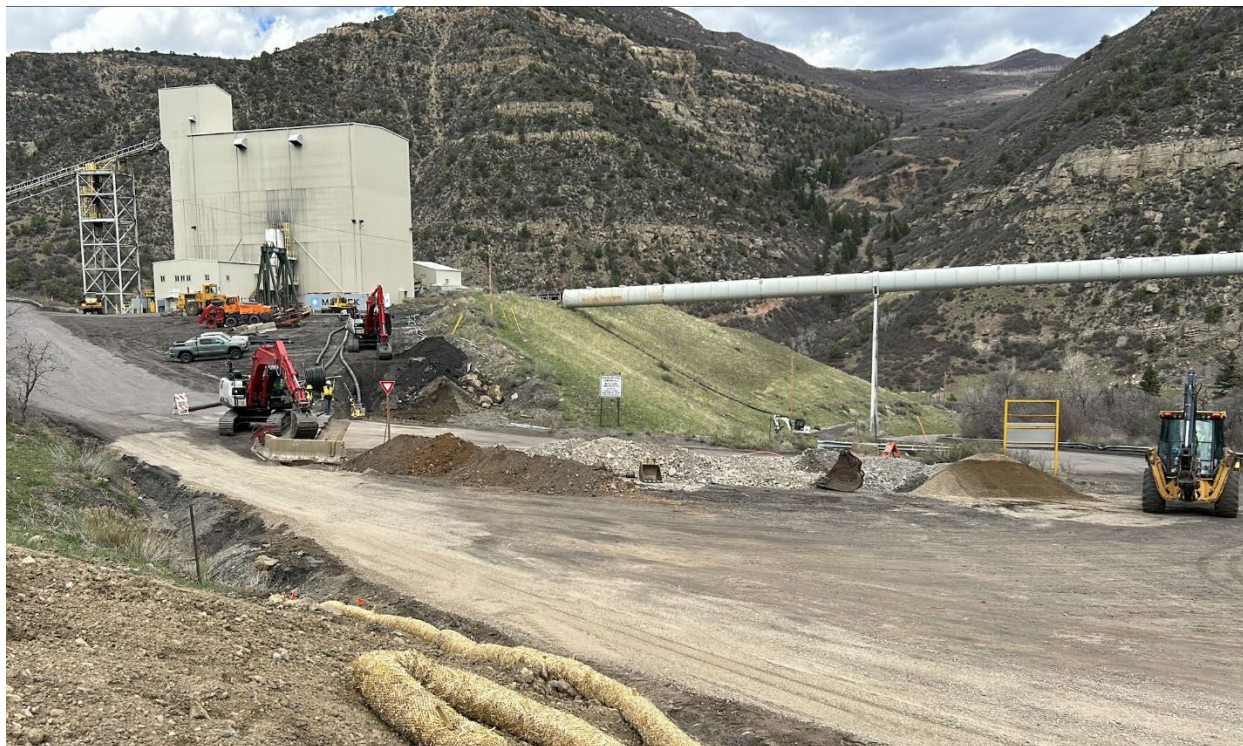
Figure 23: Work in progress to install water line

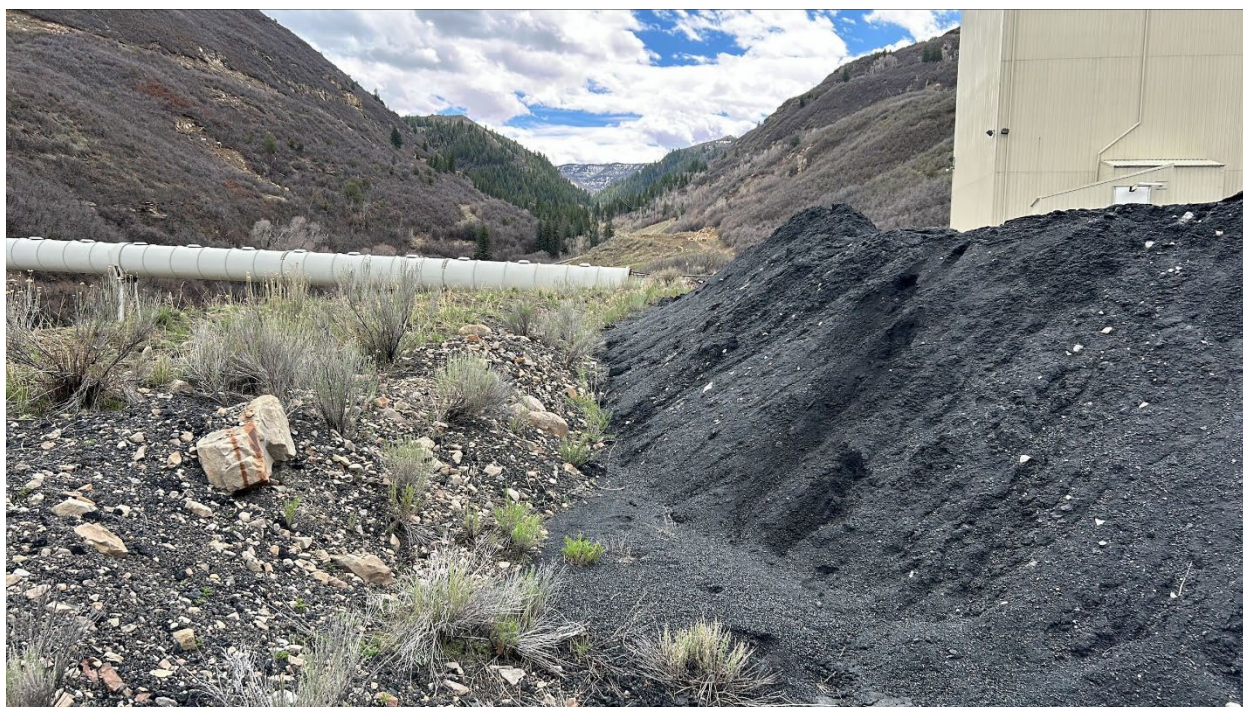
A temporary stockpile of mixed coal fines and waste was still in place on the top of the LRP. It was noted during the inspection that maintenance was required to ensure surface water could drain from the top of the pile as intended. MCC had their contractor Wells Excavating clean material from the edge of the pile immediately following the inspection and sent photographs documenting the work.

Figure 24: Fines temporarily stored on LRP

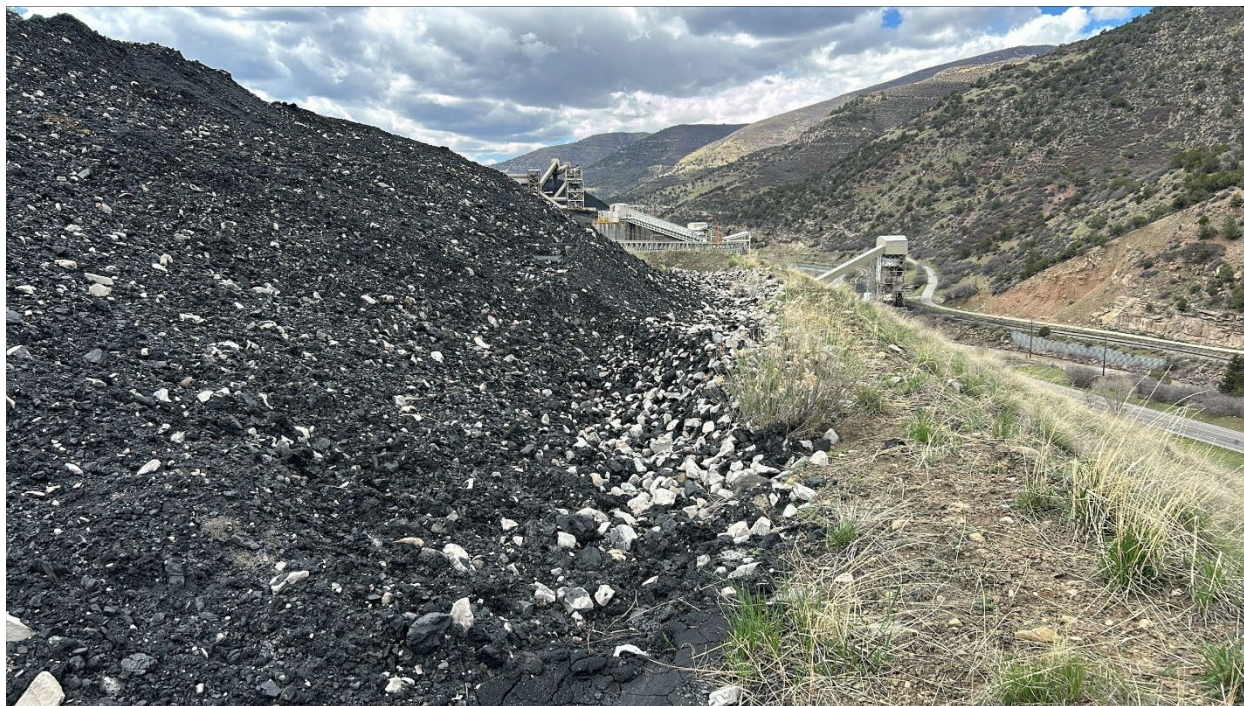
Figure 25: Refuse temporarily stockpiled at west side of LRP
