C1980007, West Elk Mine, April Inspection Report

PERMIT INFORMATION

Permit Number: C-1980-007 Mine Name: West Elk Mine Operator: Mountain Coal Company, LLC Operator Address: Jessica Wilczek 5174 Highway 133 Somerset, CO 81434	County: Delta, Gunnison Operation Type: Underground Permit Status: Active Ownership: Private
	Operator Representative Present: Rodger Polson, Ed Ogrodny, Michael Aire
Operator Representative Signature: (Field Issuance Only)

Inspection Start Date: April 18, 2024 Inspection Start Time: 10:00 Inspection End Date: Inspection End Time:	Inspection Type: Coal Complete Inspection Inspection Reason: Normal I&E Program Weather: Cloudy
Joint Inspection Agency: None	Joint Inspection Contacts:
Post Inspection Agency: None	Post Inspection Contacts:
Inspector(s): Leigh Simmons	Inspector's Signature:

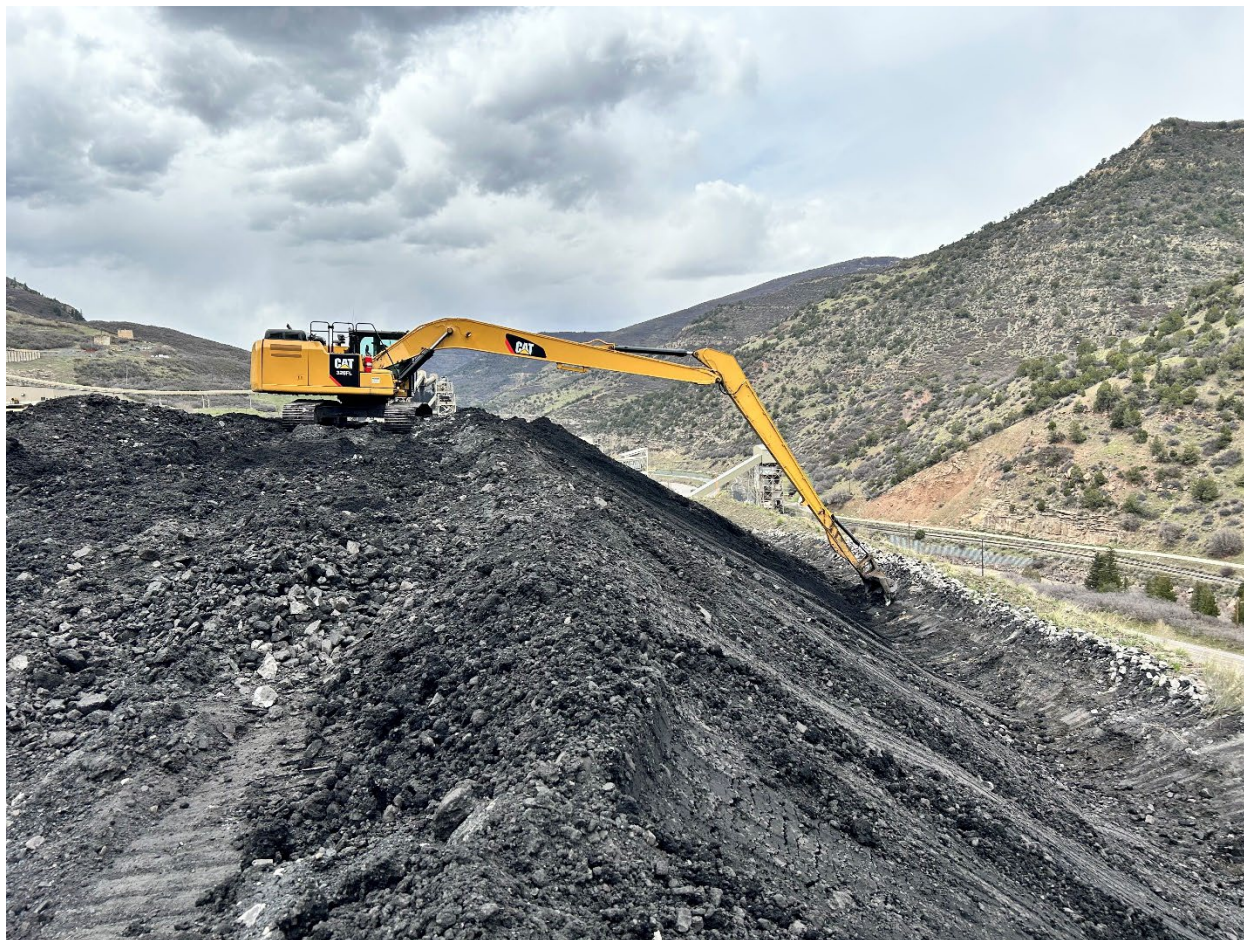
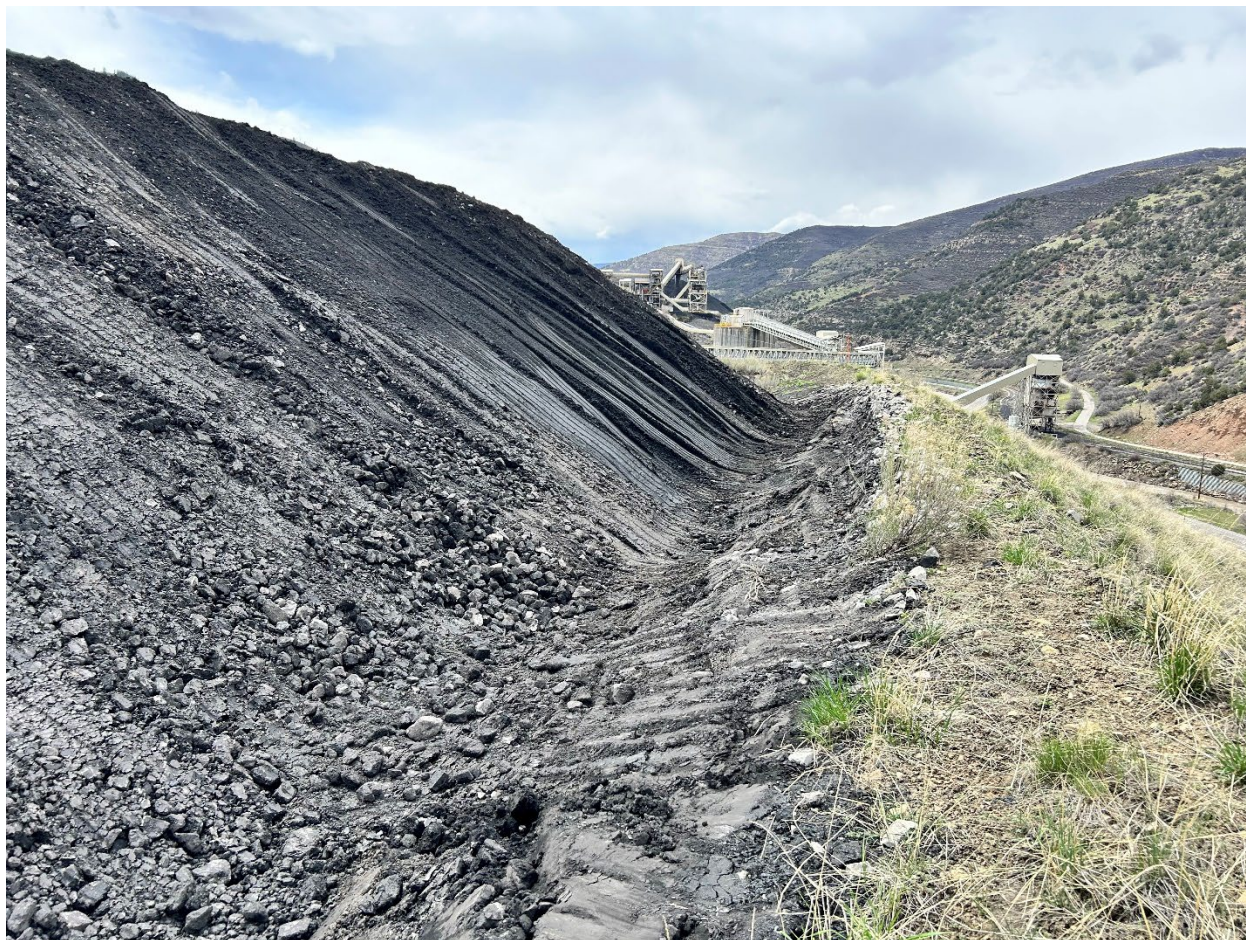
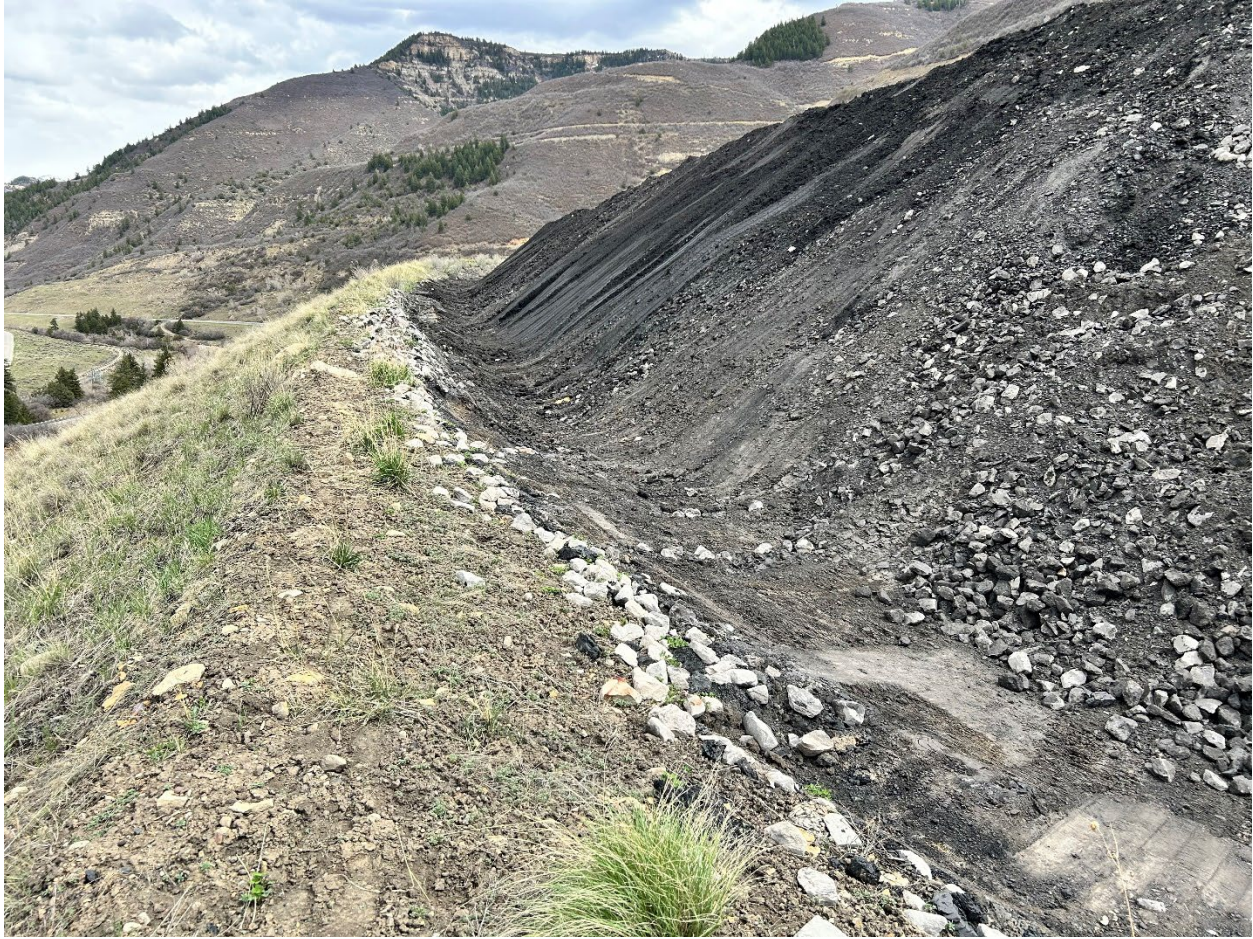
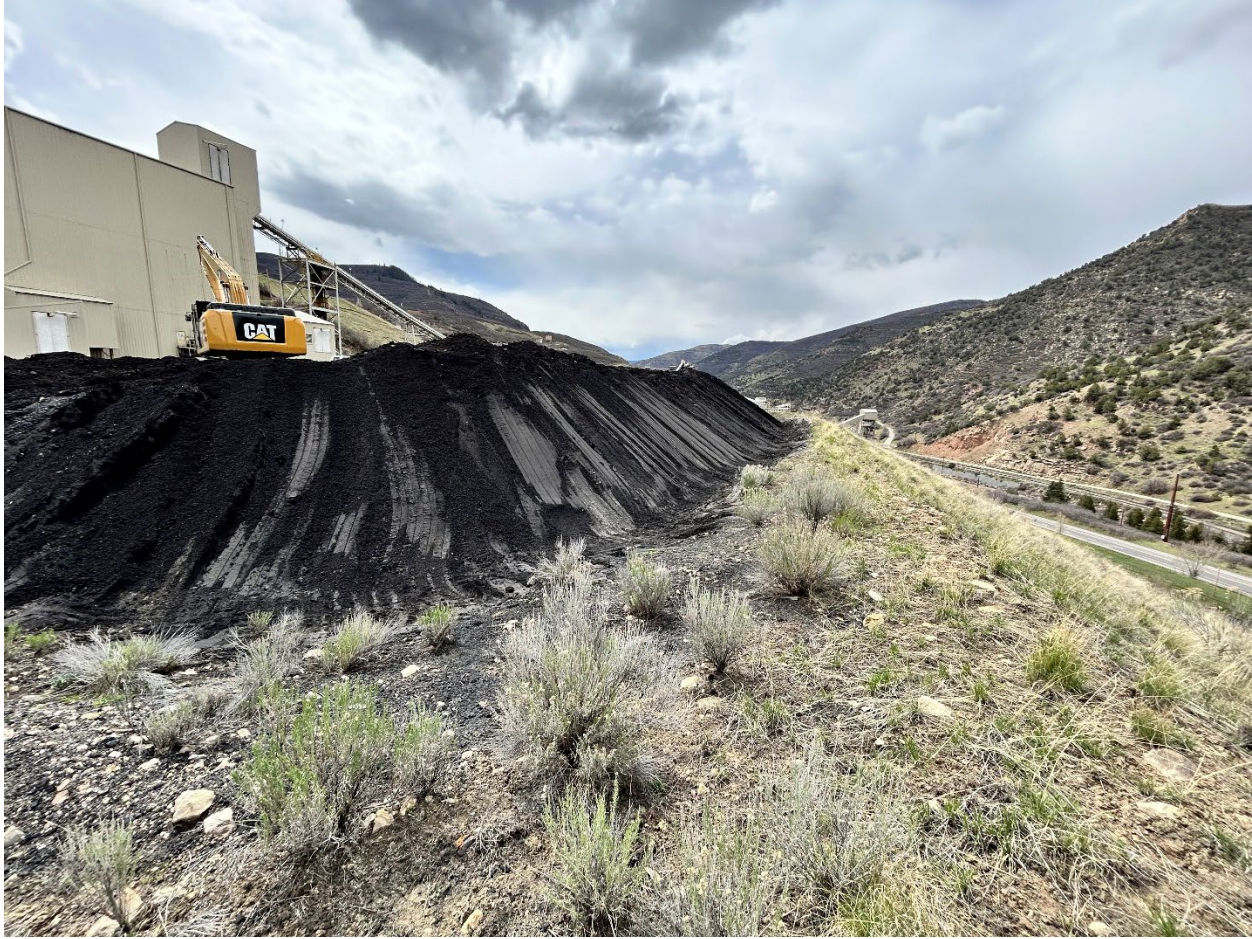
A temporary stockpile of mixed coal fines and waste was still in place on the top of the LRP. It was noted during the inspection that maintenance was required to ensure surface water could drain from the top of the pile as intended. MCC had their contractor Wells Excavating clean material from the edge of the pile immediately following the inspection and sent photographs documenting the work.

Figure 27: Work in progress to improve drainage on LRP (Photo 1 of 4 from MCC)

Figure 28: Work in progress to improve drainage on LRP (Photo 2 of 4 from MCC)

Figure 29: Work in progress to improve drainage on LRP (Photo 3 of 4 from MCC)

Figure 30: Work complete to improve drainage on LRP (Photo 4 of 4 from MCC)

Photographs documenting the maintenance work on the LRP were emailed by Ed Ogrodny following the inspection, (included as Figures 27-30).
