**22 April 2024**

<b>Permit Number:</b> C-1981-044 <b>Mine Name:</b> Williams Fork Mines <b>Operator:</b> Moffat County Mining, LLC  <b>Operator Address:</b> Ms. Miranda Kawcak 29515 Routt County Road #27 Oak Creek, CO 80467	<b>County:</b> Moffat <b>Operation Type:</b> Underground <b>Permit Status:</b> Active <b>Ownership:</b> Private  <b>Operator Representative Present:</b> Miranda Kawcak
This report was issued electronically from the Divisions' Denver Office.

Inspection Start Date: <b>22 April 2024</b> Inspection Start Time: 13:00 p.m. Inspection End Date: <b>22 April 2024</b> Inspection End Time: 5:00 p.m.	Inspection Type: <b>Coal Complete Inspection</b> Inspection Reason: Normal I&E Program Weather: Partly Cloudy
<b>Joint Inspection Agency:</b> <b>Post Inspection Agency:</b> None	<b>Joint Inspection Contacts:</b> <b>Post Inspection Contacts:</b>
<b>Inspector(s):</b> Robin A. Reilley, M.S. GISP	<b>Inspector's Signature:</b>   <b>Signature Date:</b> <b>26 April 2024</b>

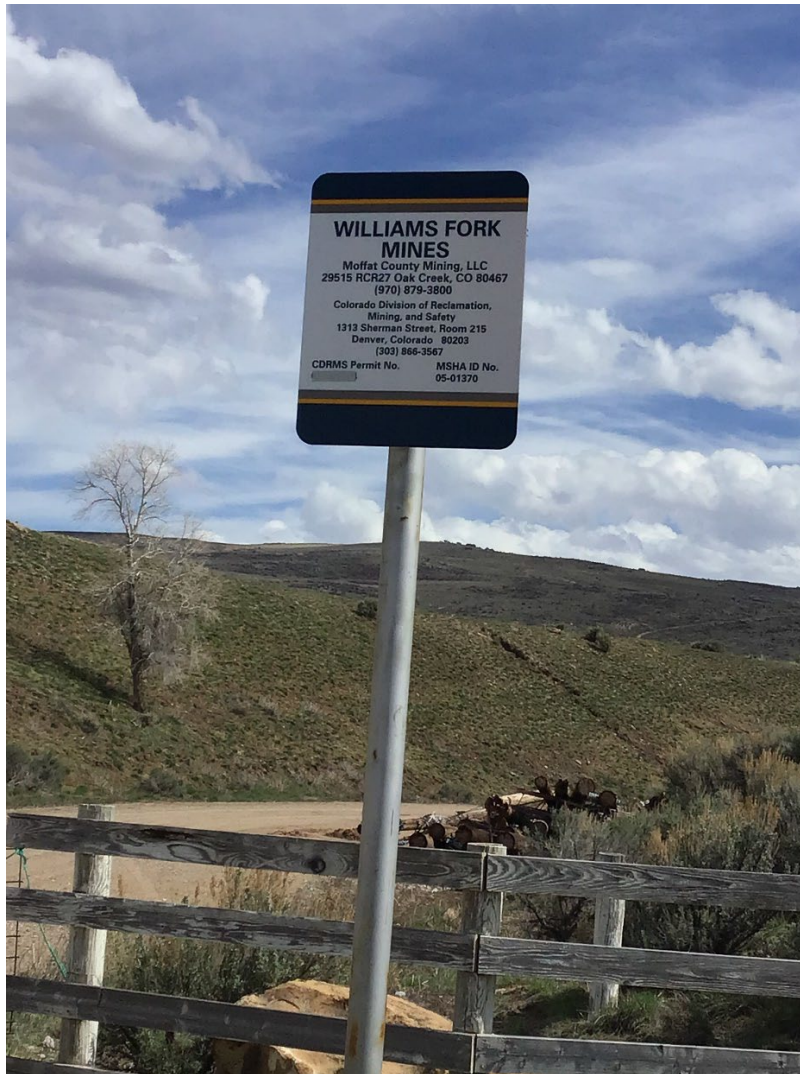
*Photo 1: Mine identification sign at main entrance.*

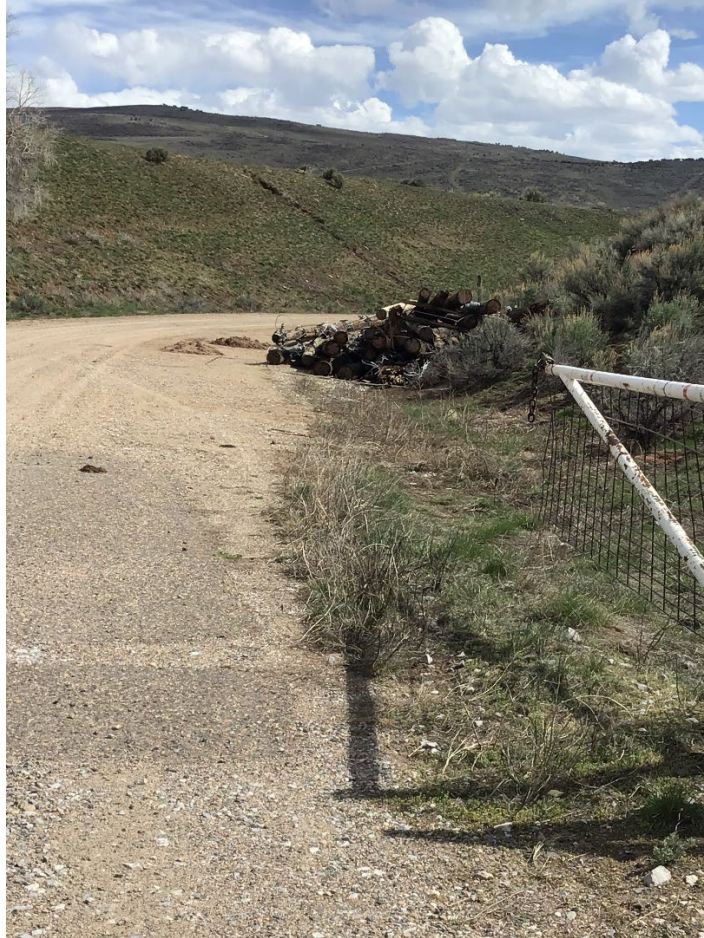
***Photo 2:*** Mine waste at entrance ready to be disposed of.

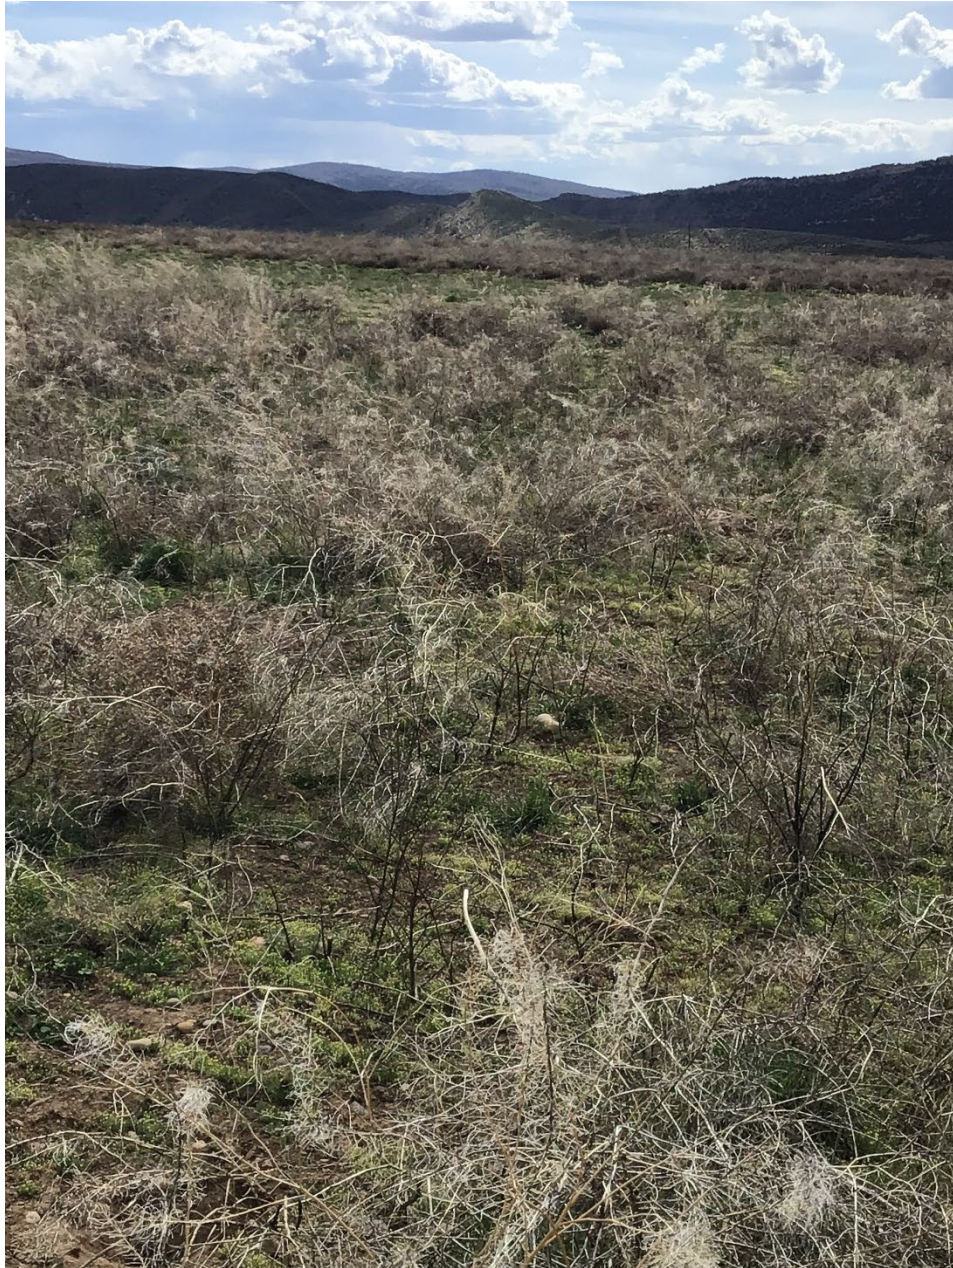
- Refuse pile has been reclaimed, capped, topsoiled and seeded.
- The refuse pile appears stable with no significant rills or gullies forming.
- The pile is vegetated, and the desired vegetation is establishing itself. The pile tends to be weedy in spots.

*Photo 3: Refuse Pile vegetation looking west.*

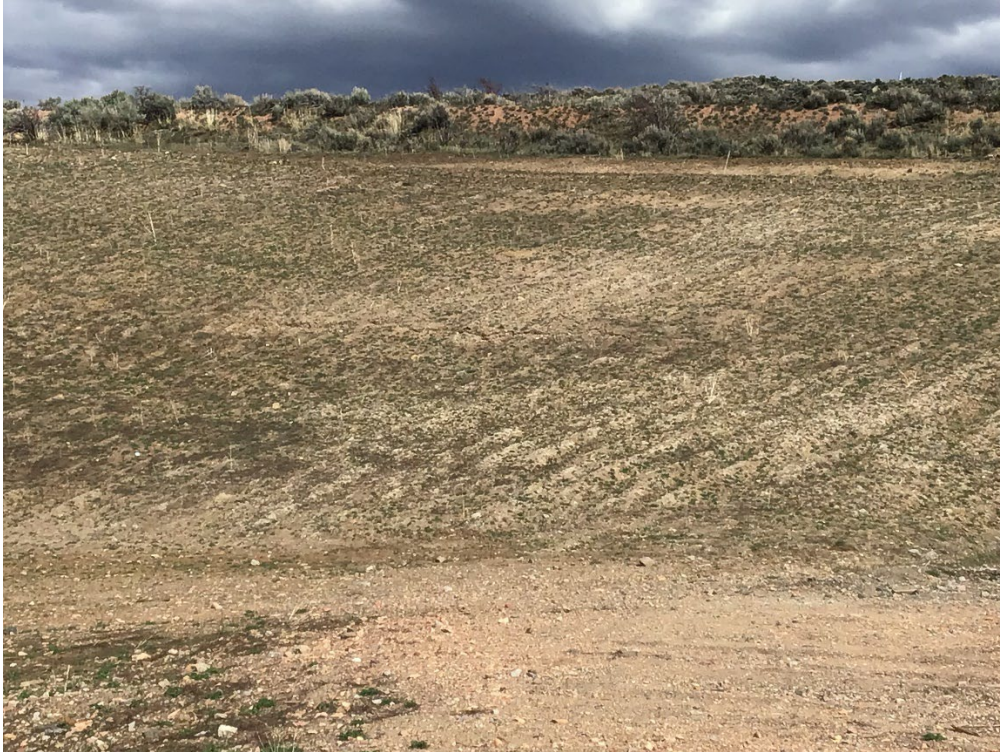
- Reclamation of the 5A Portal area is complete.
- Backfilling, grading, topsoil and seeding occurred in 2023.

***Photo 4:*** 5A portal slope looking east.

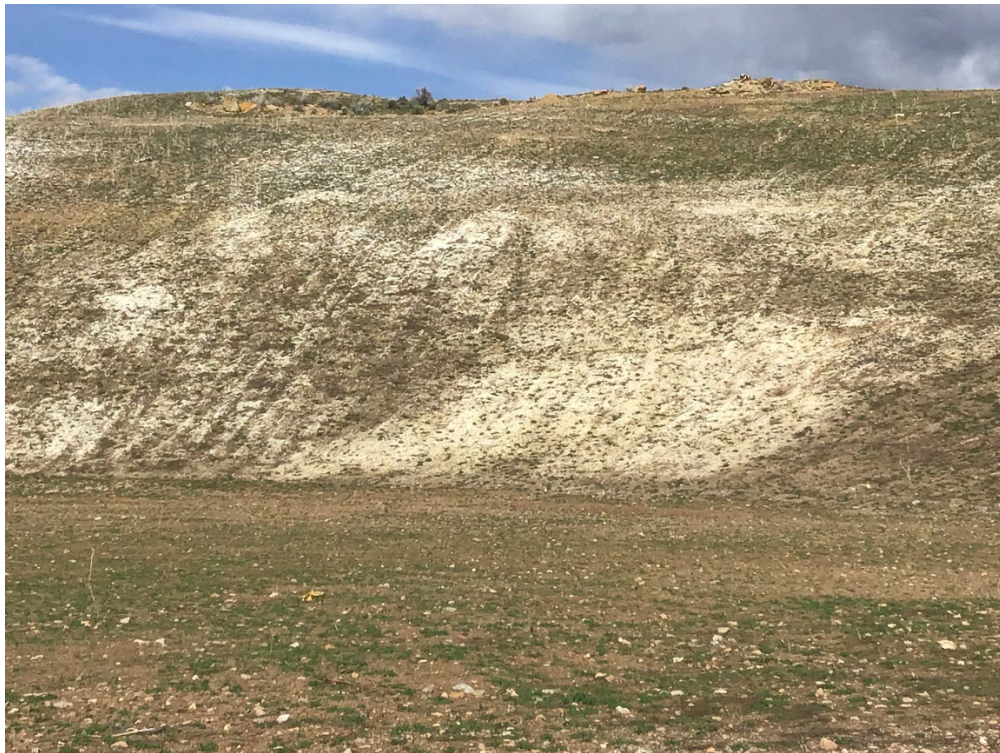
***Photo 5:*** 5A portal slope looking east. The light color is the weathered mulch applied in summer of 2023.

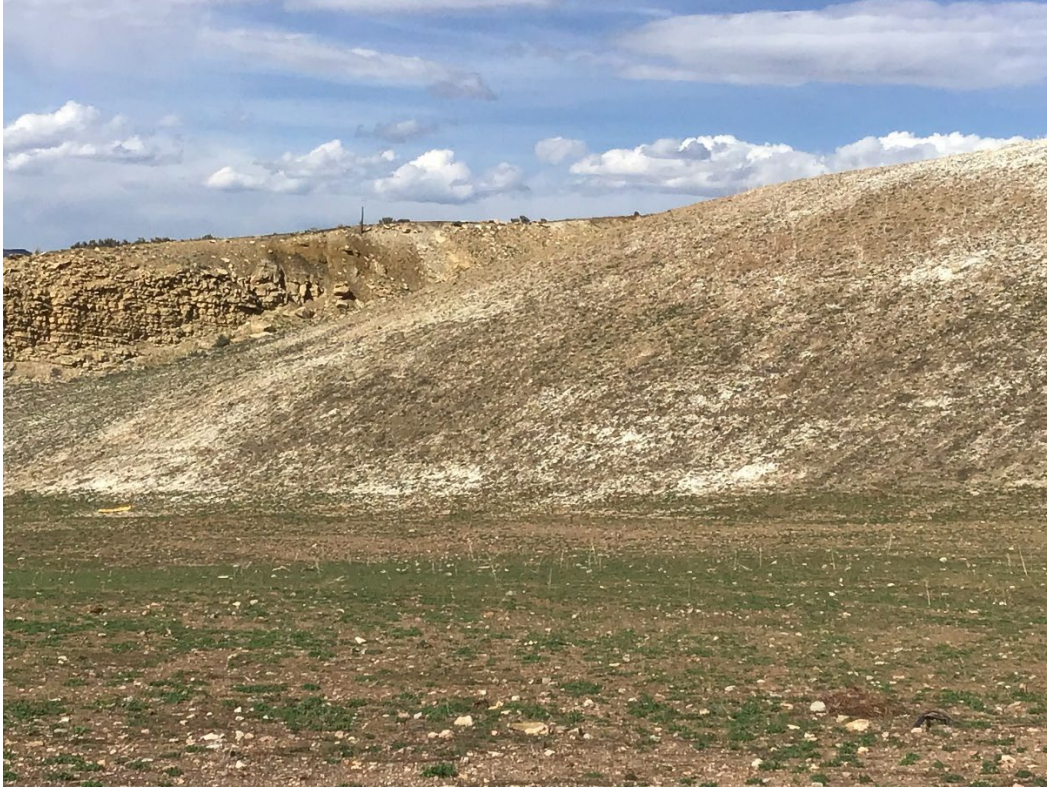
*Photo 6: 5A portal slope looking east.*

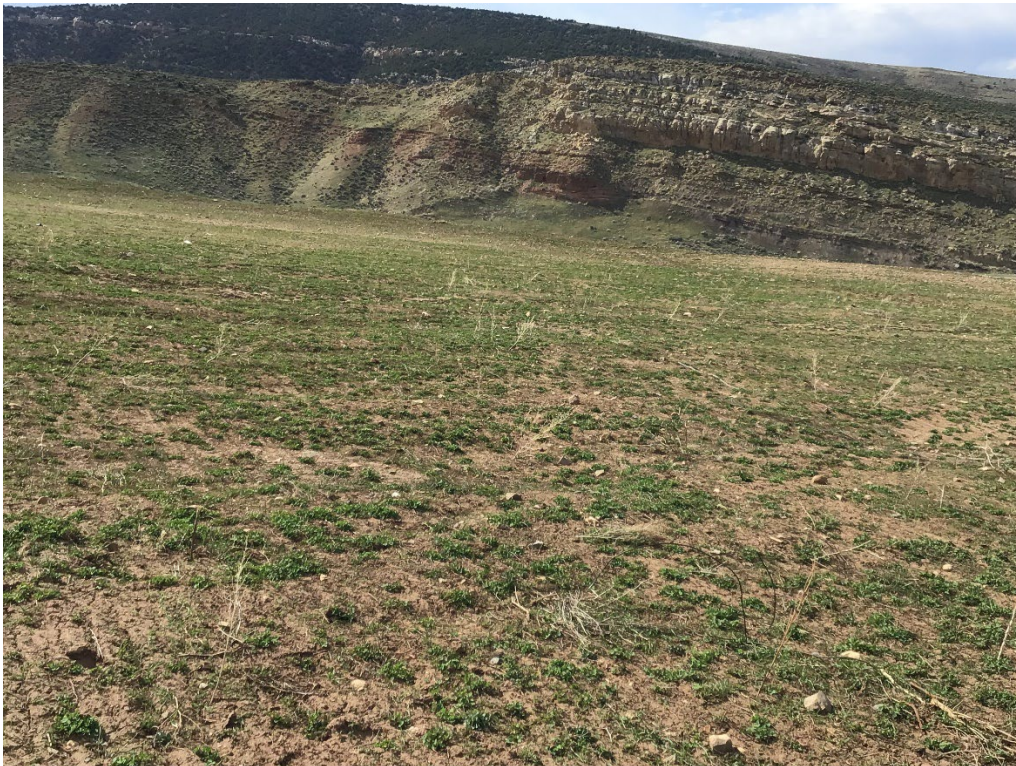
*Photo 7: Slope toward the 5AP1 Pond below the shop area.*

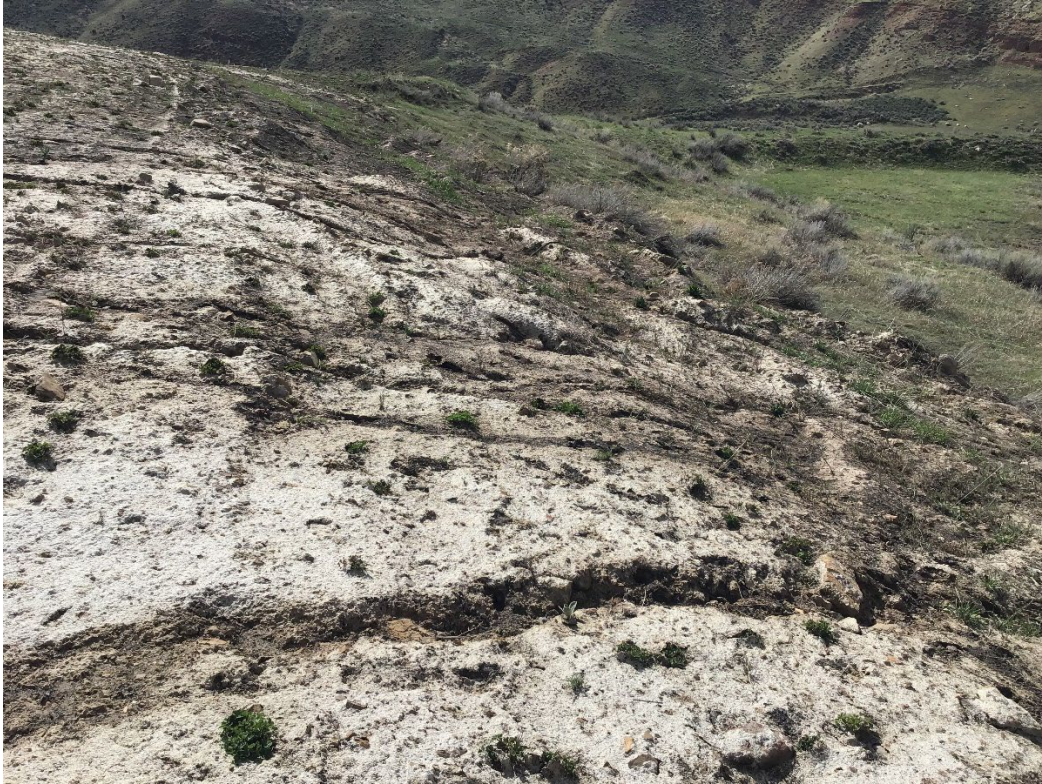
- Ponds were dry at the time of inspection.
- Pond banks and dam slopes were vegetated with established vegetation. Badger holes were present in some pond banks.
- North facing pond slope to Pond 5A1 exhibits gullies and rills from last year.
- Stream buffer zone along the Williams Fork River exhibited a sign.
- Ditches along haul road and in the cropland area appeared to be functioning adequately.

***Photo 8:** Rilling on slope to the 5API Pond.*

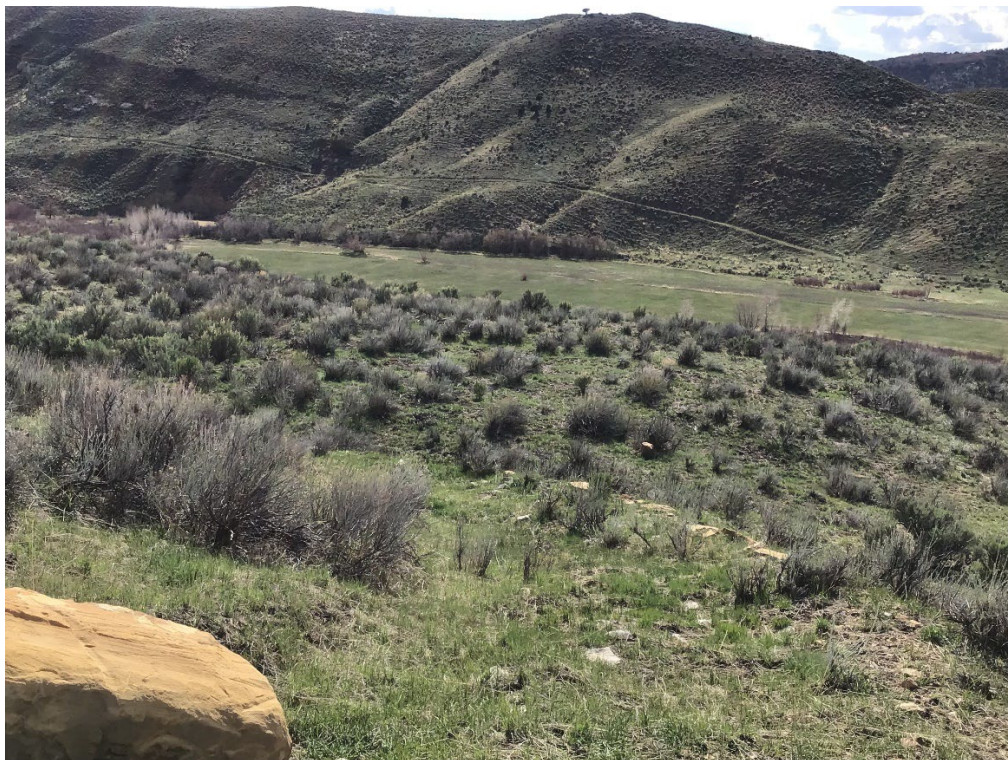
***Photo 9:** Overview of the cropland area in the bottomlands along the Williams Fork River, looking west from the 5A Portal.*

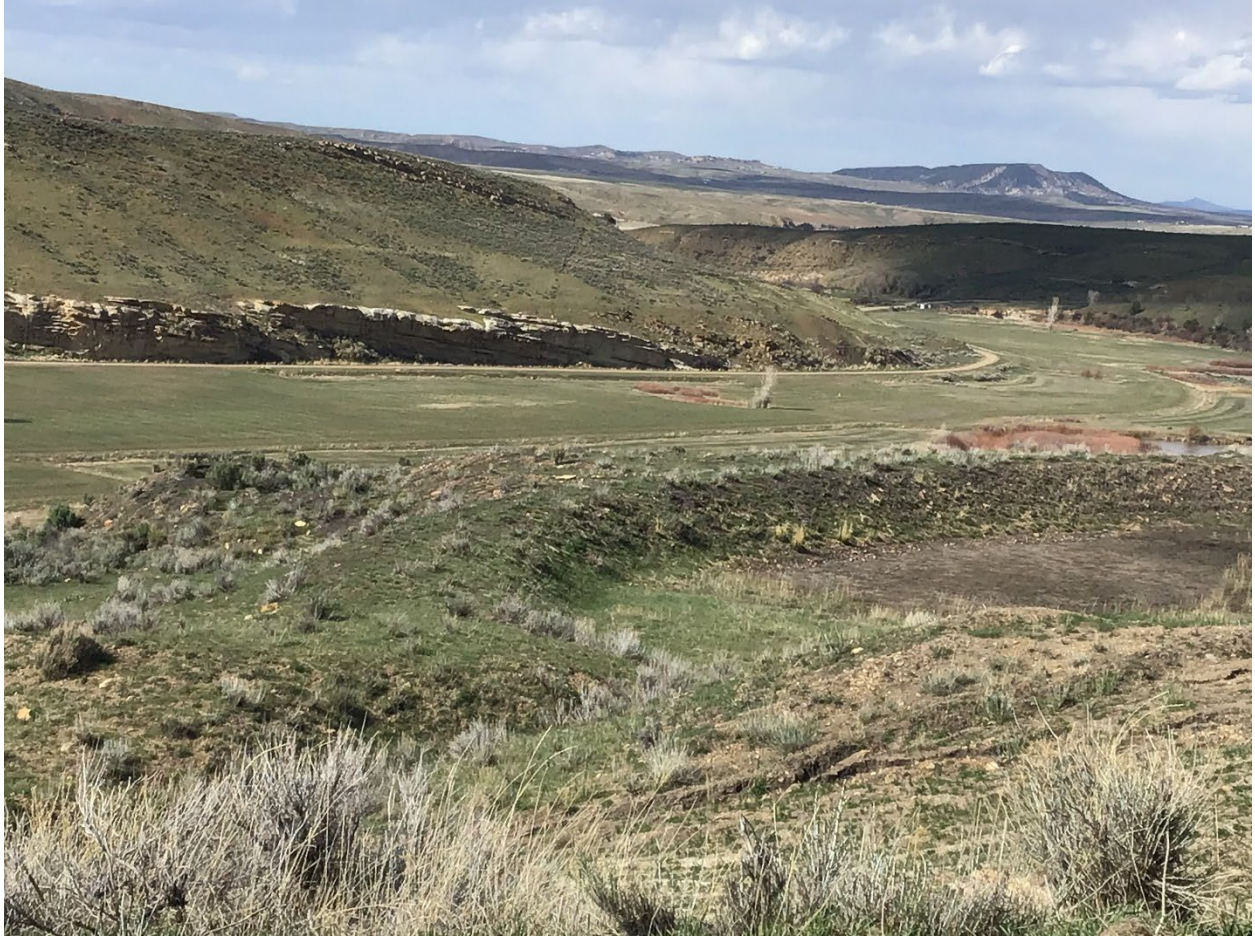
***Photo 10:** Overview of the cropland area in the bottomlands along the Williams Fork River, looking north from the 5A Portal.*

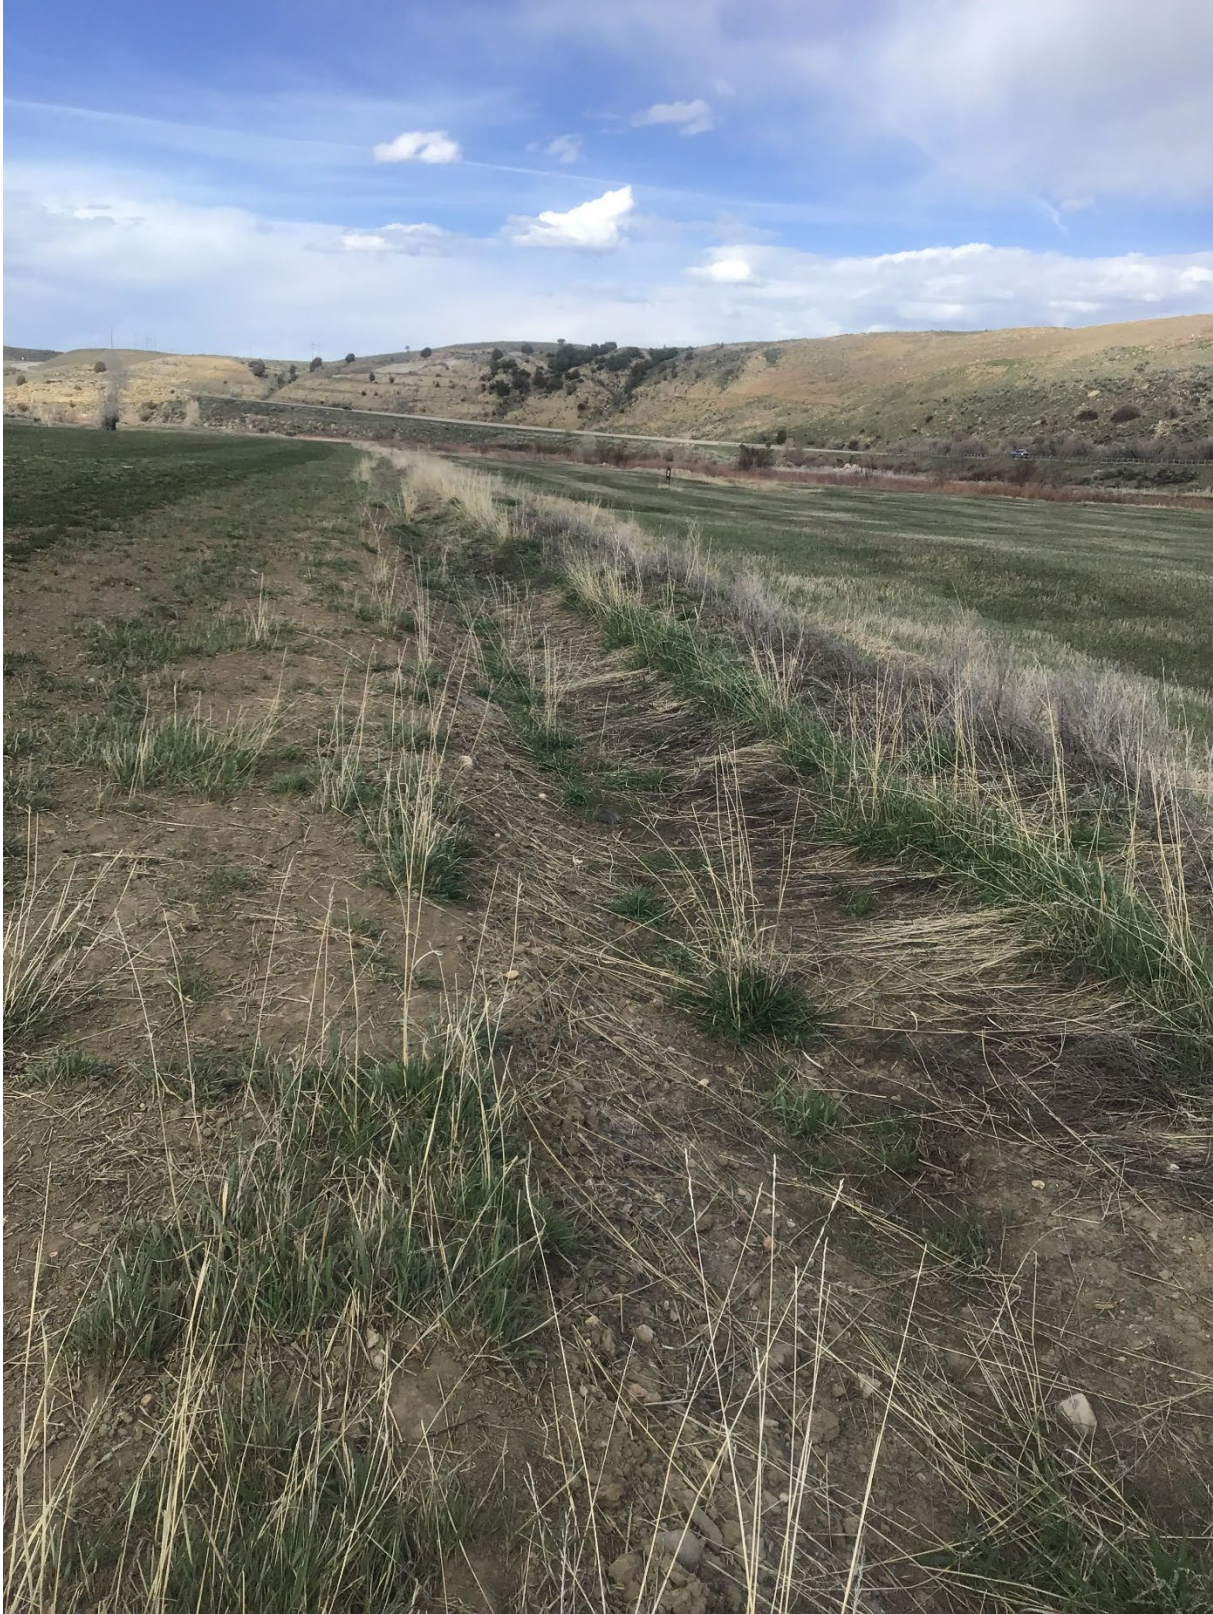
*Photo 11: Grass lined ditch that drains the cropland area, looking north.*

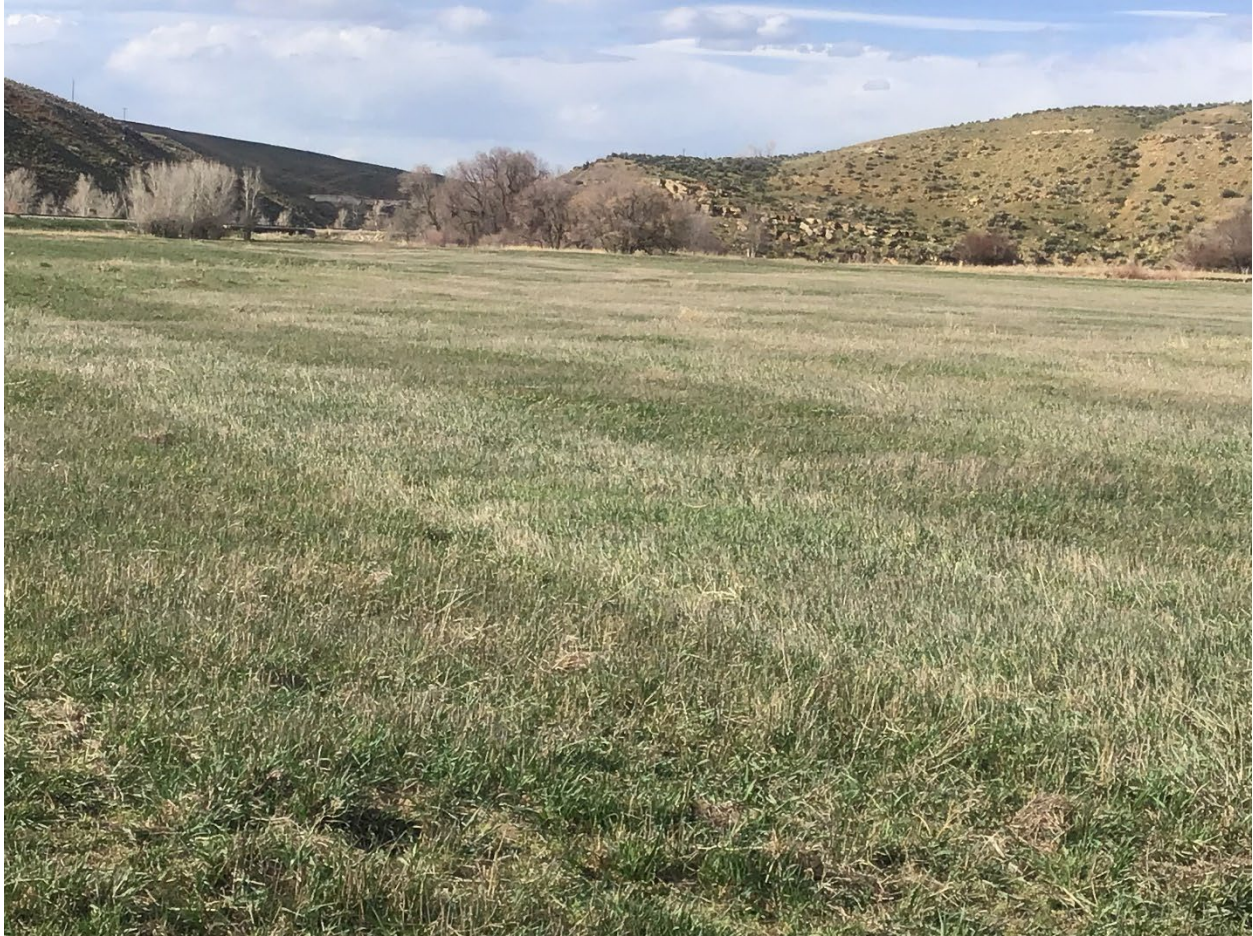
*Photo 12: Vegetation cover in the southern section of the cropland area, looking north.*
