## Inspections April 2024 Yoast and Seneca IIW

<b>Permit Number:</b> C-1994-082 <b>Mine Name:</b> Yeast Mine  <b>Operator Address:</b> Seneca Property LLC Ms. Miranda Kawcak 29515 Routt County Road No. 27 Oak Creek, CO 80467	<b>County:</b> Routt <b>Operation Type:</b> Surface <b>Permit Status:</b> Permanent Cessation <b>Ownership:</b> Private  <b>Operator Representative Present:</b>  Michael Howard
<b>Operator Representative Signature: (Field Issuance Only)</b> This report was issued electronically from the Divisions' Denver Office.

<b>Inspection Start Date:</b> 23 April 2024 <b>Inspection Start Time:</b> 12:00 a.m. <b>Inspection End Date:</b> 23 April 2024 <b>Inspection End Time:</b> 12:30 p.m.	<b>Inspection Type:</b> Coal Partial Inspection <b>Inspection Reason:</b> Normal I&E Program <b>Weather:</b> Cloudy
<b>Joint Inspection Agency:</b>  None	<b>Joint Inspection Contacts:</b>
<b>Post Inspection Agency:</b>  None	<b>Post Inspection Contacts:</b>
<b>Inspector(s):</b>  Robin Reilley, M.S. GISP	<b>Inspector's Signature:</b>

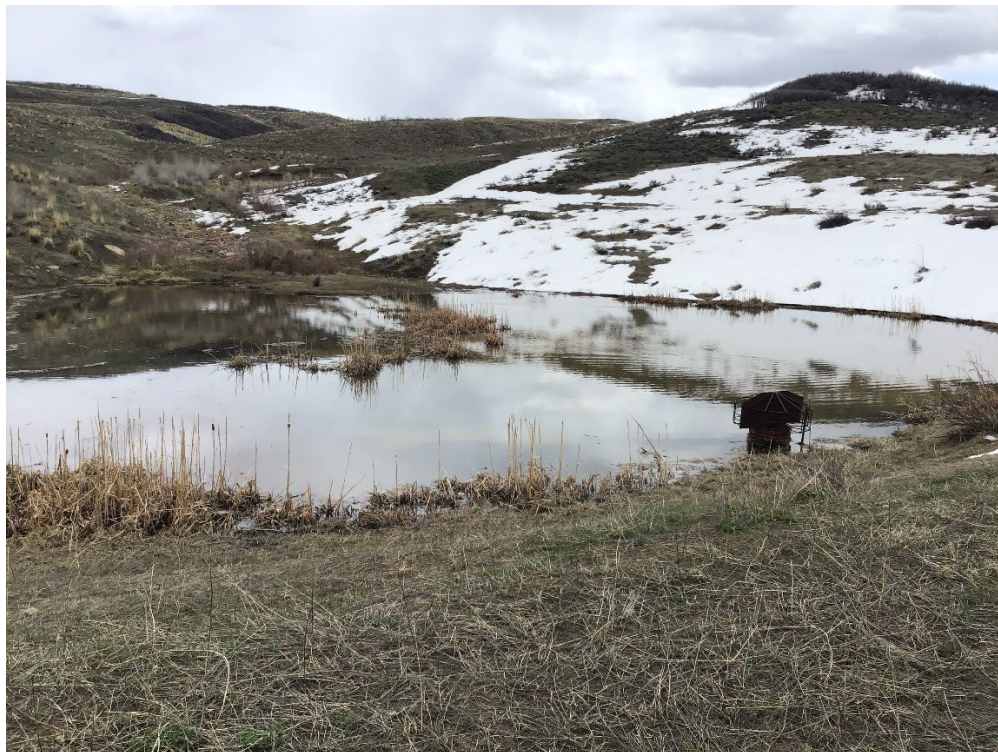
Reclamation has been completed at the site with the exception of the hillside above Pond 12.

***Photo 1: Pond 12 and reclaimed slopes above.***

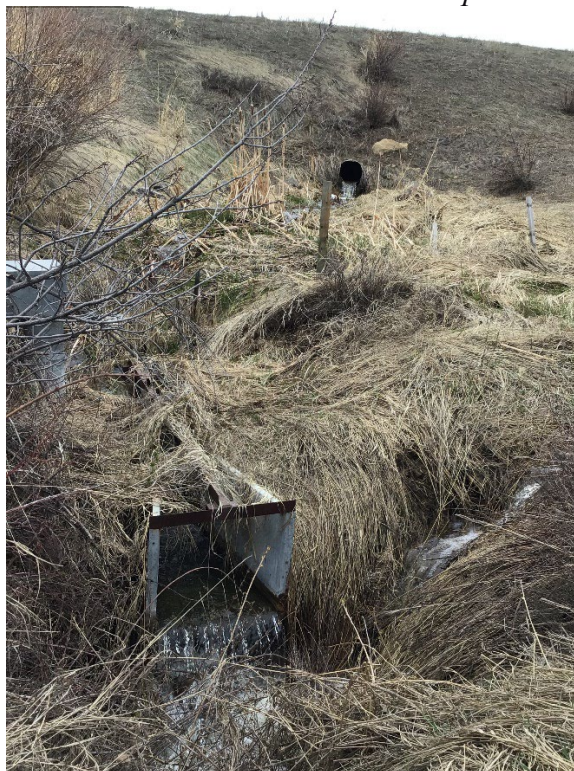
Pond 12 discharge reading at the staff gauge was at 0.25 feet. The decant culvert at Pond 13 has some pinholes allowing water to drip out of culvert.

***Photo 2: Pond 12 decant culvert and weir***

*showing discharge from pond.*

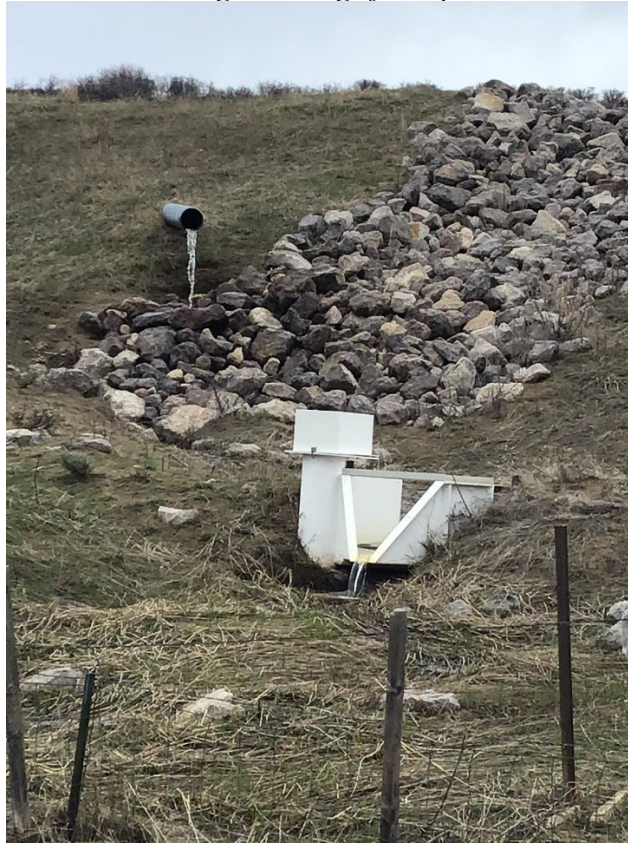
***Photo 3: Pond 13 decant culvert and weir.  
showing discharge from pond.***

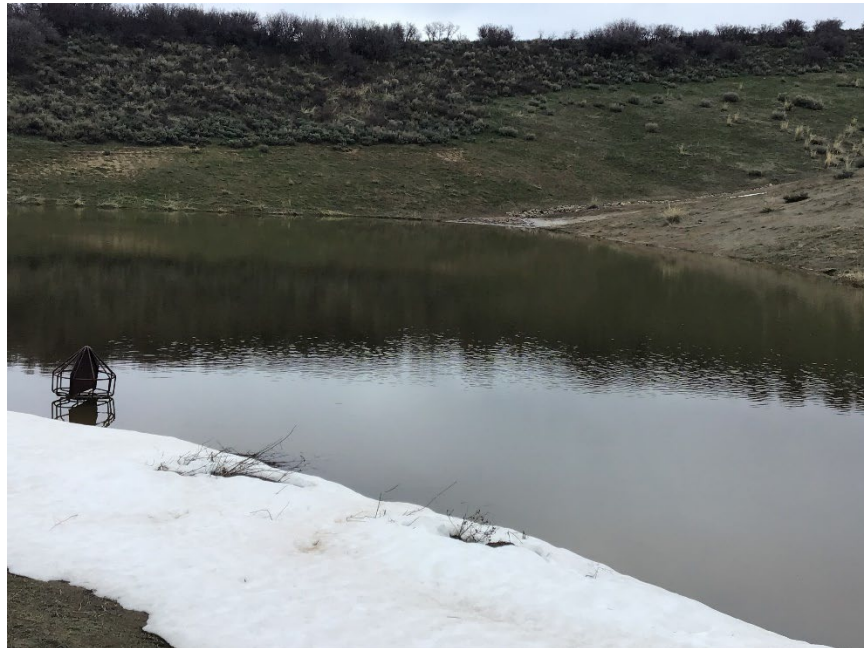
***Photo 4: Pond 13 and its decant structure.***

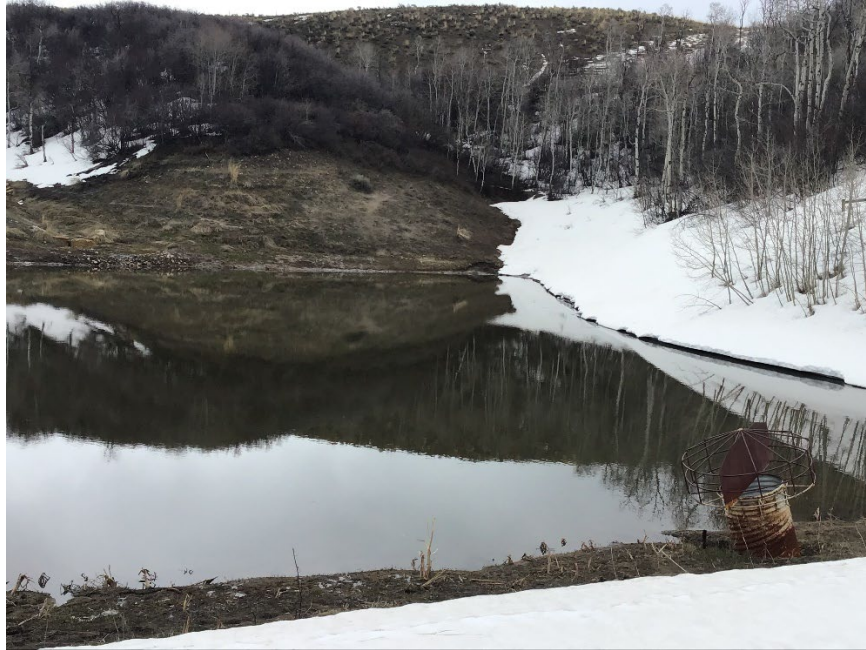
*Photo 5: Pond 14 and snow covered banks.*
