Inspections April 2024 Yoast and Seneca IIW

Division of Reclamation,
Mining and Safety

PERMIT INFORMATION

INSPECTION INFORMATION

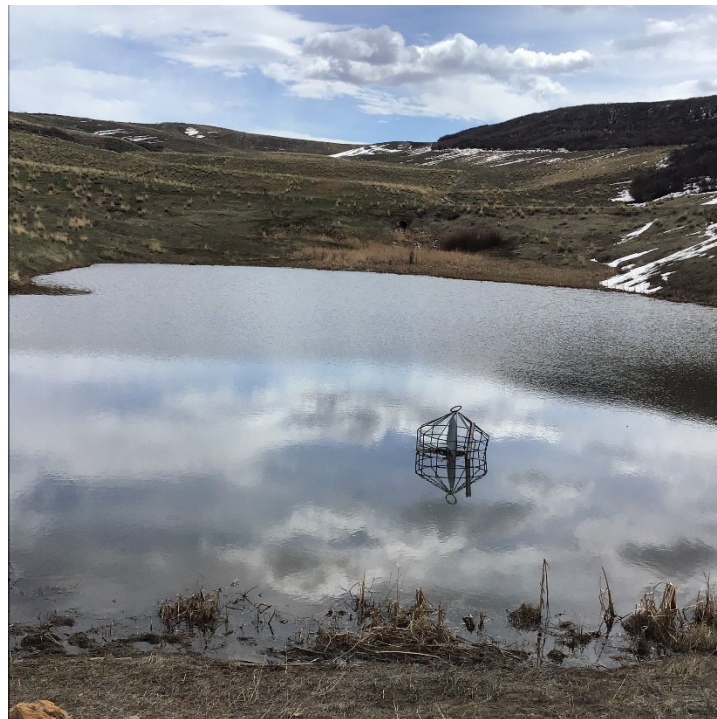
The pond banks at Pond 6 appeared stable and well vegetated. The spillway was in good repair and clear. The outslope of the dam was stable and well vegetated with no signs of seepage. Pond 6 was full and discharging clear water through its decant culvert. The water in the pond appeared turbid from runoff entering from the reclaimed slopes above.

Photo 2: Pond 6 looking toward reclaimed slopes and inlet.

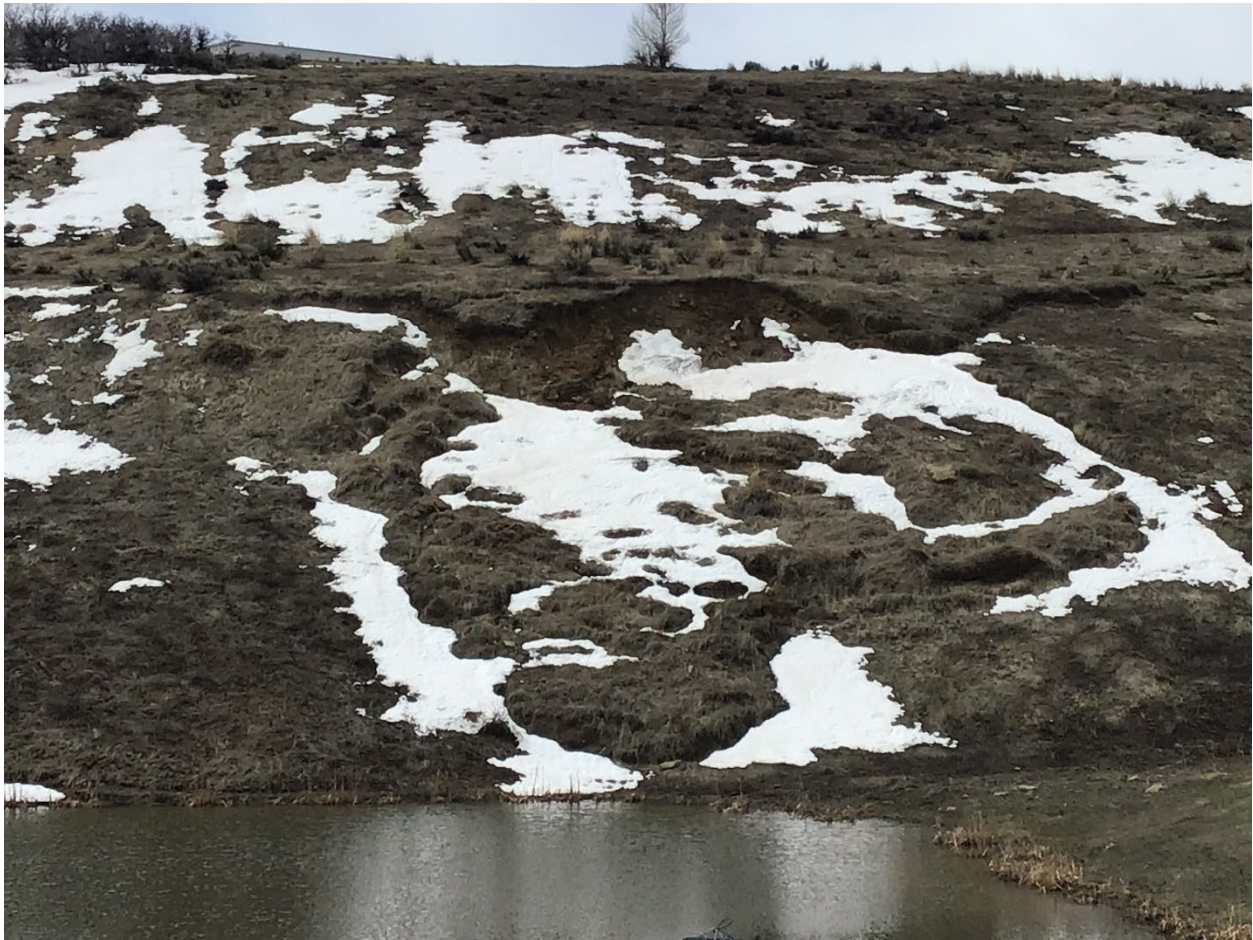
Established slump at Pond 6 was noted. The new slide (spring 2023), downstream from the slump appears to encompass approximately 1/3 of an acre. A crack exists between the two area.

Photo 3: The old slide area above Pond 6.

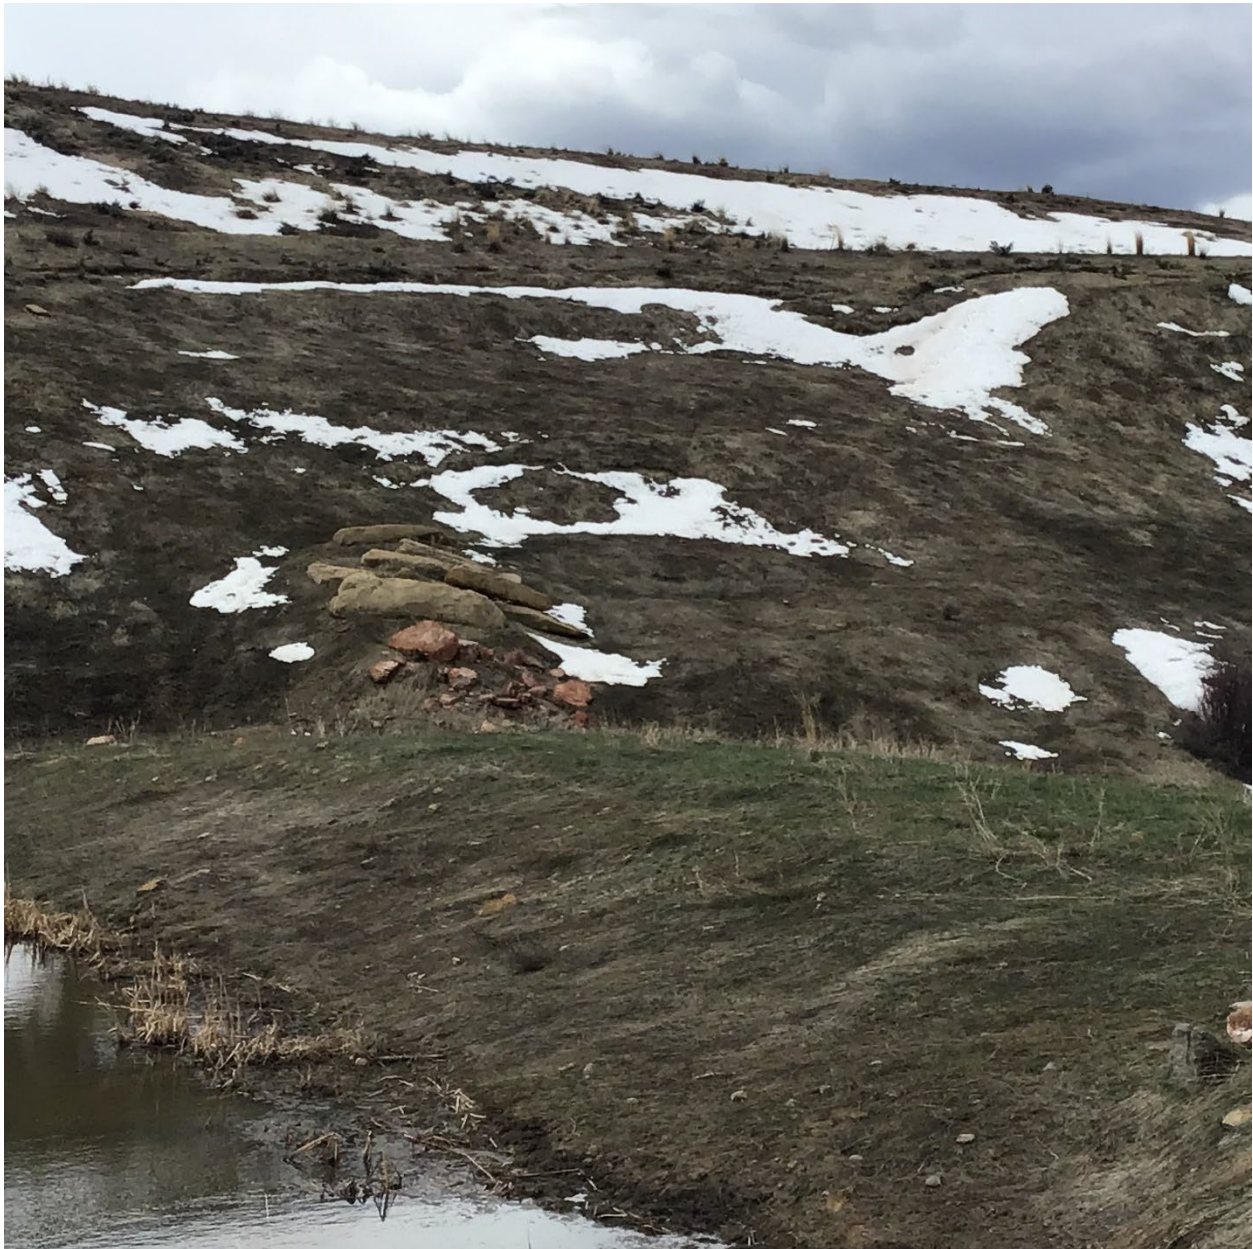
Photo 4: The crack below the haul road that expanded upslope in spring of 2023.

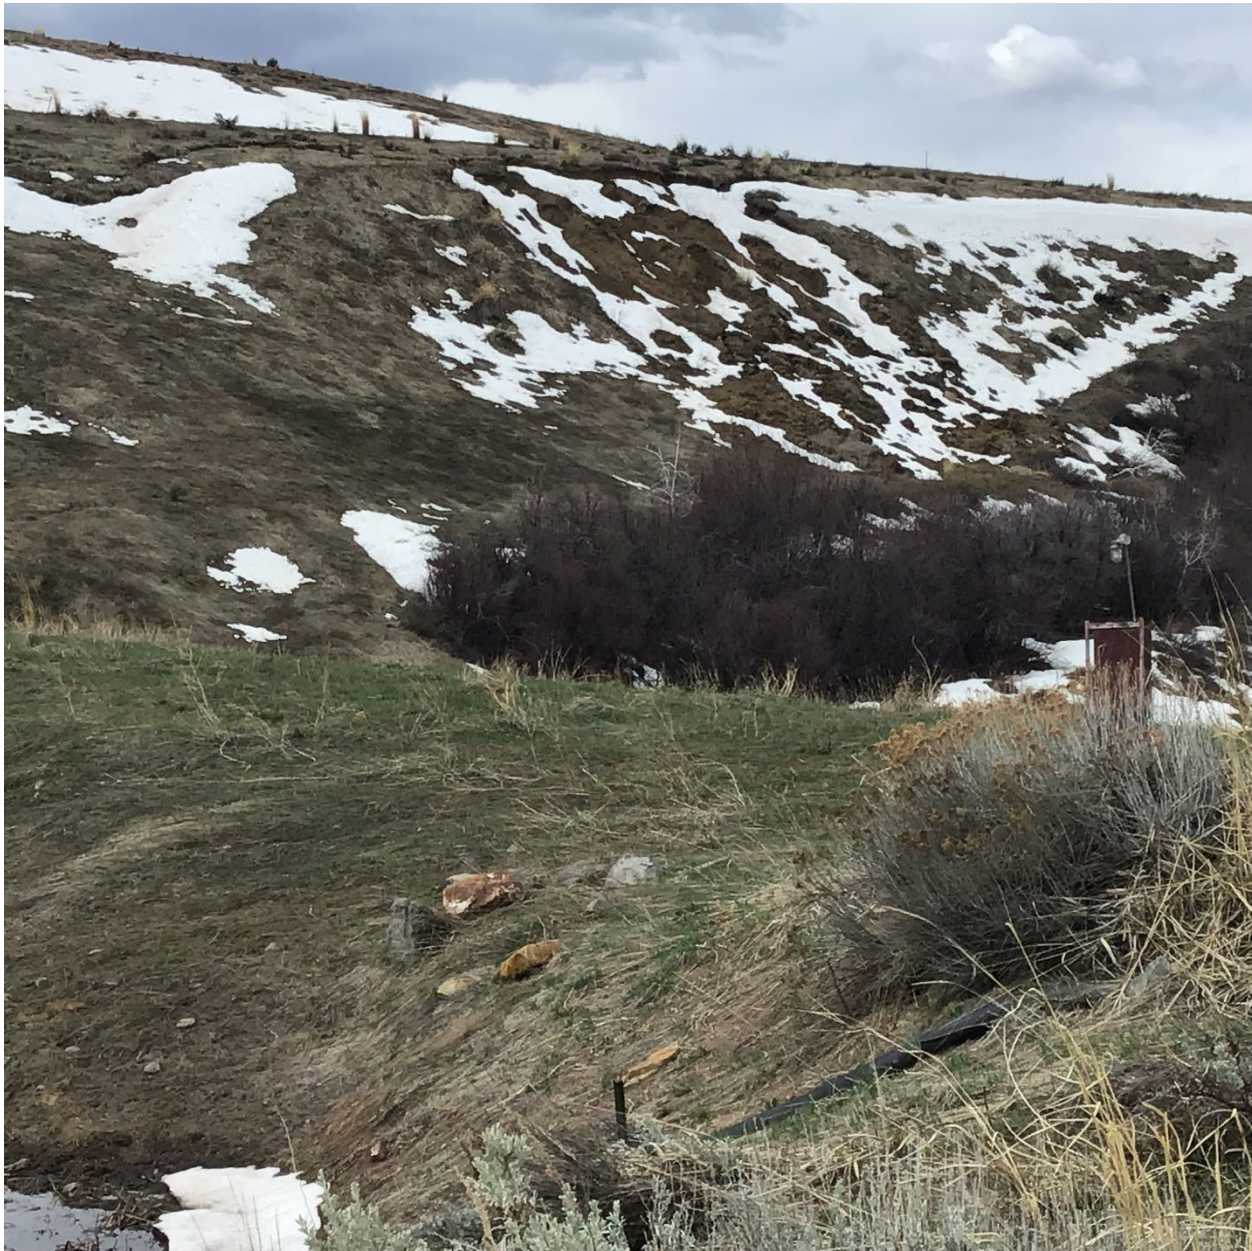
Photo 5: A crack below the haul road and the 2023 slide area above Pond 6.
