**MINERALS PROGRAM INSPECTION REPORT**  
**PHONE: (303) 866-3567**

| <b>MINE NAME:</b><br>Sand Arroyo Pit | <b>MINE/PROSPECTING ID#:</b><br>M-1978-283 | <b>MINERAL:</b><br>Sand and gravel | <b>COUNTY:</b><br>Huerfano |
| <b>INSPECTION TYPE:</b><br>Monitoring | <b>WEATHER:</b><br>Clear | <b>INSP. DATE:</b><br>April 9, 2024 | <b>INSP. TIME:</b><br>10:30 |

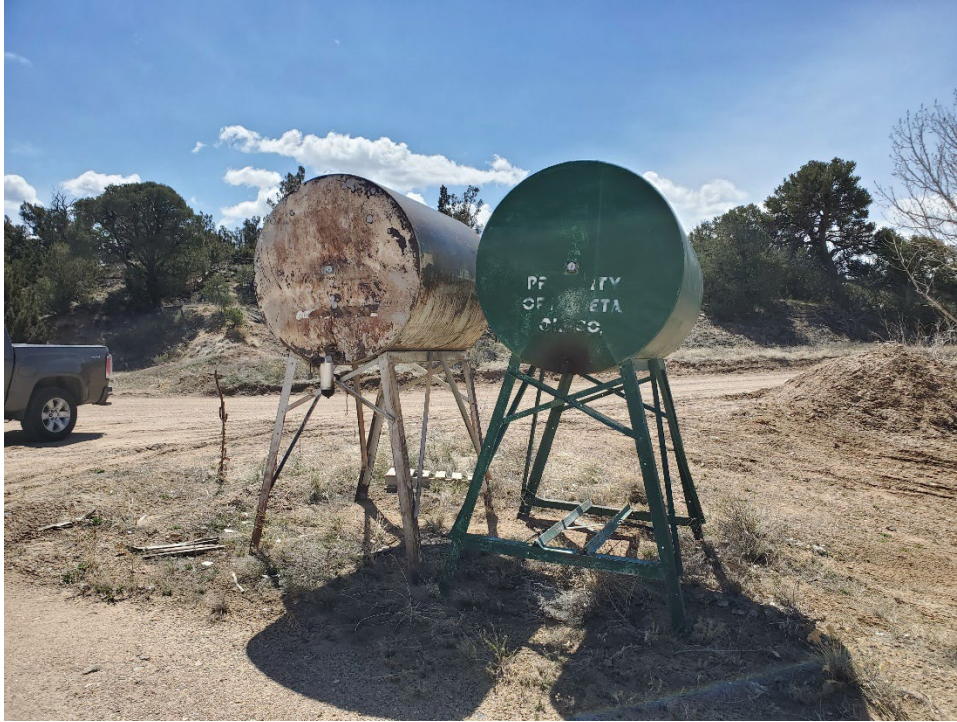
Two fuel tanks (Photo 1) were observed in the Pre-Permit Concrete Plant Use Area (see Figure 1 and 2). The Operator was informed that the tanks did not have adequate secondary containment structures. The Operator was instructed to install secondary containment structures that consisted of impermeable containment which could contain all contents of the tanks and various containers (when full) plus 10% of the total capacity. Following the inspection, Gary Vezzani (representing the Operator), informed the Division that the fuel storage tanks were empty. The Division reiterates that if they are to contain fuel in the future, secondary containment structures will be required.

**Photo 1:** Fuel tanks that will require secondary containment if they are to be used again.

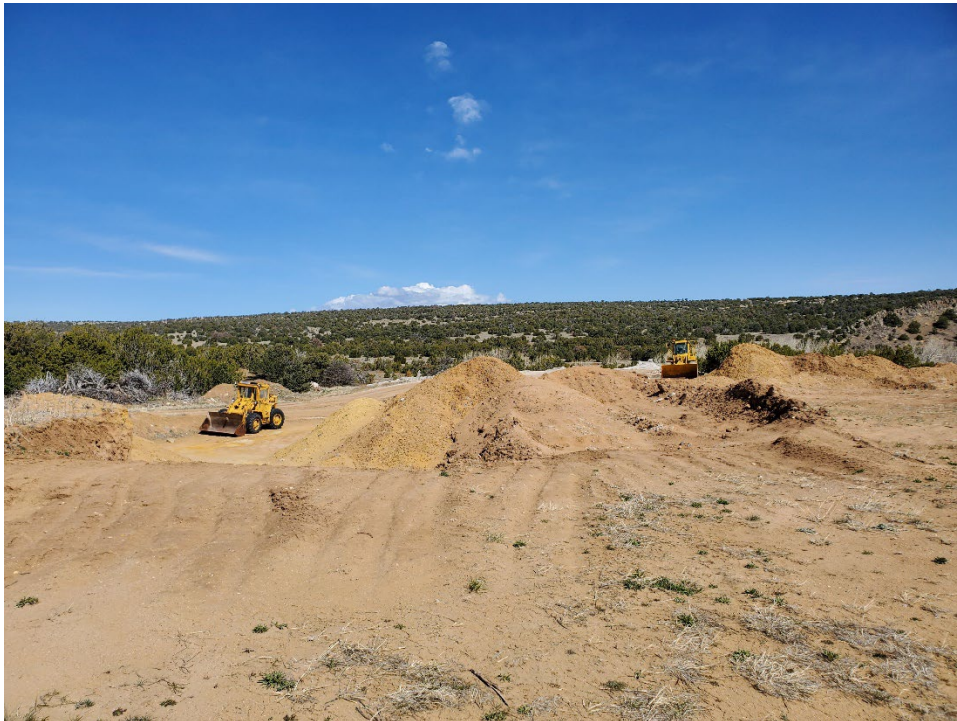
**Photo 2:** Looking north across the upland mining area.

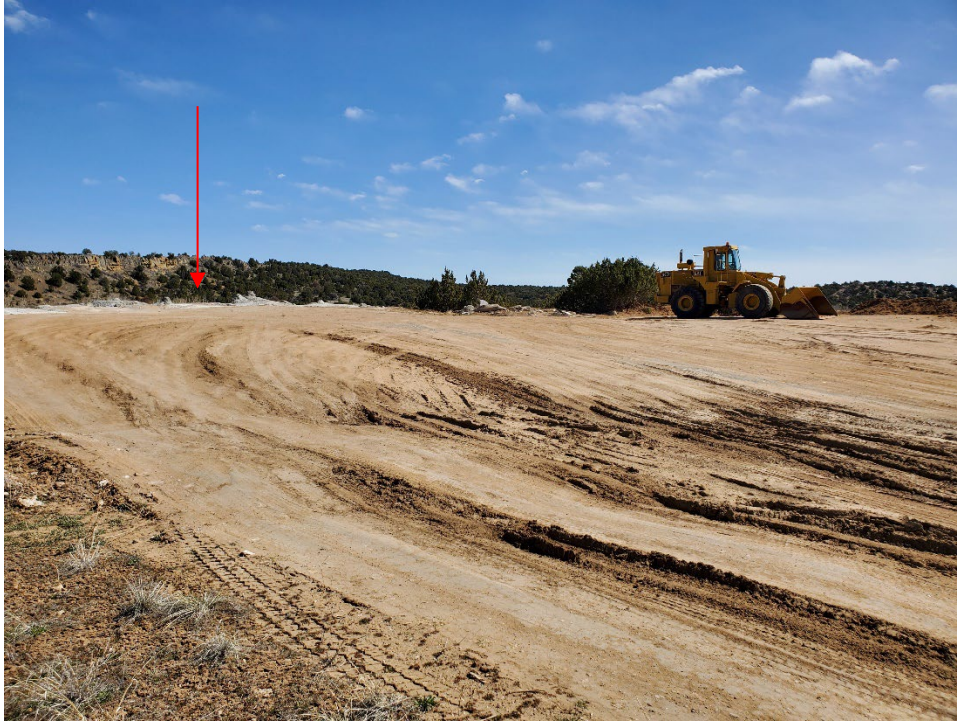
**Photo 3:** Looking north across the upland mining area. The arrow points to the uphill start of the concrete wash-out.

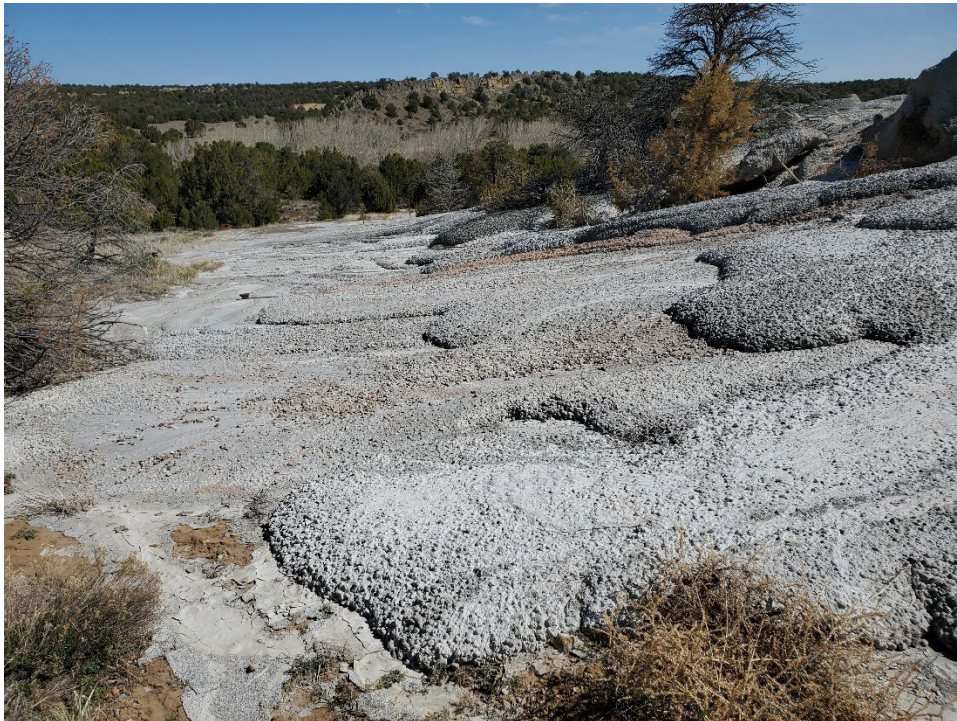
**Photo 4:** Looking downslope at the concrete washout.

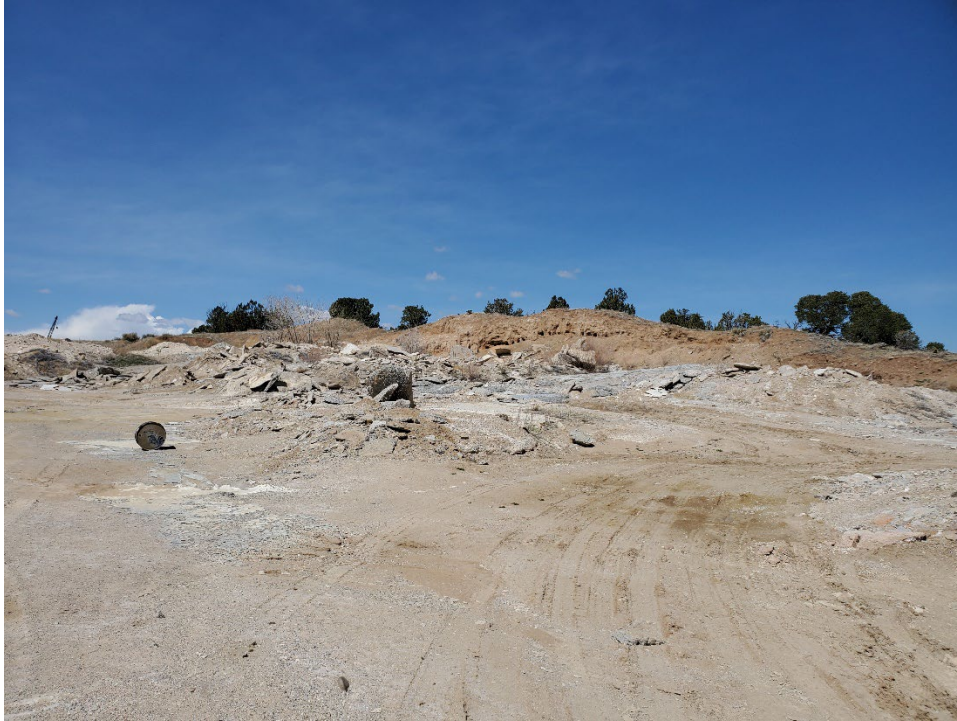
Within the Pre-Permit Concrete Plant Use Area, equipment storage and concrete slab stockpiles were observed (Photo 5). These features are approved to be located in this area per the mining plan.

**Photo 5:** Looking north-west at the concrete/equipment storage area within the permitted boundary that's part of the lease agreement.

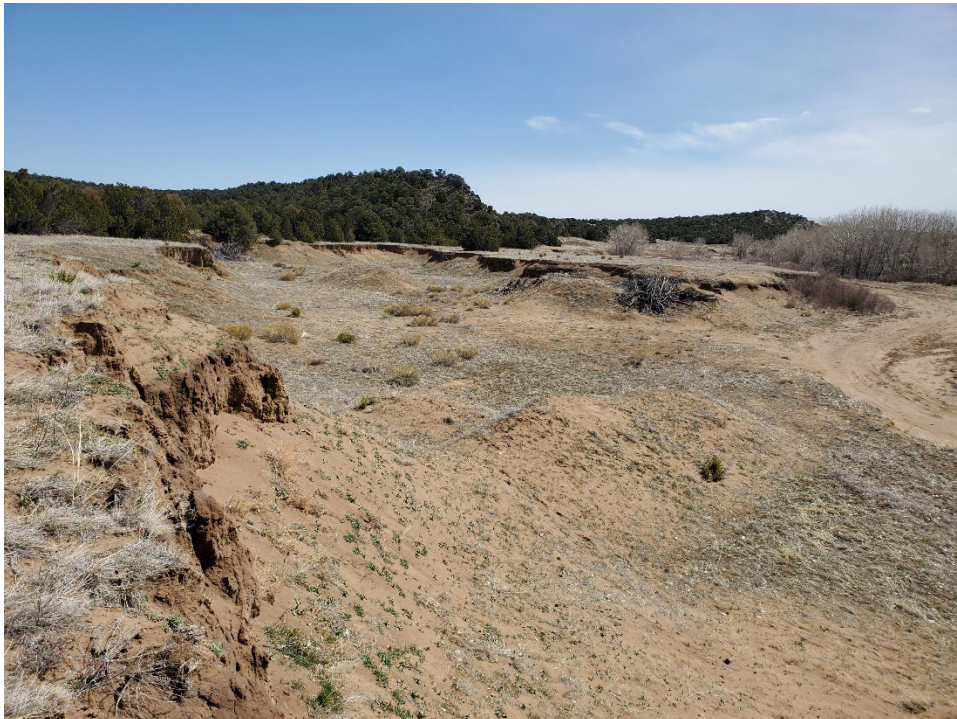
The Operator has committed to backfilling and grading mined areas within the arroyo to a 3H:1V slope, with the expectation that they may be destroyed following a flooding event. Some areas that have previously been backfilled and graded were observed during the inspection (Photos 6-7) and appear to be stable at this time. Because mining has not occurred within the arroyo in years, an establishment of willow trees has formed in some of the areas surrounding the channel (Photos 8-9). The areas that have not yet been reclaimed within the channel, if any, are nearly undistinguishable from the existing creek banks (Photos 10-16).

**Photo 6:** Looking east within the arroyo.

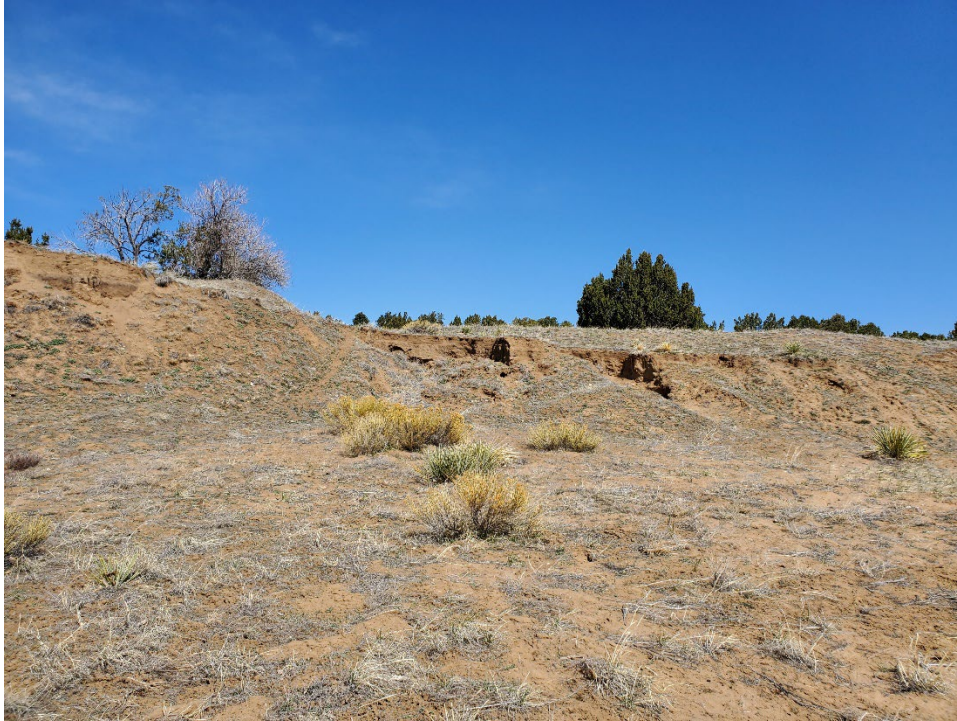
**Photo 7:** Looking north within the arroyo.

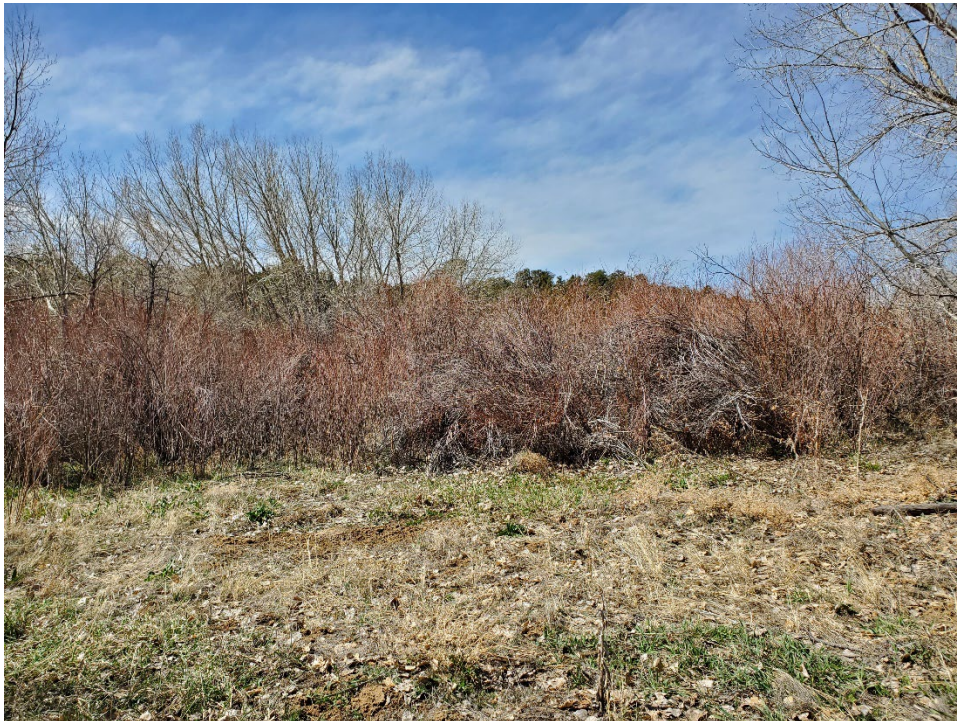
**Photo 8:** Willow establishment in lowland area.

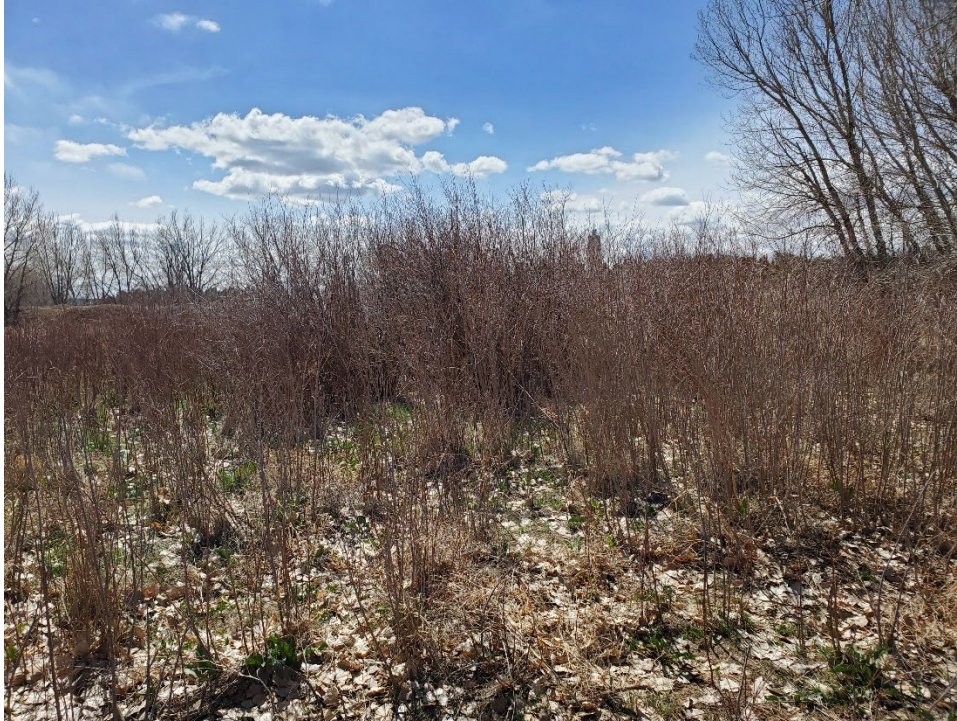
**Photo 9:** Willow establishment on top of a bank.

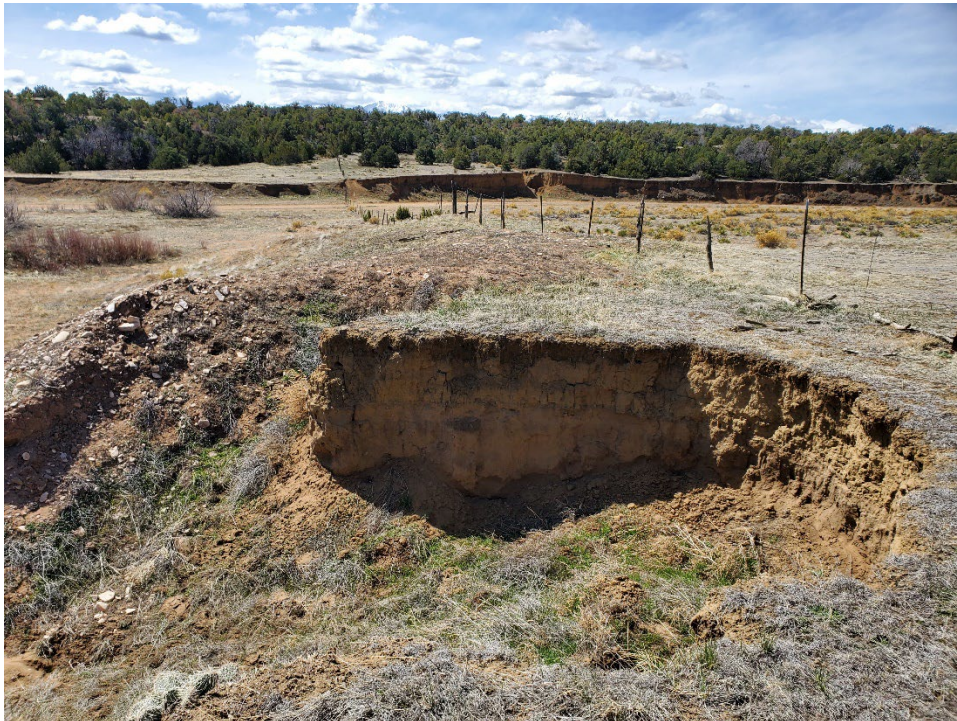
**Photo 10:** Looking at undisturbed areas along a fence beyond the permit boundary.

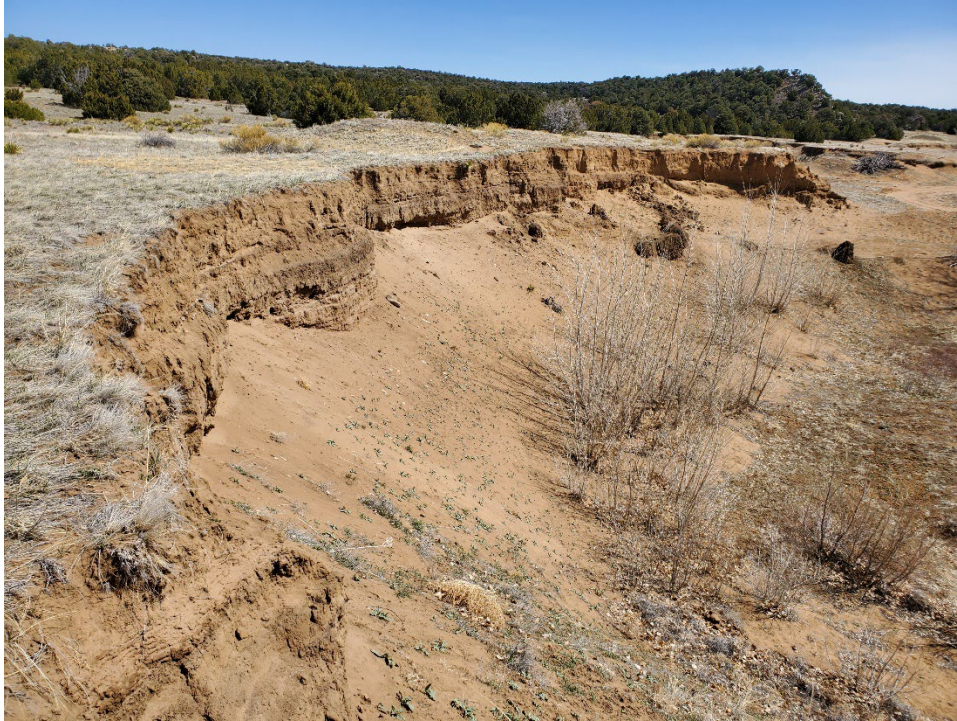
**Photo 11:** Looking east from the western border of the permit boundary.

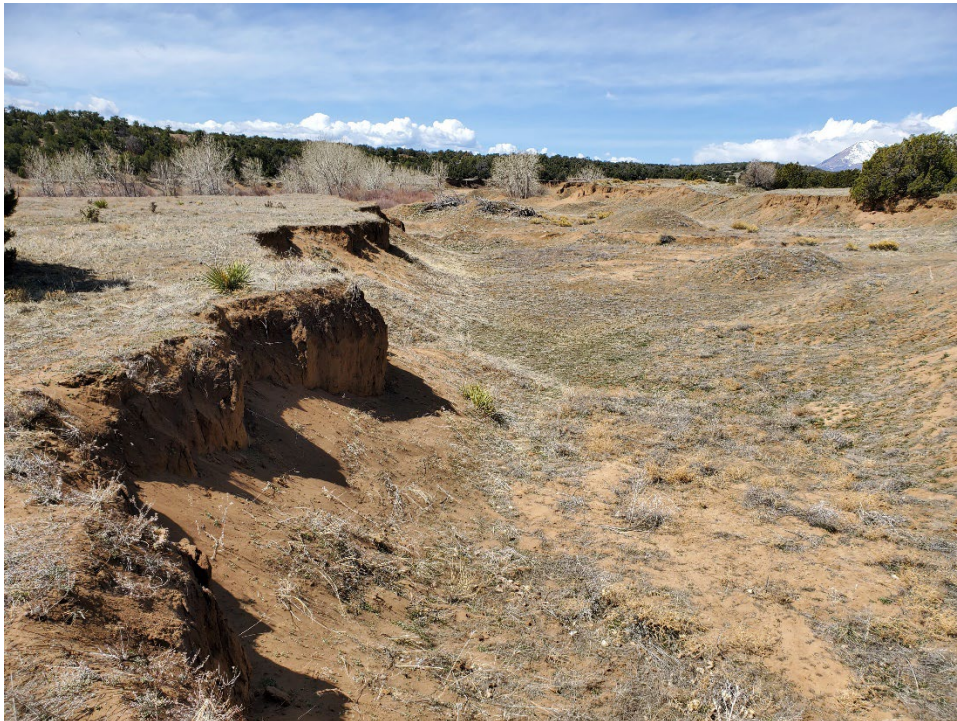
**Photo 12:** Looking east from the northernmost part of the arroyo within the permit boundary.

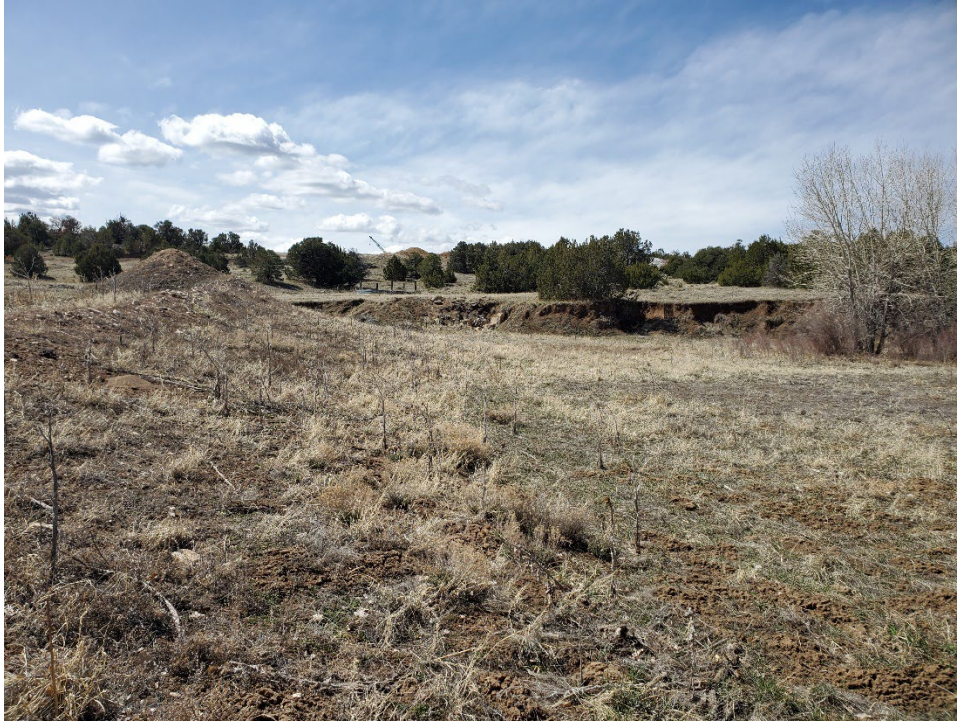
**Photo 13:** Looking south-east from the center of the arroyo area.

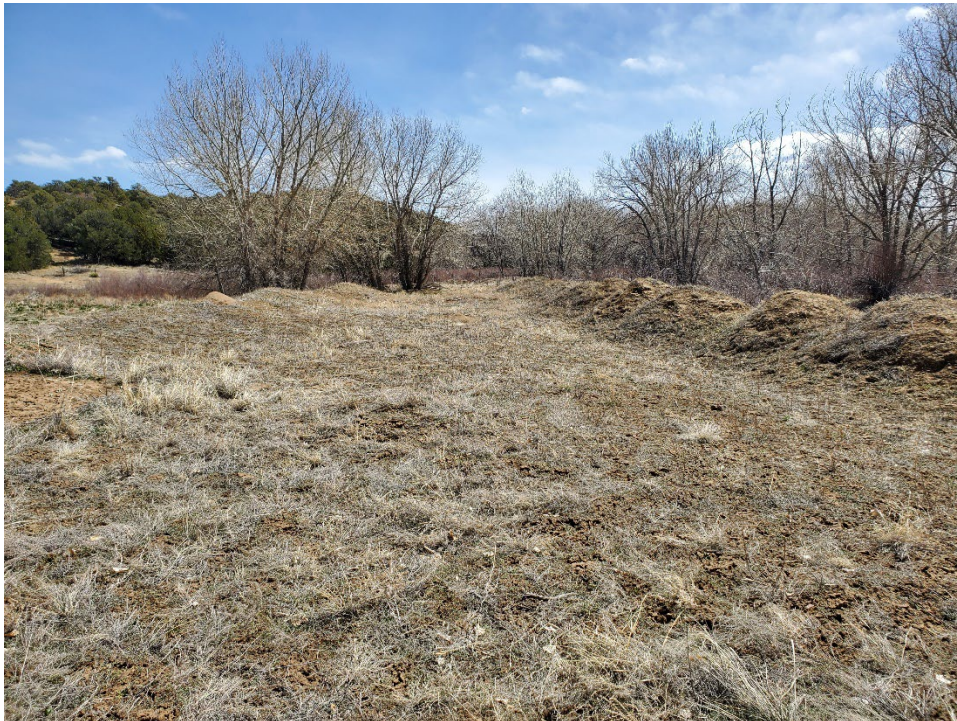
**Photo 14:** Looking east along an area designated as an active mining area on the Mining Plan map (see Figures 1 and 2 below).

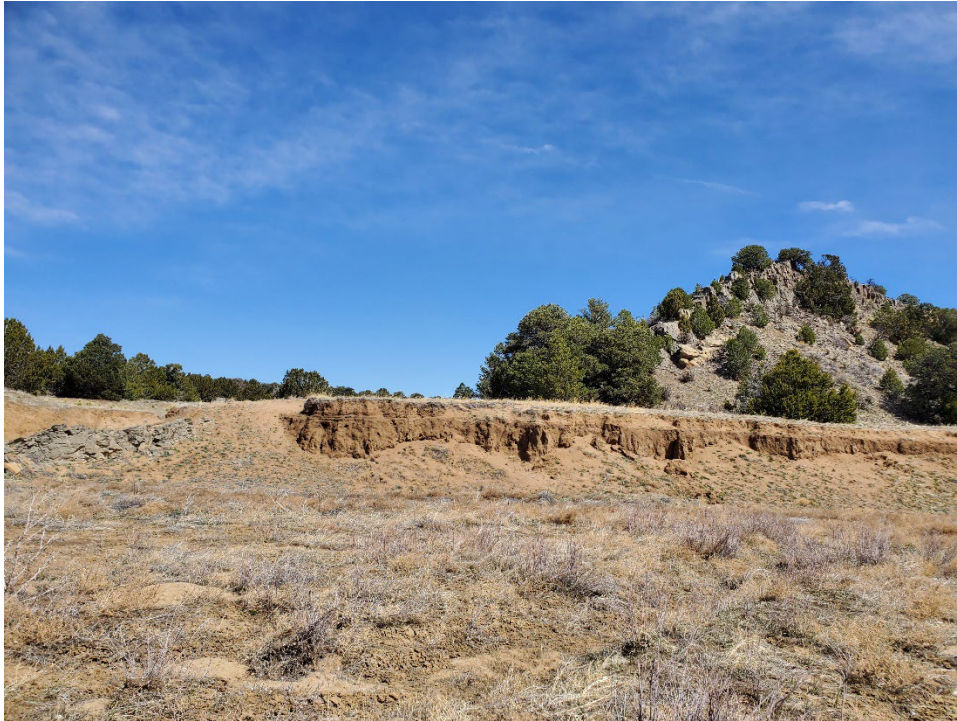
**Photo 15:** Undisturbed area within the arroyo – natural bank.

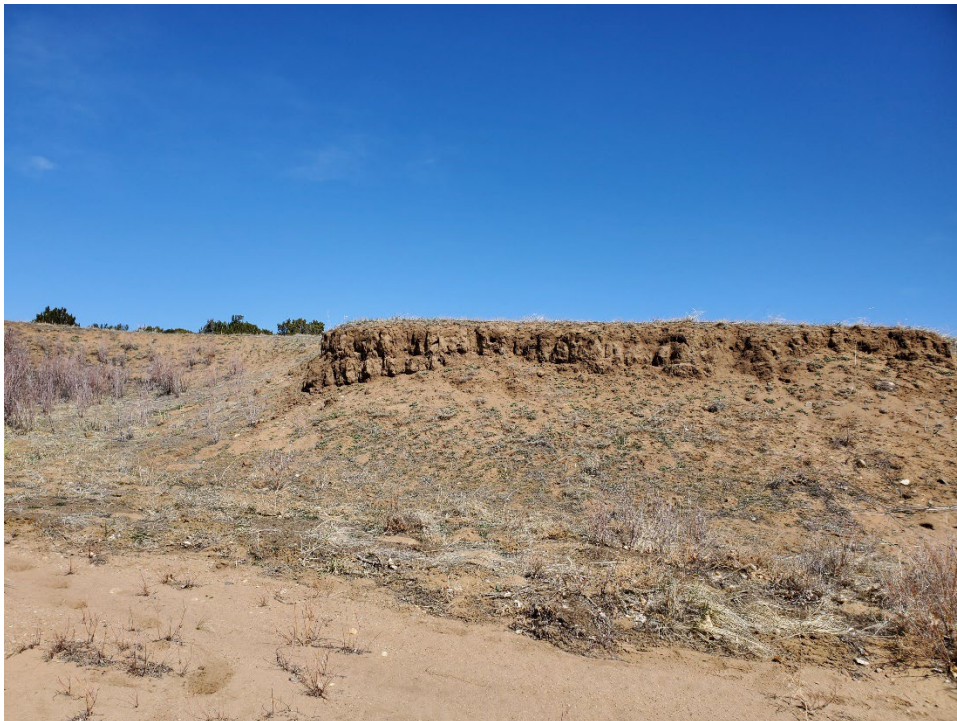
**Photo 16:** Undisturbed area within the arroyo – natural bank.

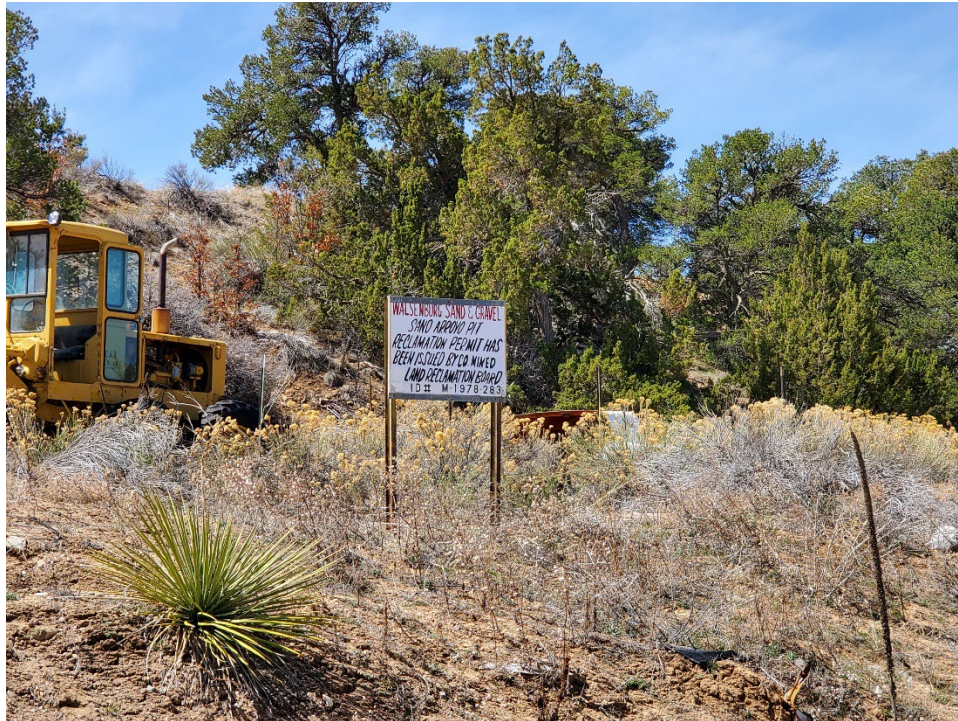
A mine sign was observed at the east entrance, past the concrete batch plant (Photo 17). However, the sign posted at what had been designated as the main mine entrance through the approval of AM1 still had the now released 111 permit's information on it. Following the inspection, the Operator sent the Division photo evidence indicating that the sign at the south (main) entrance had been updated (Photo 18). Therefore, the mine sign is posted in compliance with Rule 3.1.12(1).

**Photo 17:** Mine sign posted at the east entrance within the concrete batch plant area.

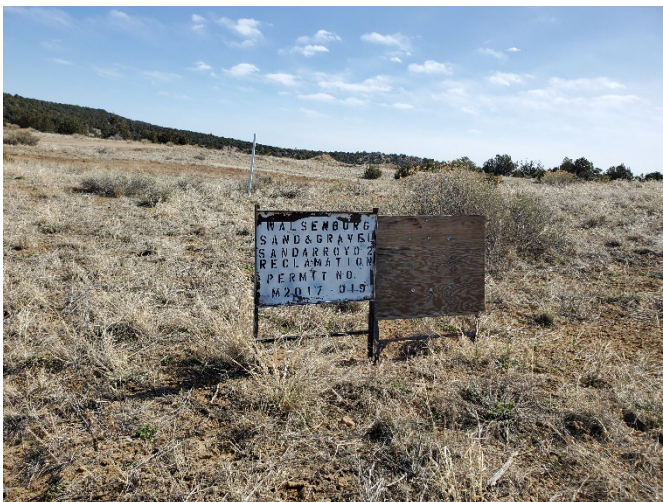
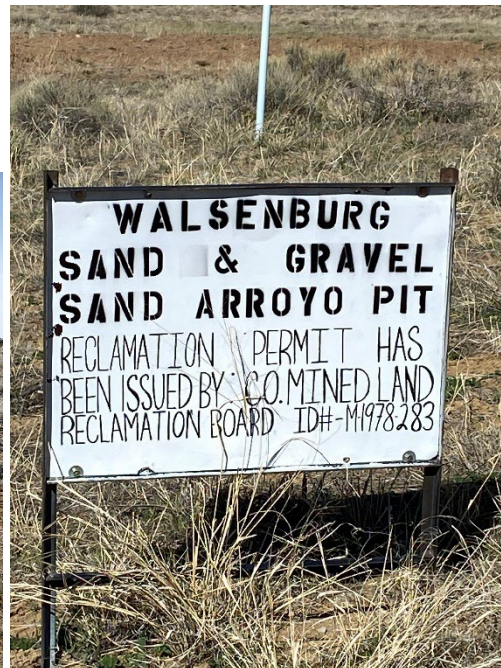
**Photo 18:** (Left) Old 111 information on the mine sign posted at the south (main) entrance during the inspection. (Right) Updated sign posted at the main entrance following the inspection.

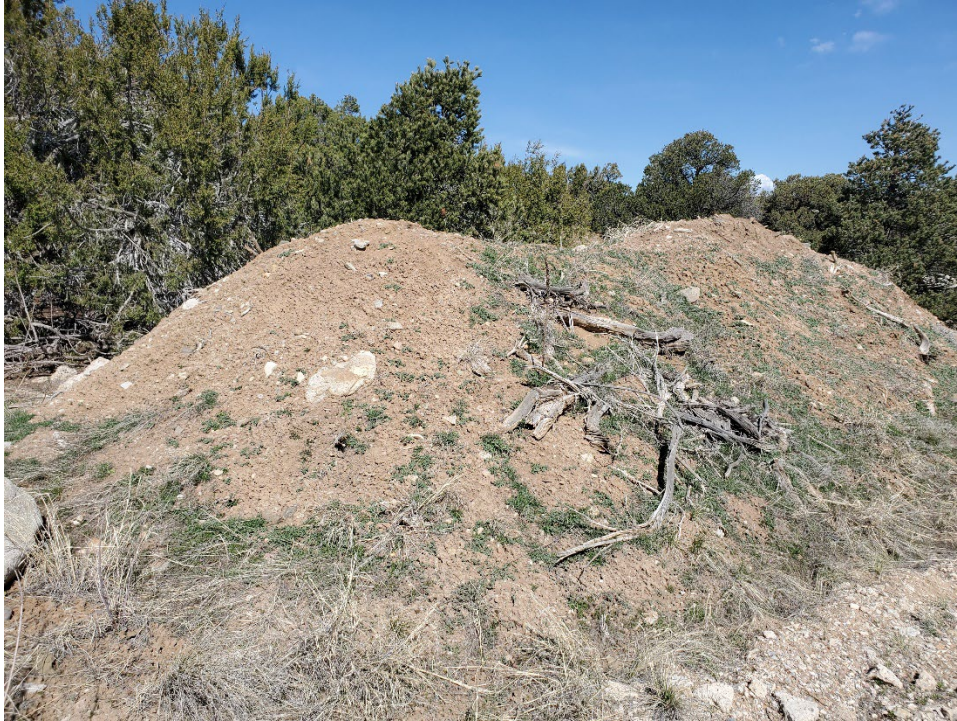
Topsoil piles were observed around the site (Photos 19-20). The piles appeared to be stable and out of the way of ongoing mining operations, pursuant to Rule 3.1.9.

**Photo 19:** Topsoil stockpile in upland area.

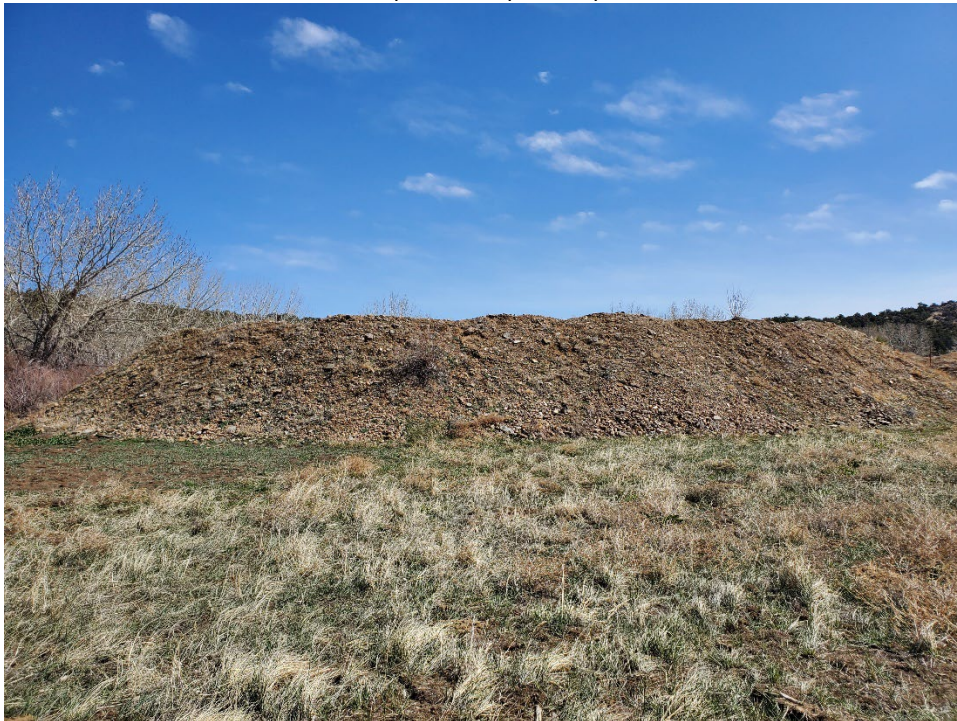
**Photo 20:** Topsoil stockpile south of the channel.
