To: Jerald Schnabel  
Castle Aggregate  
File: March 2024 Monitoring Summary

**Reference: March 2024 Geotechnical Monitoring Summary Pikeview Quarry**

PIKEVIEW QUARRY SLOPE  
MONITORING

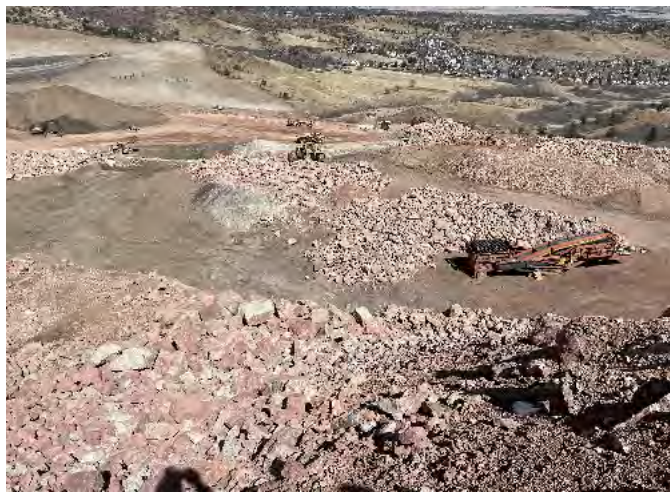
- Rock was being screened, sorted, and stockpiled as riprap for use as erosion protection in the channels.
- Topsoil was placed on areas at final grade.

6. ASTEC AND RIPRAP STOCKPILE.

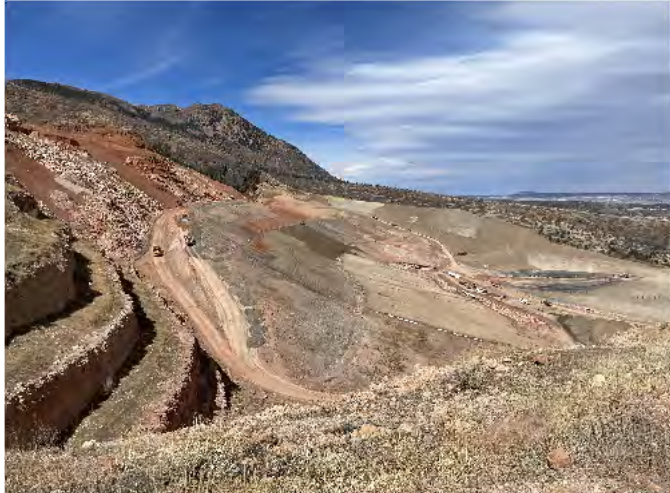
5. VIEW NORTH OF RECLAIMED SLOPE.

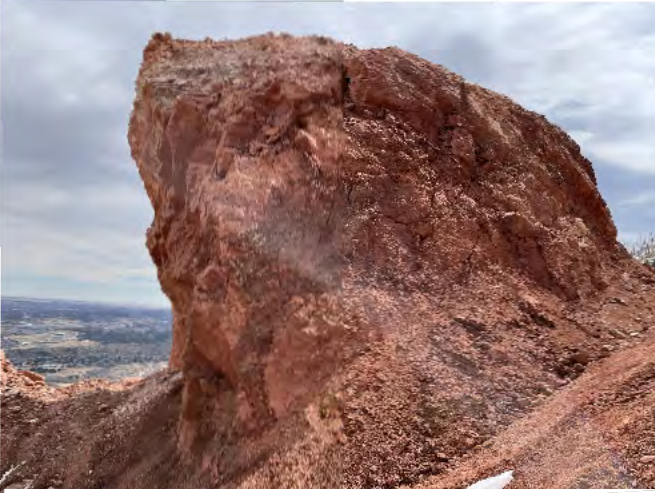
4. ROCK OUTCROPPING ALONG TOP OF HAUL ROAD.

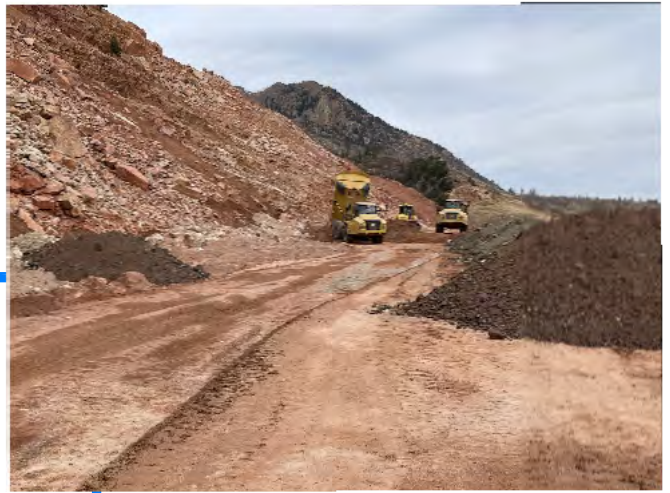
3. HAUL TRUCKS PLACING FILL ON BENCH.

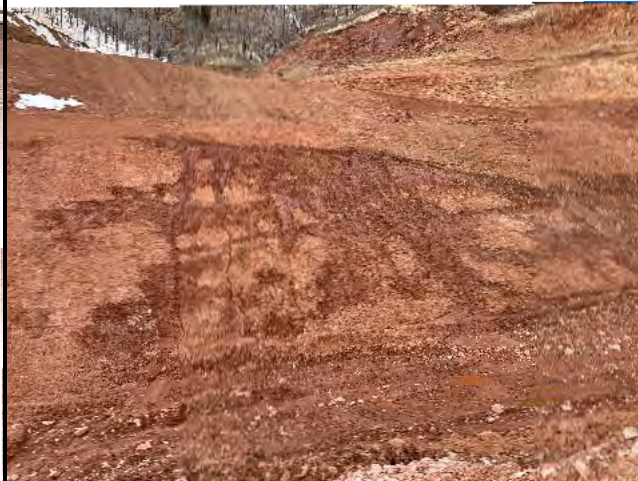
- Seepage was noted from the graded granite slopes. This seepage was observed in previous years and is expected to occur each spring.
- A safety buffer zone is being kept between the active work areas and the toe of the slide to stop any rocks that might come loose during grading operations. Compacted fill is placed in the buffer zone as the buttress fill is placed.

7. SEEPAGE ALONG HAUL ROAD CUT.

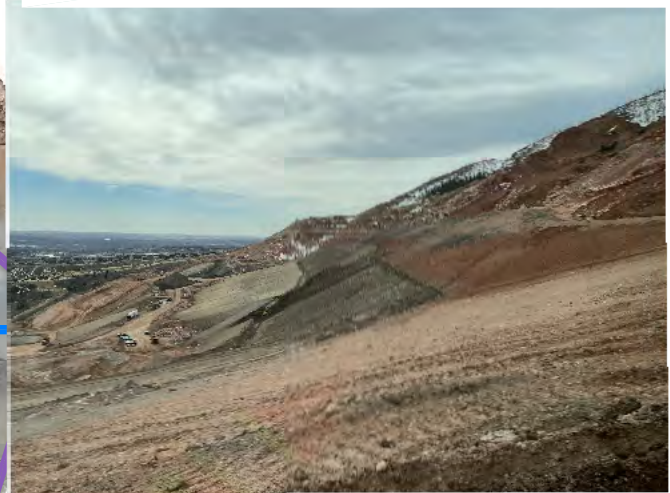
2. VIEW SOUTH OF RECLAIMED SLOPE.

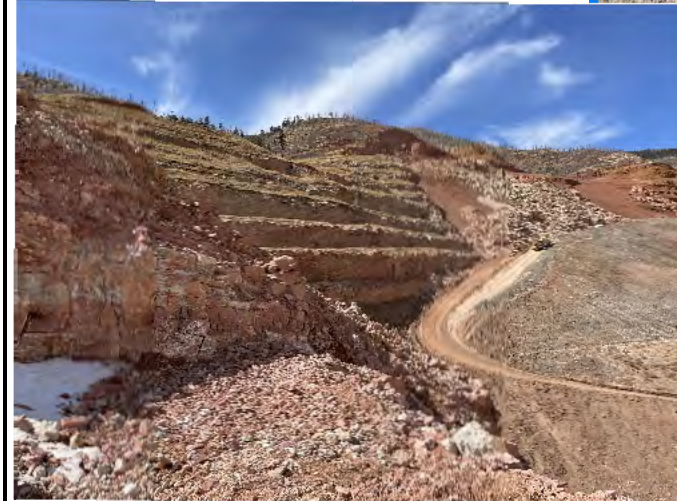
8. RECLAMATION BENCHES ON SOUTH END.

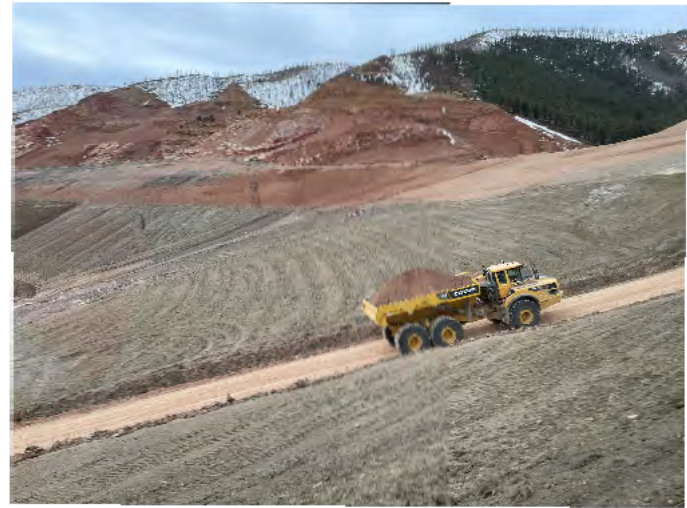
1. LOADED HAUL TRUCK CLIMBING HAUL ROAD.

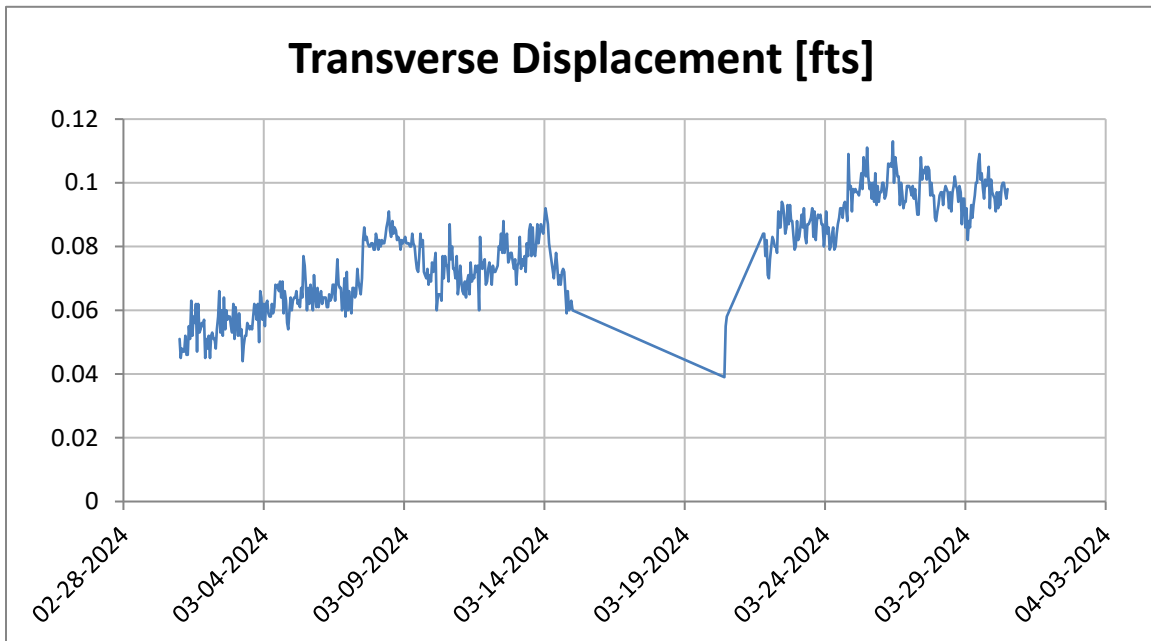
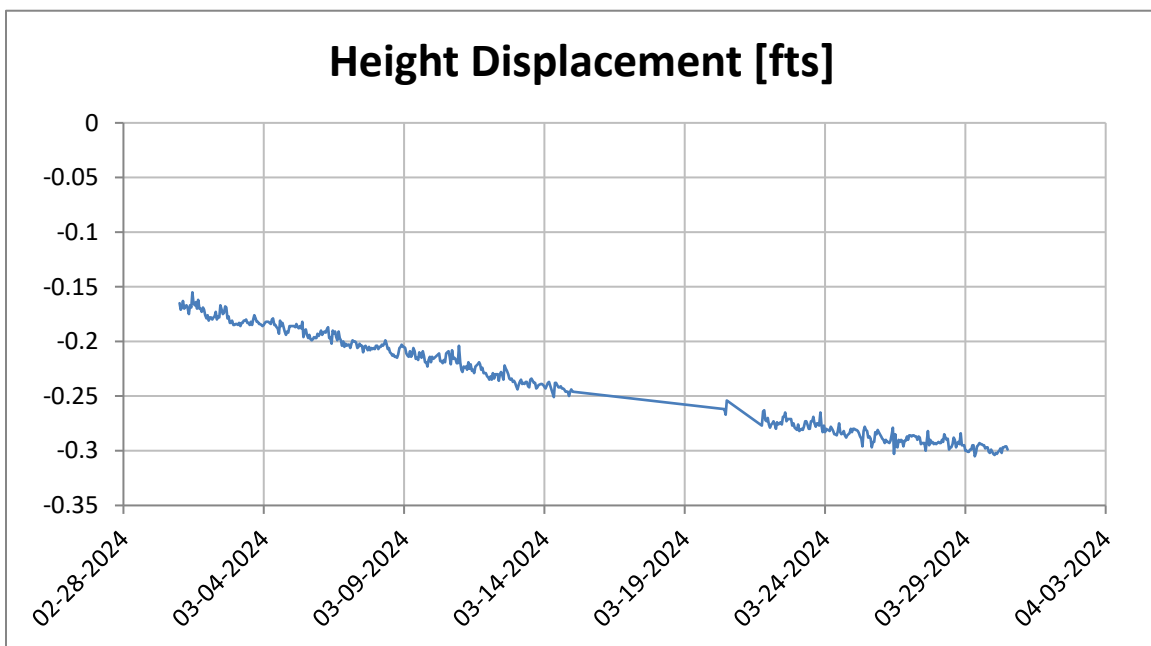
## Prism B7400-3

Prism ID	Cumulative Transverse Displacement (ft)	Cumulative Height Displacement (ft)	Monthly Delta (ft)	Cumulative Delta (ft)	Notes / Recommendations
BR1	-0.011	-0.437	0.0077	0.8210	
BR3	-0.045	-0.114	0.0128	0.1235	
CP6	-0.007	-0.014	0.0170	0.0411	
CP7	0.079	-0.009	-0.0220	0.0853	
NP4	0.031	-0.067	0.0080	0.1300	
P2	-0.014	-0.021	-0.0016	0.0275	
P5	-0.010	-0.018	0.0010	0.0208	
P25	-0.005	0.013	-0.0166	0.0152	
P33	0.084	-0.011	-0.0045	0.1068	
P32R	-0.018	0.009	-0.0266	0.0240	
P70	0.031	-0.042	-0.0002	0.0744	
B7200-1	-0.042	0.011	0.0077	0.0487	
B7200-2	0.005	-0.016	0.0027	0.0537	
B7200-3	0.189	-0.085	0.0170	0.2490	
B7300-0	-0.121	-0.122	0.0454	0.1841	
B7300-1	-0.163	-0.155	0.0352	0.3370	
B7300-2	0.016	-0.192	0.0237	0.2405	
B7300-3	0.196	-0.144	0.0510	0.2922	
B7300-4	0.185	-0.115	0.0607	0.2365	
B7400-1	-0.112	-0.514	0.2561	0.6374	Settlement movement
B7400-2	-0.032	-0.362	0.1804	0.4259	Settlement movement
B7400-3	0.098	-0.299	0.1835	0.3921	Settlement movement

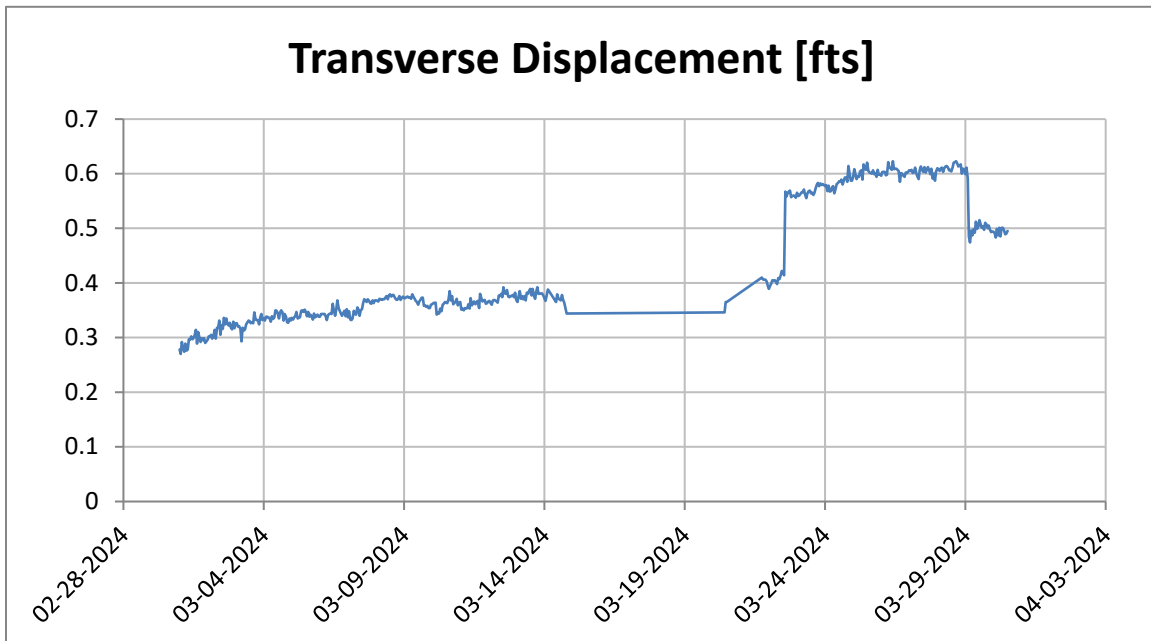
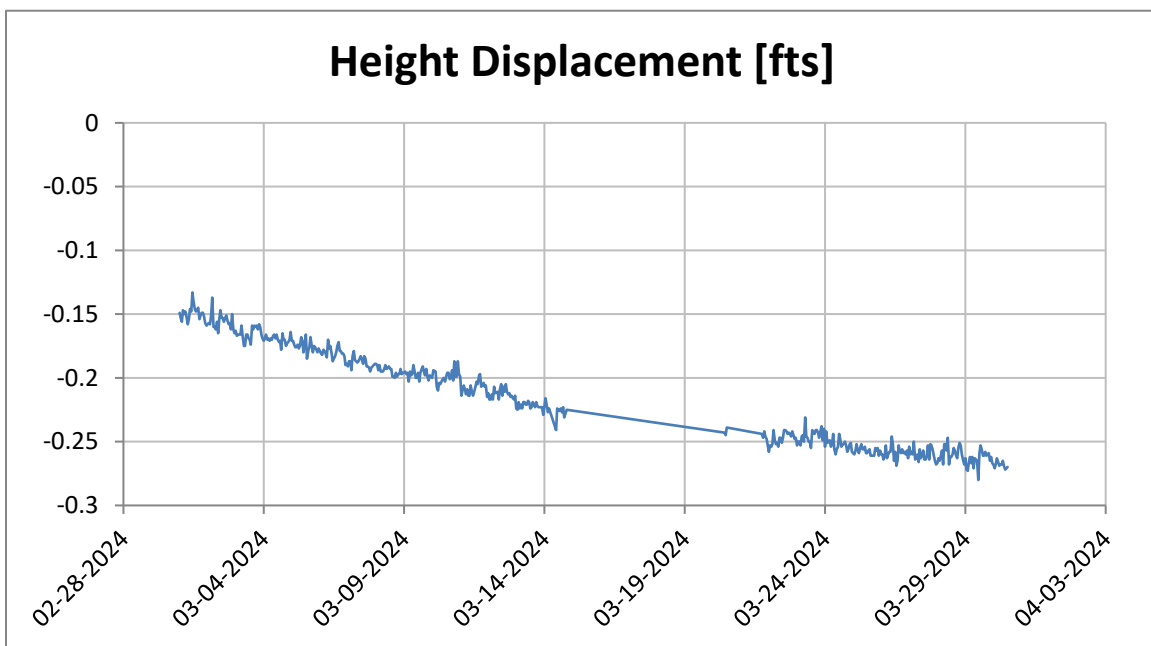
## Prism B7400-4

B7400-4	0.495	-0.270	0.3307	0.6658	Settlement movement
B7400-5	0.108	-0.076	0.0767	0.1519	Settlement movement

The data show stable conditions with no or very small settlement movements at 19 of 24 prisms. Some of the prisms recorded a small amount of settlement immediately after the heavy snow in mid-March, and this type of settlement in fill is expected due to increased moisture content. Prisms on 7400 bench continued to record slow and decreasing gradual movement as the fill consolidates along the benches. The fill is likely consolidating under its own weight and by the placement of topsoil. A small amount of settlement is common for newly placed compacted fill, and this is being recorded by the prisms, which were installed as the buttress was constructed. The previous prism installations were delayed by the topsoil and revegetation operations, and this initial settlement would not have been recorded. Plots of the transverse and height displacements for each prism are included in Appendix B.
