C-1981-035 King Mine, April 2024 Partial Inspection Report

PERMIT INFORMATION

INSPECTION INFORMATION

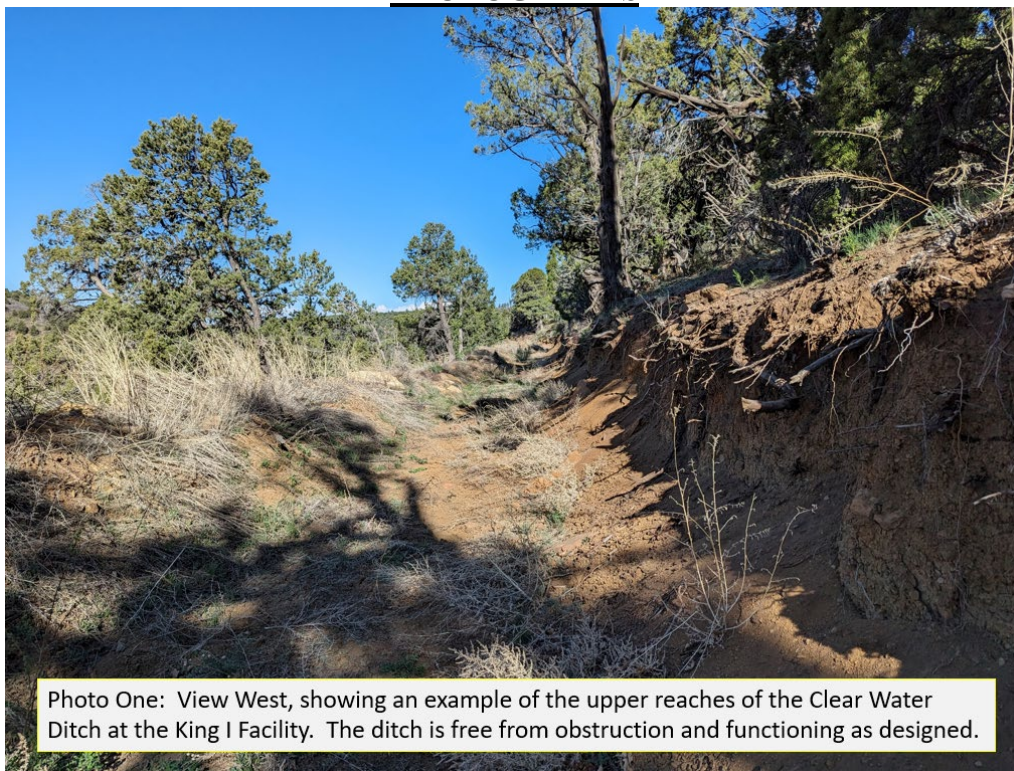
At the King I Facility the upper reaches of the Clear Water Ditch was observed. The ditch is free from obstruction and able to function as designed, no evidence of recent flow was observed, and the ditch is in good condition. Photos of the upper CWD can be seen in Photos One and Two. Also observed were the culverts along the access road leading from the Lower Refuse Pile to the Upper Refuse Pile. All culverts and internal drainage structures were free from obstruction and able to function as designed. The culverts were not plugged, and all appeared to be functioning as designed.

Photo One: View West, showing an example of the upper reaches of the Clear Water Ditch at the King I Facility. The ditch is free from obstruction and functioning as designed.

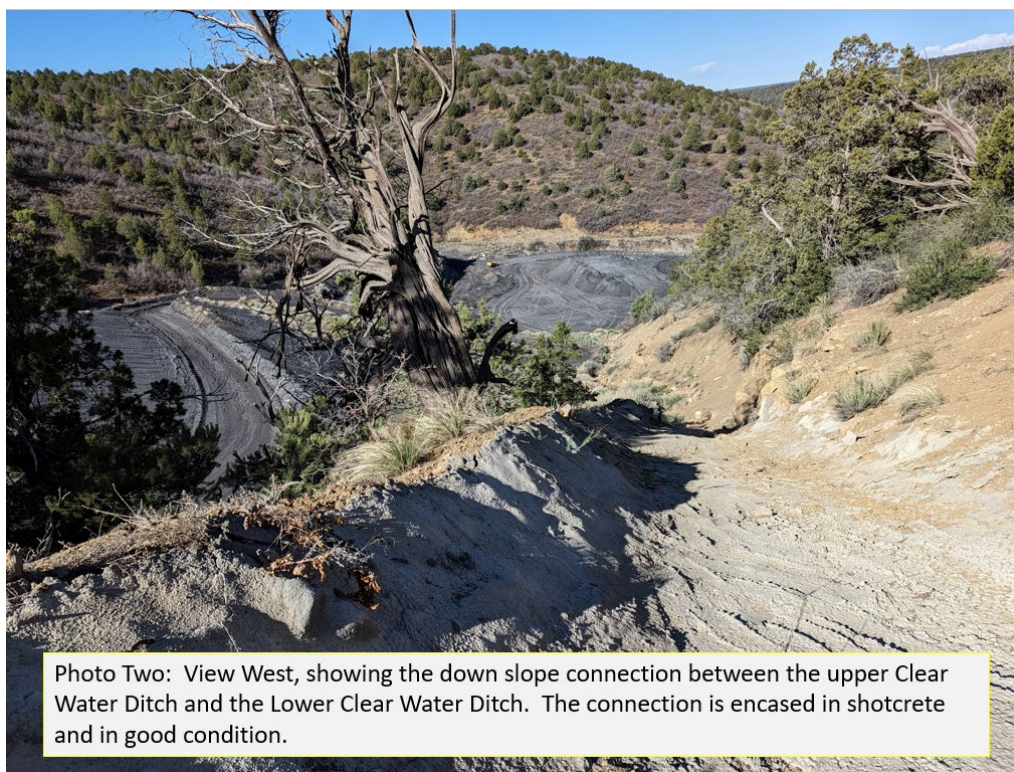
Photo Two: View West, showing the down slope connection between the upper Clear Water Ditch and the Lower Clear Water Ditch. The connection is encased in shotcrete and in good condition.

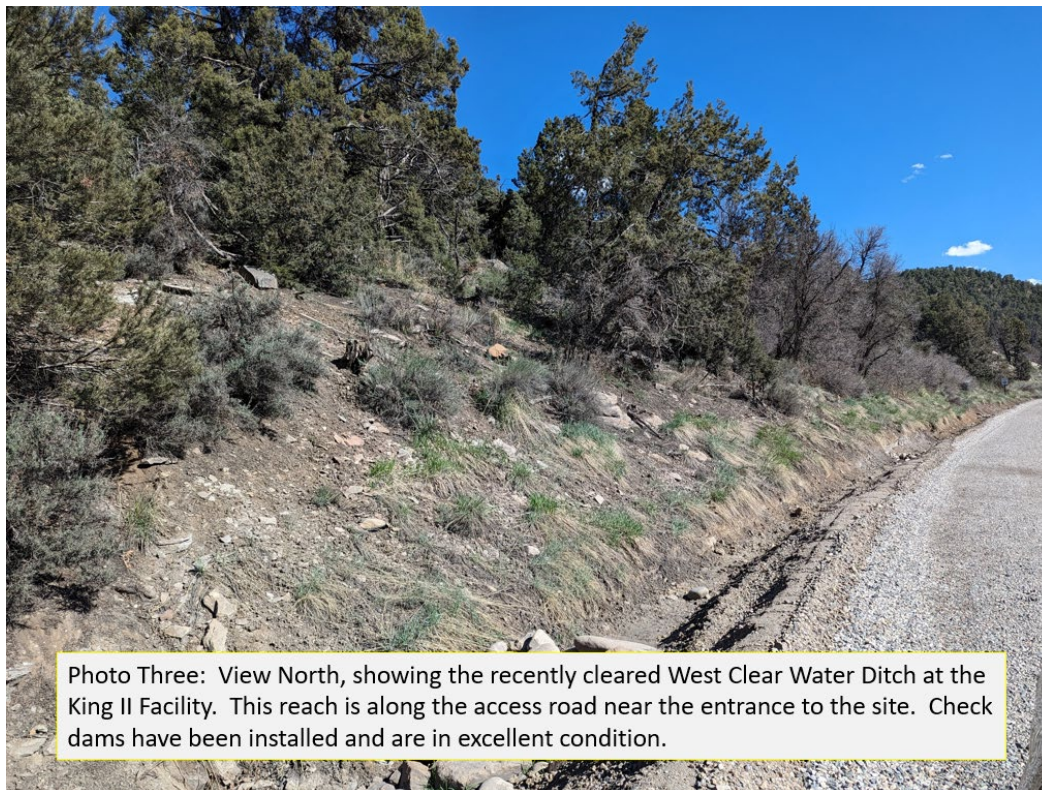
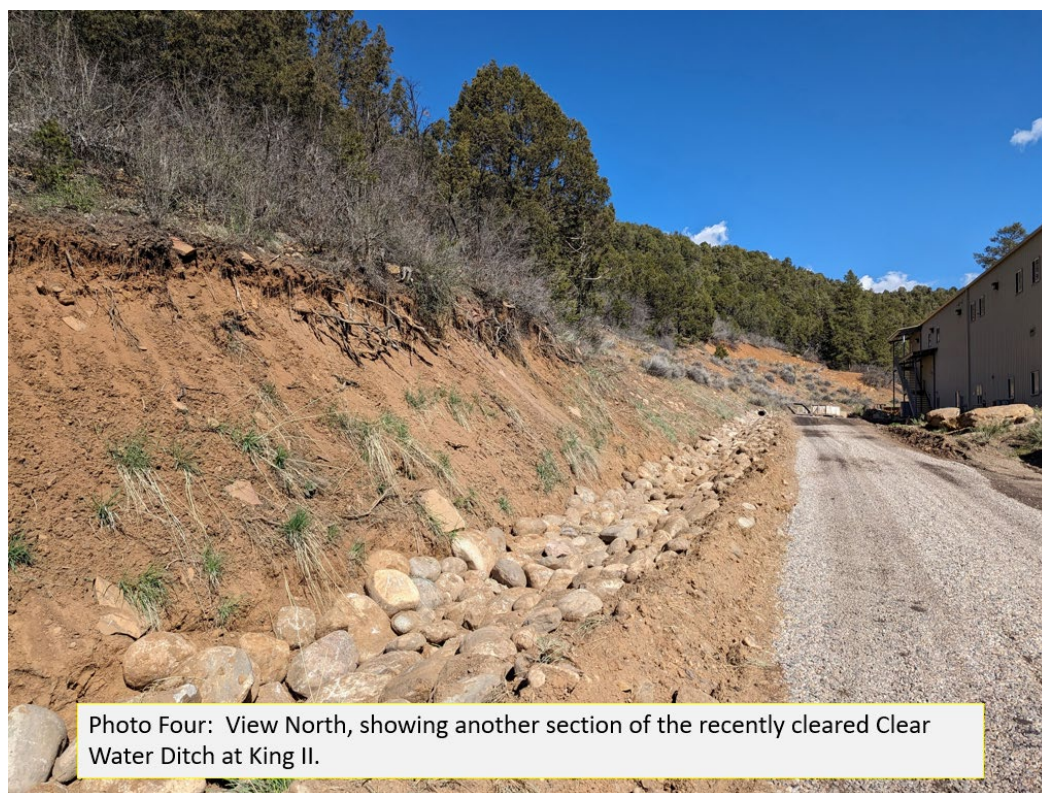
During the inspection, at the King II Facility the West Clear Water Ditch was in process of being cleared from seasonal vegetation. The ditch cleaning is part of normal maintenance and is being conducted that preserves its function during the cleaning efforts. Photos of the cleared portions can be seen in Photos Three and Four. The entire length of the ditch will be cleared as operations progress, however the function and flow is not impeded and it is still functioning as designed. The clearing efforts are approximately 3/4 of the way completed.

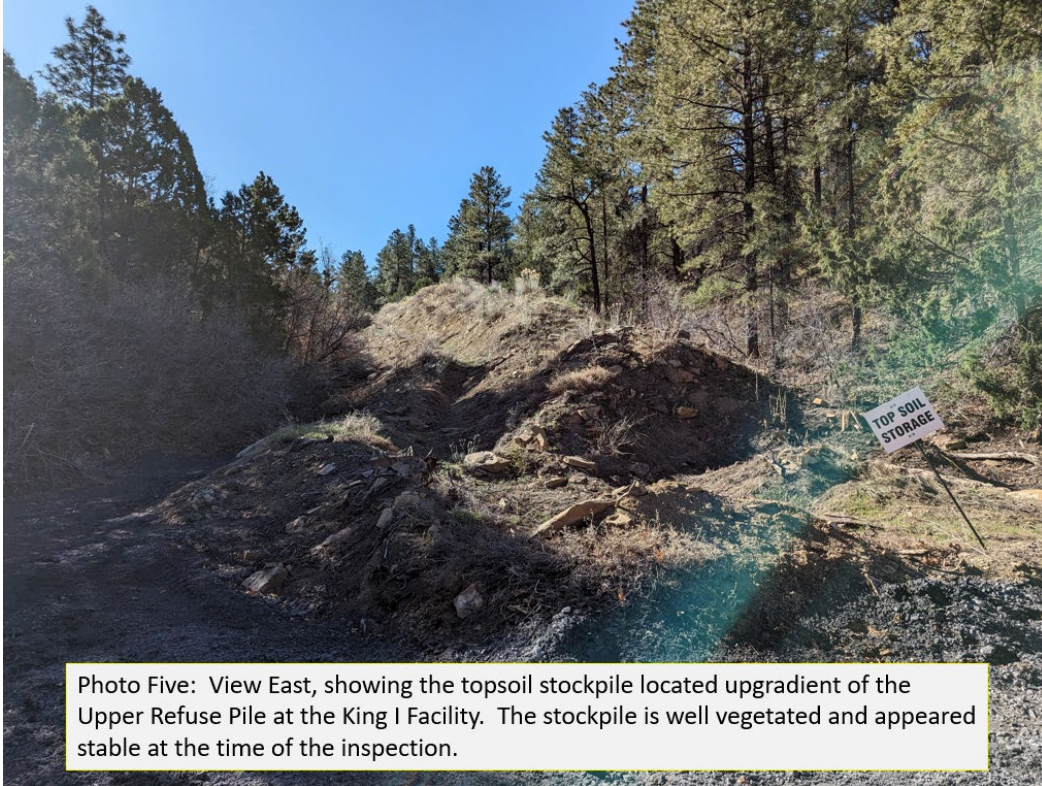
During this inspection the Topsoil stockpile located up gradient of the Upper Refuse Pile was observed. The stockpile remains in good condition and well vegetated as seen in Photo Five. The stockpile appears stable, and no evidence of material transport was noted. The ring berm around the stockpile appears to be functioning as designed. Also, the Operator has kept up on noxious weed management, and no state listed noxious weeds were noted on the stockpile.

Photo Five: View East, showing the topsoil stockpile located upgradient of the Upper Refuse Pile at the King I Facility. The stockpile is well vegetated and appeared stable at the time of the inspection.

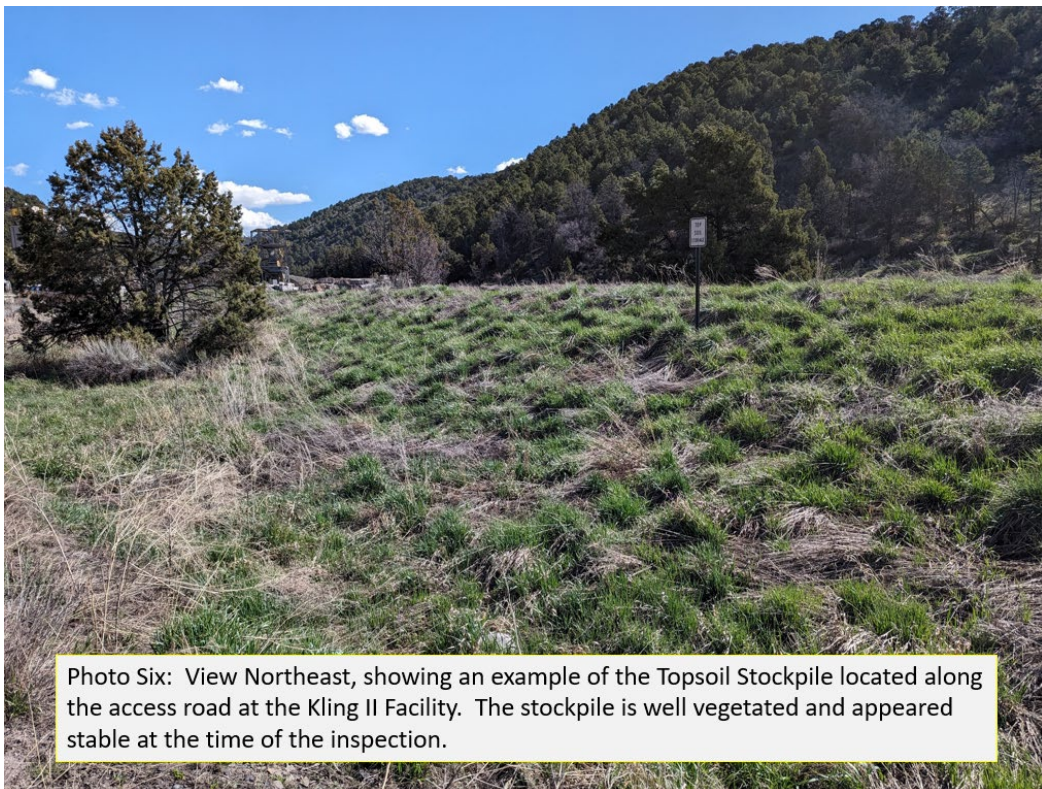
At the King II Facility there are two topsoil stockpiles in two distinct storage locations. One near the access road and one towards the Northeast end of the Affected lands near the number 2 stacker. The stockpile near the access road, that contains approximately 3,479 Cubic Yds of material, was observed to be in excellent condition as seen in Photos Six and Seven. The vegetative cover is dense and diverse with no major bare areas being exposed. The pile appeared stable at the time of the inspection and no state listed noxious weeds were noted. Similarly, the stockpile located near the number 2 stacker that contains 27,191 Cubic Yds of material, appeared stable and in good condition. It is also well vegetated, and no evidence of material transport was noted. This stockpile can be seen in Photo Eight.

Photo Six: View Northeast, showing an example of the Topsoil Stockpile located along the access road at the Kling II Facility. The stockpile is well vegetated and appeared stable at the time of the inspection.

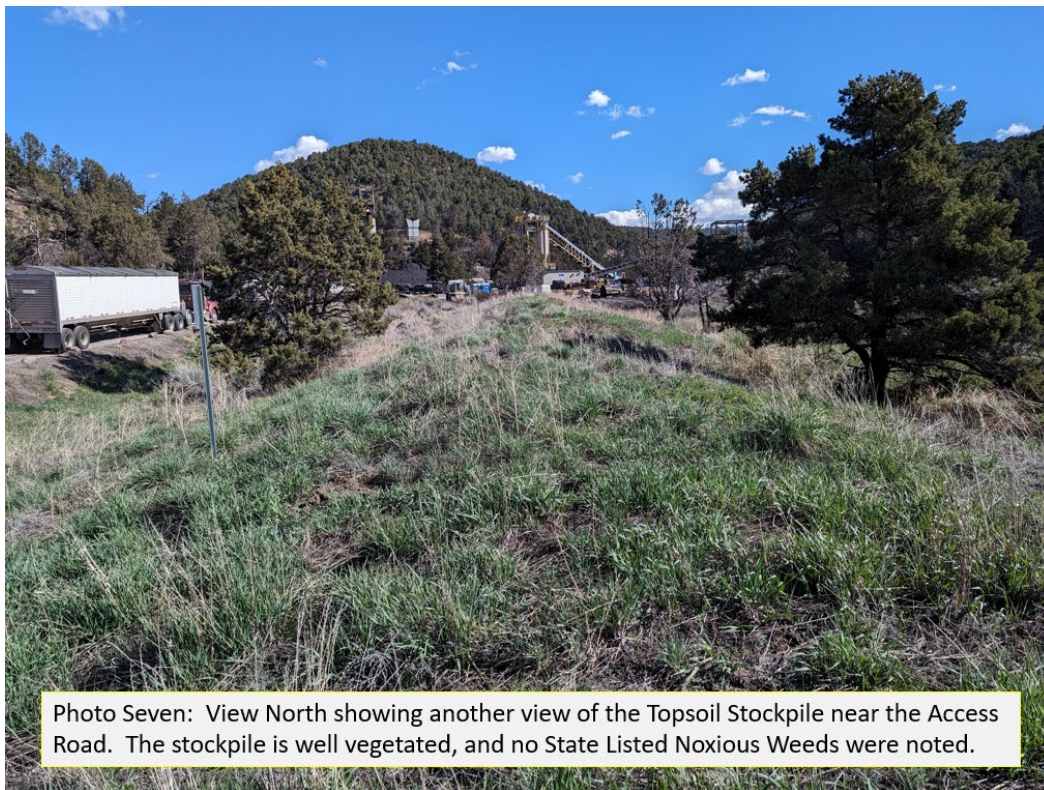
Photo Seven: View North showing another view of the Topsoil Stockpile near the Access Road. The stockpile is well vegetated, and no State Listed Noxious Weeds were noted.

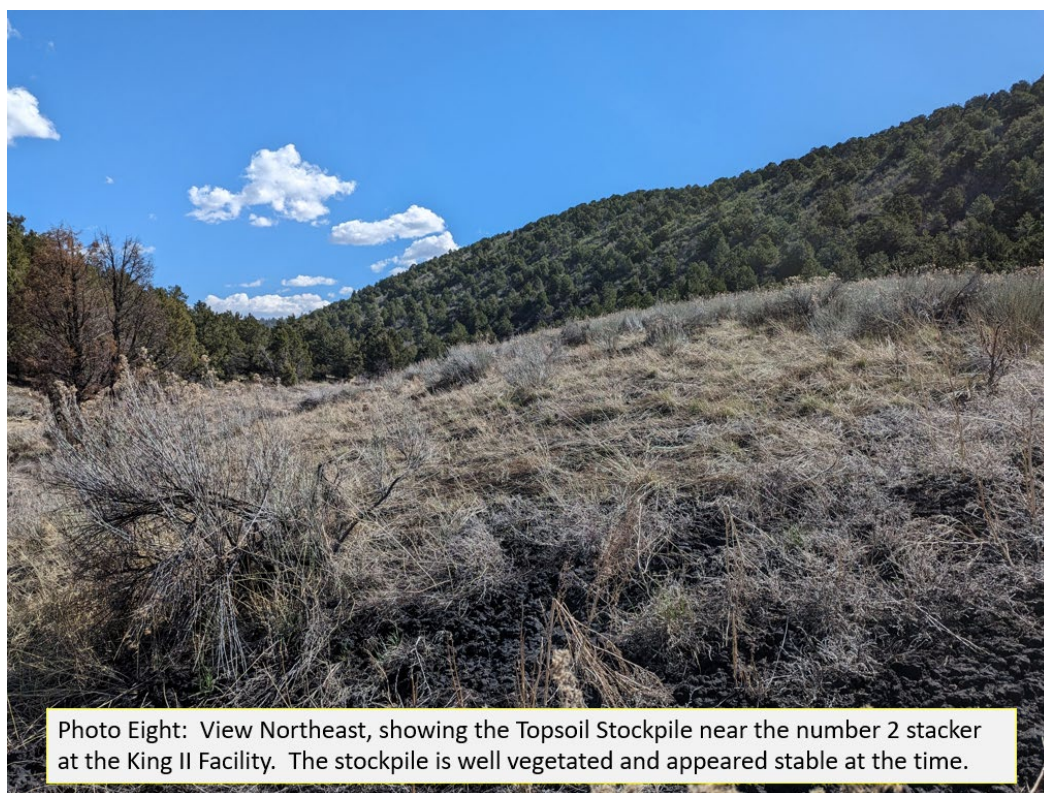
Photo Eight: View Northeast, showing the Topsoil Stockpile near the number 2 stacker at the King II Facility. The stockpile is well vegetated and appeared stable at the time.
