PERMIT INFORMATION

Permit Number: C1981033 Mine Name: Bear Mine Operator: N/A Operator Address: N/A	County: Gunnison Operation Type: Underground Permit Status: Revoked Ownership: Private
	Operator Representative Present: N/A
Operator Representative Signature: (Field Issuance Only)

INSPECTION INFORMATION

The Bear mine permit is revoked, the site has been reclaimed, and the required inspection frequency has been reduced to quarterly. The weather was clear and dry.

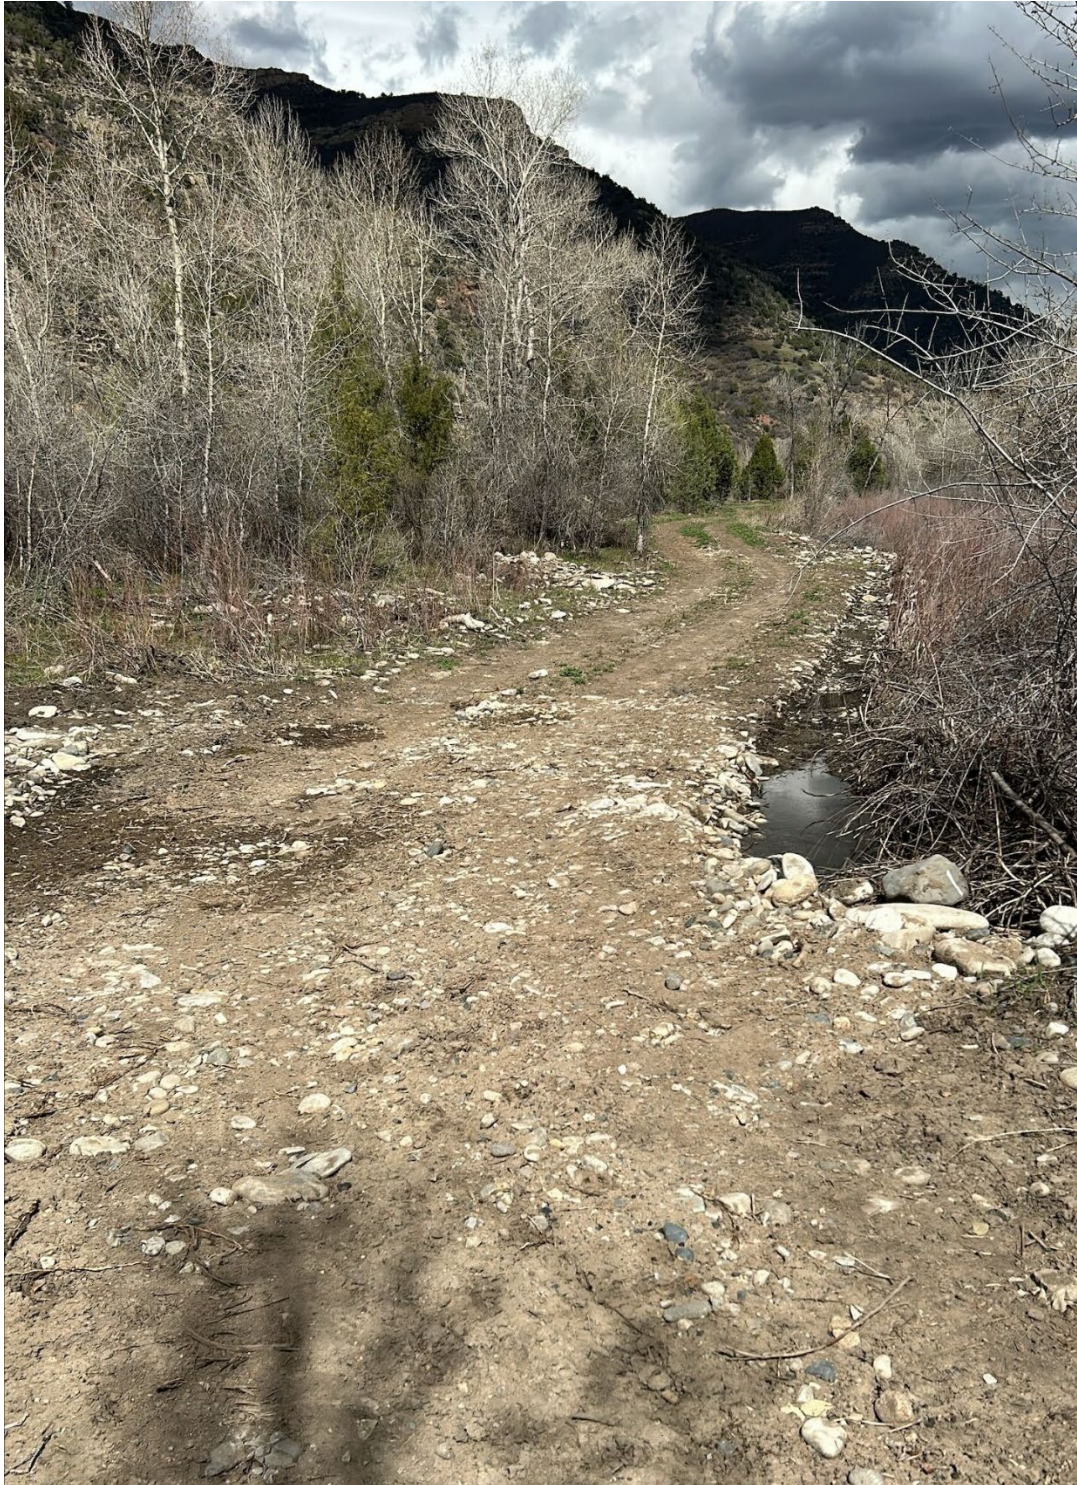
Access to the temporary road from West Elk to the bench above the slide area was good – the low spot in the road that had been completely flooded in the spring of 2023 was dry and easily passable in a truck.

Figure 1: Low spot in road from West Elk, dry

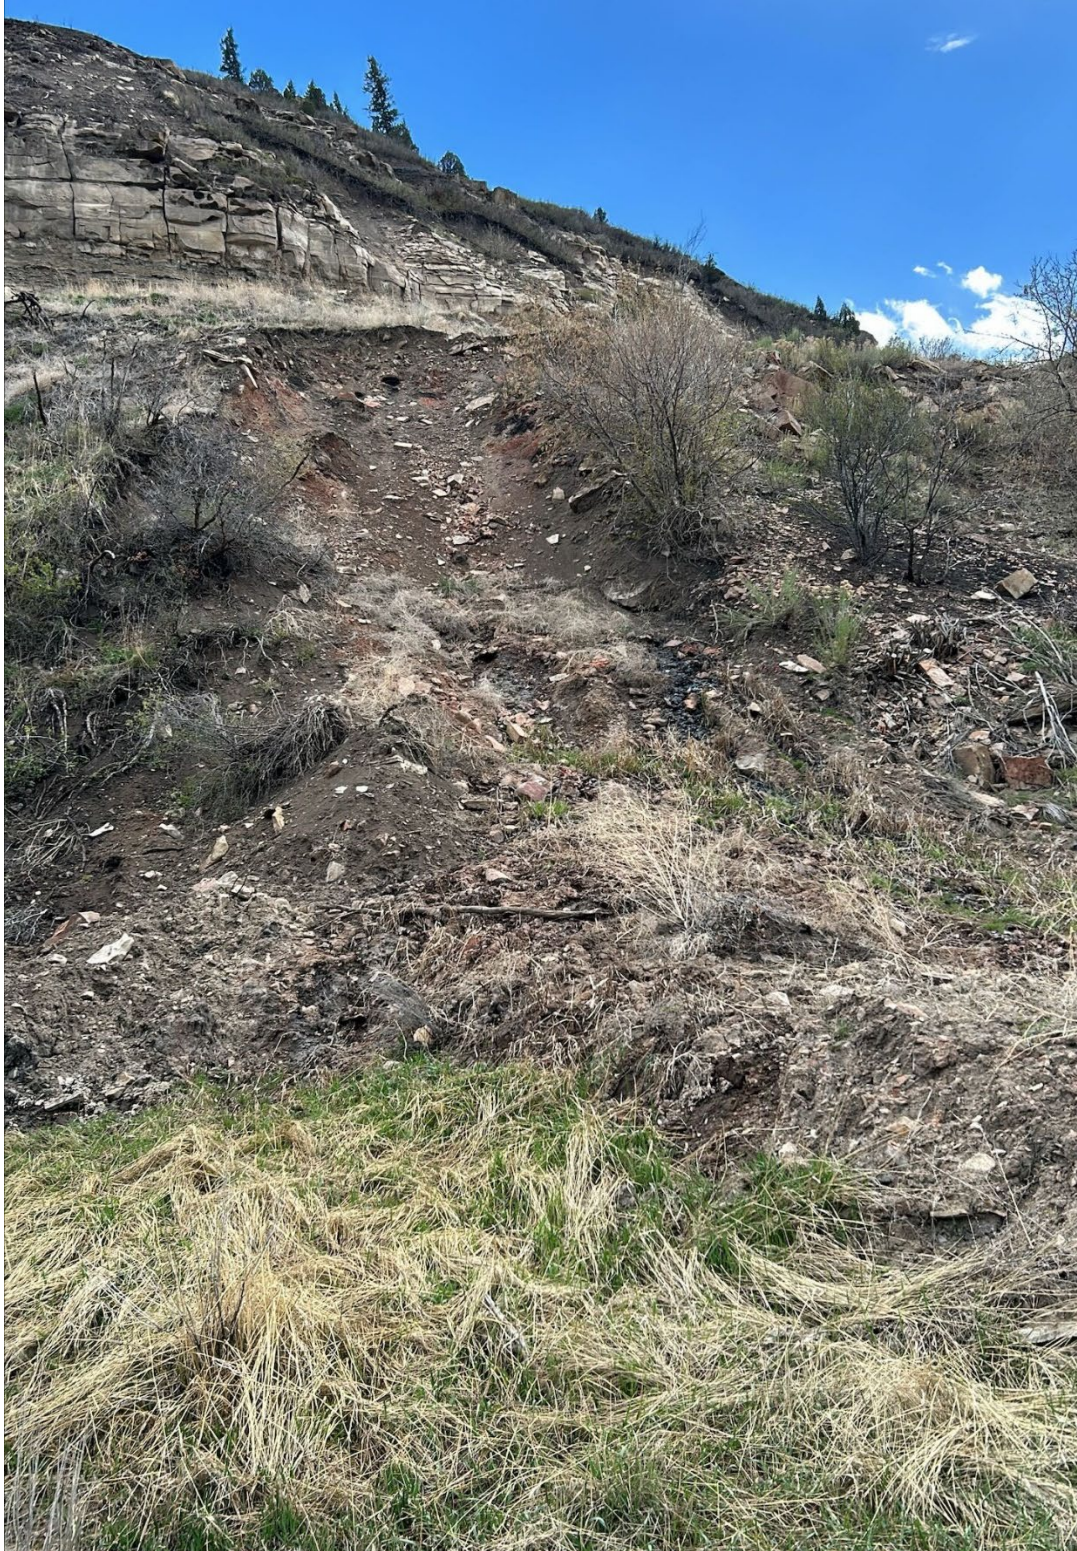
A small slide had occurred near the toe of the debris from the well-documented large slide, above and over the groundwater seep. Although the slide itself did not appear particularly significant, the debris from it had crossed and blocked the sinuous channel. This meant that some of the groundwater from the seep was not conveyed down the channel towards the river as intended but was pooling in several locations on the reclaimed pad area and within the blocked part of the channel.

Figure 2: Small slide at groundwater seep, with debris blocking sinuous channel

Repairs to the sinuous channel should be relatively straightforward if equipment can be mobilized across the bridge. Some repairs will certainly be necessary to the decking at least, but the structural integrity will need to be assessed by a qualified person before plans are made to bring equipment across.

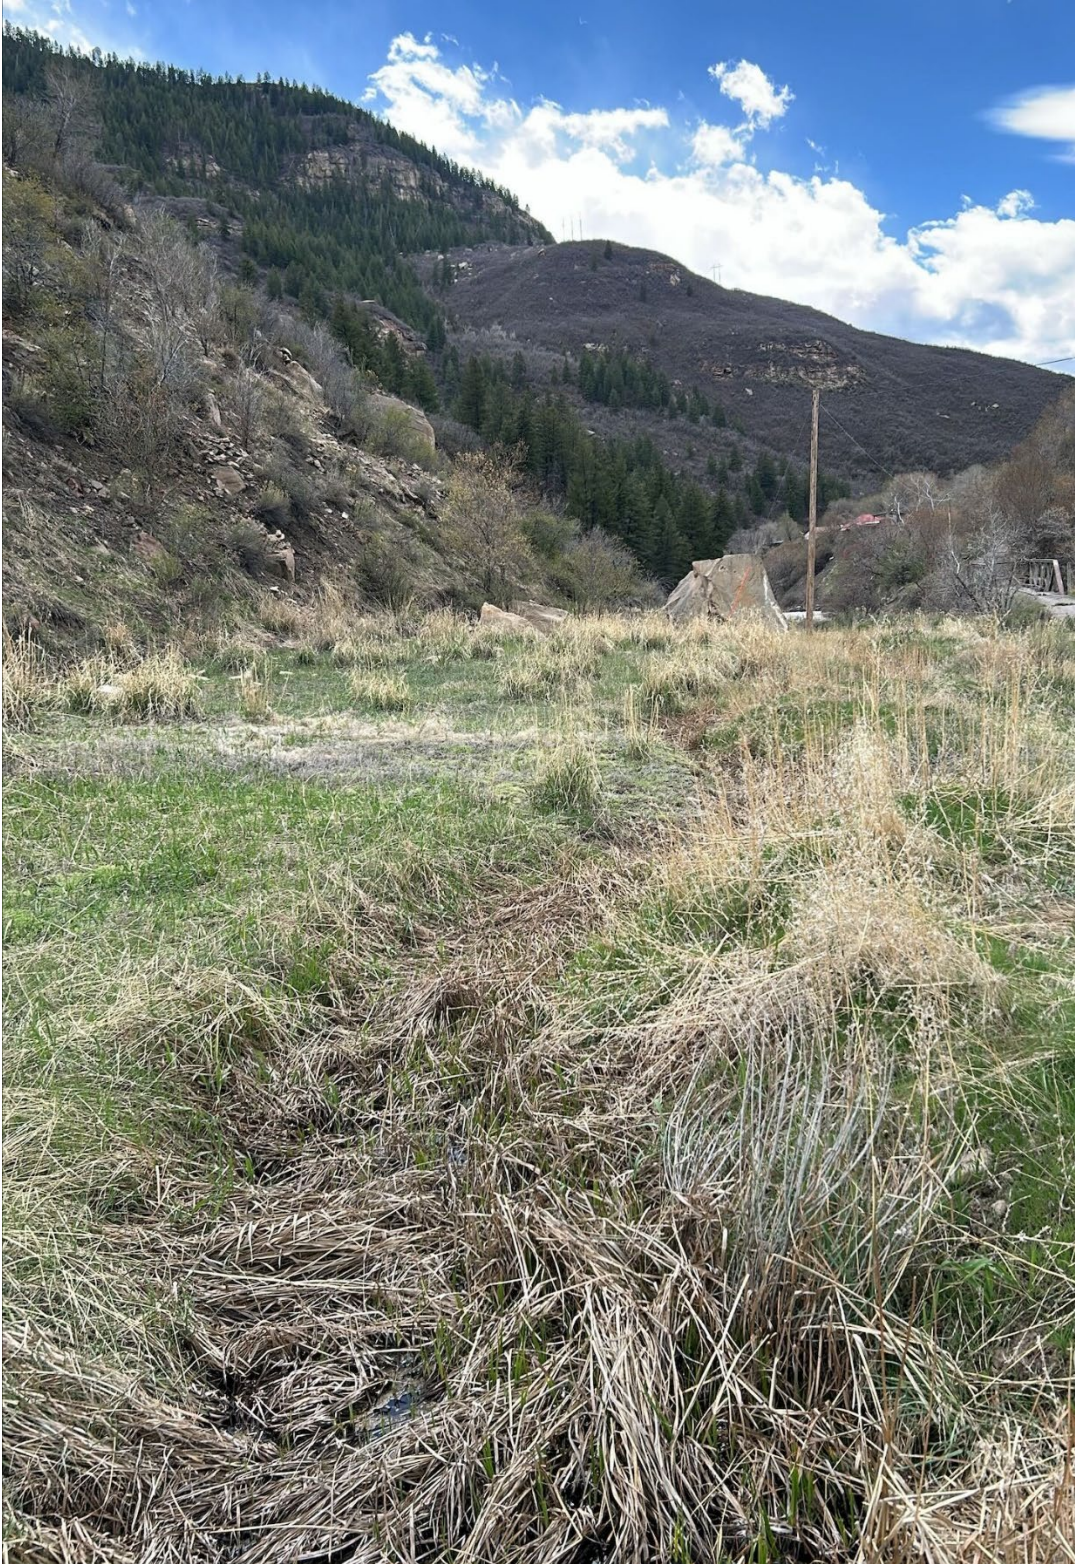
Figure 3: Sinuous channel, downstream of damage

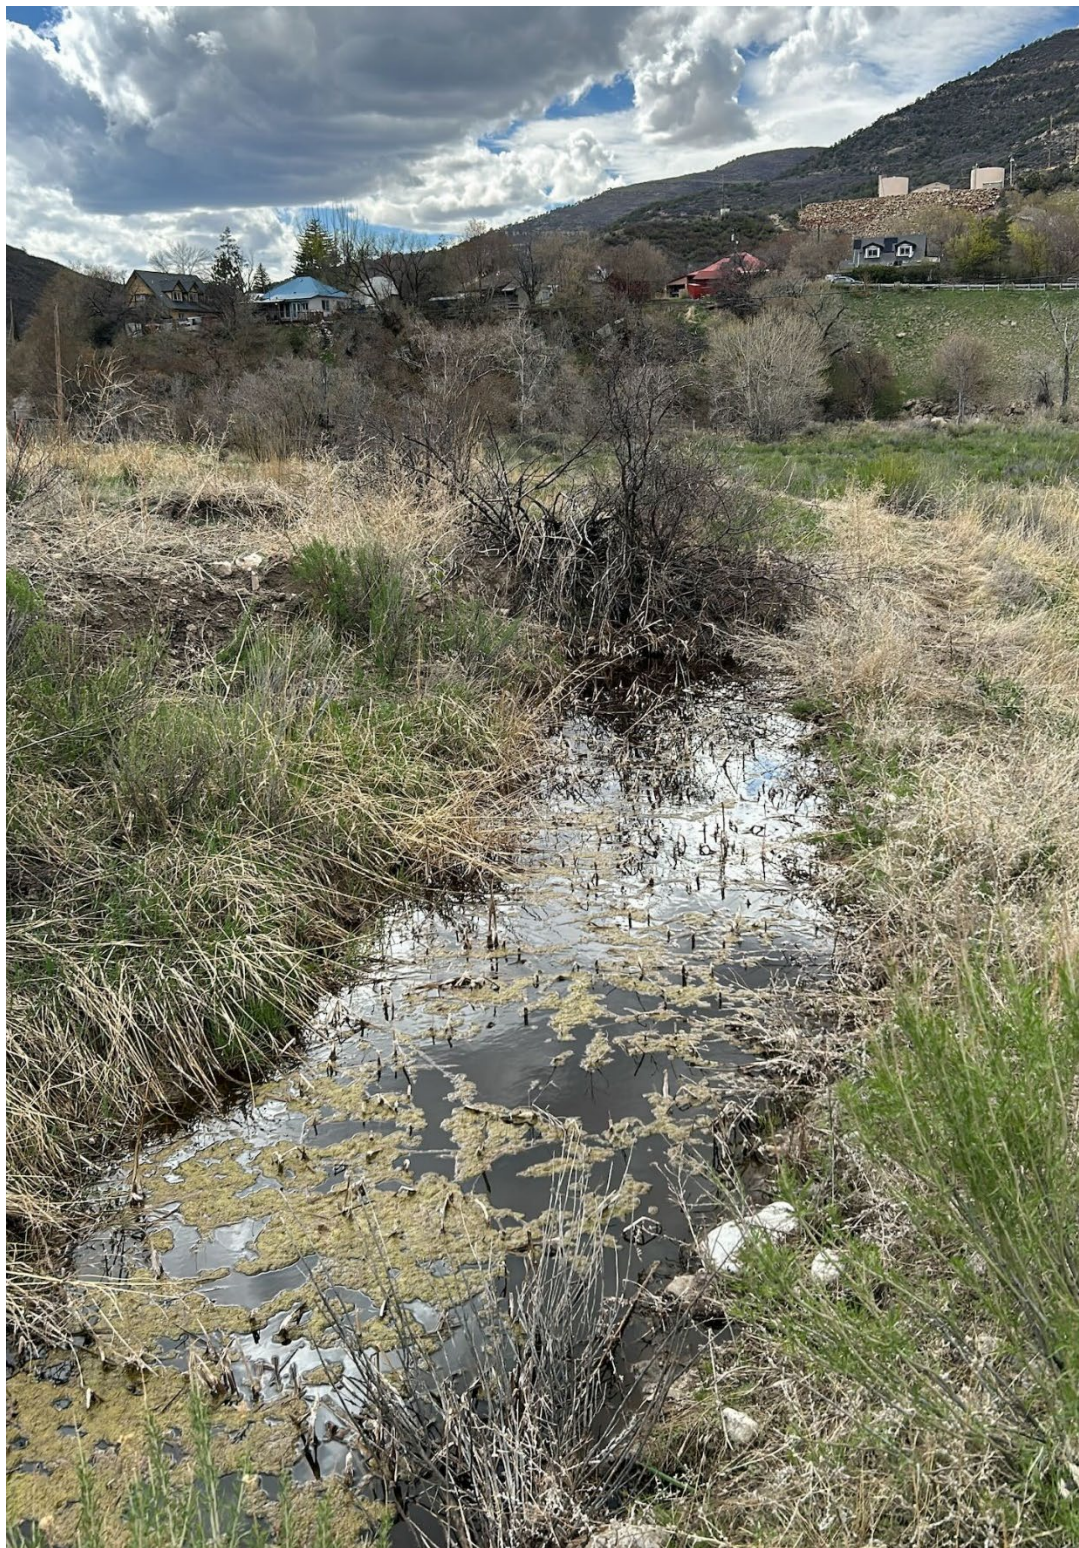
Figure 4: Sinuous channel upstream of damage, showing ponded water

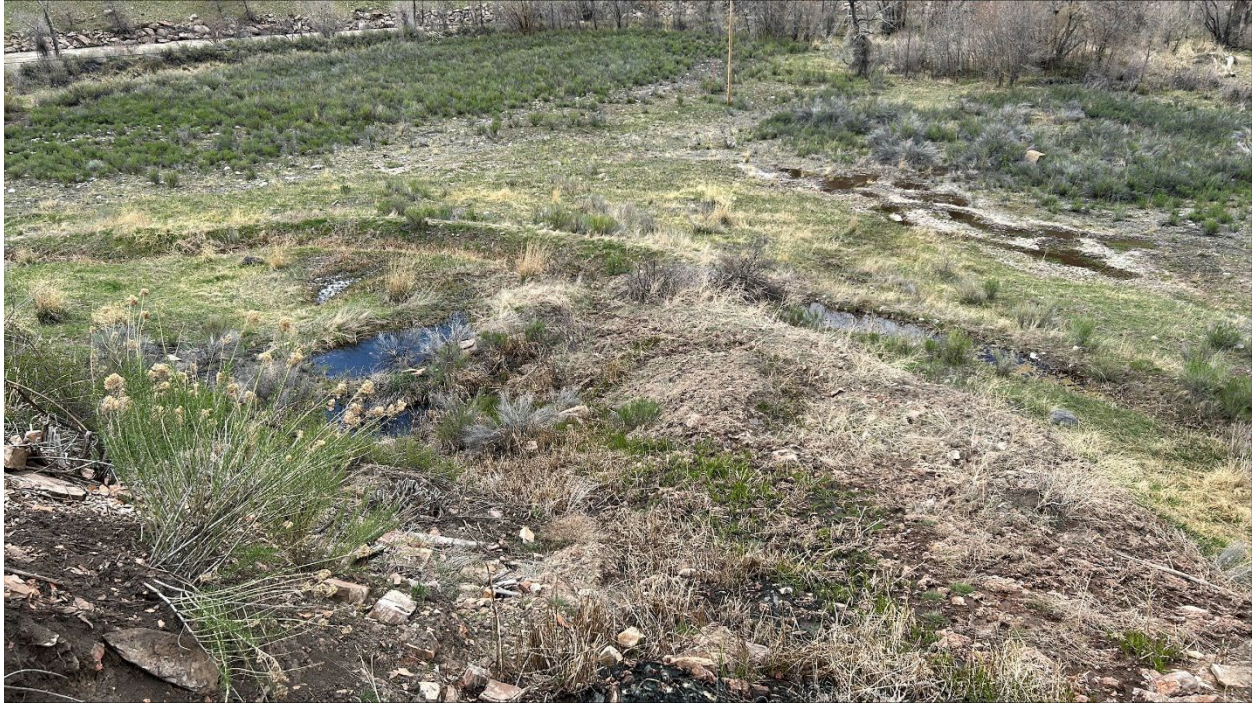
Figure 5: Small slide debris from groundwater seep

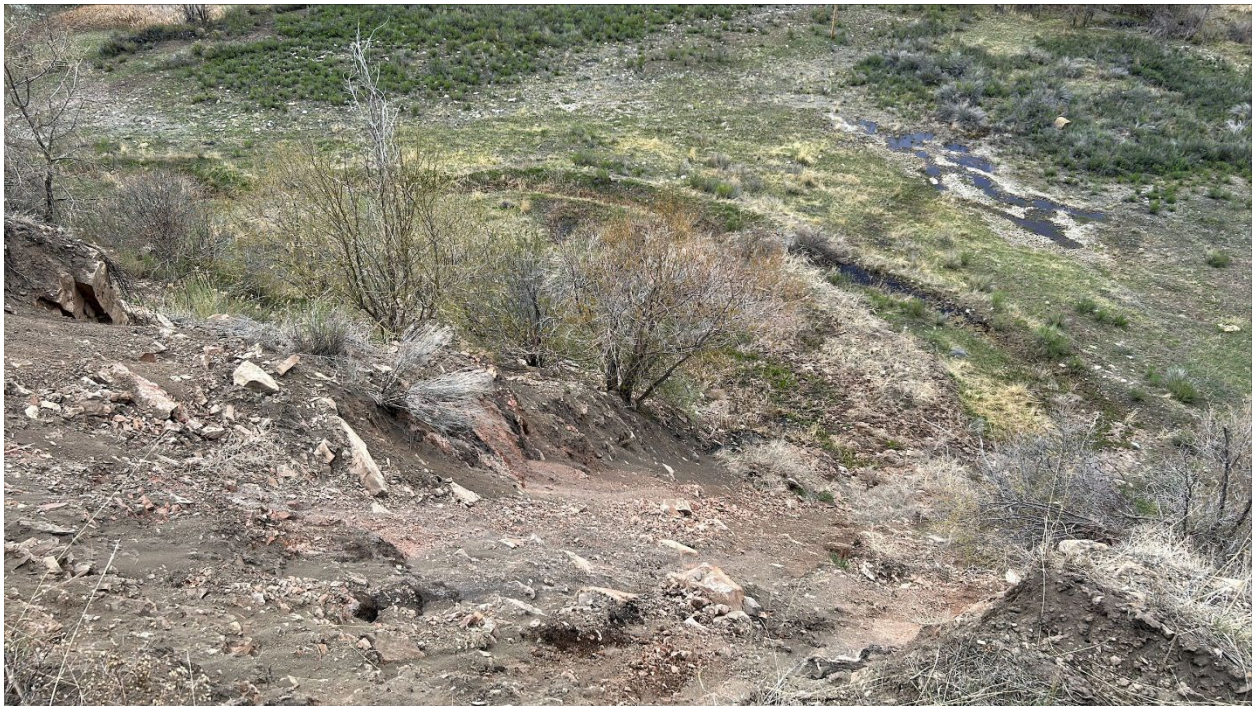
Figure 6: Small slide from above

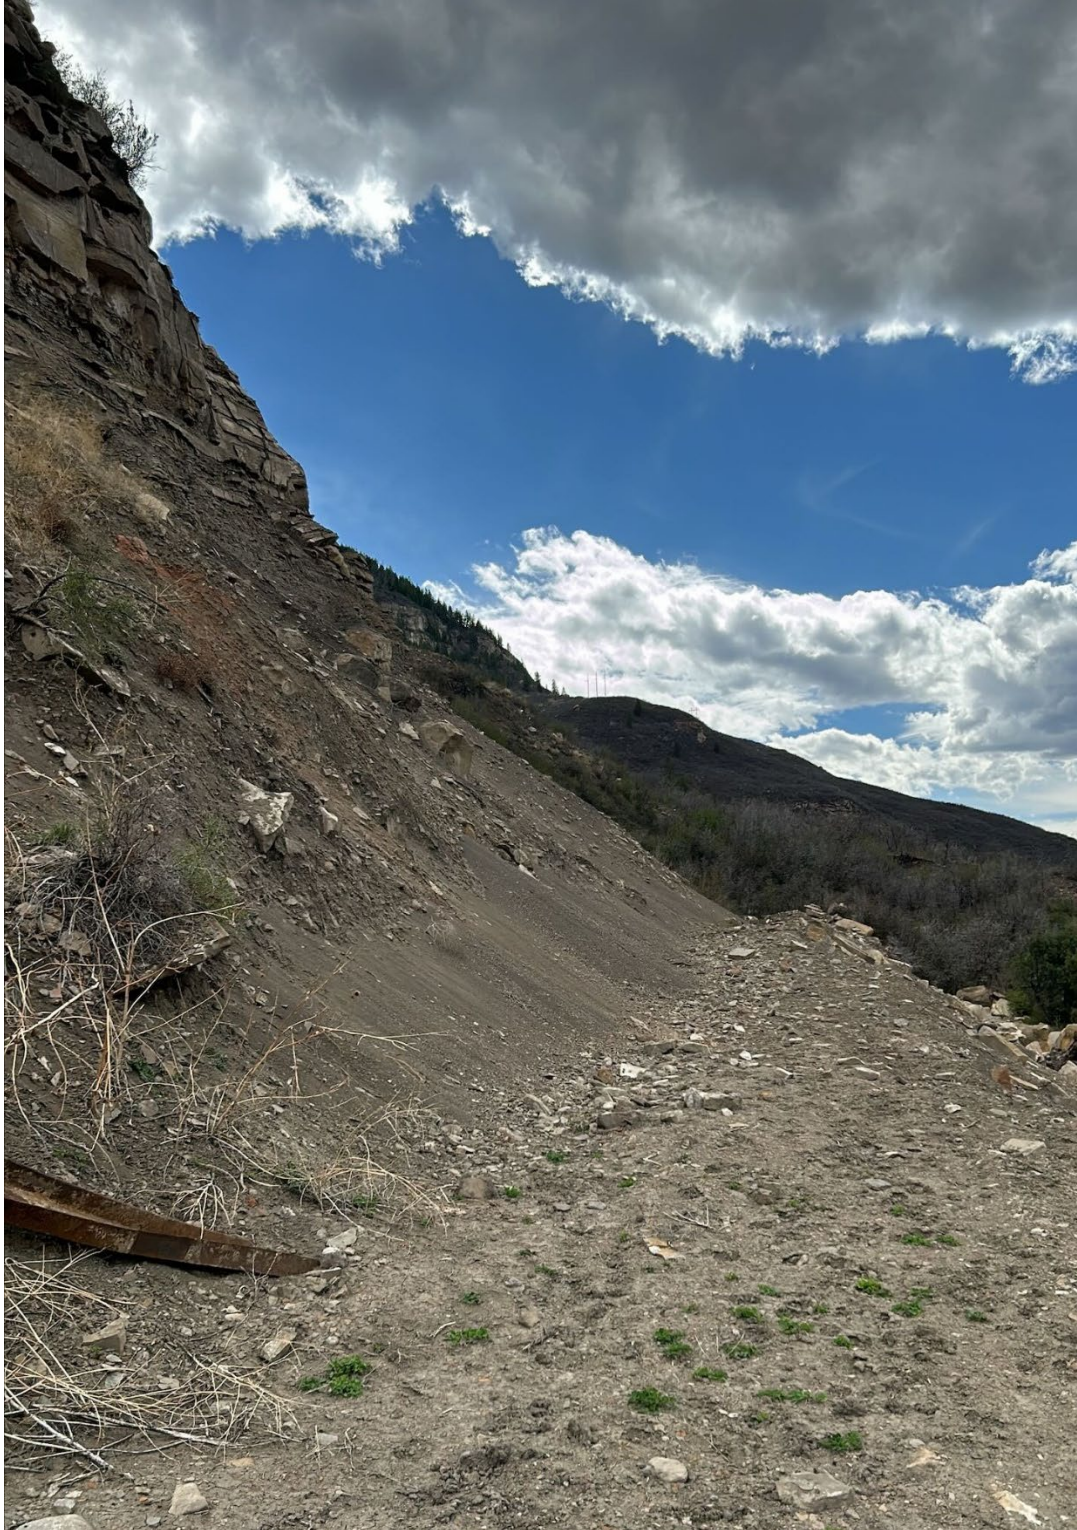
Figure 7: Road below scarpe, showing accumulation of spalled material
