C1981022, Elk Creek Mine, April Inspection Report

PERMIT INFORMATION

Permit Number: C-1981-022 Mine Name: Elk Creek Mine Operator: Oxbow Mining, LLC Operator Address: Mr Doug Smith 3737 Hwy 133 P. O. Box 535 Somerset, CO 81434	County: Delta, Gunnison Operation Type: Underground Permit Status: Active Ownership: Private
	Operator Representative Present: N/A
Operator Representative Signature: (Field Issuance Only)

Inspection Start Date: April 19, 2024 Inspection Start Time: 09:00 Inspection End Date: Inspection End Time:	Inspection Type: Coal Partial Inspection Inspection Reason: Normal I&E Program Weather: Clear
Joint Inspection Agency: None	Joint Inspection Contacts:
Post Inspection Agency: None	Post Inspection Contacts:
Inspector(s): Leigh Simmons	Inspector's Signature:

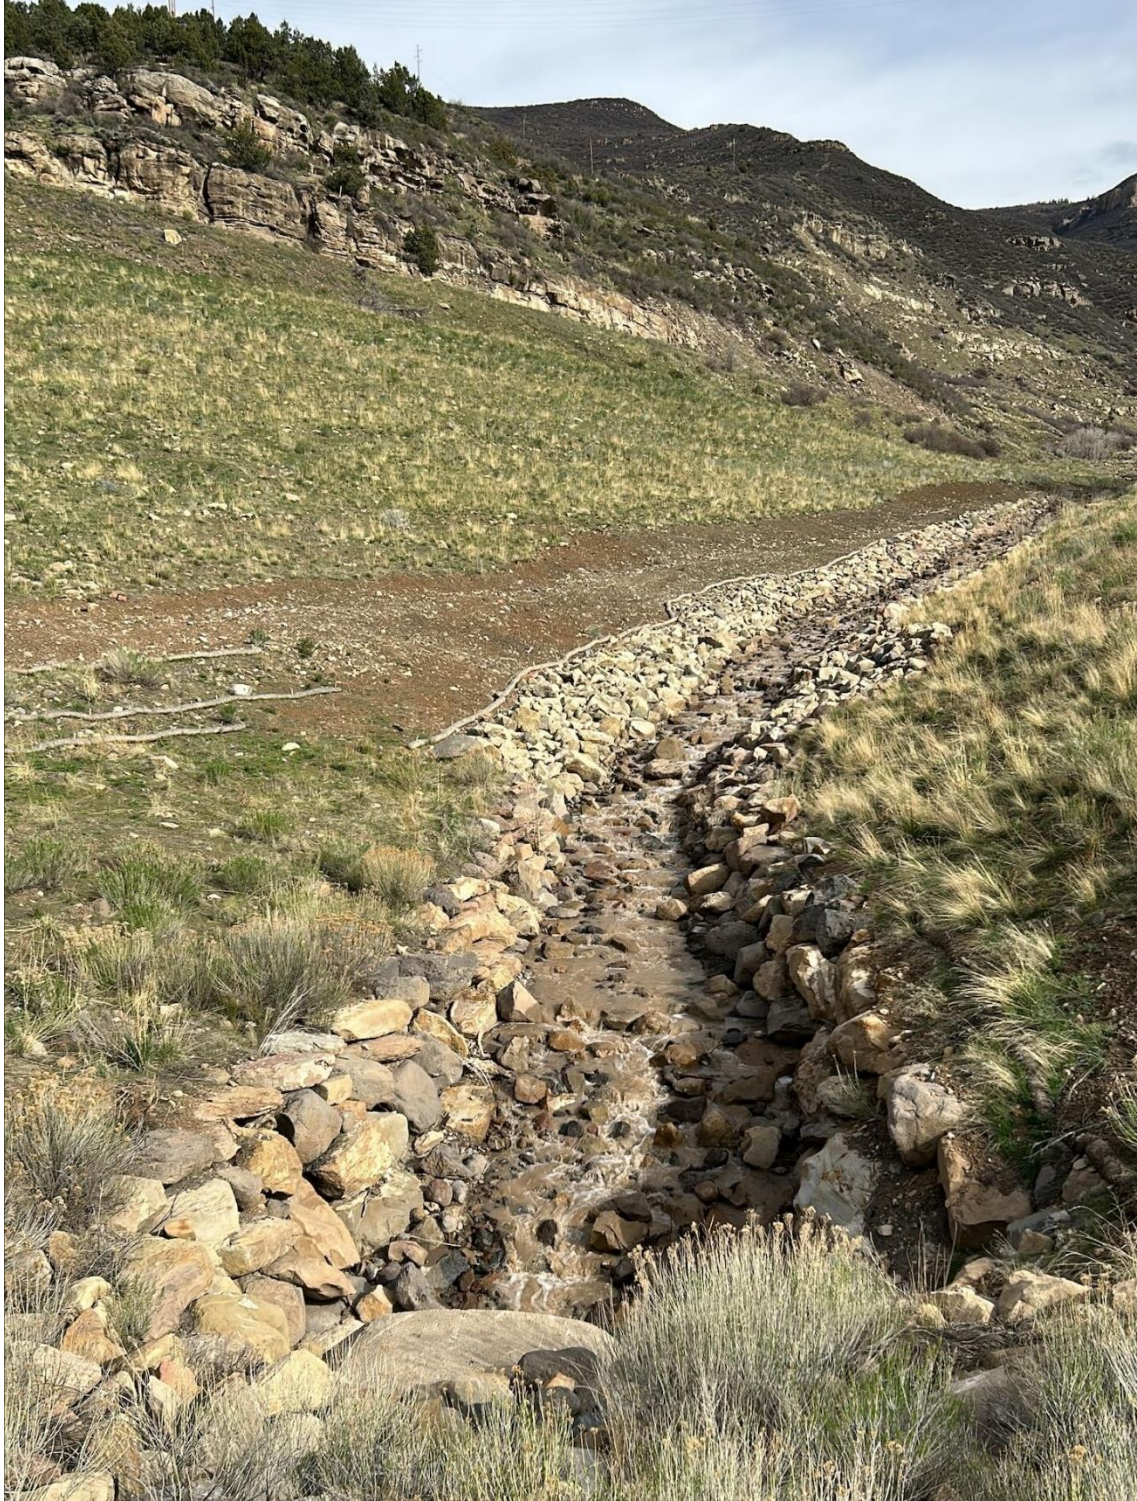
Water was flowing in the Elk Creek channel, though not at an especially high flow rate. The repairs to the lower section of the channel following the damage caused by 2023 spring run-off appeared to be stable. There was no sign of any water in the channel migrating around the remaining culvert sections, and the concrete aprons upstream of the culvert inlets seemed to be effective. Some repairs had been made to the backfill around the inlet to the middle section of culvert.

Figure 1: Lower section of Elk Creek channel, with repair on left bank

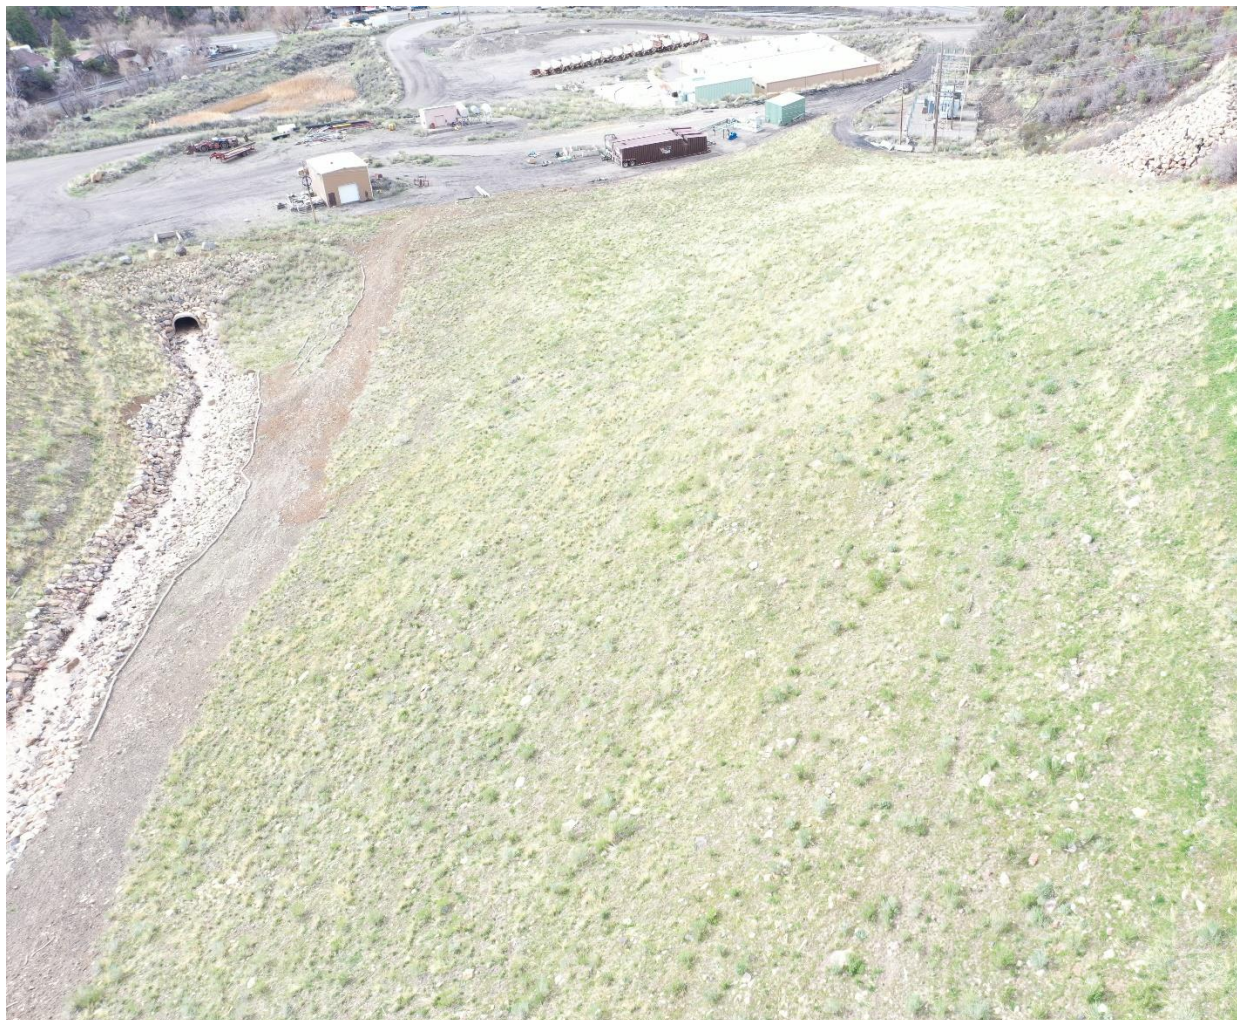
Figure 2: Lower section of Elk Creek channel from drone (1 of 2)

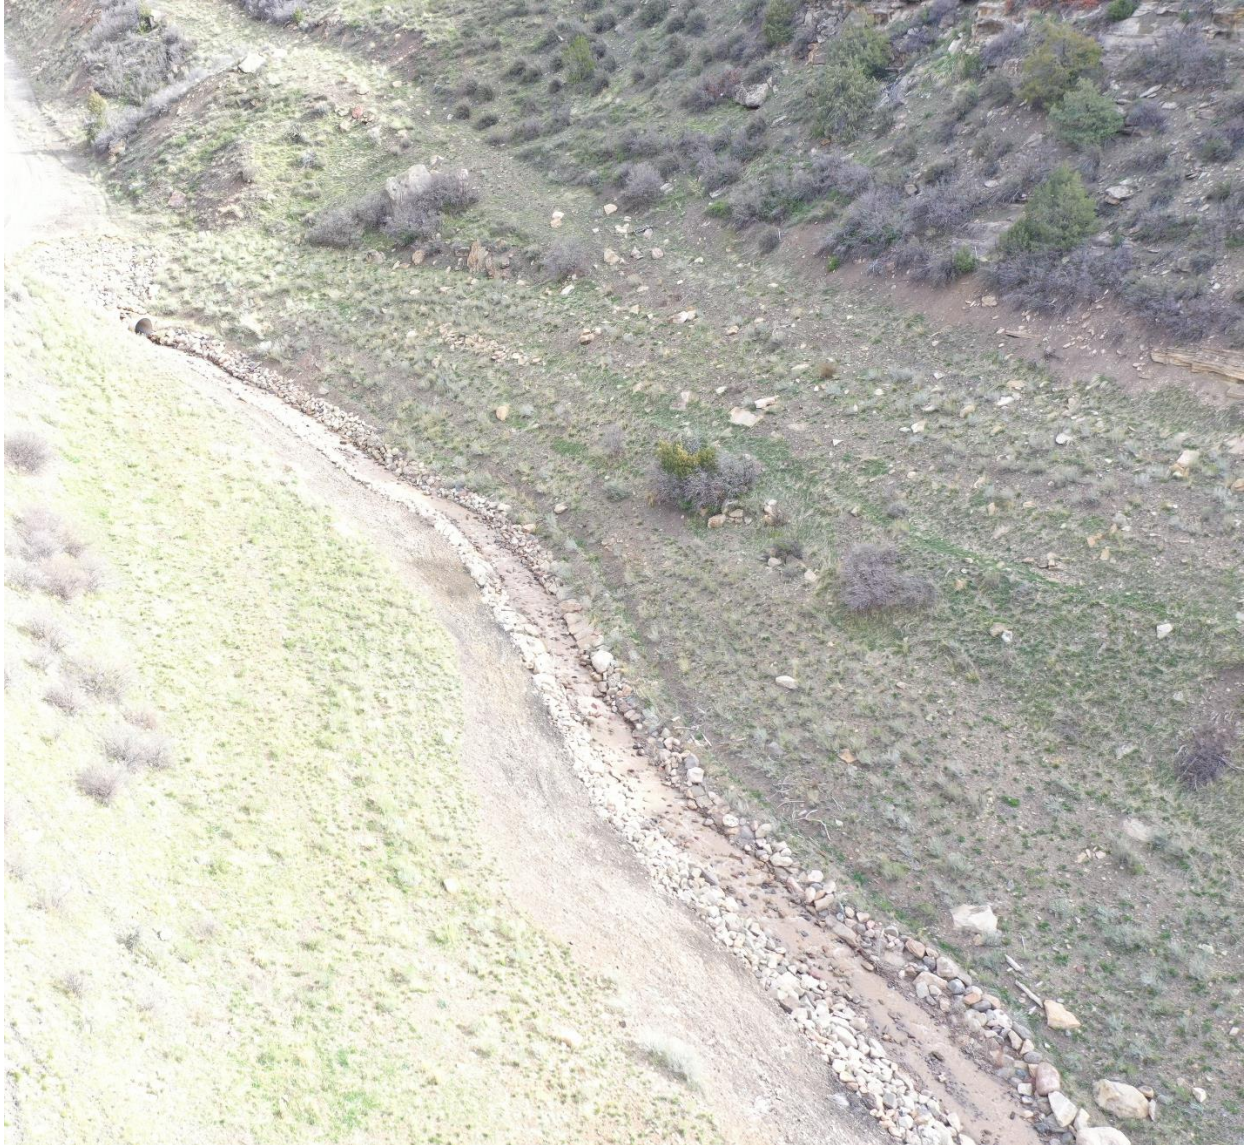
Figure 3: Lower section of Elk Creek channel from drone (2 of 2)

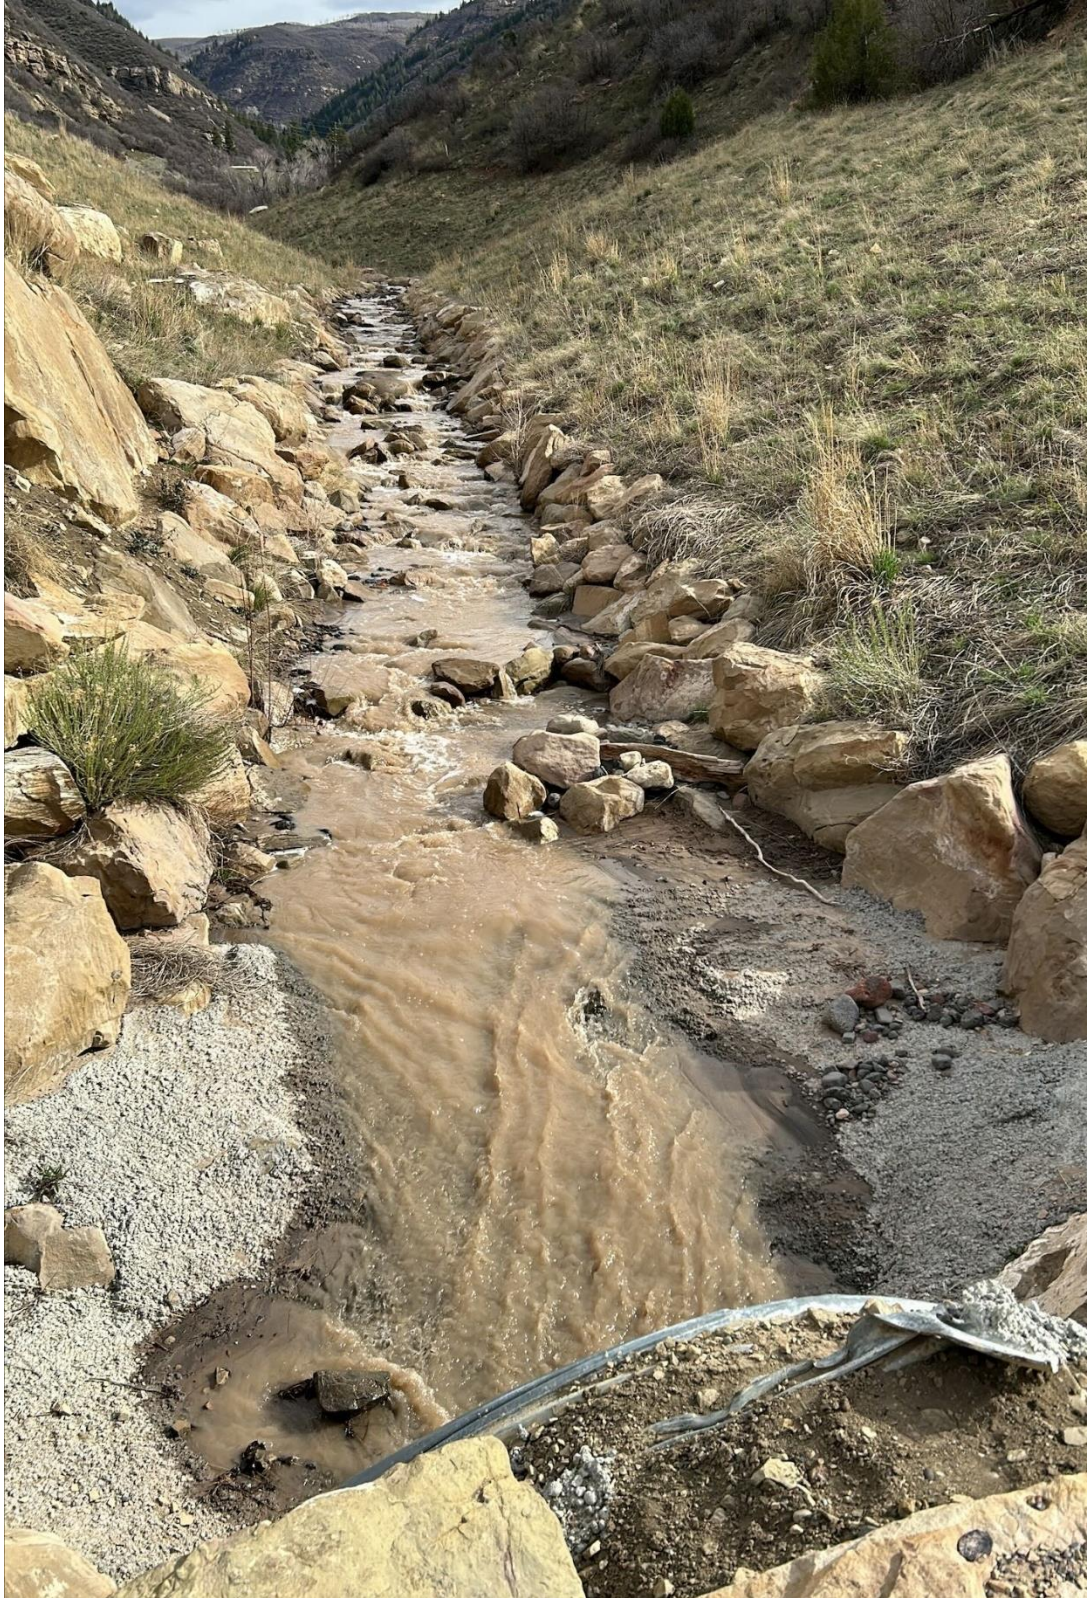
Figure 4: Upper section of Elk Creek channel

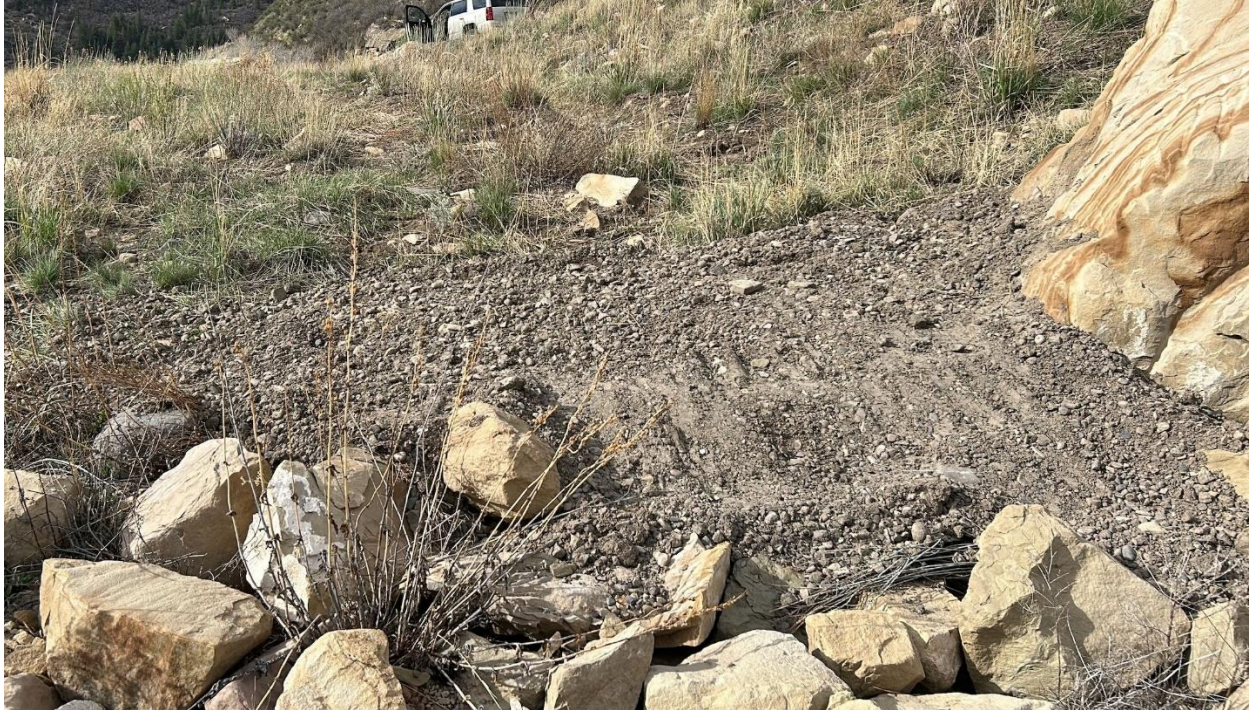
Figure 5: Repair to backfill around inlet to middle section of Elk Creek culvert

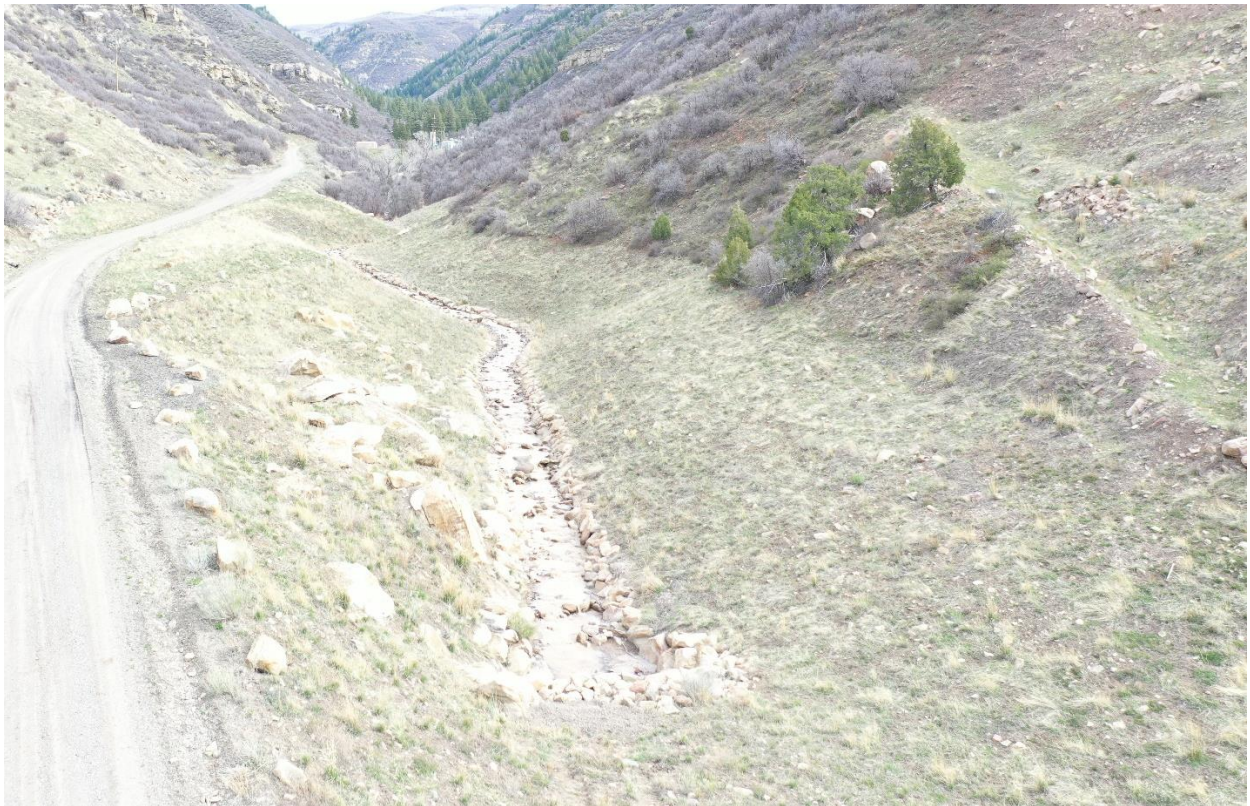
Figure 6: Upper section of Elk Creek channel from drone

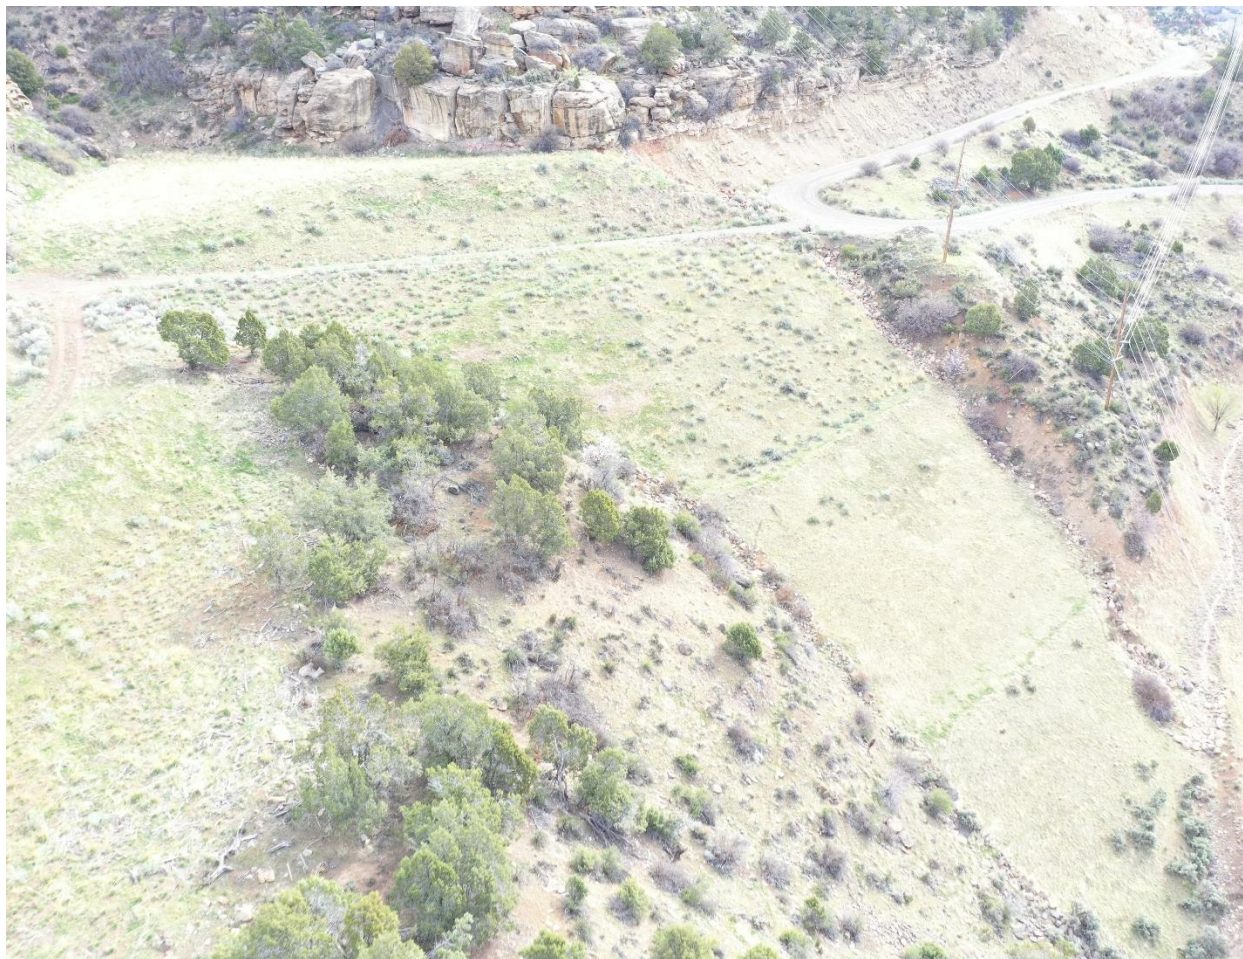
The West Valley Fill and the II West Valley Fill were both inspected using a drone. Although the images are a little over-exposed, both fills appeared to be stable and well vegetated.

Figure 8: West Valley Fill

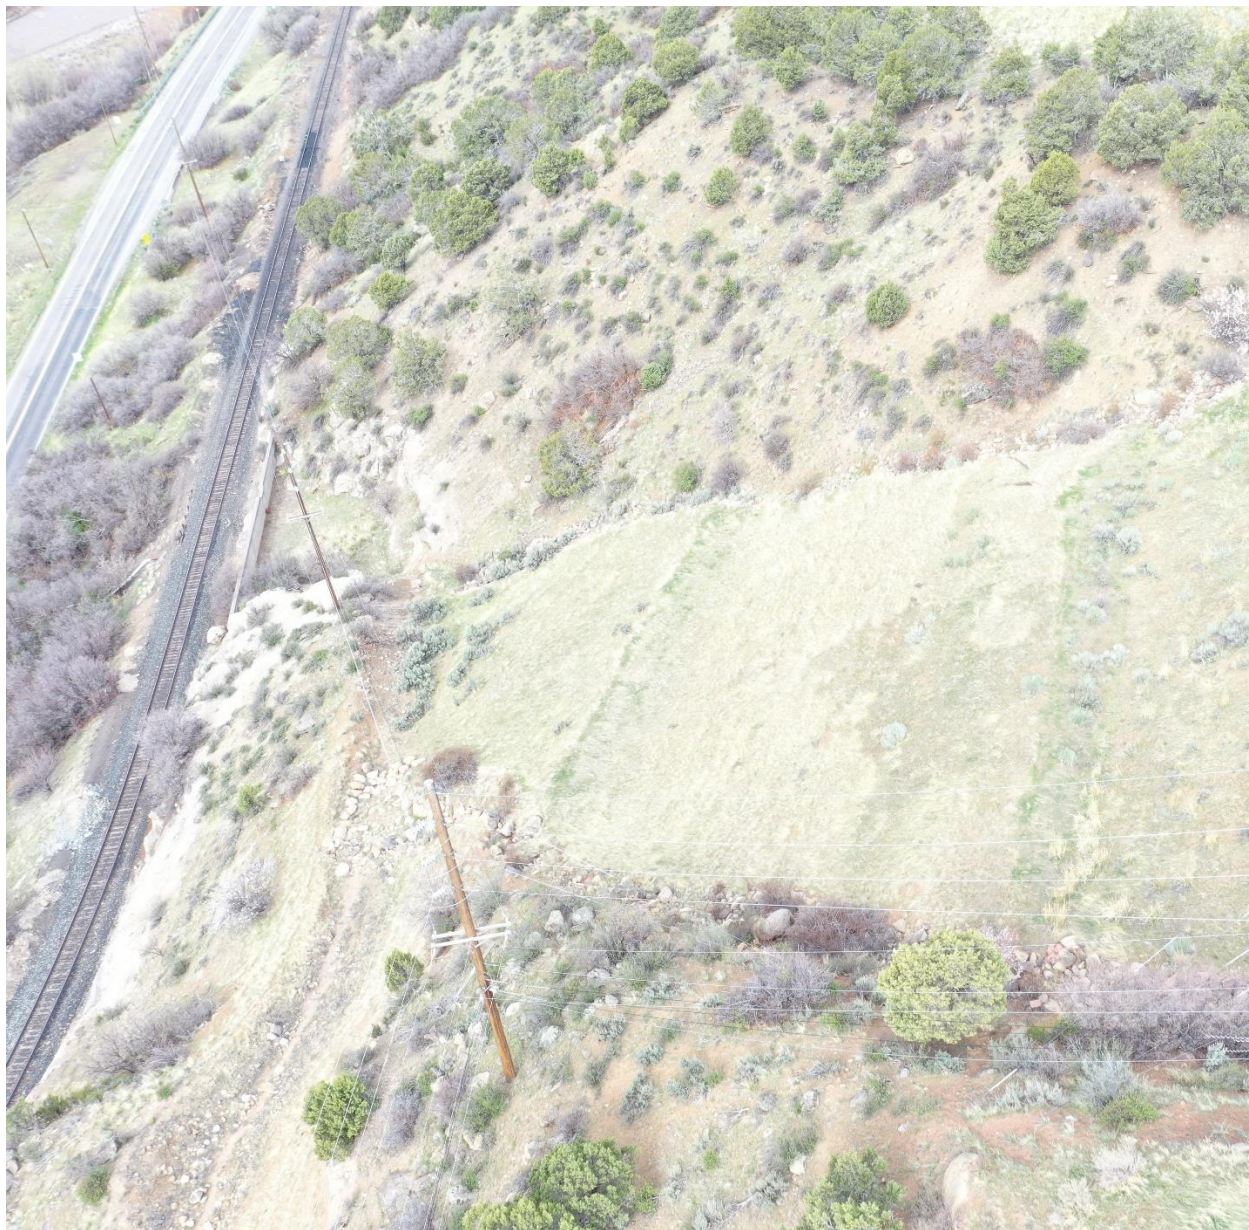
Both ponds C and E were dry.

Figure 9: Lower part of West Valley Fill, and Pond C

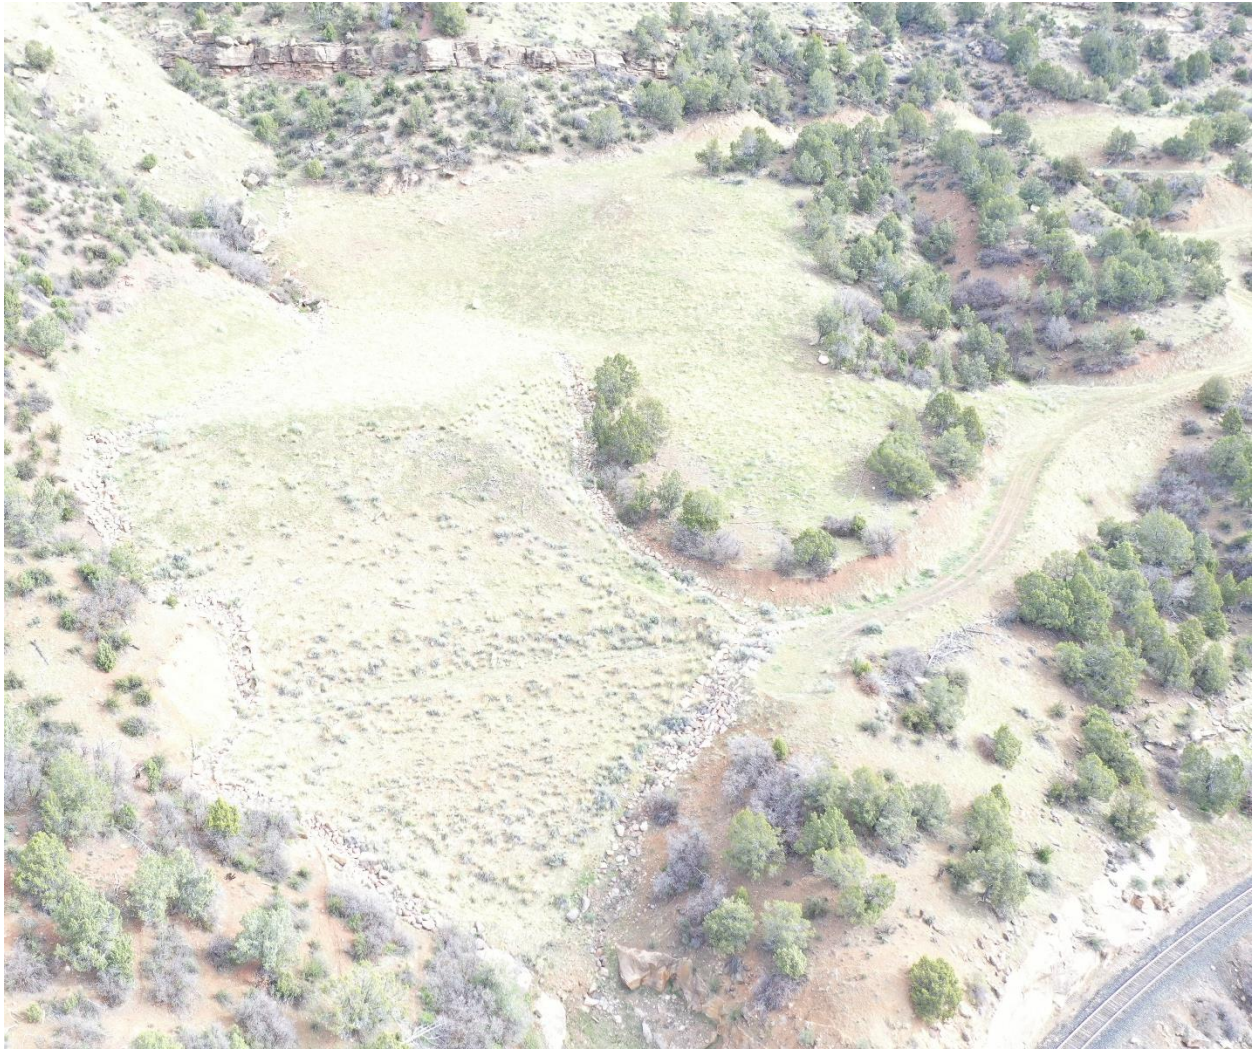
Figure 11: II West Valley Fill

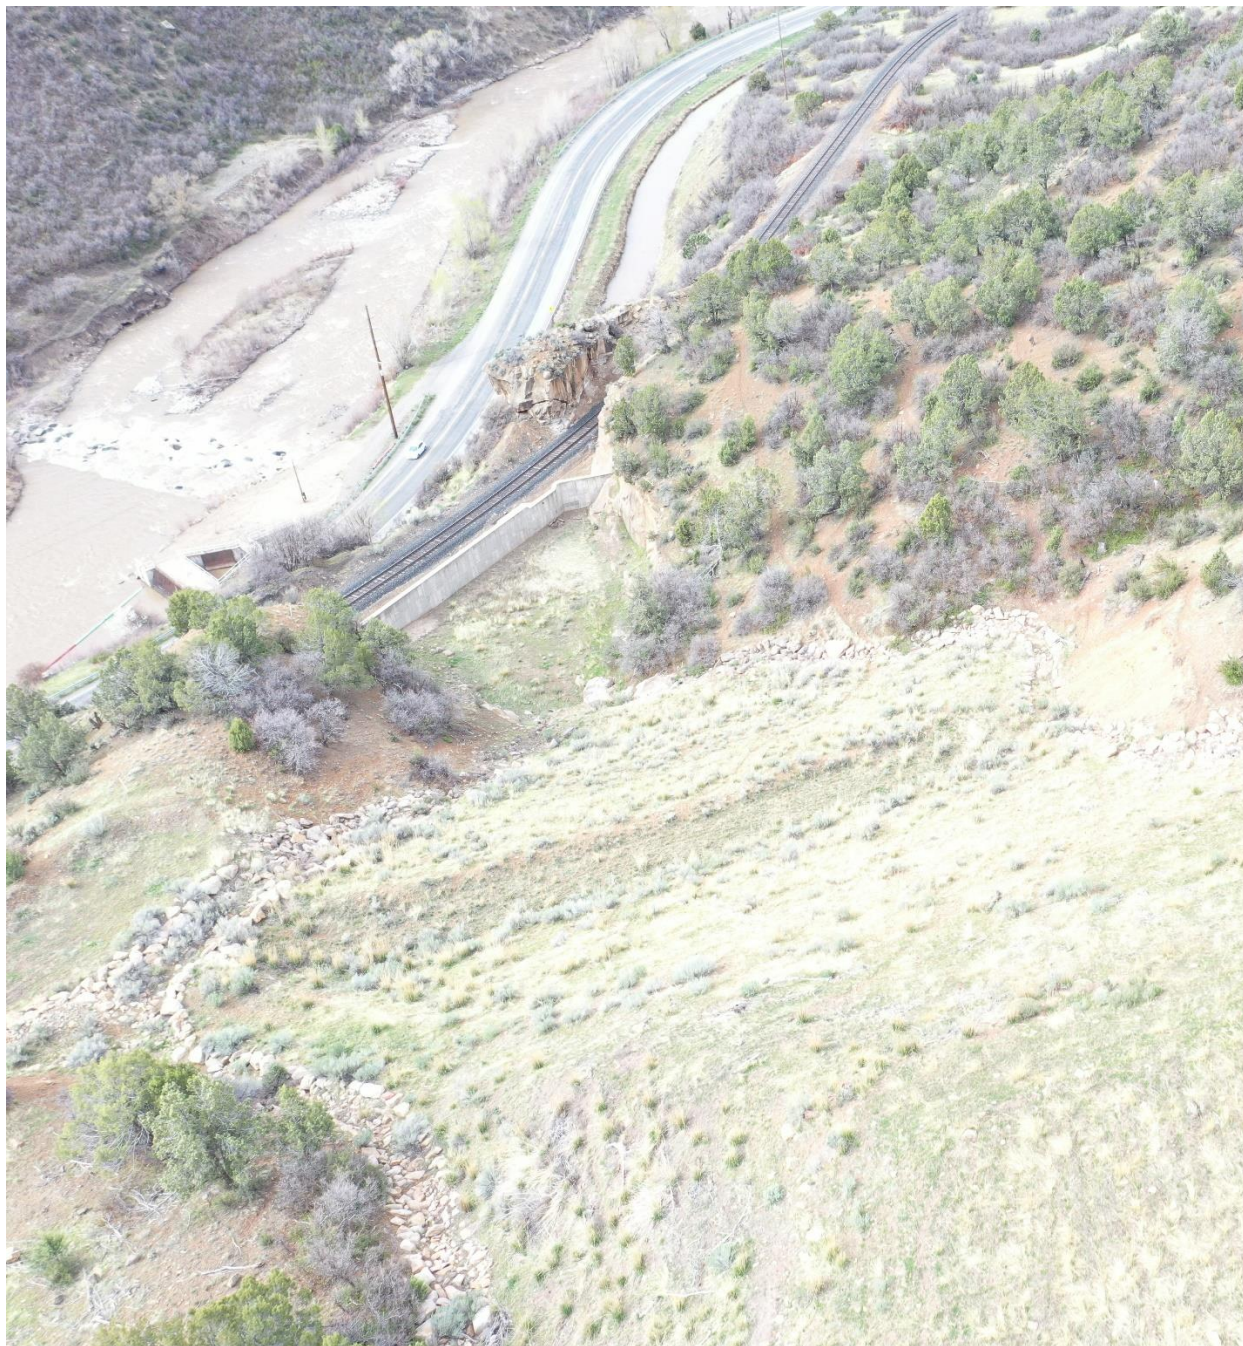
Figure 12: Lower section of II West Valley Fill, and pond E
