## Inspection April 2024

Please find the 2024 April DRMS inspection report for Trapper Miine. This was a partial inspection

**23 April 2024**

Permit Number: C1981010 Mine Name: Trapper Mine Operator: Trapper Mining, Inc. Operator Address:  Mr. Graham Roberts P.O. Box 187 Craig, CO 81626	County: Moffat Operation Type: Surface Permit Status: Active Ownership: Federal
	Operator Representative Present: Tim Cummins
This report was issued electronically from the Divisions' Denver Office.

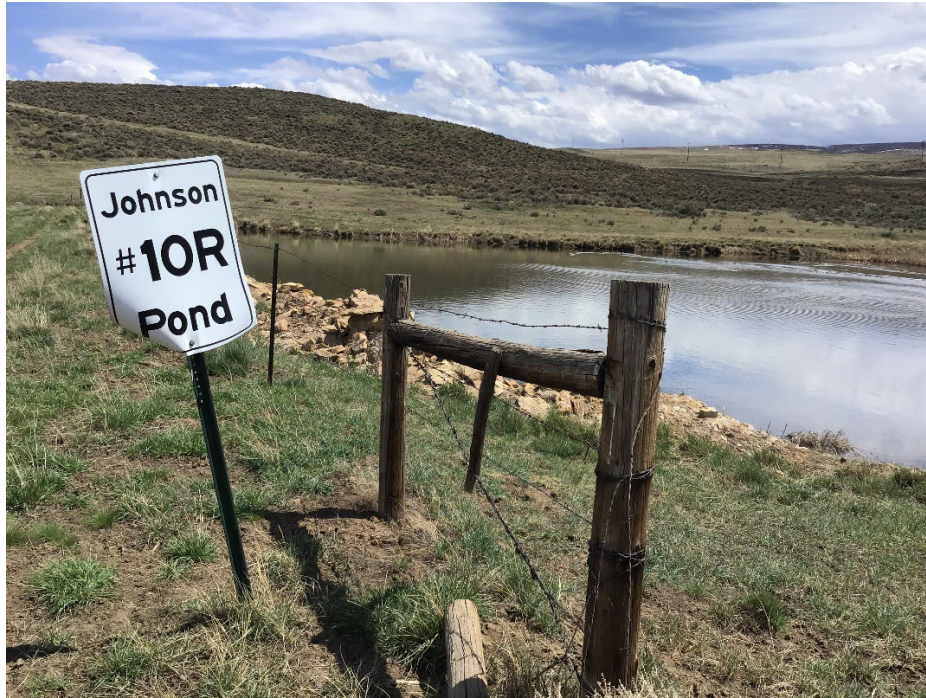
1. Johnson #10 discharging clearwater.
2. No Name #2 exhibits a large sediment fan. Spoil is piled above the pond.
3. No Name #4 was full and discharging a trickle of clearwater through the decant culvert.
4. No Name #5 was discharging through the flume. Algae was present in the stagnant water on the outlet side. Grasses were present in the outlet side drainage way. Removing grasses could increase flow and prevent algae growth early in the season.
5. East Payette #1 was discharging clearwater. A delta was present at the inlet at the time of inspection. Payette ponds #2 and #3 appeared full.
6. Middle Flume #3 was full and discharging clearwater. The pond exhibited a significant delta at the inlet.
7. East Flume appeared dry at the time of inspection.
8. East Middle Flume #1 was holding water and discharging. A delta was present.

*Photo 1: Johnson #10 Pond.*

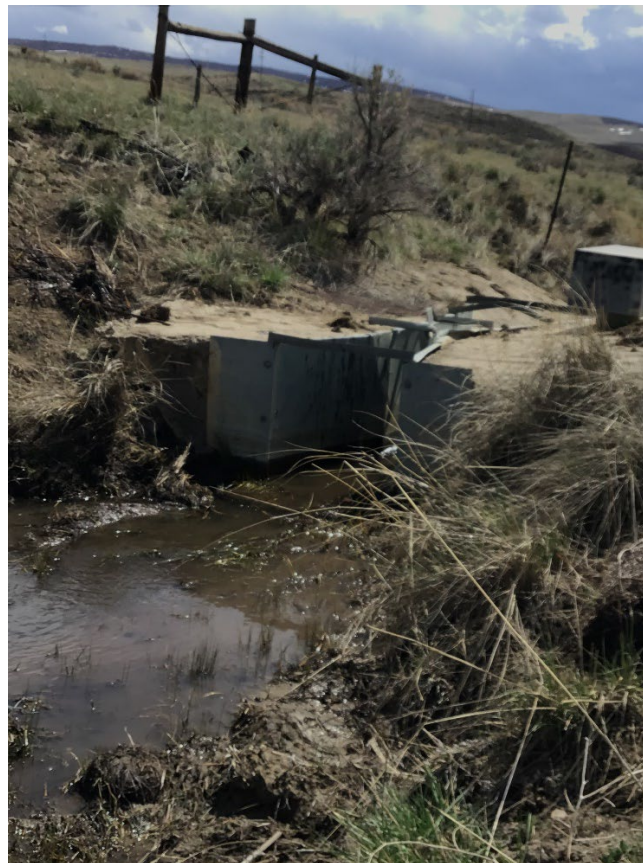
*Photo 2: Flume in Johnson #10 Pond.*

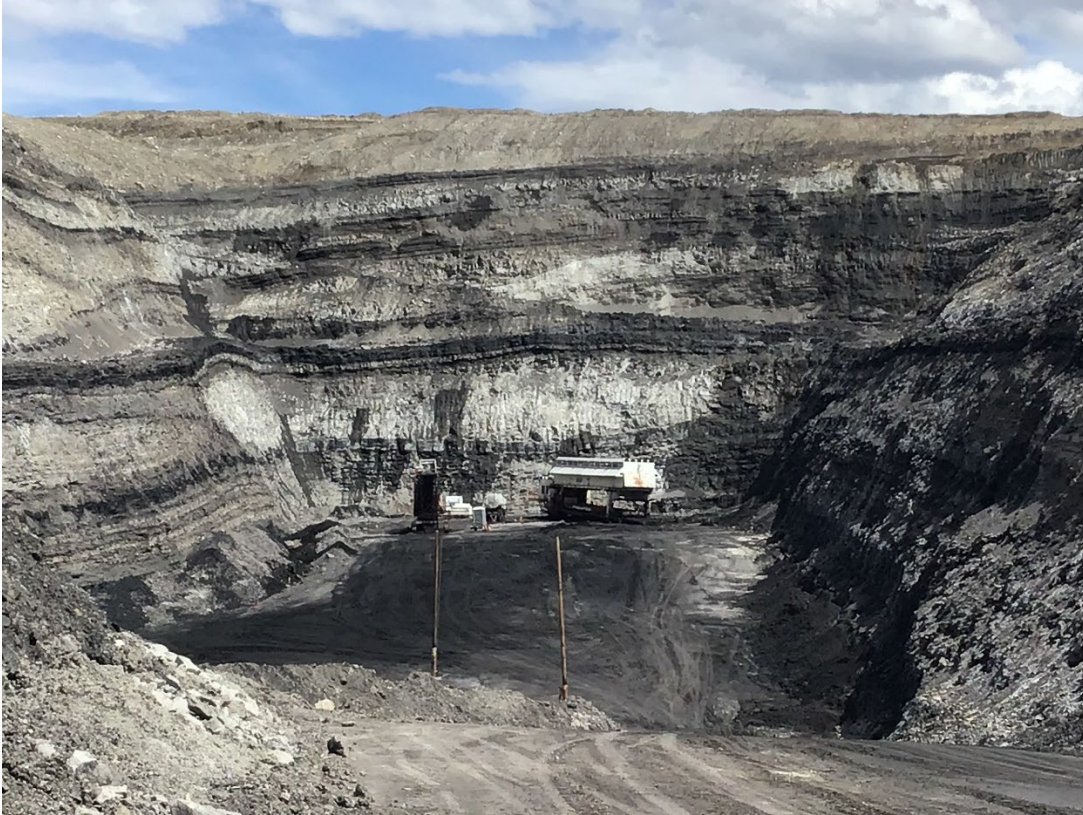
***Photo 3: Highwall miner (idle) in N Pit, looking east.***

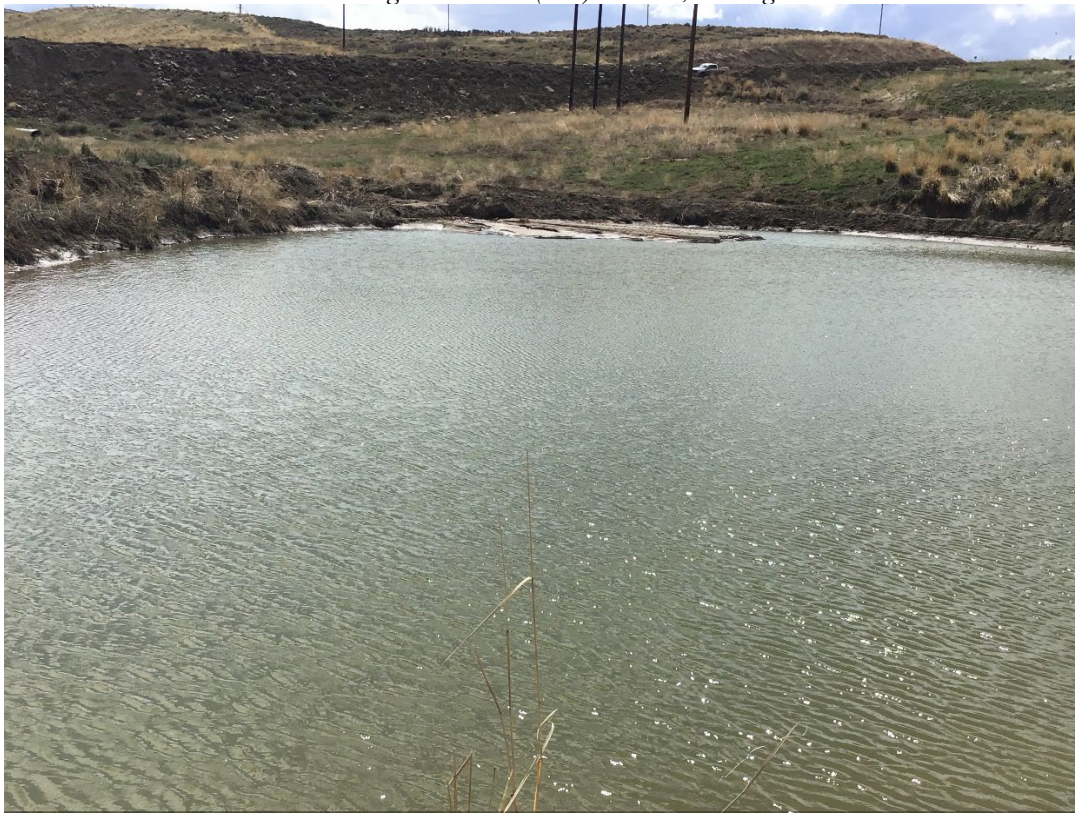
***Photo 4: East Pyeatt #1 Pond, looking southeast.***

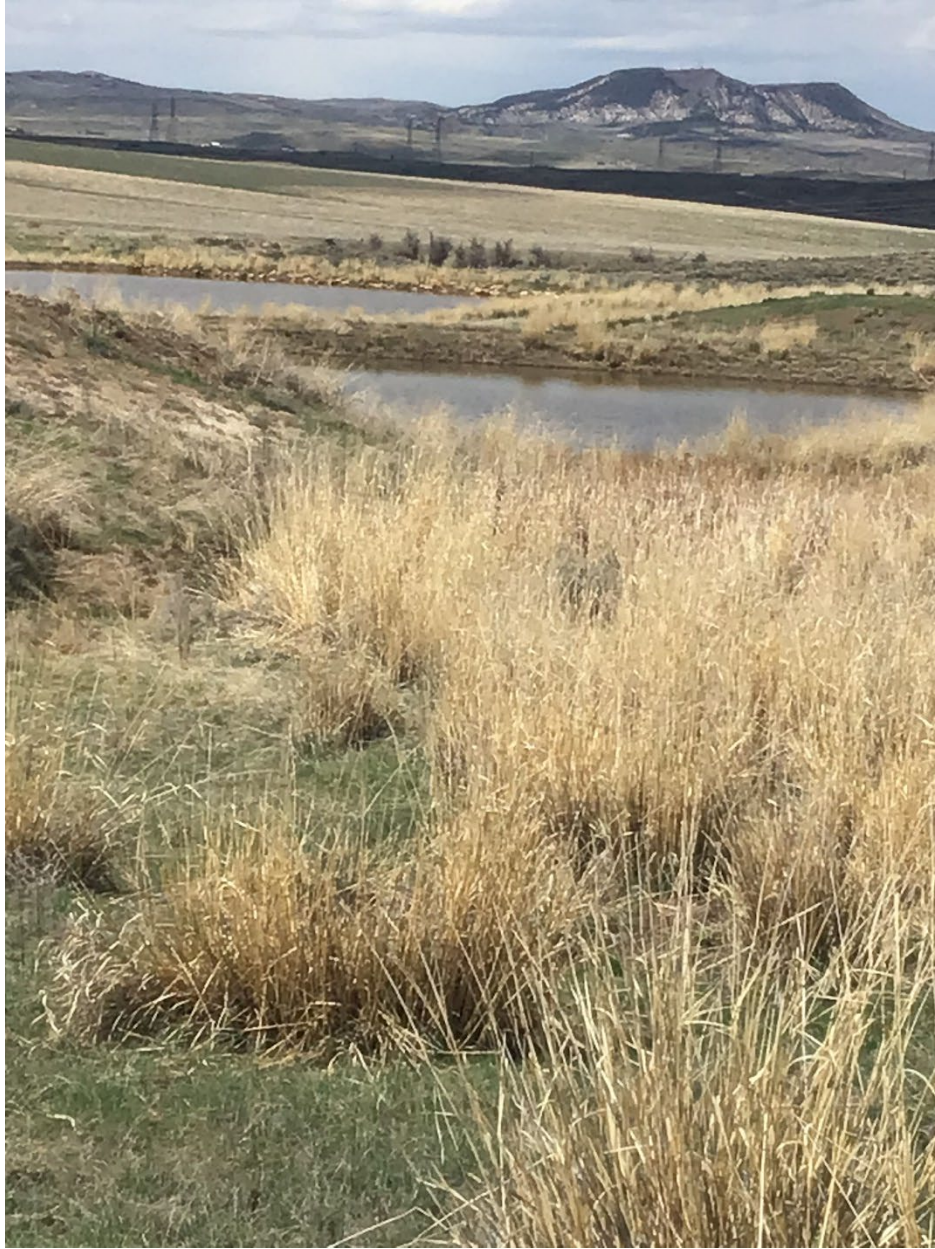
***Photo 5:*** East Pyeatt Ponds #2 and #3, looking north.

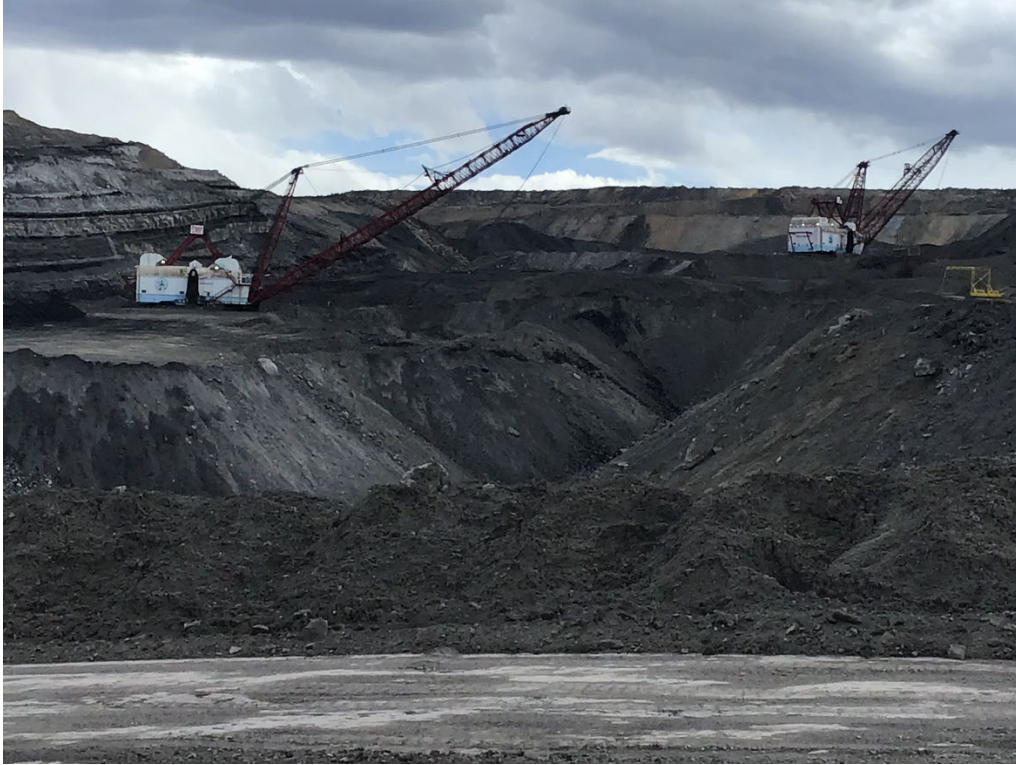
The Queen Anne dragline in the west panel remains under repair. The Baby Doe and Molly Brown draglines in L Pit were idle at the time of inspection. A shot in J Pit West had been laid out. N Pit is idle as the crew is on their off rotation for the next 10 days. The west haul ramp into the N Pit is complete. All the highwall miner openings are backfilled. The Ash Pit comprised loose ash piled around the perimeter of the flat surfaces. Operators are in the process of dozing off the piles to the desired final elevation. The flat surfaces of the Ash Pit were dry and firm, with no standing water or ruts and appeared to be functioning adequately at the time of inspection.

*Photo 6: Drag lines stationed in the L pit, looking south.*

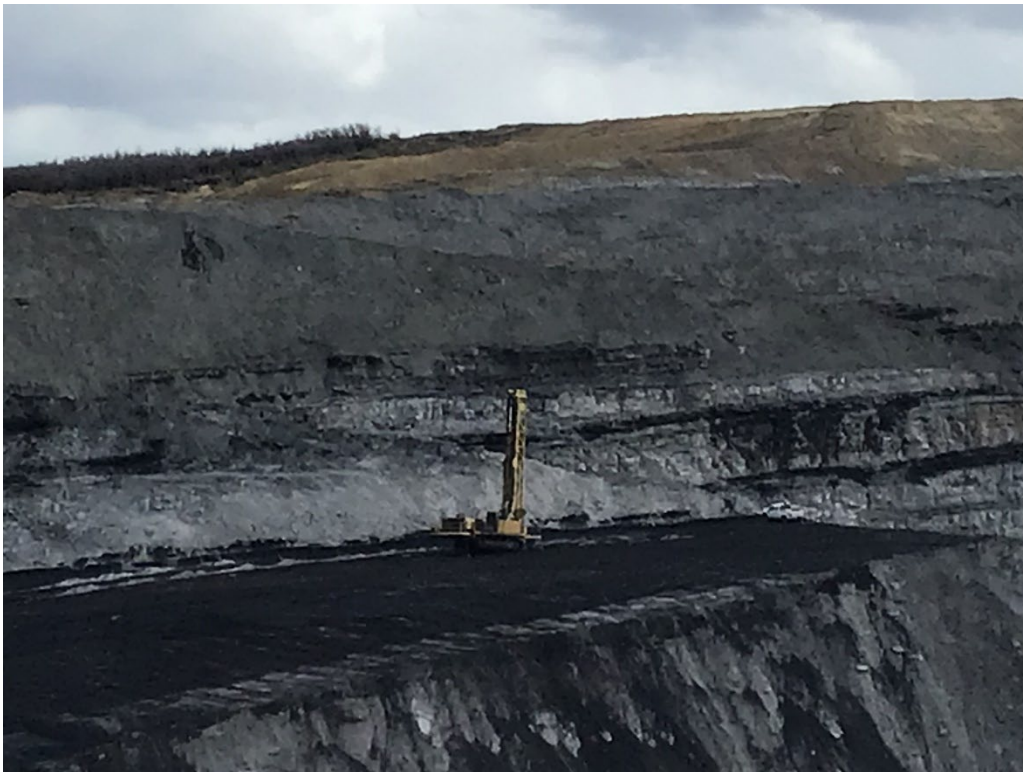
- Blasts were being prepared in L and J Pits.

*Photo 7: Blasting equipment preparing a blast in L pit, looking south.*

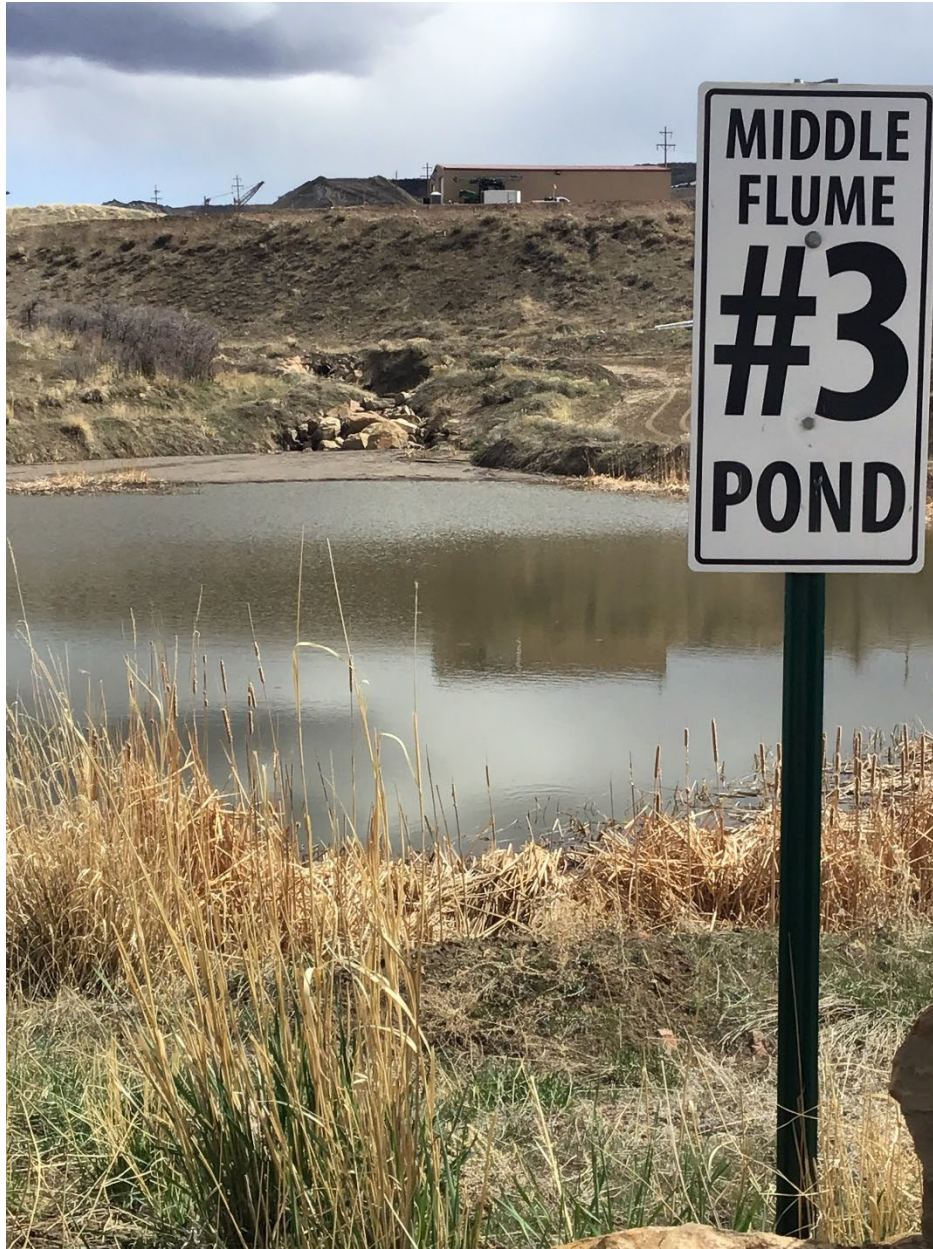
*Photo 8: Middle Flume #3 Pond, looking south.*

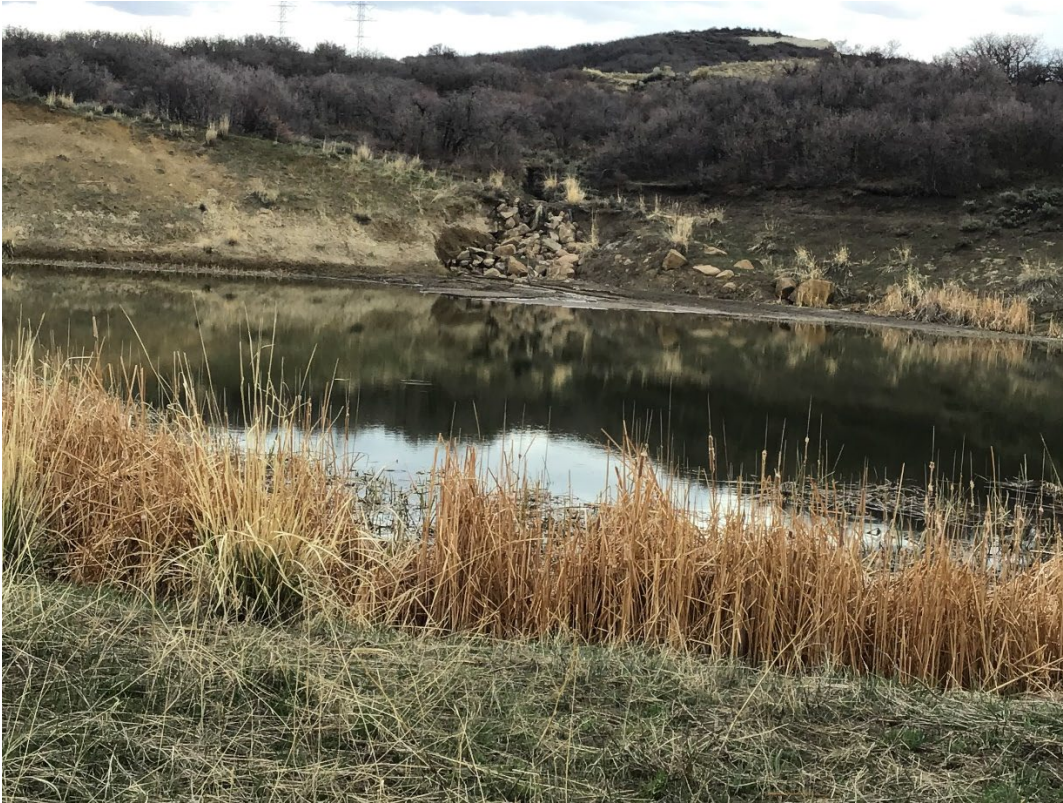
**Photo 9:** East Middle Flume #1 Pond, looking southeast.

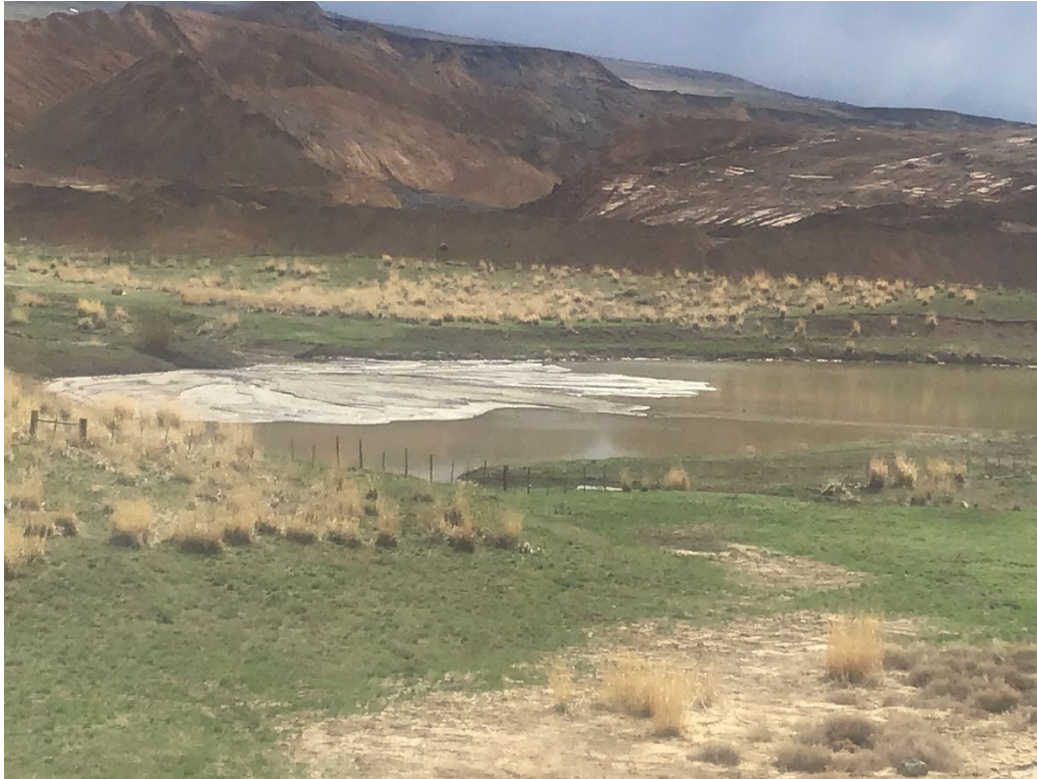
**Photo 10:** No Name #2 Pond looking south.

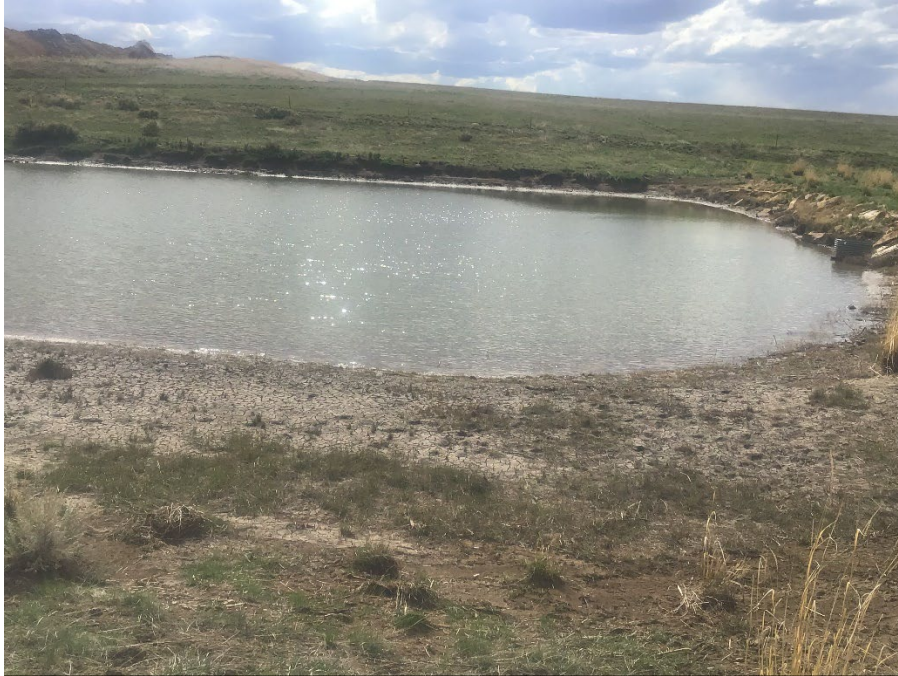
***Photo 11: No Name #4 Pond, looking north.***

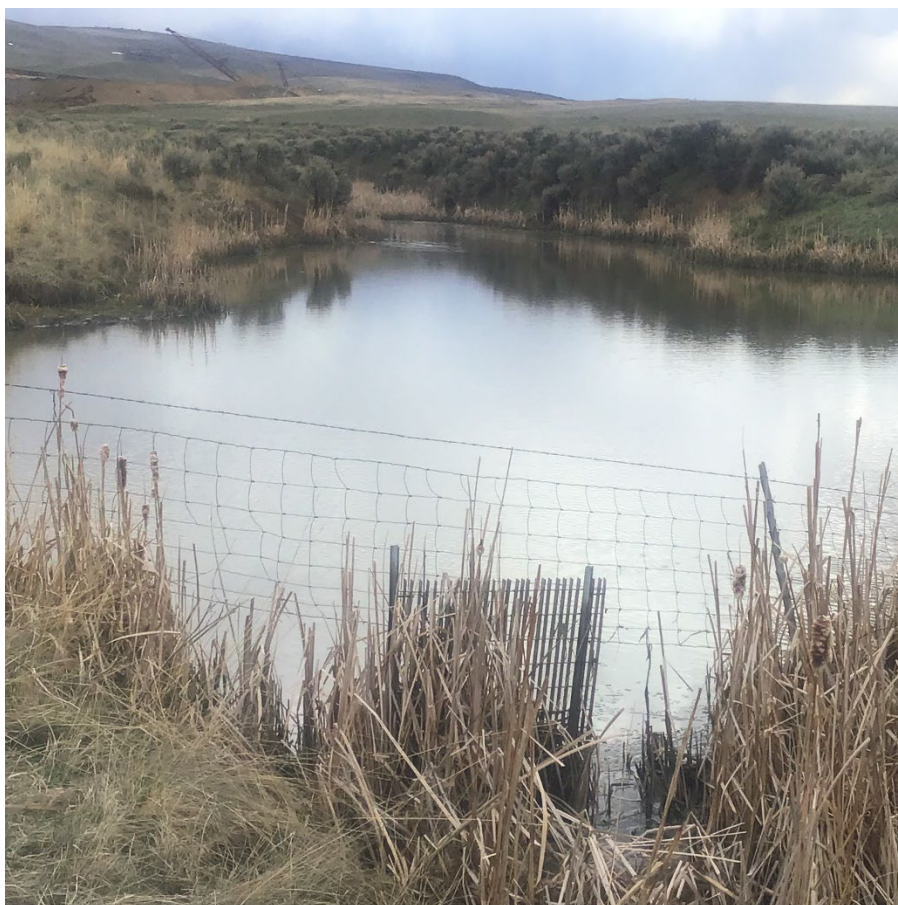
***Photo 12: No Name #5 Pond, looking west.***

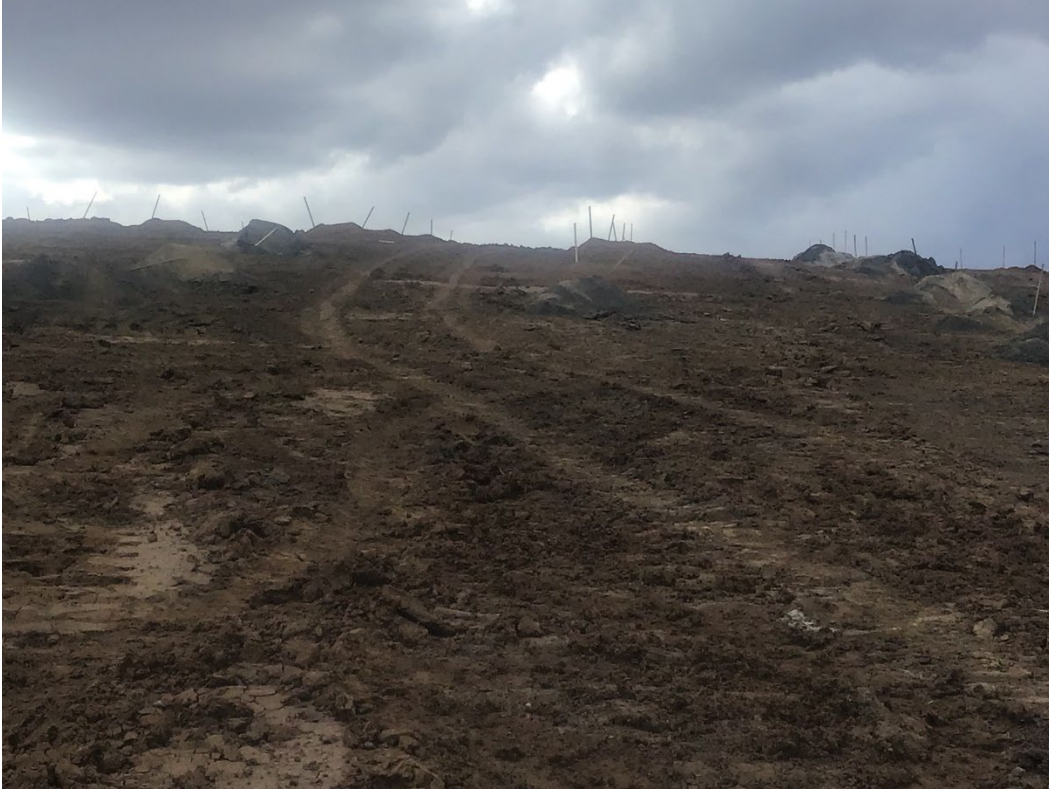
***Photo 13:*** Blast prepared in J Pit West, looking west.

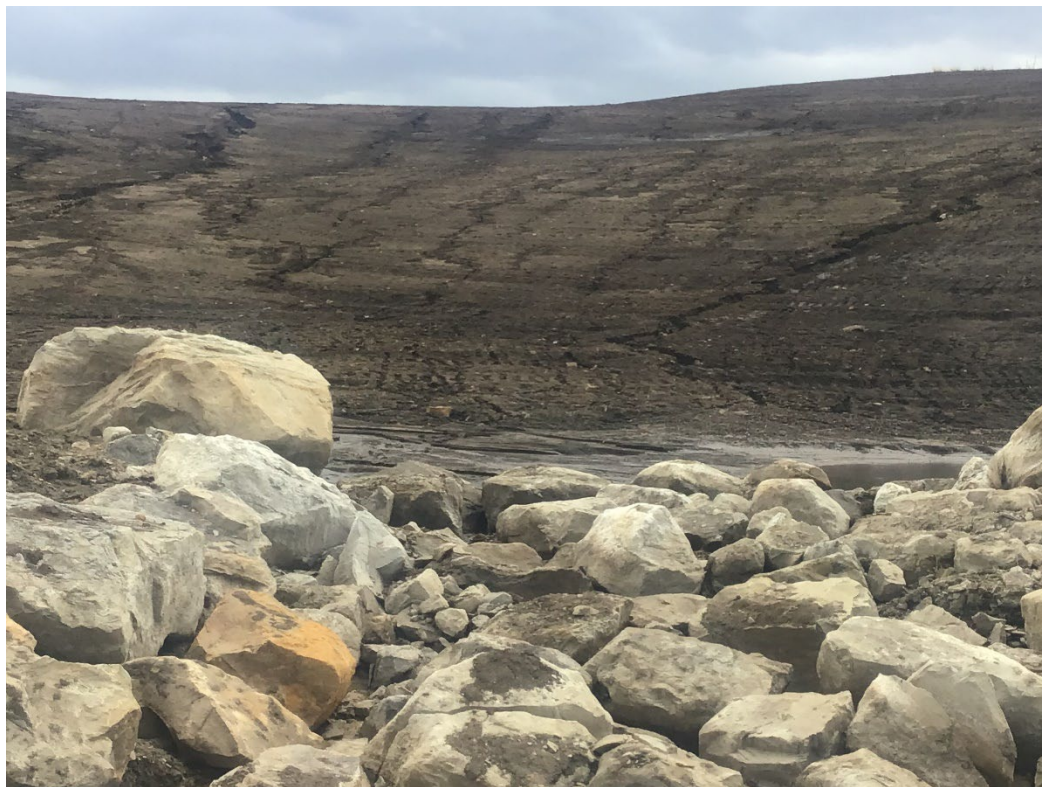
Constructed drainages in K pit and D Pit appeared to require repairs, as gullies had deepened, and rocks were dislodged from check dams. Rills were present along west and north facing hill slopes in K pit as well as in D Pit. These should be graded out as hillslopes dry this spring.

***Photo 14:*** Rills on northwest facing slope of D Pit.

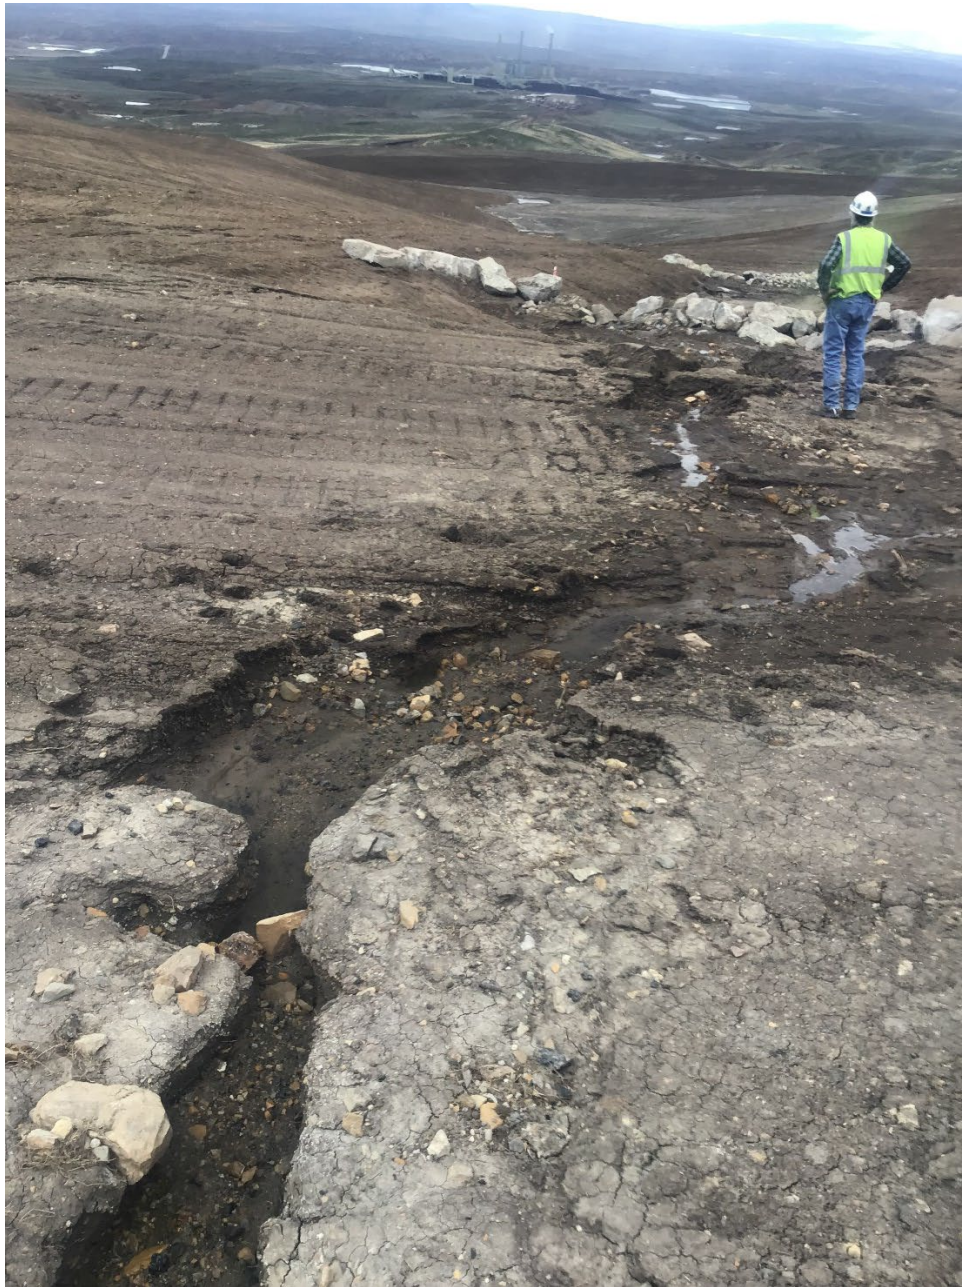
*Photo 15: Constructed drainage in D Pit, looking north.*

*Gully and rill maintenance in constructed drainages*
