DRMS Inspection Report

MINERALS PROGRAM INSPECTION REPORT
PHONE: (303) 866-3567

MINE NAME: Prock Gravel Pit	MINE/PROSPECTING ID#: M-2024-010	MINERAL: Sand and gravel	COUNTY: Delta
INSPECTION TYPE: Illegal(Unpermitted Operation)	WEATHER: Clear	INSP. DATE: April 9, 2024	INSP. TIME: 08:45
OPERATOR: Delta County	OPERATOR REPRESENTATIVE: Zach Prock	TYPE OF OPERATION: ILL - Illegal	
REASON FOR INSPECTION: Citizen Complaint	BOND CALCULATION TYPE: None	BOND AMOUNT: NA	
DATE OF COMPLAINT: NA	POST INSP. CONTACTS: None	JOINT INSP. AGENCY: None	
INSPECTOR(S): Robert Zuber, P.E.	INSPECTOR'S SIGNATURE:

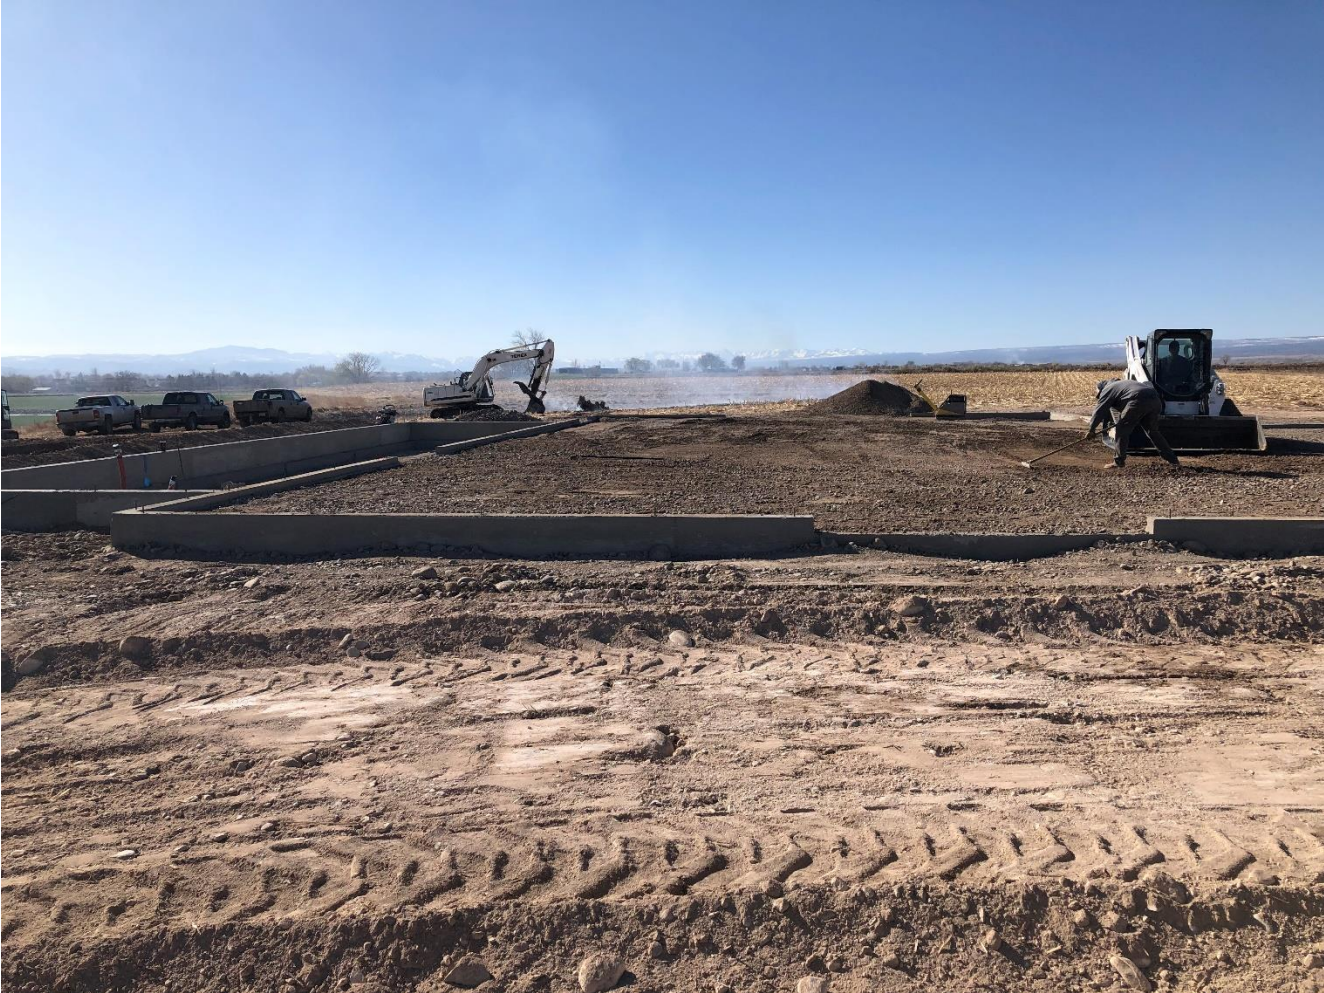
The construction area was seen south of the soil piles. Several workers were onsite constructing a foundation that is approximately the size of a large single-family home (as stated before, it will be a wedding venue). The equipment onsite (next to the construction area) was the loader, a motor grader, a skid steer, and two small excavators.

Construction area, with brush burning in background

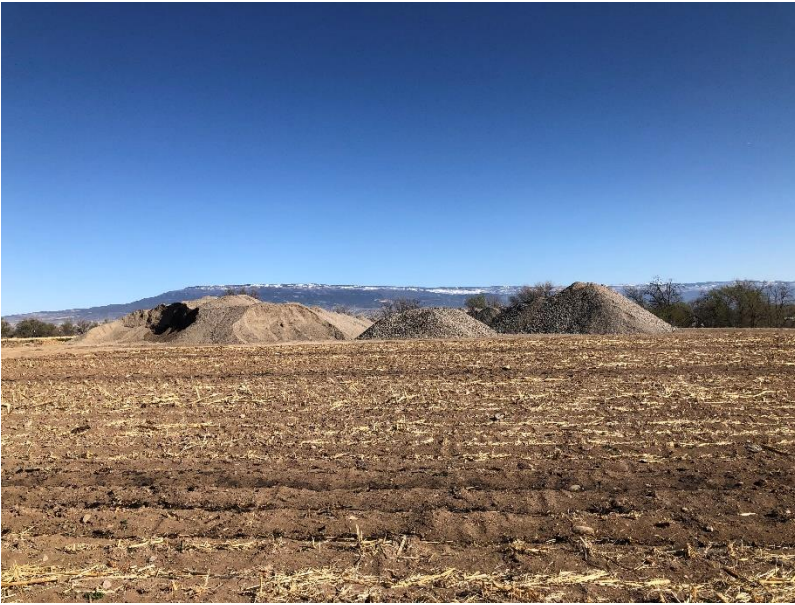
- A pile of unprocessed material was next to the pit. Its measurements were estimated as 20 feet by 80 feet and eight feet high.
- Several soil piles were seen, most were approximately the same size as the pile by the pit. One was significantly larger.
- A large rock pile was measured to be 25 feet by 75 feet and eight feet high.
- Two smaller rock piles were seen, each approximately half the size of the large rock pile.

It appears that the volume of material in the piles is smaller than the volume of the pit. The exact amount was not calculated, but it appears that the majority of the extracted material remains onsite.

Soil and rock piles, looking north from construction area

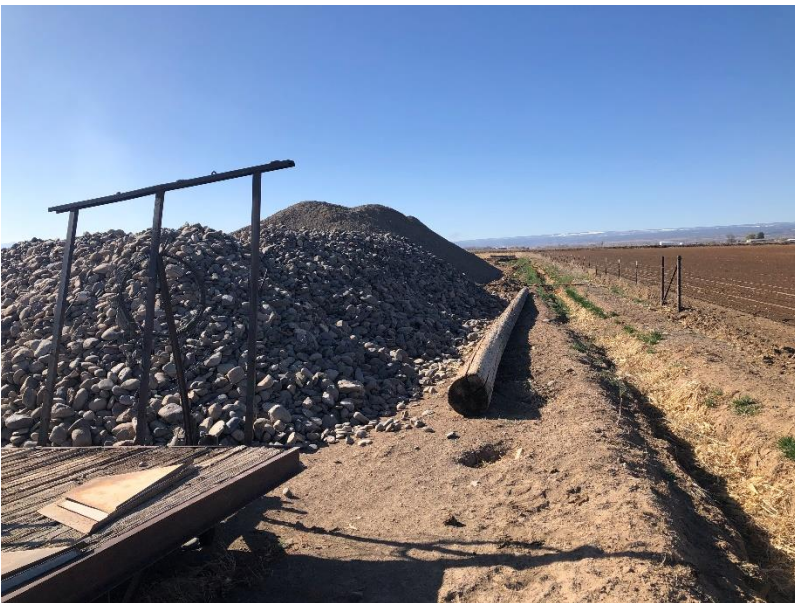
There are no receiving waters near the site, other than a small, poorly defined ditch approximately 150 feet from the pit (it is apparently a tailwater ditch for the pastures in the area). No impacts on the ditch were detected.

Rock pile along west side of site (note berm between piles and irrigation ditch)

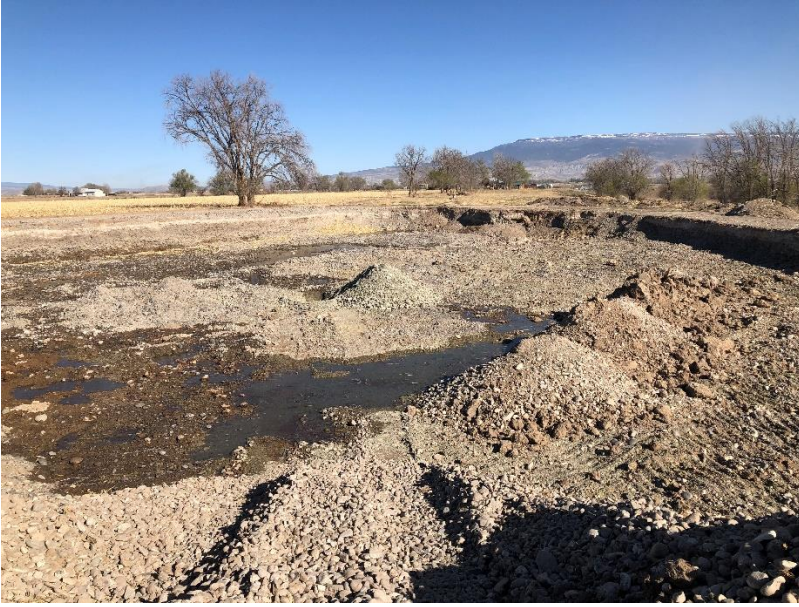
A rectangular pit was measured with a laser instrument (aka rangefinder), and the average depth was approximately 10 feet. The deepest portion of the pit was no more than 12 feet. A small amount of water was observed in the pit. Given the amount of water and the topography of the site, this water is not believed to be exposed groundwater. The width of the pit was estimated to be 150 feet, and the length was estimated to be 190 feet. No earth-moving equipment was present at the pit.

Pit, looking north

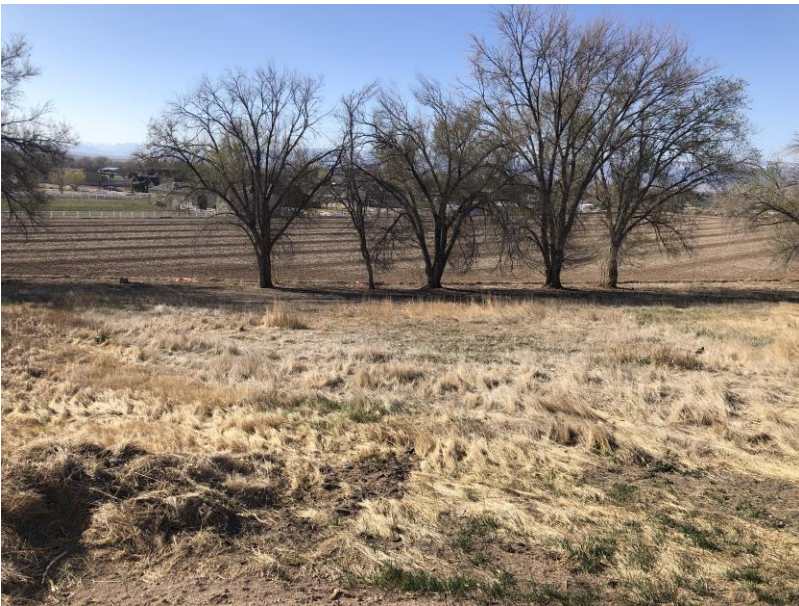
There was no indication that the pit or piles of soil and rock are negatively impacting the adjacent properties. There was no erosion on the hillside below the pit. There was no indication of significant sediment loading onto the adjacent farmland.

Slope below pit, looking northeast
