MINERALS PROGRAM INSPECTION REPORT
PHONE: (303) 866-3567

MINE NAME: Simla Highway Pit	MINE/PROSPECTING ID#: M-1995-095	MINERAL: Gravel	COUNTY: El Paso
INSPECTION TYPE: Preoperation Inspection	WEATHER: Clear	INSP. DATE: April 30, 2024	INSP. TIME: 10:00
OPERATOR: Hill Top Gravel LLC	OPERATOR REPRESENTATIVE: Blake Tope	TYPE OF OPERATION: 110c - Construction Limited Impact	
REASON FOR INSPECTION: Surety Related	BOND CALCULATION TYPE: Complete Bond	BOND AMOUNT: \$14,462.00	
DATE OF COMPLAINT: NA	POST INSP. CONTACTS: None	JOINT INSP. AGENCY: None	
INSPECTOR(S): Hunter Ridley	INSPECTOR'S SIGNATURE:

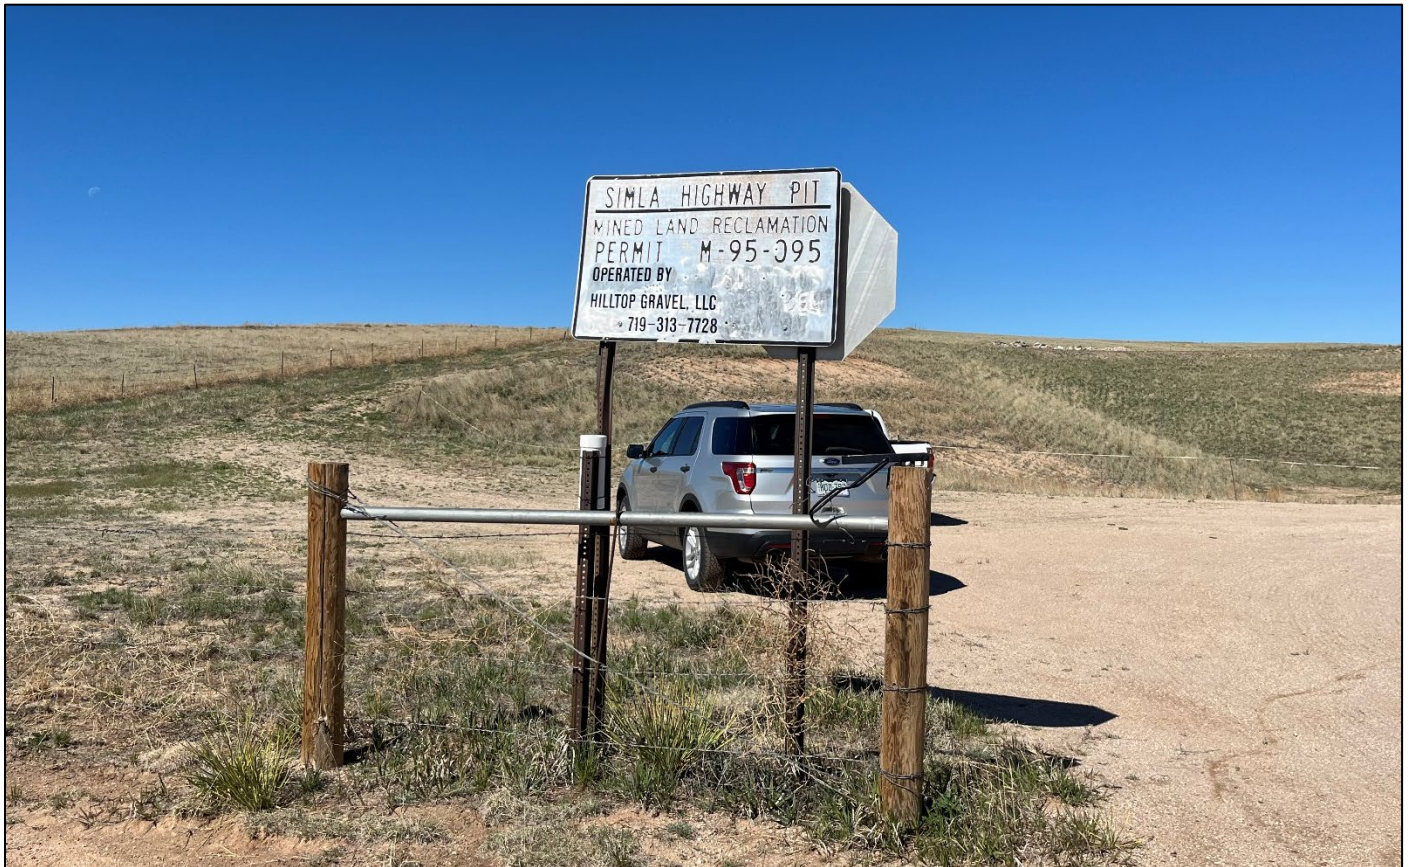
Signs and Markers: A mine sign was posted at the site entrance and contained all required information pursuant to Rule 3.1.12 (Photo 1). The two notice signs for the conversion application notice pursuant to Rule 1.6.2(1)(b) were also posted (Photo 2). The affected area boundaries were well marked with posts and fence lines. The proposed 40-acre boundary corners were also marked with t-posts. These corners were all checked via GPS and adjusted where necessary (Photo 5). The Operator is reminded that any disturbance outside the permitted 40 acres, even on land owned by the Permittee, is considered off-site damage and would be subject to enforcement action. As no buffer between mining activities and the permit boundary have been proposed, this is especially important to keep in mind.

Photo 1: Mine sign posted at the site entrance.

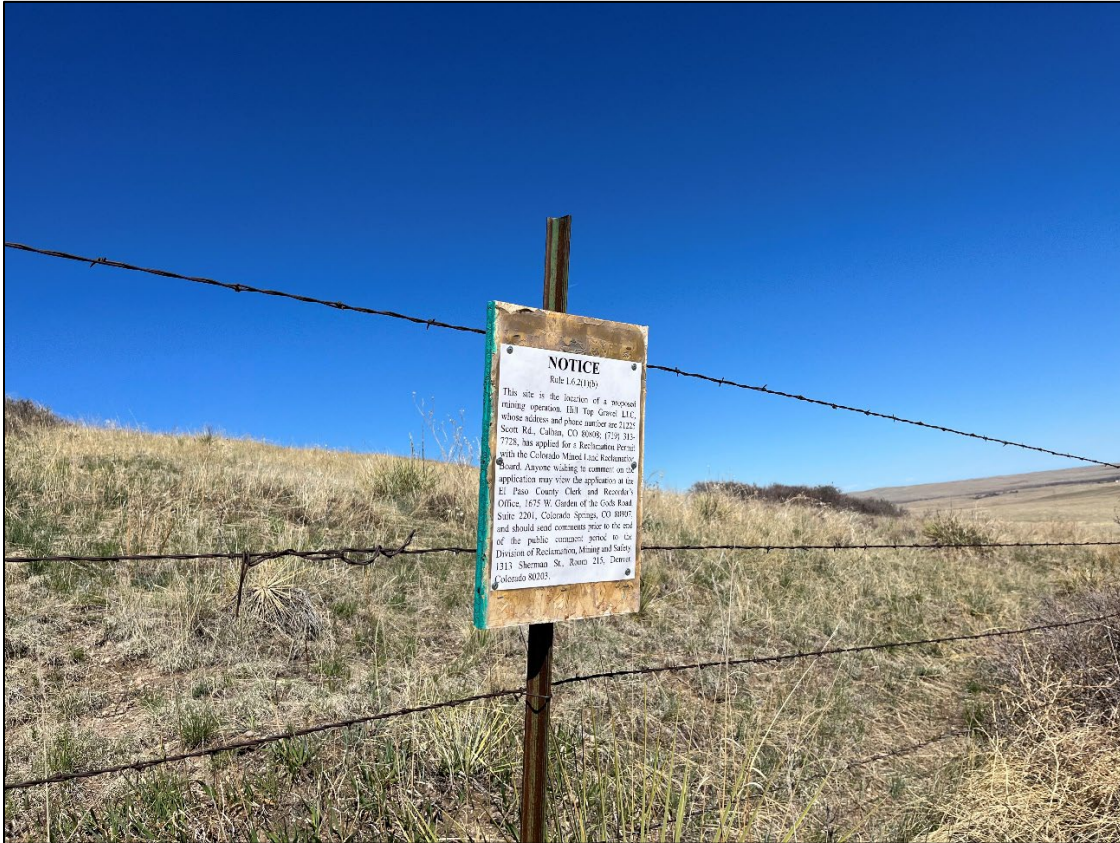
Photo 2: 112c conversion application notice signs posted.

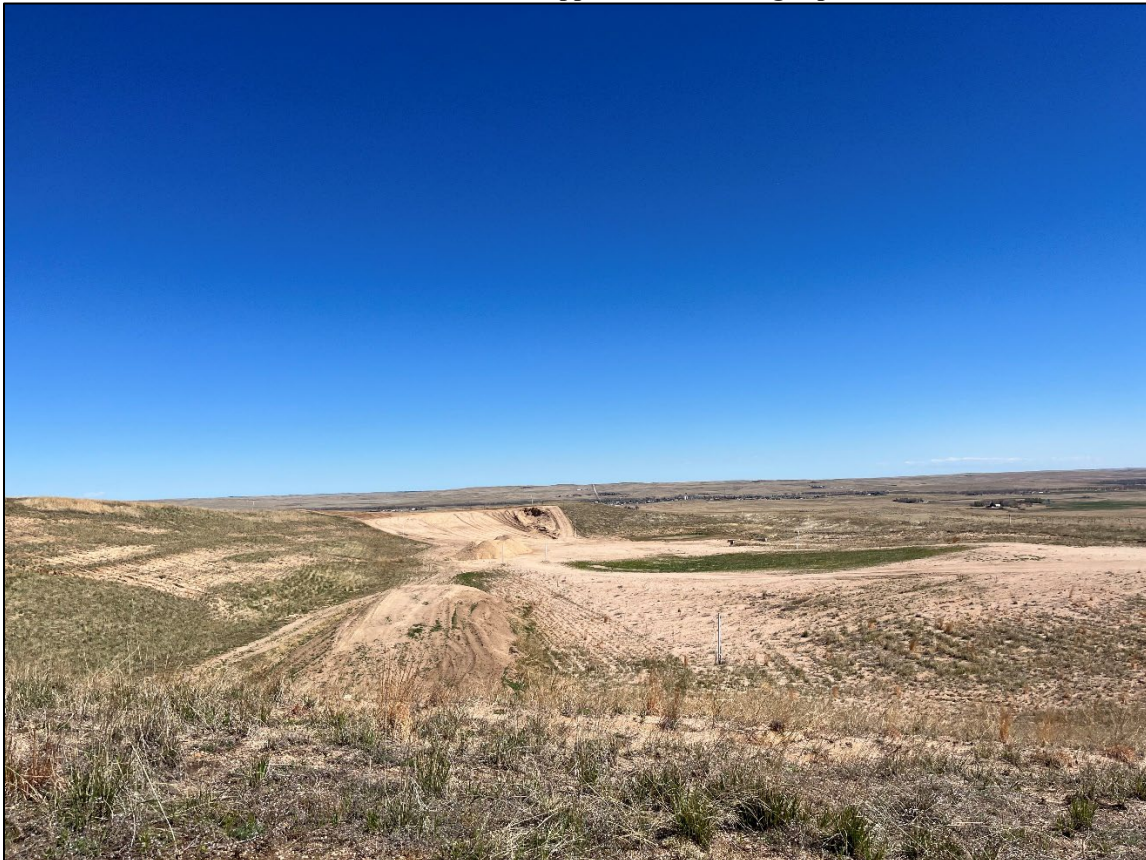
Backfilling and Grading: The proposed 112c permit conversion states that all mined slopes will remain at 3H:1V or flatter throughout mining. This alleviates the need for a bonding task to backfill or regrade highwalls for reclamation. The currently mined slope appeared to be at a 3H:1V slope (Photos 3, 8, and 10).

Topsoil: A topsoil stockpile is in the south end of the pit (Photos 3 and 10).

Photo 3: View north of the active 110 site, topsoil pile is in the foreground, the active mining slope is in the background.

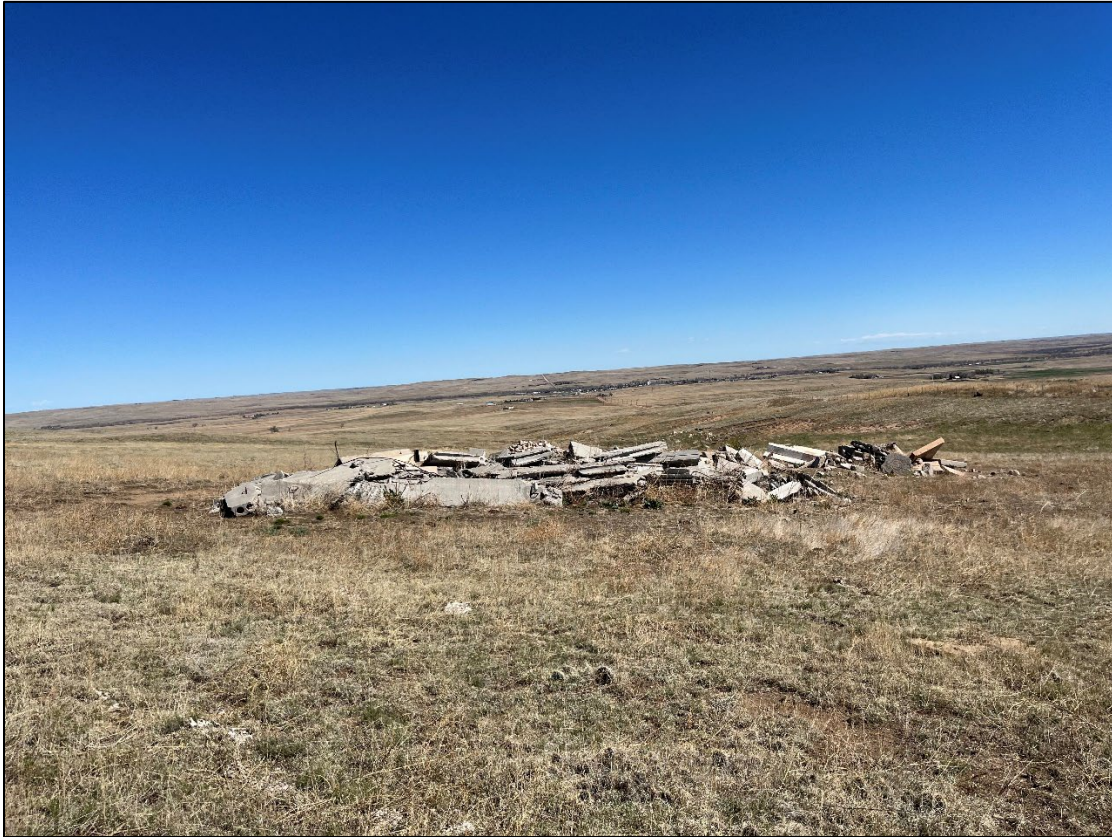
rubble was noted near the SW corner of the current 110c permit boundary (Photo 4). The maximum allowed disturbed area for the proposed 112c operation will be 40 acres, with 15 acres being bonded for initially in the first phase. The 112c operation will mine in a clockwise, 'S' shaped pattern, while slowly moving east to west. Contemporaneous reclamation will occur, but no acreage is planned to be formally released from the permit until the end of life of mine.

Photo 4: A small pile of scrap concrete is located near the southwestern corner of the 110c permit.

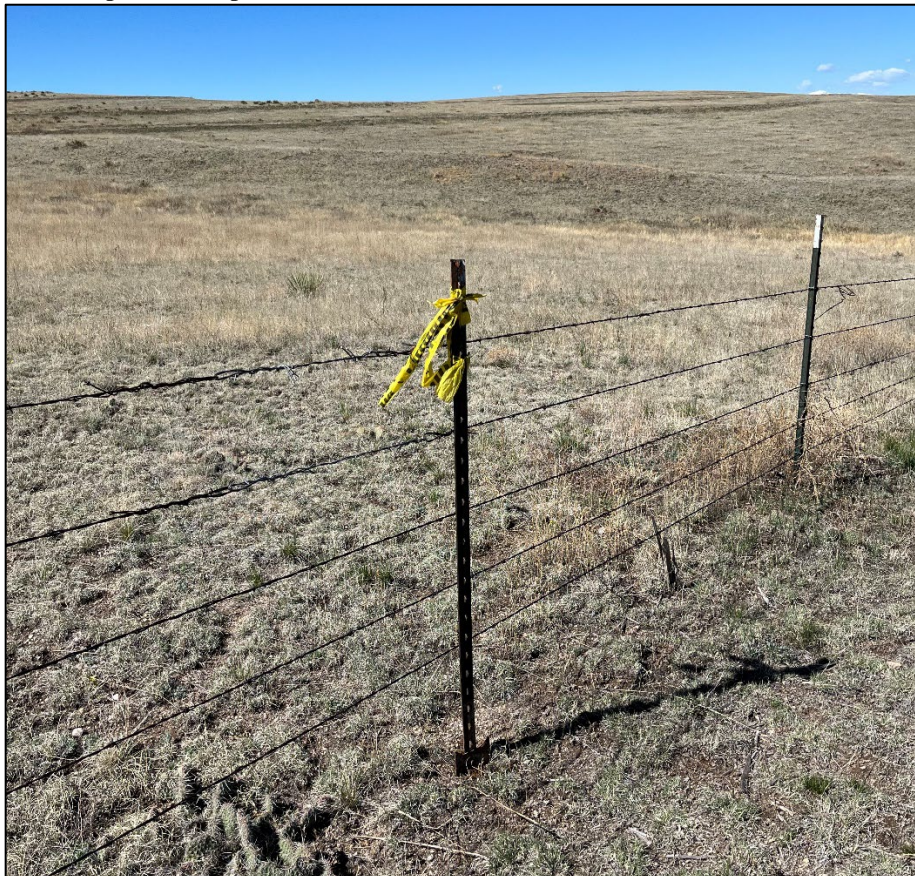
Photo 5: Example of a t-post used to mark the proposed 112c permit boundary.

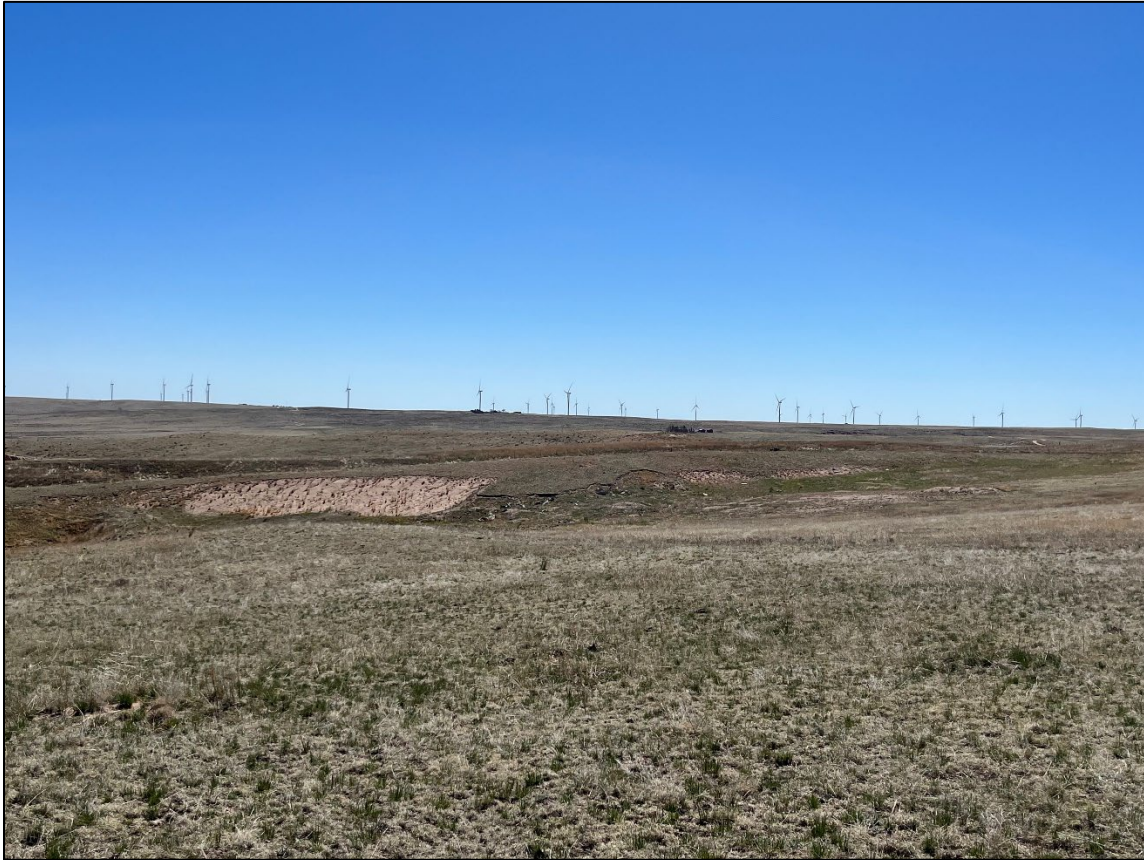
Photo 6: View east of the ephemeral drainage which bisects the proposed 112c permit acreage nearly in half.

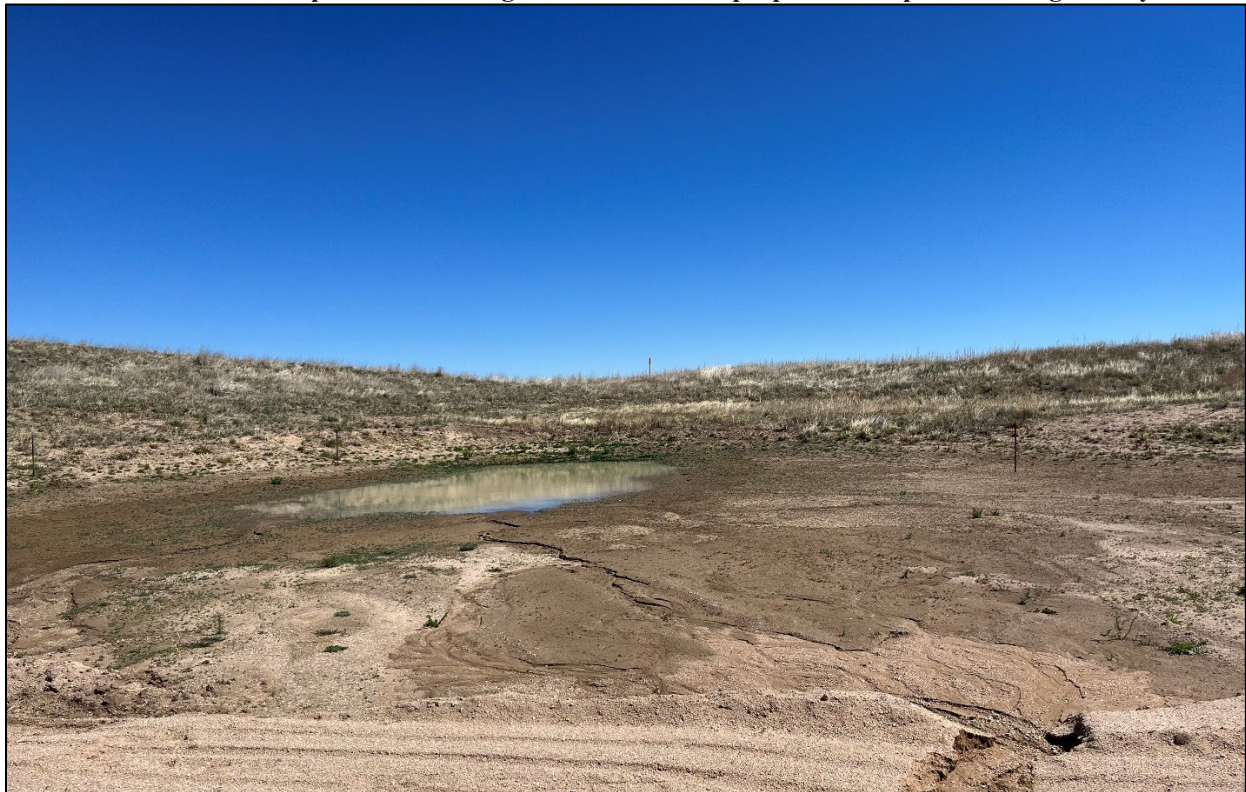
Hydrologic Balance: A small stormwater impoundment is located along the northeastern side of the current 110c permit. This impoundment appeared to be holding water and functioning, recent snowmelt and runoff was observed (Photo 7). This small impoundment will follow the path of mining as it progresses across the proposed 40 acres. No exposed groundwater and no excess erosion of the area was observed. A small ephemeral drainage is located in the middle of the proposed 112c permit boundary (Photo 6). This was not holding water at the time of inspection and is usually dry. No major erosion or bank cutting was observed.

Storm Water MGT Plan: No oil or fuel spills observed. Stormwater drains to the pit and infiltrates (Photo 7).

Photo 7: A stormwater impoundment is located along the permit's eastern edge.

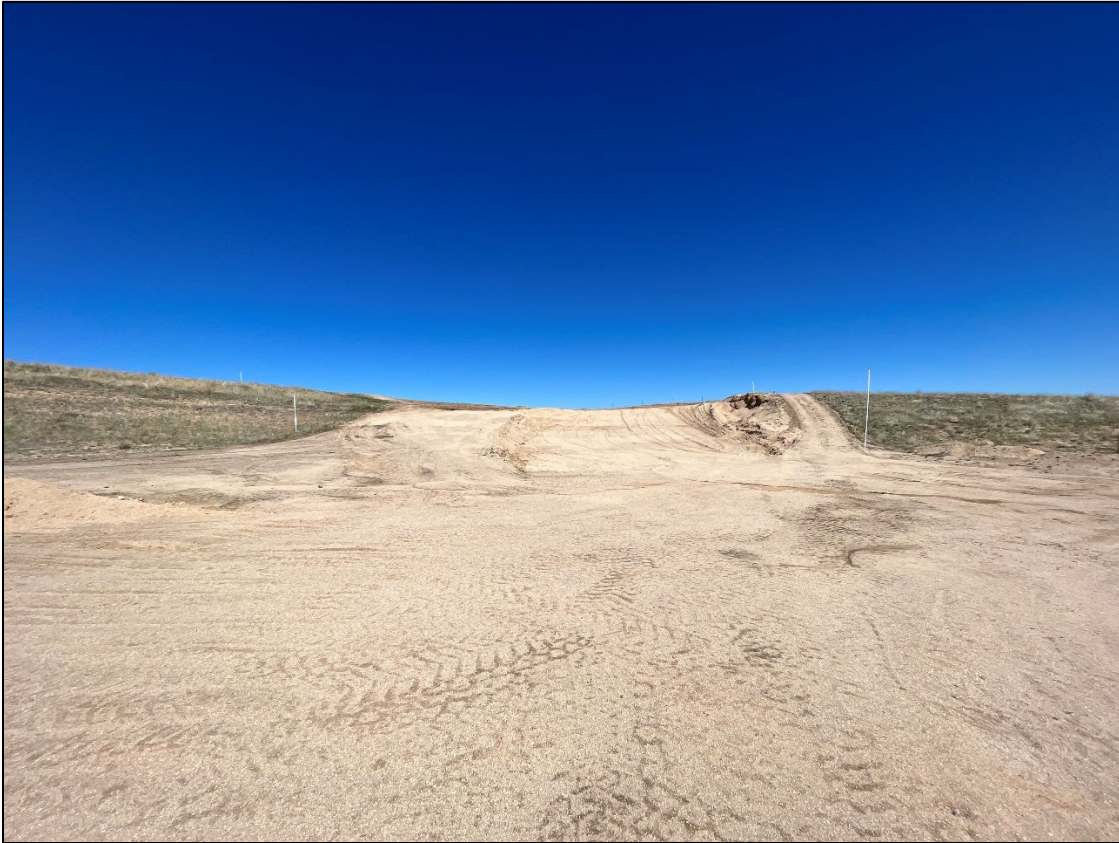
Photo 8: View north of the active mined slope.

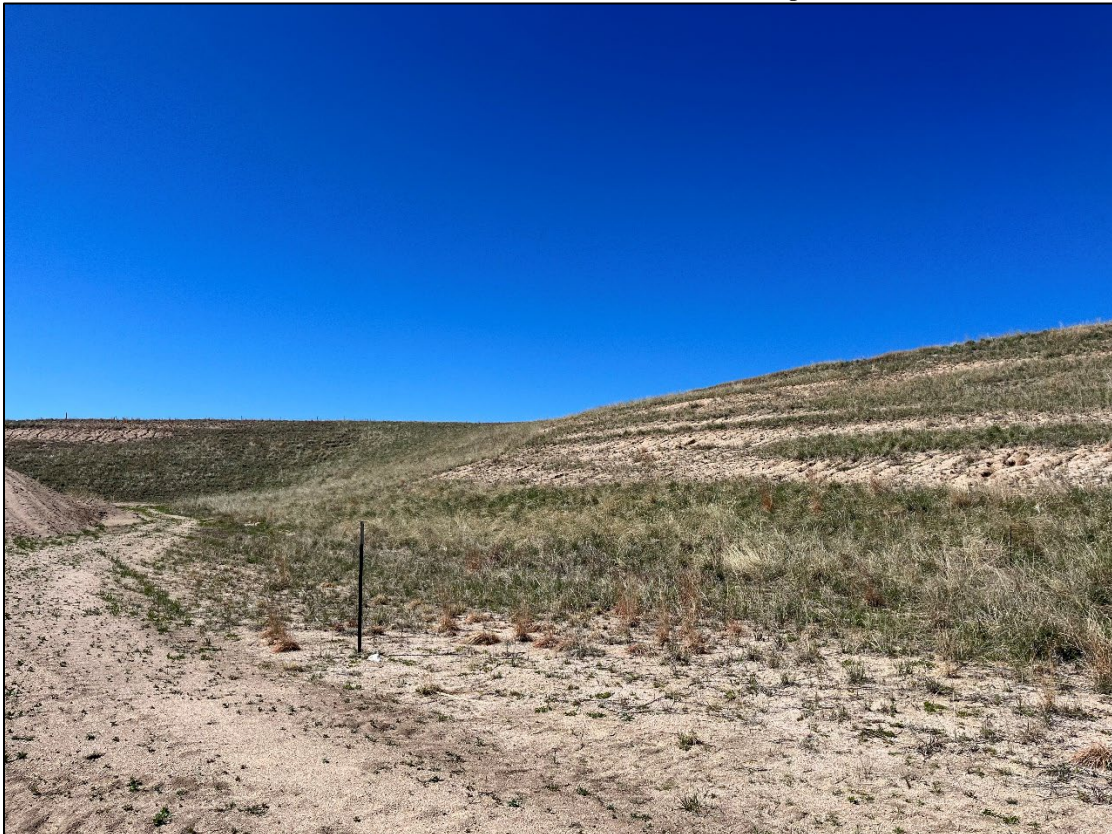
Sediment Control: Only minor erosion was observed (Photo 9) and no BMPs were needed at the time of the inspection.

Photo 9: Small erosion rills are present on the western and southern facing hillsides.

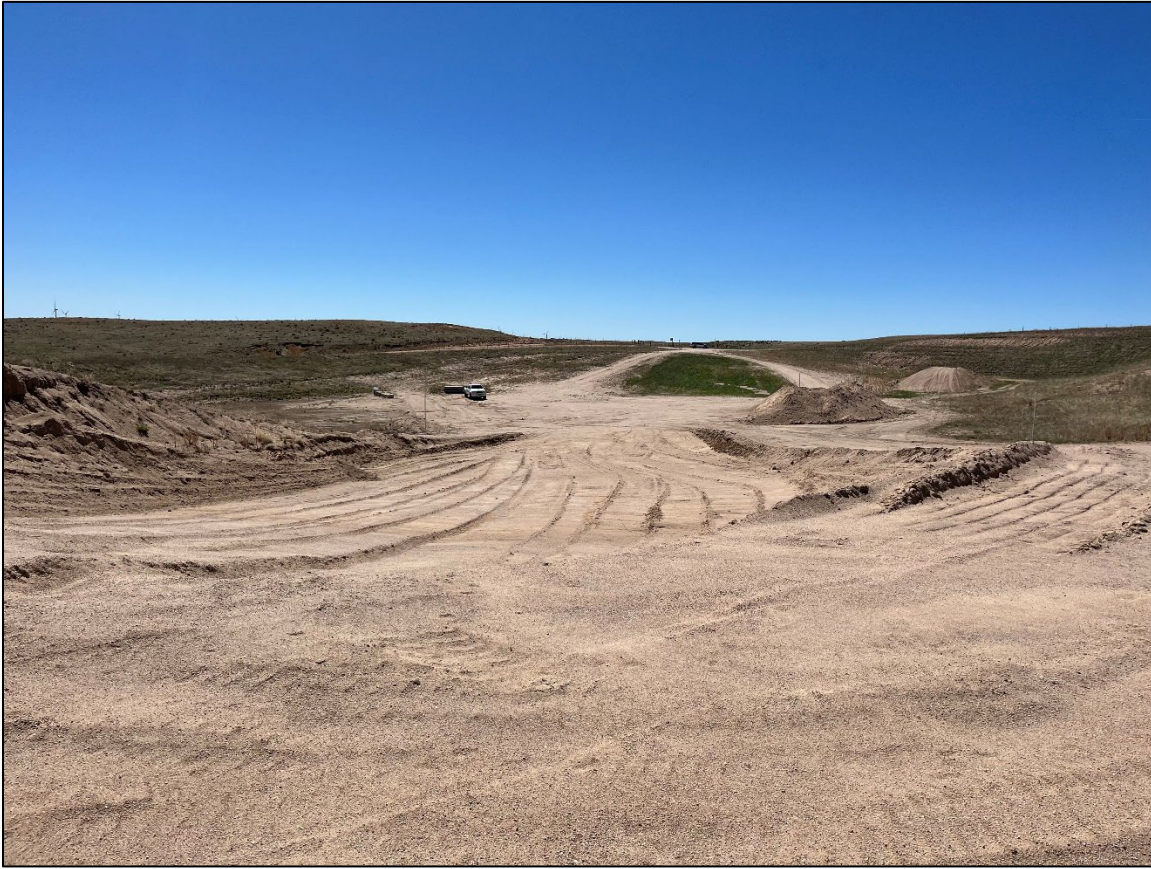
Gen. Compliance with Mine Plan: The operation appeared to be in compliance with the approved mine plan at the time of the inspection. A small stockpile is located south of the mined slope (Photo 10). A small pile of

Photo 10: View south from atop the active highwall, topsoil and product stockpiles are shown to the west.
