MINERALS PROGRAM INSPECTION REPORT
PHONE: (303) 866-3567

MINE NAME: Larson Pit	MINE/PROSPECTING ID#: M-2007-012	MINERAL: Gravel, sand and clay	COUNTY: Phillips
INSPECTION TYPE: Monitoring	WEATHER: Cloudy	INSP. DATE: April 10, 2024	INSP. TIME: 10:00
OPERATOR: Gregory Larson	OPERATOR REPRESENTATIVE: Gregory Larson	TYPE OF OPERATION: 112c - Construction Regular Operation	
REASON FOR INSPECTION: Normal I&E Program	BOND CALCULATION TYPE: None	BOND AMOUNT: \$28,889.00	
DATE OF COMPLAINT: NA	POST INSP. CONTACTS: None	JOINT INSP. AGENCY: None	
INSPECTOR(S): Jocelyn Carter Jared Ebert	INSPECTOR'S SIGNATURE:

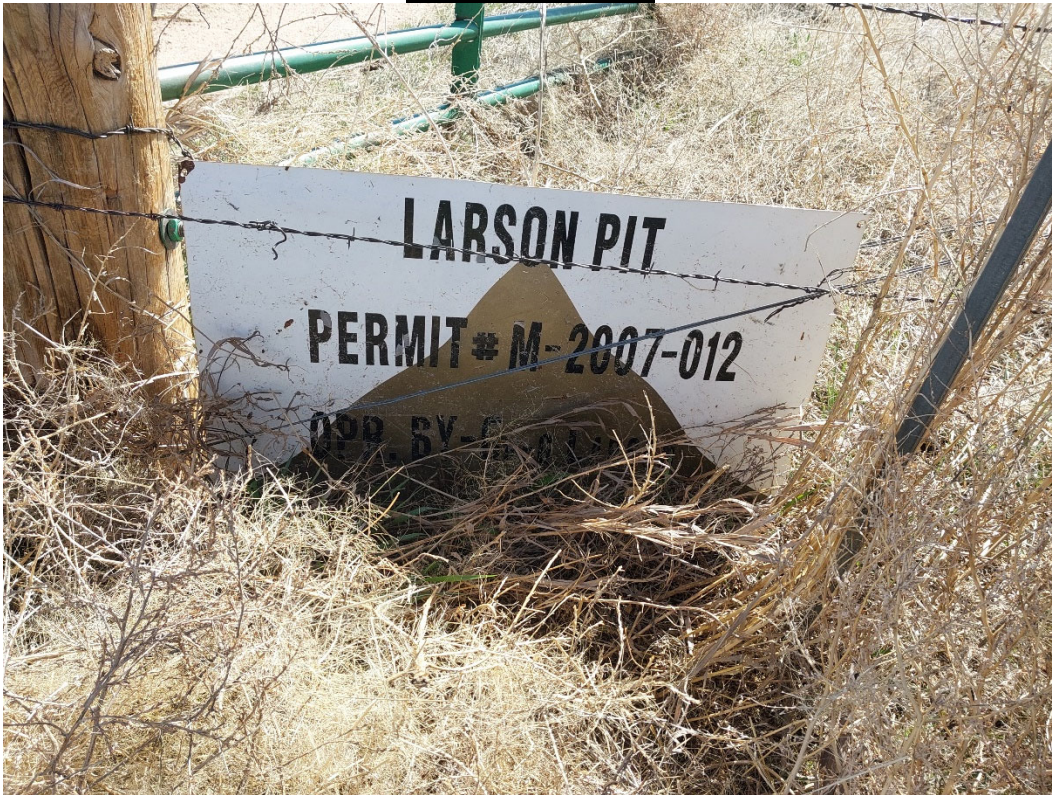
The Larson Pit is in Phillips County, about 7 miles southeast of the town of Haxtun, Colorado. To access the Larson Pit from Haxtun, travel south on Colorado Highway 59 for 6.8 miles, travel east on County Road 16 for 1 mile, the entrance is located on the southeast corner of the intersection of County Road 16 and County Road 7. The mine sign was posted at the entrance gate but obstructed by weeds.

Photo #1: Mine sign at gate entrance, partially obstructed by weeds.

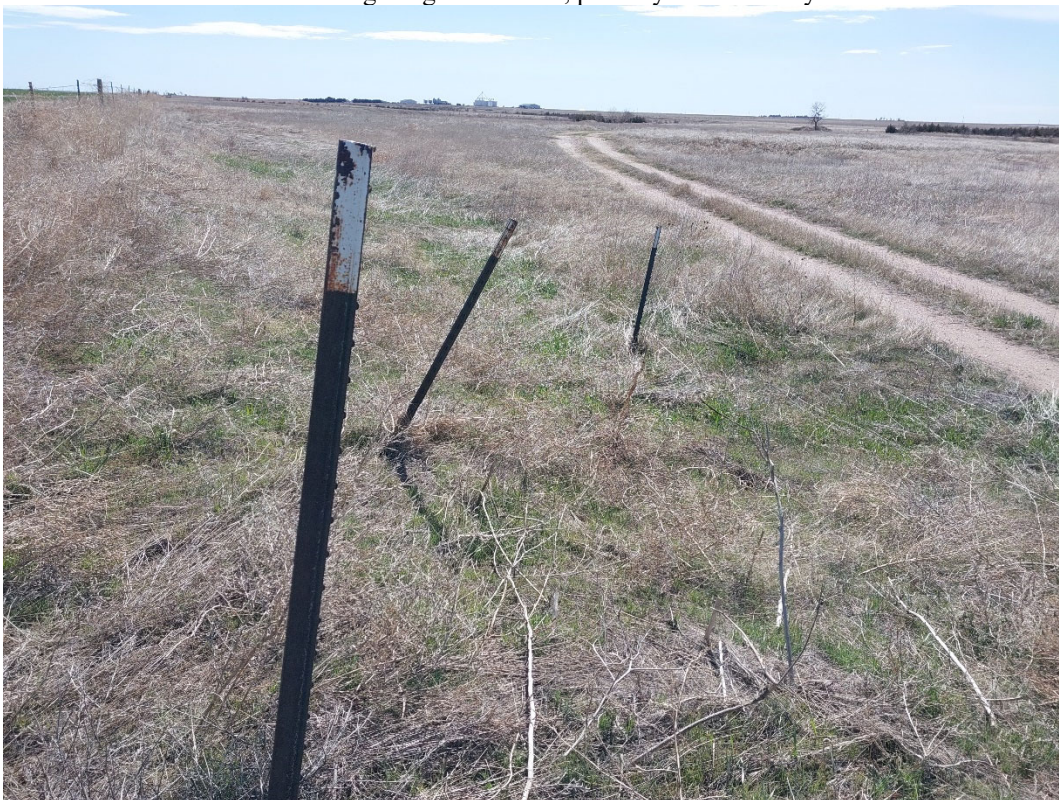
Photo #2: Northeast boundary marker with haul/access road in the background.

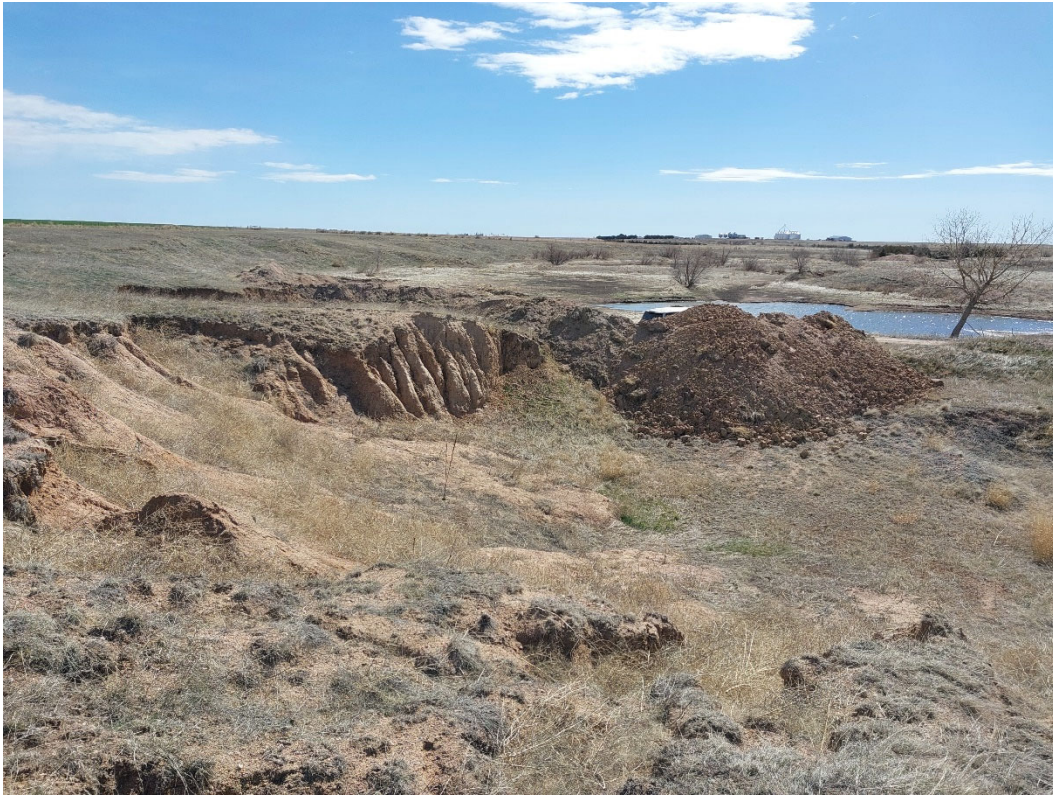
While on site, it was observed that topsoil was not being stripped or segregated/preserved as stated in the approved mining plan. There was a stockpile that appeared to be topsoil located on the northwest side of the ox bow, near the most recent mining disturbance. But it was clear that overburden and product was also being added to the stockpile. It also appeared that the mining operation was moving north, into the bank of the ox bow of Sandy Creek, creating a highwall. The approved mining plan states that the operation would progress from the north end of the ox bow and move south and west in Area #1 and progress south and east in Area#2.

The overburden/product stockpile appeared to be stable. The only issue observed with this was that it was mixed with the topsoil stockpile. This issue, discussed in the General Mine Plan Compliance section, is considered resolved.

Photo #3: View from the east end of the highwall looking south. The stockpile seen in this photo appears to be a mix of topsoil, overburden, and product.

It was agreed that if the Operator salvages topsoil from the highwall that was created and from the existing stockpile and graded the highwall in a timely manner, the Division would consider the potential violation and problem to be abated and resolved. Mr. Larson did send photos of the sight showing that topsoil had been salvaged and segregated from other mining operations and the highwall graded. Photographs of the site provided by the Operator are included in this report. The Division considers the problem to have been abated.

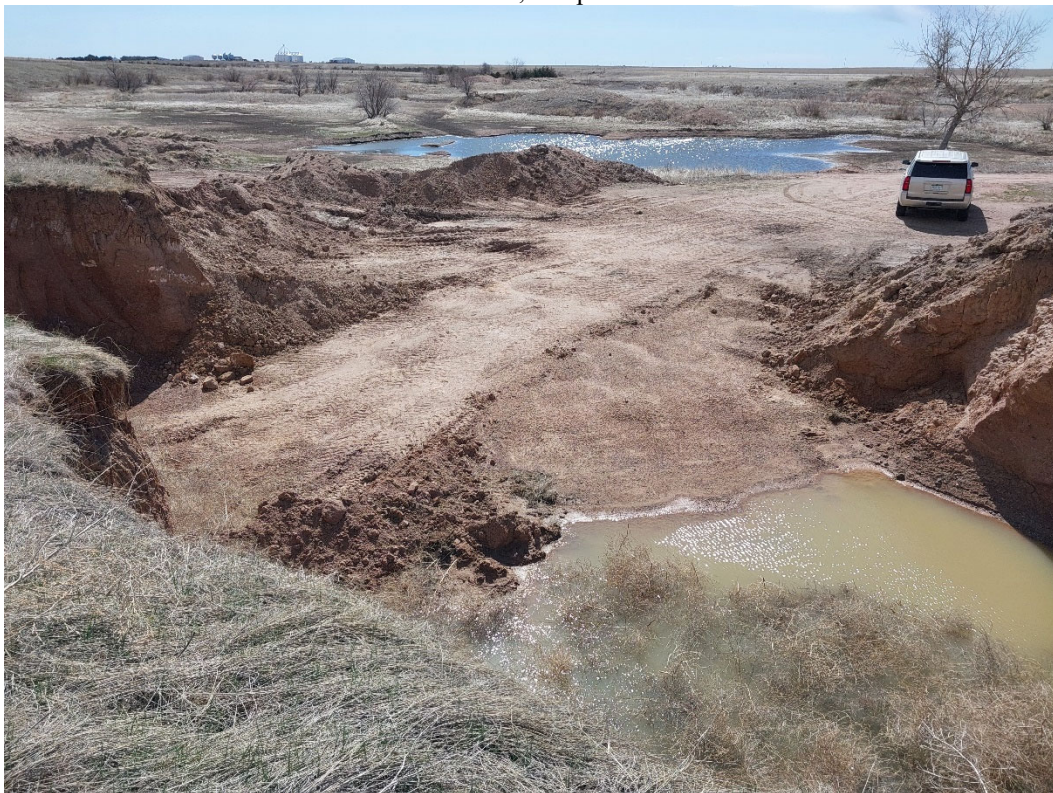
The mining operation is in the creek bed of the Sandy Creek; mining operations does not expose groundwater. There did not appear to be any alterations to the hydrologic balance due to mining. There was water retained in the creek bed and at the foot of the active mining area on the north side of the creek at the time of the inspection.

Photo #4: View from the highwall at the most recently disturbed area, looking south. Water is ponding at the deepest portion of the pit below. A portion of the stockpile of topsoil, overburden, and product can be seen at the center right of the photo.

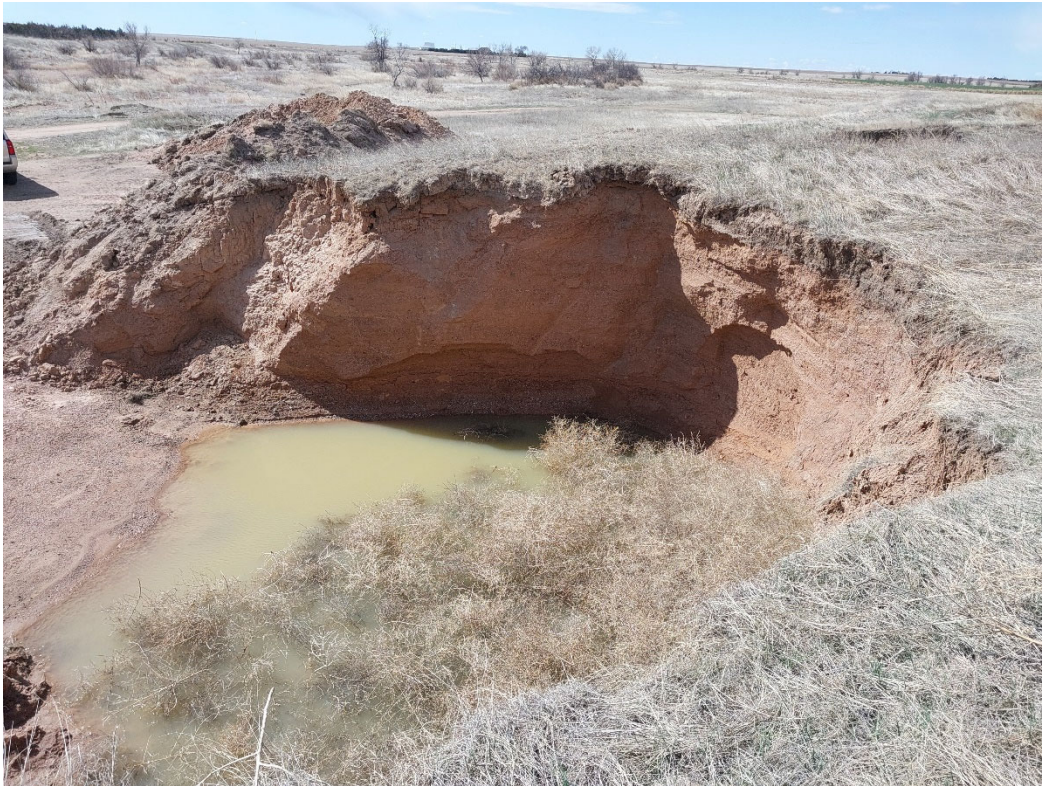
Disturbance was observed on the north side of the creek, into the ox bow feature. There were several areas that had been scarped out, with the most recent disturbance being at the center and older disturbance appearing to be on the west and east ends. The most recent area had slopes at an angle of repose and one section with an overhang, the highwall created was about 15 feet in height. The older disturbance areas were also at an angle of repose but became gentler towards the east and the developed highwalls were shorter than the most recently disturbed area.

According to annual reports, 7 acres have been backfilled and graded to date. A flood event in Fall of 2021 naturally backfilled pits and graded slopes. There was a highwall observed at the time of the inspection that required grading. The Operator provided photos of grading work to address the General Mine Plan Compliance issue, discussed earlier in this report. The grading appears to be adequate in the photos.

Photo #5: View from the highwall at the most recently disturbed area, looking west at the overhang portion of the highwall.

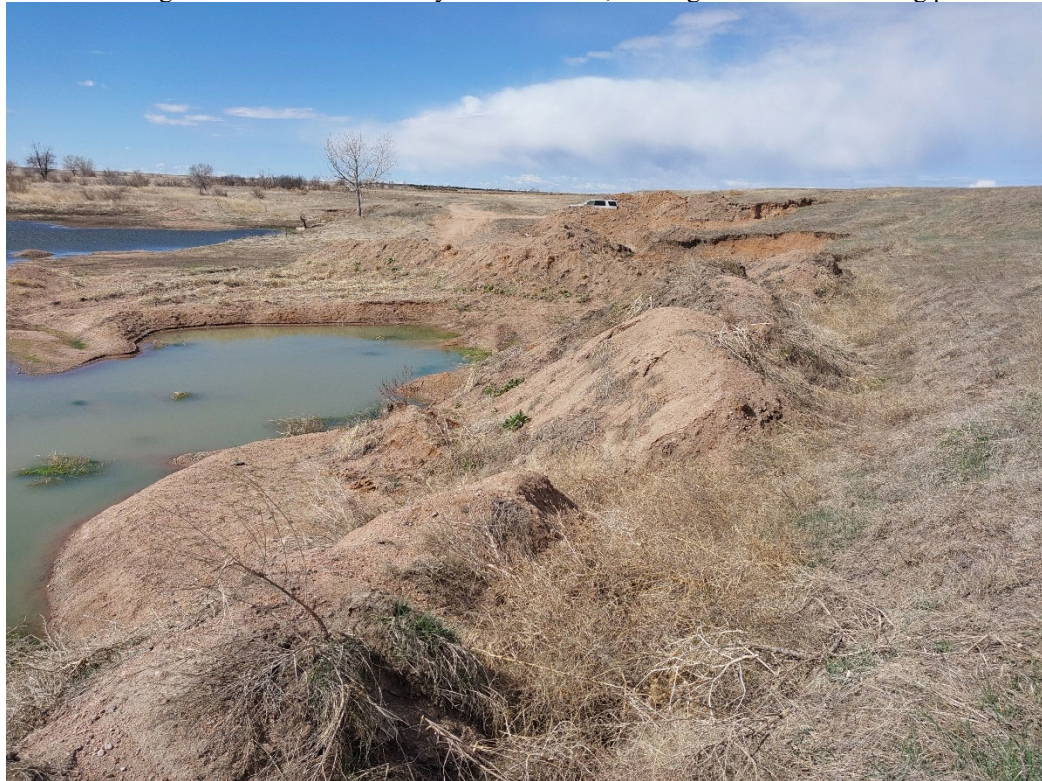
Photo #6: View from the east end of the disturbed area looking west, the mined pits can be seen on the left side with the scraped areas along the left side of the photo. Water can be seen in the mined pits.

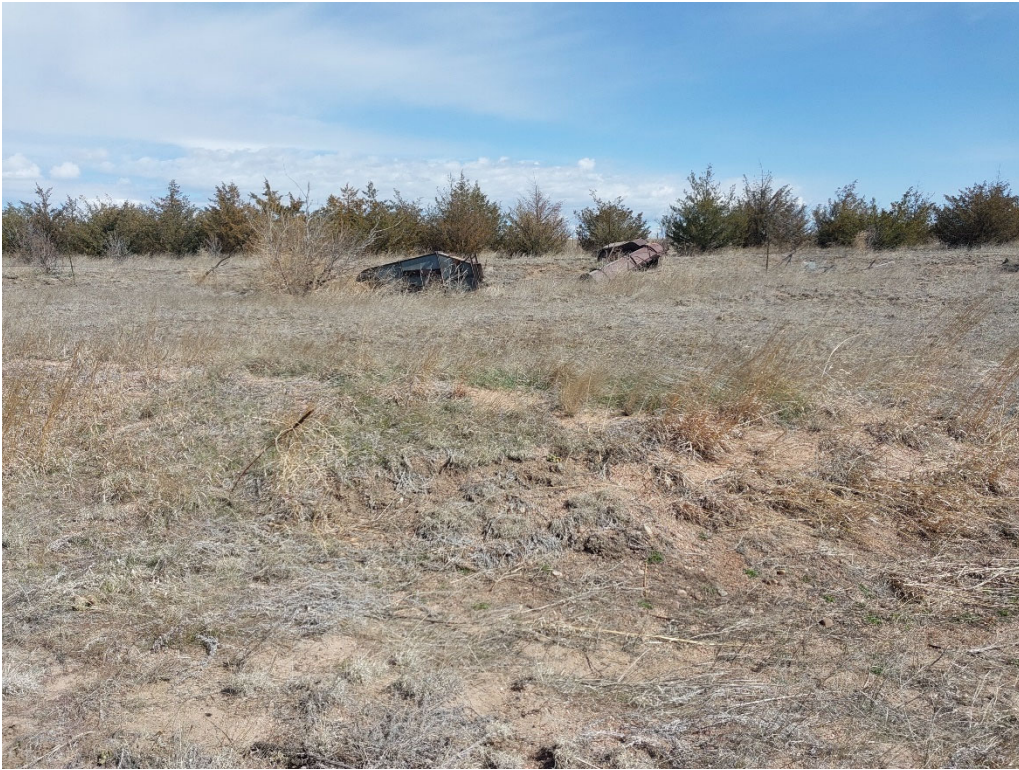
After inspecting the disturbed area, the areas to the east and south of the permit area were walked. There is some pre-law debris that was observed on the north and south sides of the creek in the eastern portion of the permit area. There are three stockpiles of material on the south side of Area #2 that were observed, one at the east end and two on the west end. The stockpile labeled as "Southwest Stockpile" in the map provided below was vegetated and appeared to be older than the other two, which were not well vegetated but stable.

Photo #7: Pre-law debris observed on the north side of the creek in Area #3. Photo taken from the creek looking northeast.

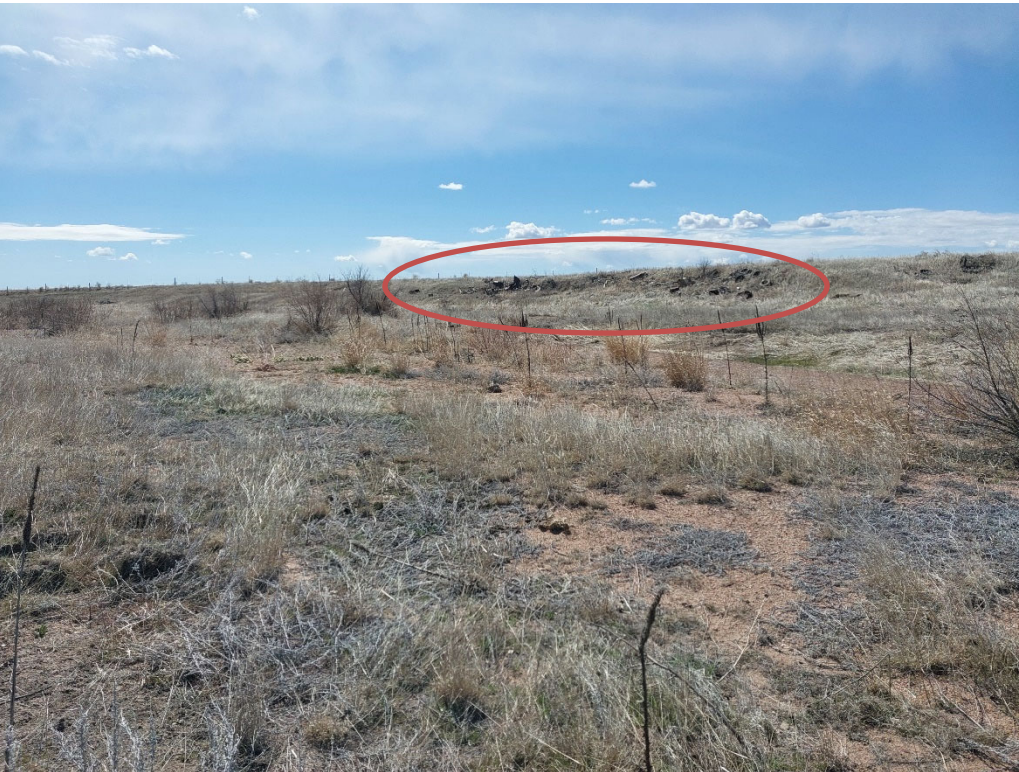
Photo #8: Taken from the creek bed in Area #3 looking east southeast; pre-law debris on the south side of the creek can be seen in the photo.

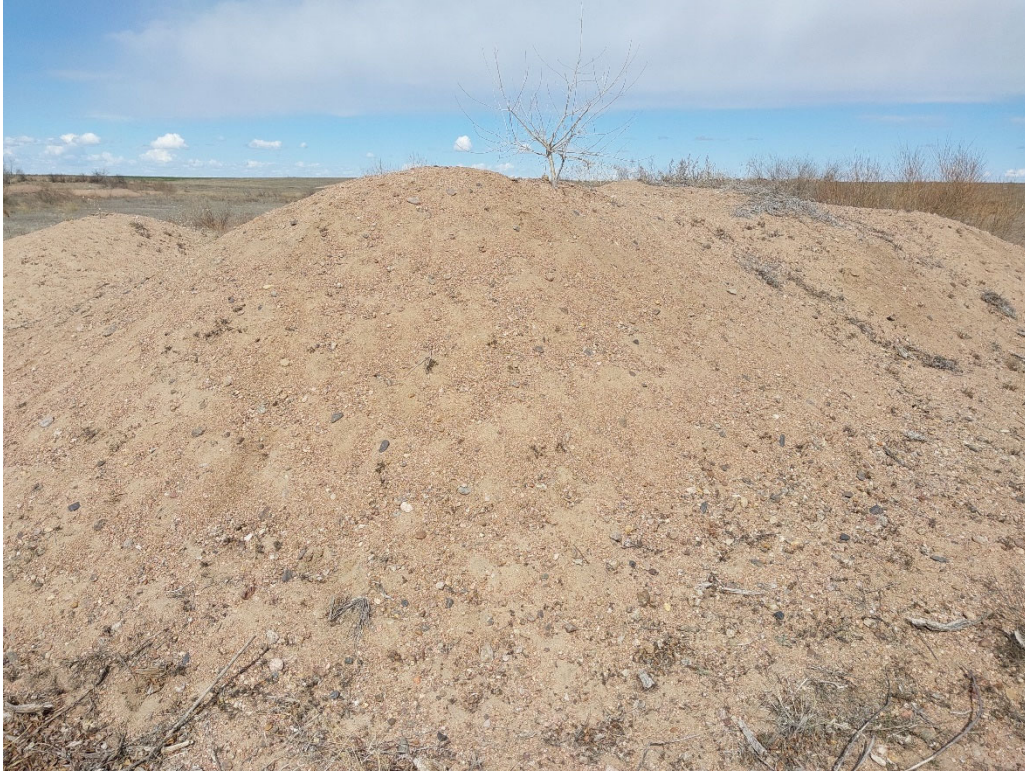
Photo #9: Stockpile of material on the south side of the creek at the east end of Area #2, labeled as “East Stockpile” on the map provided below; looking north.

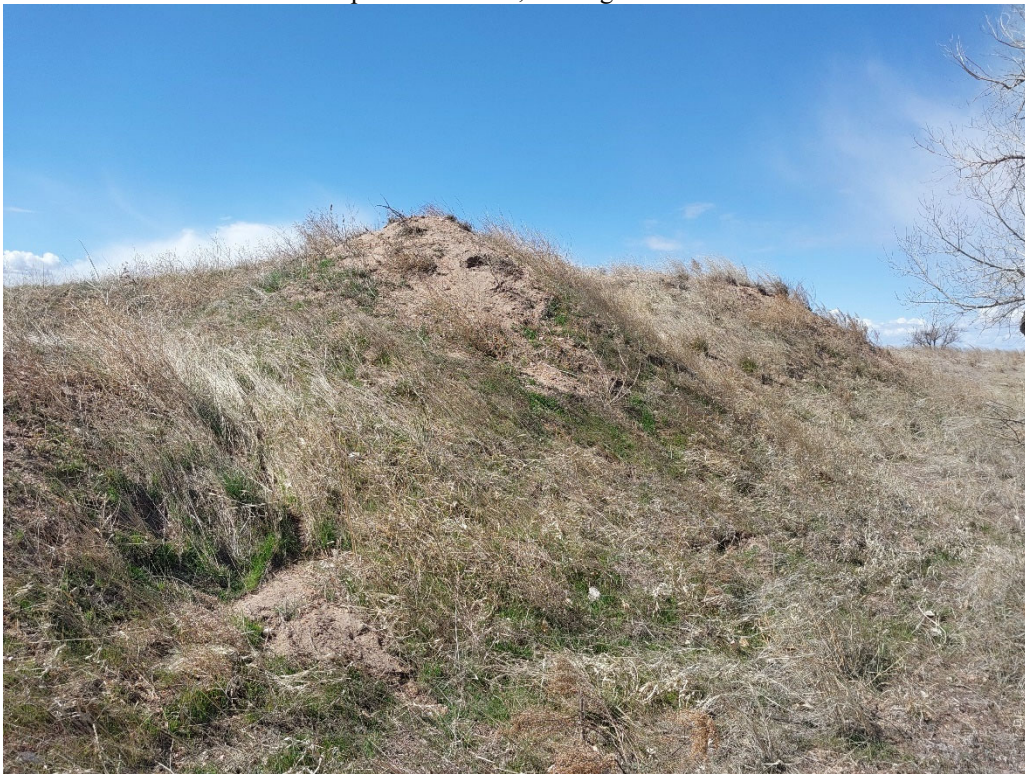
Photo #10: Vegetated stockpile observed on the south side of the creek on the west end of Area #2, labeled “Southwest Stockpile” on the map provided below; looking south.

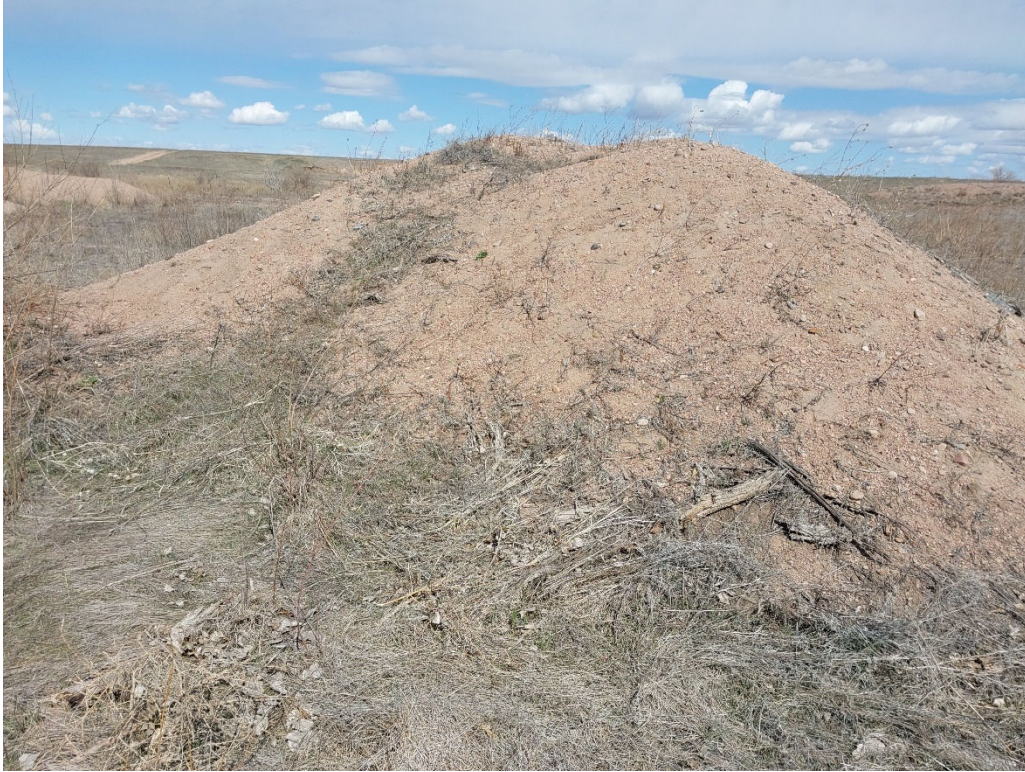
Photo #11: Stockpile located on the west end of Area #2, labeled “Northwest Stockpile” on the map provided below; looking northwest.

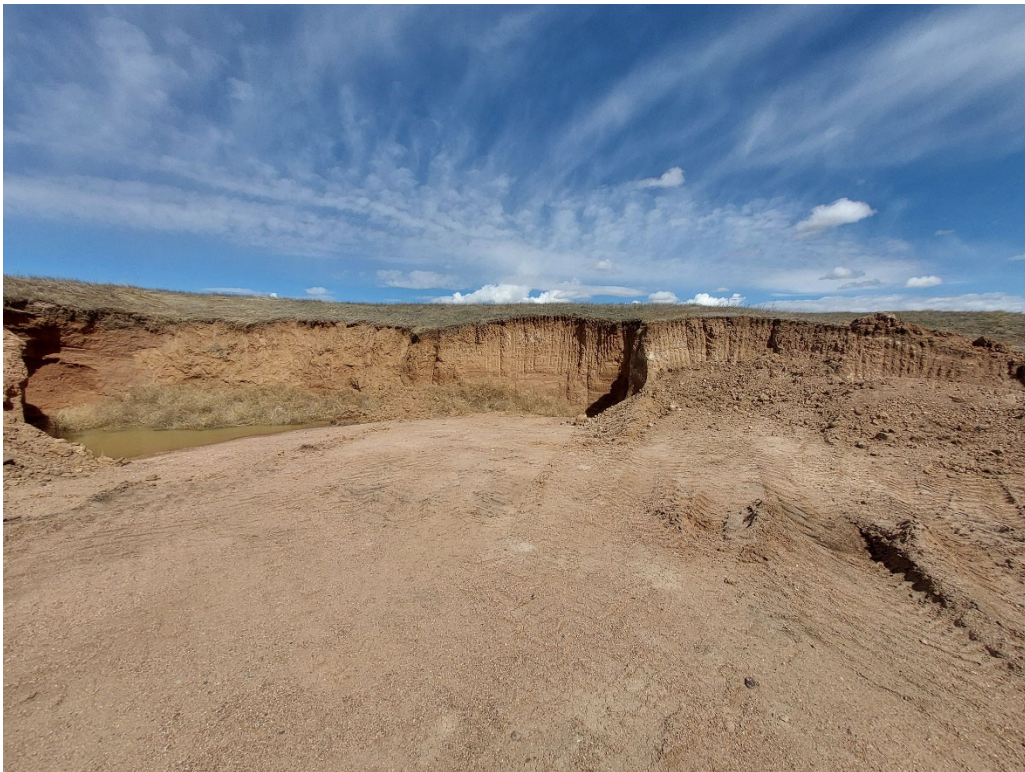
Photo #12: View of the most recently disturbed area from the base of the pit, looking north.

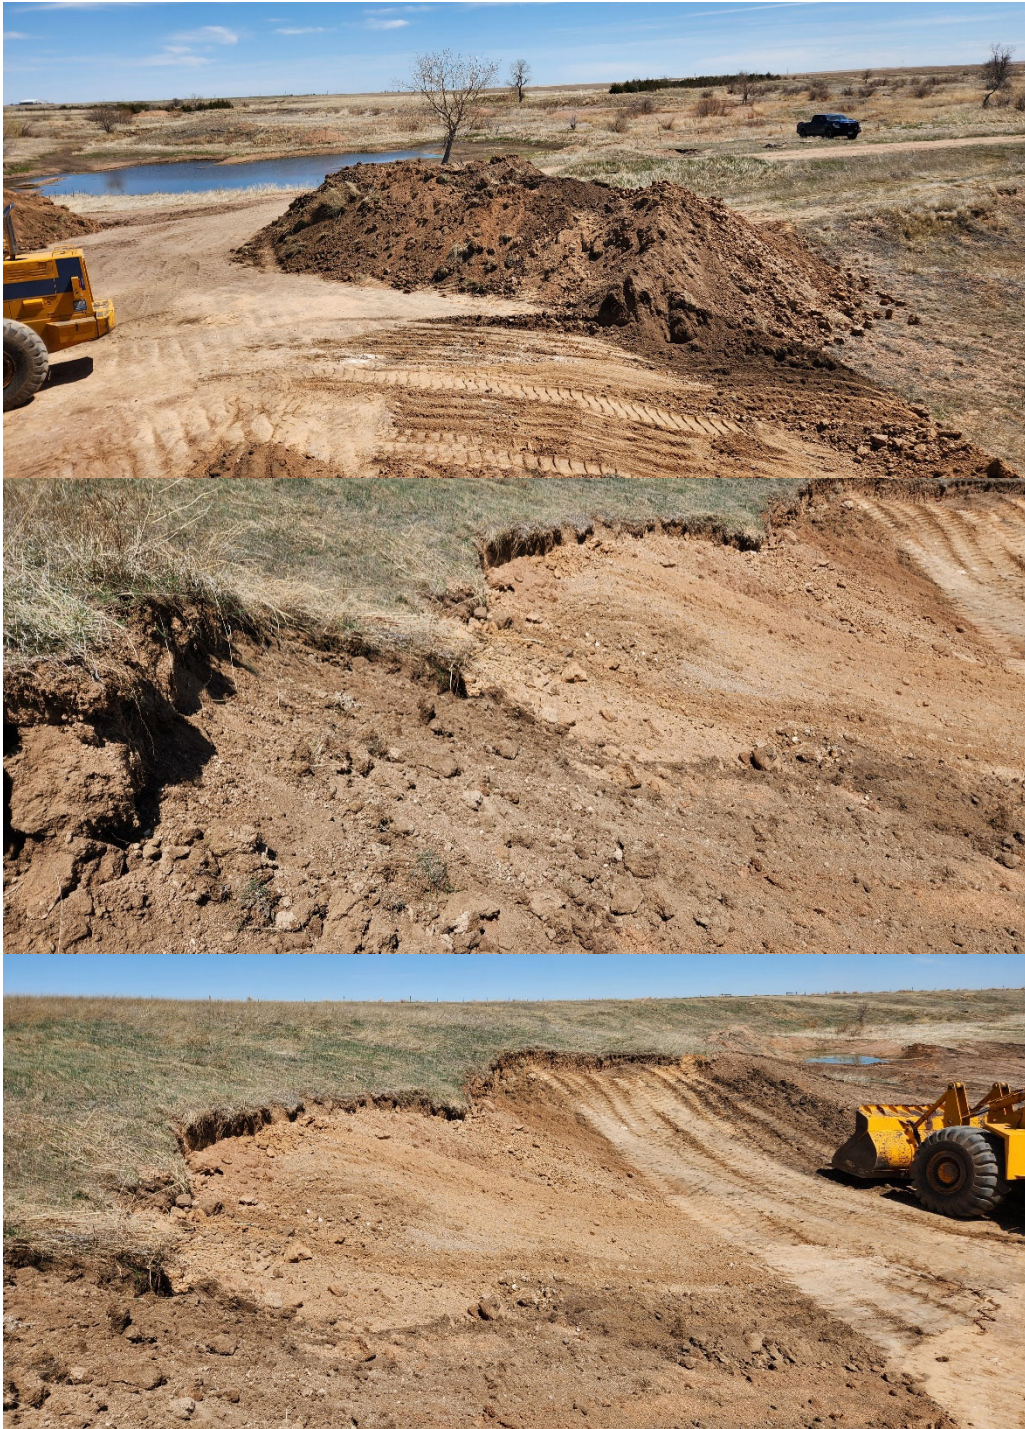
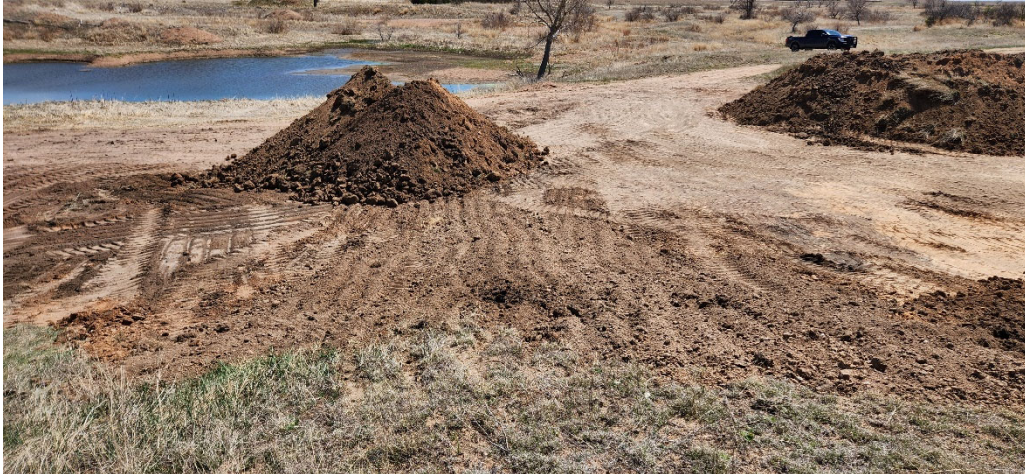
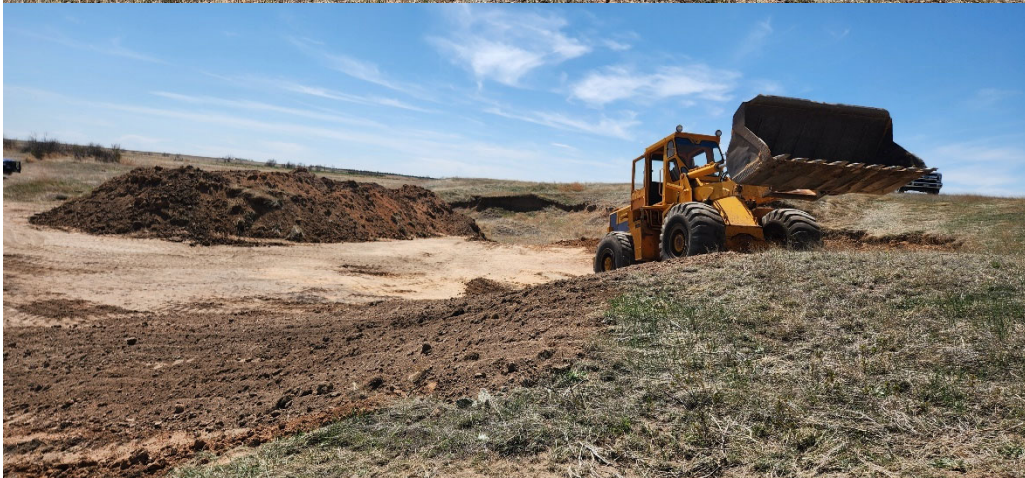
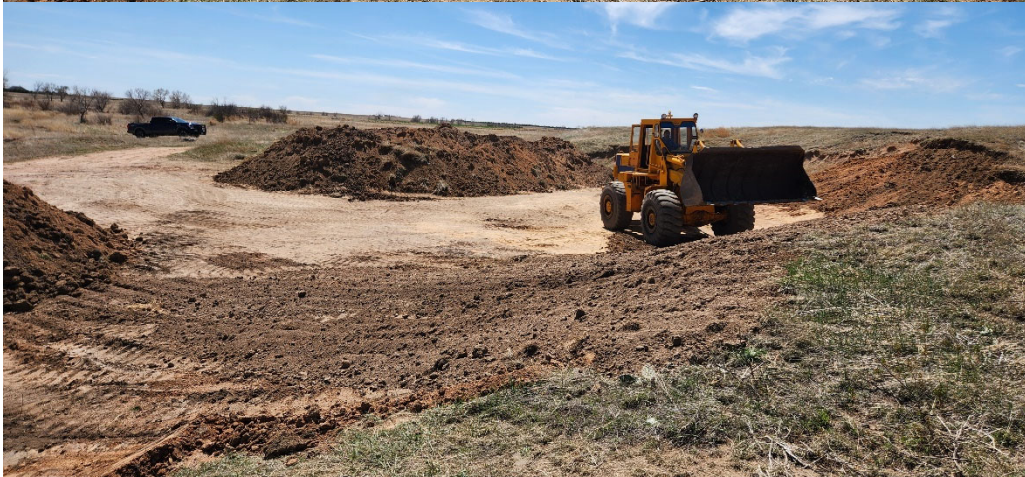
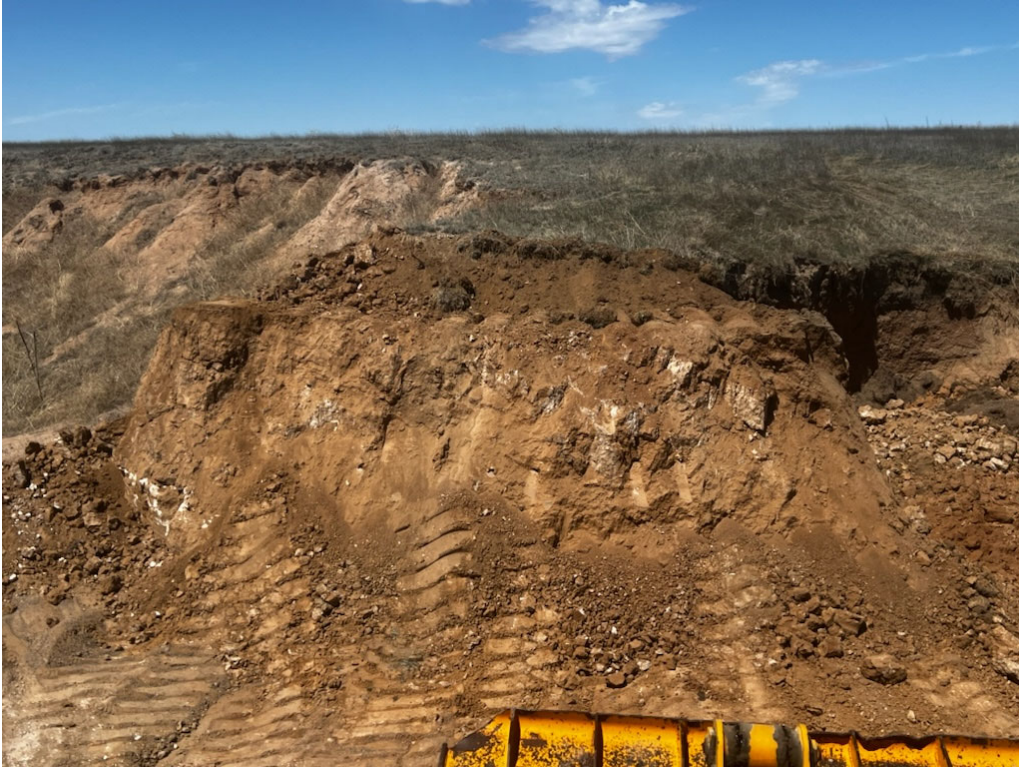
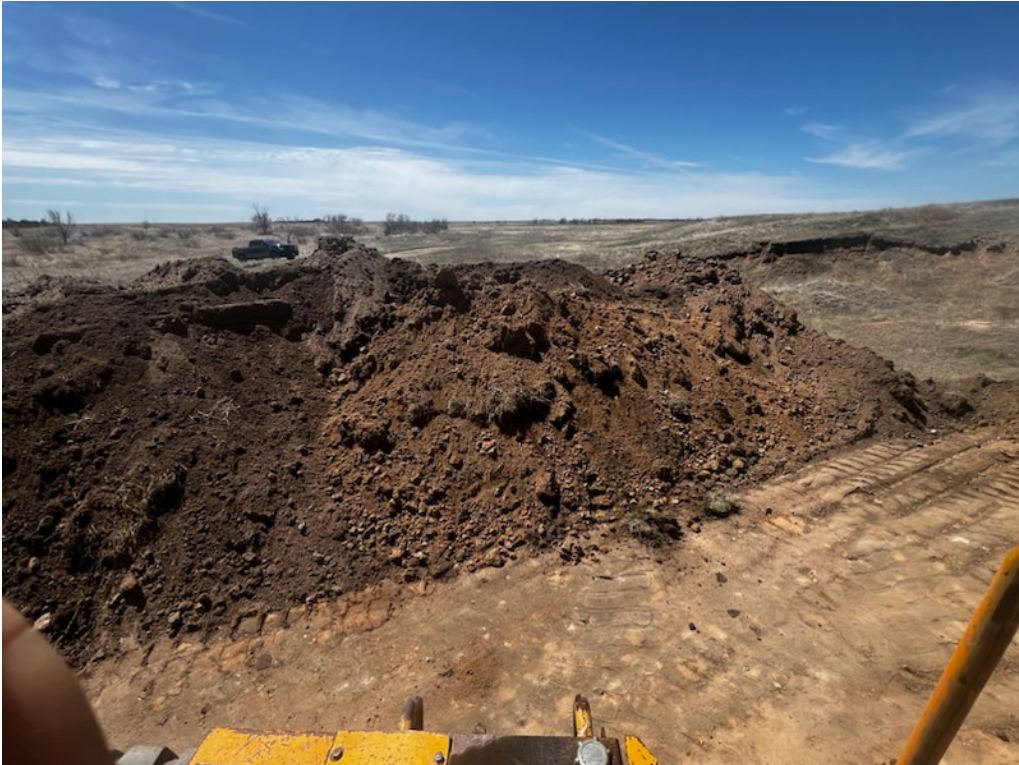
The following photos were taken by the operator and submitted to DRMS on April 26, 2024 in order to abate the issues discussed in the General Mine Plan Compliance section of this report.
