Fall 2023 Subsidence and Geologic Field Observations

Southern Panels and Sunset Trail Mining Areas

April 2024

831-032.914

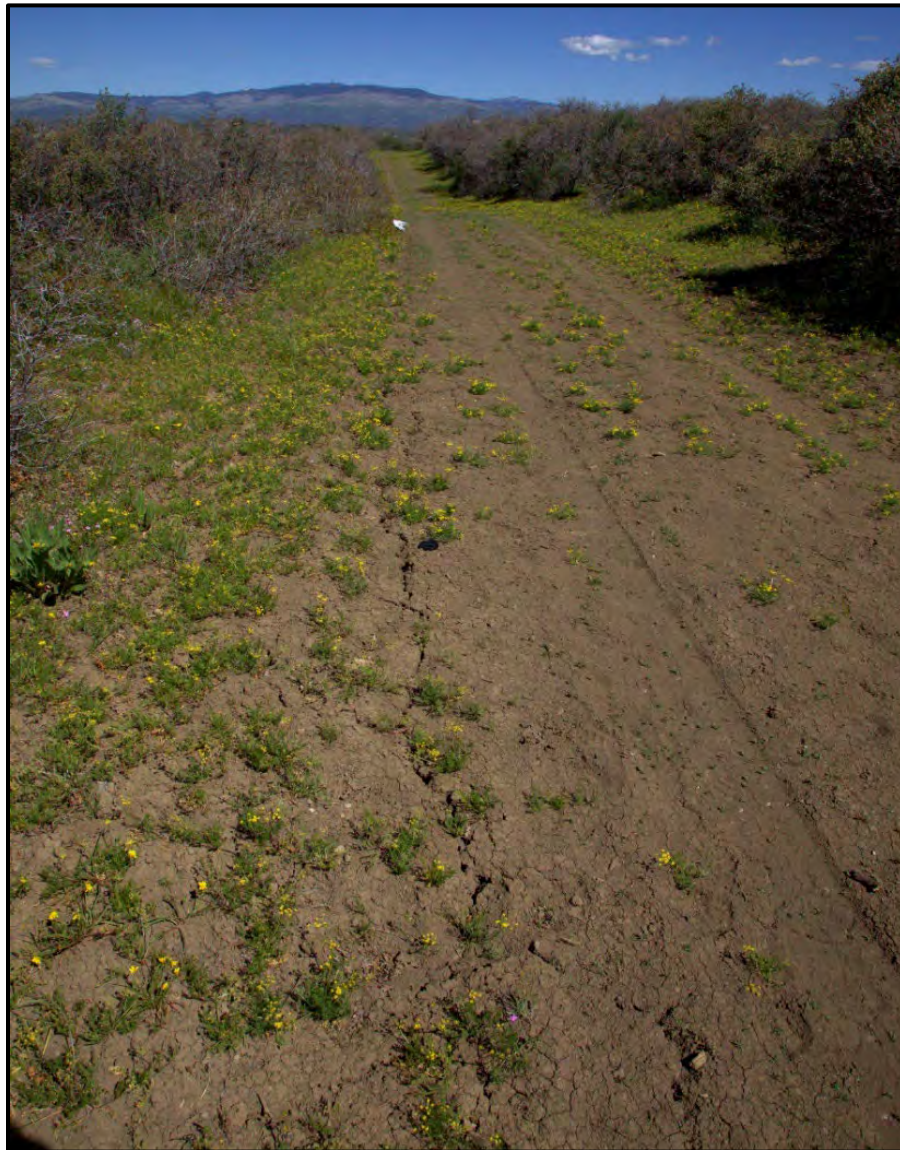
Cracks were observed along the existing road over the E14 Headgate between Crosscuts 23 and 22 during our spring 2022 site visit (Figure 1). No cracks had been observed along this traverse prior to mining in Longwall Panel E14. Therefore, the cracks were deemed to be subsidence-related features. The E-seam overburden thickness at this location is approximately 650 to 700 feet.

Figure 1: Southeast view of subsidence crack parallel to road on Traverse C-C' located over the E14 Headgate, between crosscuts 23 and 22 during spring 2022 visit.

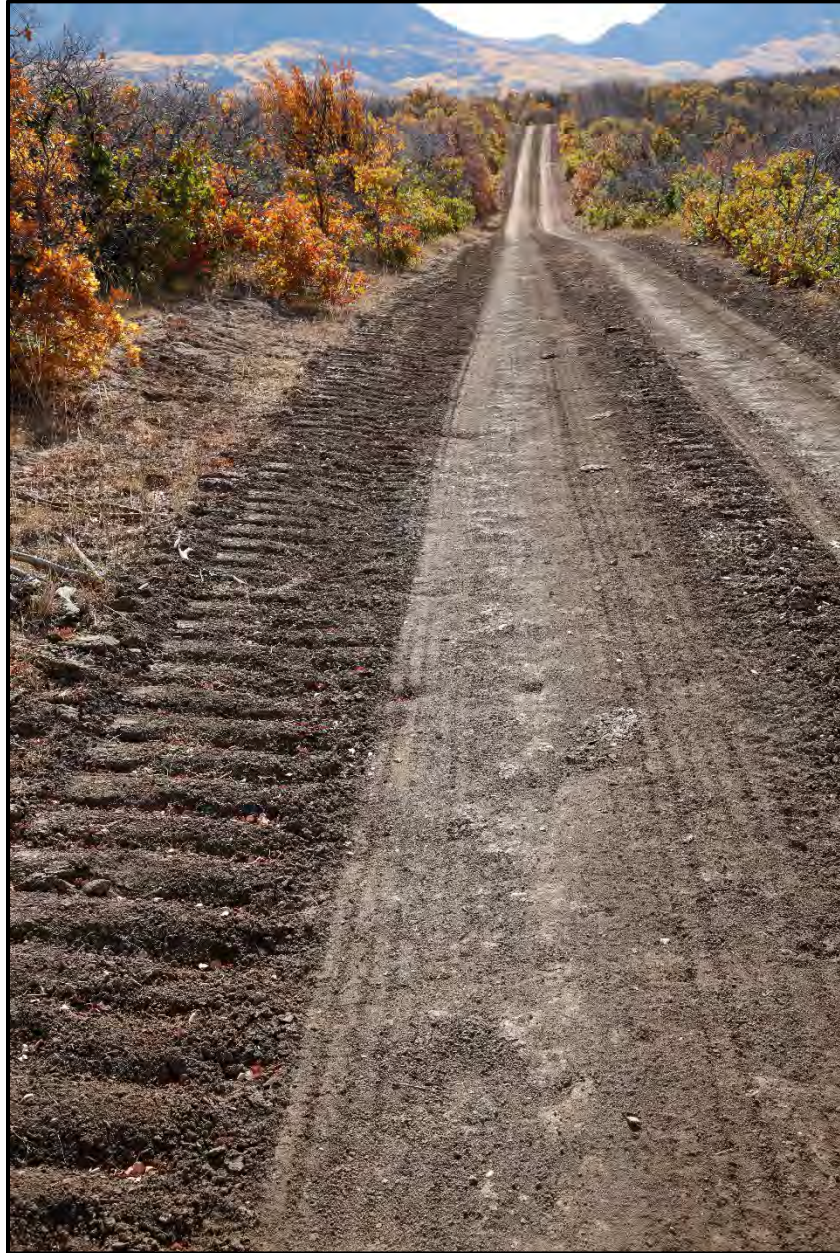
During the fall 2023 site visit, no new cracks were observed, and previously observed cracks were no longer discernable. The road has been subject to heavy truck traffic and routine grading making the observations along the road difficult as shown in Figure 2.

Figure 2: Access road along Longwall Panel E14 Headgate following roadwork in fall 2023.

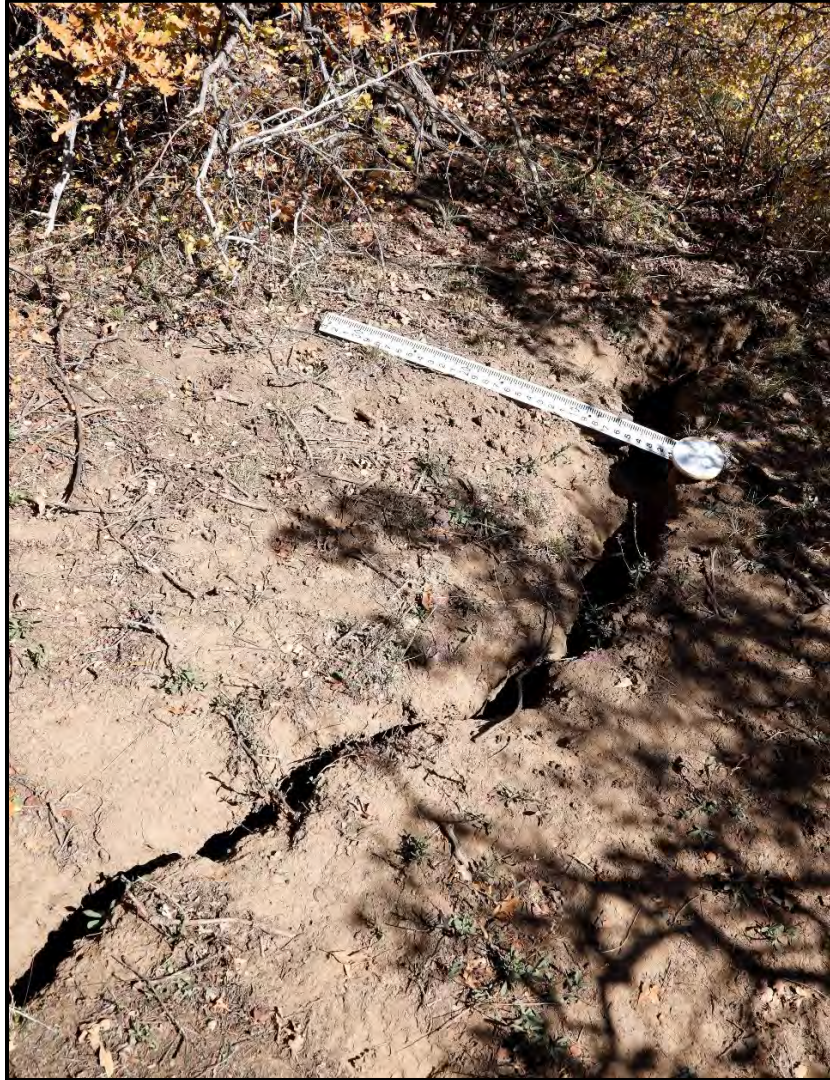
New cracks were first observed south of the access road overlying the north end of E-seam Longwall Panel E14 during the fall 2022 site visit. As shown on Map 1, the cracks were observed at Location 2 adjacent to cross cut 17 of the E14 Headgate. A series of parallel cracks were

observed roughly parallel to the E14 Headgate with an orientation of South 40° East. The largest of the observed cracks followed the topographic contour for approximately 100 feet (Figure 3).

Figure 3: The largest of the cracks observed at Location 2 in fall 2022, south of the across road on Traverse C-C’.

The location of these cracks is consistent with locations where the tilt and horizontal displacement are largest near the edge of the panel as shown in Figure 3 of Exhibit 60E (WWE 2018). The existence of the series of parallel cracks was likely a combination of these horizontal strains in combination with the natural sloped hillside. In total, there were 5 cracks observed with the

dimensions of the cracks generally decreasing in the downhill direction towards the center of the longwall panel.

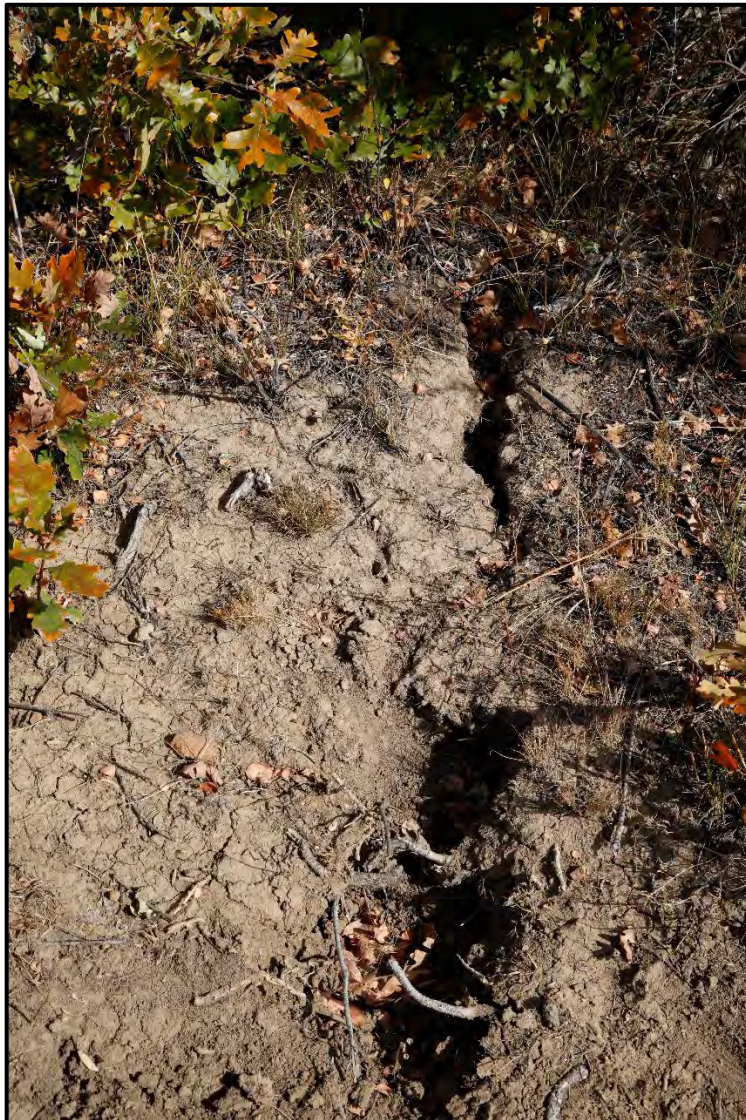
During the fall 2023 site visit, these cracks were still evident but were much less prominent. The smaller cracks had largely healed/sealed, especially where cattle or large game trails occurred. The larger cracks continue to heal; however, the sealing process appears to have stopped as some of the largest cracks remain open (Figure 4).

Figure 4: One of the largest of the cracks at Location 2, south of the across road on Traverse C-C' during fall 2023 visit showing continued healing.

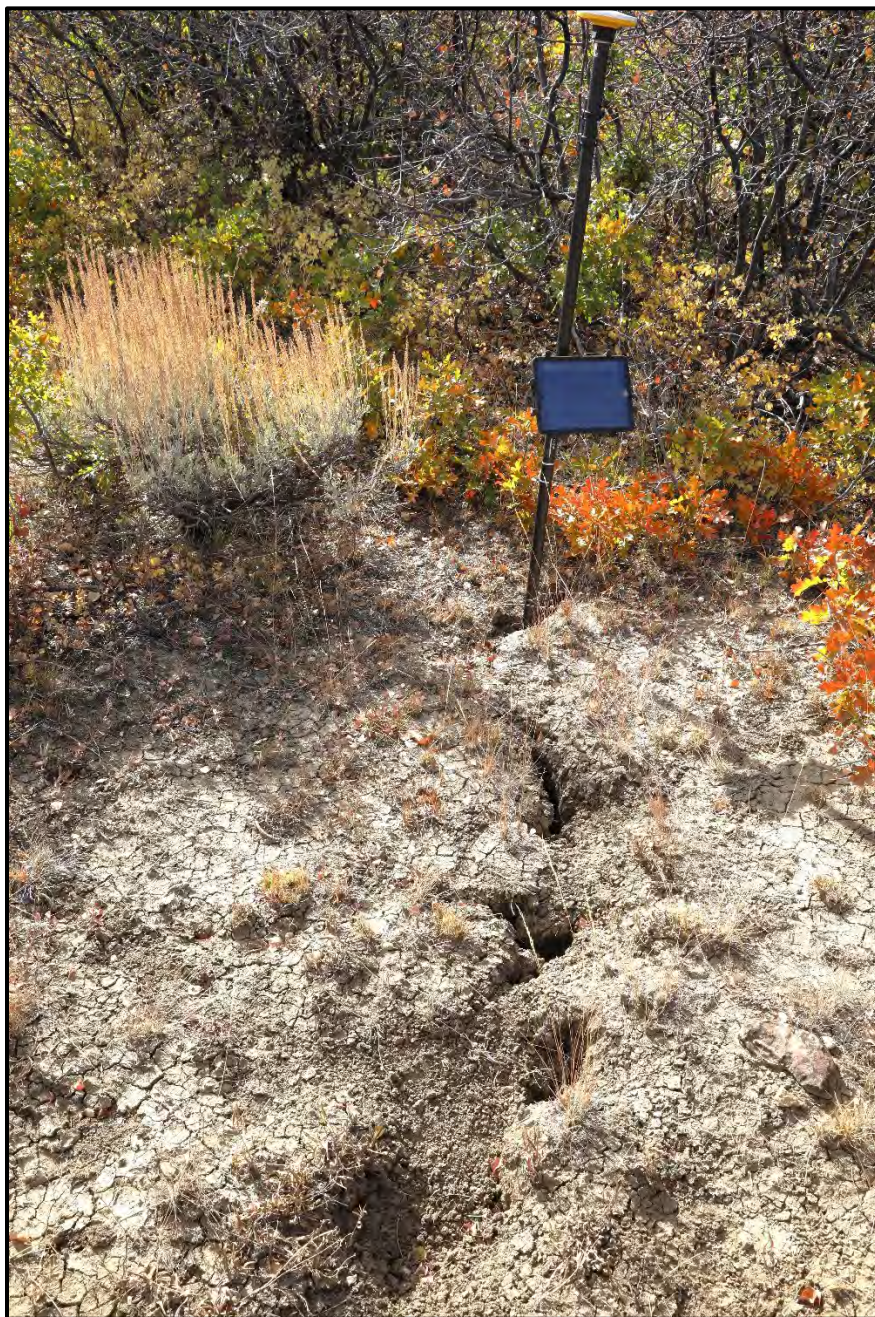
The mining of Panel E14 occurred from mid-April to mid-October with the longwall passing underneath this traverse during June 2022. While no discernable subsidence features were observed along this traverse during either our fall 2022 or spring 2023 site visits, cracks were observed during the fall 2023 site visit.

The newly observed cracks were located on both sides of the access road but were not seen on the road itself. This fact may indicate that the cracks were present, but not observed, prior to the fall 2023 site visit. The majority of the observed cracks were located on the eastern side of the road with E-seam overburden depth of roughly 500 to 600 feet. In general, the orientation of the cracks was north-south along the downslope of the topography away from the road that follows a ridgeline over Panel E14. The maximum depth of the cracks was 1.5 to 2.0 feet with a maximum width of approximately 4 inches. Figure 5 shows the largest of the cracks observed at Location 4 in the fall 2023.

Figure 5. Crack observed along D-D' over Longwall Panel E14 during fall 2023 site visit.

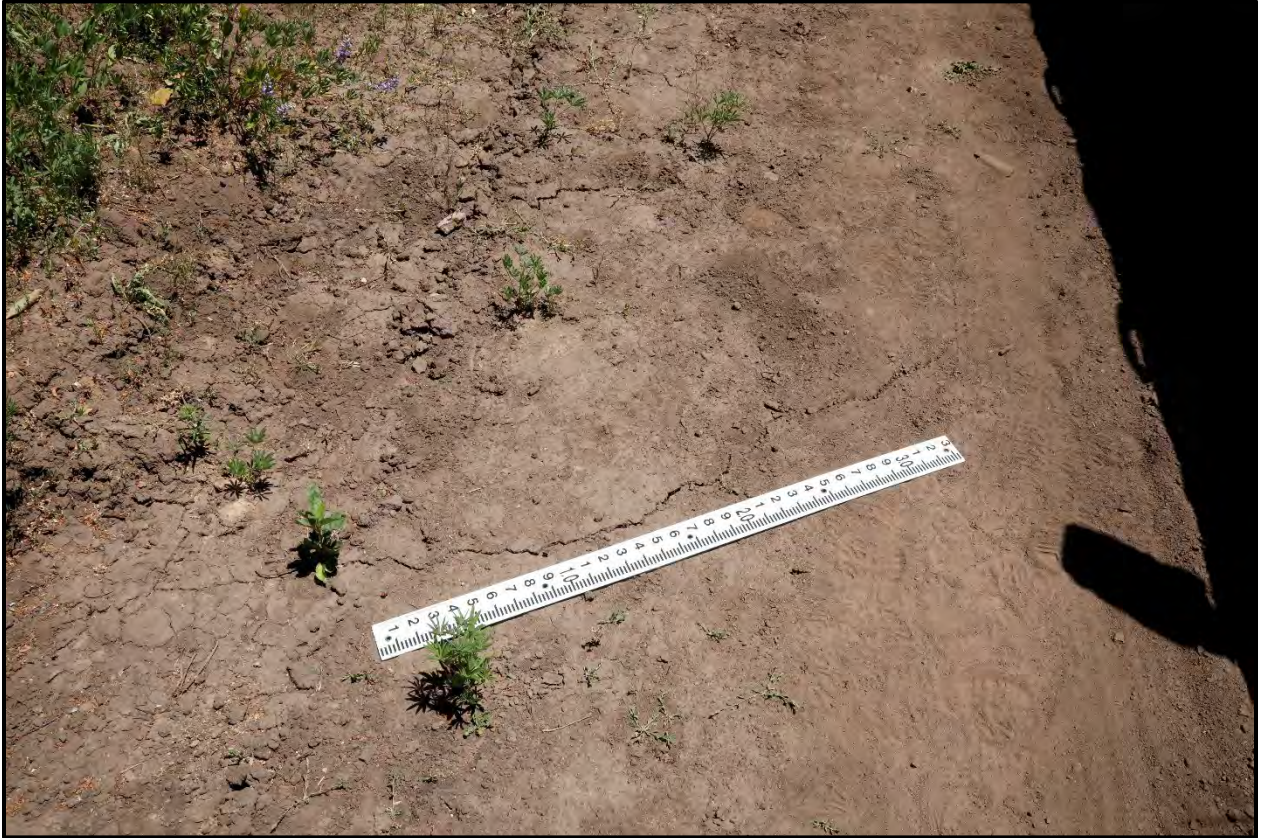
New cracks were observed along the north side of the access road overlying the north end of E-seam Longwall Panel SS3 during the spring 2023 site visit. As shown on Map 1, the cracks were observed between Location 3a and 3b. A series of parallel cracks were observed roughly parallel each other with an orientation of South 37° East. The cracks had no discernable depth or width and were not perpendicular to the road (Figure 6). It is unclear whether these observed cracks were related to mining subsidence; however, their consistent orientation was noteworthy and merited documentation. Longwall mining occurred under Locations 3a to 3b during the months of December 2022 and January 2023.

Figure 6: Example of a newly observed crack along the north side of E-seam Longwall Panel SS3 during spring 2023 site visit

During the fall 2023 site visit, the access road for Traverse E-E' had undergone significant work to install water bars prior to winter. The location could not be accessed by our vehicle, so the traverse was observed on foot. The roadwork made observations challenging and, for the most part, the previous cracks were not observed with the exception of one small crack observed on the north side of the road.
