**MINERALS PROGRAM INSPECTION REPORT**  
**PHONE: (303) 866-3567**

<b>MINE NAME:</b> Siskin	<b>MINE/PROSPECTING ID#:</b> M-1987-116	<b>MINERAL:</b> Stone	<b>COUNTY:</b> Custer
<b>INSPECTION TYPE:</b> Preoperation Inspection	<b>WEATHER:</b> Clear	<b>INSP. DATE:</b> May 1, 2024	<b>INSP. TIME:</b> 10:45
<b>OPERATOR:</b> Colorado Quarries Inc	<b>OPERATOR REPRESENTATIVE:</b> Aaron Tezak	<b>TYPE OF OPERATION:</b> 110c - Construction Limited Impact	
<b>REASON FOR INSPECTION:</b> Preoperation Inspection	<b>BOND CALCULATION TYPE:</b> None	<b>BOND AMOUNT:</b> \$30,700.00	
<b>DATE OF COMPLAINT:</b> NA	<b>POST INSP. CONTACTS:</b> None	<b>JOINT INSP. AGENCY:</b> None	
<b>INSPECTOR(S):</b> Amber M. Gibson	<b>INSPECTOR'S SIGNATURE:</b>

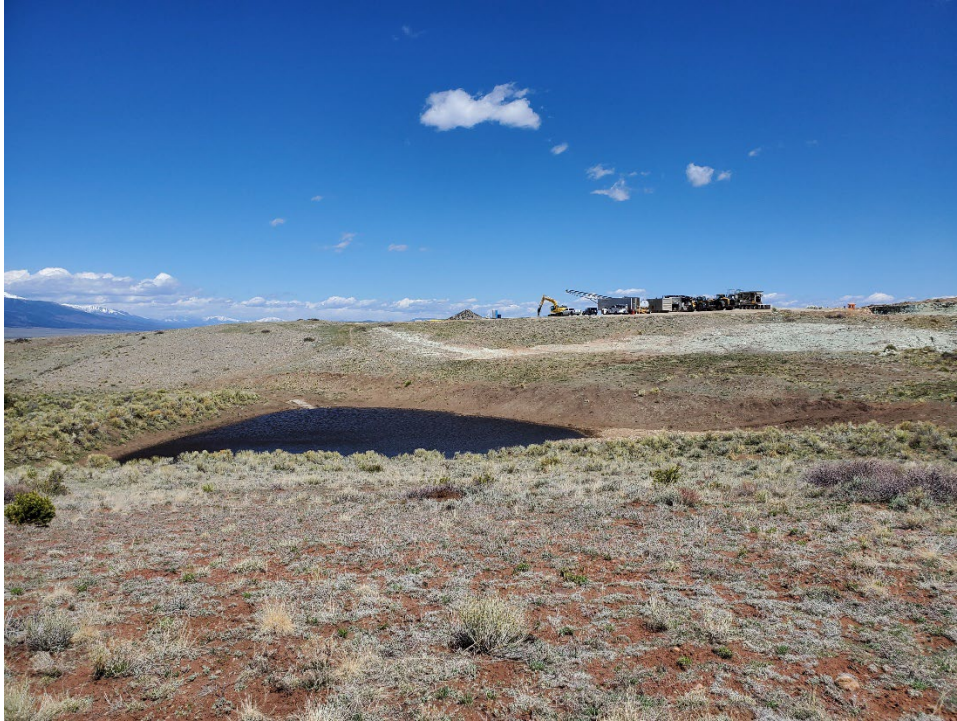
In the permit/affected boundary area proposed in CN1, two intermittent streams cut across the proposed affected area, as well as two perennial ponds (See Applicant's Maps C-1, C-2, and C-3). These features were observed during the inspection. The northern pond and both drainages/streams were dry. The Applicant stated during the inspection that the north pond rarely contains water. The pond in the southern portion of the proposed permit area was holding water at the time of the inspection (Photo 1). The Applicant stated that they have never seen the southern pond dry.

**Photo 1:** Looking north at the current site and the perennial pond located within the southern portion of the proposed CN1 boundary.

There was no evidence of off-site run-off observed during the inspection. In the CN1 application, the Applicant proposes to install stormwater berms around the disturbed areas, and a 100 foot setback from the drainages, to help prevent surface water from entering and from leaving the site. The water that falls within the disturbed areas is expected to infiltrate into the ground within 72 hours of a precipitation event. If the water does not infiltrate within that time, the Applicant has proposed to pump sediment-free water from the pit into discharge points in compliance with a CDPHE discharge permit.

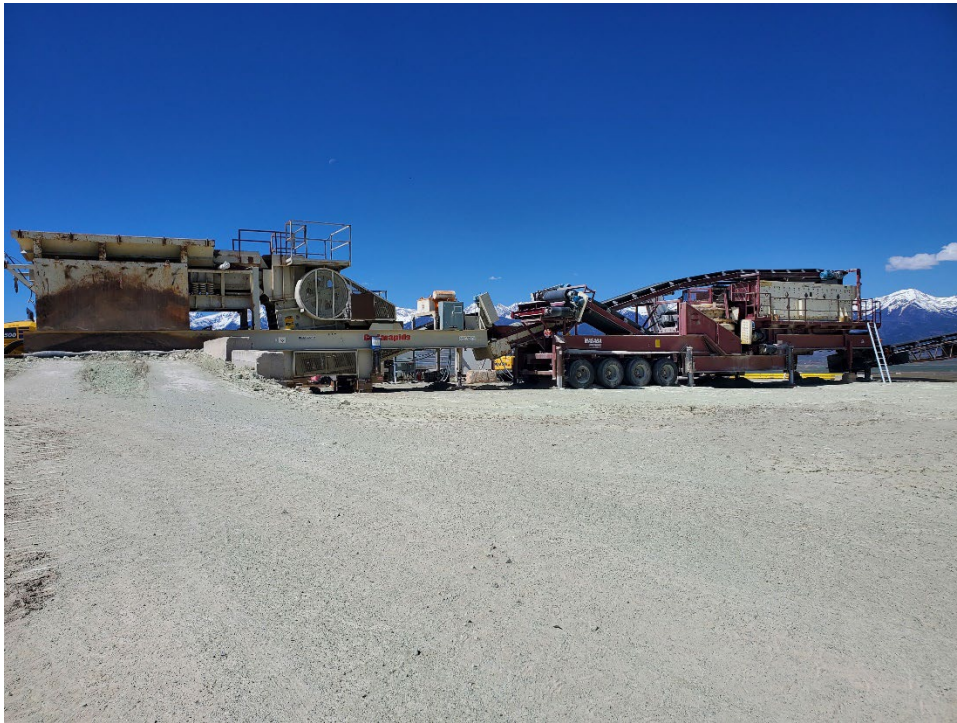
The area currently affected at the site has remained around three acres for years. Disturbance at this site includes a processing area with portable equipment (Photo 2), a pit excavation area, product stockpiles (Photo

**Photo 2:** Looking south at some of the portable equipment on site.

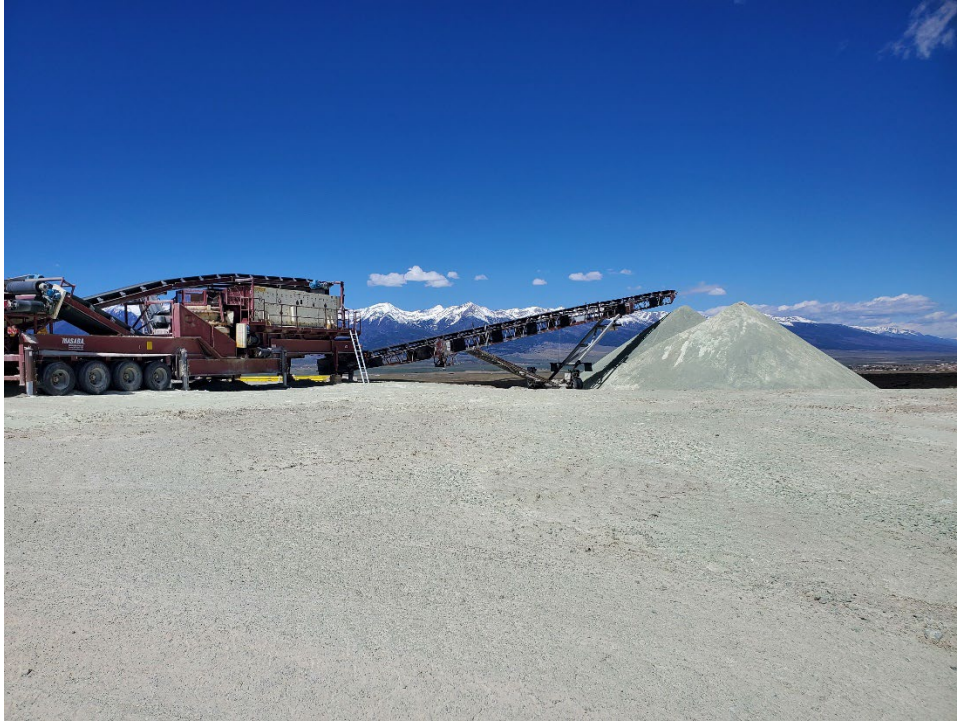
3), and a topsoil pile. The pit has approximately 750 feet of highwalls around the perimeter. The highwalls, ranging from a few feet tall to between 8 and 10 feet tall in some areas, appeared to be stable at the time of the inspection (Photos 4-6). Mining disturbance observed during the inspection appears to have been conducted in compliance with the Applicant/Operator's currently approved plan.

**Photo 3:** Product stockpiles on site.

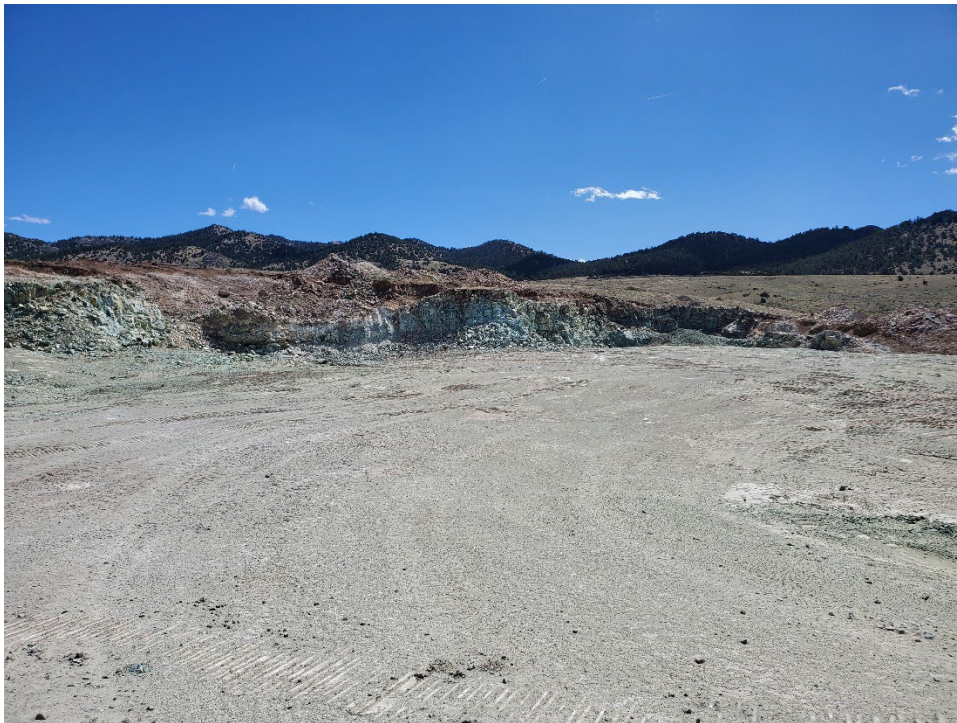
**Photo 4:** Looking east at the start of the highwalls along the eastern side of the pit.

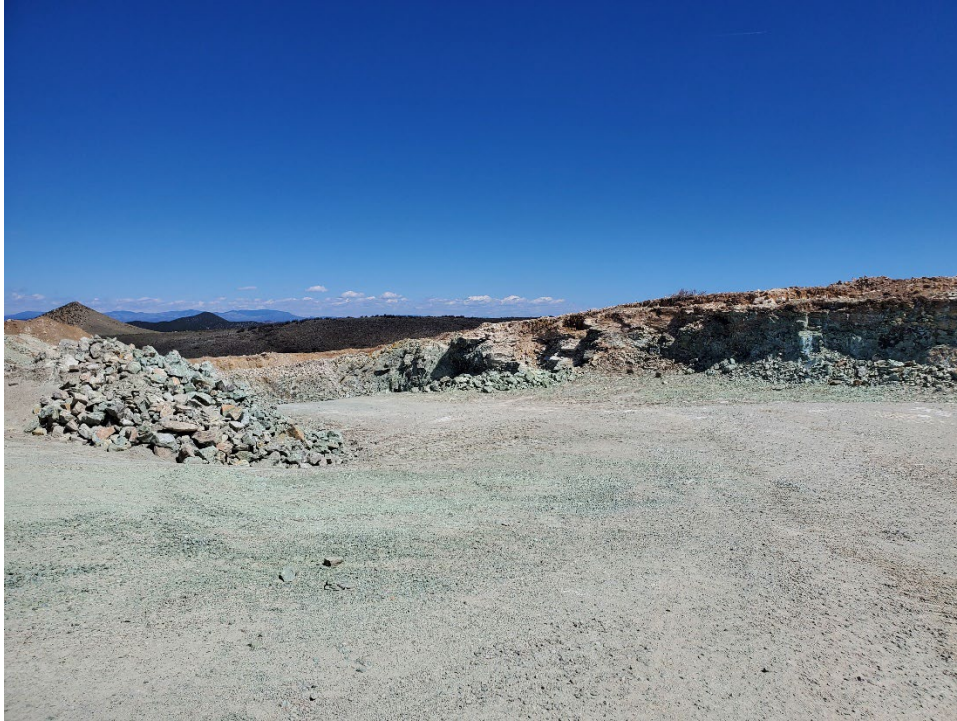
**Photo 5:** Looking west at highwalls in the current pit.

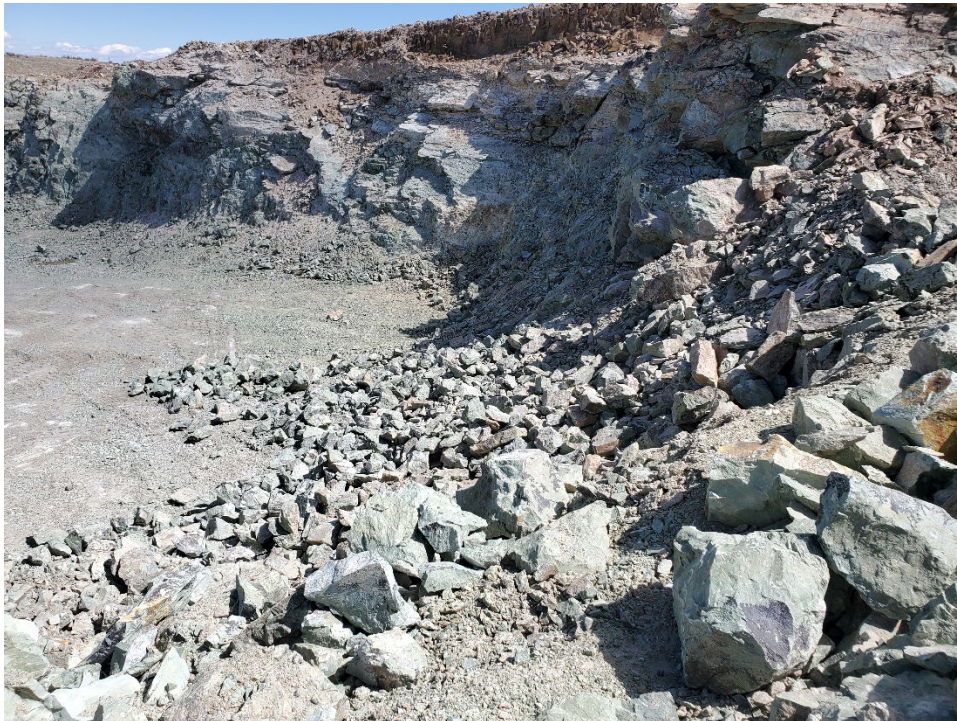
**Photo 6:** Looking north-east along the highwalls in the pit.

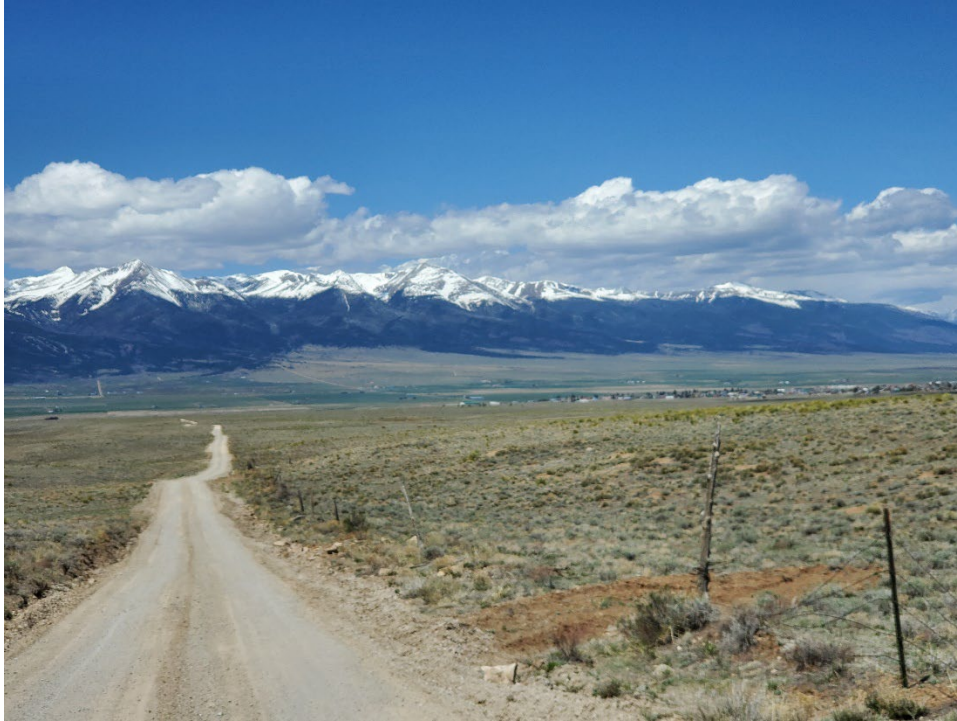
Various ranch fences were observed along the access road (Photo 7) and throughout the proposed permit area. The Applicant had stated during the inspection that many of the fences within the proposed permit boundary are old ranch fences. However as addressed in the Division's adequacy review, per Rule 6.4 the Applicant shall determine the owner(s) of all fences within 200 feet of the proposed boundary and update Exhibits C and S of the CN1 application accordingly.

**Photo 7:** Fence along the north-side of the access road.

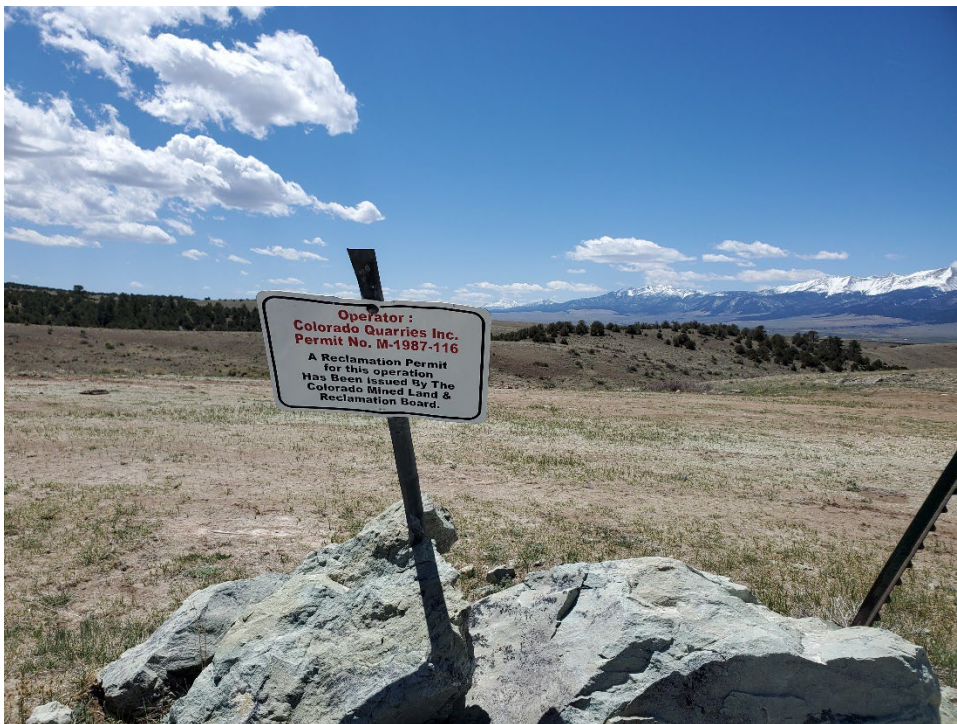
A mine sign was observed at the entrance to the currently disturbed area (Photo 8). This sign appears to be in compliance with Rule 3.1.12(1). Additionally, a notice of a proposed mining operation was posted on the entrance gate on the restricted portion to the CR 344 access road in compliance with Rule 1.6.2(1)(b) (Photo 9).

**Photo 8:** Mine sign posted at the current operation.

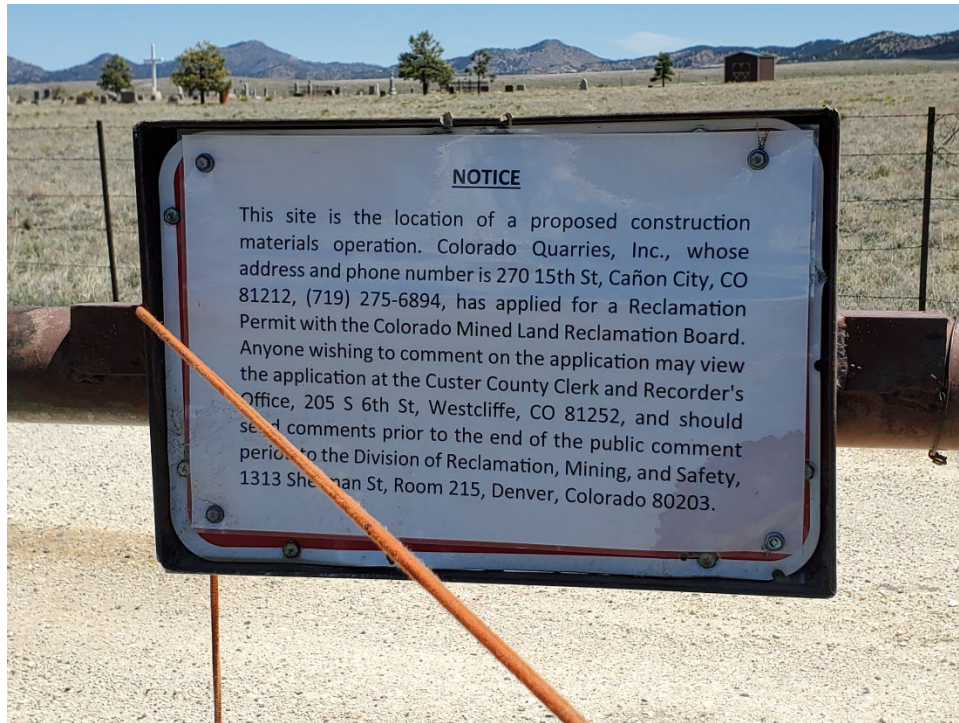
**Photo 9:** Notice sign posted on the entrance gate in compliance with Rule 1.6.2(1)(b).

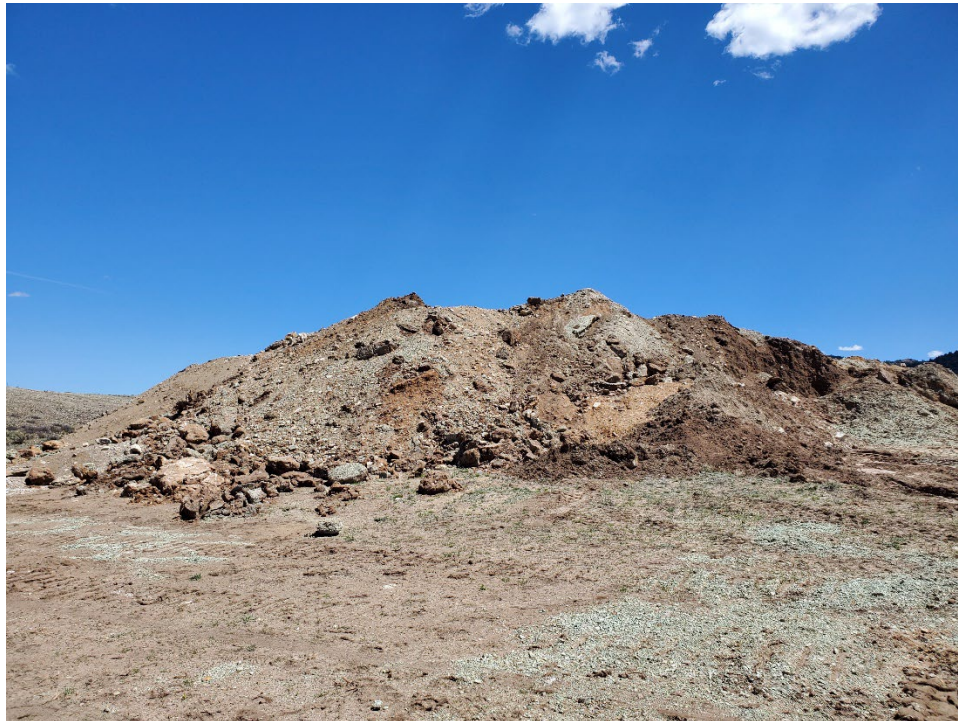
Topsoil was observed in the western portion of the current operation, away from ongoing mining operations in compliance with Rule 3.1.9(3) (Photo 10). The Applicant was told that they will need to stabilize the topsoil

**Photo 10:** Topsoil stockpile in the west side of the current operation.

pile with a vegetative cover (per Rule 3.1.9(1)), to which they stated they plan to stabilize the pile upon approval of CN1. The Division reminds the Operator that per Rule 3.1.9(4), the topsoil stockpile shall be rehandled as little as possible until replacement on regraded, disturbed area. If the pile is to be re-located and stabilized upon the approval of CN1, the planned configuration/stabilization **shall be reflected** in the Applicants adequacy response pertaining to the Division's topsoil concerns.

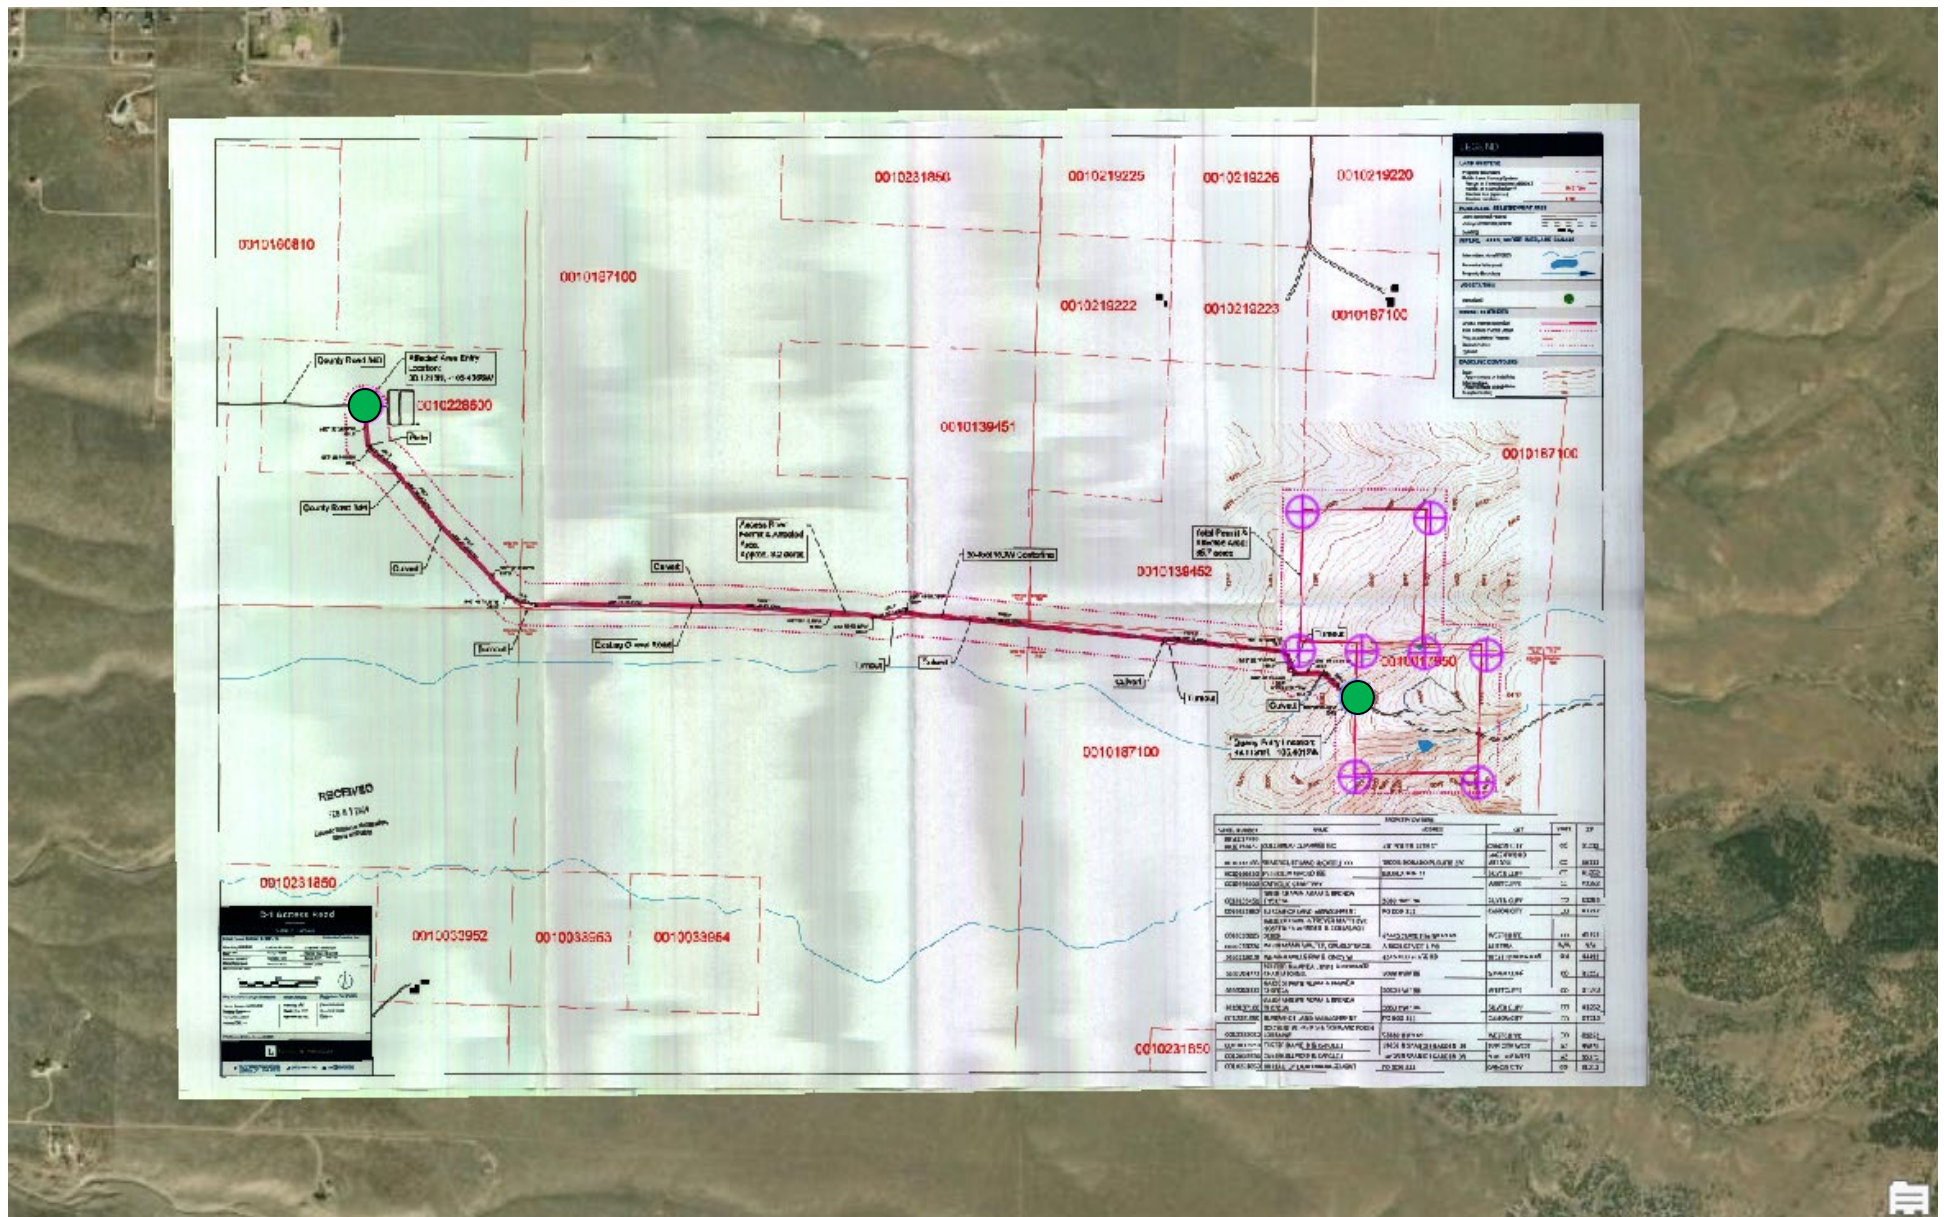
The Applicant had placed boundary markers around the proposed mining area prior to the inspection. The Applicant and the Division located each of the erected markers and collected approximate coordinates using the Esri Field Maps application (See Figure 1). The markers appear to be placed within this area in the orientation reflected on the maps in the CN1 application. Once approved, and prior to operation, the Applicant shall also place markers along the access road to be in compliance with Rule 3.1.12(2). During the inspection, the Applicant stated that they plan to install additional markers for line-of-sight, pit boundaries, and set-backs during each phase, upon approval of CN1.

**Figure 1:** An image of the Applicant's Map C-1, georeferenced into Esri's ArcOnline platform. The map was georeferenced using the Applicant provided access coordinates to the access road and entrance to the mining area (green circles). The purple cross-hair icons indicate the boundary marker locations collected in the field by the Division using Esri's Field Maps application.
