Keenesburg inspection report

PERMIT INFORMATION

Permit Number: C-1981-028 Mine Name: Keenesburg Strip Mine Operator: Coors Energy Company Operator Address: Mr. Ben Moline P.O. Box 4030 Golden, CO 80402	County: Weld Operation Type: Surface Permit Status: Permanent Cessation Ownership: Private
	Operator Representative Present: None
Operator Representative Signature: (Field Issuance Only)

Inspection Start Date: April 10, 2024 Inspection Start Time: 11:00 Inspection End Date: April 10, 2024 Inspection End Time: 11:50	Inspection Type: Coal Partial Inspection Inspection Reason: Normal I&E Program Weather: Cloudy
Joint Inspection Agency: None	Joint Inspection Contacts:
Post Inspection Agency: None	Post Inspection Contacts:
Inspector(s): Robert Zuber, P.E.	Inspector's Signature:

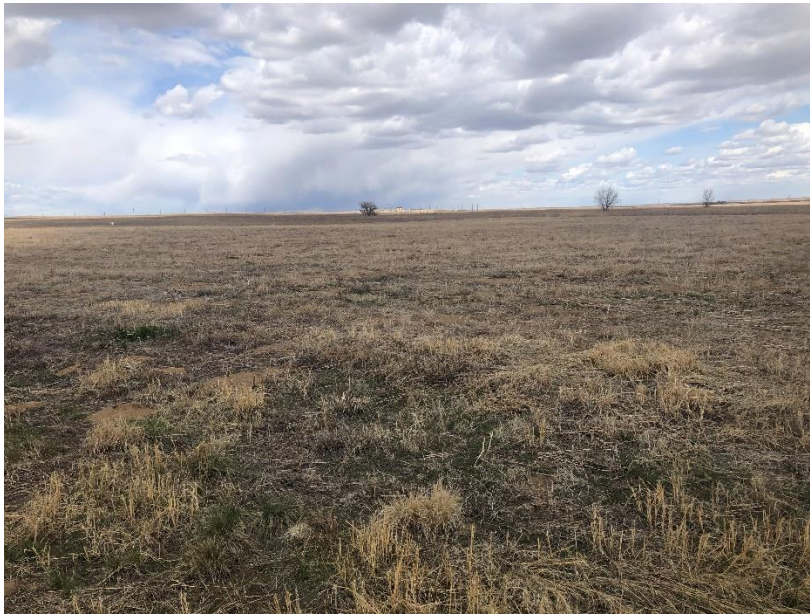
Area 25, looking northwest

The site is in Permanent Cessation. Most reclamation activities were completed in the fall of 2020. Due to poor success in some areas, however, Coors Energy reclaimed some areas again (harrowing and seeding) in the spring of 2022 and fall of 2023. It appeared that Area 25 had recently been mowed.

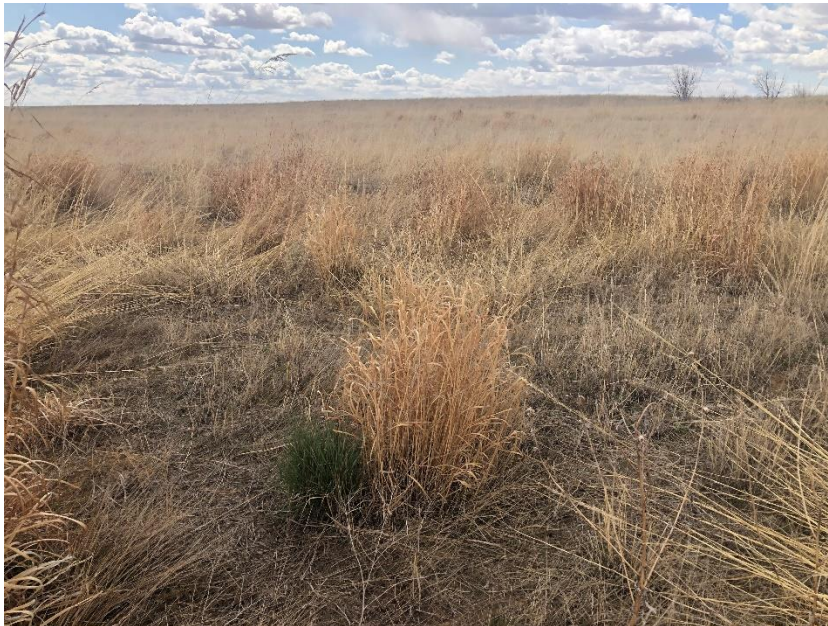
Some green grasses were emerging in many locations, including Areas 33, 35, and 36.

Emerging grass in Area 35

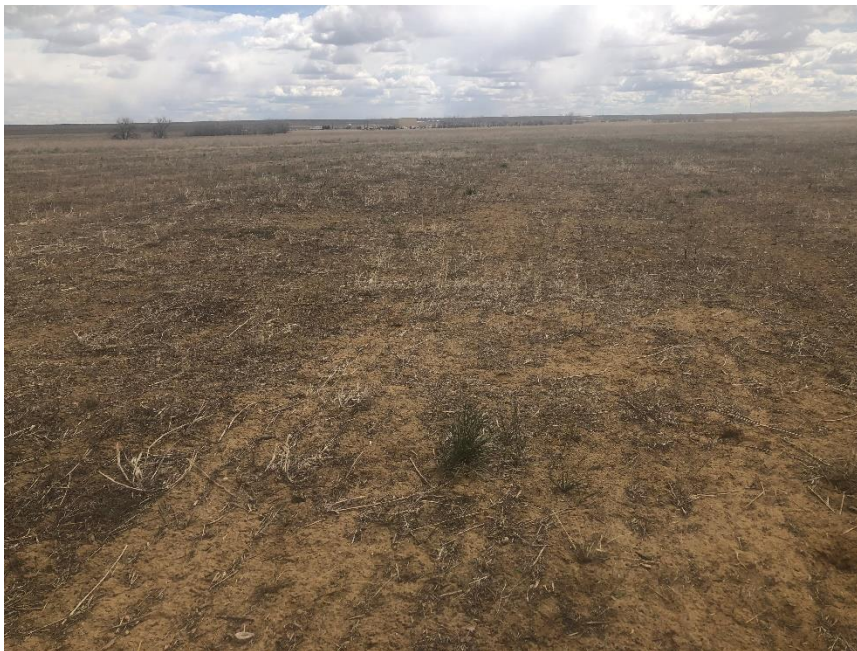
Emerging grass in Area 36, which was harrowed and seeded in 2023

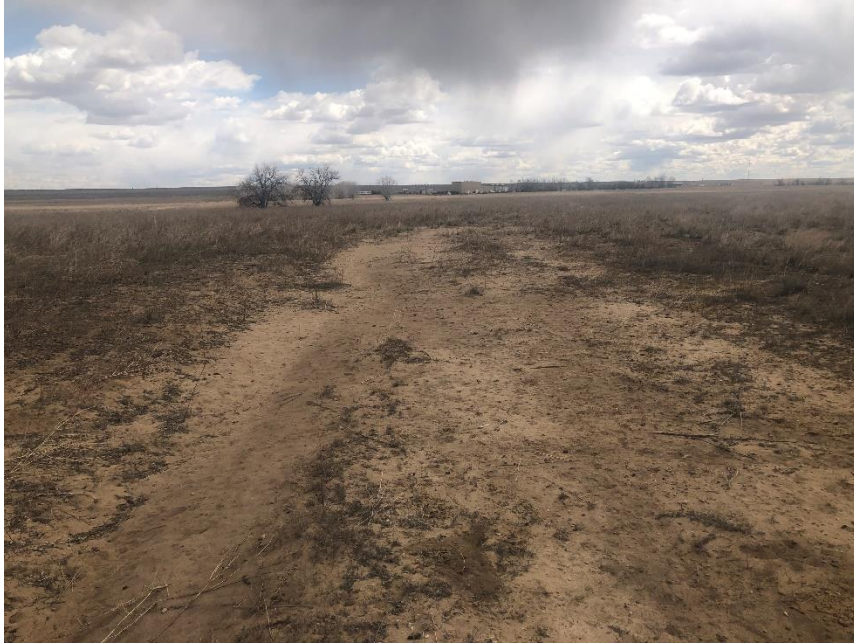
No erosion problems were seen onsite. The vegetation cover remains very good at the southwest portion of the site (older reclamation). A large bare area was seen in the southern portion of Area 37.

Bare ground in Area 37

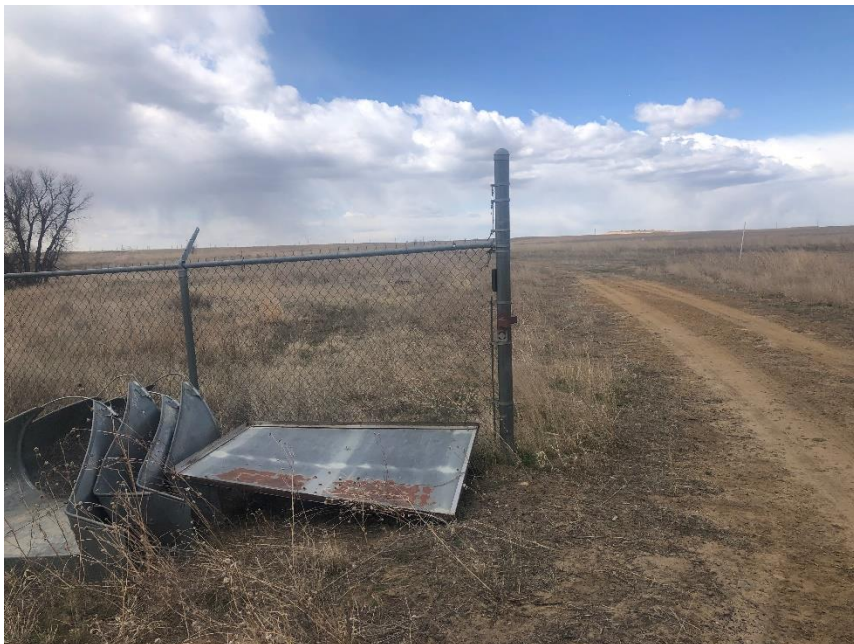
The entrance sign was laying on the ground, apparently blown over by strong winds in Eastern Colorado.

Entrance sign on ground
