MINERALS PROGRAM INSPECTION REPORT PHONE: (303) 866-3567

MINE NAME:		MINE/PROSPECTING ID#:	MINERAL:	COUNTY:
Debetz Pit		M-1977-283	Sand and gravel	Adams
INSPECTION TYPE:		WEATHER: Clear	INSP. DATE:	INSP. TIME:
Monitoring			April 3, 2024	11:00
OPERATOR:		OPERATOR REPRESENTATIVE:	TYPE OF OPERATION:	
Adams County		Trevor Graf	112c - Construction	Regular Operation
REASON FOR INSPECTION:		BOND CALCULATION TYPE:	BOND AMOUNT:	
Normal I&E Program		None	\$0.00	
DATE OF COMPLAINT:		POST INSP. CONTACTS:	JOINT INSP. AGENCY:	
NA		None	None	
INSPECTOR(S):	INSPECTOR'S SIGNATURE:		SIGNATURE DATE:	
Nikie Gagnon			May 14, 2024	
	Ai	Kie Gagnon

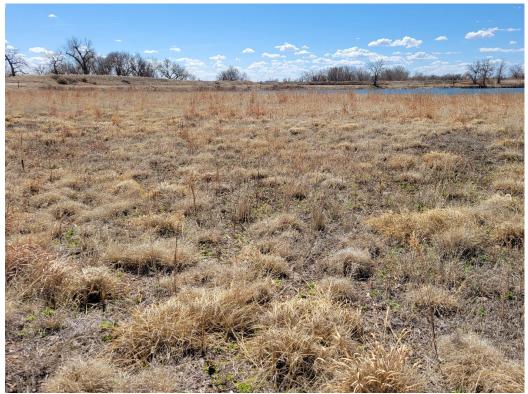
In 2015, the inert fill area was topsoiled and seeded with native plants. The Division observed newly planted cottonwood and willow trees on the eastern side of the lake, consistent with the approved reclamation plan. A dense cover of native grasses was observed in this area, including switchgrass, sand bluestem, blue grama. Willows were observed growing along the shoreline on the east side of the pond.

Photo 1: Looking south across the inert fill area in the northeast part of the permit area.

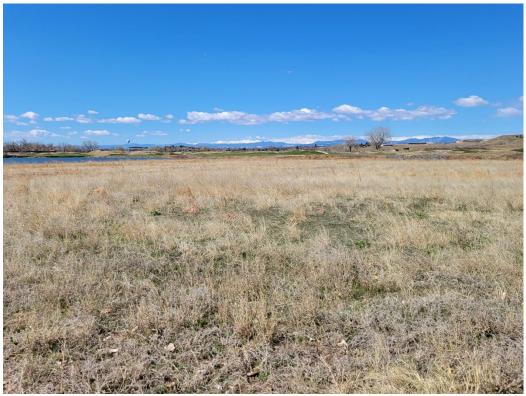
Photo 2: Looking west across the northeast part of the permit area.

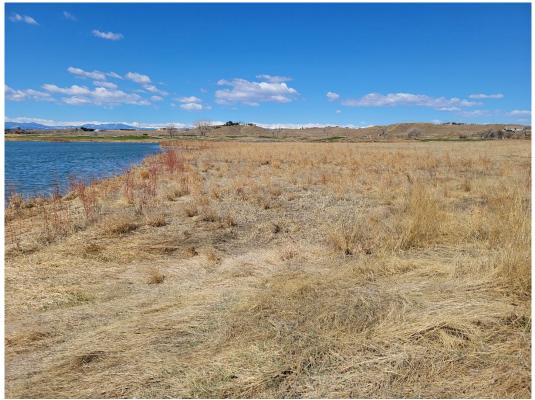
In the annual report, the Operator stated that over the past year they conducted weed control around the reservoir and removed tamarisk trees. During this inspection, the Division observed a few young tamarisk trees along the eastern shoreline of the pond. Adams County will need to continue to monitor and treat/remove the trees as necessary to prevent restablishment.

Photo 3: Looking at the north eastern edge of the reservoir. A few young Tamarisk trees observed here.

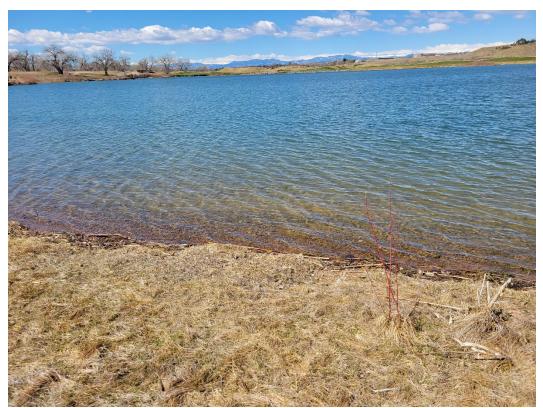
In 2014, the Division approved Technical Revision 2 (TR2) to address the shoreline slopes. The slopes on the southern and western sides were regraded to 3H:1V and vegetated. Four different areas were armored with rip rap to provide stability. In 2019, the County installed additional riprap along the southern side of the reservoir to control erosion. During this inspection, the Division observed the bank stabilization and armoring work along the shoreline. The shoreline is vegetated on all sides of the pond. No new erosion concerns were observed.

Photo 4: Gentle slopes along shoreline on the southeast side of the lake.

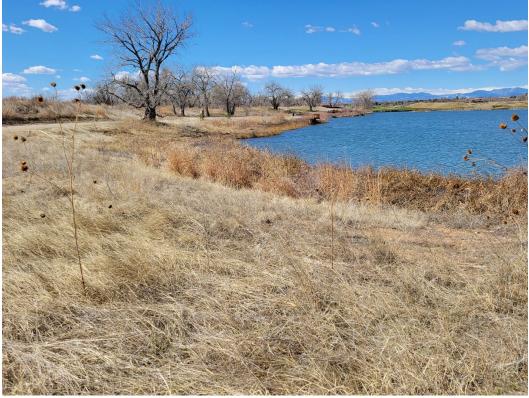
Photo 5: Gentle slopes along shoreline on the south side of the lake.

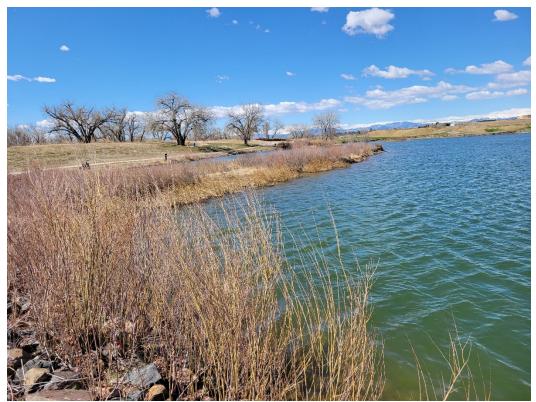
Photo 6: View of the southwest side of the lake near the fishing pier. Rip rap installed to stabilize the shoreline.

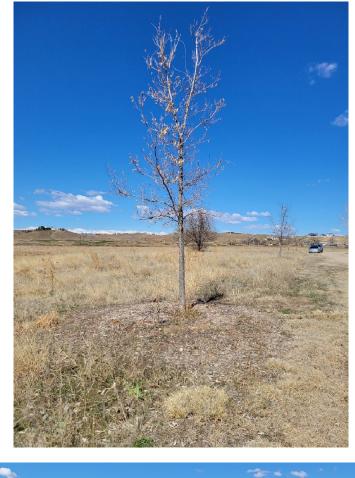
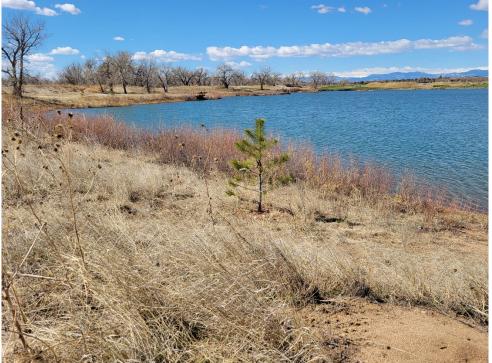
Photo 7 & 8 : Looking at trees planted along the bike path east of the pond.

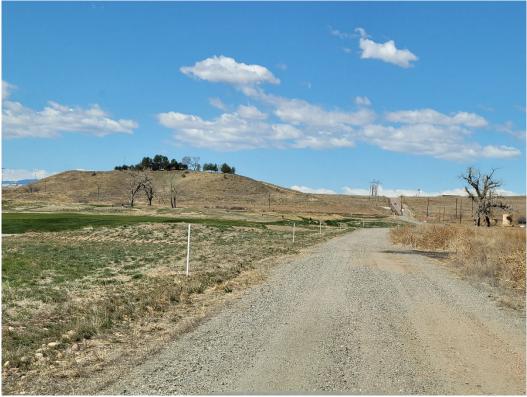
Photo 9: Looking down access road towards the entrance. Permit boundary marked by white posts around the side.

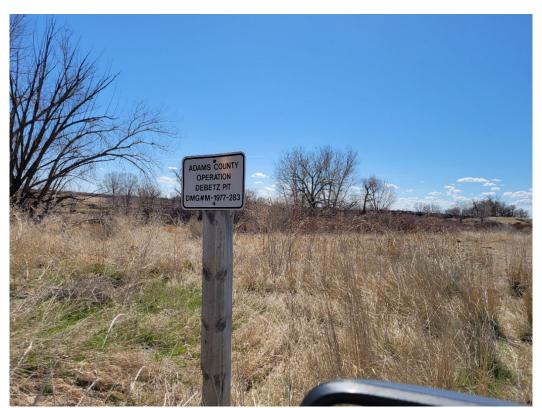
Photo 10: Mine sign posted off Riverdale Road, at the entrance to the access road.

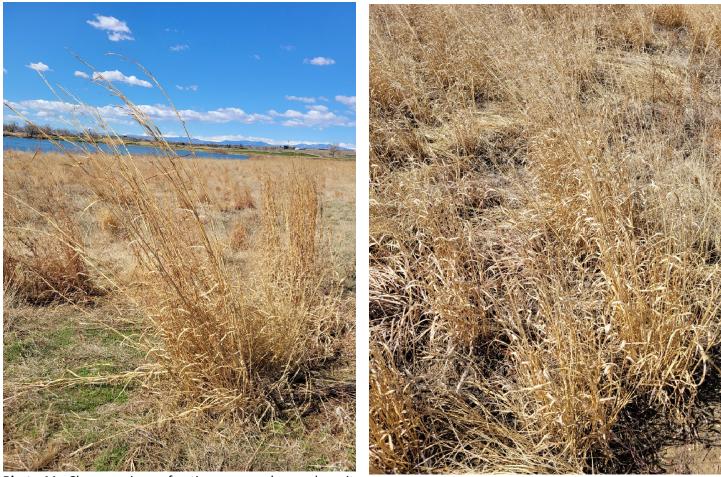
Photo 11: Close-up views of native grasses observed on site.
