Roadside Mine, C-1981-041, April Inspection Report

PERMIT INFORMATION

Permit Number: C-1981-041 Mine Name: Roadside Portals Operator: Snowcap Coal Company, Inc. Operator Address: MS Tonya Hammond 743 Horizon Court, Suite 334 Grand Junction, CO 81506	County: Mesa Operation Type: Underground Permit Status: Active Ownership: Private
	Operator Representative Present: Tonya Hammond
Operator Representative Signature: (Field Issuance Only)

INSPECTION INFORMATION

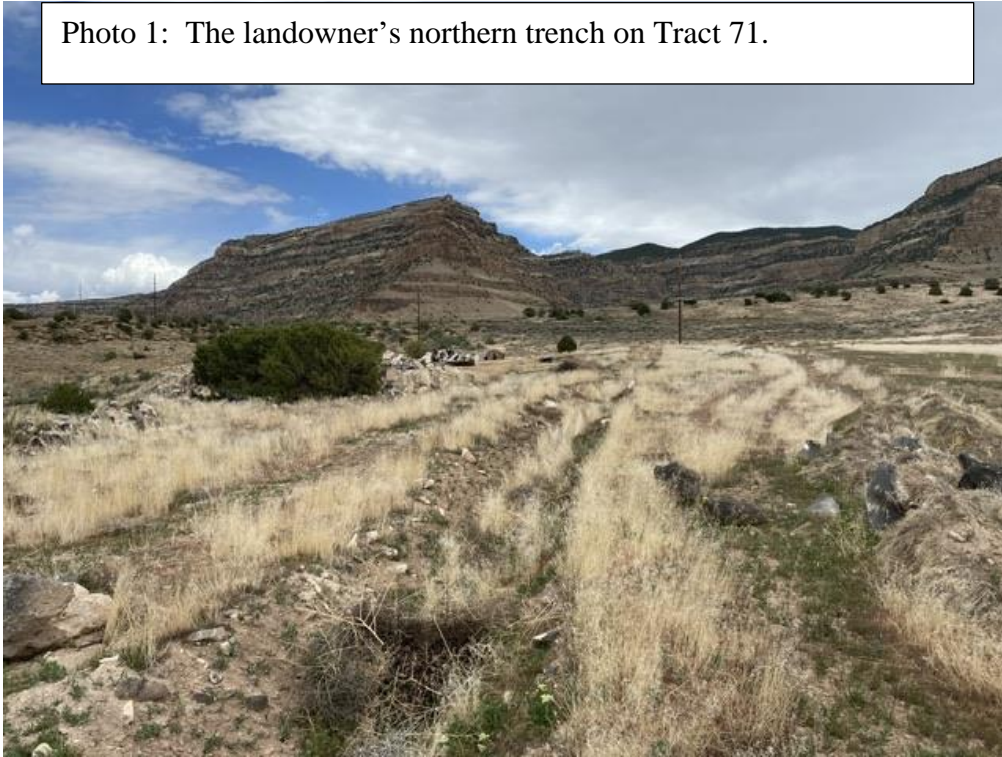
During the inspection, all of the landowners buried pipelines and exposed trenches on Tract 71 were not receiving water (Photo 1). The trenches located on the eastern and northern part of Tract 71 had no indications of recent water application. The Landowner's middle Field was also observed to be dry. There was no indication of recent water application to the field. Likewise, all of the landowner's trenches on top of the Tract 70 Mesa were dry. There were no signs that there had been recent water application to the trenches. The Carey Pit, located in the southwestern portion of the permit area, had a small puddle of water in the bottom from recent precipitation events (Photo 2).

Photo 1: The landowner's northern trench on Tract 71.

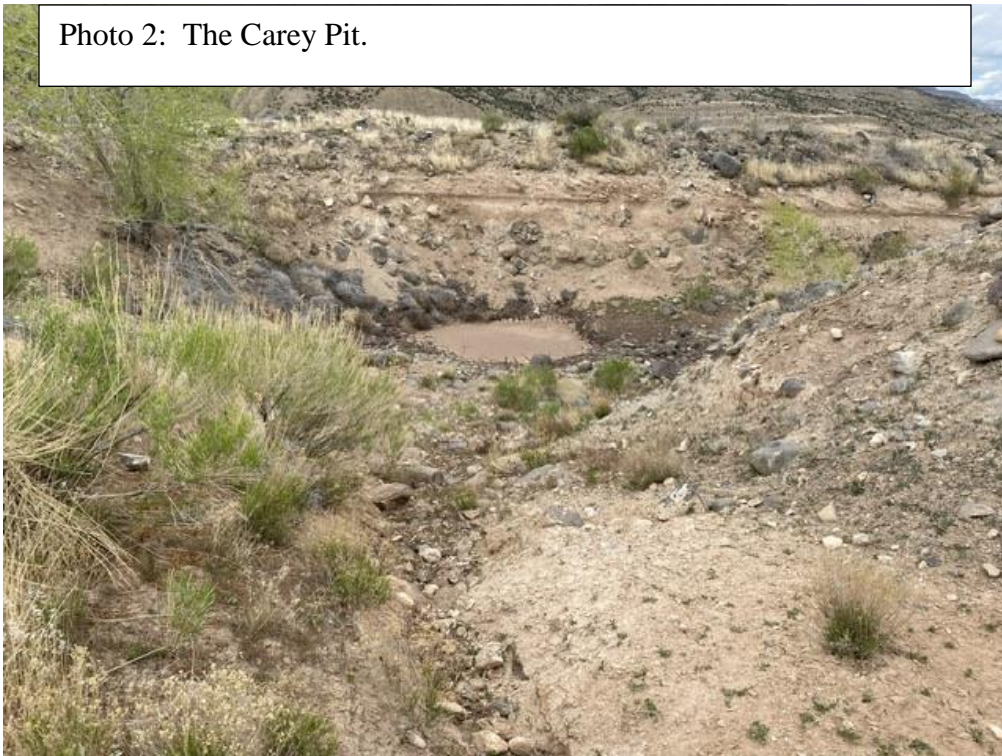
Photo 2: The Carey Pit.

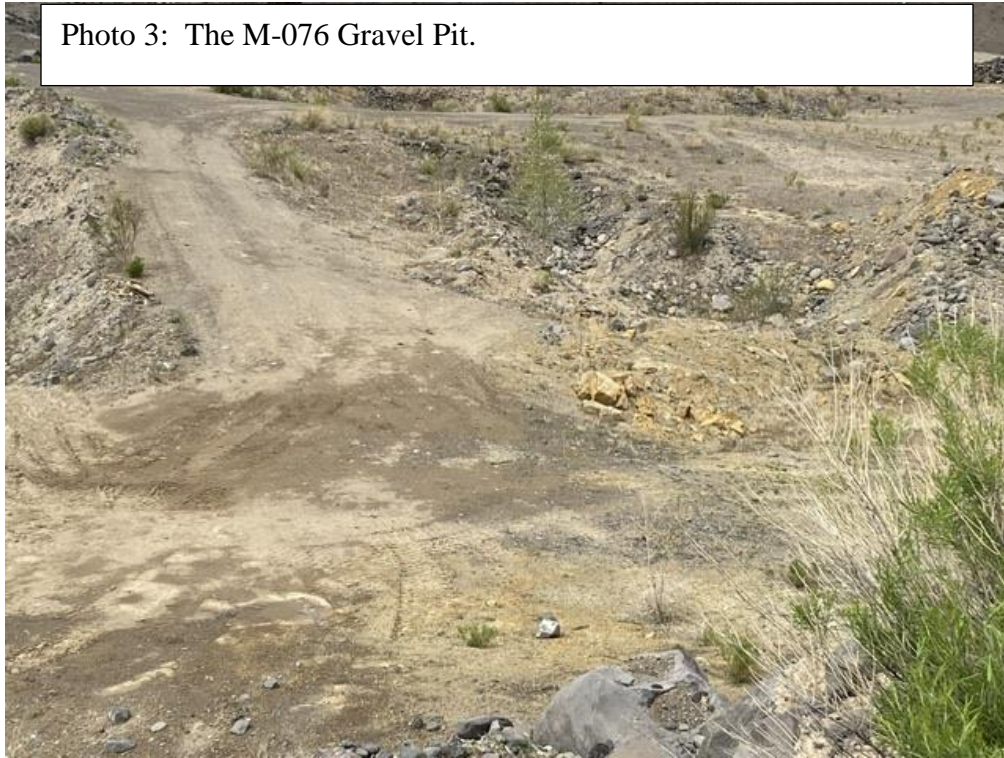
During this inspection, the Division observed no indications that water flowing out of the buried pipeline into the M-076 gravel pit had occurred. Only damp soils and small puddles were observed from precipitation events that

had occurred a couple of days prior to the inspection (Photo 3).

Photo 3: The M-076 Gravel Pit.

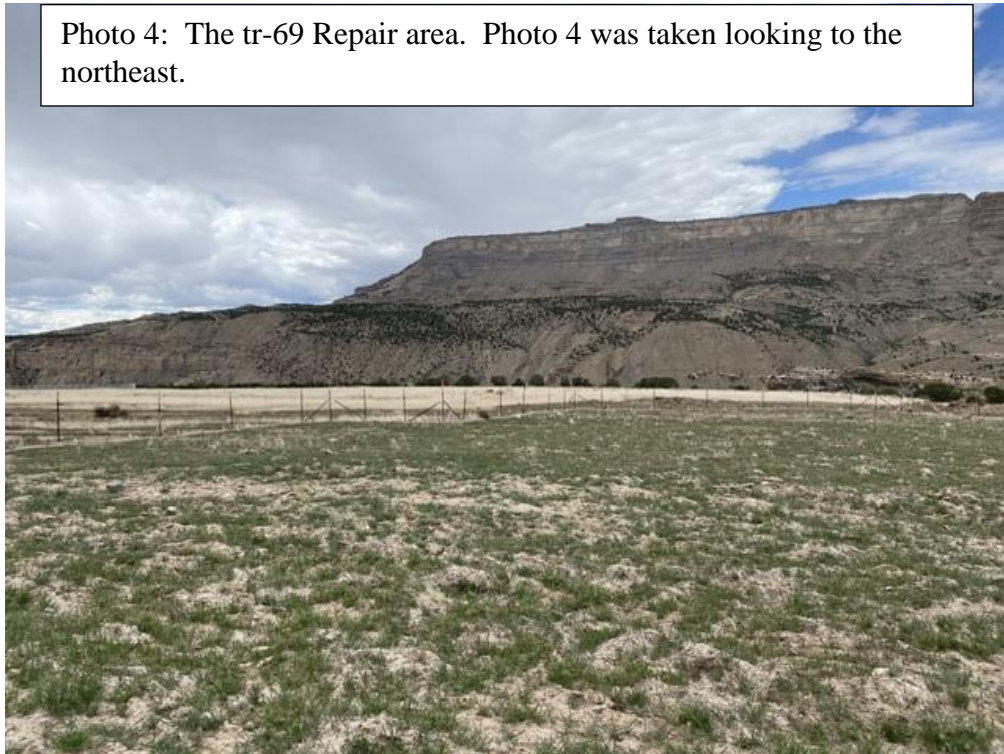
During this inspection the repair area was stable with no indications of erosional features. The seeds from last fall had begun to germinate and grow. Much of the reclaimed area had new vegetative growth (Photos 4 and 5). The operator's representative stated that spring weed spraying on the 0.4 acres had occurred on April 17th. Withering weeds were observed at the reclaimed area, confirming the representative's statement (Photo 6). The straw waddles placed at the southern and western portions of the reclaimed area were in good condition and there were no off-site impacts observed. The Fencing around the repair area was stable and in good condition. Posted on the one of the southern facing fence posts was a mine identification sign. The sign was posted in a location with an unobstructed view shed. The sign displayed the mine's permit number, permittee's contact information and the Division's contact information.

Photo 4: The tr-69 Repair area. Photo 4 was taken looking to the northeast.

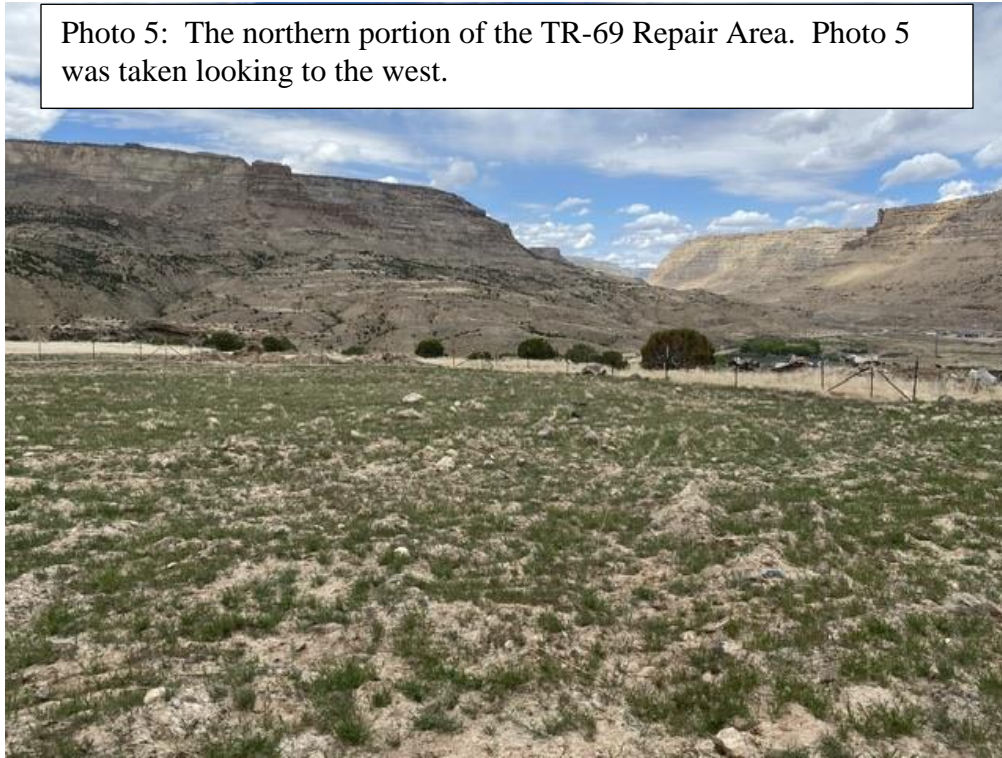
Photo 5: The northern portion of the TR-69 Repair Area. Photo 5 was taken looking to the west.

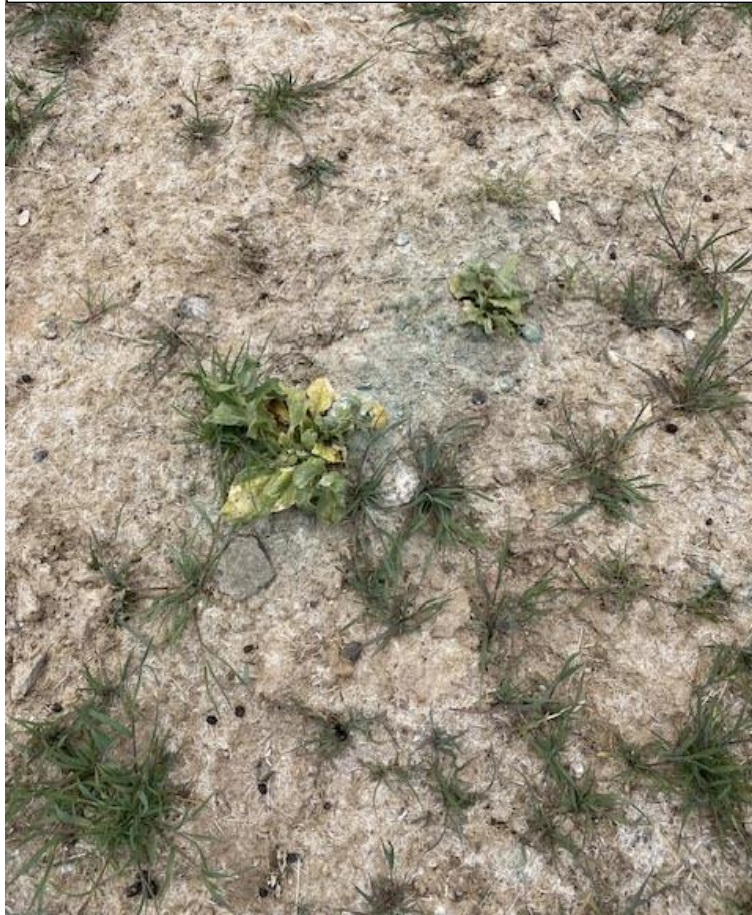
Photo 6: Weeds Sprayed at the TR-69 Repair Area.
