**MINERALS PROGRAM INSPECTION REPORT**  
**PHONE: (303) 866-3567**

<b>MINE NAME:</b> Ignacio Pit	<b>MINE/PROSPECTING ID#:</b> M-1992-054	<b>MINERAL:</b> Sand and gravel	<b>COUNTY:</b> La Plata
<b>INSPECTION TYPE:</b> Surety-Related Inspection	<b>WEATHER:</b> Clear	<b>INSP. DATE:</b> May 7, 2024	<b>INSP. TIME:</b> 14:00
<b>OPERATOR:</b> LBCR, LLC	<b>OPERATOR REPRESENTATIVE:</b> Brian Abeln	<b>TYPE OF OPERATION:</b> 112c - Construction Regular Operation	
<b>REASON FOR INSPECTION:</b> Surety Related	<b>BOND CALCULATION TYPE:</b> Complete Bond	<b>BOND AMOUNT:</b> \$117,894.00	
<b>DATE OF COMPLAINT:</b> NA	<b>POST INSP. CONTACTS:</b> None	<b>JOINT INSP. AGENCY:</b> None	
<b>INSPECTOR(S):</b> Dustin Czapla	<b>INSPECTOR'S SIGNATURE:</b>

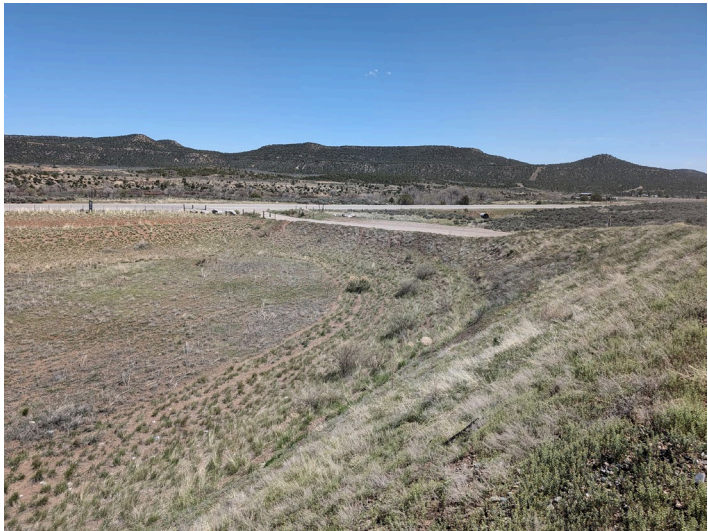
Phase D Area

The pit is separated into four phases, A-D. The Phase D area has been mined out and reclamation has been completed. Slopes around the pit in this area have been reduced to 3H:1V and appear stable. Revegetation has taken place and vegetative cover is becoming well established. The Phase C area has been mined out and regraded. An overburden stockpile is still located in this area. Mining has moved into areas A and B. A road has been constructed, running north from the Phase C area to the Phase B area, along the west side of the Phase A and B areas. Topsoil and overburden have been stripped and stockpiled, and gravel extraction has begun.

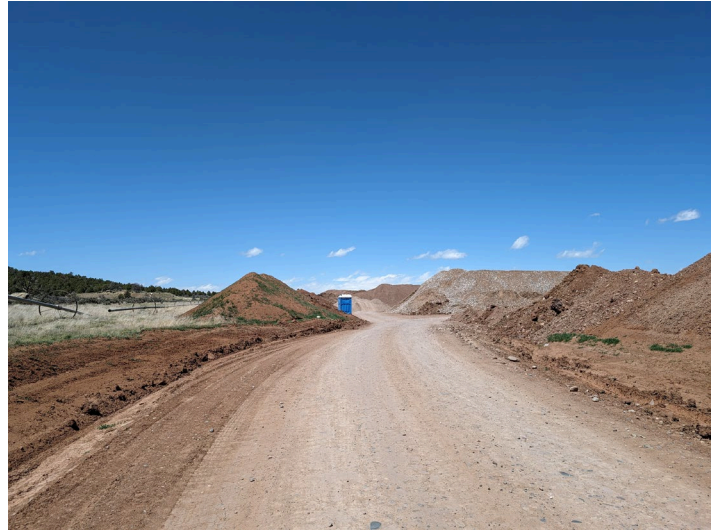
New road to Phase A and B areas
