May Partial Inspection Report

Division of Reclamation,
Mining and Safety

Permit Number: C-1981-018 Mine Name: Deserado Mine Operator: Blue Mountain Energy, Inc Operator Address: Mr Kurtis Blunt 3607 County Road 65 Rangely, CO, 81648	County: Moffat, Rio Blanco Operation Type: Underground Permit Status: Active Ownership: Private
	Operator Representative Present: Kurtis Blunt
Operator Representative Signature: (Field Issuance Only)

Inspection Start Date: May 1, 2024 Inspection Start Time: 09:45 Inspection End Date: May 1, 2024 Inspection End Time: 12:15		Inspection Type: Coal Partial Inspection Inspection Reason: Normal I&E Program Weather: Cloudy	
Joint Inspection Agency: None		Joint Inspection Contacts: NA	
Post Inspection Agency: None		Post Inspection Contacts: NA	
Inspector(s): Todd Jesse	Inspector's Signature:

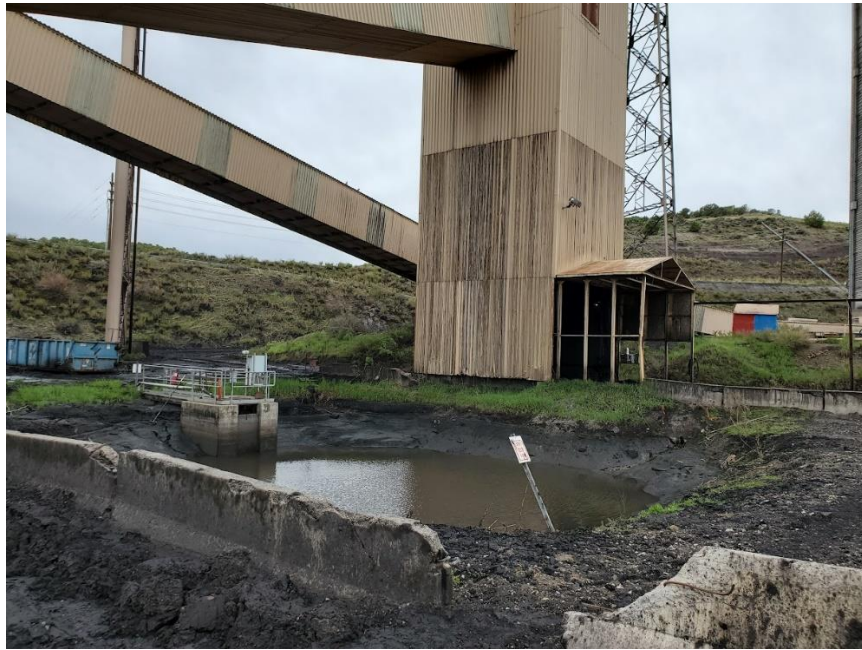
There are three ponds located in the main facilities area: the DP-1 Pond, the PP-1 Pond and the PP-2 Pond. The DP-1 Pond is located on the southern part of the lower facilities bench. DP-1 collects all runoff from the from the three facilities benches. The outlet structure was clear of debris and the pond was discharging at the time of inspection. The embankments appear stable with well-established vegetative cover. There were no erosional concerns identified. The ditches that convey water from the benches to the pond are in good condition with no maintenance items noted. The PP-1 Pond is located on the middle bench of the facilities area near the prep plant. The pond was below the discharge level. There were no erosion or stability issues identified in the PP-1 Pond (Photo 1). The PP-2 Pond is located on the upper facilities bench. The embankment was stable with no erosional features identified. The outlet structure was in good condition with no vegetation obscuring the outlet. Water diversion ditches throughout the main facilities area were unobstructed and stable (Photo 2).

Photo 1: View to the southeast of pond PP-1

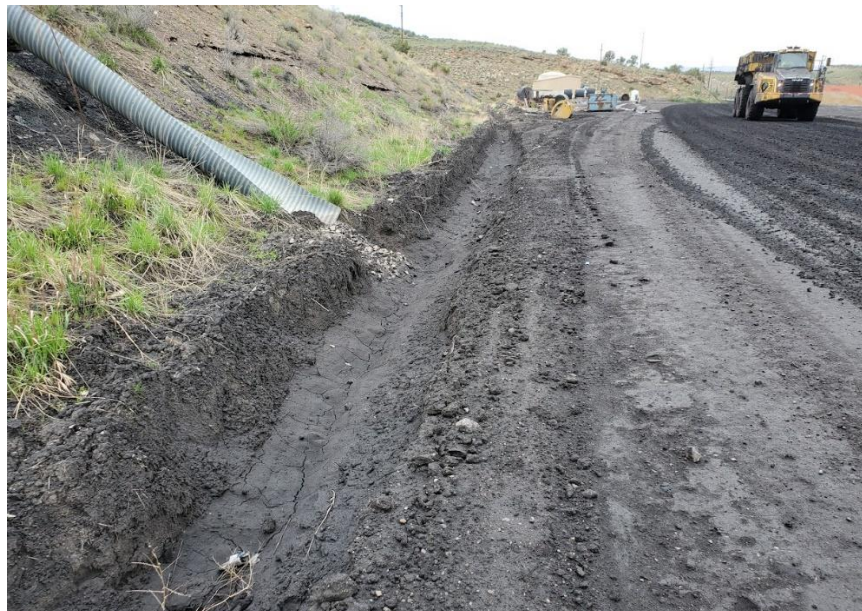
Photo 2: View to the northwest of ditch in facilities area

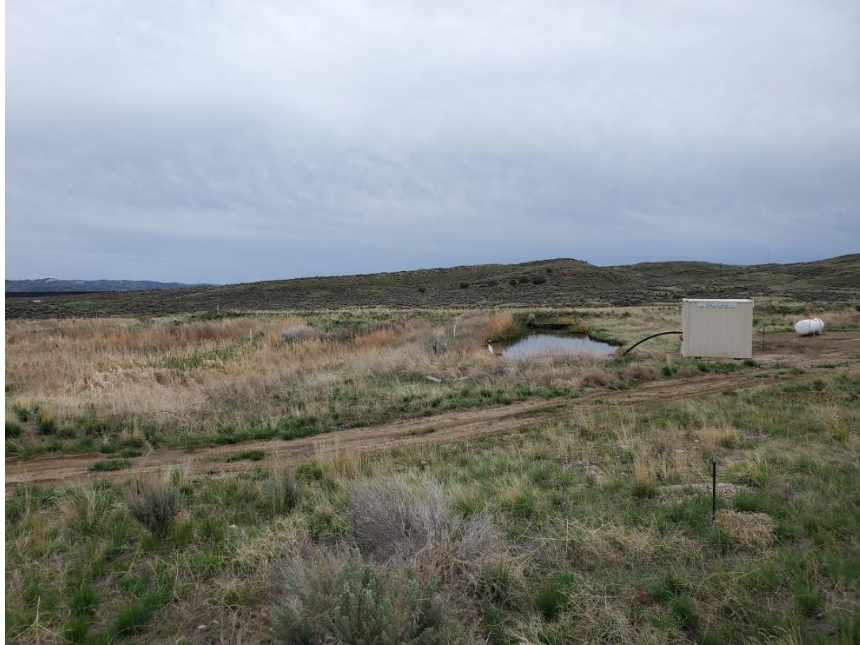
The B Seam Dewatering System No. 1 was active during the inspection. Cells were impounding water. (Photo 3) There was well established vegetation on the embankments of the cells. The cells were stable with no erosional or other stability features noted. The Last Chance Pond was discharging at the time of the inspection.

Photo 3: View to the east of B Seam Dewatering System #1

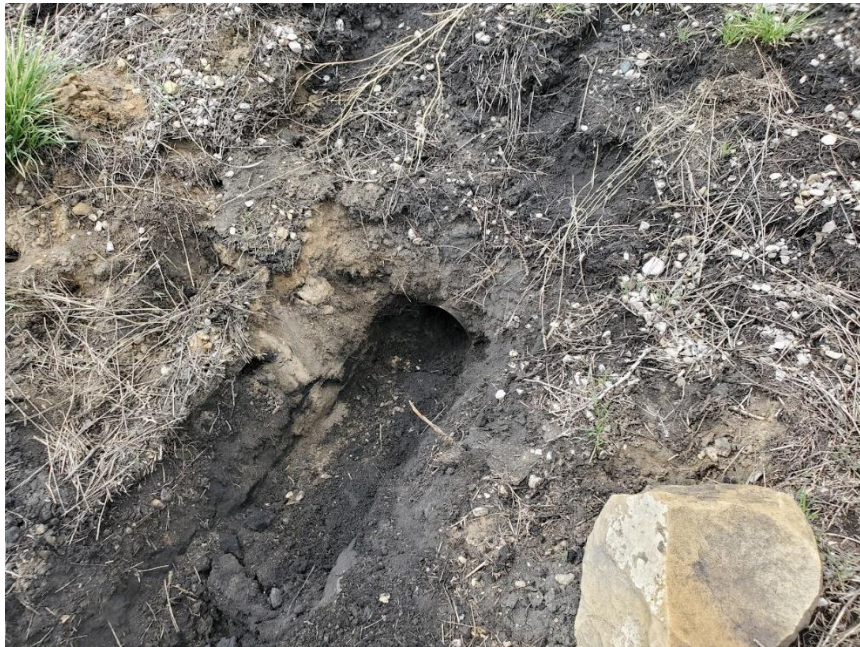
Culverts around the Nitrogen Plant to the south of the Slot Storage were partially filled with sediment. The culverts were cleared by the operator during the inspection and now appear to be free of obstruction and able to properly convey water. (Photo 4)

Photo 4: View to the south of culvert that was cleared next to the Nitrogen Plant.

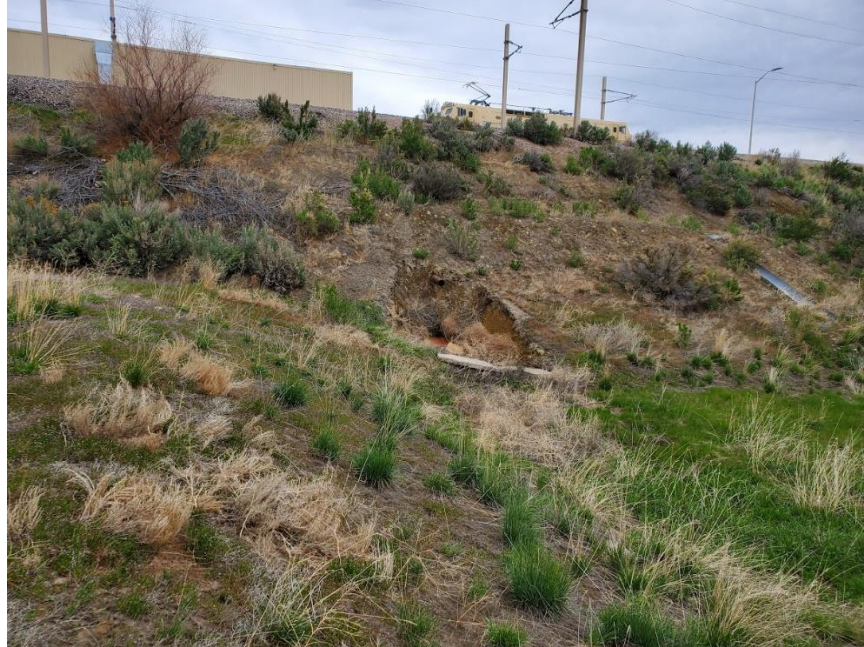
The RS-1 Sump and the RR-1 Pond are located at the south side of the Rail Loadout. The RS-1 Sump was. There were no indications of erosion. The RR-1 Pond was also dry. The embankments of the pond seem stable. The erosion feature on the northern embankment that has been noted in previous inspection reports does not appear to have grown in size. (Photo 6) The Rail Loadout Storage South Ditch has been cleared of brush and appears to be able to conduct water normally. (Photo 7)

Photo 5: View to the north of erosional scar in the Rail Loadout Pond. The scar does not appear to have grown in size.

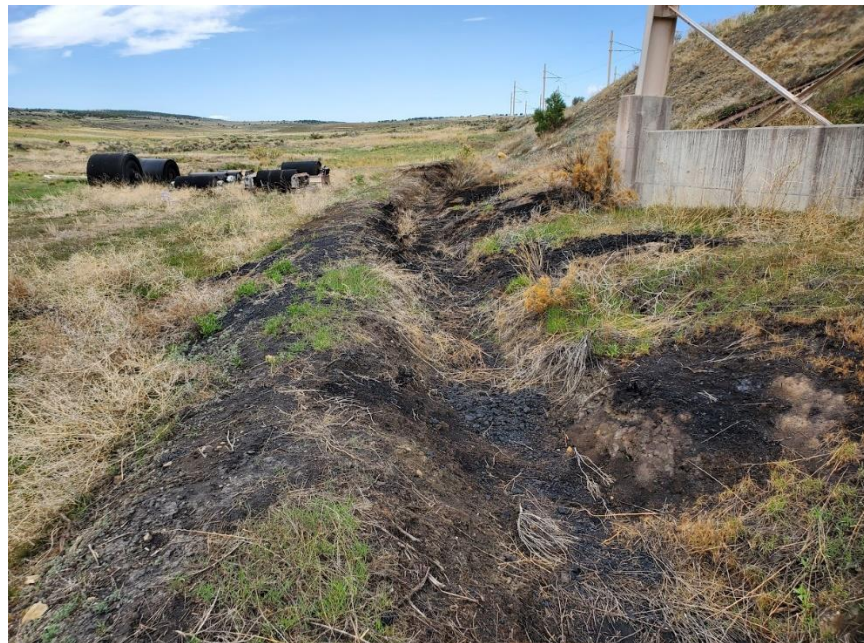
Photo 6: View to the west of Rail Loadout Ditch after it was cleaned.

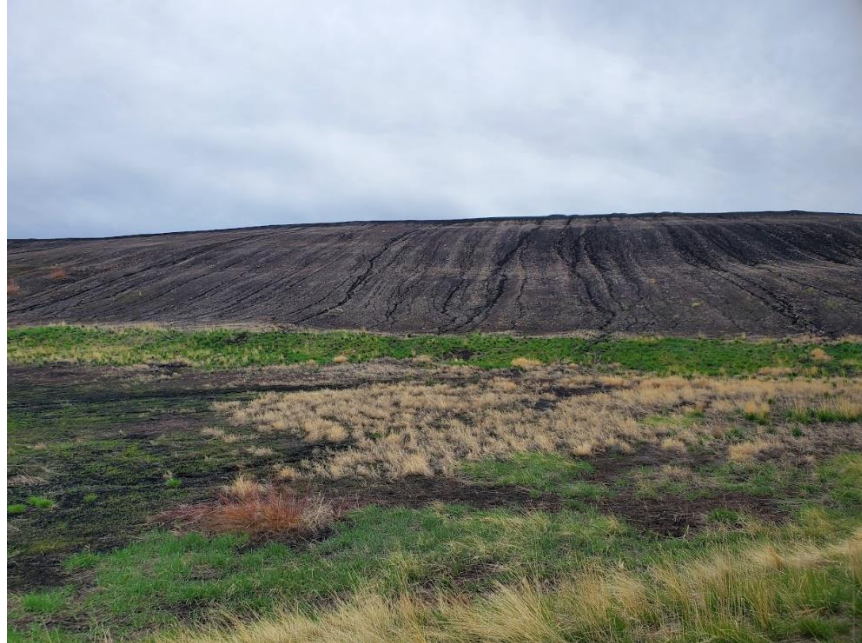
During the inspection refuse material was being placed in windrows on the RP-2/3/4, RP-5a, and RP-A Refuse Pile. The piles were stable. Erosion on the slopes of the pile has been noted in previous Division inspection reports. The rills are beginning to enlarge and will to be filled in once crews are able.

Photo 7: View to the south of rills that have extended into the RP-4 Pond.

1. Please fill animal burrow in the embankment of Pond RP-4.
2. Please repair the rills on the embankments to Pond RP-4.

Please fill animal burrow in the embankment of Pond RP-4 and provide the Division with photos of the completed maintenance item by June 15, 2024. Please complete repairing the rills on the embankments of Pond RP-4 when regrading the refuse pile slopes above the pond in the spring.

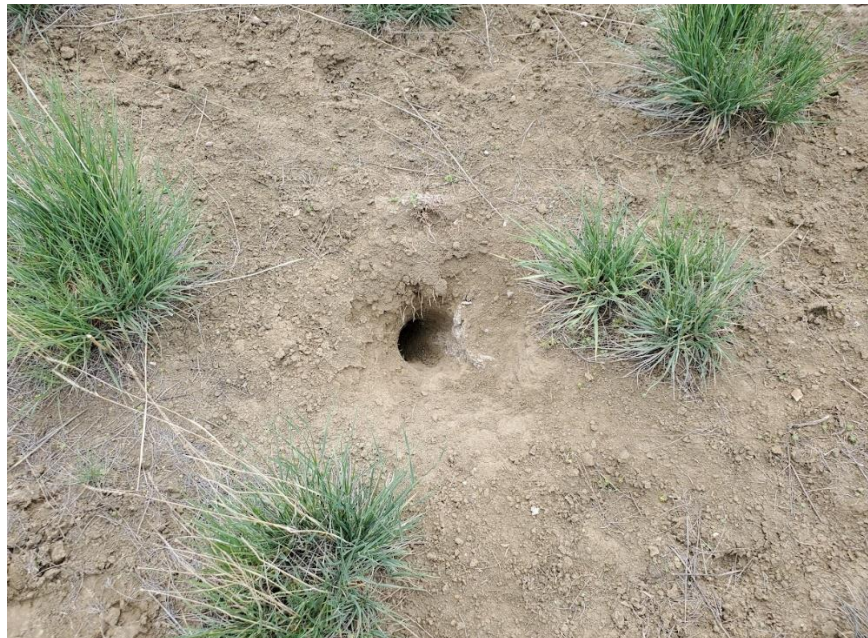
erosional features were noted on the embankments of the conveyance ditches. The trash rack was clear of debris. The RP-4 Pond is located at the northwest base of the pile. The pond was holding minor amounts of water during the inspection. **The southern embankments directly below the stack are beginning to show signs of erosion. The rills that have formed on the embankments of the refuse pile are now cutting into the vegetated embankment. Please repair the rills that have formed on the pond embankment. (Photo 7) An animal burrow was discovered on the opposite embankment. Please fill the animal burrow on the pond embankment. (Photo 8)** The outlet for the RP-4 Pond is capped with a trash rack. The outlet was clear of debris.

Photo 8: View to the southeast of animal burrow in the RP-4 Pond embankment.
