# MINERALS PROGRAM INSPECTION REPORT PHONE: (303) 866-3567

MINE NAME:	MINE/PROSPECTING ID#:	MINERAL:	COUNTY:
Stewart Pit II	M-2009-010	Sand and gravel	Kit Carson
INSPECTION TYPE:	WEATHER: Foggy	INSP. DATE:	INSP. TIME:
Monitoring		February 16, 2024	13:30
OPERATOR:	<b>OPERATOR REPRESENTATIVE:</b>	TYPE OF OPERATION:	
McCormick Excavation & Paving, LLC	None	112c - Construction Regular Operation	
REASON FOR INSPECTION:	BOND CALCULATION TYPE:	BOND AMOUNT:	
Normal I&E Program	None	\$3,919.00	
DATE OF COMPLAINT:	POST INSP. CONTACTS:	JOINT INSP. AGE	NCY:
NA	None	None	
INSPECTOR(S):	INSPECTOR'S SIGNATURE:	SIGNATURE DATE:	
Elliott Russell	The Prull	March 15, 2024

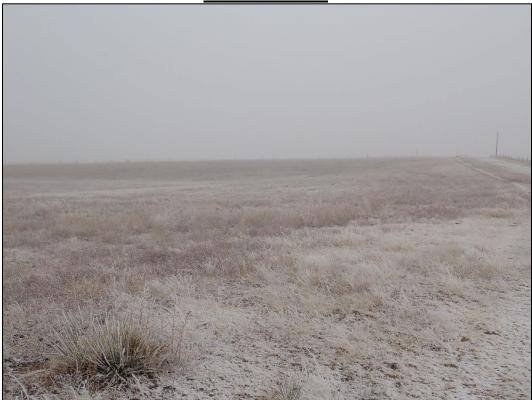
Photo 1. Sample photo of the reclaimed northern mining area; looking north.

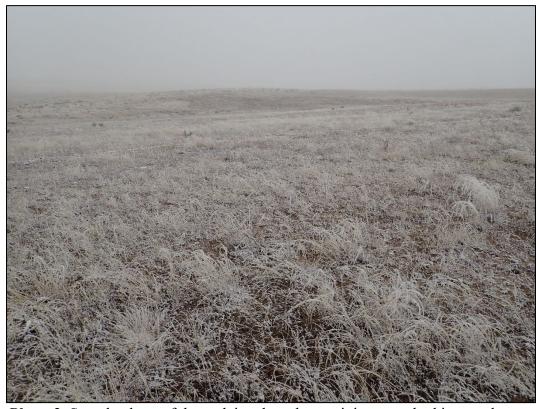
Photo 2. Sample photo of the reclaimed northern mining area; looking northwest.

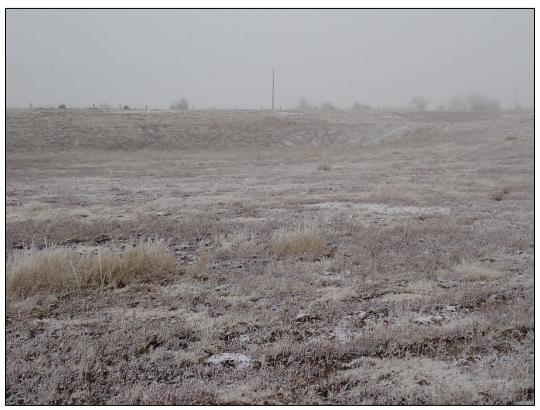
Photo 3. Sample photo of the reclaimed southern mining area; looking southeast.

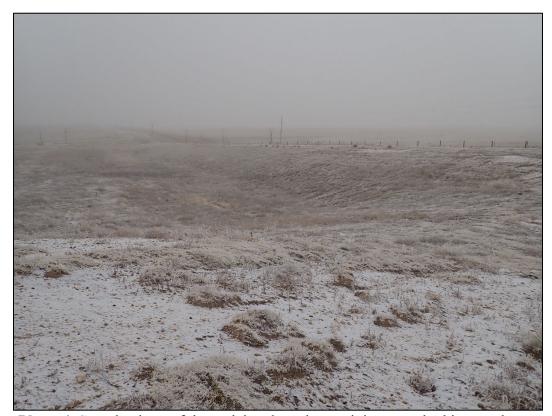
**Photo 4.** Sample photo of the reclaimed southern mining area; looking northeast.

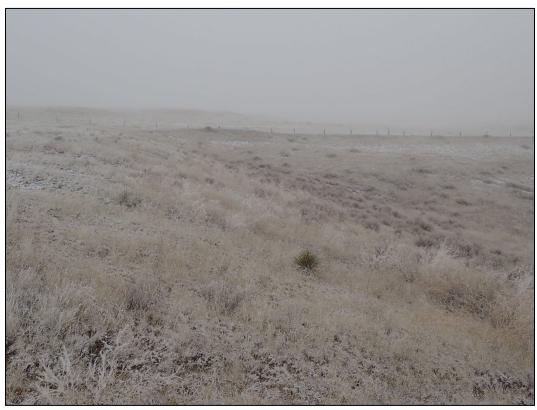
**Photo 5.** Sample photo of the reclaimed mining area located to the west of the southern mining area; looking south.
