TECHNICAL MEMORANDUM

DATE: December 19, 2023

SUBJECT: Vermillion Creek Restoration at Diamond Peak Ranch - 2023 Adaptive Management
Phase 1 and 2

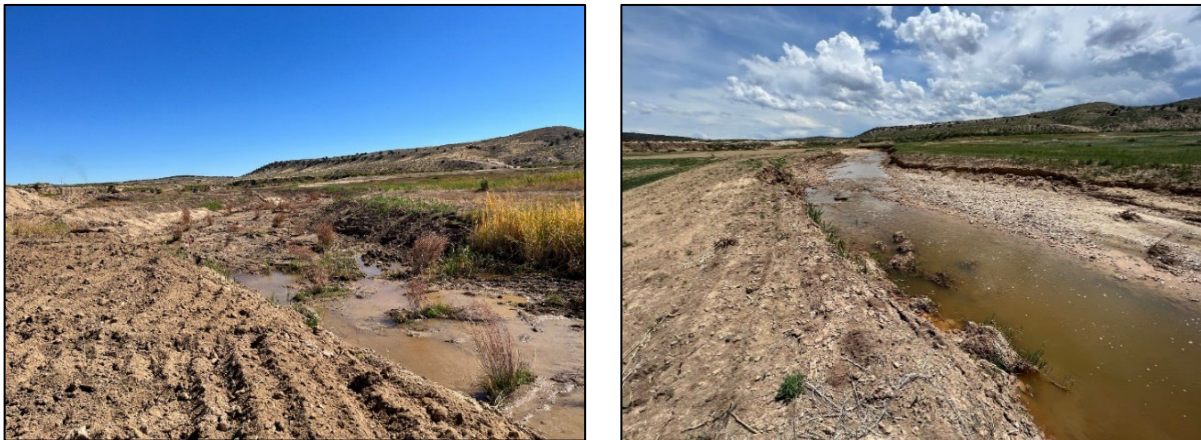
Figure 1. Post-construction channel (left photo) was SEM stage 2 (Channelization). Note the trapezoidal channel shape with no defined channel. SBS and transplants were installed to create disturbance including bank erosion to help push the channel further along the evolution trajectory. Post-flood channel (right photo) has widened and aggraded, moving towards SEM between Stage 5 and 6.

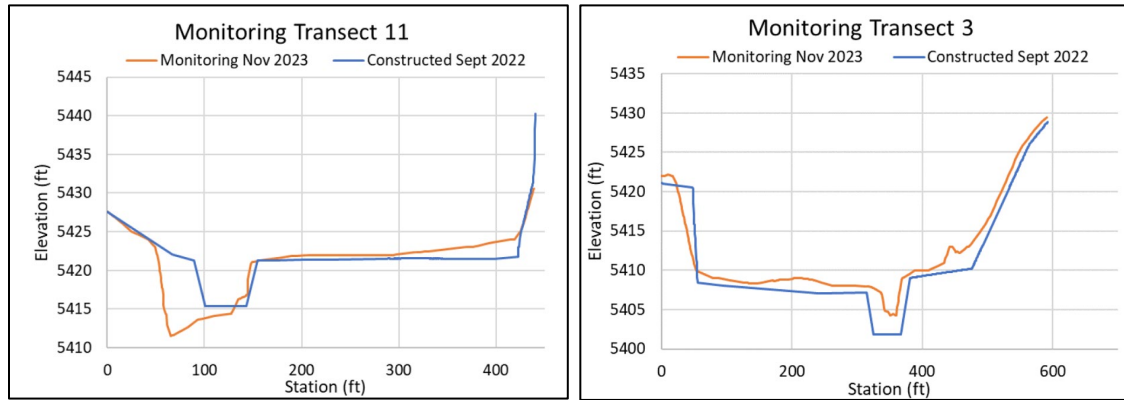
Cross sectional survey data were collected and analyzed for channel adjustment to add another line of evidence for the Project's SEM trajectory. Repeat cross sectional data from pre- and post-flood show the channel has mainly incised and widened upstream of the low water crossing at Station 52+20 and aggraded and widened downstream of the low water crossing (Figure 5 and Appendix C). This data comparison reinforces field assessment observations that indicate the flood has moved Vermillion Creek along the stream evolution as intended.

Figure 5. Repeat cross sectional survey data show the channel has incised and widened upstream of the low water crossing structure at Station 52+20 (left, transect 11 near Station 69+00) and aggraded and widened downstream (right, transect 3 near Station 22+00).

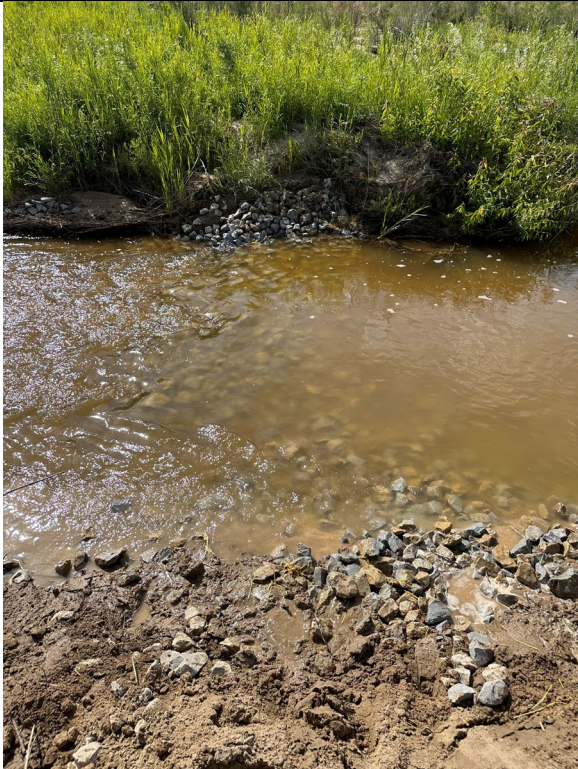
Photo 14: 5/25/23 Height of high flow debris measurement near cross section STA 2+40

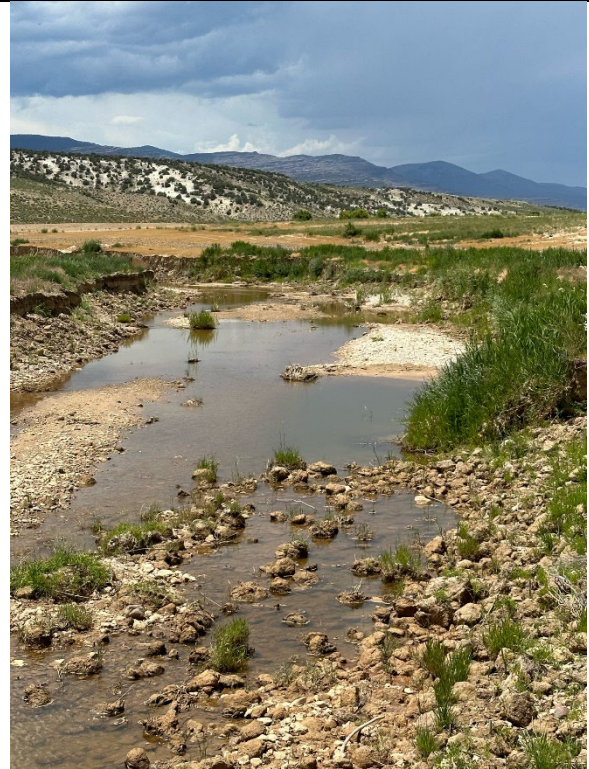
Photo 15: 6/16/2023 Downstream Check Dam BMP repaired

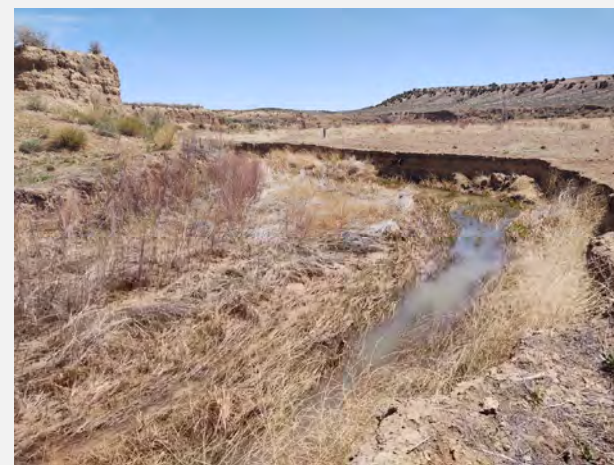
Fig. 7. The on-site reference reach in the impact channel, showing a likely developmental outcome of the mitigation. Photograph reproduced from the Baseline FACWet assessment report (JEC 2021).

Once vegetation is sufficiently established to bind the sandy soils, channels should begin passively forming as suggested by the on-site reference reach identified in the (former) impact channel (**Fig. 7**).

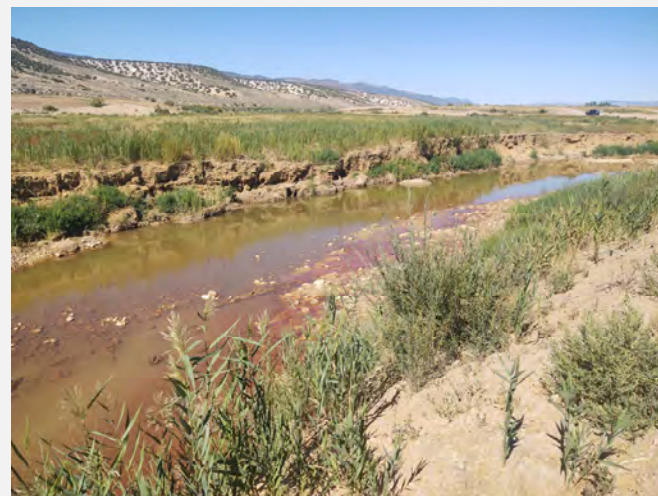
Fig. 8. One the extreme examples of impaired water distribution, found in the upper reach.

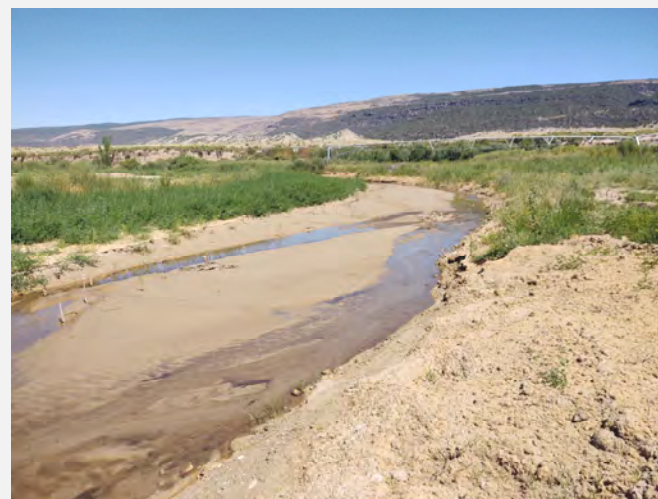
Only minor impairment to Water Outflow occurs other than the limitations set by the condition of the Water Source (C).

Fig. 9. View northwest near the bottom of the site. Water outflow is no wholly characteristic but still able to support down-valley habitats.

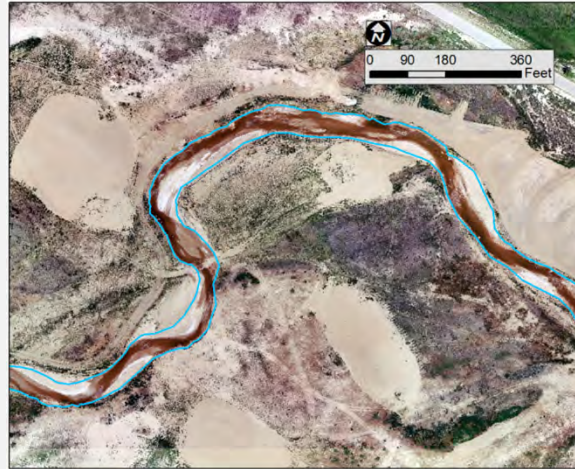
Fig. 10. Drone imagery illustrating the pattern of bar formation that formed after the 2022 flood. The freshly graded Little Joe mitigation site can be seen on the right side of the photograph. The blue line delineates the approximate extent of the inset floodplain in 2023.

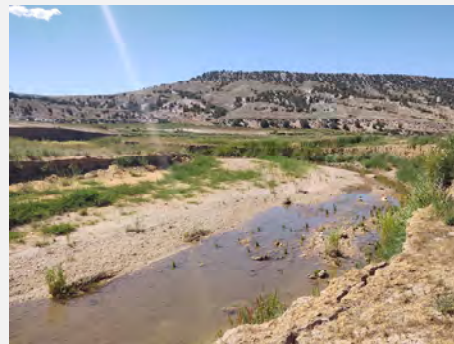
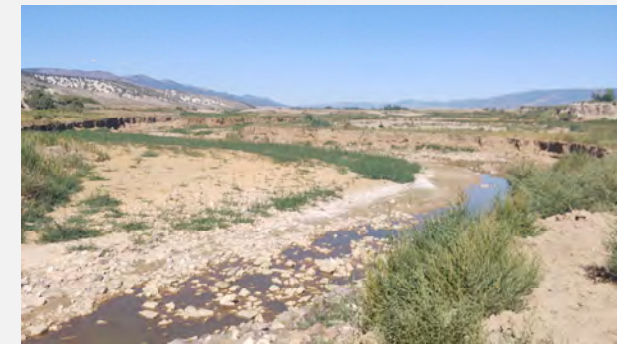
Fig. 11. Two examples of the good degree of variation in cross-sectional elevation, creating the foundation for development of diverse habitats. The geomorphic component that is missing is the channel system, which likely can only form in concert with vegetation development.

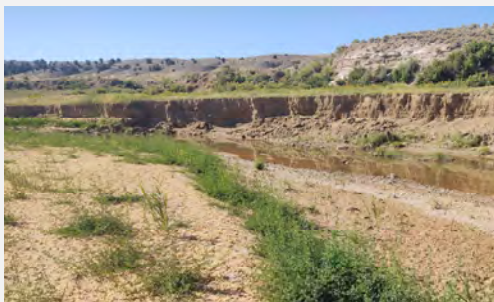
Fig. 20. High, erodible floodplain scarps are common in the upper mitigation reach. They are in character with Vermillion Creek regional reference reaches

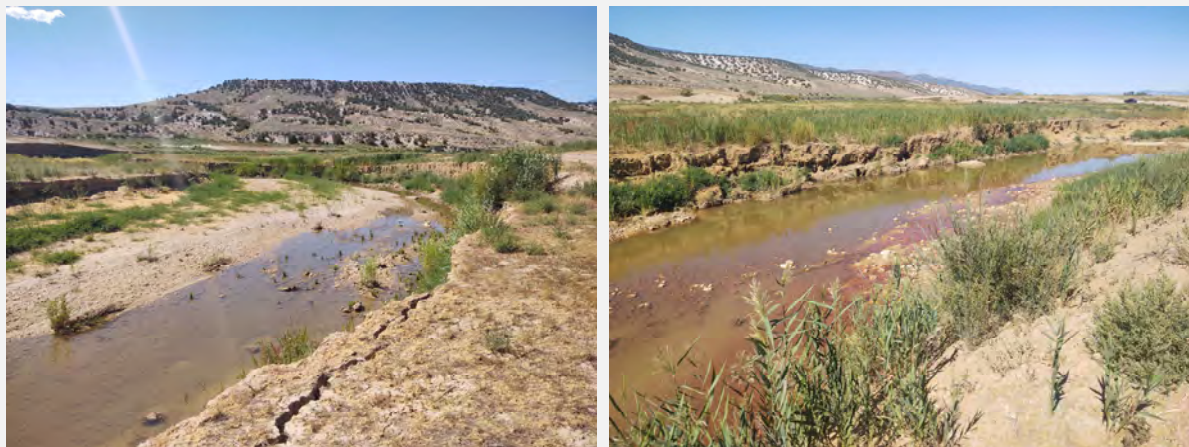
Fig. 22. Vegetation establishment is at a rudimentary stage. The majority of vegetation coverage appears to be comprised of ruderal species.

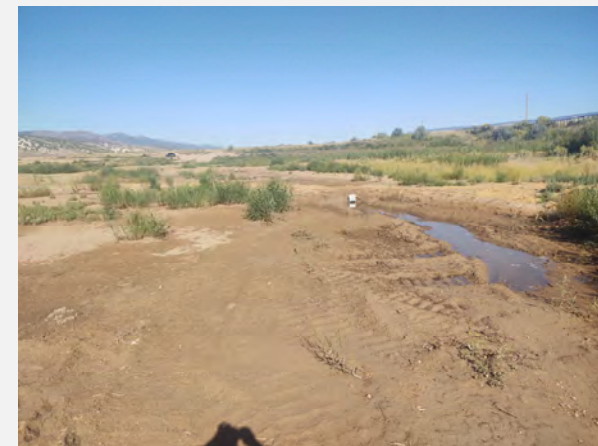
Fig. 30. View northwest showing the predominantly bare soil conditions.
