Native/Pierre Inspection Problem Abatement Photos

May 13, 2024

This letter is to address three of the required corrective actions stemming from the Native/Pierre Mine inspection conducted on March 13, 2024. The report for this inspection was signed and received on April 11, 2024. This letter will address those correction action items that have a due date of May 13, 2024 per the inspection report.

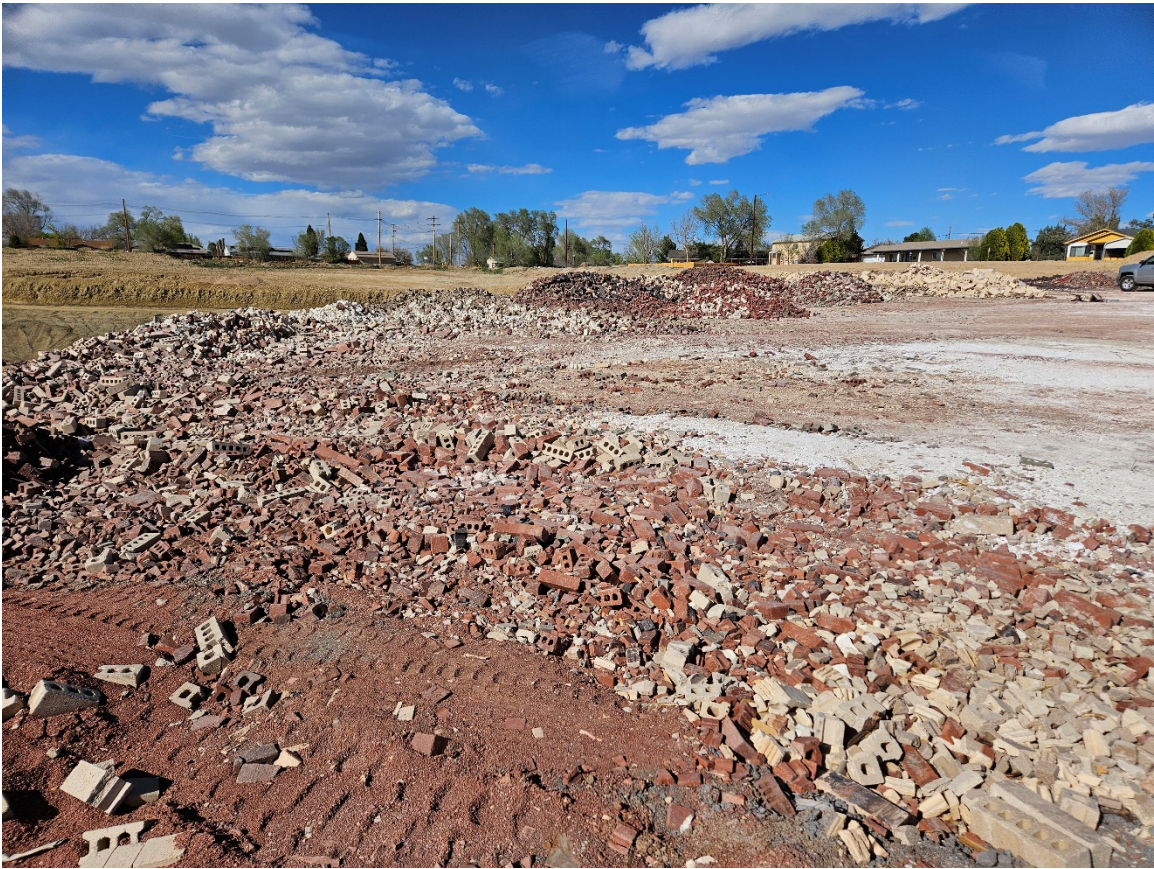
PROBLEM: Trees, wooden pallets, plastic wrap, and plastic banding were mixed in with the approved discarded brick backfilling material. These items are not inert materials per Rule 1.1(22) and the incorporation of them with backfill material does not comply with Rule 3.1.5(9).

Photo at top of brick backfill looking to the east

CORRECTIVE ACTION COMPLETED: Non-inert material was removed from the brick backfill, including from the top, bottom, and slope. Additionally, plant workers were trained to not use the bins where brick is discarded during the manufacturing process to discard any other type of trash. Ongoing maintenance will be completed to ensure non-inert materials are not present in the brick backfilling material at the mine.

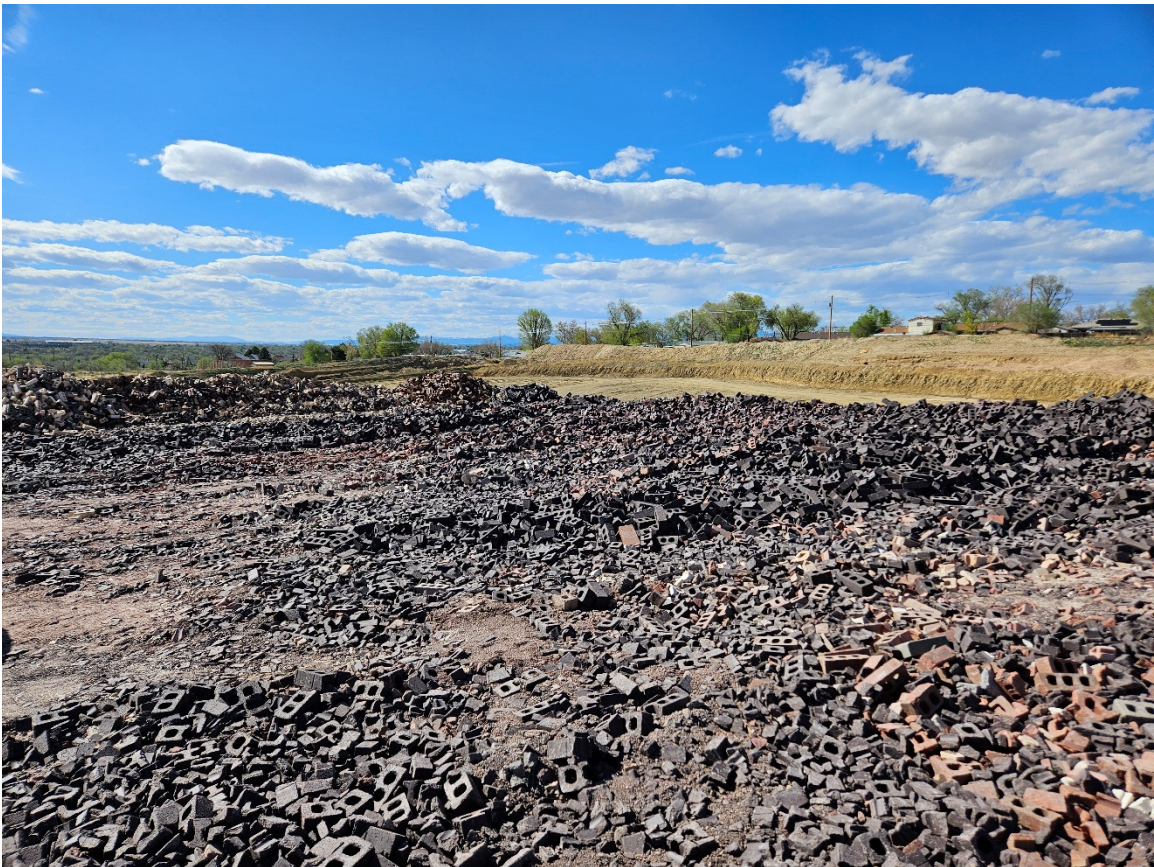
Photo at top of brick backfill looking to the northwest

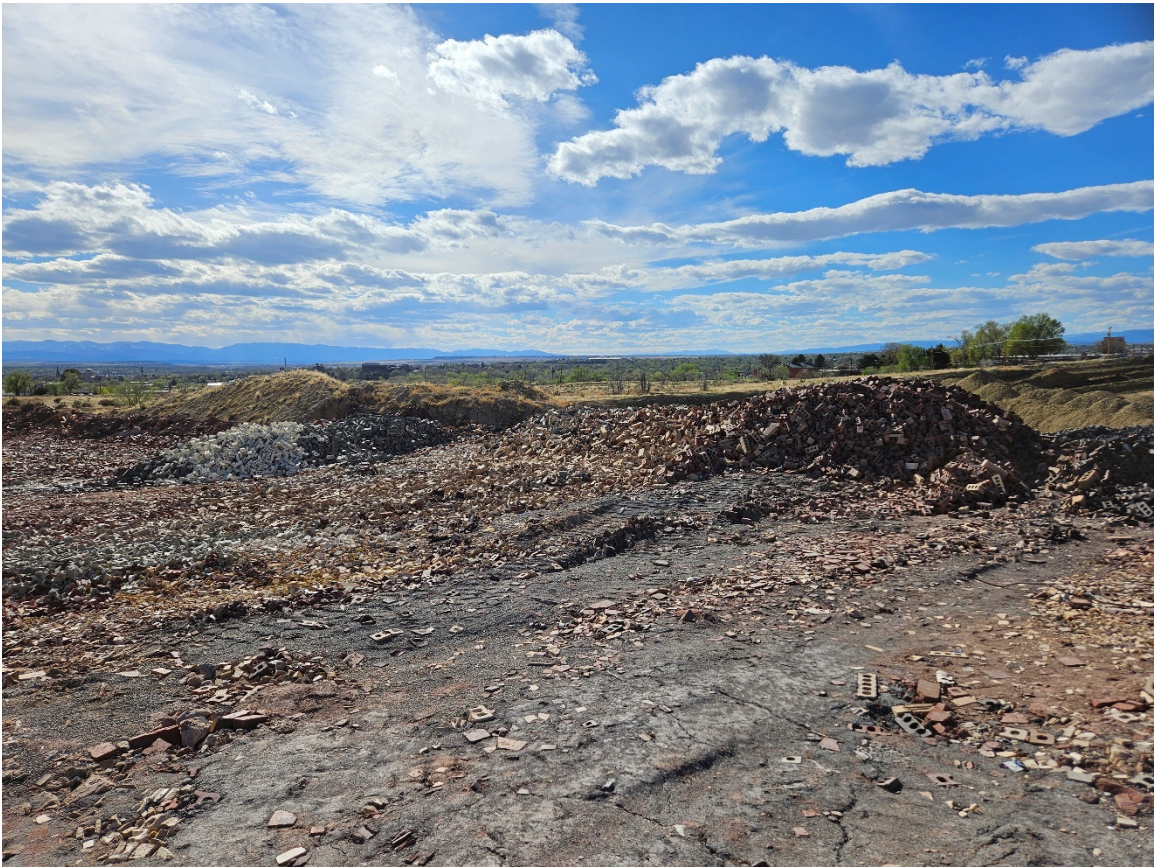
Photo at top of brick backfill looking to the northwest while standing further west

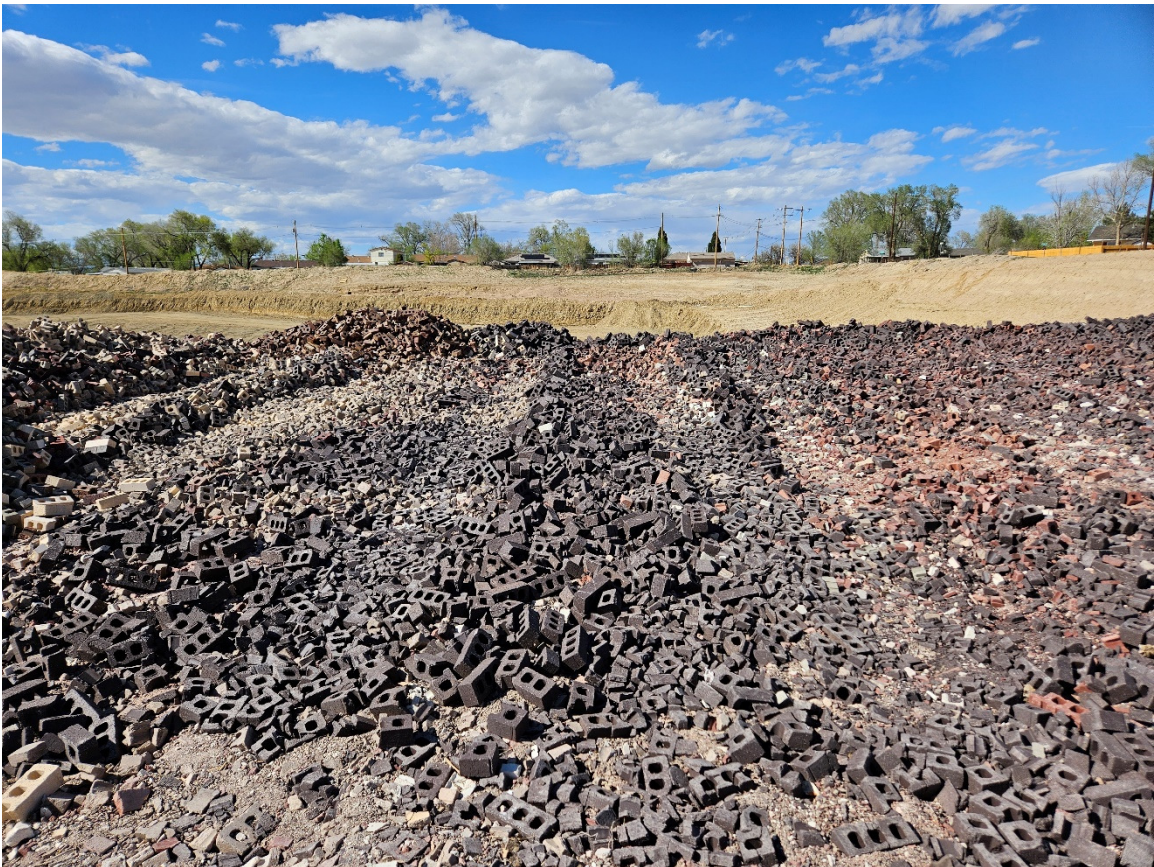
Photo at top of brick backfill looking to the north

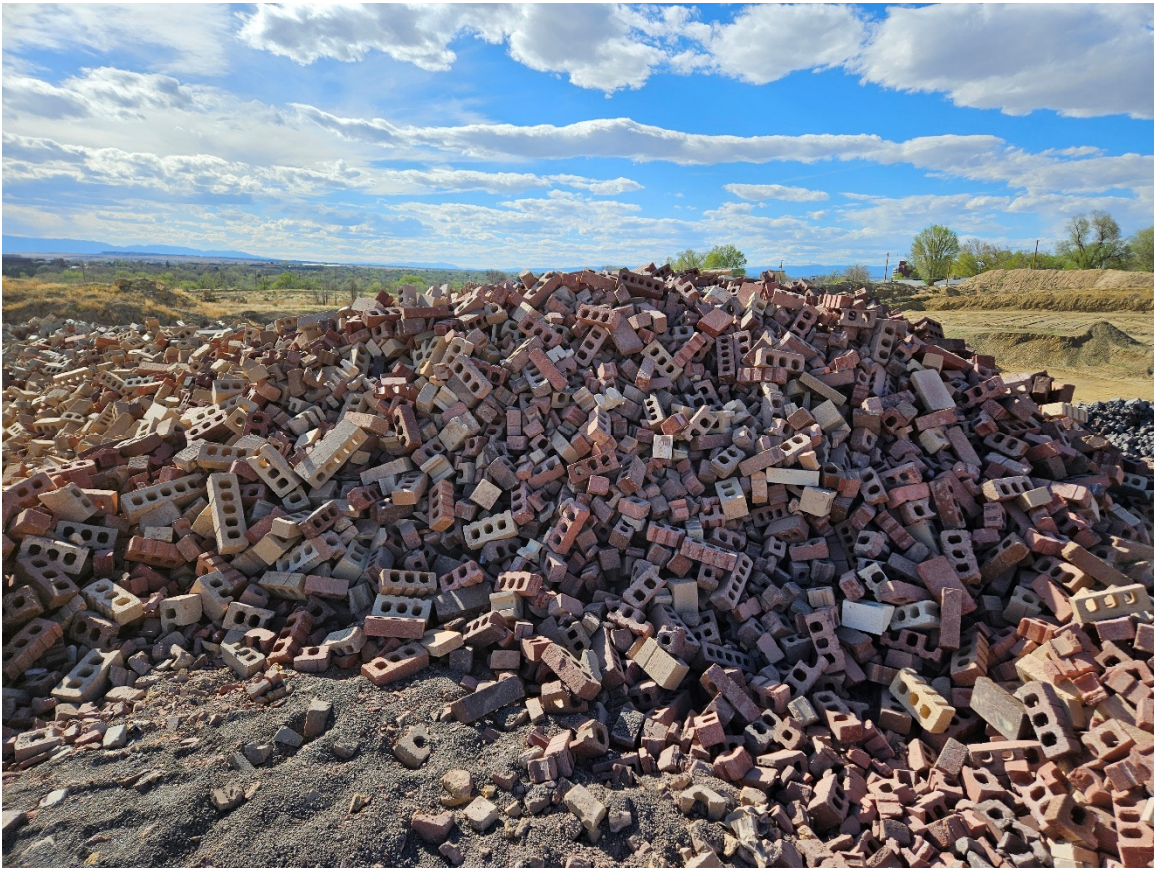
Photo of closeup of brick pile at top of brick backfill

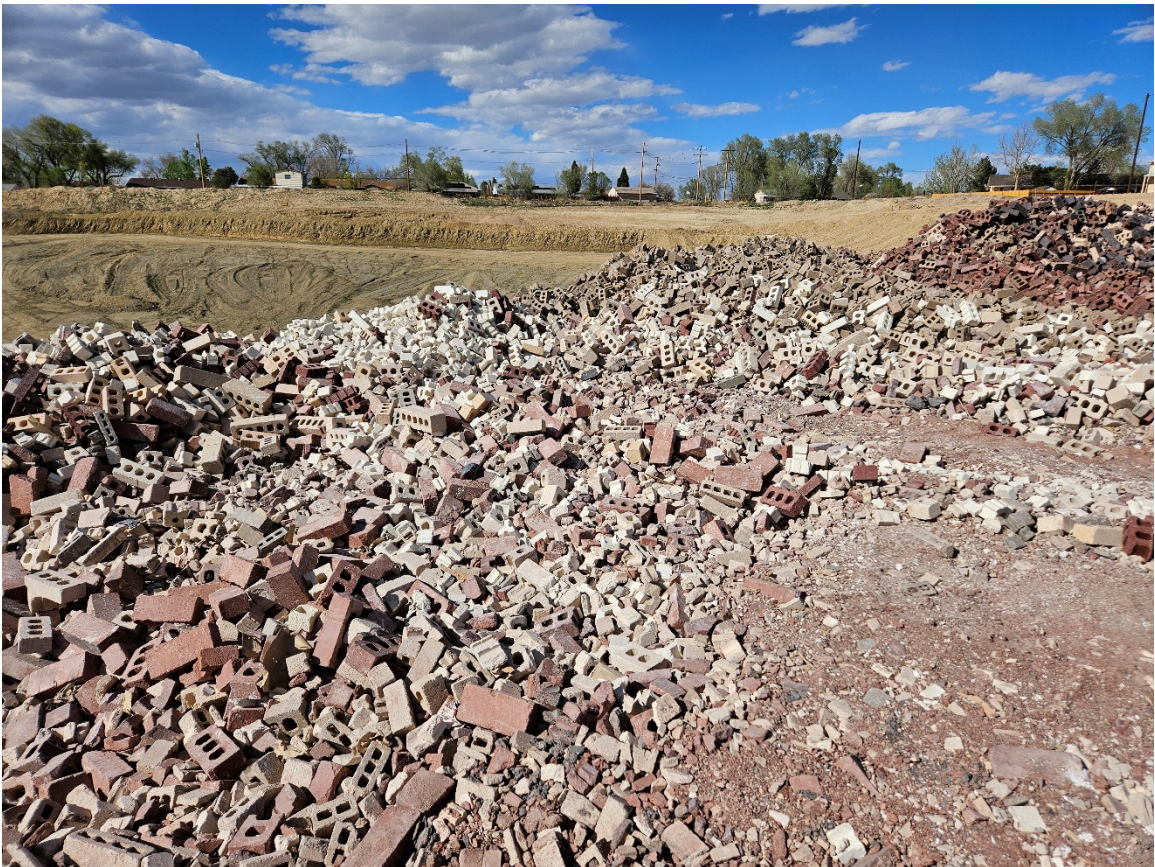
Photo of second closeup of brick piles at top of brick backfill

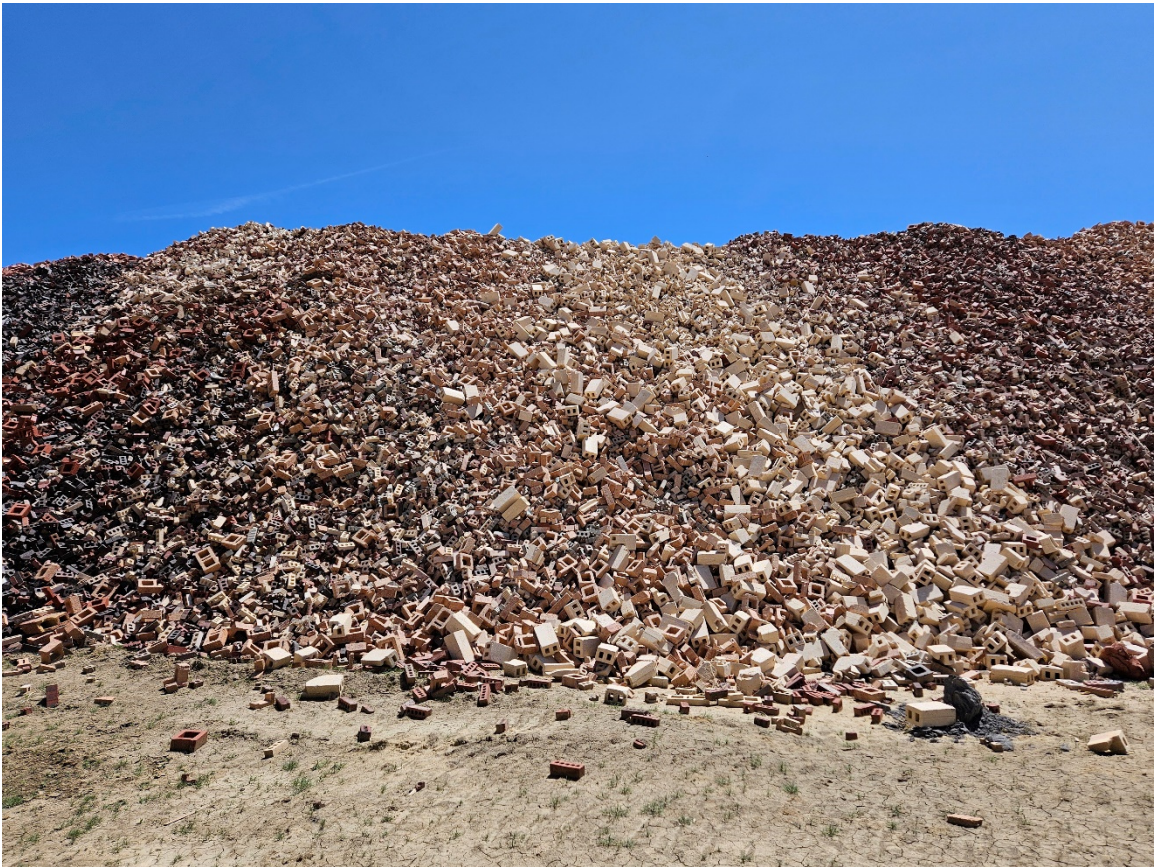
Photo at bottom of brick backfill looking to the south

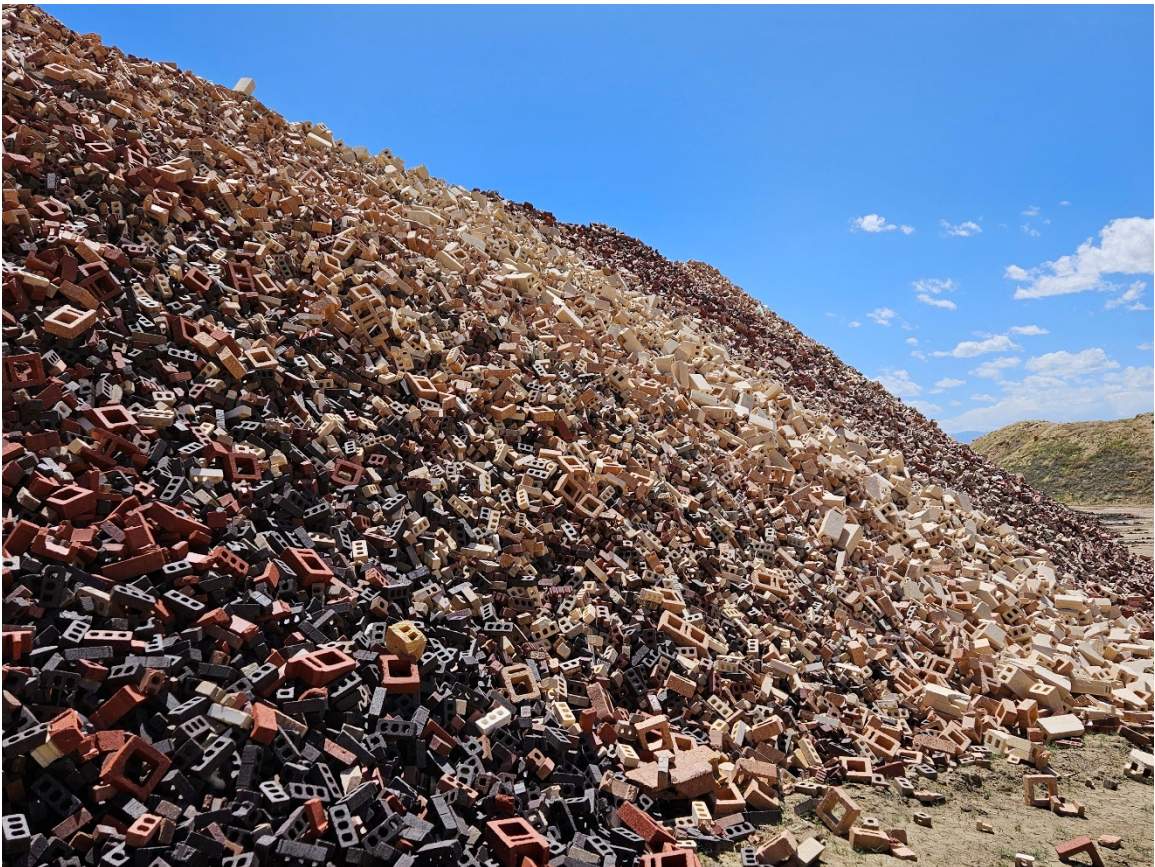
Photo at bottom of brick backfill looking to the west

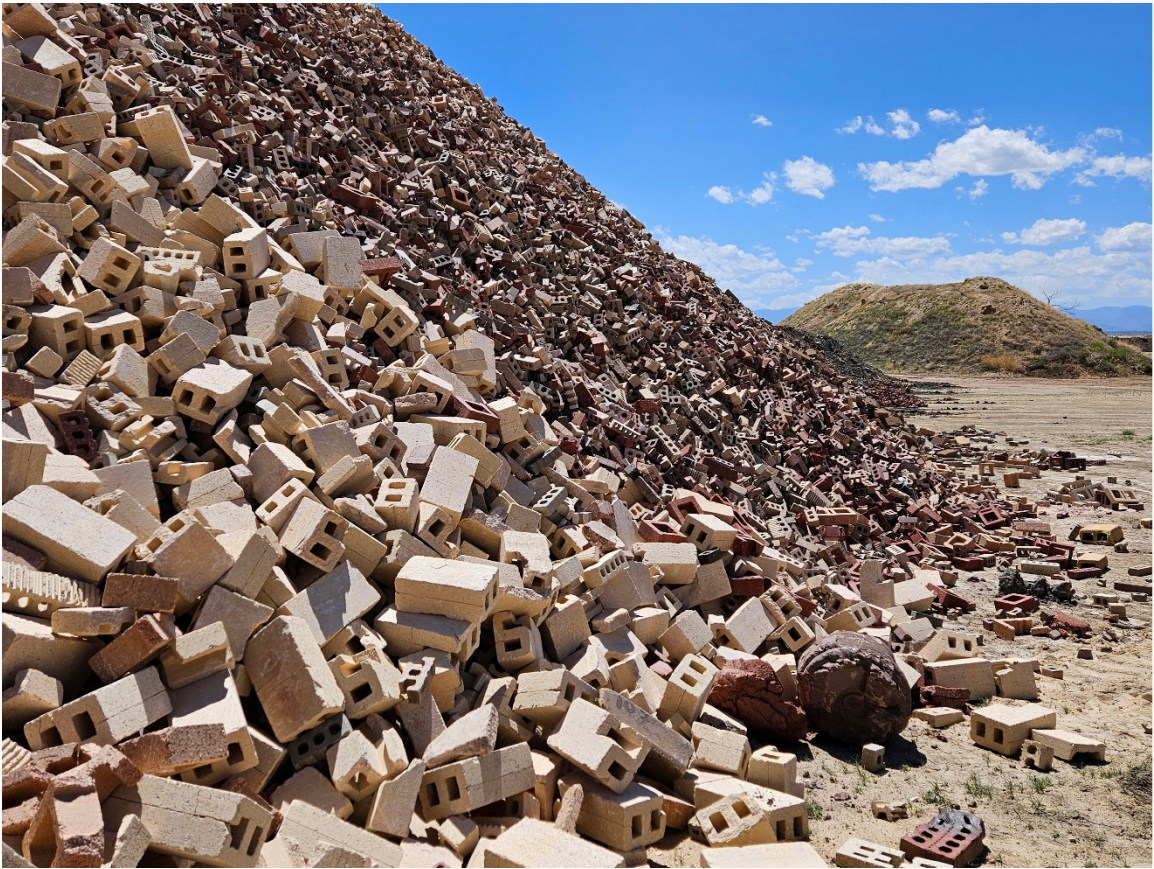
Photo at bottom of brick backfill looking to the west while standing further west

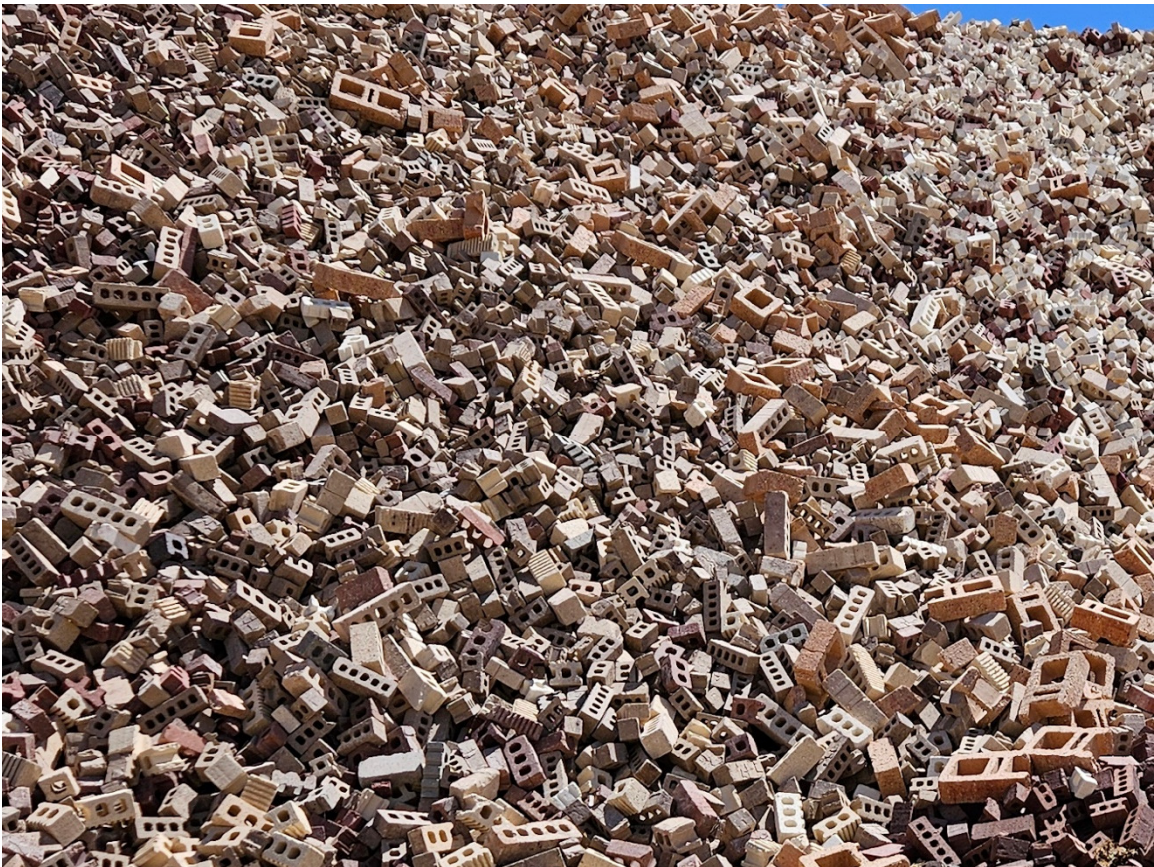
Photo of closeup of brick backfill material at bottom

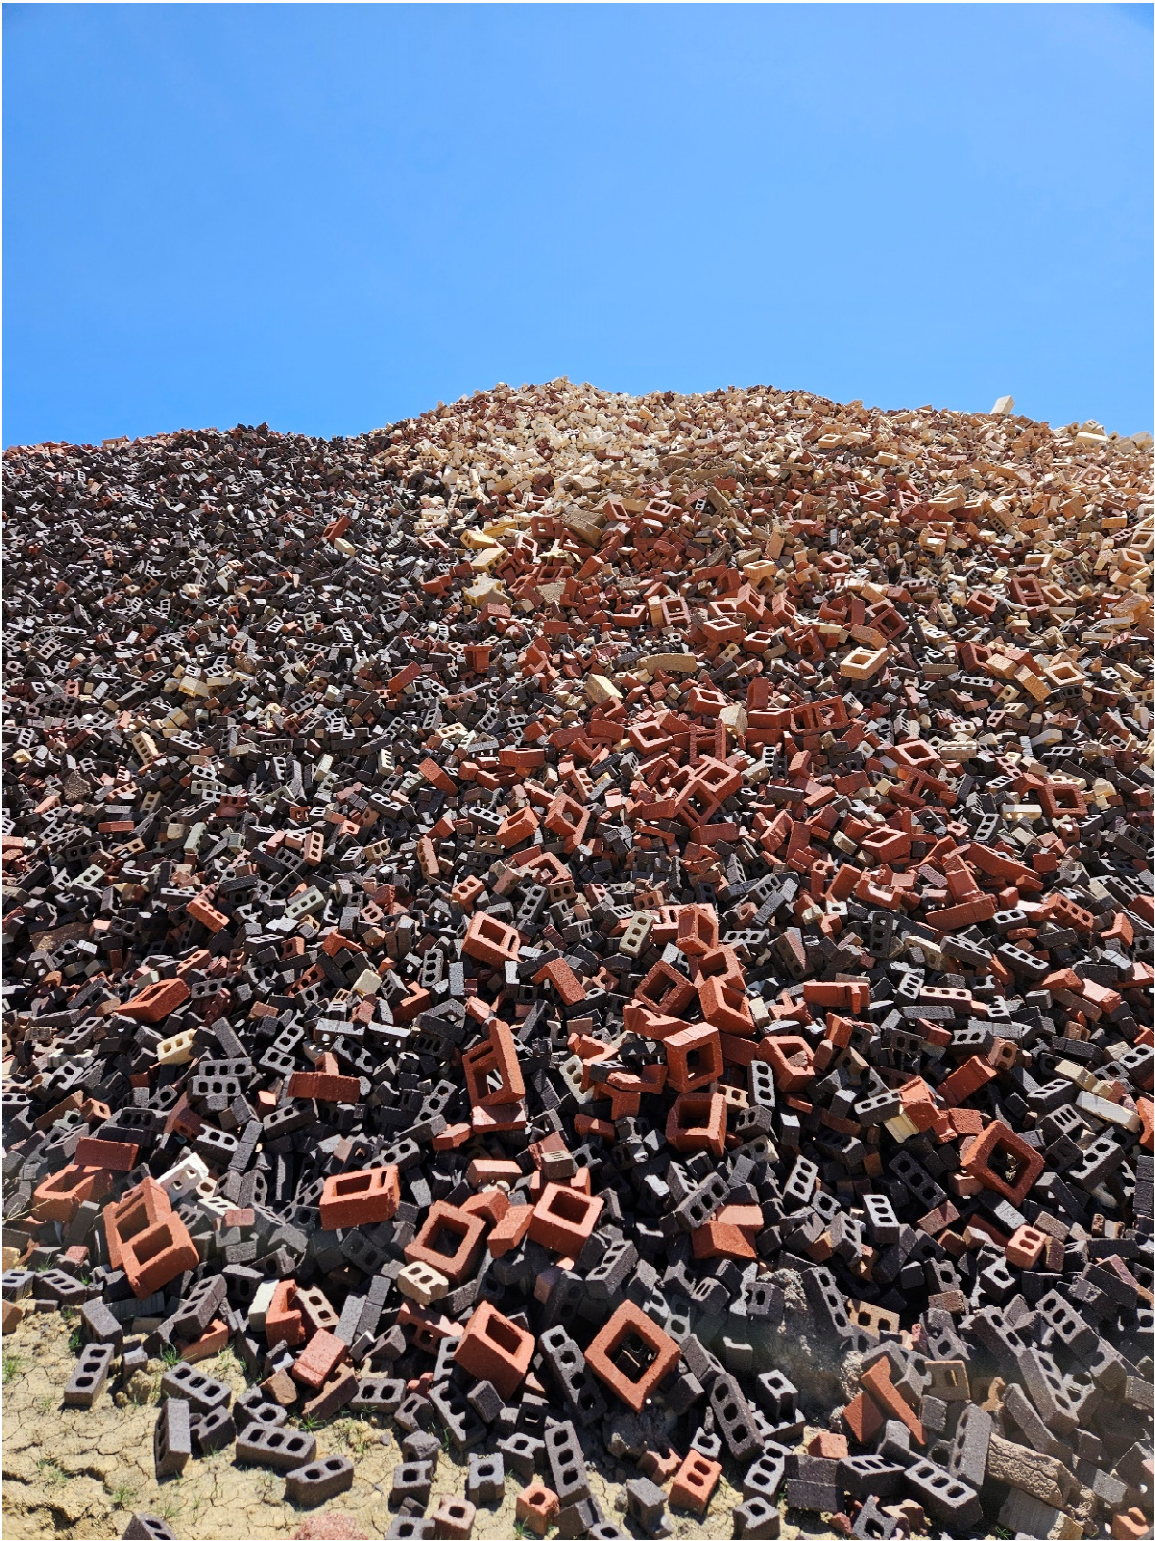
Photo of second closeup of brick backfill material at bottom

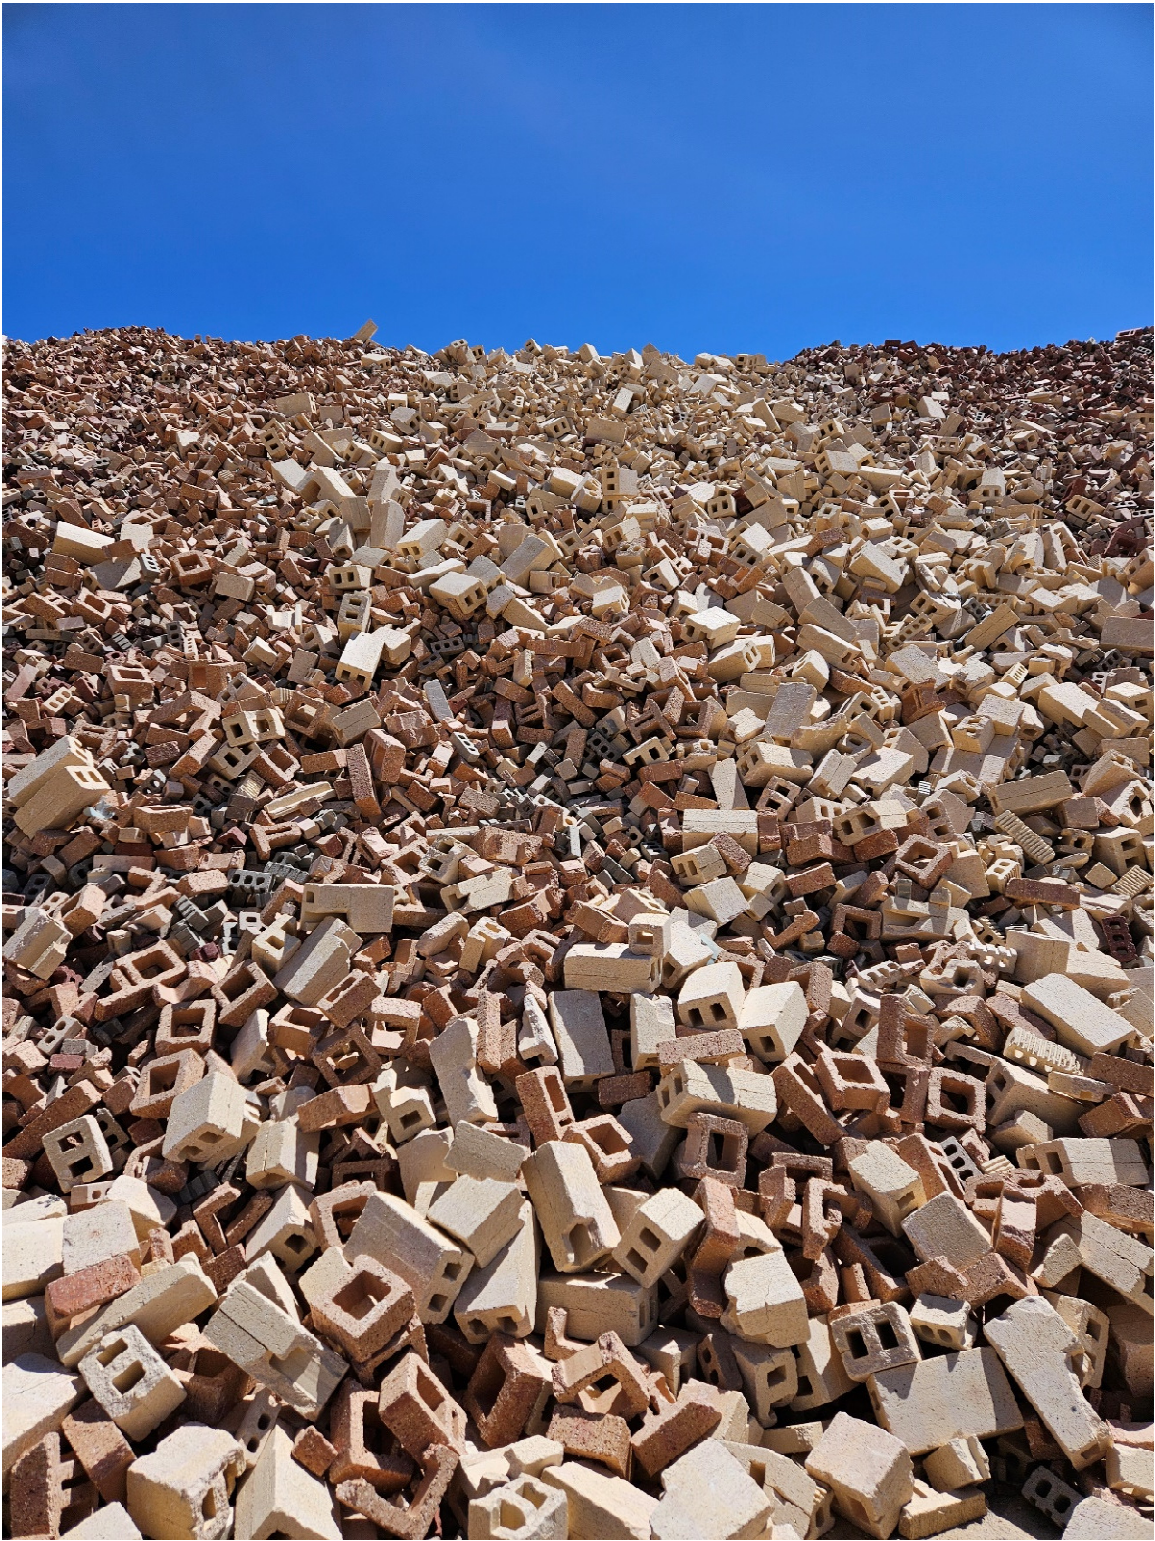
Photo of third closeup of brick backfill material at bottom

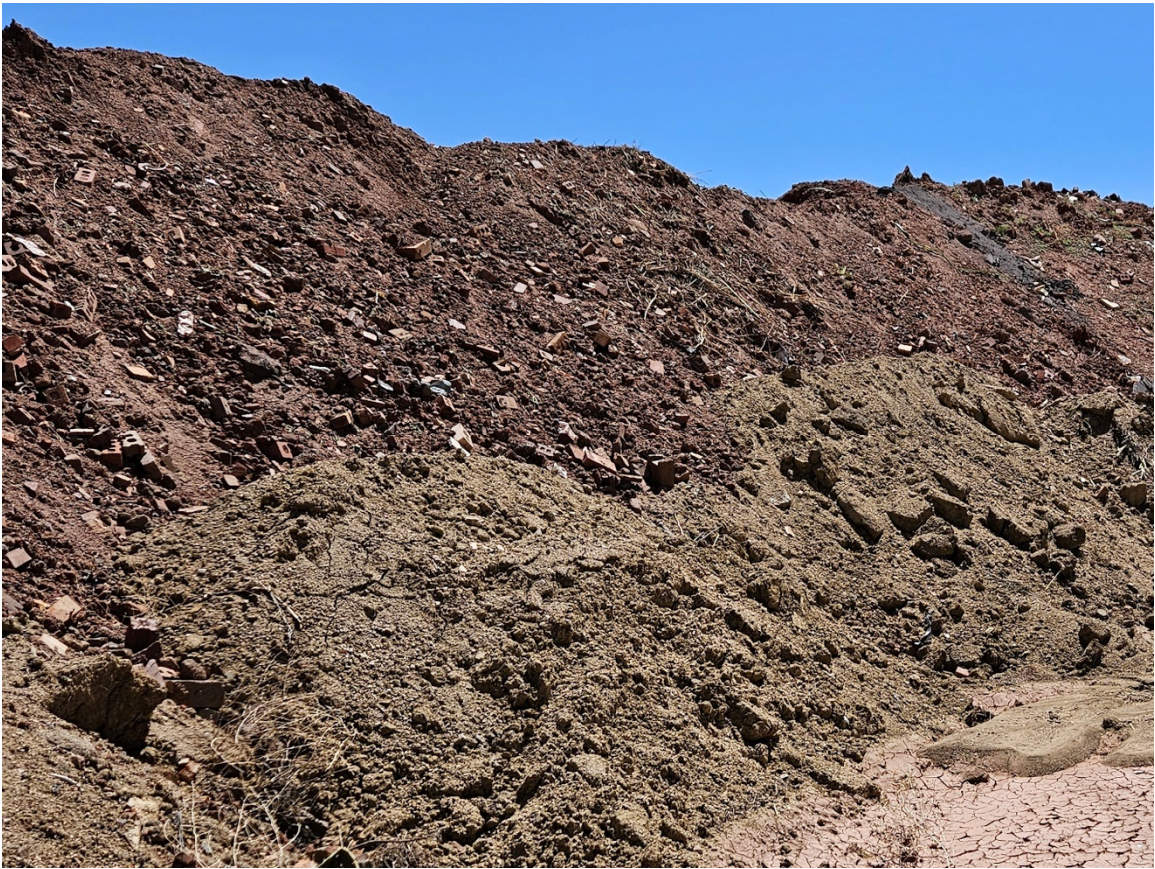
Photo of brick backfill material on ramp to pit floor with trees removed.

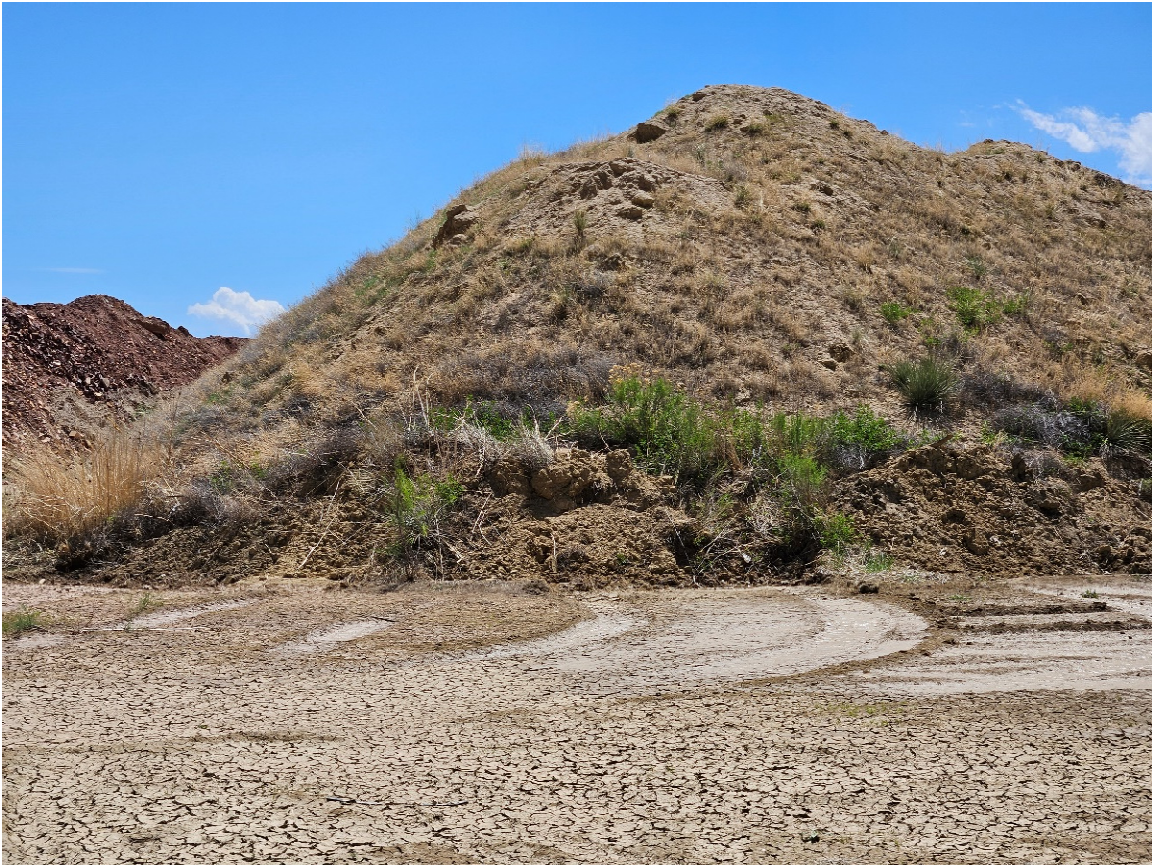
PROBLEM: Tamarisk (salt cedar) trees are present within or have volunteered into the permit area and are becoming established. This is a problem for failure to employ weed control methods for a state listed noxious weed species within the permitted area, and to reduce the spread of weeds to nearby areas as required by Section 3.1.10 (6) of the rule.

Photo of topsoil stockpile looking west with tamarisk plants removed

CORRECTIVE ACTION COMPLETED: The tamarisk plants were removed from near the topsoil stockpile. As tamarisk is an ongoing issue since tamarisk was known to be established near the Fountain River, the existing weed control plan shall be followed.

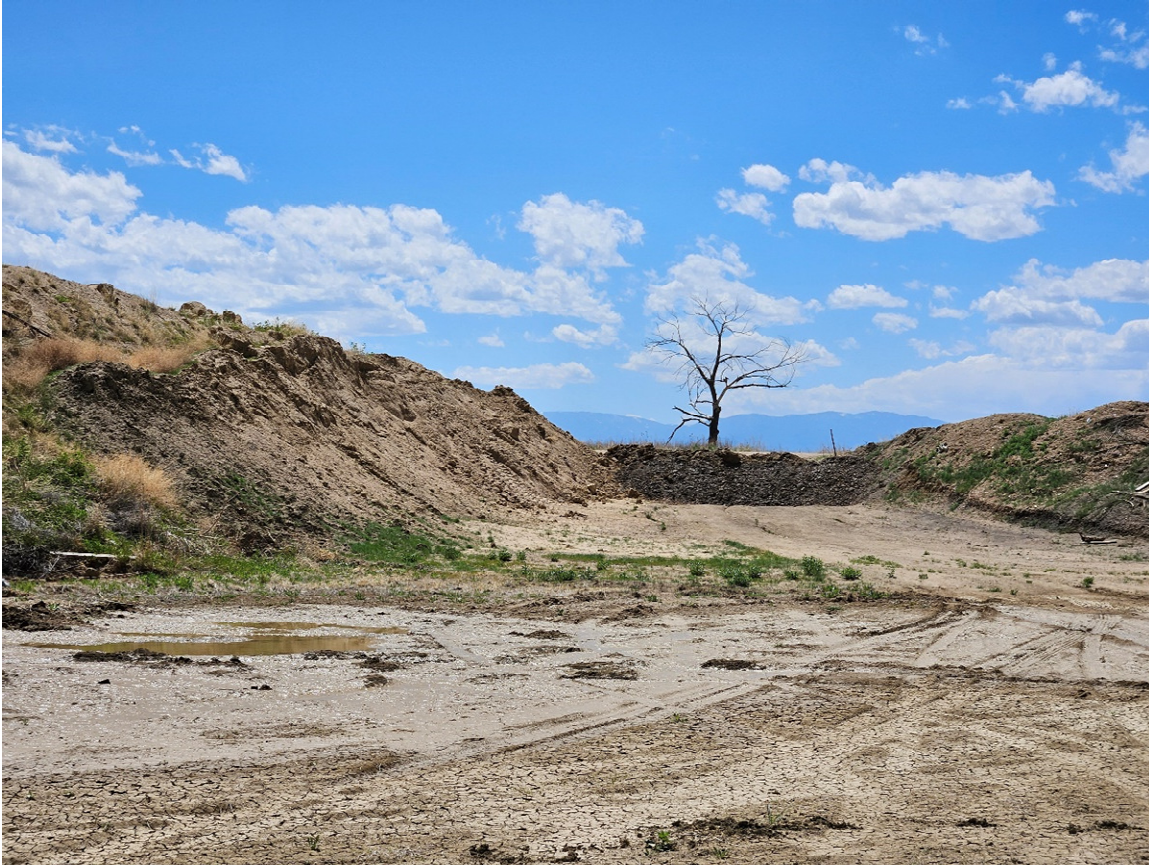
PROBLEM: The topsoil stockpiles do not have stable slopes and therefore susceptible to erosion Rule 3.1.9(1).

Photo of north side of topsoil stockpile with side re-sloped to be at angle of repose

CORRECTIVE ACTION COMPLETED: The slopes of the topsoil stockpile have been re-sloped to be at the angle of repose. The disturbed areas of the topsoil stockpile slopes shall be revegetated in accordance with our permit.
