To: Jerald Schnabel  
Castle Aggregate  
File: April 2024 Monitoring Summary

From: Paul Kos  
Denver, CO 80202  
Date: May 20, 2024

**Reference: April 2024 Geotechnical Monitoring Summary Pikeview Quarry**

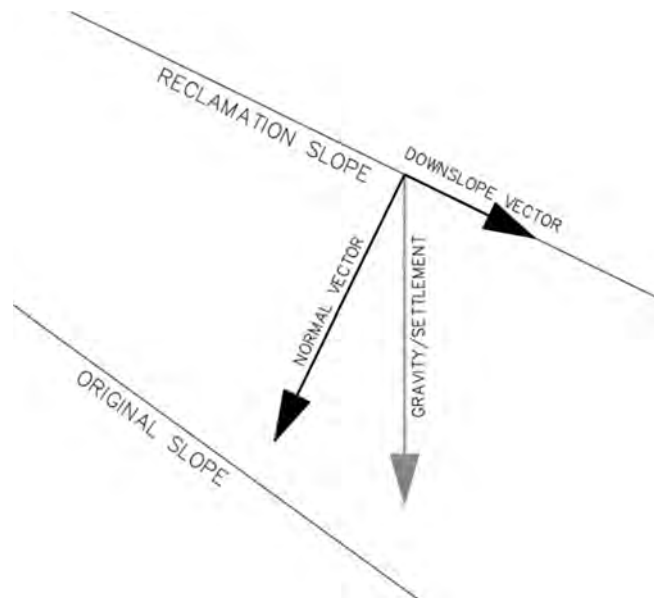
- Cracking was observed on the graded slopes near the upper extents of the fill slope. These tension cracks were observed to be approximately 100 feet long and 2 inches wide. The nature and location of these cracks suggests ongoing settlement of the buttress fill as the likely cause of the cracking. The settlement of the fill on a sloping foundation results in a downslope vector that is causing the cracking. The location near the upper extent of the fill is expected considering the in-situ material further uphill would not experience the settlement that occurs in the fill. Stantec has observed similar cracks on mine slope regrades including sites that did not have a landslide component. The cracks at the other regrade projects also occurred at the upper extent of the fill slope. The vector diagram below shows the settlement due to gravity and the resulting movements normal and parallel to the slope.

- Restricted access to the ungraded landslide slopes should continue.
- All monitoring should continue at current frequencies.
- All alerts shall continue to be taken seriously even if data errors are suspected.
- The upper fill slope should continue to be monitored for signs of increased or ongoing cracking. The area where cracking was observed will be covered with topsoil and erosion control matting in the near future, and the cracking will no longer be visible.
- Areas where cracking has been observed should be graded and compacted to prevent infiltration of runoff through the cracks.

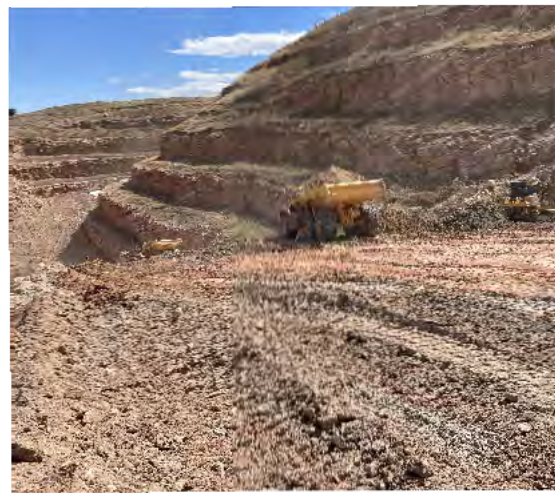
6. PLACING COMPACTED FILL ON BUTTRESS.

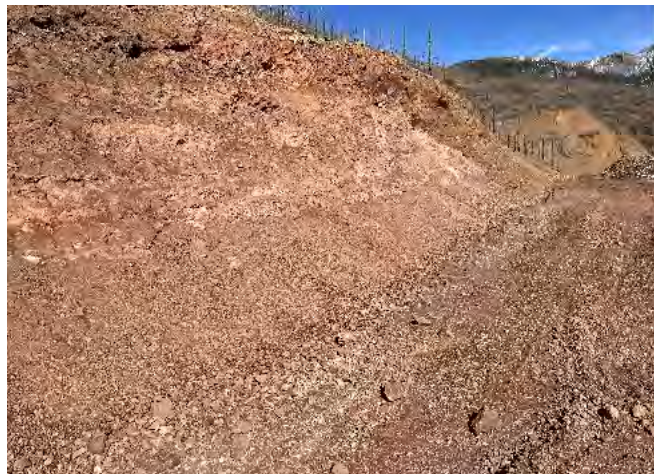
5. BENCHING ON SOUTH PEAK.

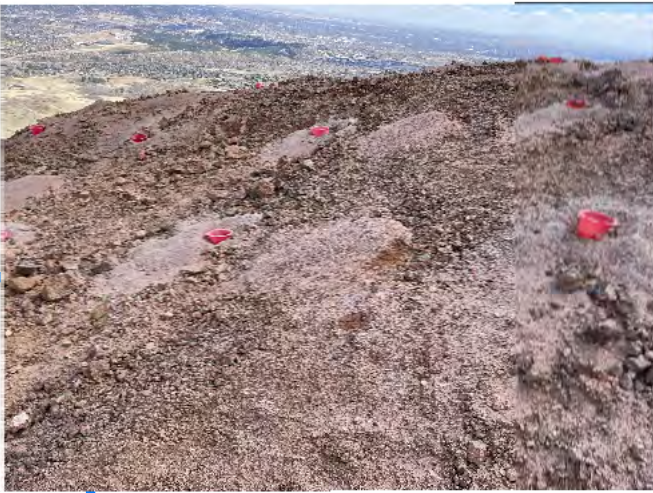
3. BLASTING PREPARATION ON SOUTH PEAK.

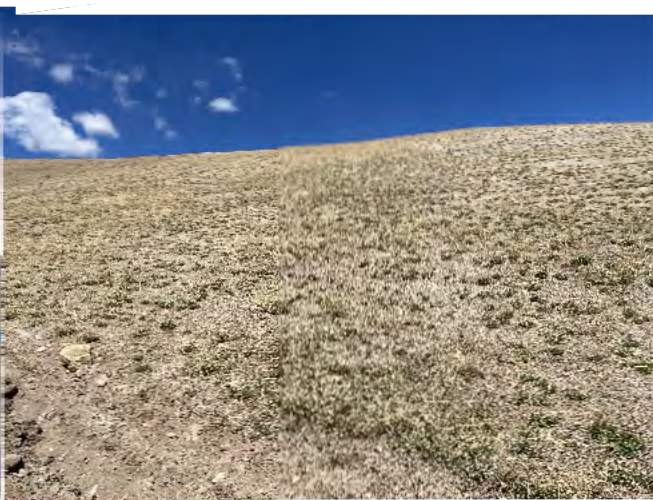
2. GROWTH MEDIUM WITH GRASS ON NORTH SLOPE.

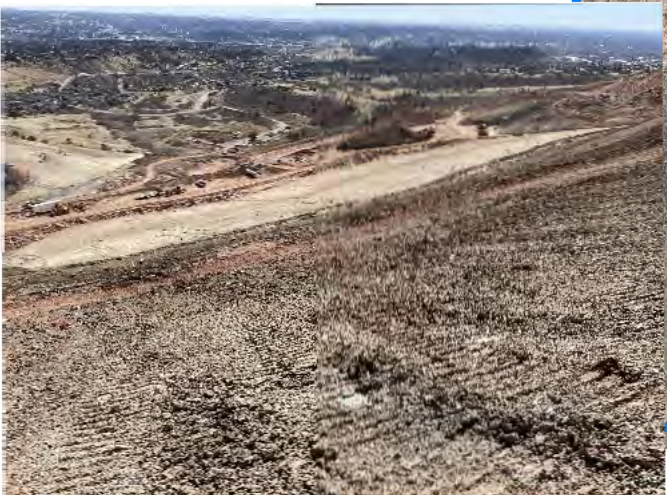
8. SLOPE BELOW CRACKING AREA. NO SIGNS OF MOVEMENT.

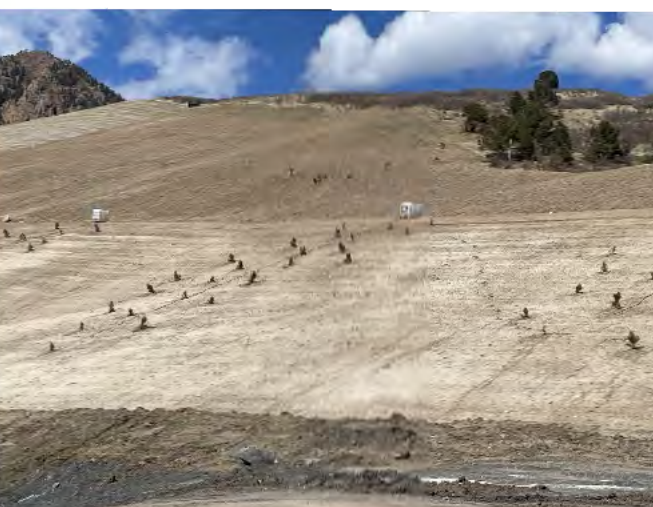
1. GROWTH MEDIUM WITH TREES ON NORTH SLOPE.

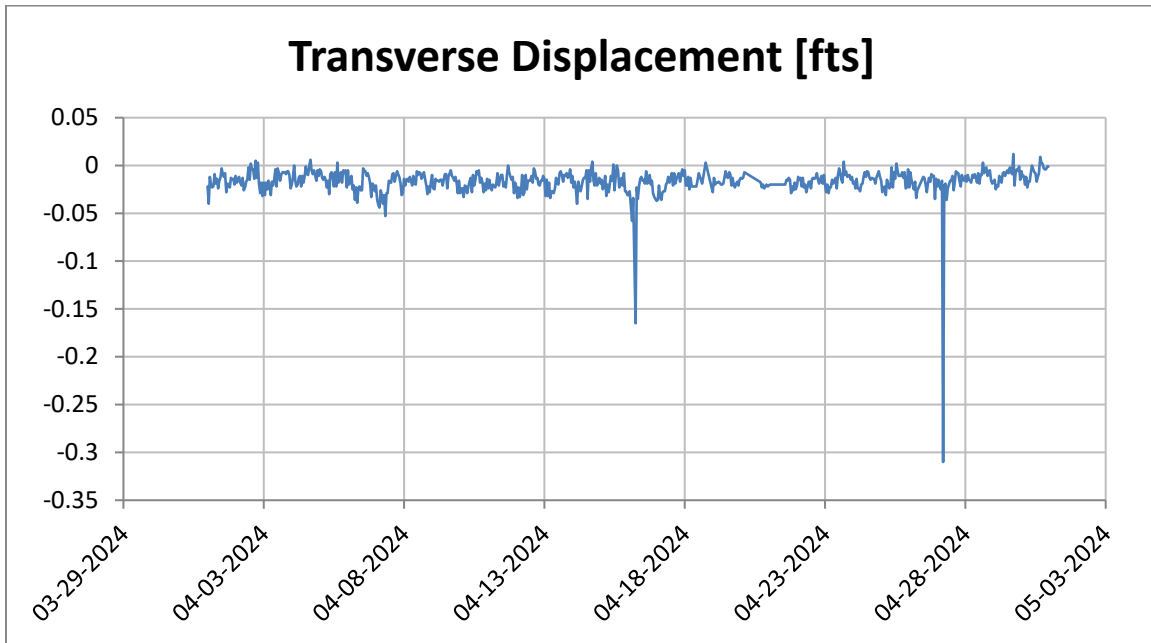
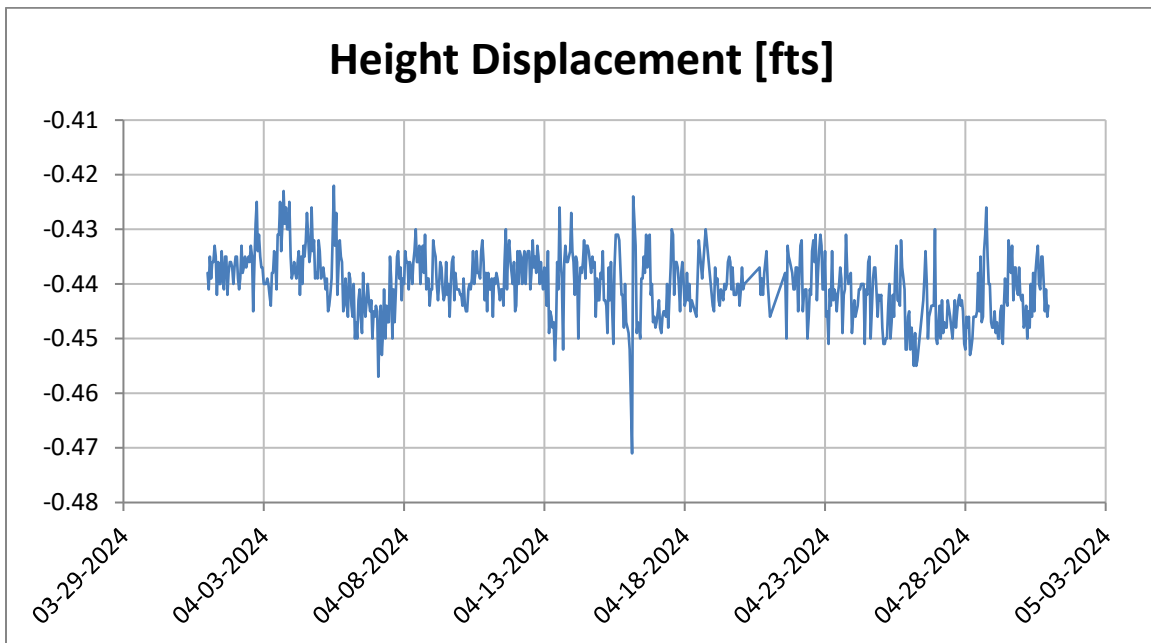
## Prism BR1

1. Survey accuracy is +/-0.016 feet.
2. Alert threshold is +/-0.35 feet.
3. Transverse displacement is in the horizontal direction. Positive direction means closer to the robotic total station.
4. Height displacement is in the vertical direction. Positive direction means higher in elevation.
5. Prism previously recorded slope creep movements.

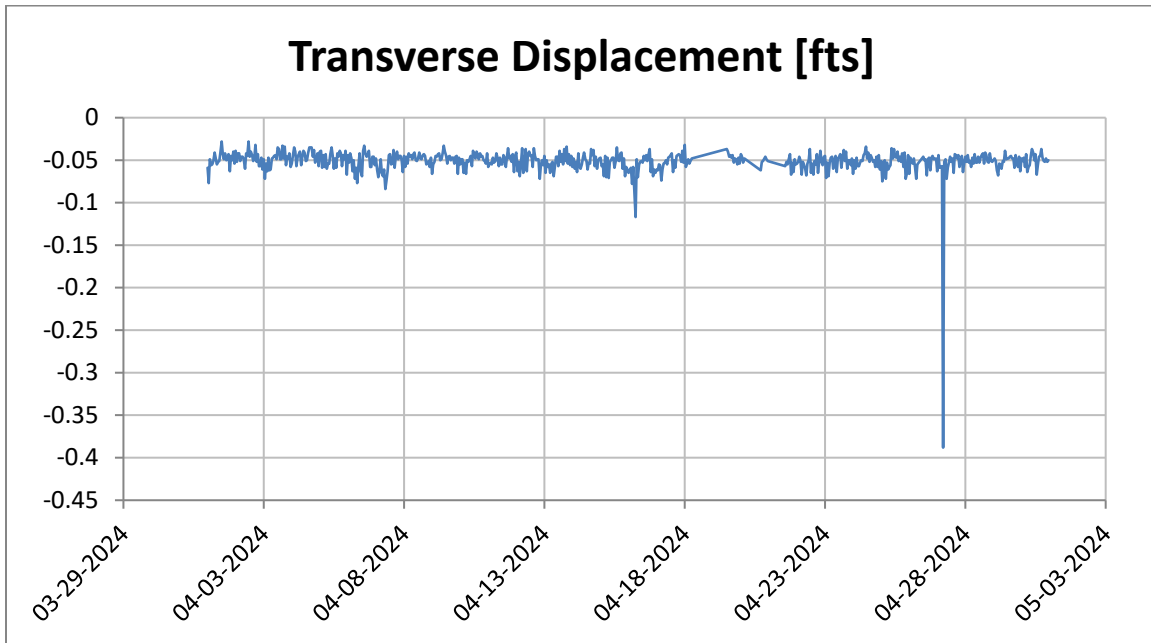
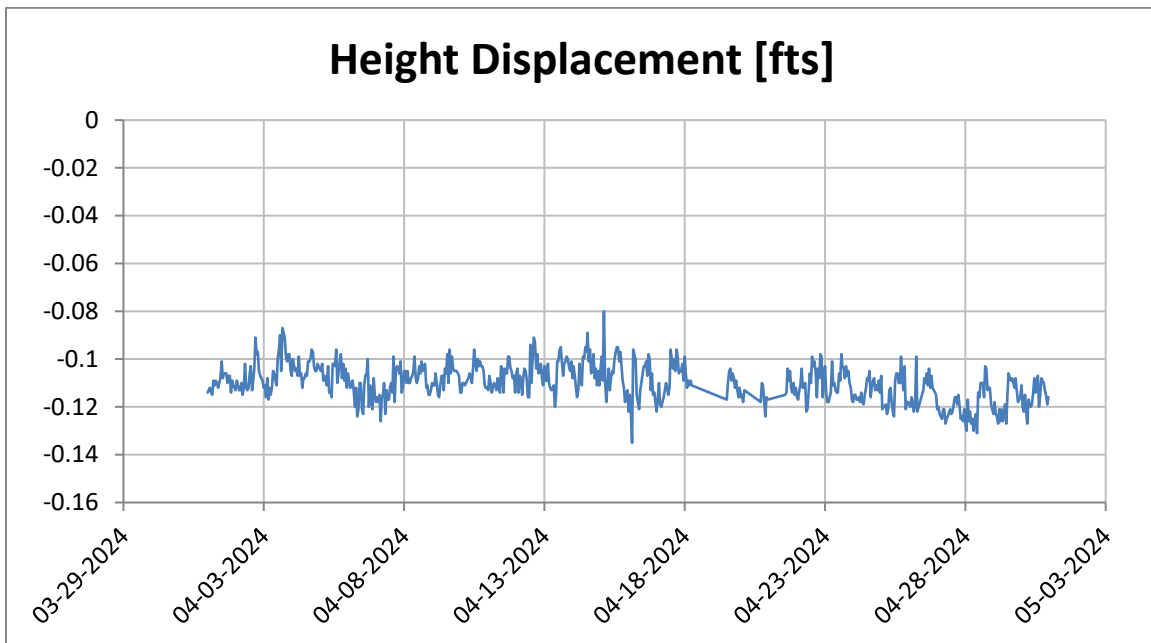
## Prism BR3

1. Survey accuracy is  $\pm 0.016$  feet.
2. Alert threshold is  $\pm 0.35$  feet.
3. Transverse displacement is in the horizontal direction. Positive direction means closer to the robotic total station.
4. Height displacement is in the vertical direction. Positive direction means higher in elevation.
5. Prism previously recorded slope creep movements.

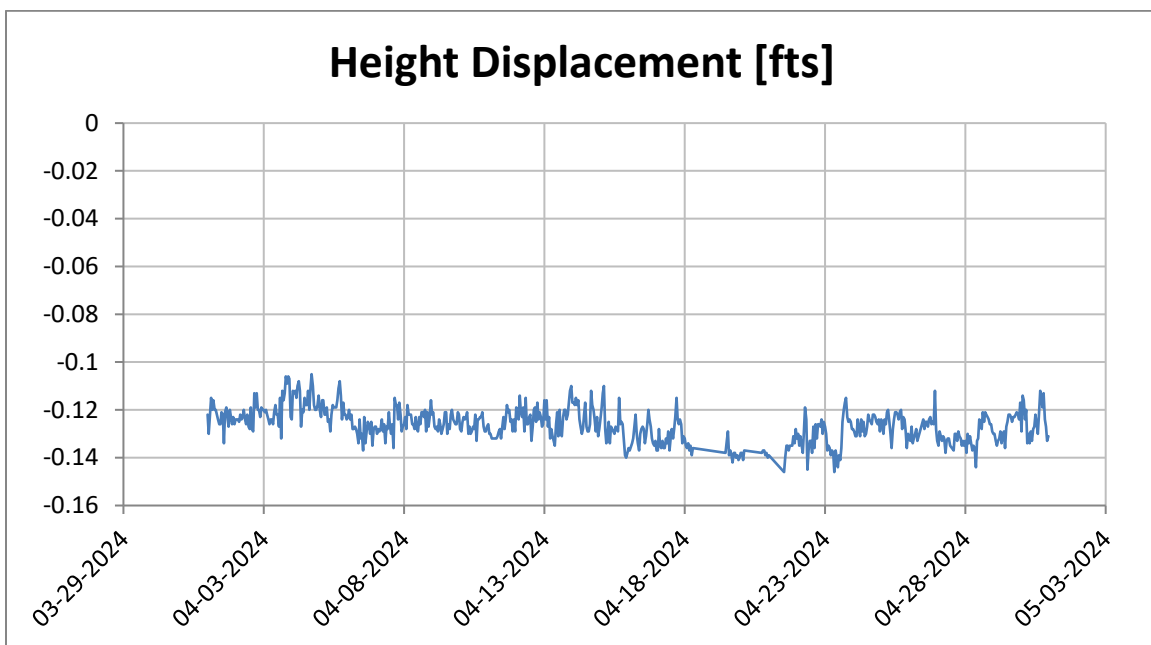
## Prism B7300-0

| Prism ID | Cumulative Transverse Displacement (ft) | Cumulative Height Displacement (ft) | Monthly Delta (ft) | Cumulative Delta (ft) | Notes / Recommendations |
|---|---|---|---|---|---|
| B7300-0 | -0.837 | -0.131 | 0.8022 | 0.9935 | Data jump on 4-23. No movement before or after offset. |

1. Survey accuracy is +/-0.016 feet.
2. Alert threshold is +/-0.35 feet.
3. Transverse displacement is in the horizontal direction. Positive direction means closer to the robotic total station.
4. Height displacement is in the vertical direction. Positive direction means higher in elevation.
5. Data shift believed to be caused by revegetation operations impacting the prism.

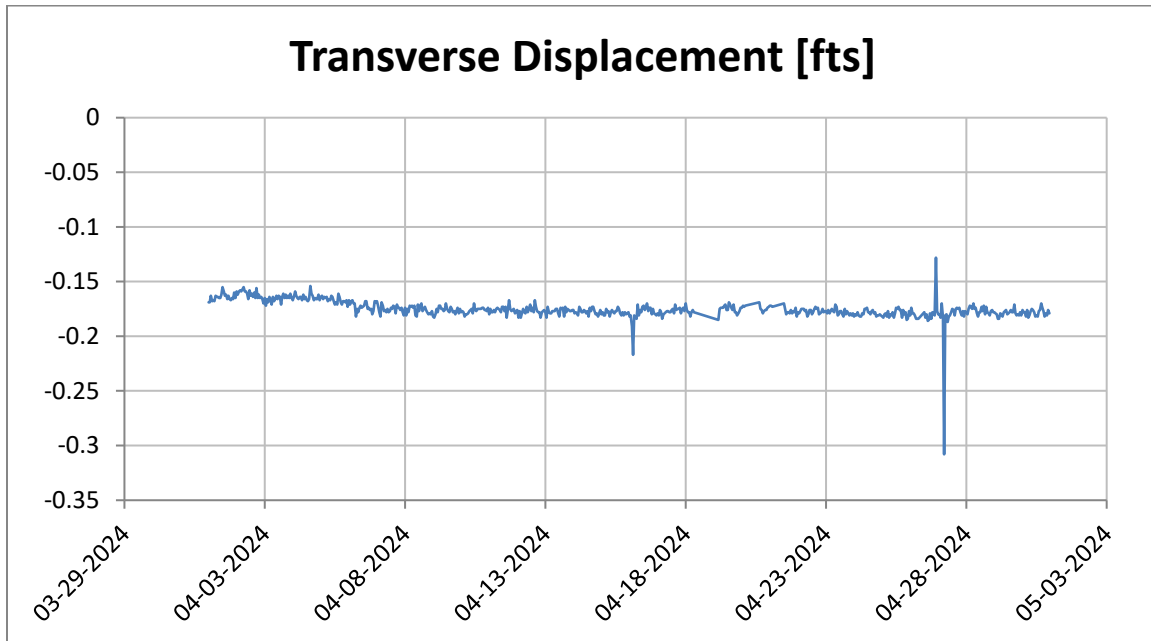
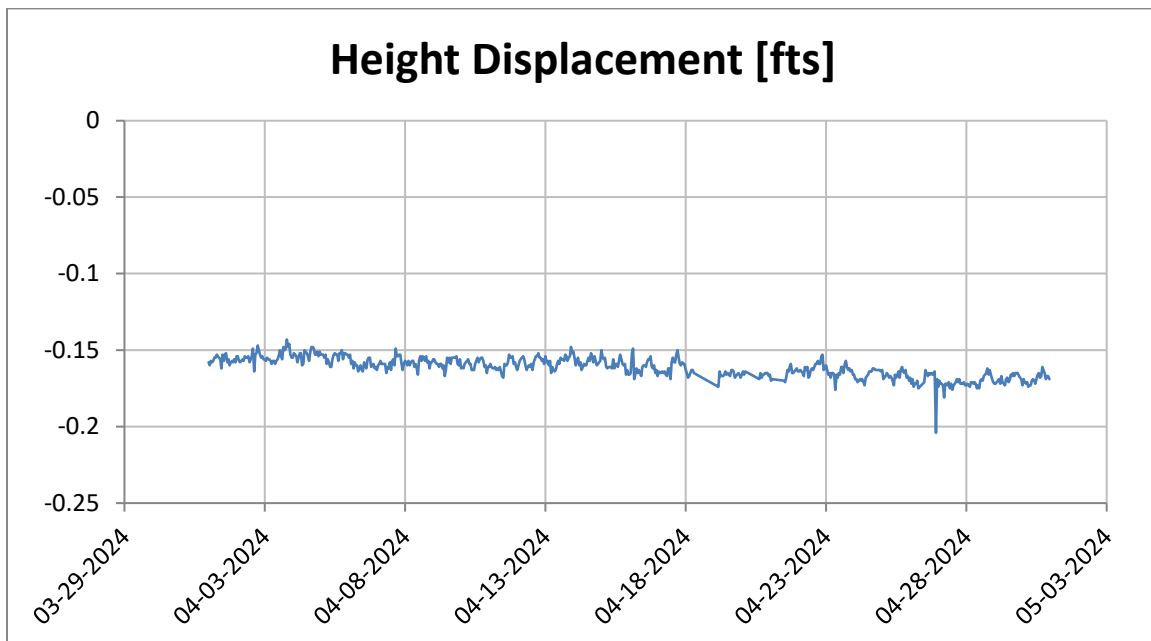
## Prism B7300-1

| Prism ID | Cumulative Transverse Displacement (ft) | Cumulative Height Displacement (ft) | Monthly Delta (ft) | Cumulative Delta (ft) | Notes / Recommendations |
|---|---|---|---|---|---|
| B7300-1 | -0.179 | -0.169 | 0.0308 | 0.3743 | Slope creep |

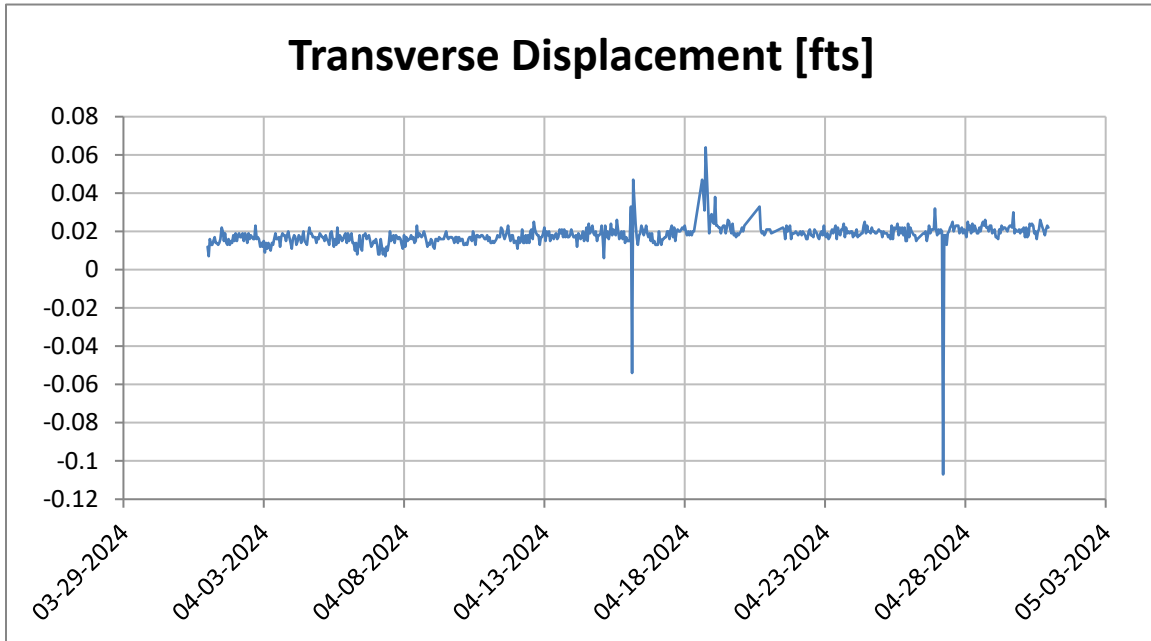
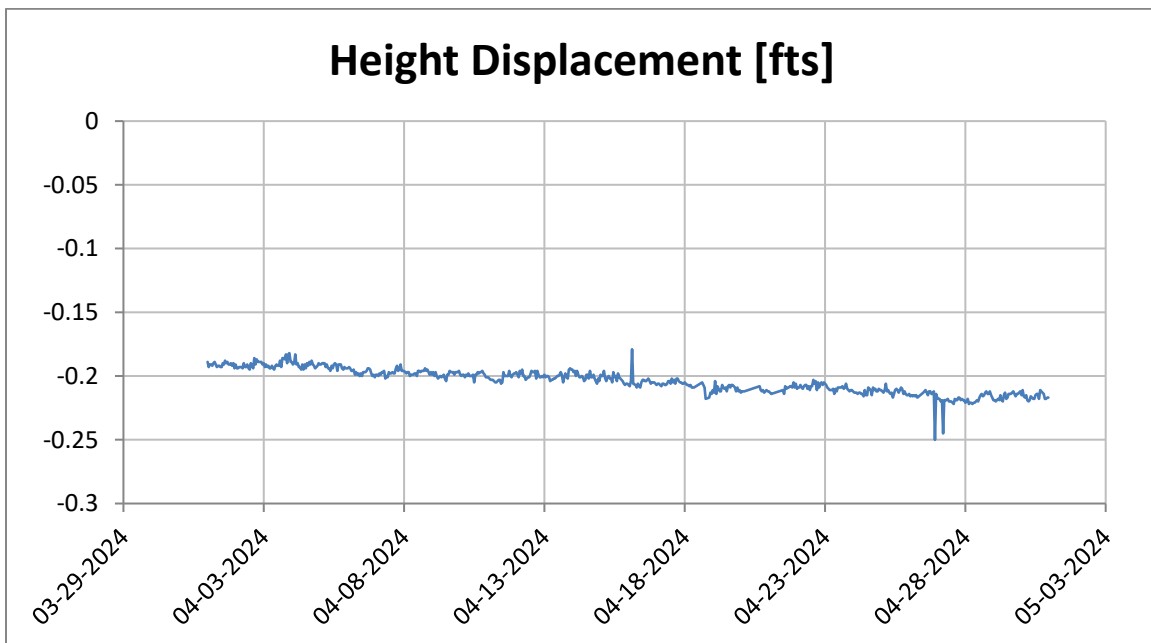
## Prism B7300-2

| Prism ID | Cumulative Transverse Displacement (ft) | Cumulative Height Displacement (ft) | Monthly Delta (ft) | Cumulative Delta (ft) | Notes / Recommendations |
|---|---|---|---|---|---|
| B7300-2 | 0.022 | -0.217 | 0.0344 | 0.2741 | Slope creep |

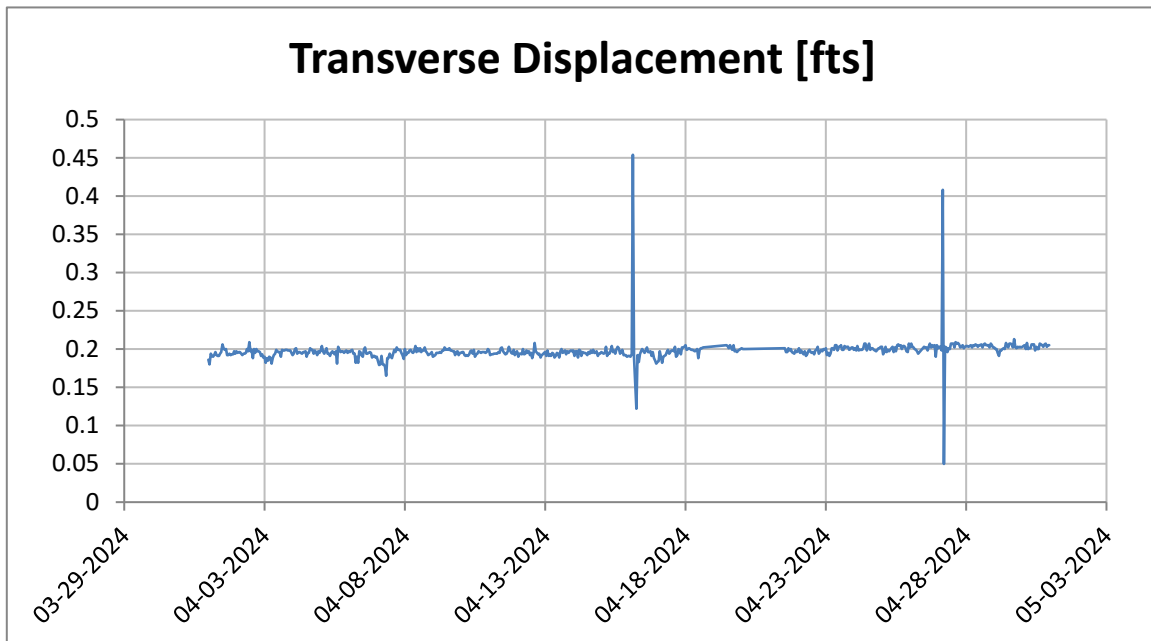
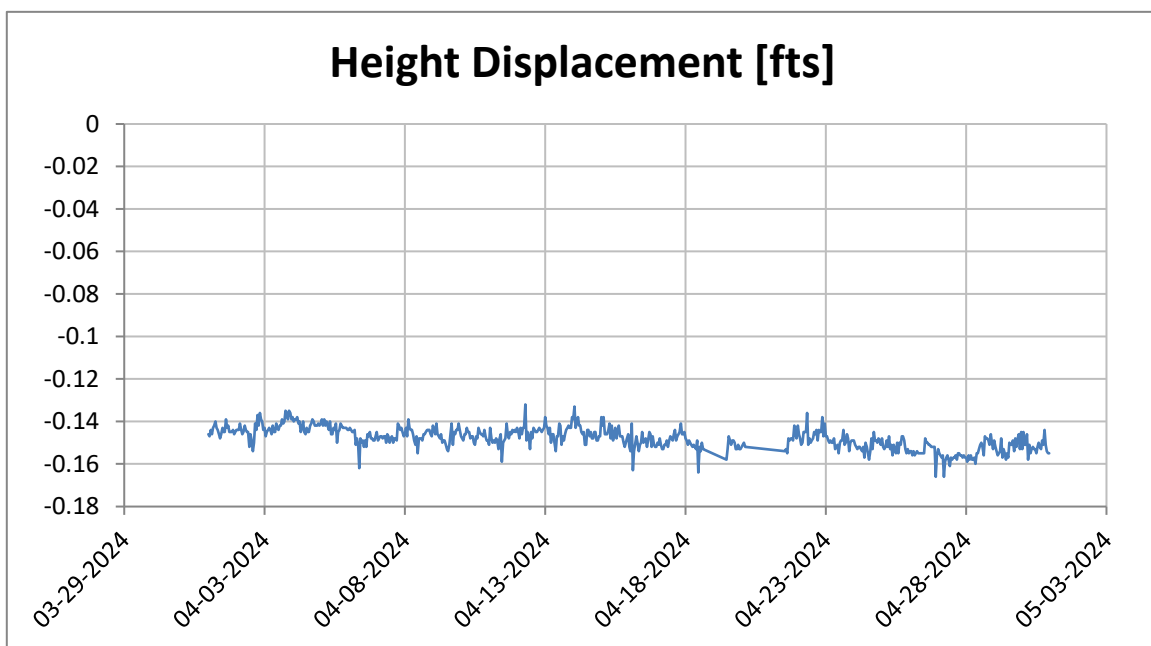
## Prism B7300-3

| Prism ID | Cumulative Transverse Displacement (ft) | Cumulative Height Displacement (ft) | Monthly Delta (ft) | Cumulative Delta (ft) | Notes / Recommendations |
|---|---|---|---|---|---|
| B7300-3 | 0.205 | -0.155 | 0.0260 | 0.3138 | Slope creep |

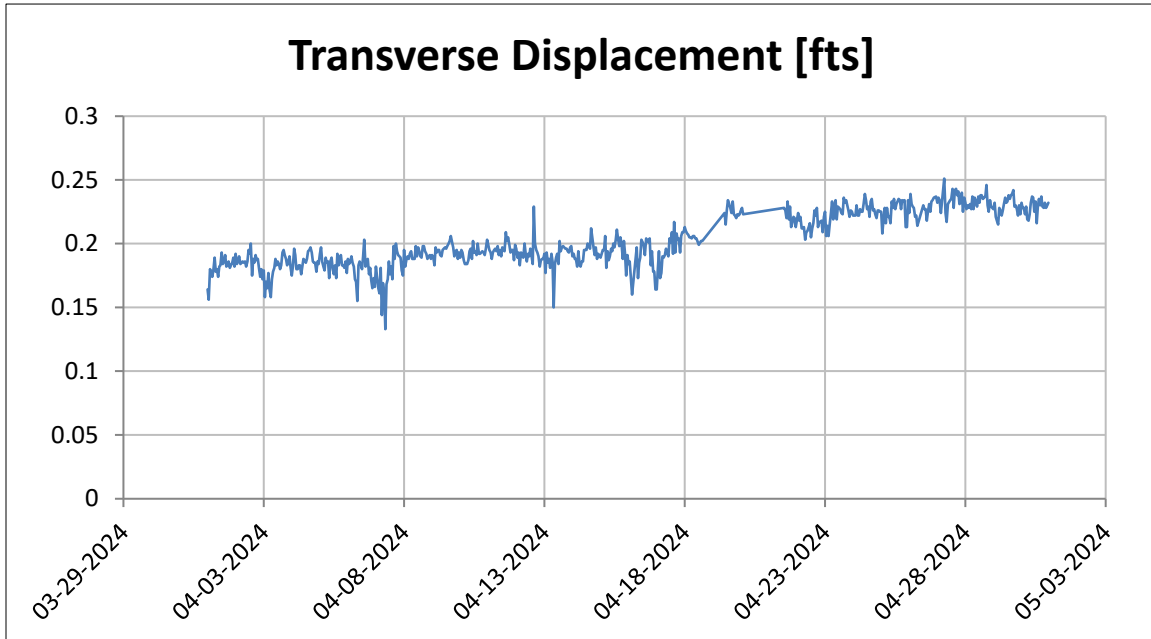
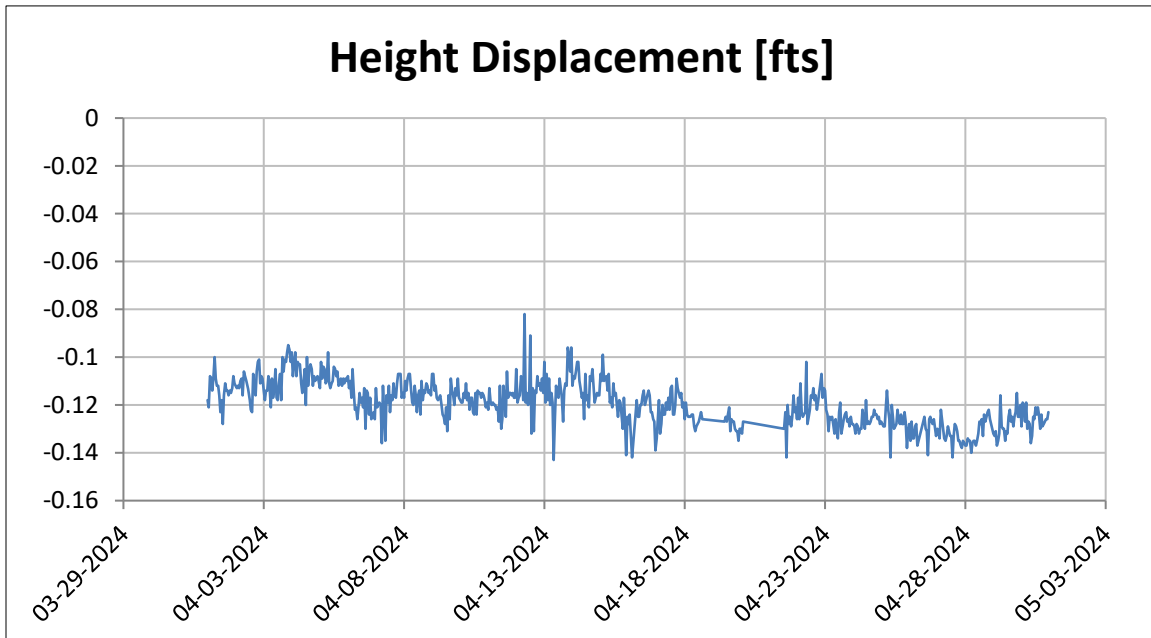
## Prism B7300-4

| Prism ID | Cumulative Transverse Displacement (ft) | Cumulative Height Displacement (ft) | Monthly Delta (ft) | Cumulative Delta (ft) | Notes / Recommendations |
|---|---|---|---|---|---|
| B7300-4 | 0.232 | -0.123 | 0.0676 | 0.2913 | Slope creep |

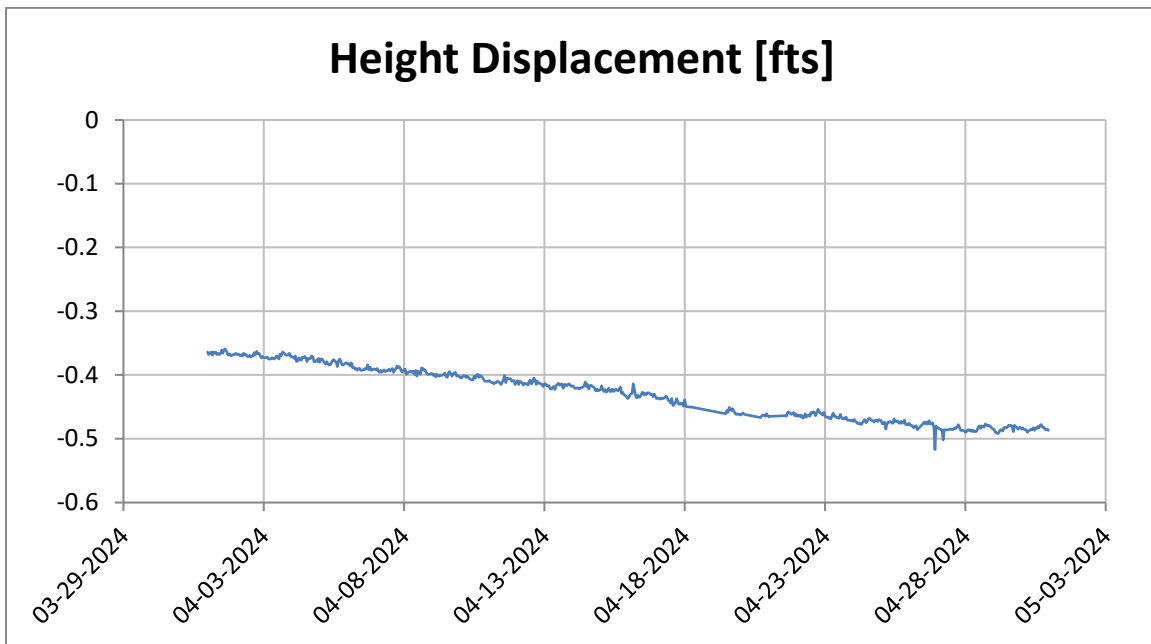
## Prism B7400-2

| Prism ID | Cumulative Transverse Displacement (ft) | Cumulative Height Displacement (ft) | Monthly Delta (ft) | Cumulative Delta (ft) | Notes / Recommendations |
|---|---|---|---|---|---|
| B7400-2 | -0.041 | -0.487 | 0.5864 | 1.0206 | Slope creep |

1. Survey accuracy is +/-0.016 feet.
2. Alert threshold is +/-0.35 feet.
3. Transverse displacement is in the horizontal direction. Positive direction means closer to the robotic total station.
4. Height displacement is in the vertical direction. Positive direction means higher in elevation.
5. Movement believed to be settlement of the compacted fill.

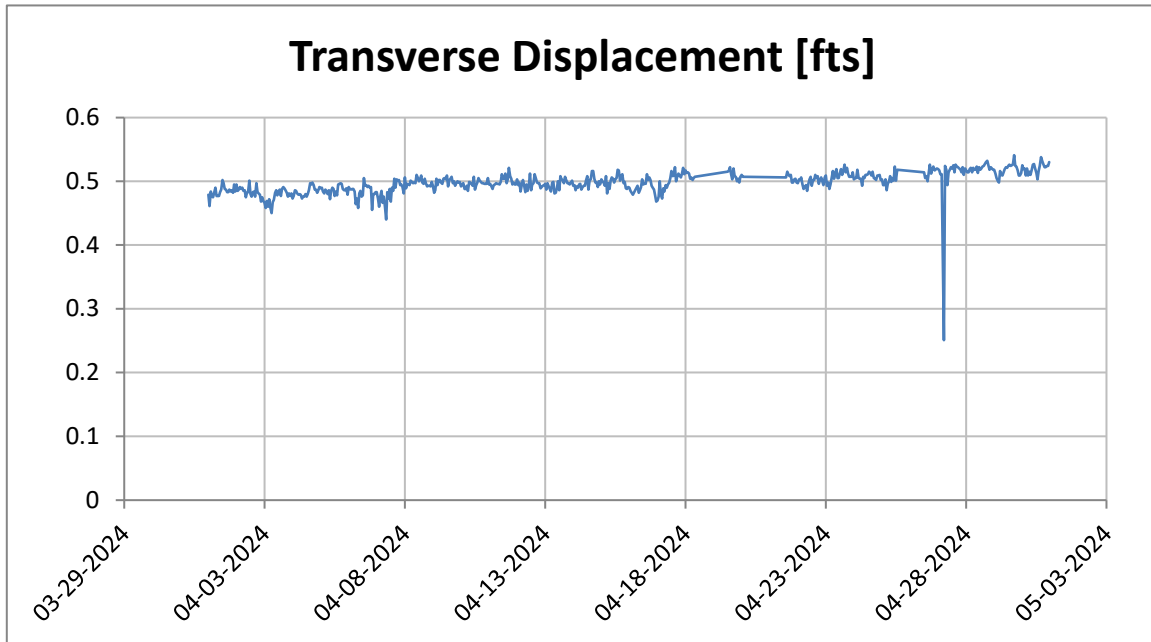
## Prism B7400-4

| Prism ID | Cumulative Transverse Displacement (ft) | Cumulative Height Displacement (ft) | Monthly Delta (ft) | Cumulative Delta (ft) | Notes / Recommendations |
|---|---|---|---|---|---|
| B7400-4 | 0.530 | -0.307 | 0.0743 | 0.7094 | Slope creep |

1. Survey accuracy is +/-0.016 feet.
2. Alert threshold is +/-0.35 feet.
3. Transverse displacement is in the horizontal direction. Positive direction means closer to the robotic total station.
4. Height displacement is in the vertical direction. Positive direction means higher in elevation.
5. Movement believed to be settlement of the compacted fill.

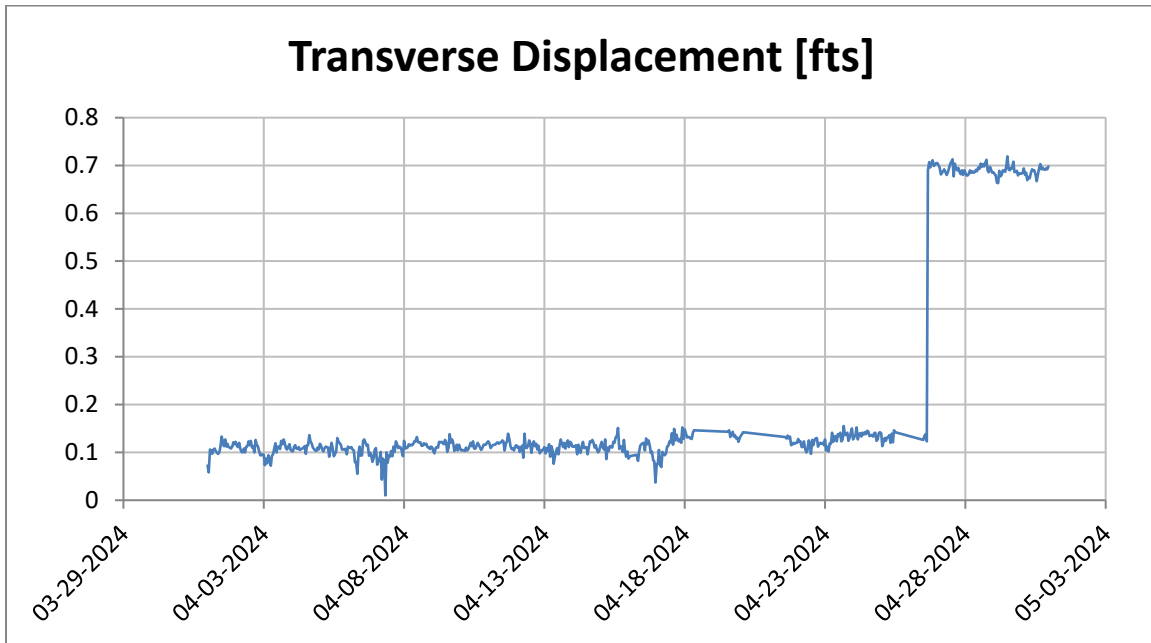
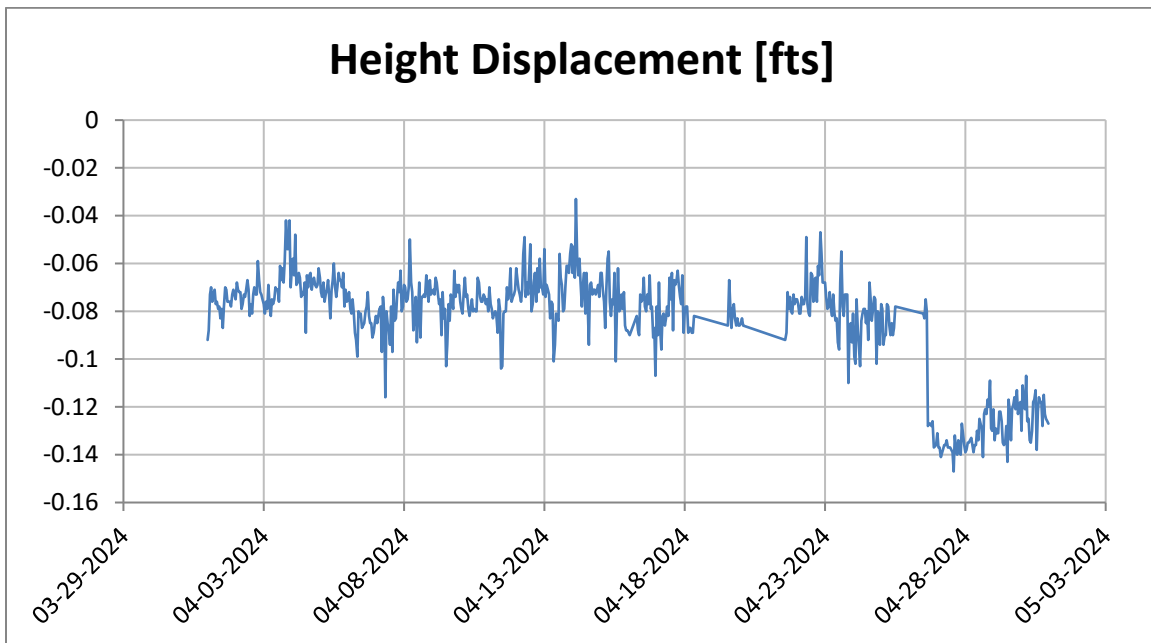
## Prism B7400-5

| Prism ID | Cumulative Transverse Displacement (ft) | Cumulative Height Displacement (ft) | Monthly Delta (ft) | Cumulative Delta (ft) | Notes / Recommendations |
|---|---|---|---|---|---|
| B7400-5 | 0.698 | -0.127 | 0.6256 | 0.7672 | Data jump on 4-26. No movement before or after offset. |

1. Survey accuracy is +/-0.016 feet.
2. Alert threshold is +/-0.35 feet.
3. Transverse displacement is in the horizontal direction. Positive direction means closer to the robotic total station.
4. Height displacement is in the vertical direction. Positive direction means higher in elevation.
5. Data shift believed to be caused by revegetation operations impacting the prism.

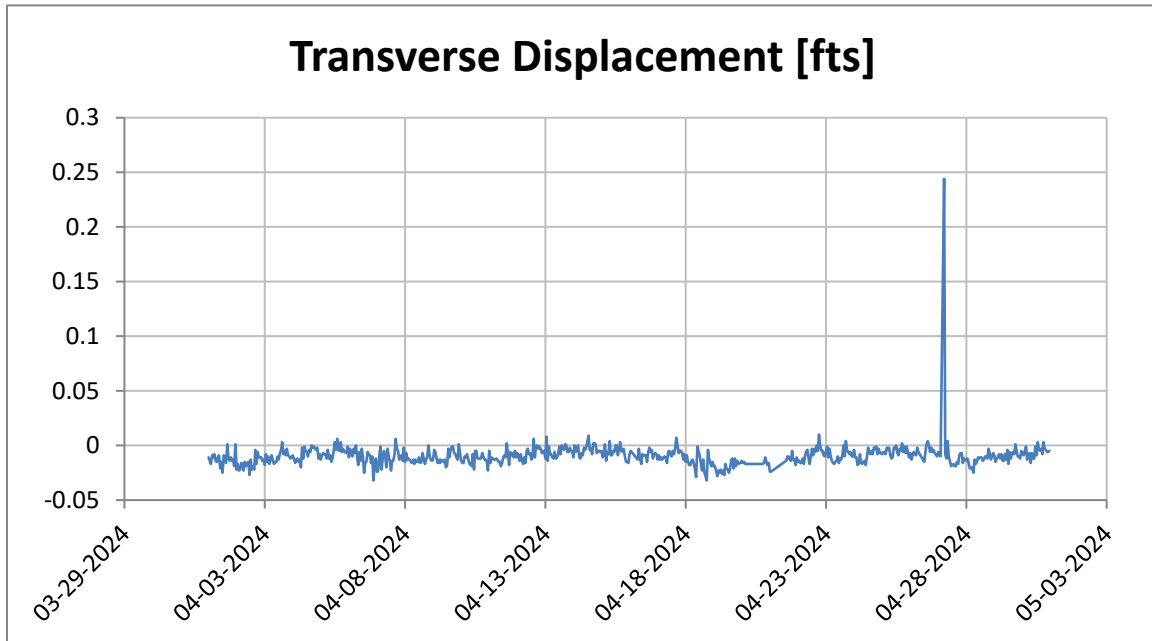
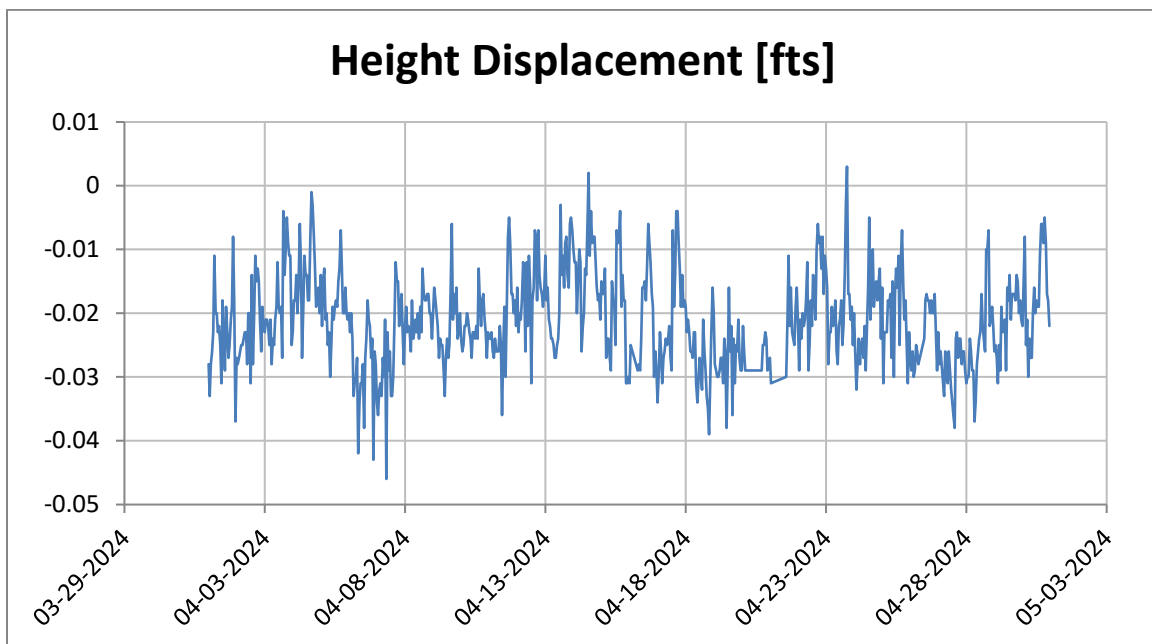
## Prism P2

| Date(s) | Alert | Cause/Actions taken | Resolved |
|---|---|---|---|
| 27-Apr | P2 regression limits | Snow and fog at time of alerts. Readings in positive and negative directions. No work being performed at time of alerts. | 27-Apr |

1. Survey accuracy is  $\pm 0.016$  feet.
2. Alert threshold is  $\pm 0.35$  feet.
3. Transverse displacement is in the horizontal direction. Positive direction means closer to the robotic total station.
4. Height displacement is in the vertical direction. Positive direction means higher in elevation.
5. Regression limit received on April 27.

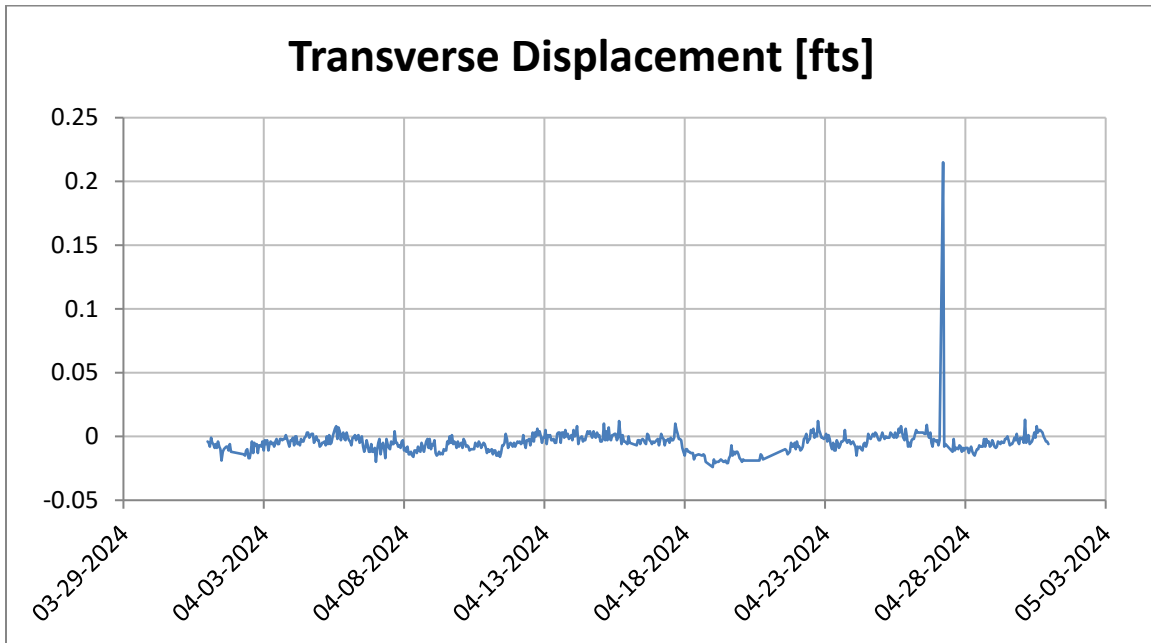
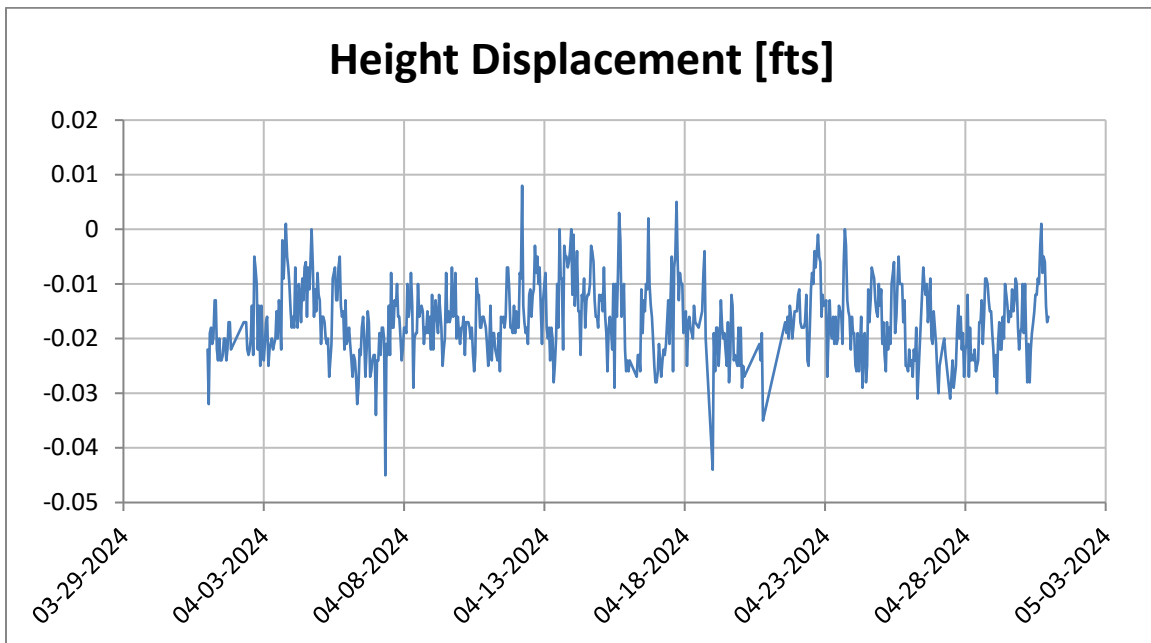
## Prism P5

| Date(s) | Alert | Cause/Actions taken | Resolved |
|---|---|---|---|
| 27-Apr | P5 regression limits | Snow and fog at time of alerts. No work being performed at time of alerts. | 27-Apr |

1. Survey accuracy is  $\pm 0.016$  feet.
2. Alert threshold is  $\pm 0.35$  feet.
3. Transverse displacement is in the horizontal direction. Positive direction means closer to the robotic total station.
4. Height displacement is in the vertical direction. Positive direction means higher in elevation.
5. Regression limit received on April 27.

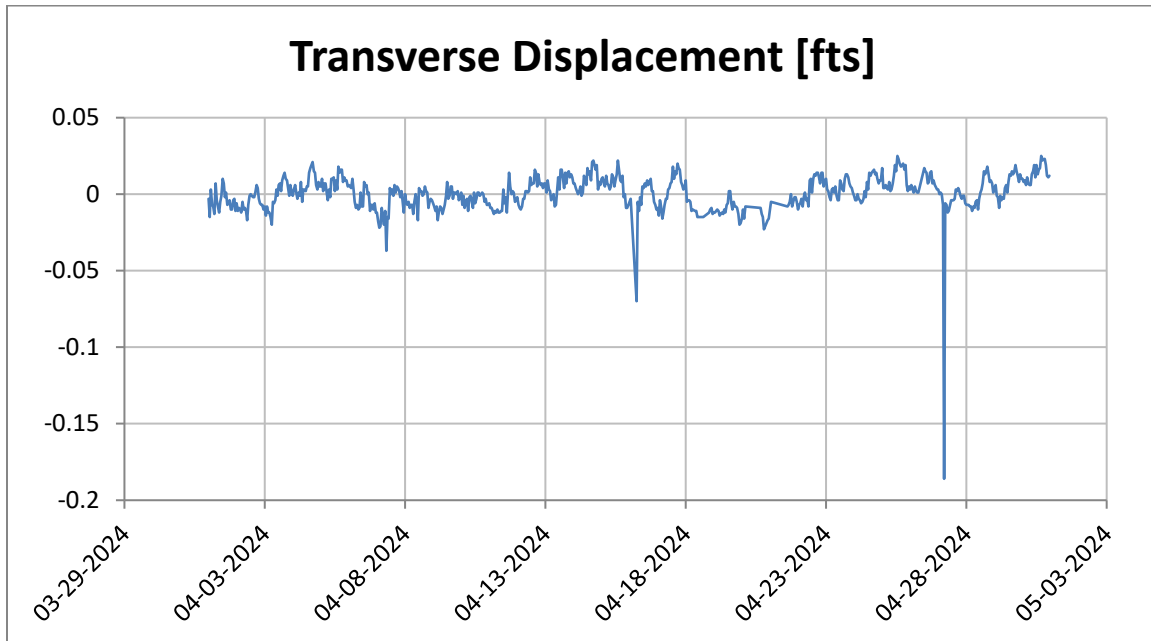
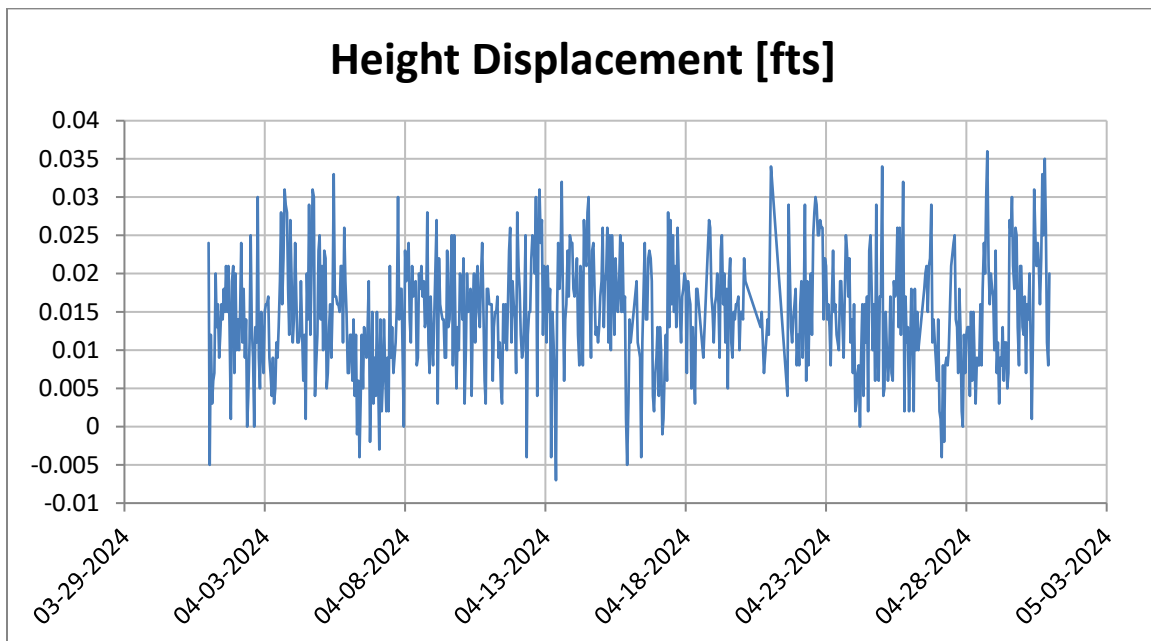
## Prism P25

| Date(s) | Alert | Cause/Actions taken | Resolved |
|---|---|---|---|
| 16-Apr | P25 regression limits | Snow and fog at time of alerts. Readings in positive and negative directions. | 16-Apr |
| 27-Apr | P25 regression limits | Snow and fog at time of alerts. Readings in positive and negative directions. No work being performed at time of alerts. | 27-Apr |

1. Survey accuracy is  $\pm 0.016$  feet.
2. Alert threshold is  $\pm 0.35$  feet.
3. Transverse displacement is in the horizontal direction. Positive direction means closer to the robotic total station.
4. Height displacement is in the vertical direction. Positive direction means higher in elevation.
5. Regression limits received on April 16 and 27.
