To: Jerald Schnabel  
Castle Aggregate  
File: April 2024 Monitoring Summary

From: Paul Kos  
Denver, CO 80202  
Date: May 20, 2024

**Reference: April 2024 Geotechnical Monitoring Summary Pikeview Quarry**

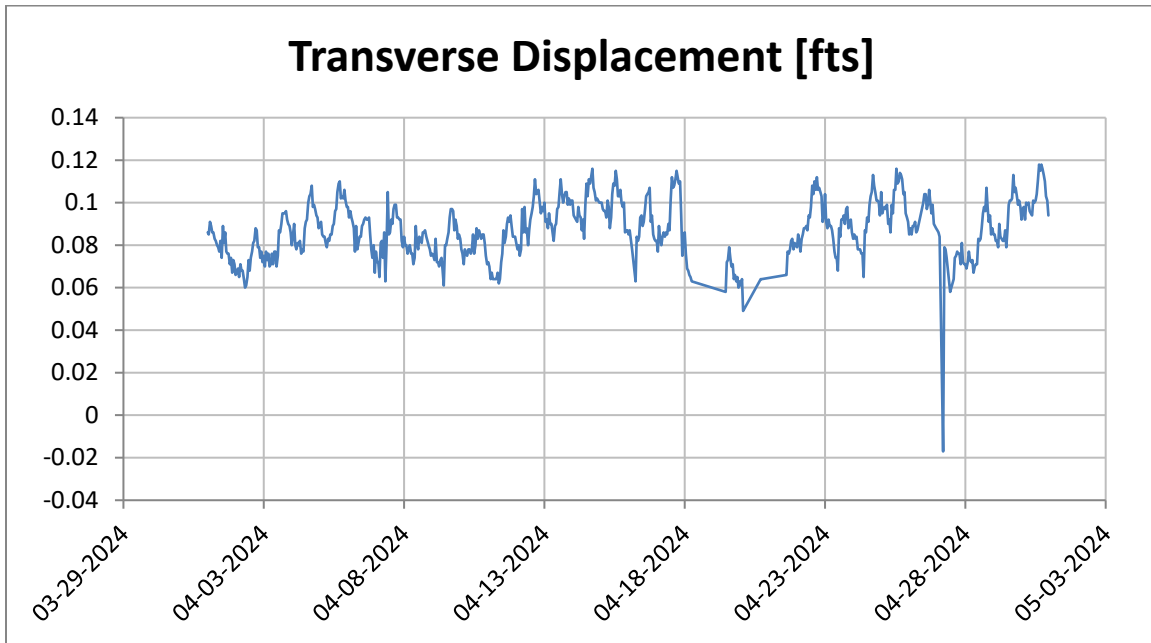
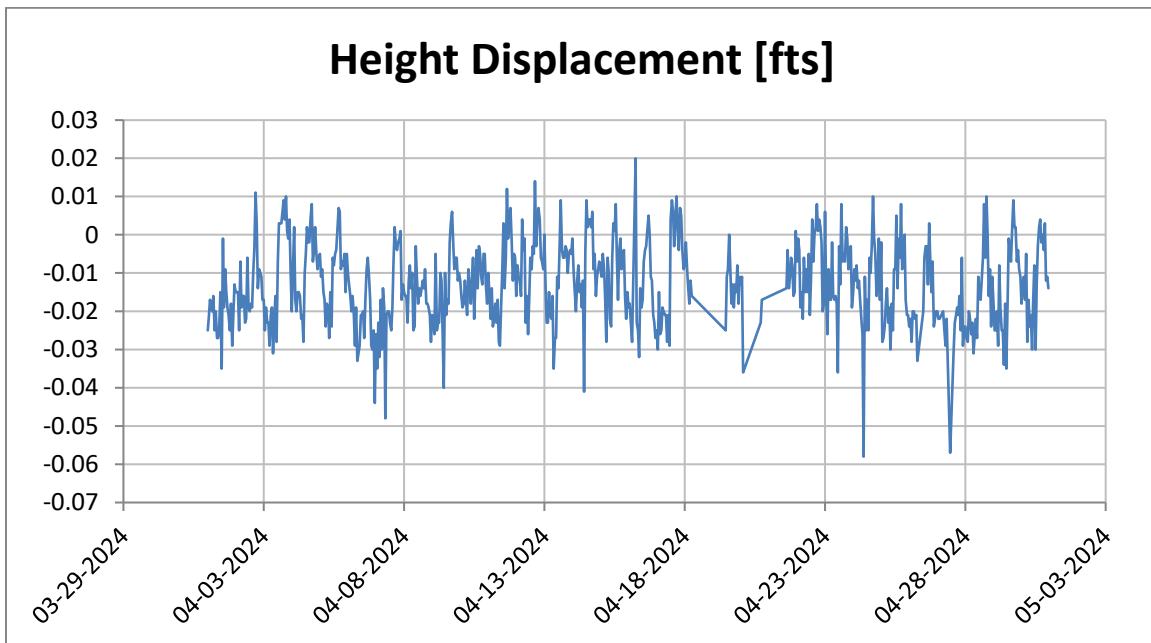
## Prism P33

| Date(s) | Alert | Cause/Actions taken | Resolved |
|---|---|---|---|
| 16-Apr | P33 regression limit | Snow and fog at time of alerts. Readings in positive and negative directions. | 16-Apr |
| 27-Apr | P33 regression limit | Snow and fog at time of alerts. No work being performed at time of alerts. | 27-Apr |

1. Survey accuracy is  $\pm 0.016$  feet.
2. Alert threshold is  $\pm 0.35$  feet.
3. Transverse displacement is in the horizontal direction. Positive direction means closer to the robotic total station.
4. Height displacement is in the vertical direction. Positive direction means higher in elevation.
5. Regression limits received on April 16 and 27.
