## Henderson Mine, M-1977-342, Inspection Report

**MINERALS PROGRAM INSPECTION REPORT**  
**PHONE: (303) 866-3567**

<b>MINE NAME:</b> Henderson Mine	<b>MINE/PROSPECTING ID#:</b> M-1977-342	<b>MINERAL:</b> Molybdenum	<b>COUNTY:</b> Clear Creek, Grand
<b>INSPECTION TYPE:</b> Monitoring	<b>WEATHER:</b> Clear	<b>INSP. DATE:</b> May 22, 2024	<b>INSP. TIME:</b> 09:00
<b>OPERATOR:</b> Climax Molybdenum Company	<b>OPERATOR REPRESENTATIVE:</b> Miguel Hamarat and Geoff Niggeler	<b>TYPE OF OPERATION:</b> 112d-3 - Designated Mining Operation	
<b>REASON FOR INSPECTION:</b> Normal I&E Program	<b>BOND CALCULATION TYPE:</b> None	<b>BOND AMOUNT:</b> \$170,904,202.00	
<b>DATE OF COMPLAINT:</b> NA	<b>POST INSP. CONTACTS:</b> None	<b>JOINT INSP. AGENCY:</b> None	
<b>INSPECTOR(S):</b> Jared Ebert Nikie Gagnon	<b>INSPECTOR'S SIGNATURE:</b>

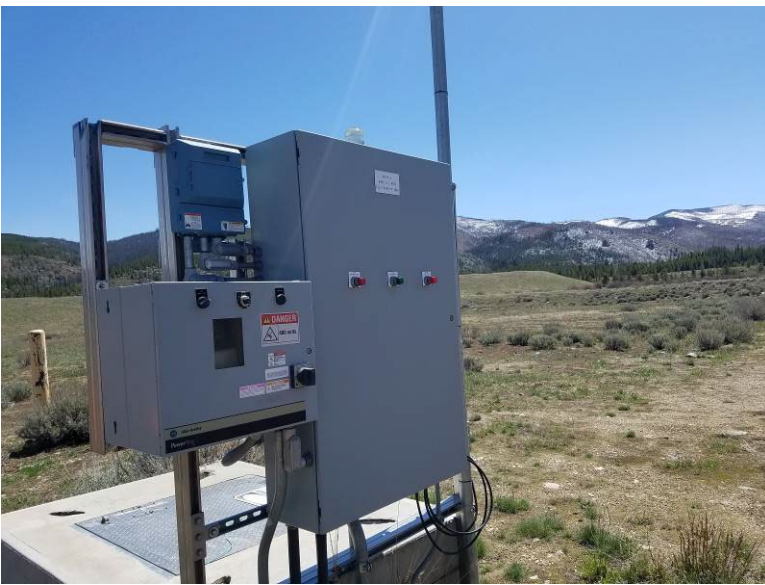
Extraction Well MLEX-2 was observed. This well is part of the Groundwater Extraction System. This well was not operating at the time of the inspection. According to Mr. Niggeler, CMC has portable generators that could be deployed to these wells should they lose power. These wells are routinely monitored and inspected for functionality by CMC staff.

**Figure 1. MLEX -2 Extraction Well controls**

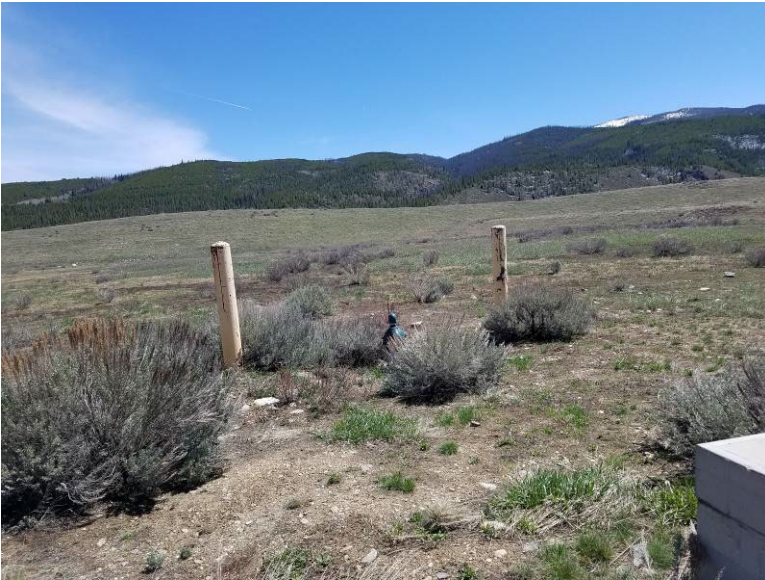
**Figure 2. MLEX - 2 Well**

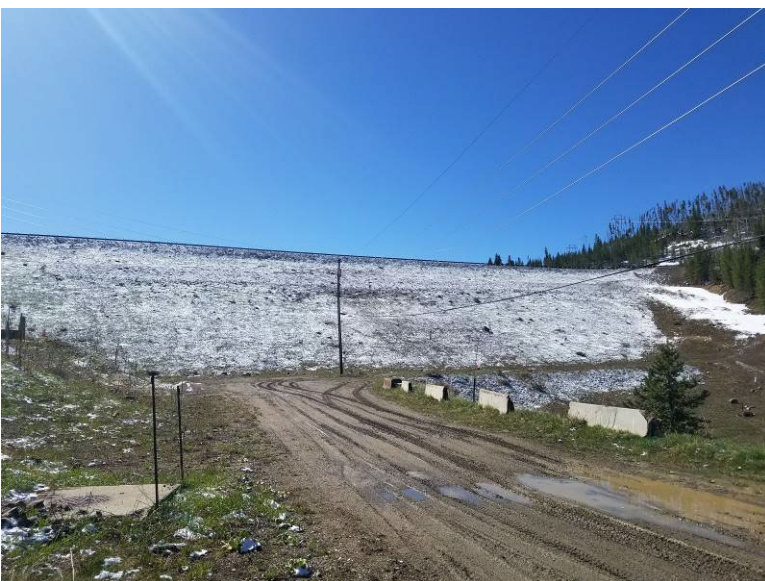
The East Branch Reservoir ("EBR") was observed. At the time of the inspection the Barge Return Pipeline was discharging water into the EBR. The dam embankment of the EBR was covered with a thin layer of snow but overall appeared stable. The EBR was discharging into the drainage that flows to the south east end of the Tailings Storage Facility ("TSF"). The East Branch Pump Station was observed and no problems were noted.

**Figure 3. Dam face of EBR**

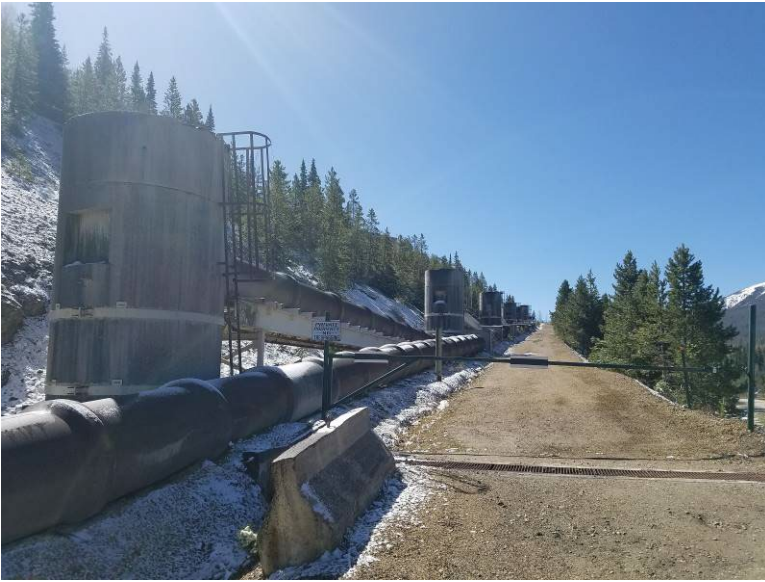
The Tailings Delivery Line ("TDL") and the Emergency Cutout Line was observed on the east side of the Mill. These reinforced concrete pipes appear to be in working order, no problems were noted. We followed the TDL to the TSF where CMC was actively depositing tailings at the crest of 1 Dam. CMC was utilizing spigots to deposit the tailings. The TDL is partially buried in places; where it was exposed, the TDL was visible and no problems were noted.

**Figure 4. TDL and Emergency Cutout Line observed east of the Mill.**

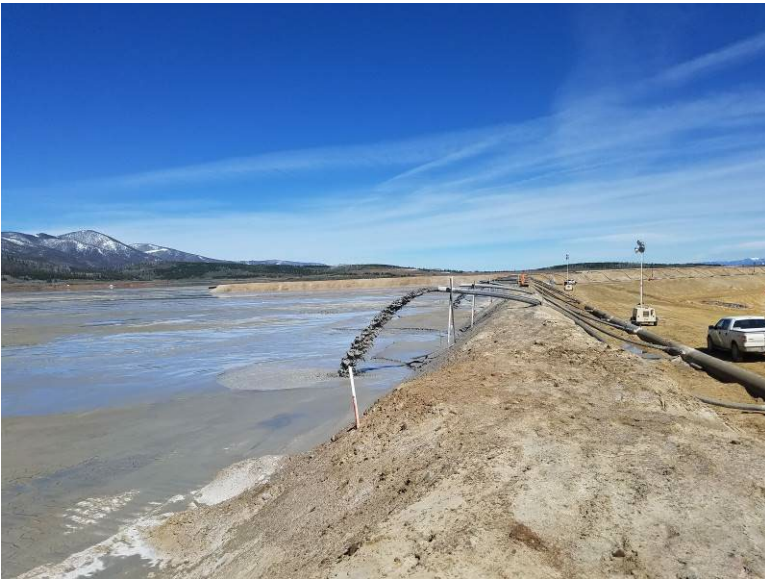
**Figure 5. Active tailings deposition on 1 Dam crest.**

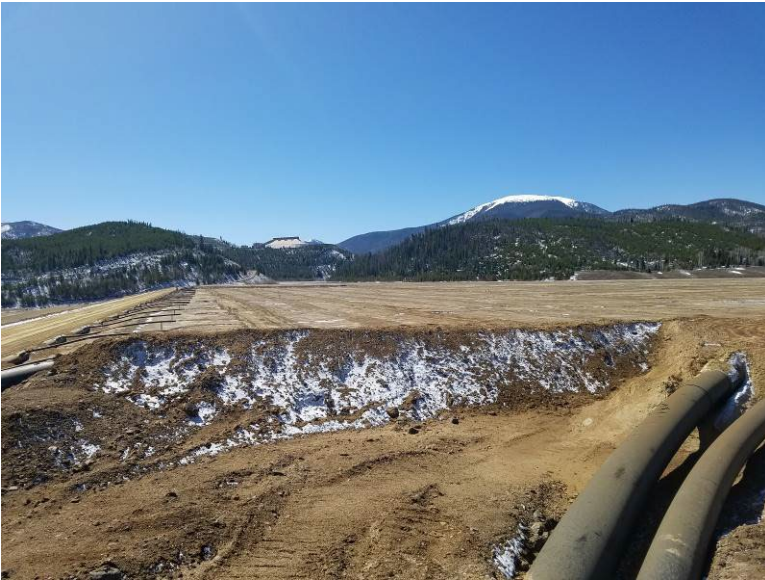
At the time of the inspection, the Operator was applying Coherix dust control surfactant to the surface of 1 Dam. It appears the surface of 3 Dam had already been treated with Coherix.

**Figure 6. Top of 3 Dam. Treated for dust control.**

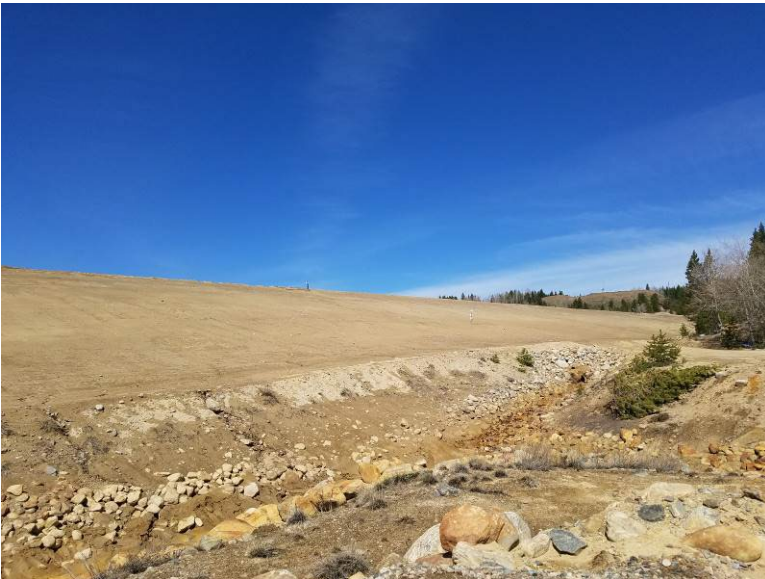
3 Dam was observed. The face of the dam appeared stable with only minor rills observed. CMC appears to have recently repaired a rill that had formed on the south side of the 3 Dam face. The seep water collection system below 3 Dam was observed, this area appeared in good repair and the discharge point into the 3 Dam Seep Water Pipeline appeared clear of debris and functional.

**Figure 7. Face of 3 Dam and seep water collection area.**

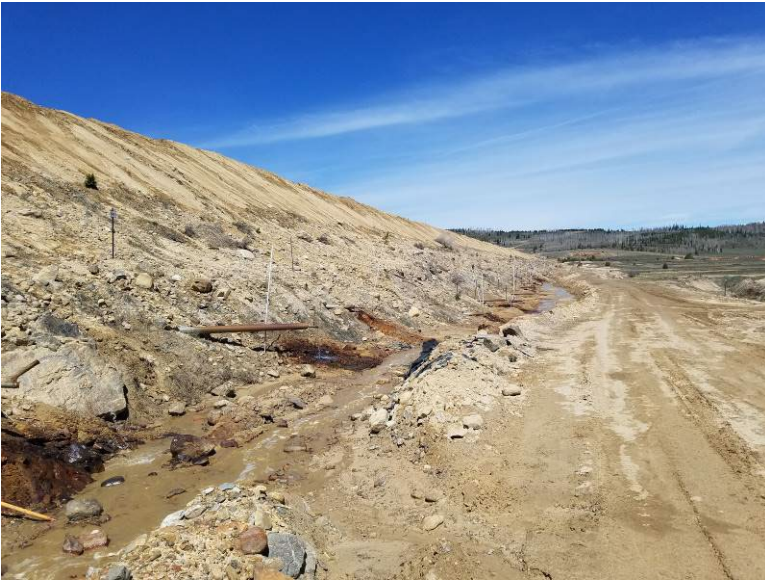
1 Dam was observed. Multiple horizontal drains were observed discharging water into the seep water collection system at the toe of the dam. Some standing water was observed in the seep water collection area but it appears the majority of the storage capacity of this area was available. Seep water was observed flowing to the Ute Park Pump Station. Several rills and gullies have formed on the face of 1 Dam. According to Mr. Niggeler, CMC monitors these rills and once they extend through two bench heights, they are repaired. Several larger rills were observed that will likely need to be repaired. On the north end of the TSF, sands that have been cleaned out of the seep water collection system are stockpiled, windrowed and allowed to dry. This material is then use to repair the rills on the face of the dam.

**Figure 8. Toe of 1 Dam. Horizontal drains discharging into the seep water collection system.**

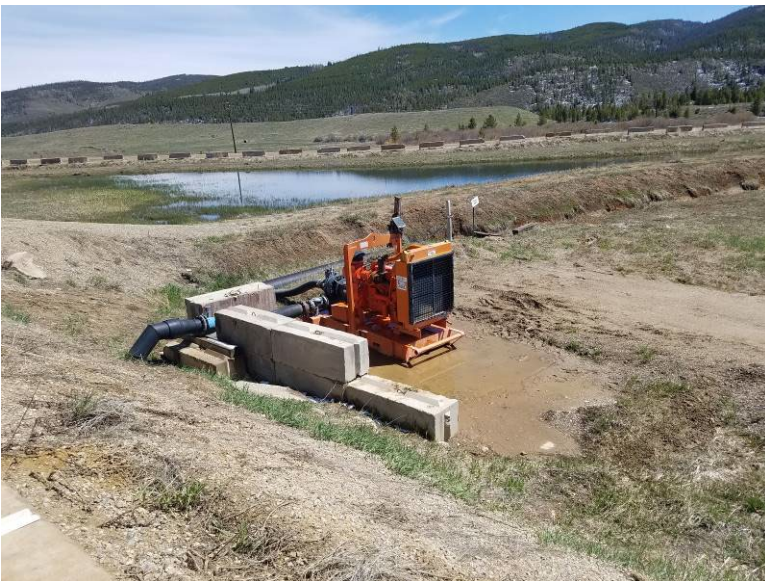
The emergency diesel back-up pump for the Ute Park Pump Station was observed. The pump is staged and ready for use.

**Figure 9. Back-up diesel pump staged and ready for the Ute Park Pump Station.**

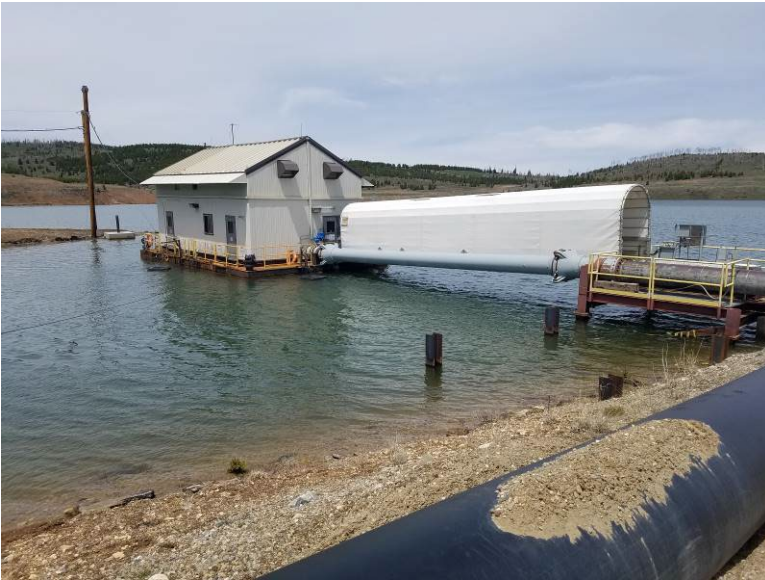
The Barge Pump Station was observed and it appeared to be functional.

**Figure 10. Barge Pump Station**

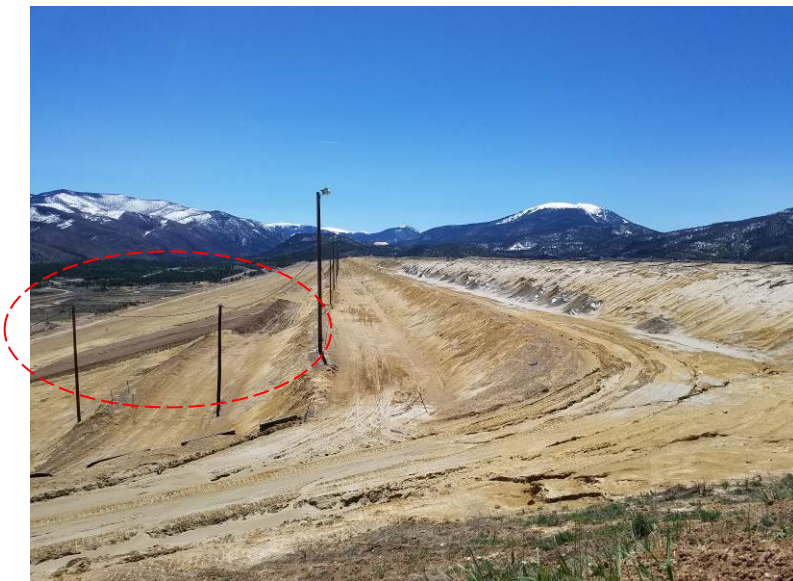
CMC has established revegetation test plots in two locations on 1 Dam. Two plots were observed on the face of 1 Dam at the north end of the TSF. Three plots were observed on the northwest end of the TSF beach of 1 Dam. CMC is testing various topsoil replacement types, depths and layering schemes to better determine the most effective way to establish vegetation on the TSF upon closure of the operation and to best facilitate TSF long term stability. Vegetation is beginning to establish on the three test plots observed in the beach area.

**Figure 11. From the north end of the TSF, 1 Dam looking southeast. Two revegetation test plots visible on the face of 1 Dam.**

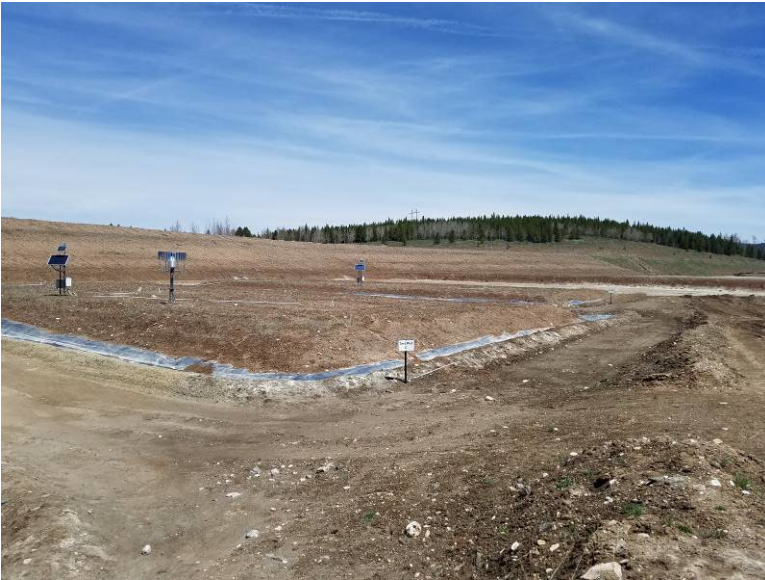
**Figure 12. Revegetation test plots on the beach area on 1 Dam.**
