MINERALS PROGRAM INSPECTION REPORT
PHONE: (303) 866-3567

MINE NAME: Nichols Gravel Pit	MINE/PROSPECTING ID#: M-1981-013	MINERAL: Sand and gravel	COUNTY: Mesa
INSPECTION TYPE: Surety-Related Inspection	WEATHER: Clear	INSP. DATE: May 14, 2024	INSP. TIME: 14:00
OPERATOR: Nichols Gravel Pit, L.L.P.	OPERATOR REPRESENTATIVE: Mike Anson	TYPE OF OPERATION: 112c - Construction Regular Operation	
REASON FOR INSPECTION: Surety Related	BOND CALCULATION TYPE: Complete Bond	BOND AMOUNT: \$115,474.00	
DATE OF COMPLAINT: NA	POST INSP. CONTACTS: DRMS	JOINT INSP. AGENCY: None	
INSPECTOR(S): Amy Yeldell	INSPECTOR'S SIGNATURE:

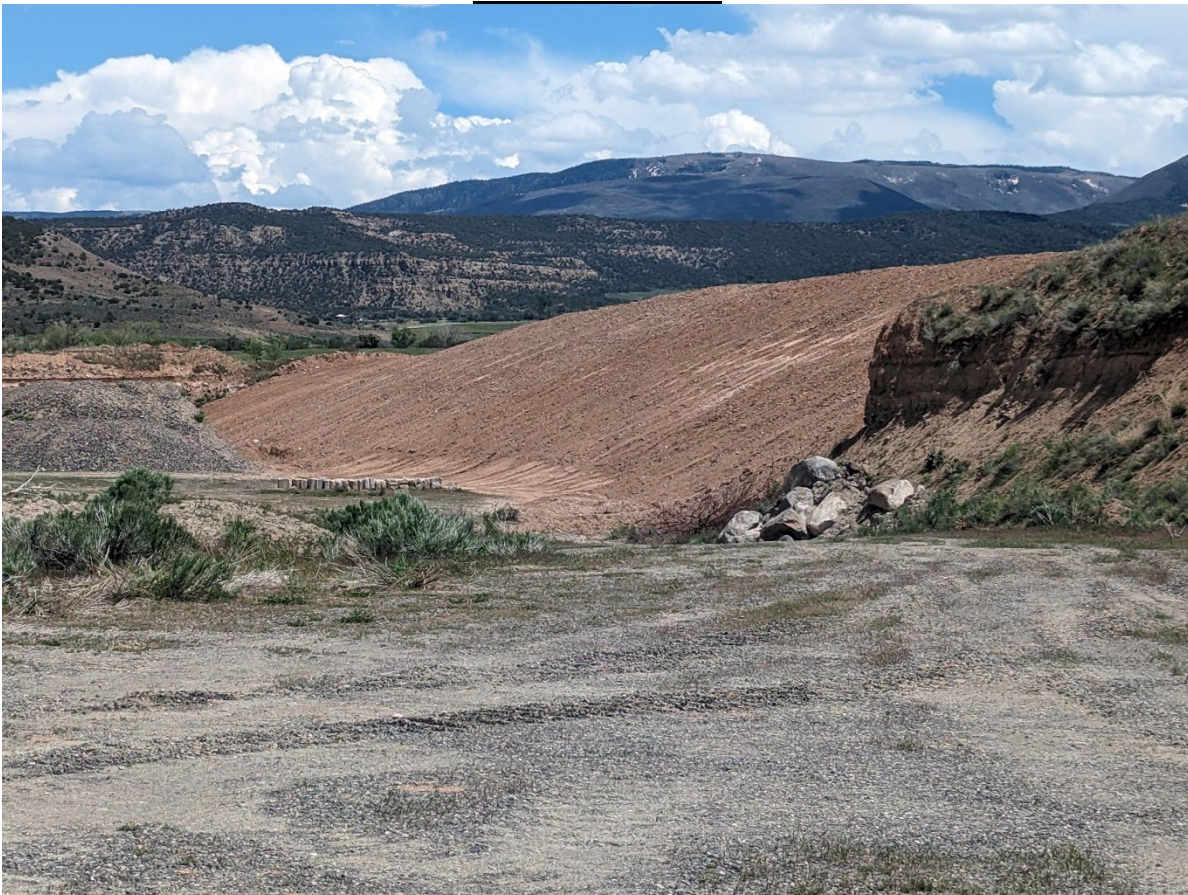
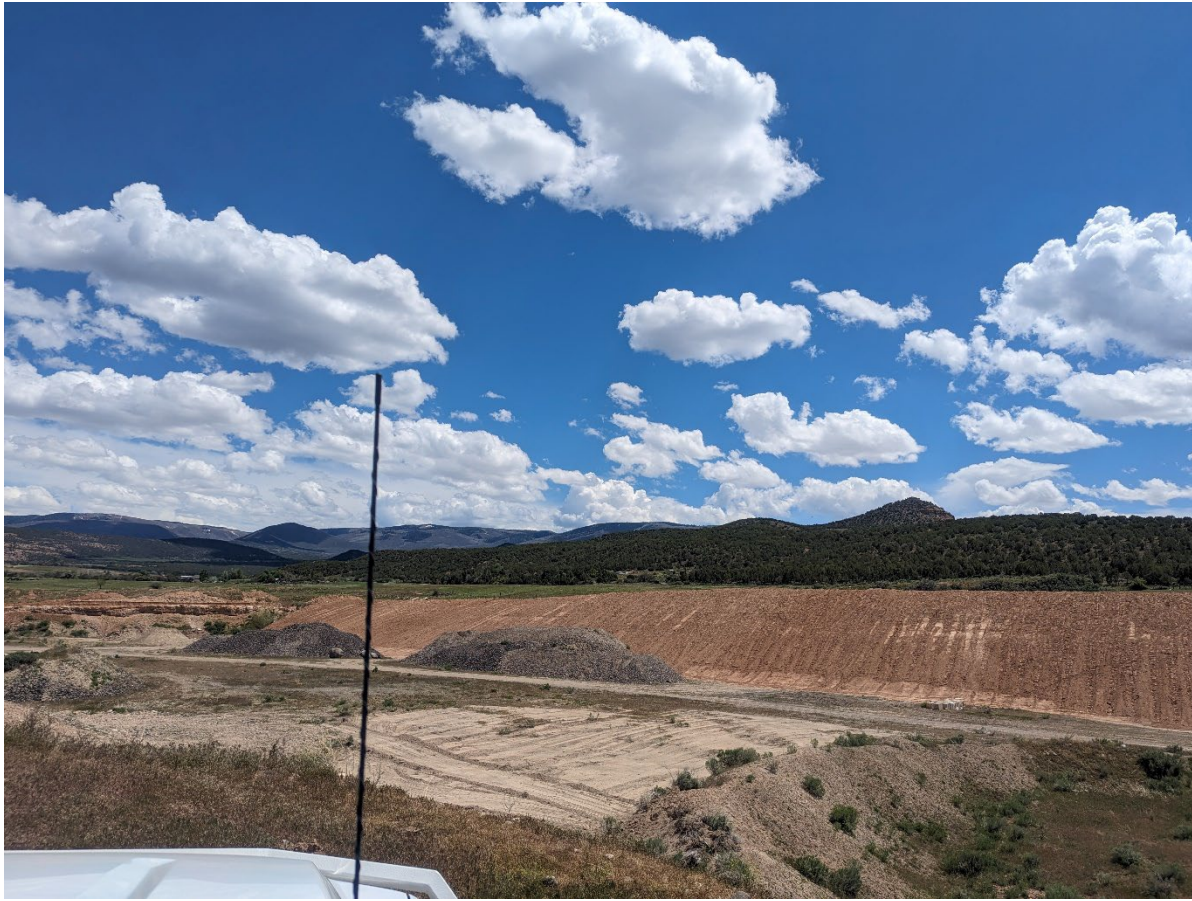
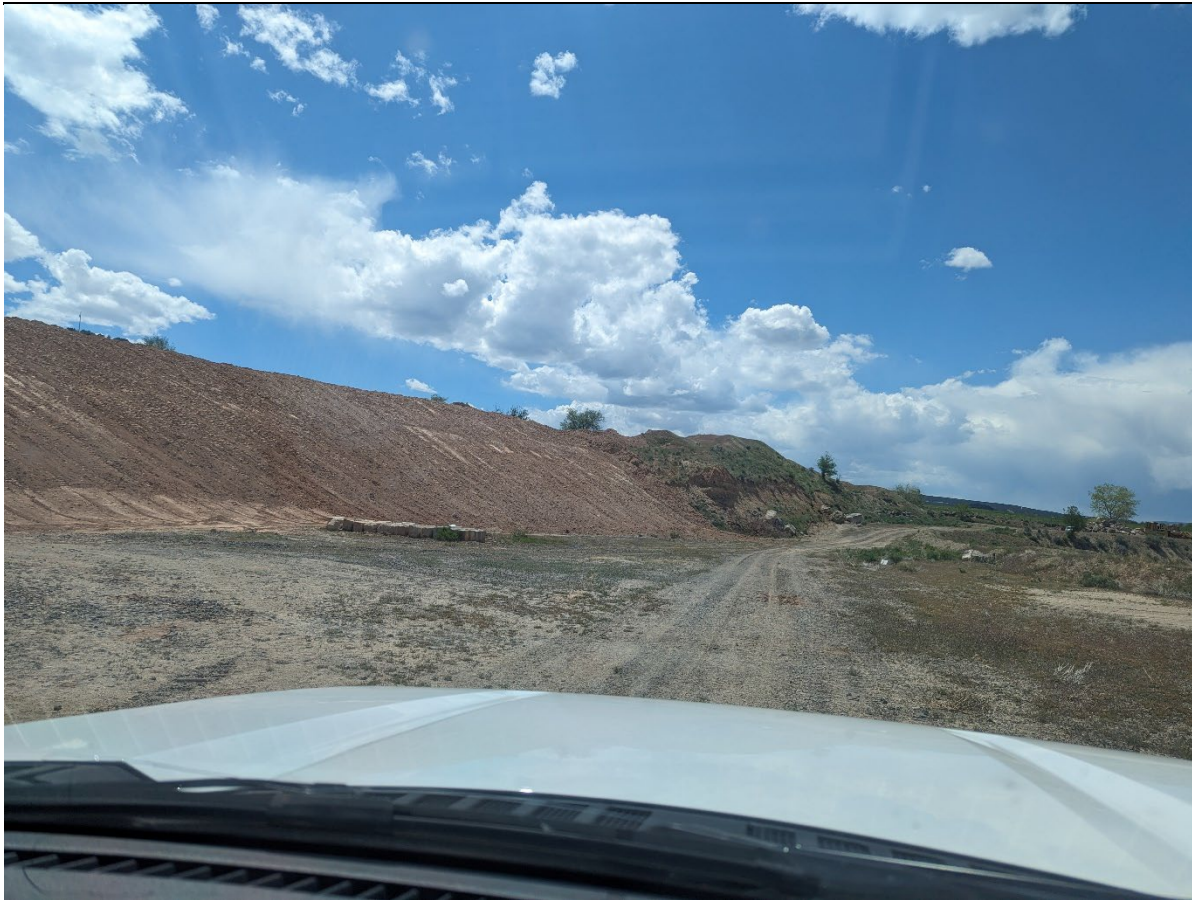
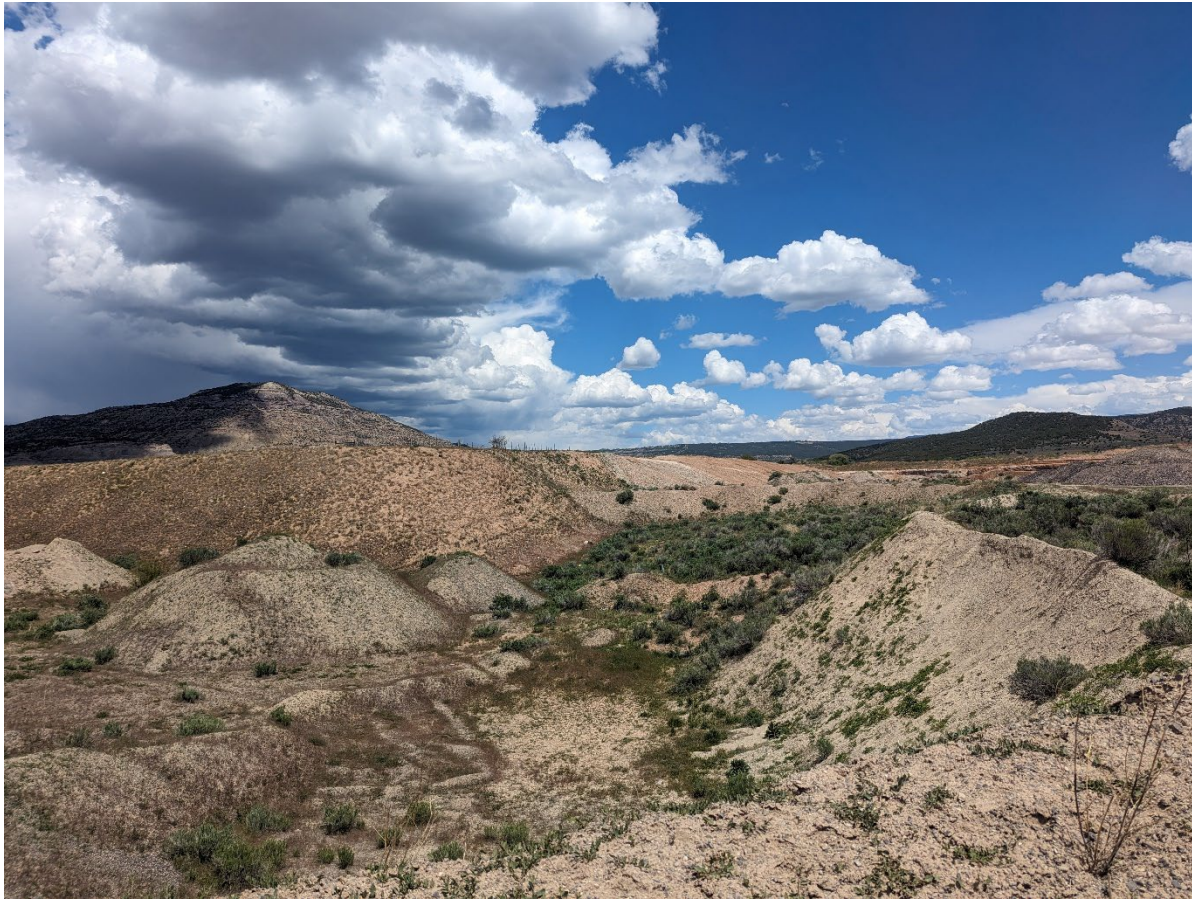
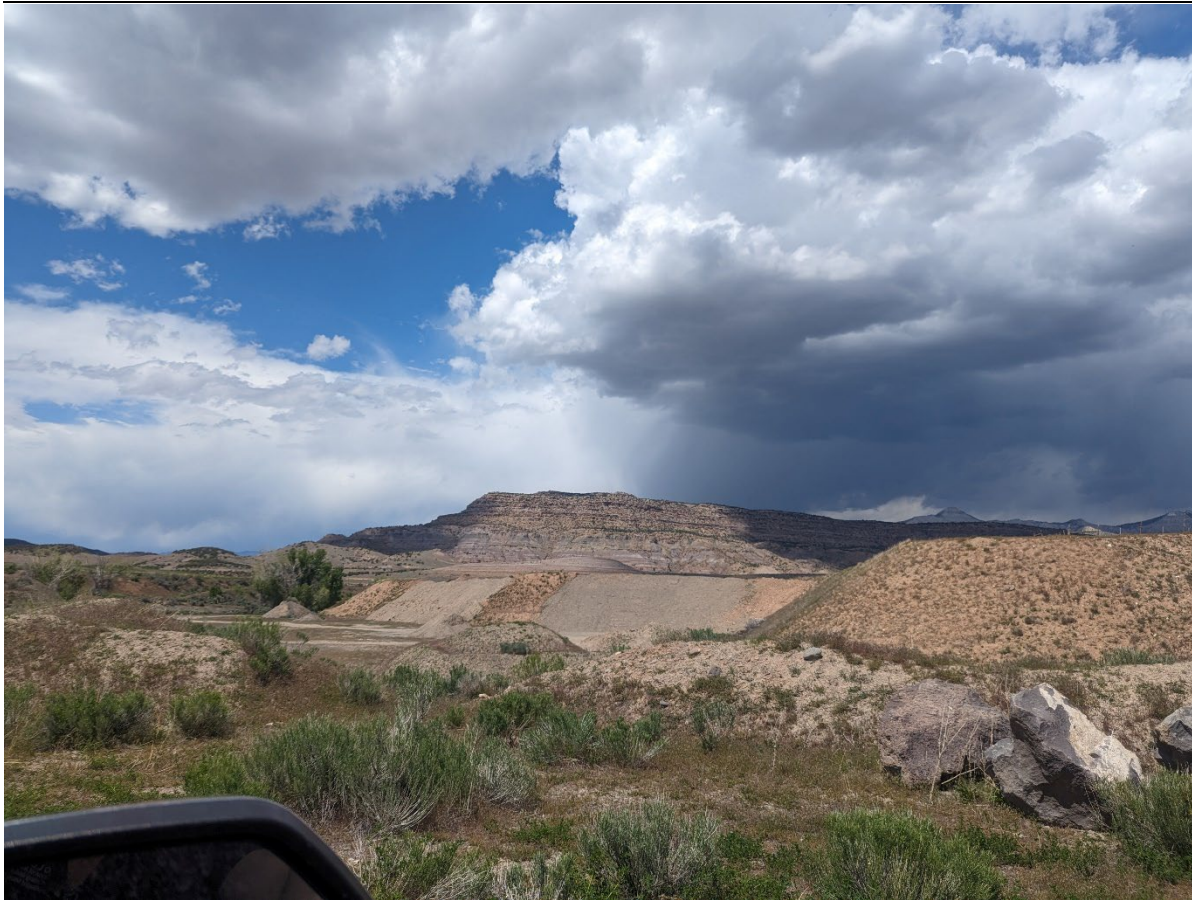
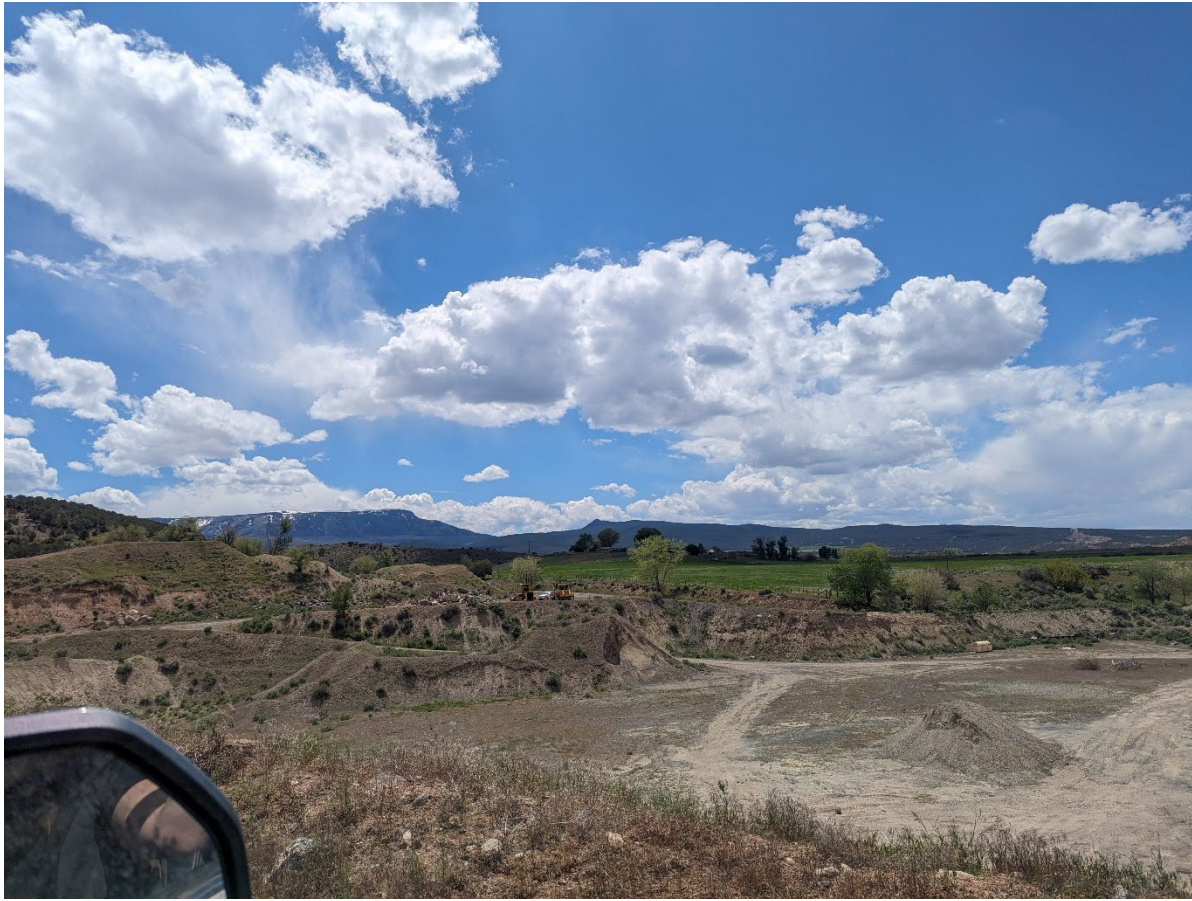
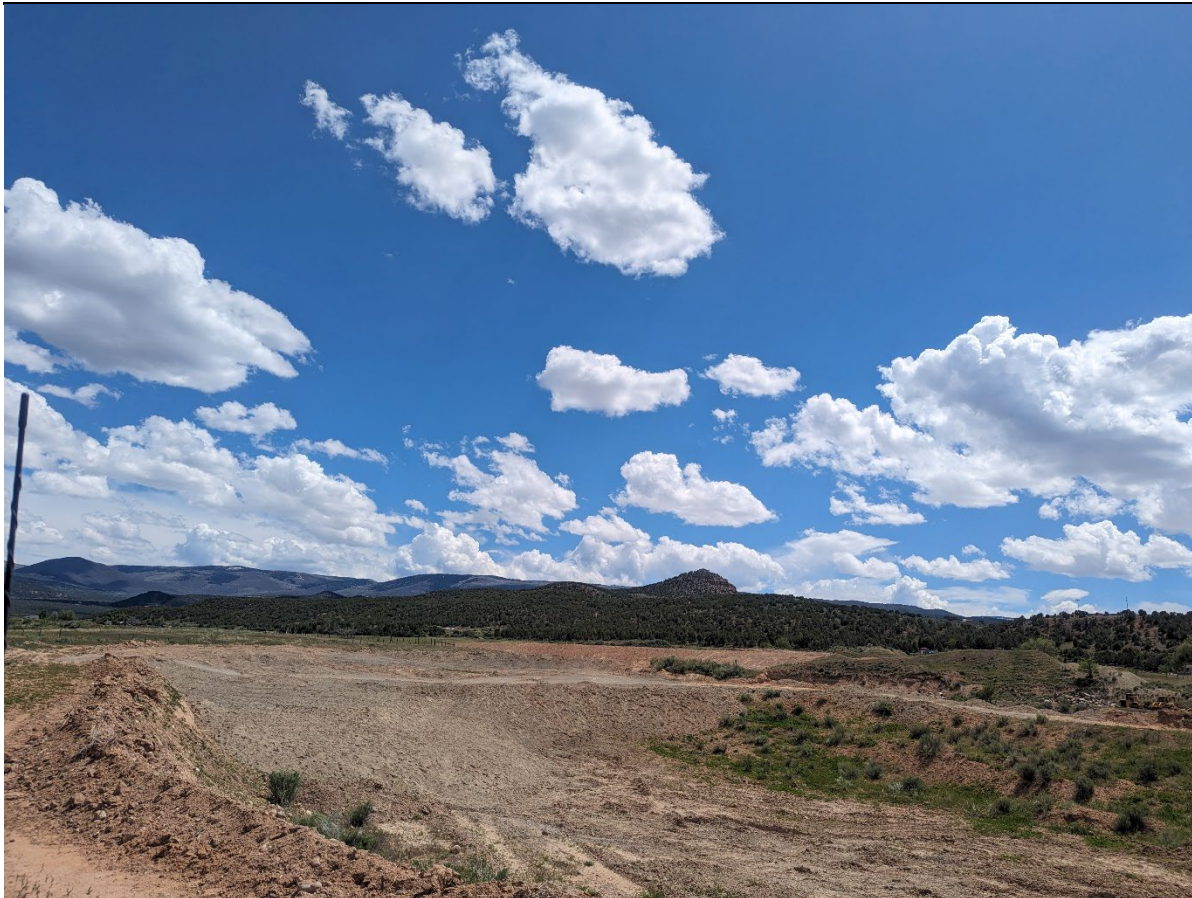
Significant grading has occurred compared to the previous inspection. Approximately 700 LF of the exterior upper southern highwall has been graded to a 2H: 1V. The western portion of the southern highwall remains unchanged (600 LF). The southeastern corner and eastern side remains near vertical. According to Mr. Anson if the material is not processed this summer those slopes will also be graded. These slopes can be cut/full (400LF). The upper northern highwall has also been graded to a 2H: 1V with some areas near the fence corner being steeper. Approximately 840 LF is properly graded to a 2H: 1V on the northeast side. 400 LF will require additional backfill material and blending to get to a 2H: 1V around the fence corner.

Portions of the northwest highwall have also been graded. The hole above the highwall in the northwest corner has also been partially regraded. Approximately 300 LF of grading work remains in this area.

Photos **X-XX** show the recently regrade slopes throughout the pit.
