Permit Number: C-1981-038 Mine Name: Bowie No. 1 Mine Operator: Bowie Resources, LLC Operator Address: Mr. Basil Bear P.O. Box 1488 Paonia, CO 81428	County: Delta Operation Type: Underground Permit Status: Active Ownership: Private Operator Representative Present: None
Operator Representative Signature: (Field Issua	nce Only)

A complete inspection was conducted by Rob Zuber of DRMS on May 22, 2024. No Bowie Resources Limited (BRL) representative was at the inspection.

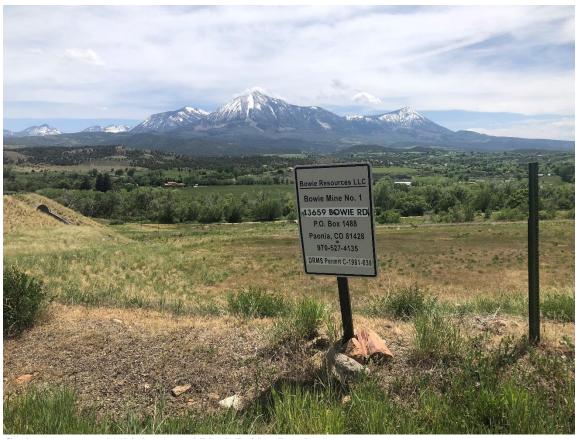
No erosion or other problems were seen with the Coal Storage Area beside the intersection of Highway 133 and Black Bridge Road.

Coal storage area by highway and Black Bridge Road

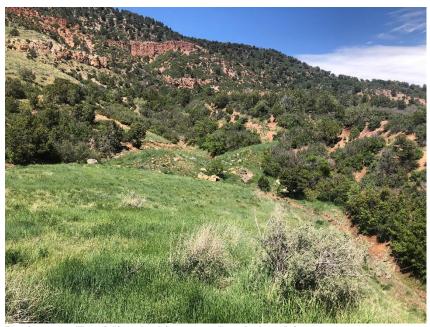
No erosion was seen at the reclaimed ponds at the East Mine (Ponds 1-4) or the West Mine, including the reclaimed road and the West Mine Fan.

Drainage at East Mine, looking up at Ponds 1 and 2

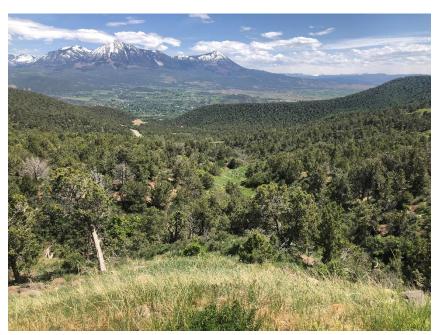
Drainage at East Mine, looking down at Ponds 3 and 4

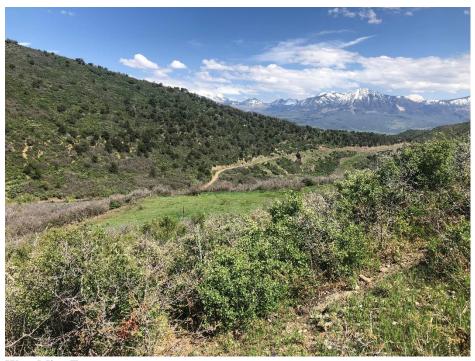
West Mine Fan

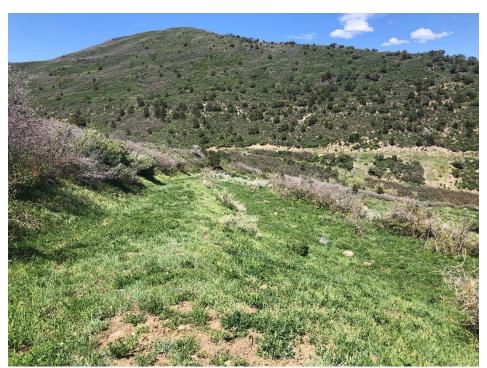
Reclaimed road at West Mine
