### MINERALS PROGRAM INSPECTION REPORT

<b>MINE NAME:</b> Mattics Pit	<b>MINE/PROSPECTING ID#:</b> M-2021-044	<b>MINERAL:</b> Aggregate & gravel	<b>COUNTY:</b> Cheyenne
<b>INSPECTION TYPE:</b> Monitoring	<b>WEATHER:</b> Clear	<b>INSP. DATE:</b> April 23, 2024	<b>INSP. TIME:</b> 11:00
<b>OPERATOR:</b> Cheyenne County	<b>OPERATOR REPRESENTATIVE:</b> Victor Gibbs	<b>TYPE OF OPERATION:</b> 112c - Construction Regular Operation

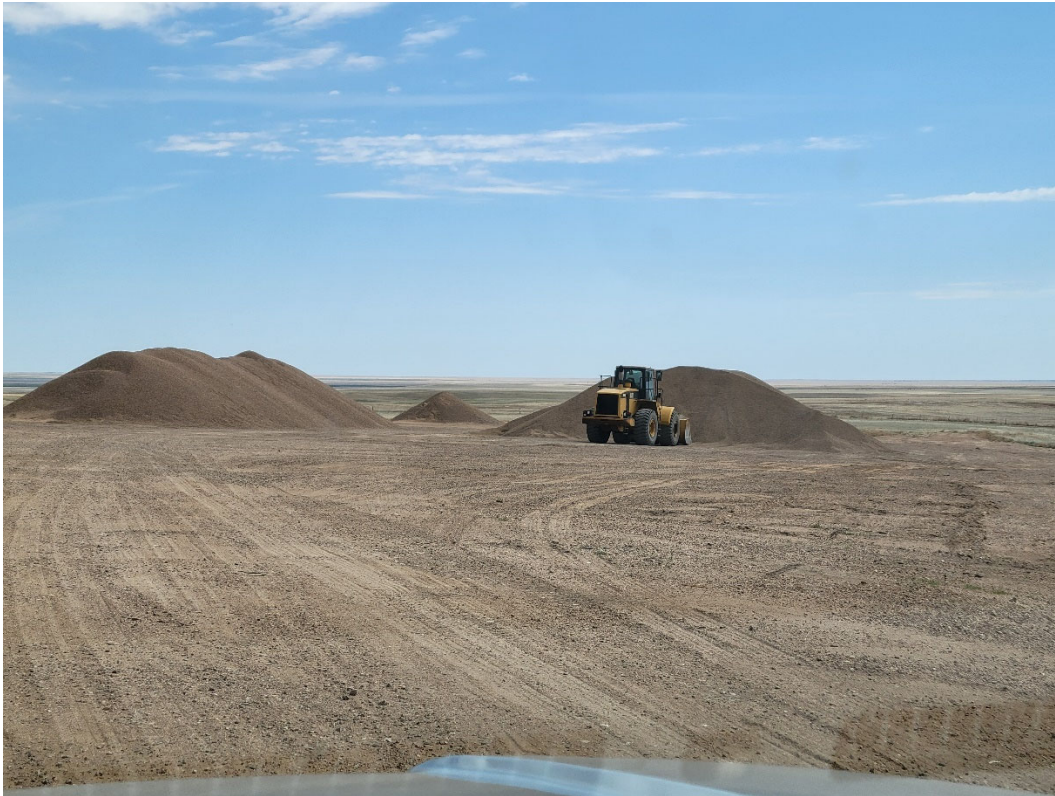
Photo 1: Stockpiles stored in disturbance area on the southeast side of Mining Area 1 in the Phase 1.

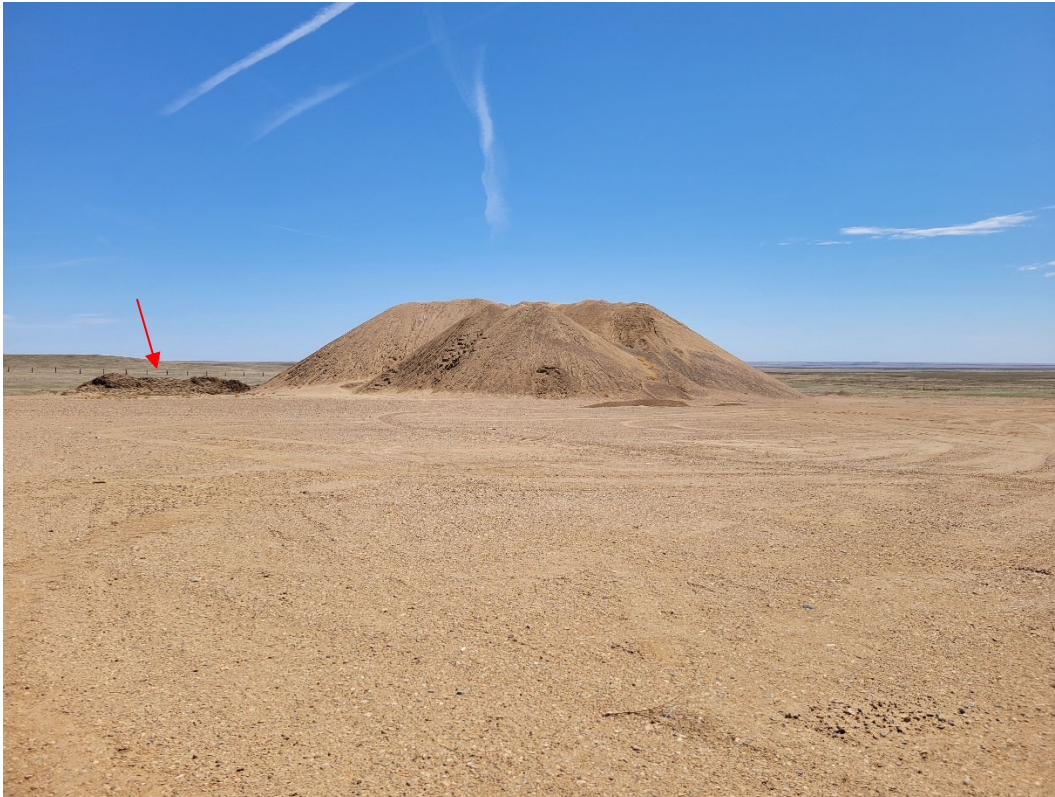
**PROBLEM 3:** The Division observed topsoil stockpiles in Mining Area 1 do not have established vegetation on them and are therefore susceptible to erosion. Rule 3.1.9(1) states if topsoil is not replaced into the backfill area within a time short enough to avoid deterioration of the topsoil, vegetative cover or other means shall be employed so that the topsoil is protected from erosion.

The Division observed topsoil stored in piles along the eastern edge of the stockpile area in Phase 1 (See Photos 3 & 4). The topsoil does not have a vegetative cover and showed signs of erosion. Per Rule 3.1.9 (1), if topsoil is not replaced on a backfill area within a time short enough to avoid deterioration of the topsoil, vegetative cover or other means shall be employed so that the topsoil is protected from erosion, remains free of any contamination by toxic or acid-forming material, and is in a usable condition for reclamation. As noted in Problem 2, the topsoil stockpiles need to be stabilized by seeding with the seed mix that was submitted as part of the approved Reclamation Plan. The Operator shall demonstrate compliance by submitting seed tags, a bill of sale or photographs of seeding activities.

Photo 3: Looking east at a stockpile in Mining Area 1. Topsoil is stored along the disturbance boundary behind the stockpile (red arrow).

**CORRECTIVE ACTIONS:** The operator shall seed the stockpiles with the seed mix that was submitted as part of the approved Reclamation Plan. If no seed mix has been provided, the operator shall submit a seed mix for approval as a technical revision to the permit along with the appropriate \$216 revision fee to the Division by the corrective action date. The Operator shall demonstrate compliance by submitting seed tags, a bill of sale or photographs of seeding activities. The Operator may also request a follow up inspection.

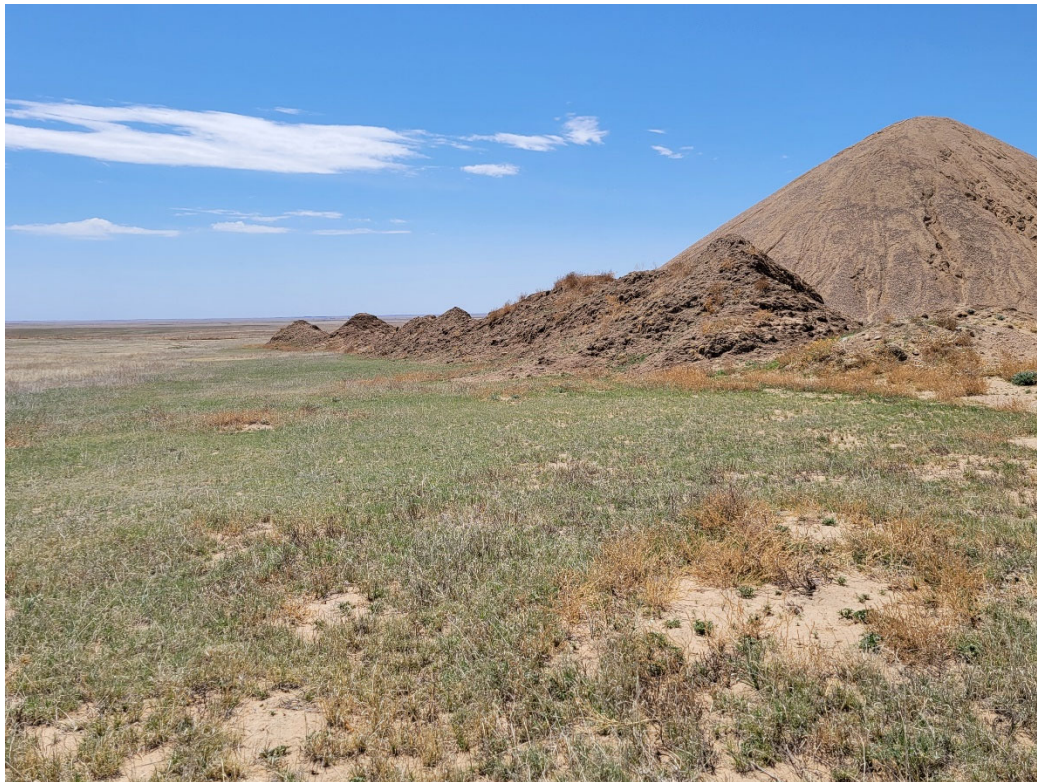
Photo 4: Closeup of topsoil piles sitting on the eastern edge of Mining Area 1.

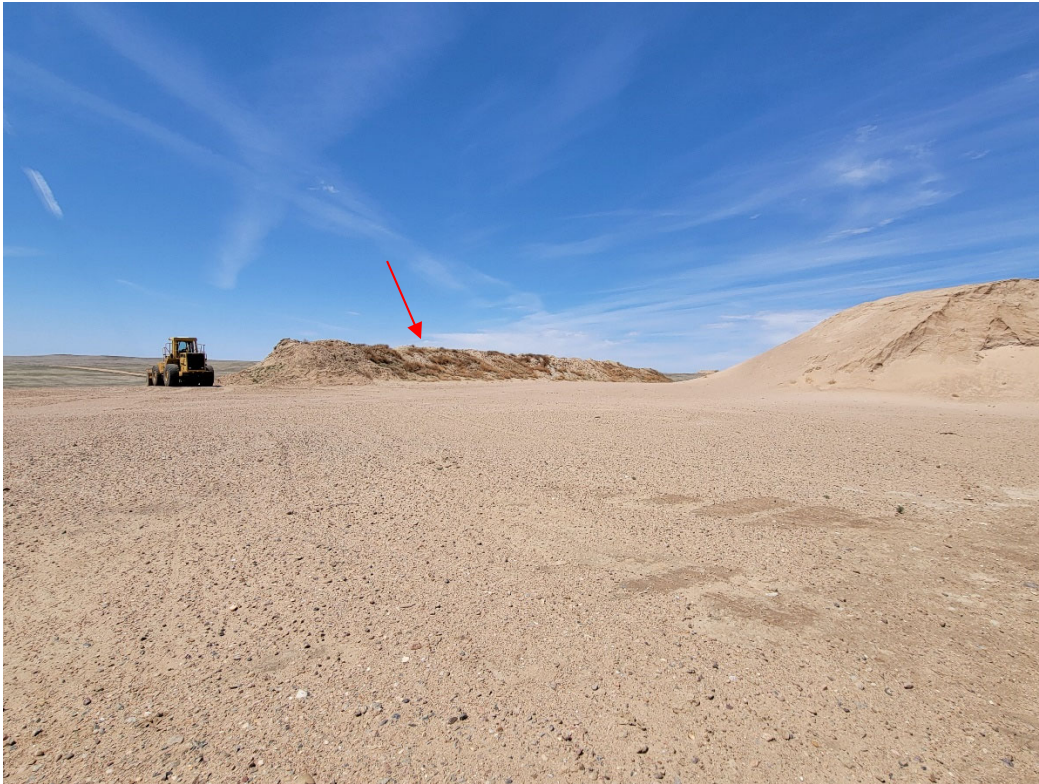
Photo 5: Looking northwest at overburden storage (red arrow) and a sand stockpile on the right in Mining Area 1.

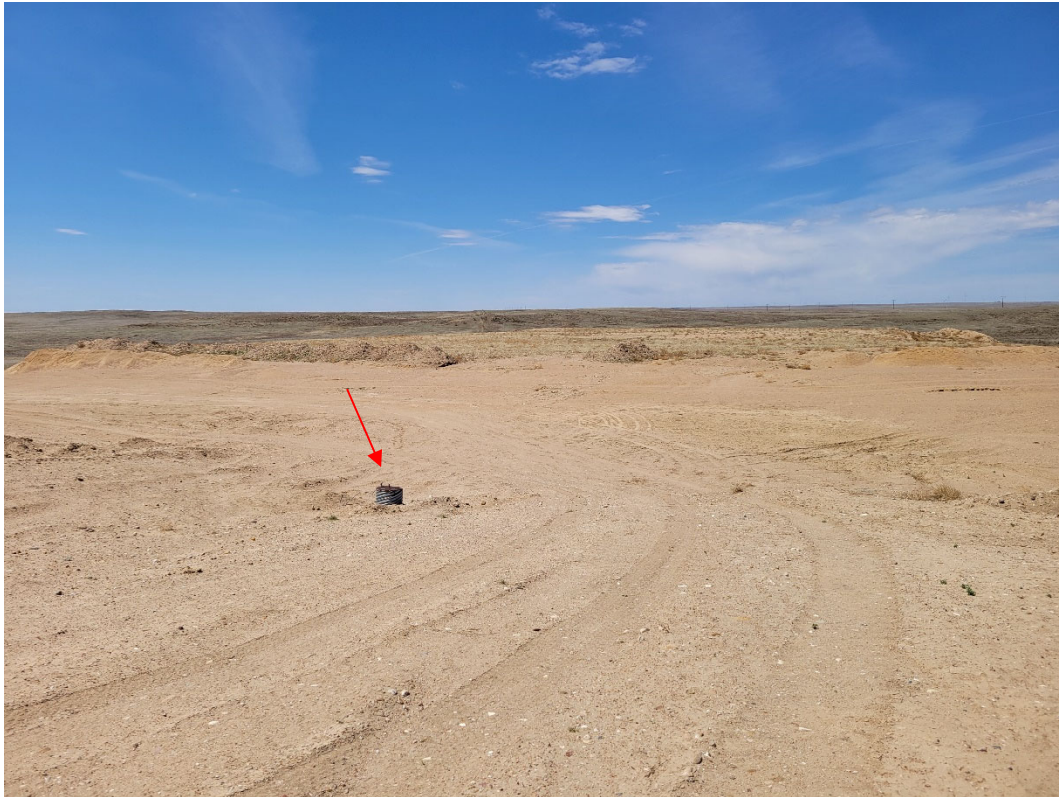
Photo 7: Looking west across Mining Area 2. Water well in center of pit noted by arrow.

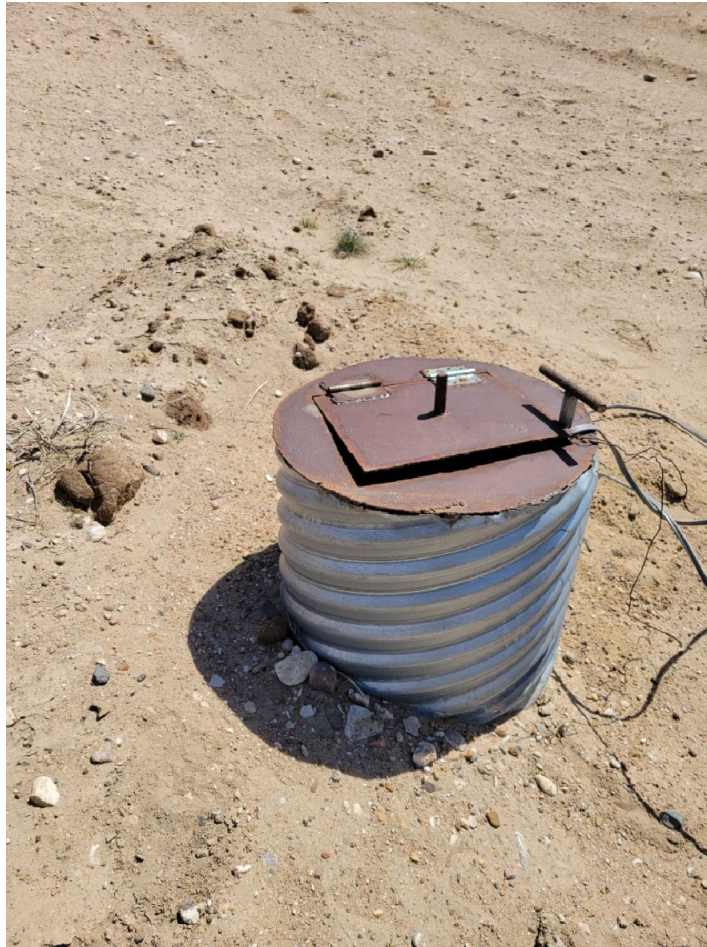
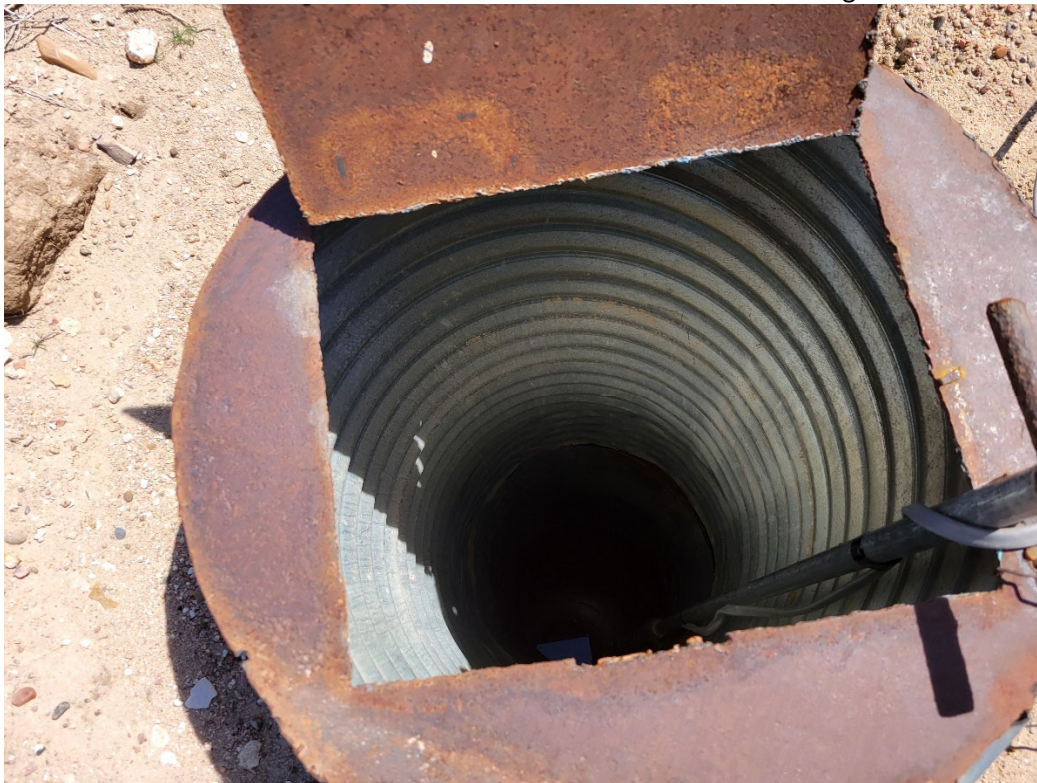
**PROBLEM 1:** The Division observed a water well in the Phase 1 Mining Area 2. This well is not shown on the approved Exhibit C Mining Plan Map and a structure agreement has not been submitted for this well. Per Rule 6.4.7(2)(a), please locate on the map (in Exhibit C) the well, within the affected land boundary. Additionally, per Rule 6.4.19, where the affected lands are within two hundred (200) feet of any significant, valuable and permanent man-made structure, the applicant shall: (a) provide a notarized agreement between the applicant and the person(s) having an interest in the structure, that the applicant is to provide compensation for any damage to the structure; or (c) where such an agreement cannot be reached, the applicant shall provide an appropriate engineering evaluation that demonstrates that such structure shall not be damaged by activities occurring at the mining operation.

A water well was observed in the center of Mining Area 2 in Phase 1 (See Photos 9 & 10). This well is not shown on the Exhibit C map submitted with the 2019 112c application. Additionally, Exhibit S does not contain a structure agreement for the water well. As noted in Problem 3, Per Rule 6.4.7(2)(a), the Division will require the Operator to revise the Exhibit C Mining Map showing the well within the affected land boundary. Additionally, Per Rule 6.4.19(a) the Operator shall determine the owner of the well and submit a notarized structure agreement for the well. Or, the operator could choose to update the mining and reclamation plan to demonstrate how the well will be protected during the operation with an appropriate engineering evaluation per Rule 6.4.19(c).

Photos 9 & 10: Groundwater Well observed in the center of Mining Area 2.

**CORRECTIVE ACTIONS:** The Operator shall determine the owner of the well and submit a notarized structure agreement for the well. Or, the operator could choose to update the mining and reclamation plan to demonstrate how the well will be protected during the operation with an appropriate engineering evaluation per Rule 6.4.19(c).

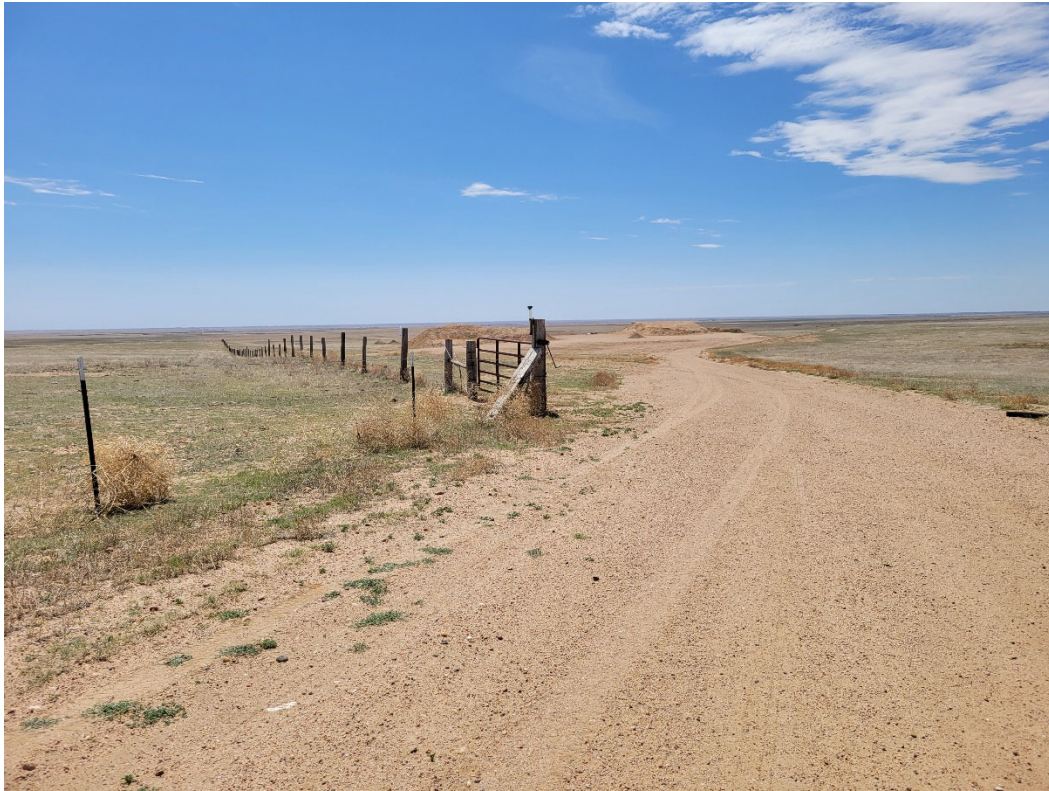
Photo 13: Entrance on the north side leading to Phase 1 Mining Area 1.

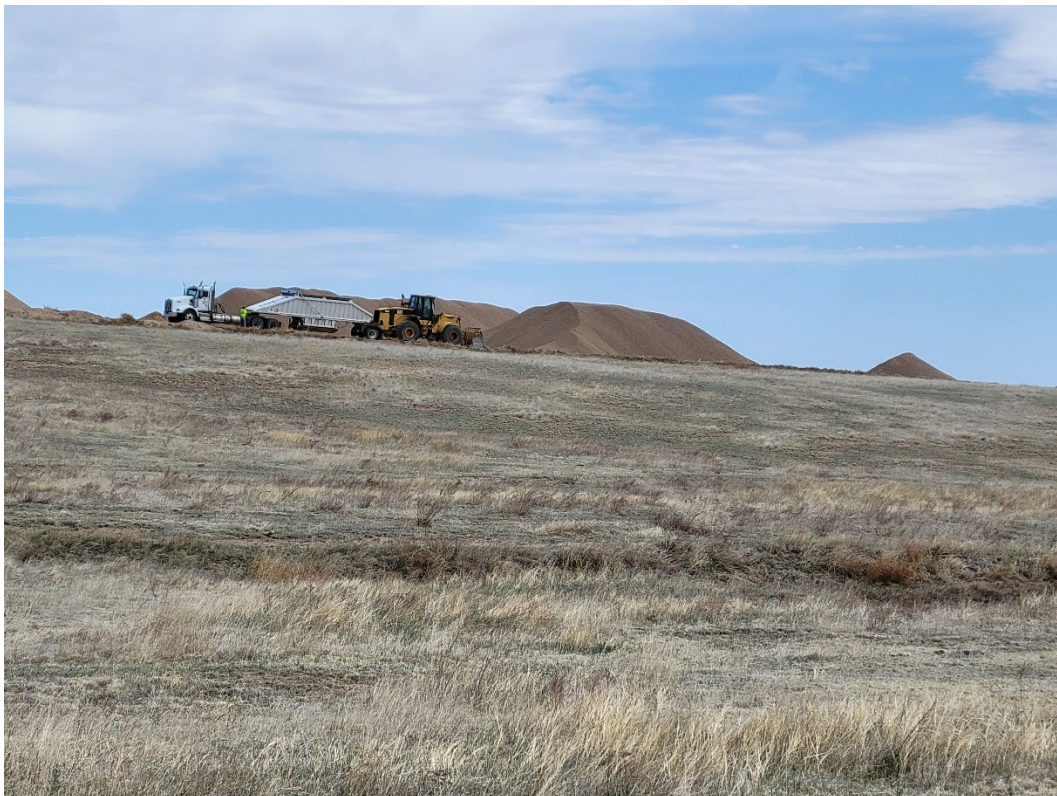
Photo 16: Dump truck picking up stockpiled material from Mining Area 1.
