Bowie #2 inspection report

Permit Number: C-1996-083 Mine Name: Bowie No. 2 Mine Operator: Bowie Resources, LLC Operator Address: Mr. Basil Bear P.O. Box 1488 Paonia, CO 81428	County: Delta Operation Type: Underground Permit Status: Active Ownership: Private
	Operator Representative Present: Basil Bear
Operator Representative Signature: (Field Issuance Only)

Inspection Start Date: May 22, 2024 Inspection Start Time: 06:50 Inspection End Date: May 22, 2024 Inspection End Time: 13:00	Inspection Type: Coal Complete Inspection Inspection Reason: Normal I&E Program Weather: Clear
Joint Inspection Agency: None	Joint Inspection Contacts:
Post Inspection Agency: None	Post Inspection Contacts:
Inspector(s): Robert Zuber, P.E.	Inspector's Signature: <i>Robert D. Zuber</i> Signature Date: 5/24/2024

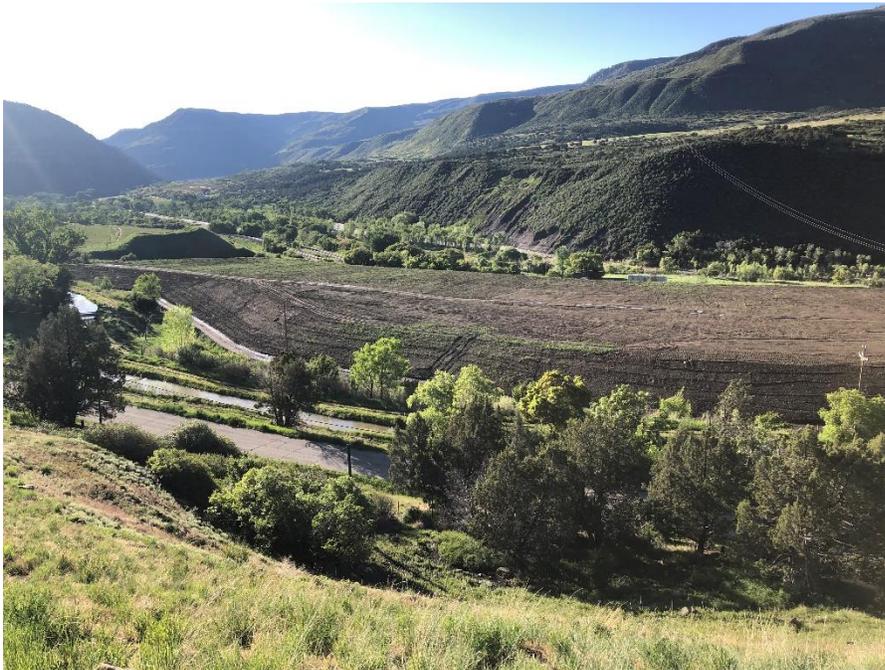
Gob Piles 1, 2, 3, and 4 appeared stable. No problem was identified at the repaired blow out on Gob Pile #4, which occurred in the spring of 2023.

Gob Pile #3, from above

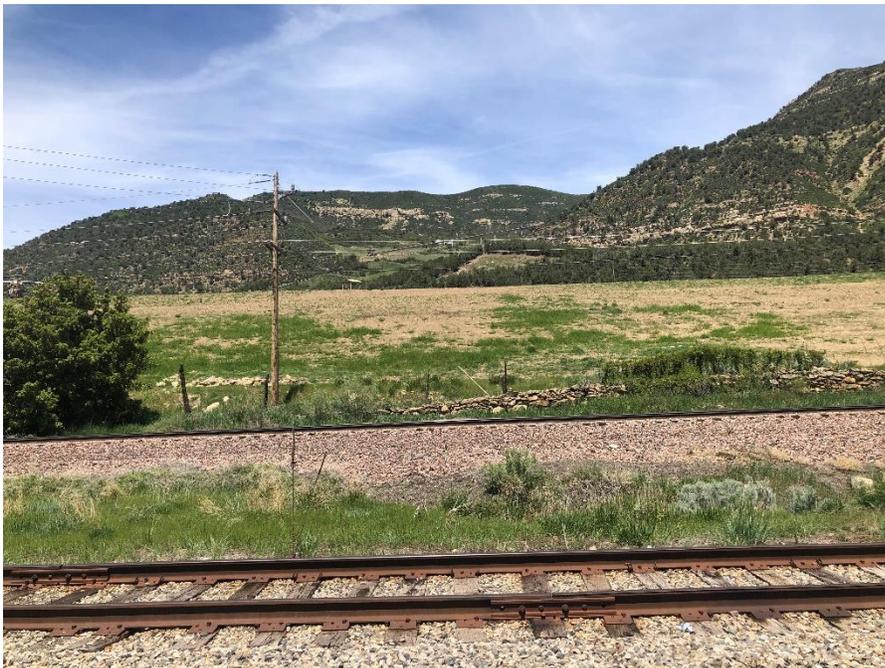
Gob Pile #3, from below

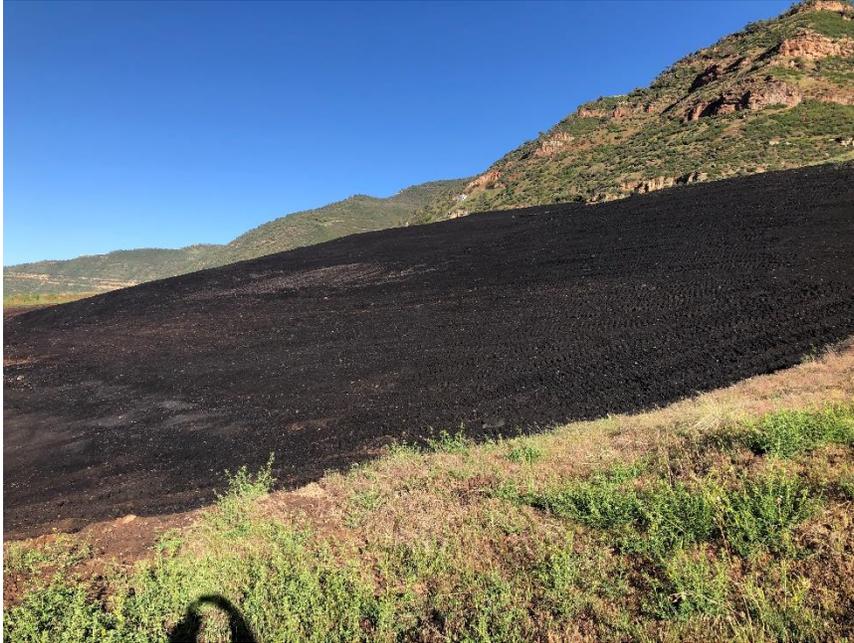
The small ditches and BMPs on the upper part of Gob Pile #2 appeared to be functioning. No puddles were observed on the area where gob has recently been spread. The rills on Gob Pile #2 (discussed in previous inspection reports) have been graded in preparation for the placement of coverfill material.

Graded slope at Gob Pile #2

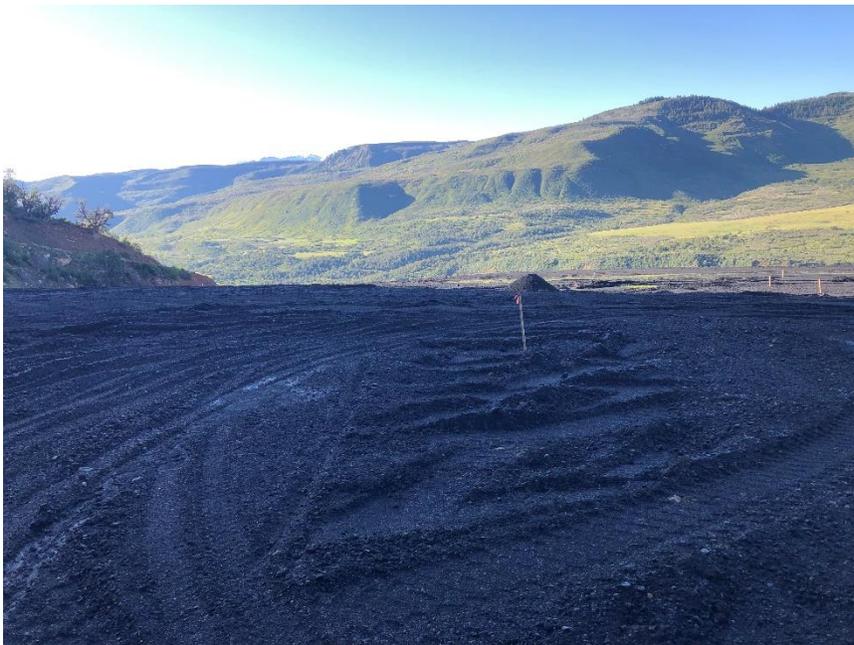
Waste material placed on Gob Pile #2

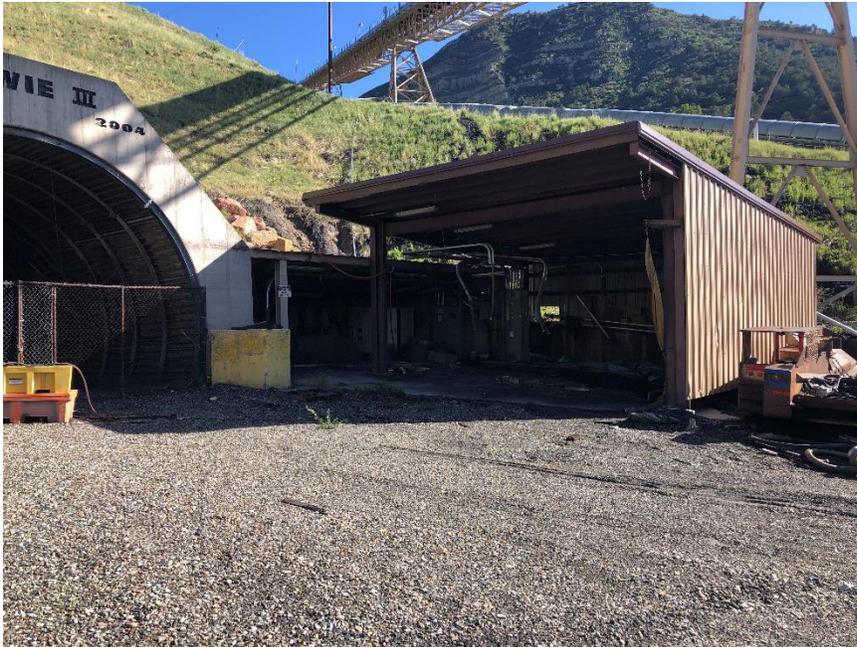
Storage shed at B Portal Bench

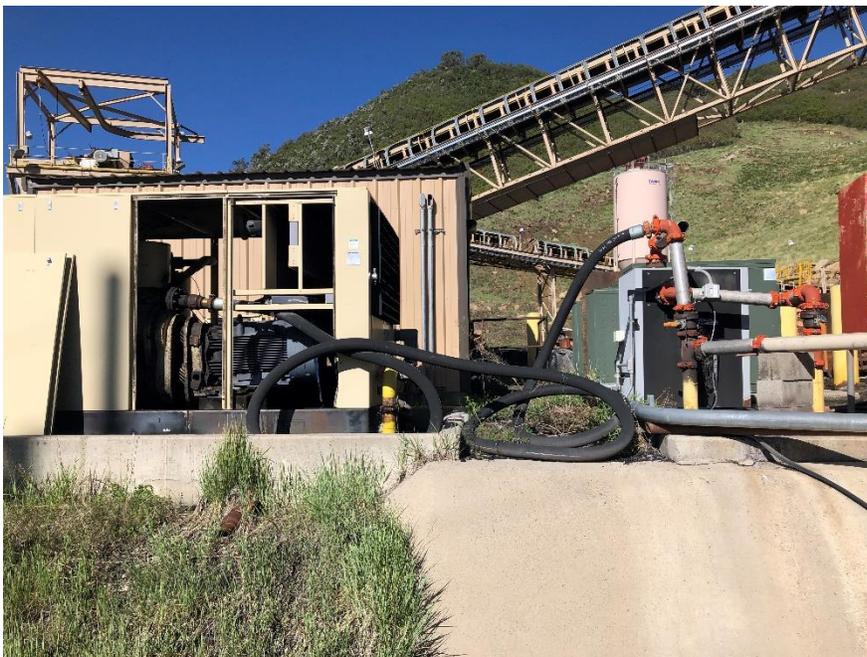
Compressor and other equipment at B Portal Bench

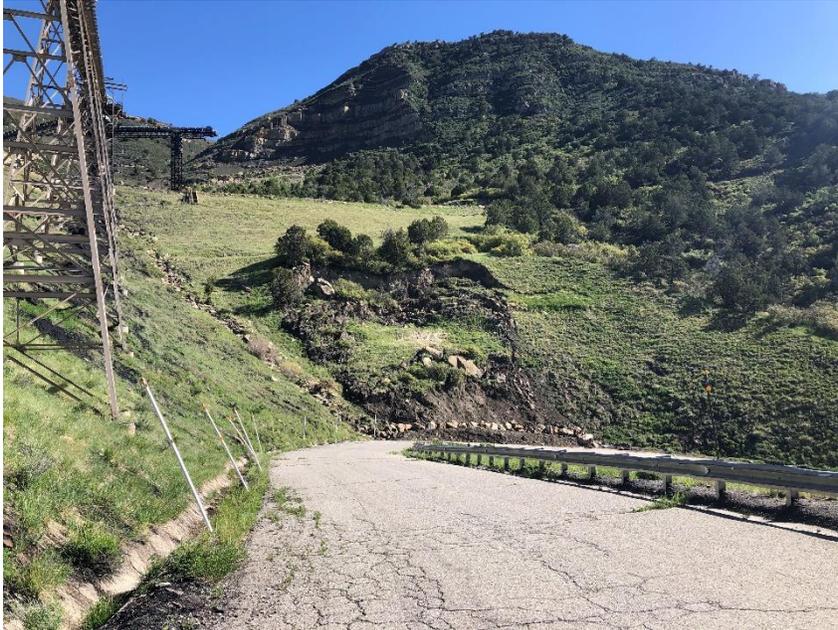
The road to the portals was in adequate condition. The slopes adjacent to this road are generally stable, except for the slide at Curve 10 (see Slides and Other Damage section).

No problems were seen on the slopes above and below the benches. The slides above the B Portal Bench and Curve 11 (noted in the past) look stable. The slide above Curve Number 10 appears to have not moved more since April. This is an ongoing project for BRL.

Slide at Curve 10

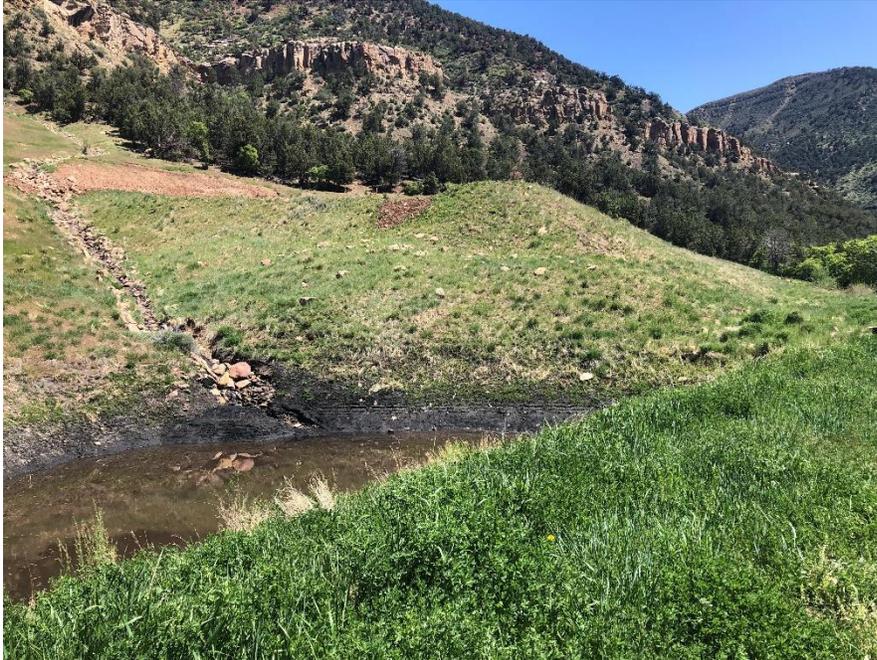
Pond F

Some thistle plants were seen, including near the ditch east of Gob Pile #2 and above Pond F. Mr. Bear indicated that he has begun spraying weeds this spring and will continue through the summer.

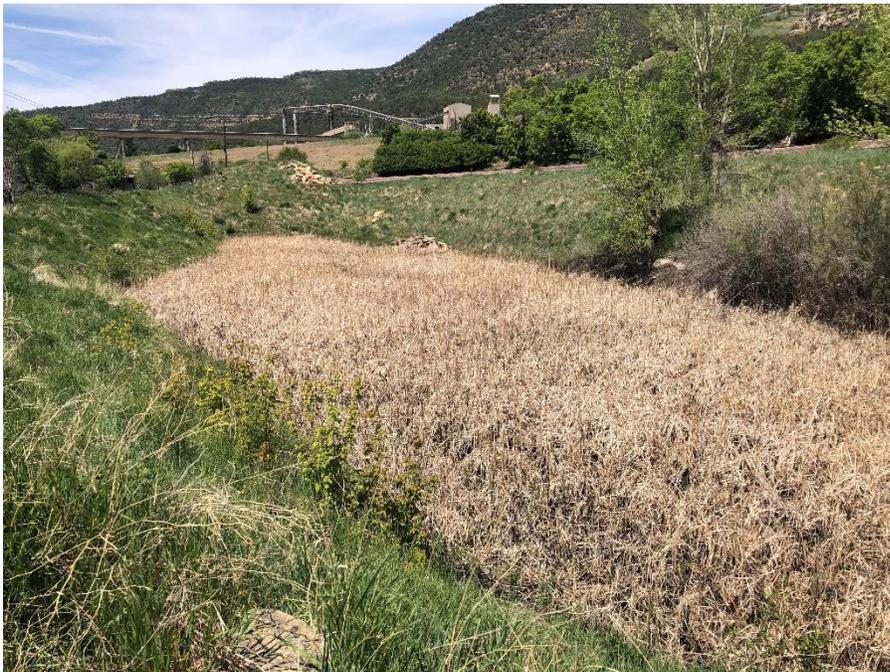
Six sediment ponds were inspected: B, C, D, F, J, and K. None of the ponds were close to discharging, but most contained visible water. Pond K was dry. The bottom of Pond J is obscured by cattails, and no water was seen, but it is likely that there was water on the bottom of the pond. No significant problems were identified with embankments, spillways, inlet channels, or other features of the ponds.

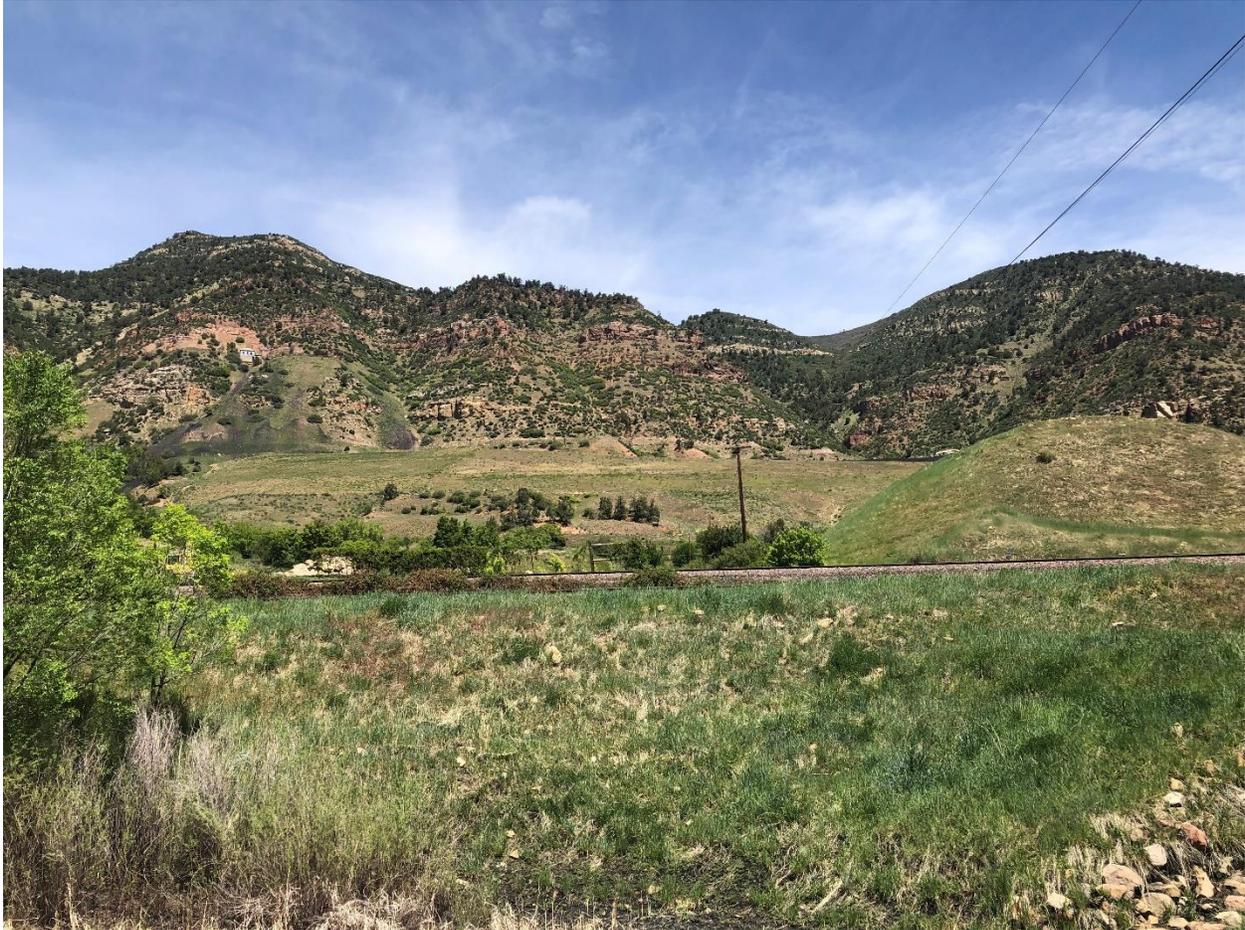
Looking towards Gob Pile #4 from Pond J, with topsoil stockpile on right
