**MINERALS PROGRAM INSPECTION REPORT**  
**PHONE: (303) 866-3567**

| <b>MINE NAME:</b><br>Pikeview Quarry | <b>MINE/PROSPECTING ID#:</b><br>M-1977-211 | <b>MINERAL:</b><br>Limestone (general),<br>granite gneiss and do | <b>COUNTY:</b><br>El Paso |
| <b>INSPECTION TYPE:</b><br>Monitoring | <b>WEATHER:</b> Clear | <b>INSP. DATE:</b><br>May 21, 2024 | <b>INSP. TIME:</b><br>10:00 |

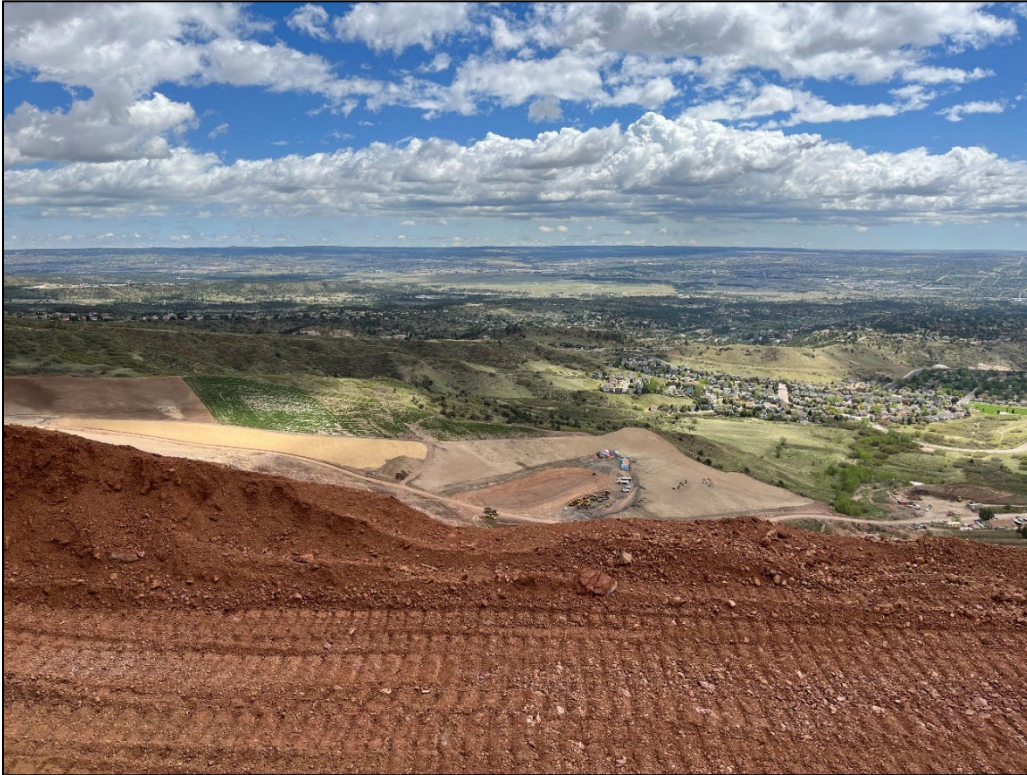
**Backfilling and Grading:** Mr. Schnabel indicated that material for the final slopes of the buttress were taken from the lower and south borrow areas at the site. The shop area is no longer being used for fill material but is being backfilled slightly to meet final grade (Photo 1). Subgrade contouring and topsoiling has been completed or is near completion on the first four lifts. All placed backfill continues to be tested for compaction in accordance with the approved specifications.

**Photo 1: View east of the shop borrow area, currently receiving minimal backfill.**

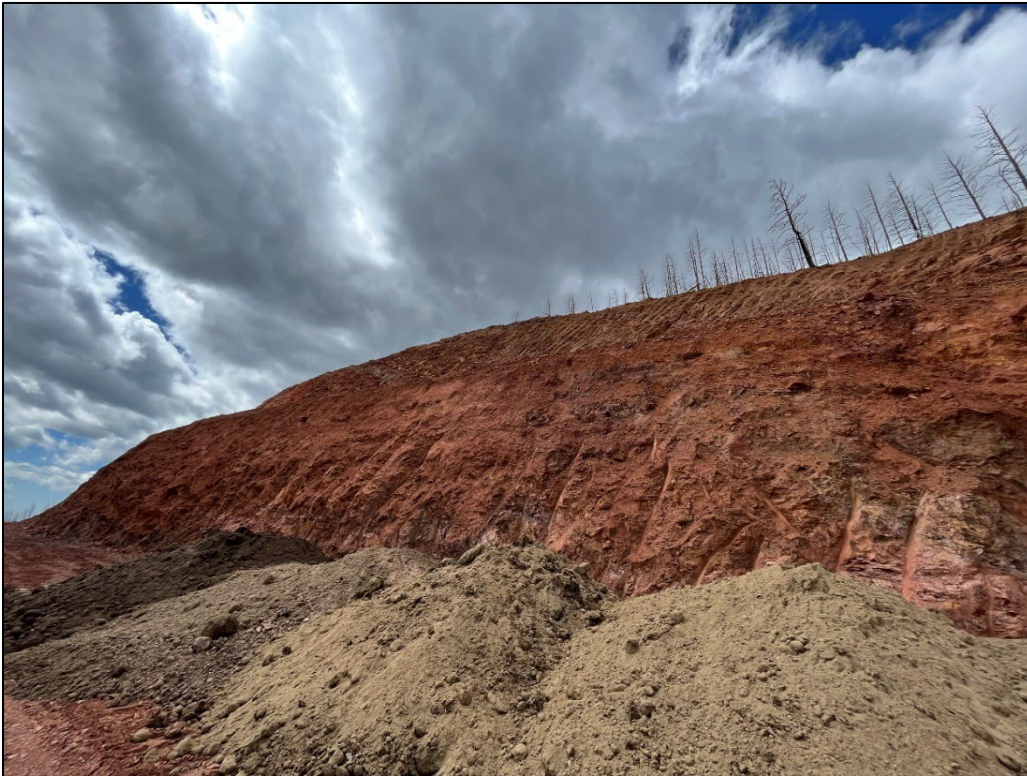
The near vertical highwalls in the South Peak, Forest Service owned area is receiving topsoil on the ~30 ft benches and will be revegetated with grass, shrubs, and trees (Photo 2).

**Photo 2: View north of final south peak highwalls, material has been placed on the bench in preparation for final topsoiling.**

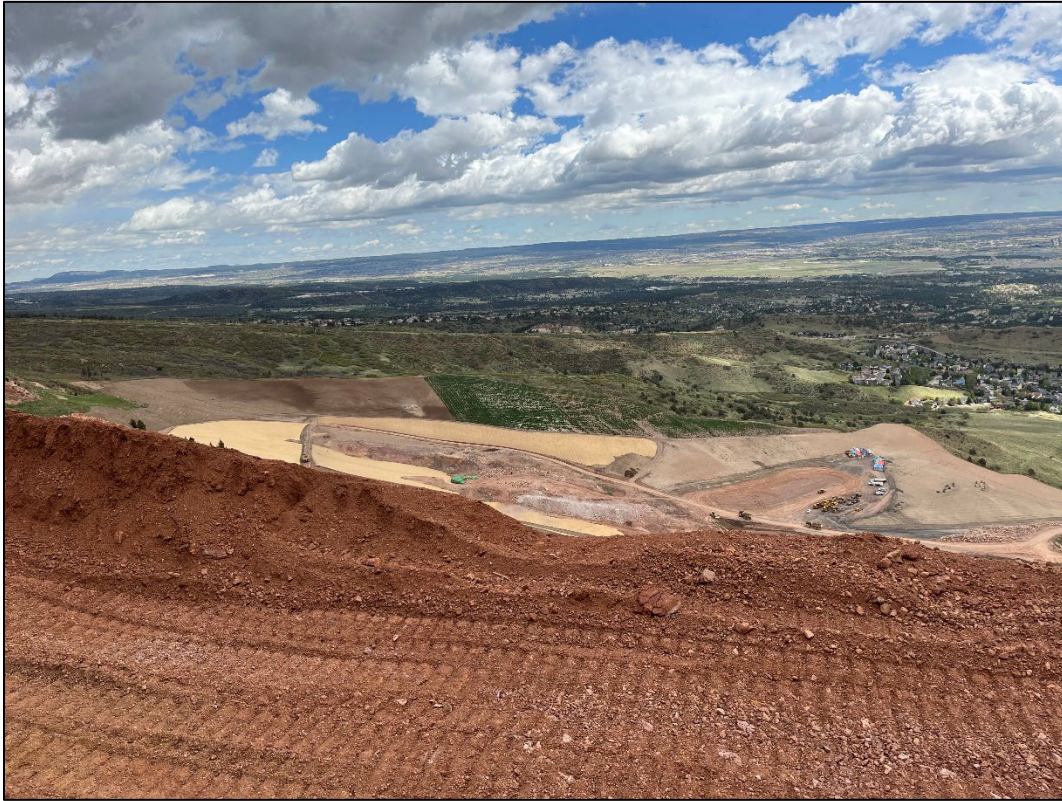
**Explosives:** Drilling and blasting at the site have been completed, with a total of three blasts taking place. Efforts were focused in the 'Dragon's Back' and South Peak areas (Photo 3). Rubblized material in this area is being hauled for use in the drainage channels as rip rap and for use as compacted material at the floor of the buttress.

Preliminary cuts for the main north ditch are partially in place at the site (Photo 3). In final reclamation, each drainage terrace will have prisms permanently installed. TR 24 will address minor changes and re-designs needed for the upper drainage channels at the site. This re-design will also help incorporate the three natural seeps from the slope and direct these to the east, out of and around the reclaimed slope. Rip rap which will be used to construct and stabilize these channels is already onsite. Additional material was recently sourced from the blasting of the 'Dragon's back' and South Peak areas. Much of this rip rap material is currently stored near the south borrow area.

**Photo 3: View northeast of the recently topsoiled, seeded, and matted northern area, the recently blasted 'Dragon's back' area is also visible along with preliminary cuts for the main north ditch.**

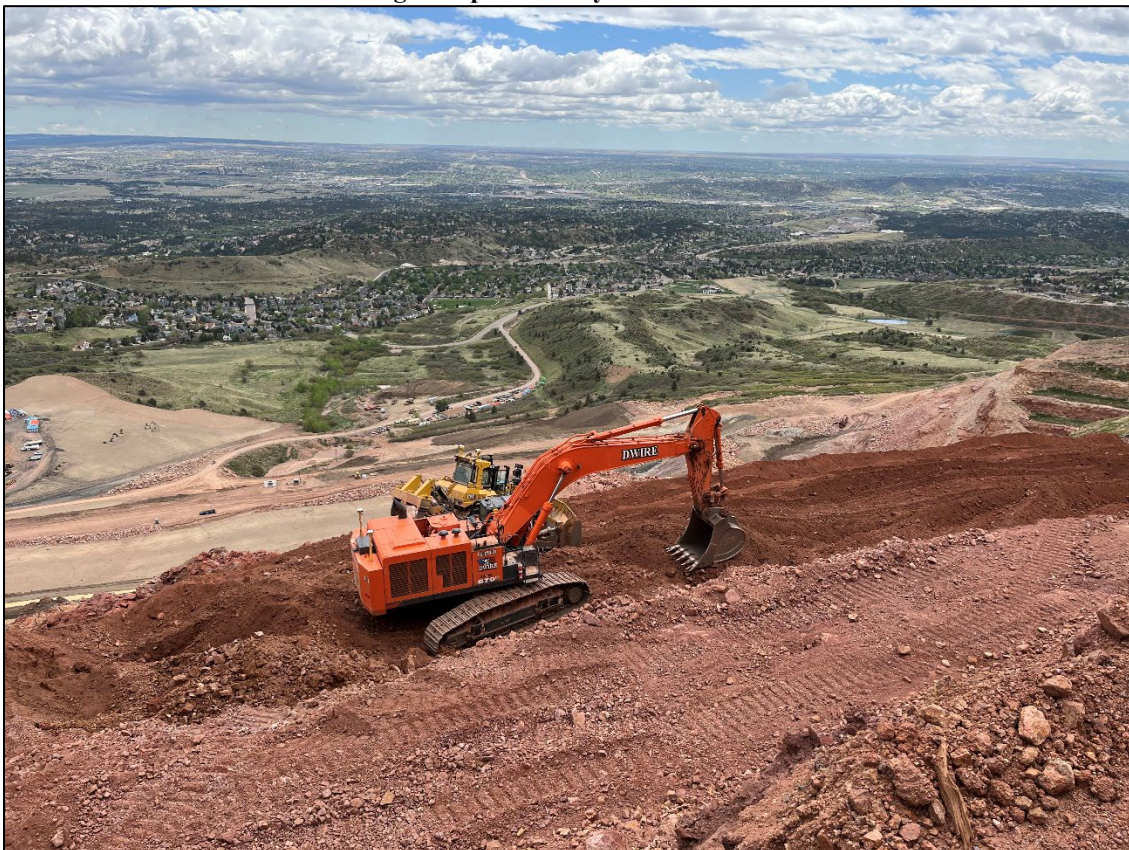
**Roads:** Minimal equipment remains onsite as earthwork comes to near completion at the site (Photo 4). The uppermost road located just below the South Peak has been blasted to final configuration and so is no longer in place. Mr. Schnabel expressed the Forest Service's request for no formal roads to remain on their portion of the property in final reclamation. All other roads on site are maintained. A water truck should be used in times of high wind and dry conditions to reduce dust.

**Photo 4: Excavators and dozers are working on the upper slope fill.**

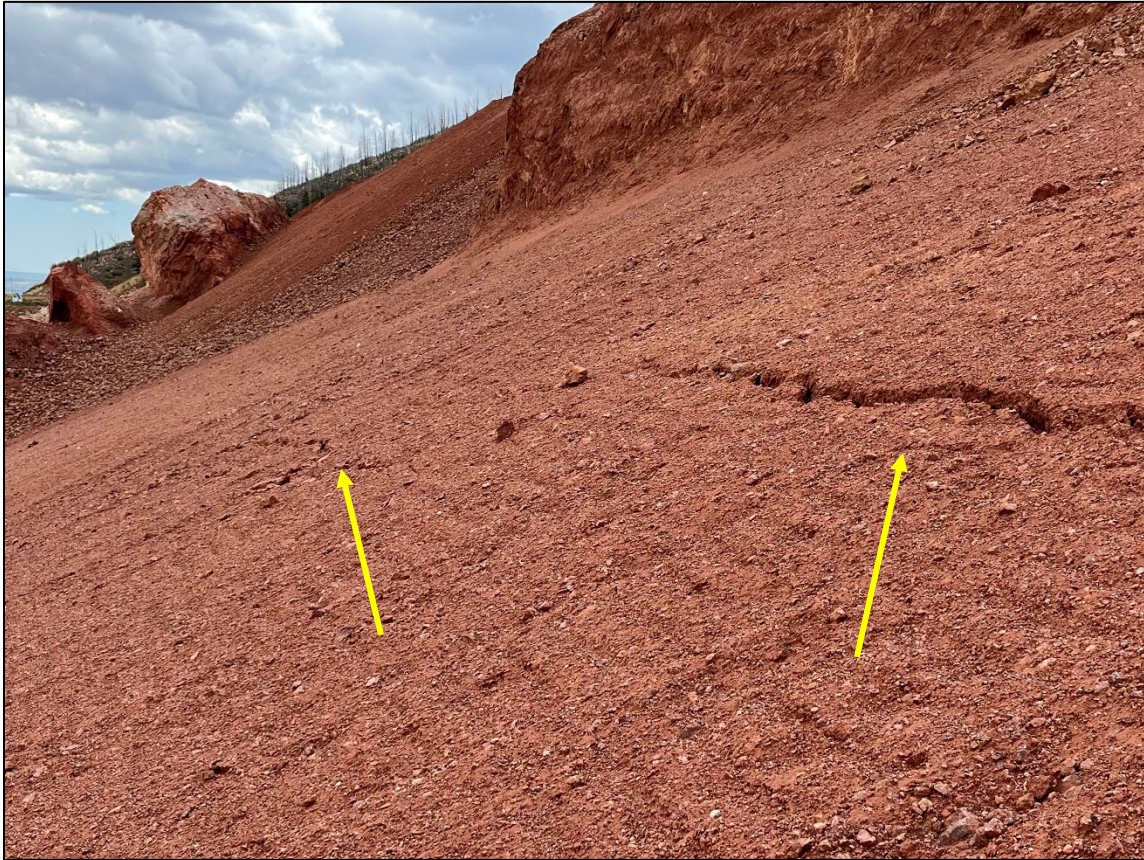
The site's April geotechnical report noted that two tension cracks had formed on the upper slope fill. The report described these features as ~100ft x 2in cracks which were noted at the site's visual inspections on April 3<sup>rd</sup> and April 25<sup>th</sup>. The report cited the cause of these cracks as expected settlement from the buttress below (Photos 5-8). The Division observed this area during the inspection and found that the two original cracks had progressed

**Photo 5: View south of the two cracks noted on the upper fill slope.**

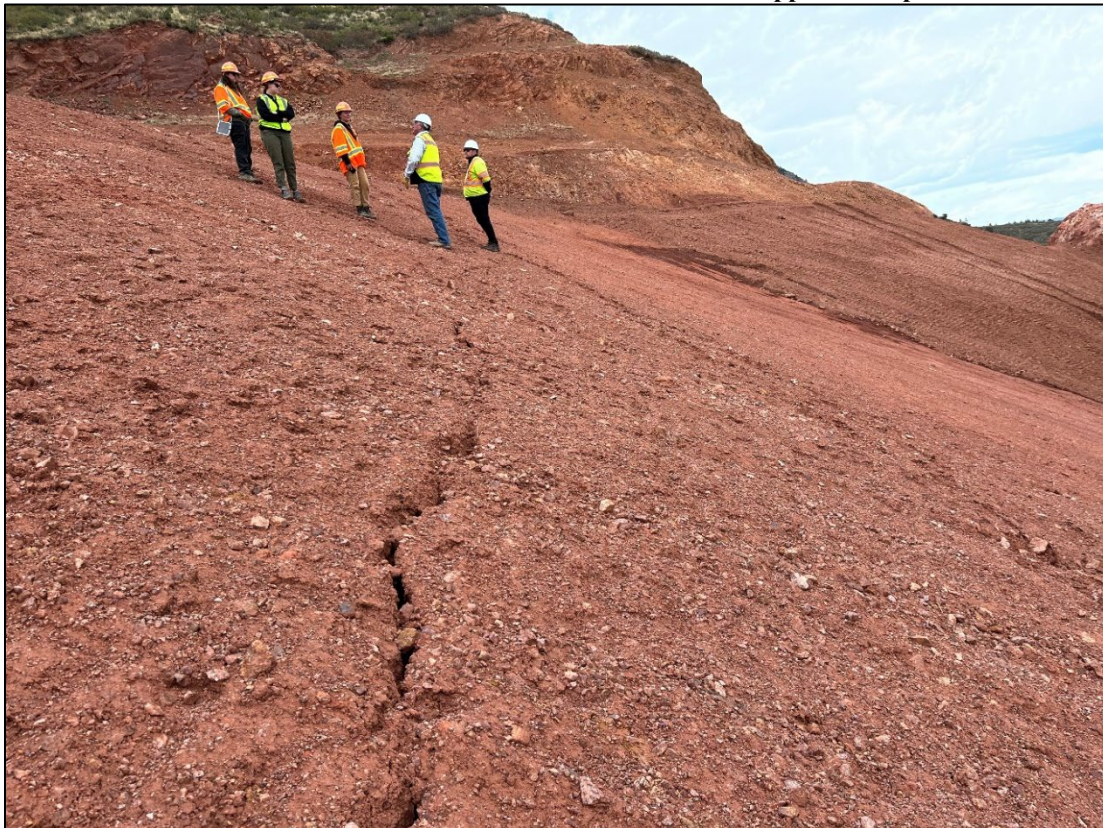
**Photo 6: View north of the first crack noted on the upper fill slope; this was the deepest crack noted on site.**

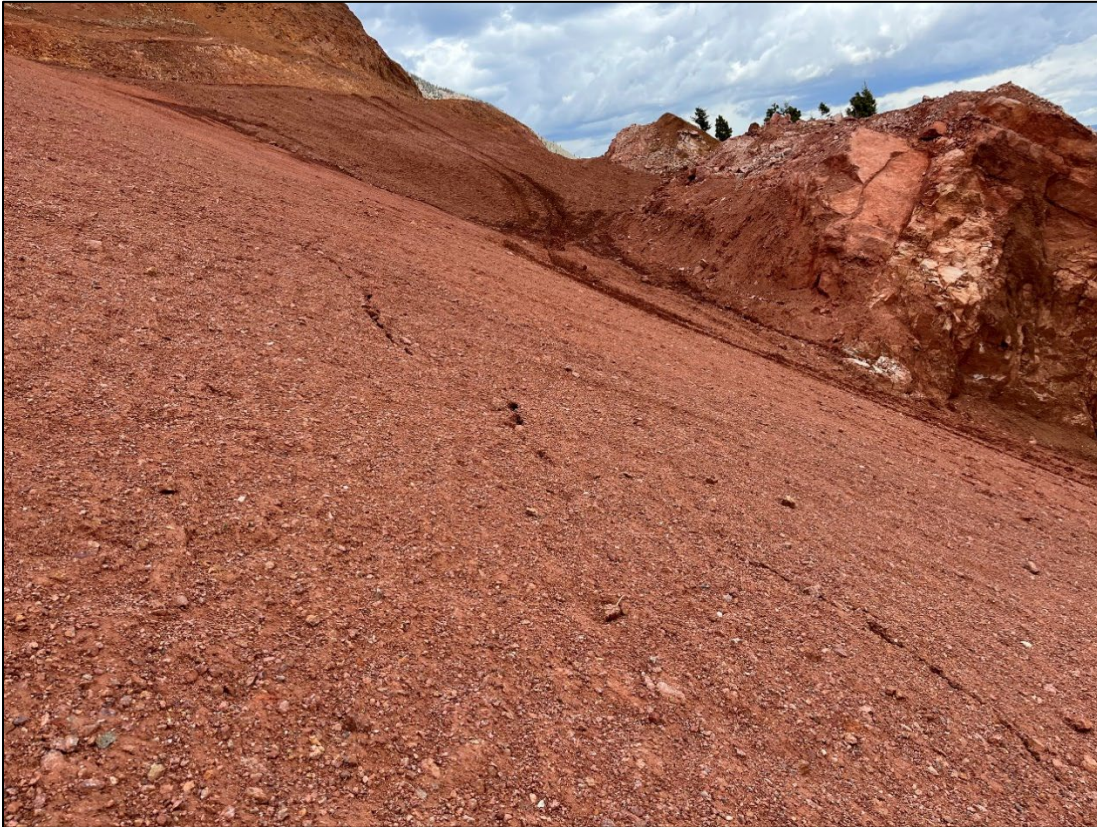
slightly in length and depth and that a third, smaller crack was also forming (Photo 7). However, these cracks overall remained superficial in depth and length. All cracks are located above the historic landslide area. No mounding or bulging of material was noted in the area immediately below the cracks or further down on the next bench (Photo 9). Compaction tests were done above and below the crack area and showed compaction results above the 90% requirement. Mr. Kos explained that remediation of these cracks will consist of minimal regrading of the slope before final topsoiling. Two additional prisms are also planned to be installed above and below the area of the cracks to monitor any additional movement. Stantec will continue to monitor these prisms closely over the next months as final topsoiling takes place. Should the movement of these prisms remain minimal in over time, the Division has no major concern for slope stability.

**Photo 7: View facing north showing a small, third crack feature on the upper fill slope, located just above the Kiewit Cliffs feature.**

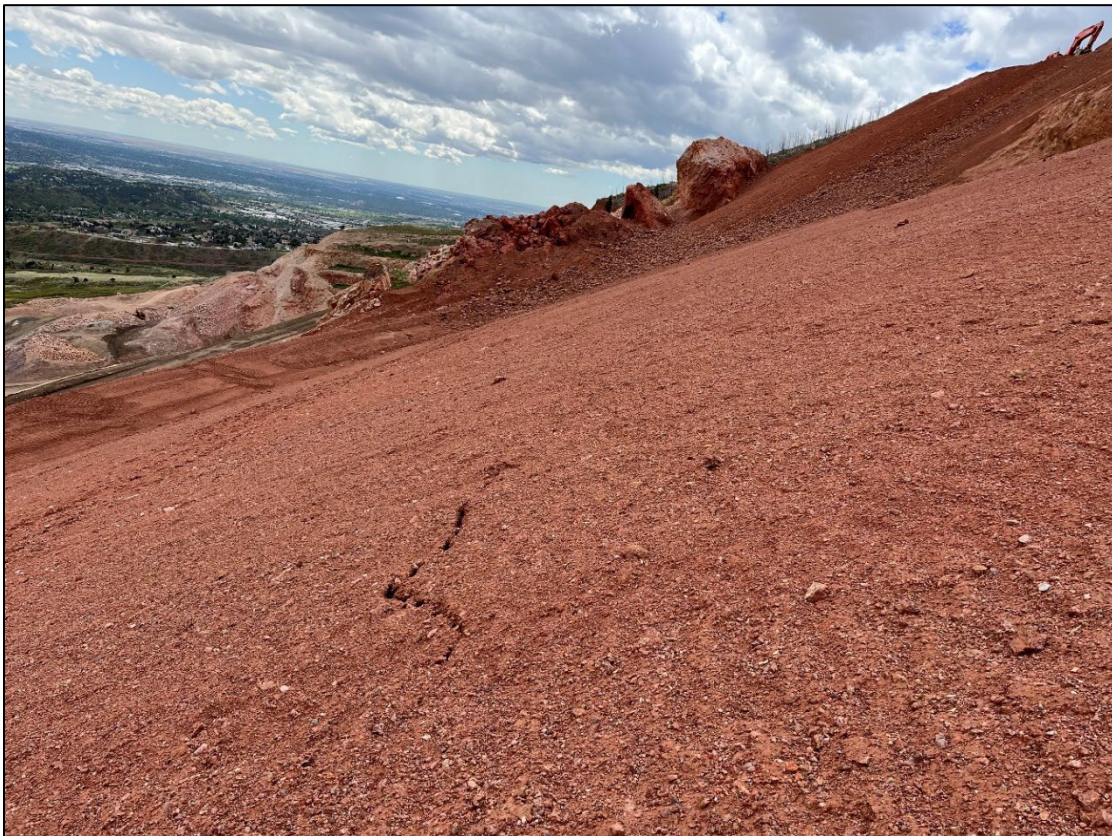
**Photo 8: View south of the first crack on the upper fill slope.**

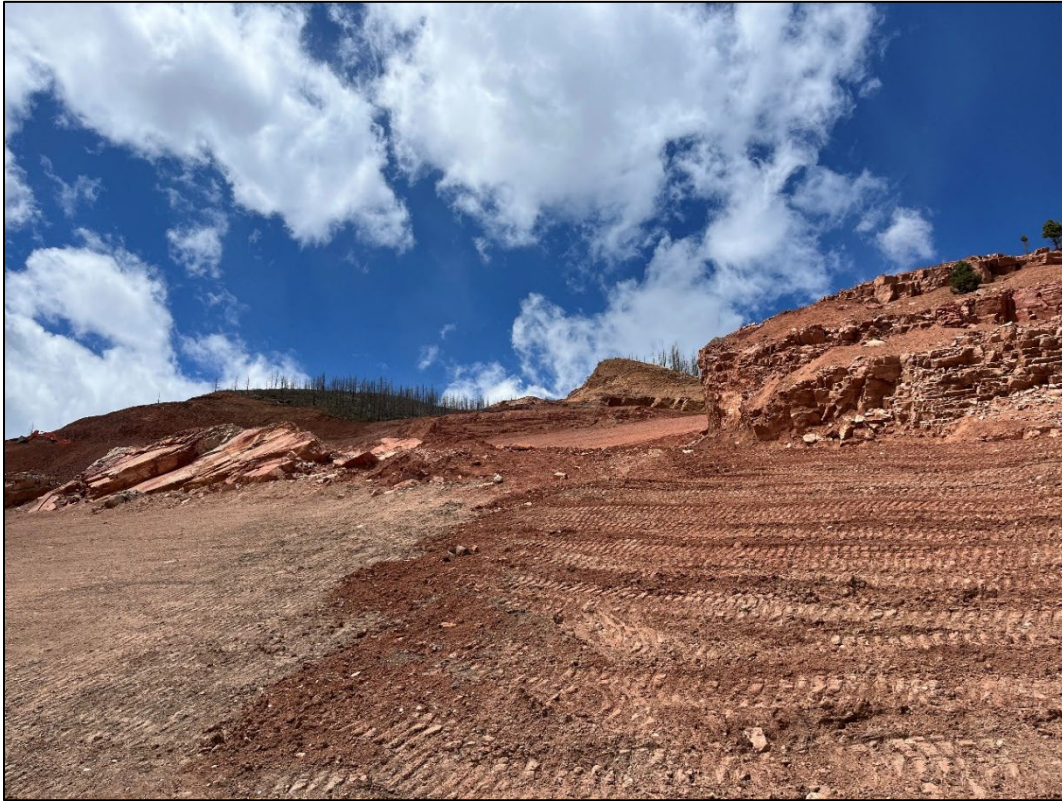
**Photo 9: View west from beneath the tension crack area, no mounding or bulging of material in this area was observed.**

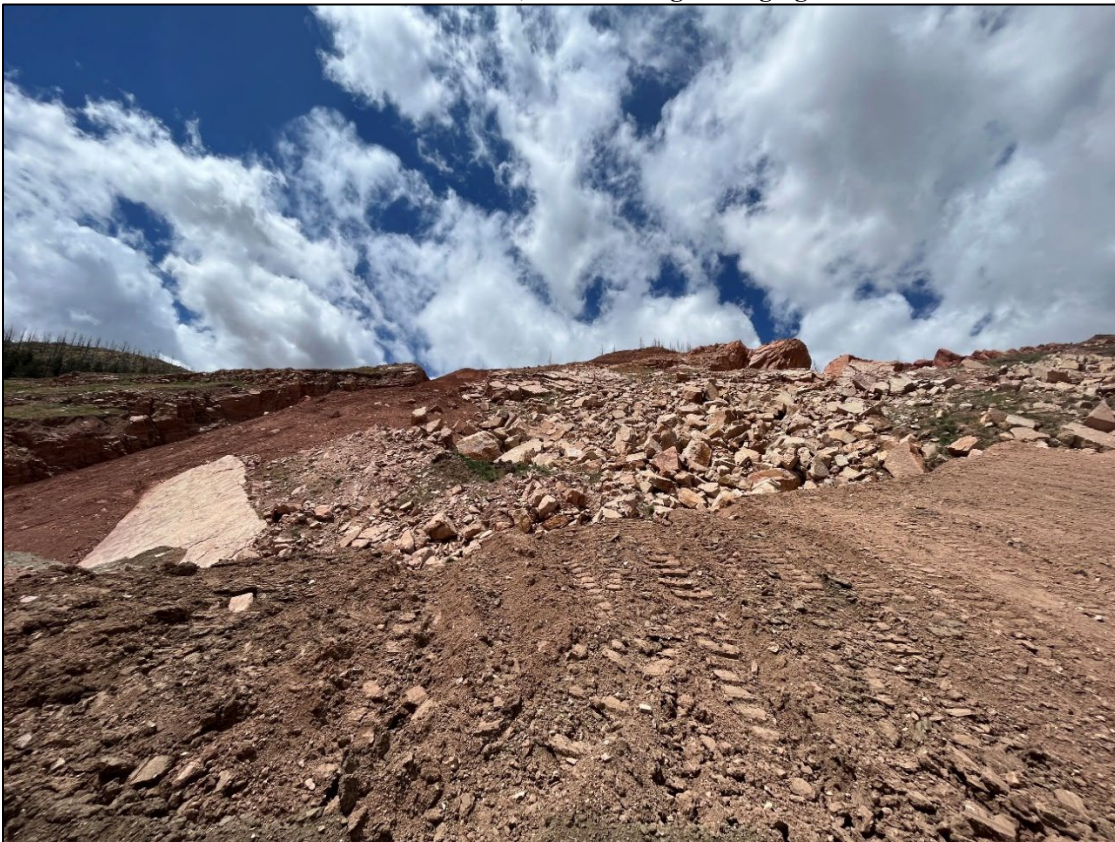
**Fish and Wildlife:** No negative impact on wildlife was observed. Two fox cubs were seen using a rocky area at the fifth bench as a den. This area is planned to be partially backfilled to a 2H:1V slope while leaving some rocky topography to accommodate Bighorn sheep and other wildlife who frequent this area (Photo 10).

**Photo 10: This slope, located to the west, will be partially filled in as a 2H:1V slope; some of the rocky material will remain partially exposed to allow for Bighorn sheep and other wildlife habitat.**

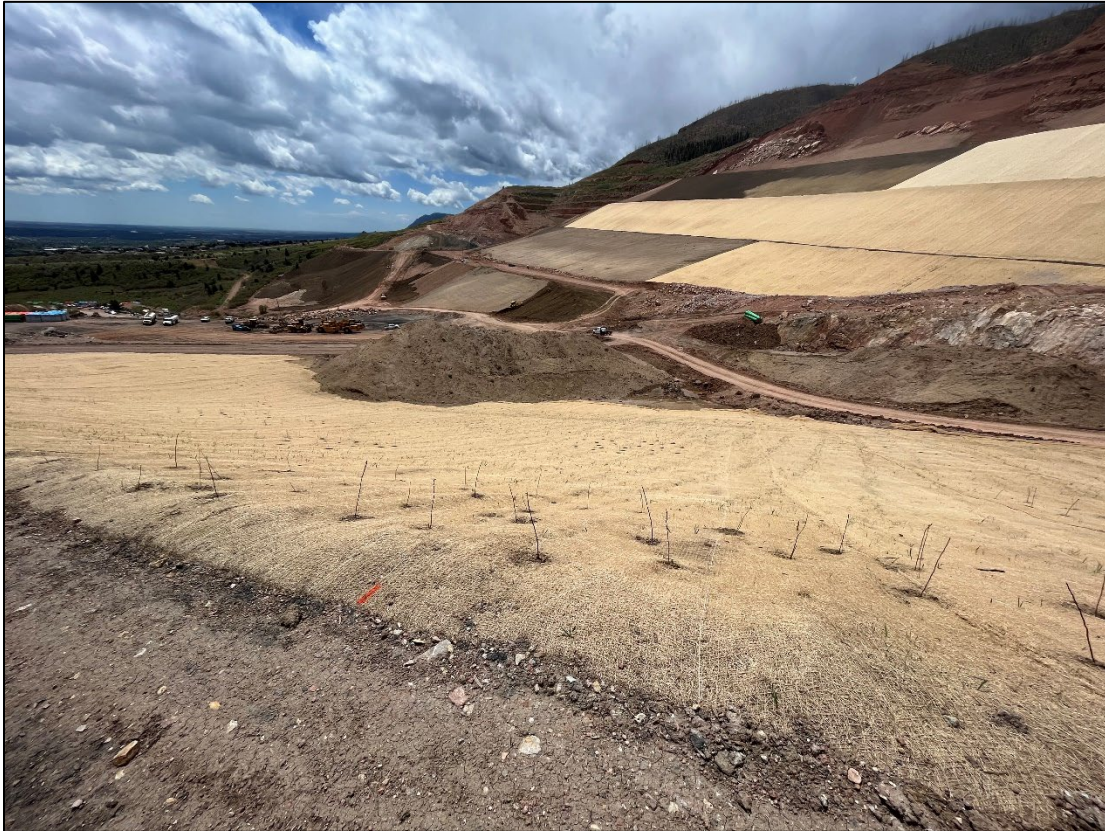
**Revegetation & Topsoil:** The first bench of the buttress has been fully topsoiled and seeded. The second, third and fourth benches are near completion. Several thousand shrubs / trees have already been planted across the north borrow area and first buttress slope (Photo 11). Topsoil is also being place in the north borrow area (Photo 3). Mr. Kos stated that enough topsoil was on site presently to complete the 6 in reclamation requirement. However, the site continues to take in more topsoil as it is available to aid in revegetation efforts. Site personnel continues to work closely with the USFS to refine tree and shrub species and placement for final revegetation, especially as sourcing some species has proved to be a challenge. Any new tree or shrub species that are ultimately added to the site can be updated through the process of Technical Revision 24.

**Photo 11: View southwest of tree and shrub planting in the north borrow area, topsoiling and matting efforts on the first four benches is also visible.**

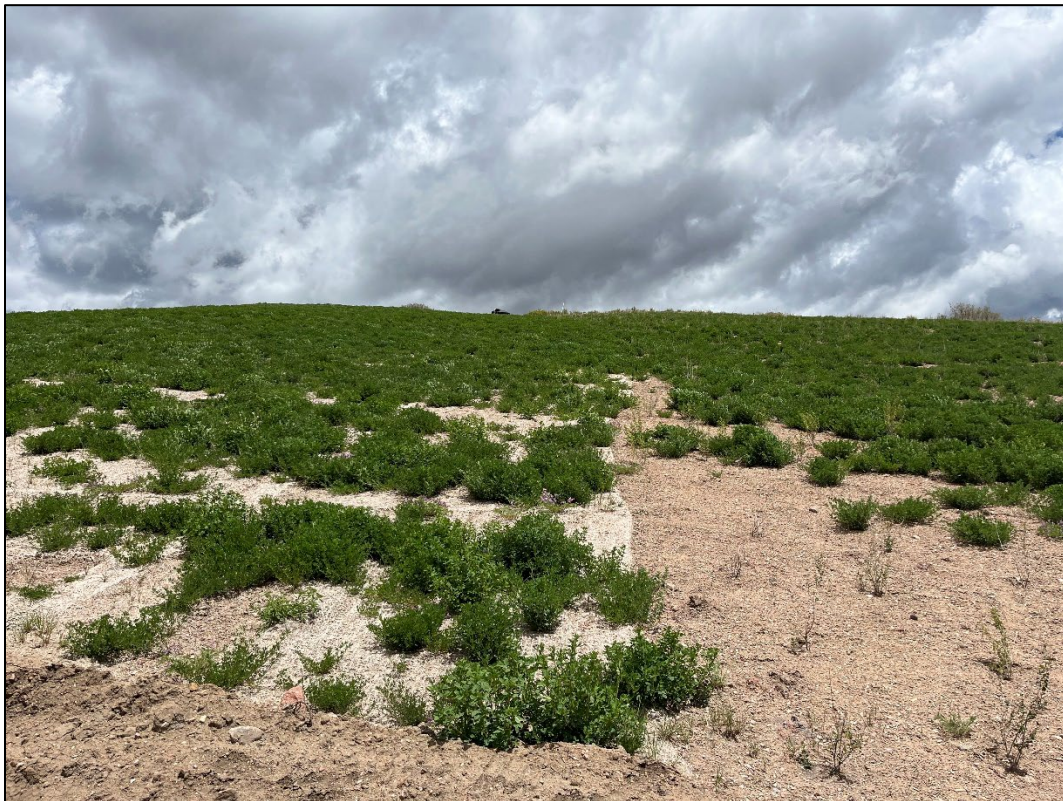
Placement of a 30% coconut fiber and 70% straw mat is the final stage of revegetation on the buttress slopes. Matting is rolled down from the top of the slope and stapled in place to ensure stability as vegetation takes root. Seed and mulch mix are laid beneath this and ultimately secured in place and protected from erosion by the mat. The mat will biodegrade in approximately 2 years' time. This matting has also been laid down in the north borrow area and is already seeing the growth of grass species on Forest Service property. Revegetation in the City's property on this northern portion continues to be monitored but may need additional seeding and revegetation efforts to encourage grass growth between the flourishing shrubs (Photo 12).

**Photo 12: View north of a hillside on the northern end of the site; this area was seeded in previous years, but grass is struggling to thrive between the shrubbery.**

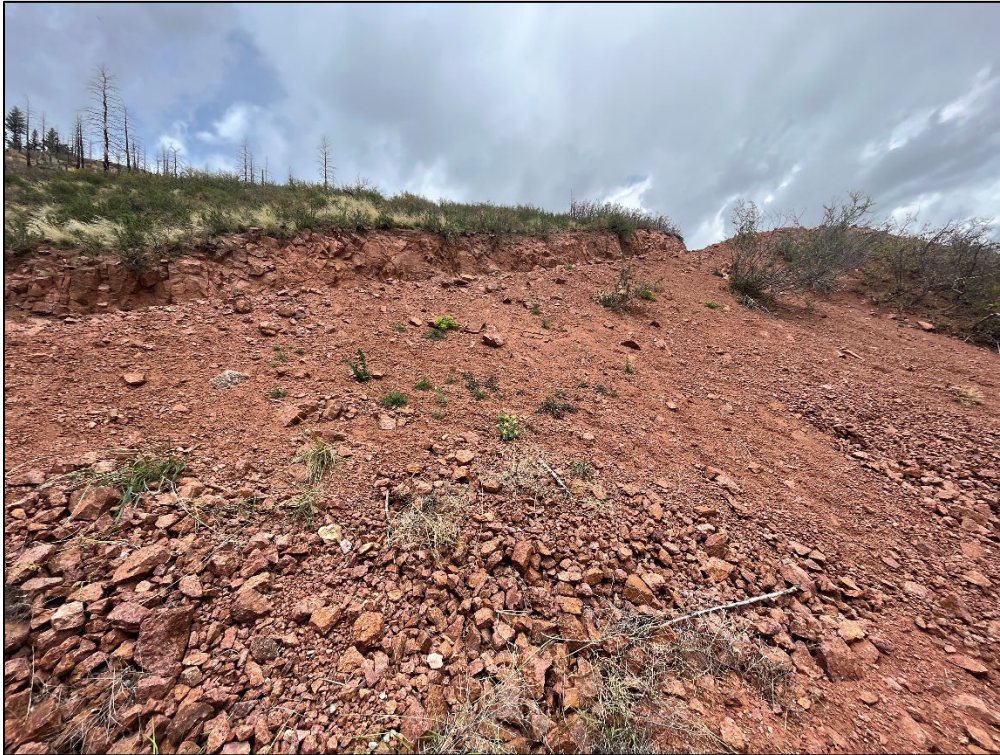
Weeds currently being treated at the site include a List A noxious weed species, Myrtle spurge along with common knapweed, thistle, and mullein (Photo 13).

**Photo 13: View of a hillside in the southwestern portion of the permit, Riverbend is currently treating Myrtle spurge, knapweed, thistle, and mullein in this area.**
