MINERALS PROGRAM INSPECTION REPORT
PHONE: (303) 866-3567

MINE NAME: Henderson Mine	MINE/PROSPECTING ID#: M-1977-342	MINERAL: Molybdenum	COUNTY: Clear Creek, Grand
INSPECTION TYPE: Monitoring	WEATHER: Clear	INSP. DATE: April 24, 2024	INSP. TIME: 09:00
OPERATOR: Climax Molybdenum Company	OPERATOR REPRESENTATIVE: Ben Bates Shelby Epperson	TYPE OF OPERATION: 112d-3 - Designated Mining Operation	
REASON FOR INSPECTION: Normal I&E Program	BOND CALCULATION TYPE:	BOND AMOUNT: \$170,904,202.00	
DATE OF COMPLAINT: NA	POST INSP. CONTACTS: None	JOINT INSP. AGENCY: None	
INSPECTOR(S): Joel Renfro Brock Bowles Amber Gibson	INSPECTOR'S SIGNATURE:

SIGNATURE DATE: May 28, 2024

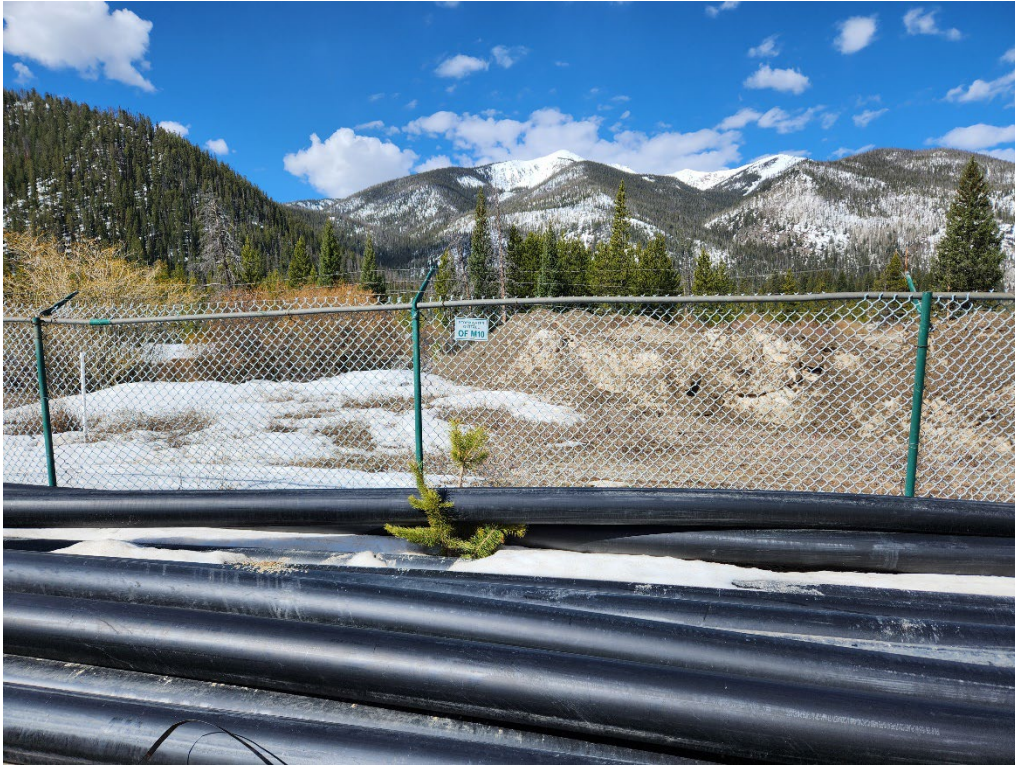
Photo 1. View of OF-M10

OF-M10: The BMP's of this outfall location consist of rip-rap, which was covered with snow at the time of inspection.

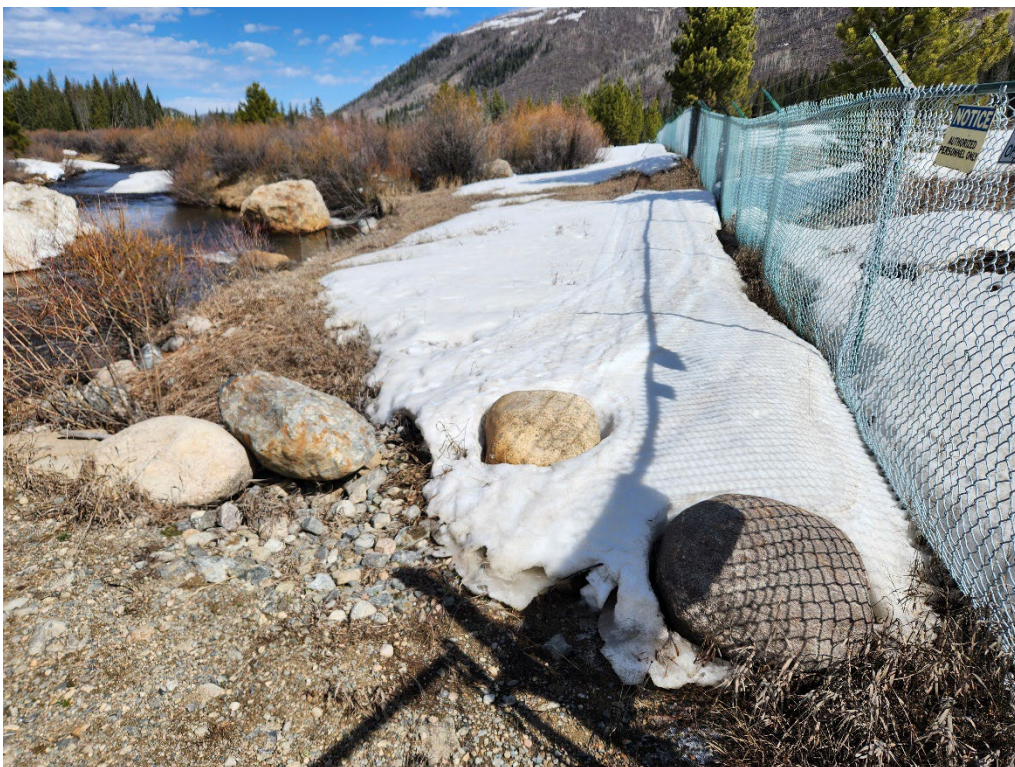
Photo 2. View of OF-M15

OF-M15: The BMP's of this outfall location consist of rip-rap. This outfall was mostly covered in snow but appeared to be in good condition.

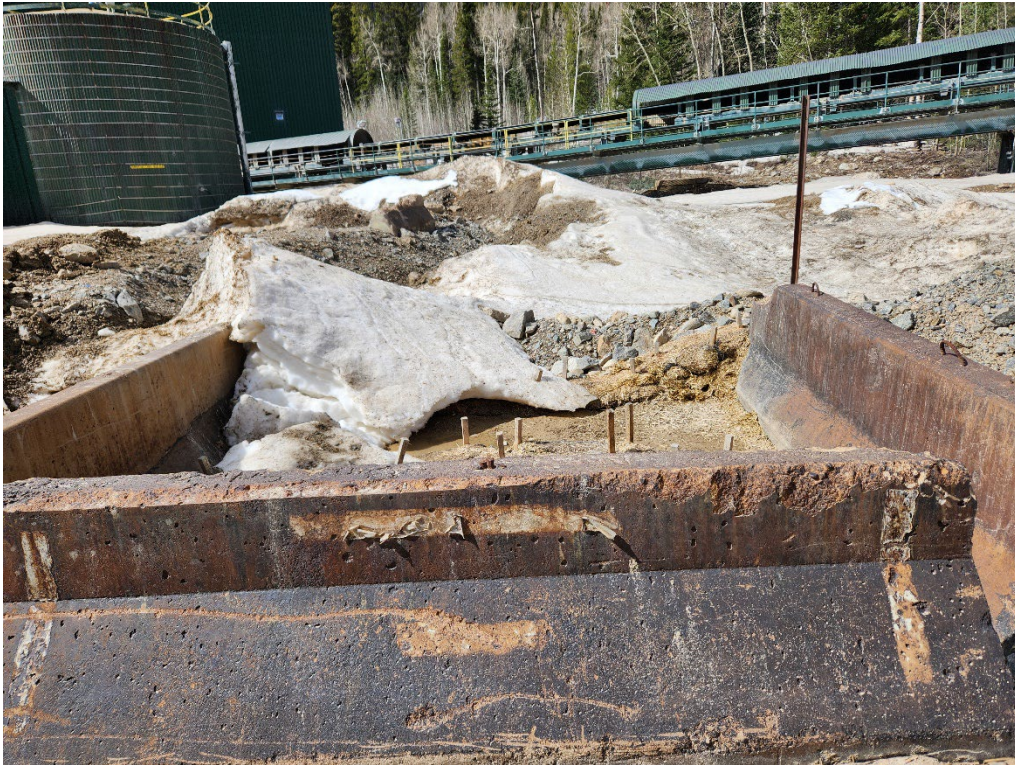
Photo 3. View of OF-M08

OF-M08: The BMP's of this outfall location consist of rip-rap that directs stormwater into a drainage pipe that discharges stormwater north of this location. Snow covered most of the rip-rap, but it appeared to be in good condition.

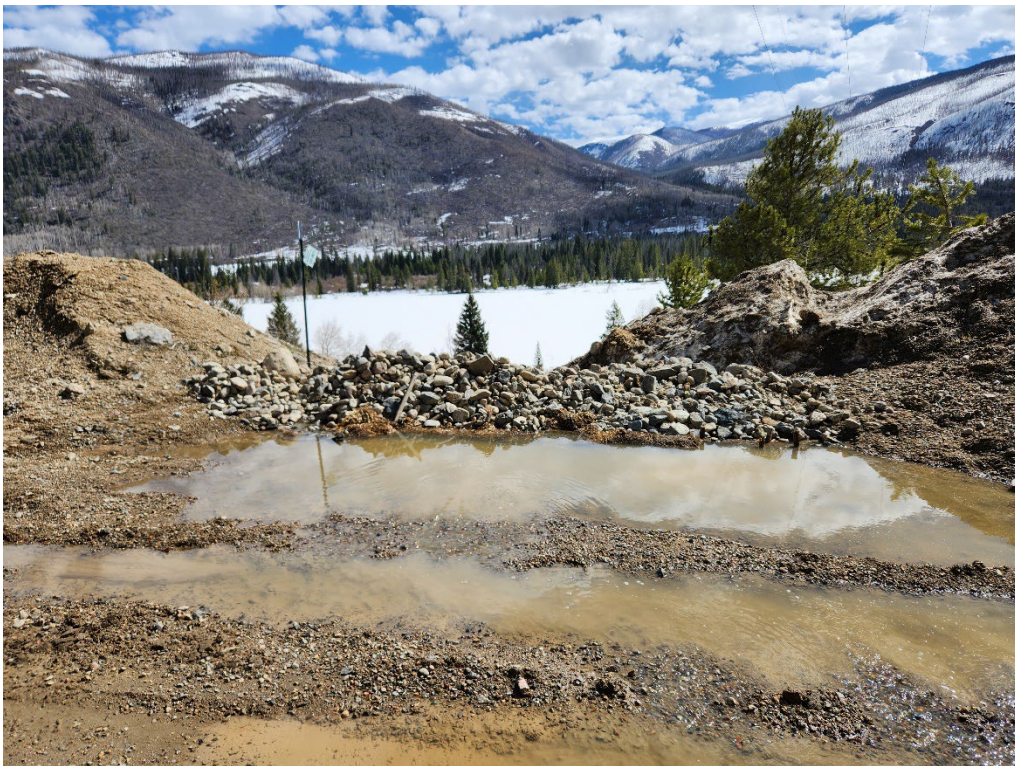
Photo 4. View of OF-M11

OF-M11: The BMP's of this outfall location consist of wattles in front of a rock check dam leading to a rip-rap outfall. The Division observed water moving through this structure during the inspection. This outfall location appeared to be in good condition.

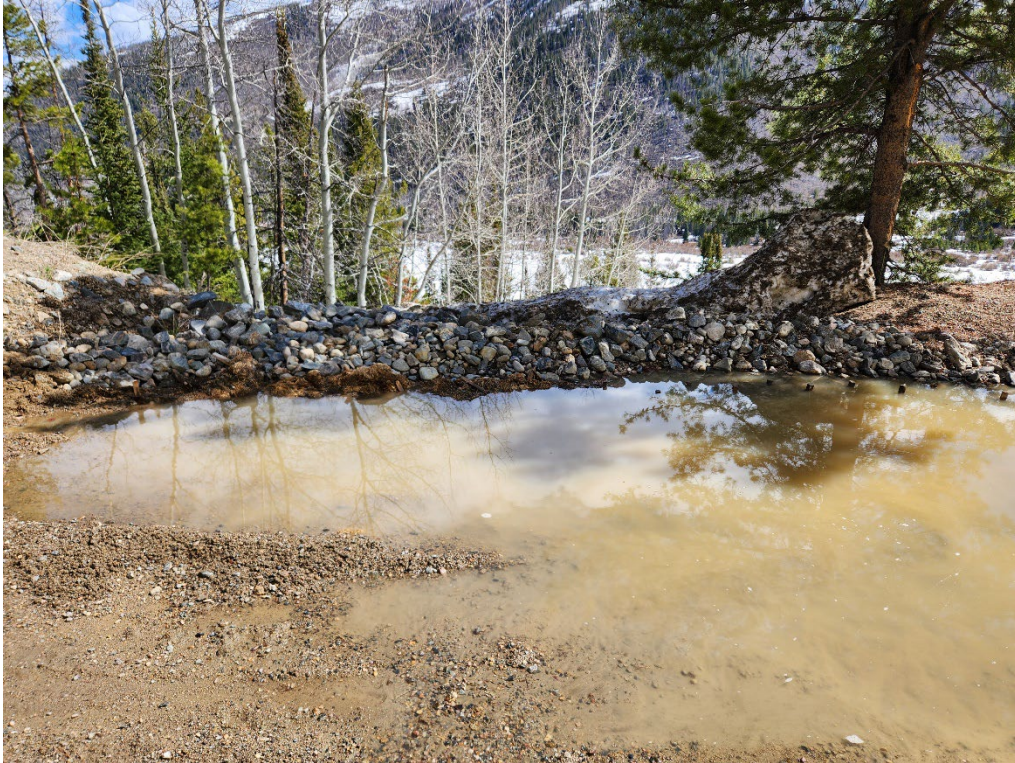
Photo 5. View of OF-M07

OF-M07: The BMP's of this outfall location consist of wattles in front of a rock check dam leading to a rip-rap outfall. The Division observed water moving through this structure during the inspection. The wattles are in poor condition, but this outfall location appears to be working well.

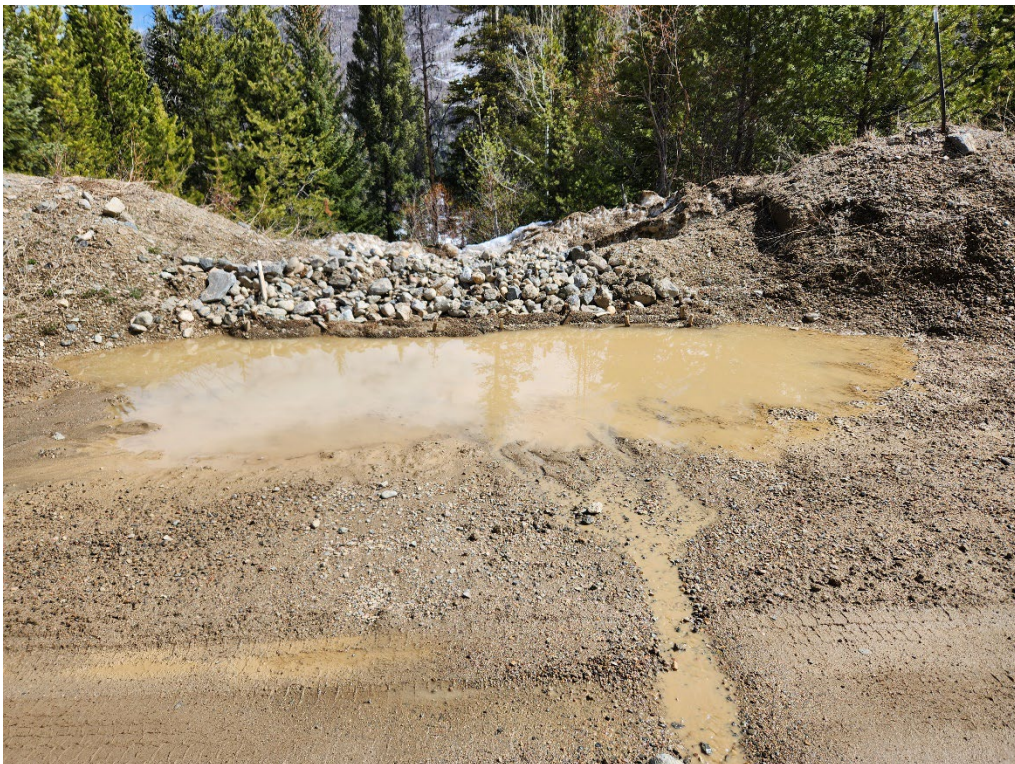
Photo 6. View of OF-M12

OF-M12: The BMP's of this outfall location consist of wattles in front of a rock check dam leading to a rip-rap outfall. The Division observed water moving through this structure during the inspection. This outfall location appears to be in good condition.

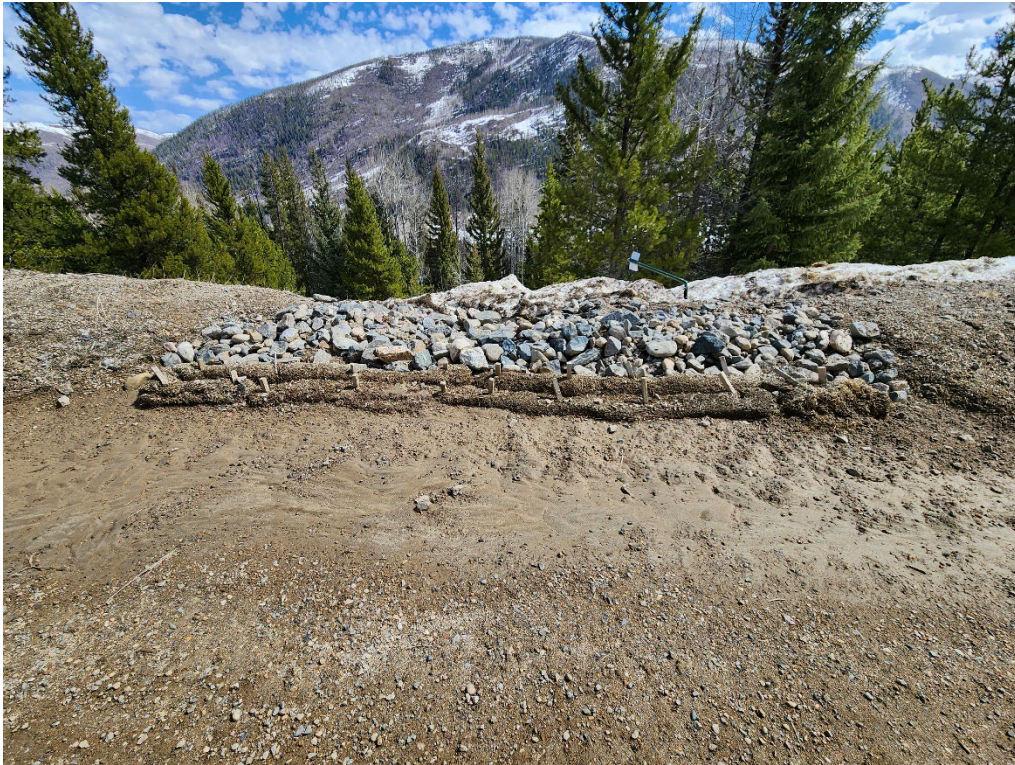
Photo 7. View of OF-M06

OF-M06: The BMP's of this outfall location consist of wattles in front of a rock check dam leading to a rip-rap outfall. No water was observed moving through this structure during the inspection. This outfall location appears to be in good condition.

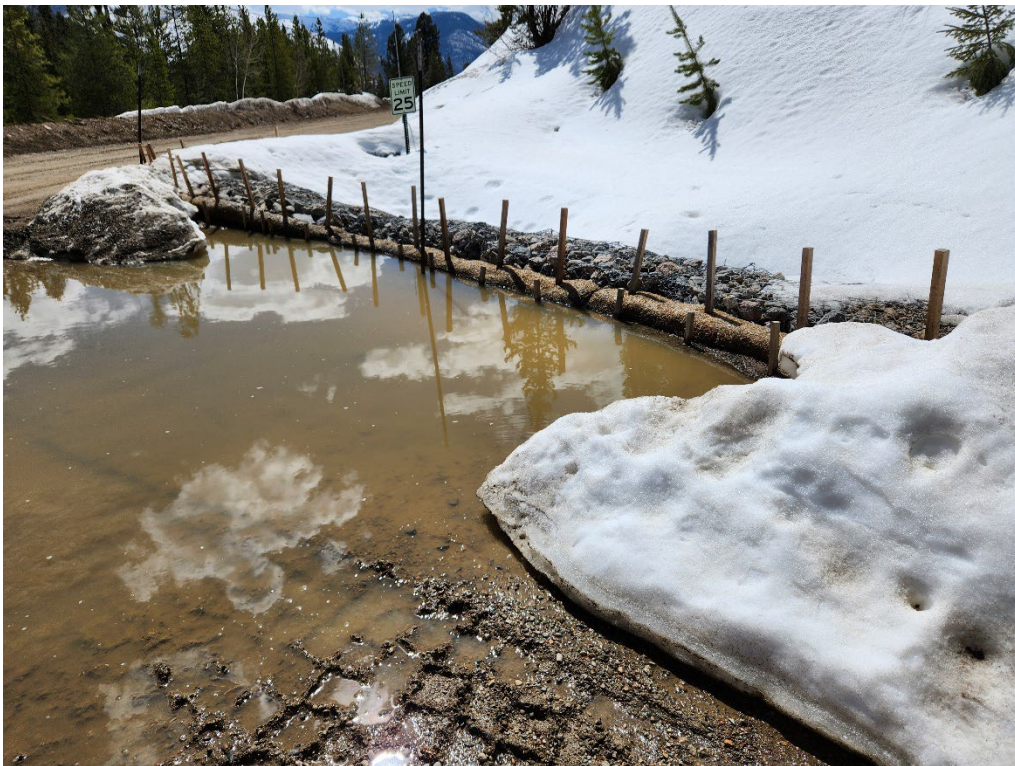
Photo 8. View of OF-M05

OF-M05: The BMP's of this outfall location consist of wattles in front of a rock check dam. Stormwater that goes through this structure converges with clean water coming from the south. Water then enters a grate and is discharged up north. The grate was covered with snow at the time of inspection.

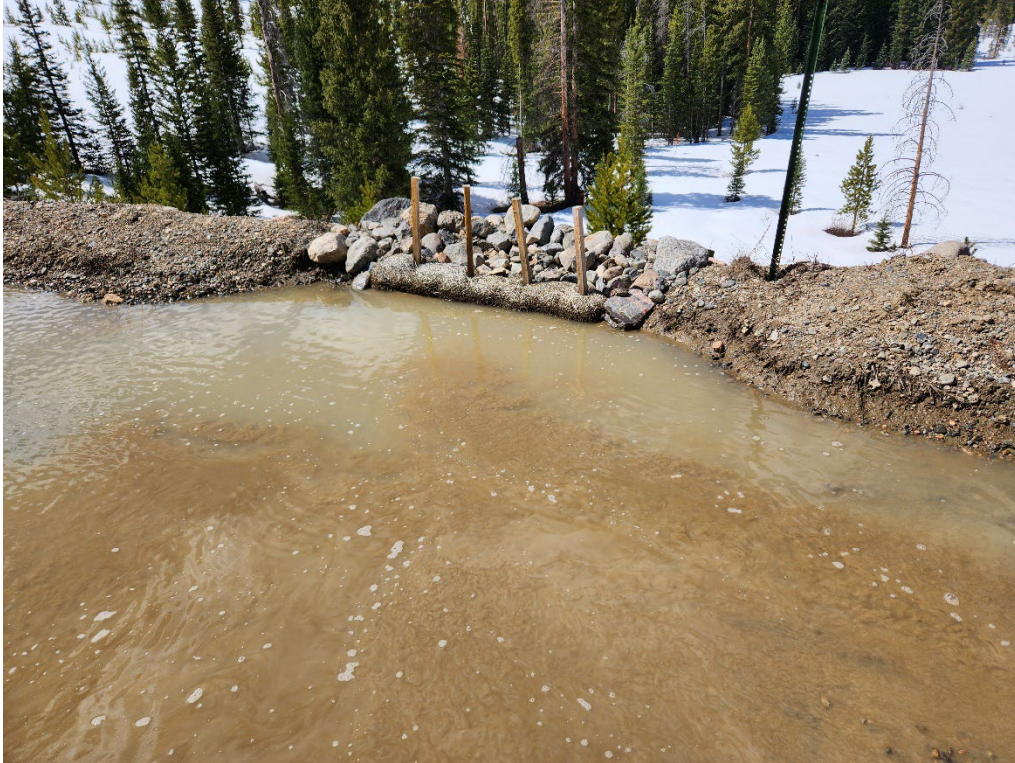
Photo 9. View of OF-M20

OF-M20: The BMP's of this outfall location consist of wattles in front of a rock check dam leading to a rip-rap outfall. The Division observed water moving through this structure during the inspection. This outfall location appears to be in good condition.

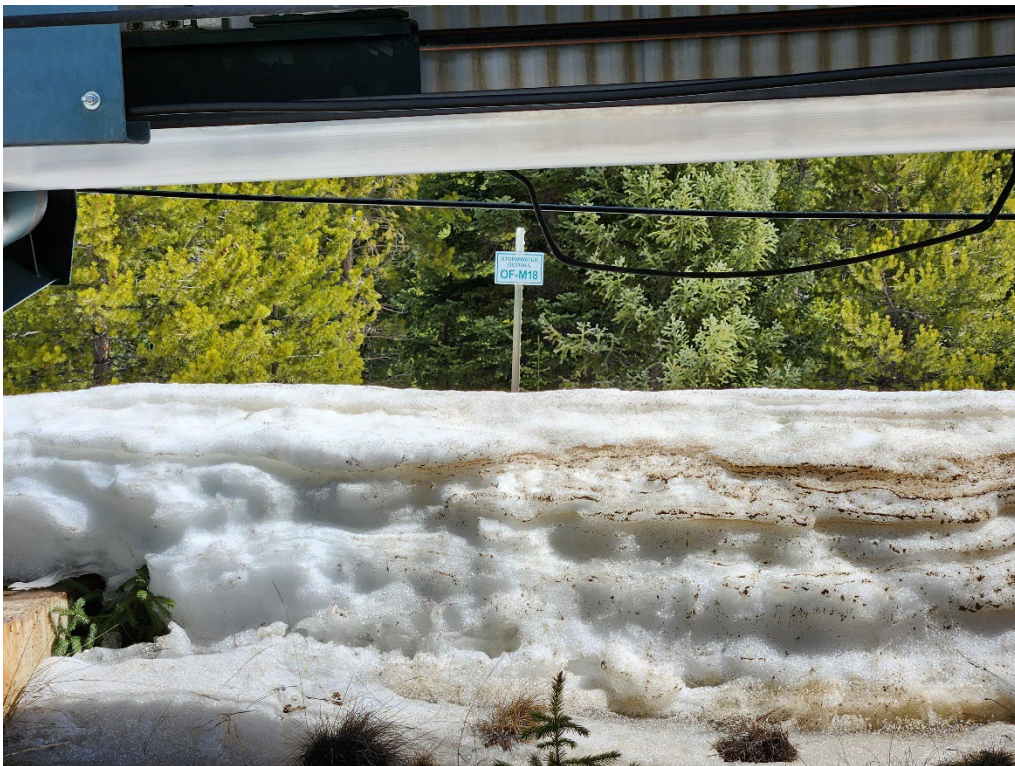
Photo 10. View of OF-M18

OF-M18: The BMP's of this outfall location consist of rip-rap, which was covered with snow at the time of inspection.

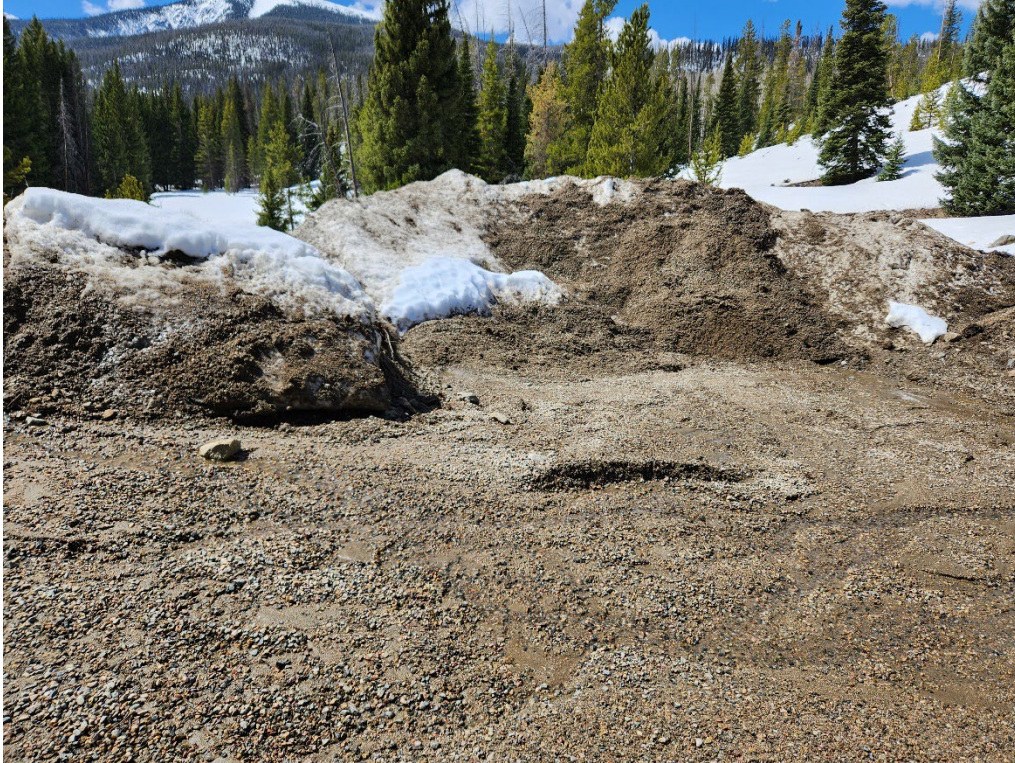
Photo 11. View of OF-M04

OF-M04: The BMP's of this outfall location consist of wattles in front of a rock check dam leading to a rip-rap outfall. These structures were covered in snow at the time of inspection.

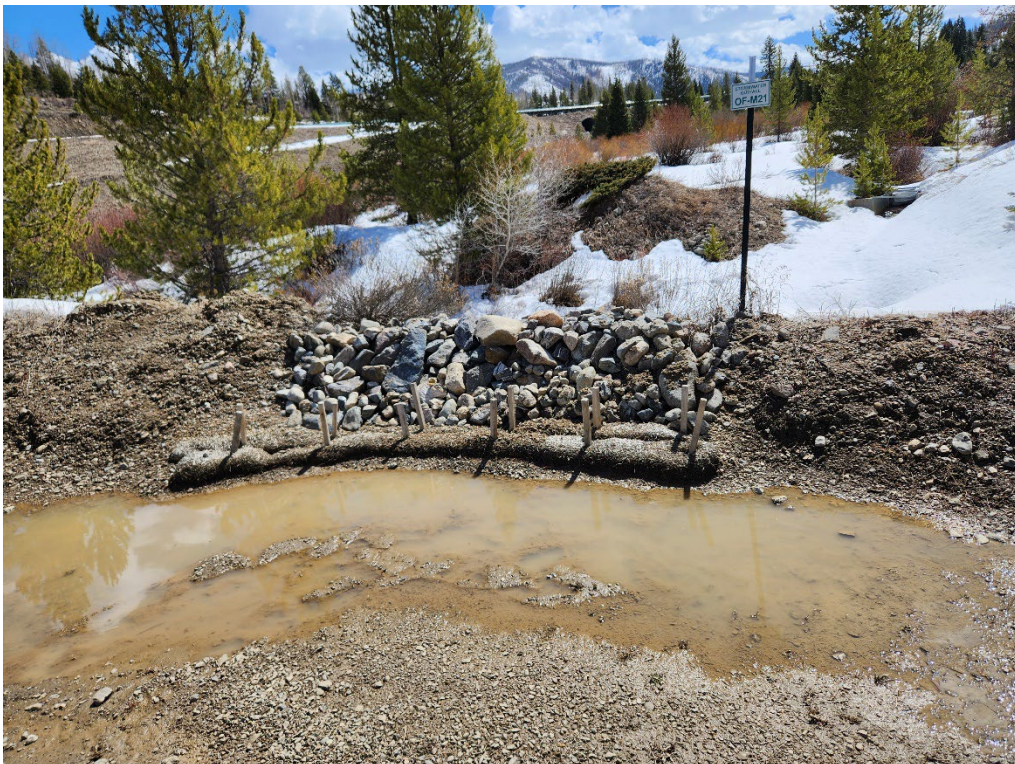
Photo 12. View of OF-M21

OF-M21: The BMP's of this outfall location consist of wattles in front of a rock check dam leading to a rip-rap outfall. This outfall location appears to be in good condition.

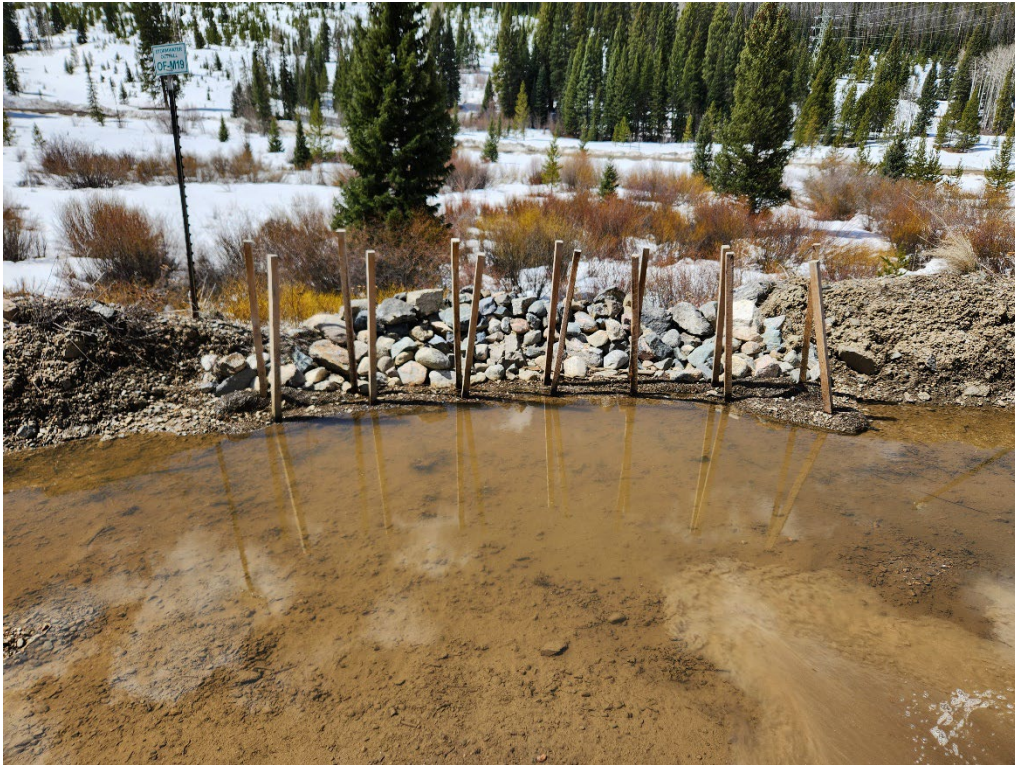
Photo 13. View of OF-M19

OF-M19: The BMP's of this outfall location consist of wattles in front of a rock check dam leading to a rip-rap outfall. The Division observed water moving through this structure during the inspection. This outfall location appears to be in good condition.

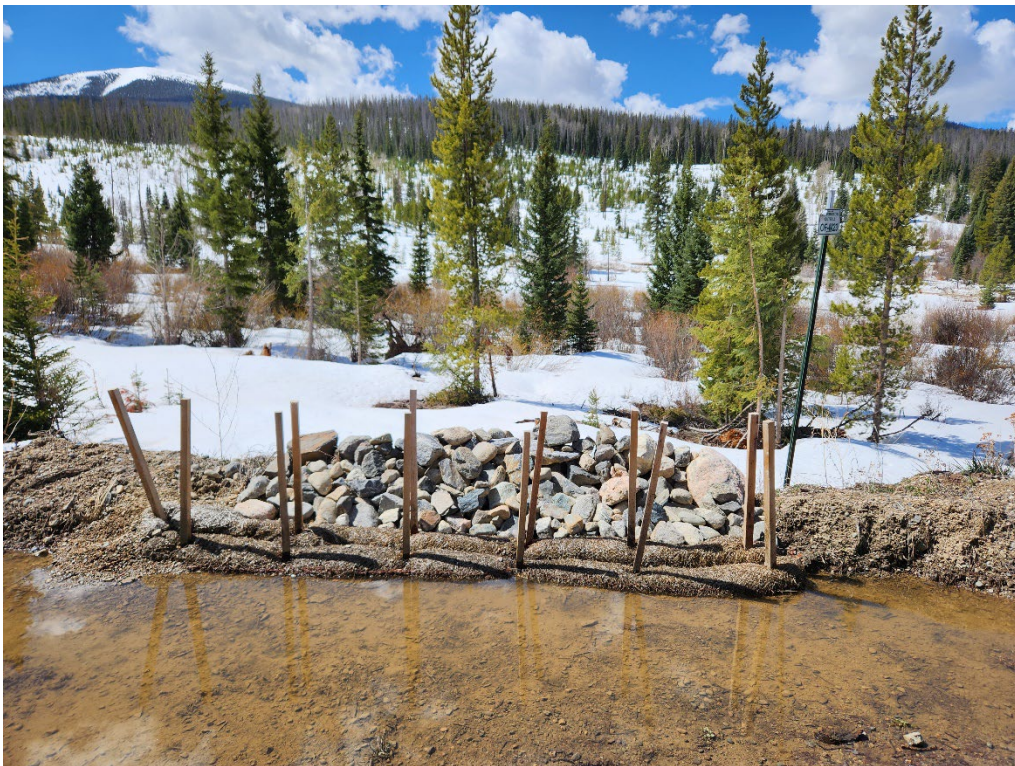
Photo 14. View of OF-M23

OF-M23: The BMP's of this outfall location consist of wattles in front of a rock check dam leading to a rip-rap outfall. The Division observed water moving through this structure during the inspection. Some water appeared to be pooling on the sides of the wattles and rock check dam, but the structure appears to be working well.

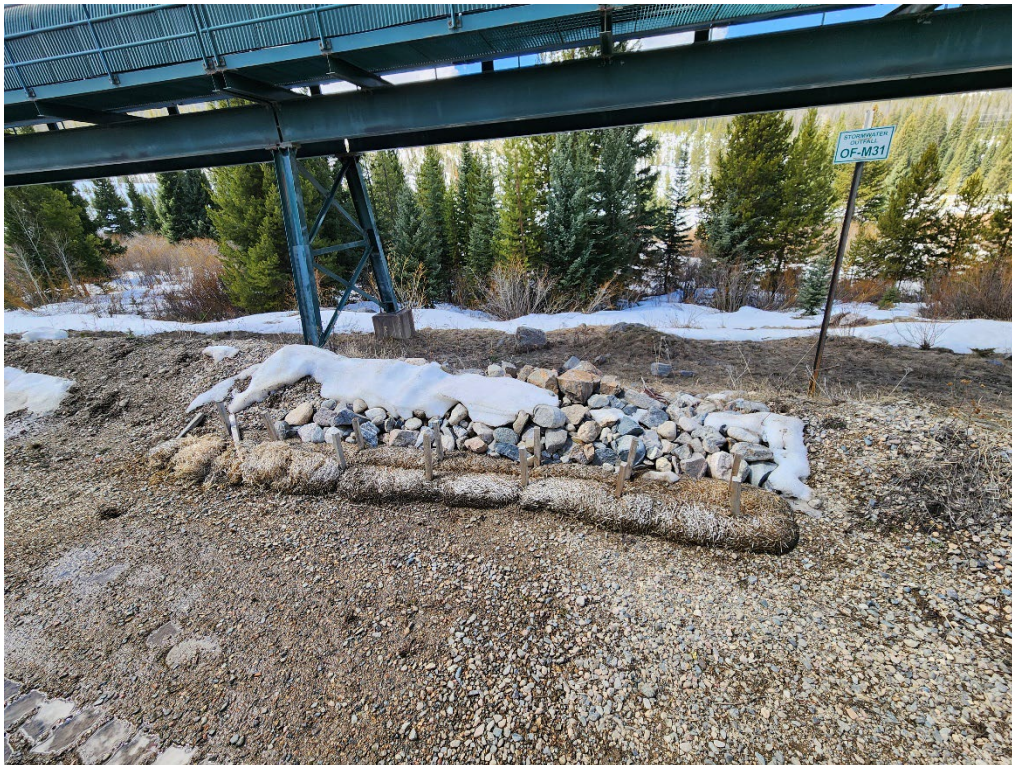
Photo 15. View of OF-M31

OF-M31: The BMP's of this outfall location consist of wattles in front of a rock check dam leading to a rip-rap outfall. No water was moving through this structure during the inspection. This outfall location appears to be in good condition.

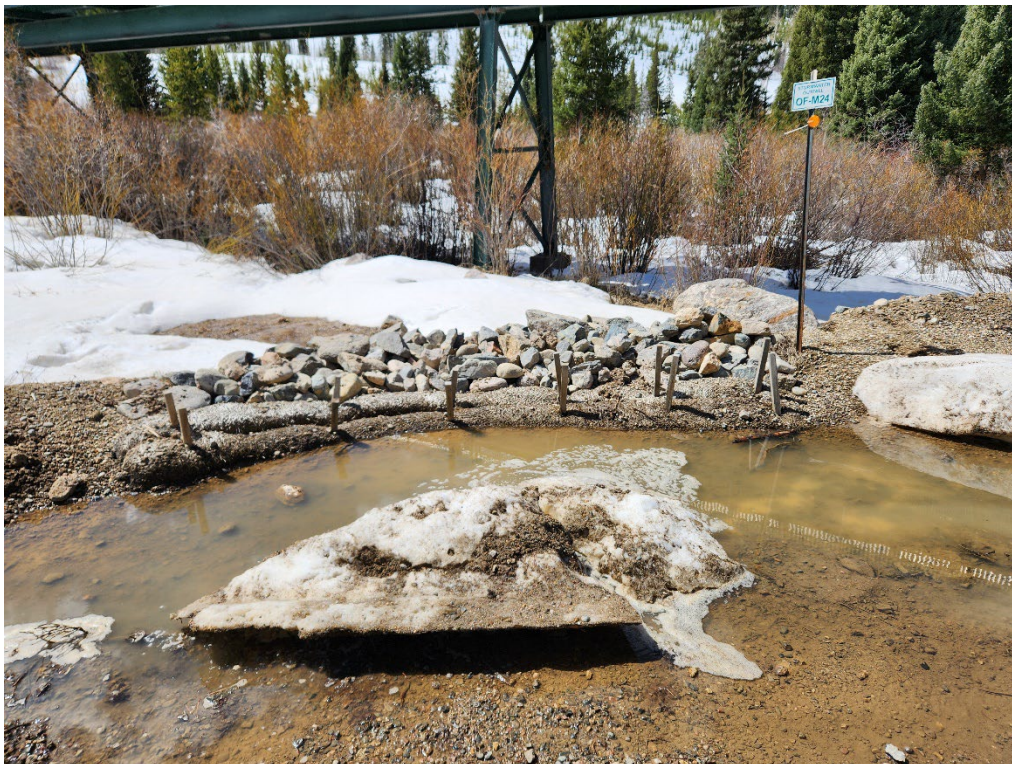
Photo 16. View of OF-M24

OF-M24: The BMP's of this outfall location consist of wattles in front of a rock check dam leading to a rip-rap outfall. The Division observed water moving through this structure during the inspection. This outfall location appears to be in good condition.

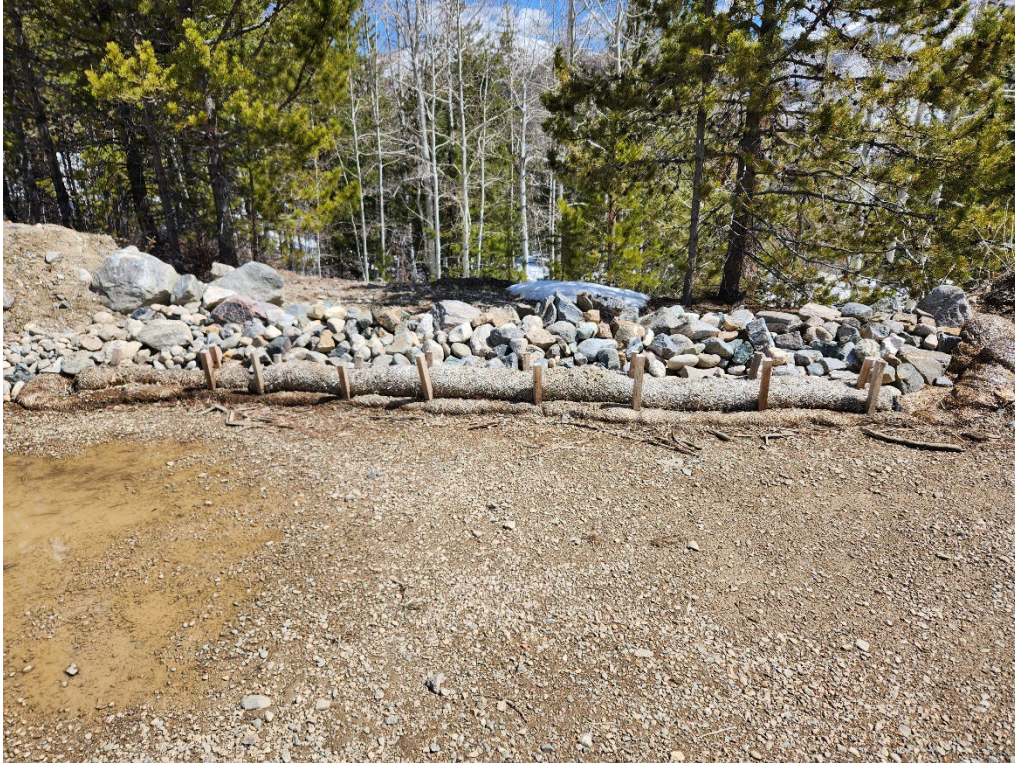
Photo 17. View of OF-M30

OF-M30: The BMP's of this outfall location consist of wattles in front of a rock check dam leading to a rip-rap outfall. The Division observed water pooling to the northwest side of the wattles, but no water was running off. This outfall location appears to be in good condition.

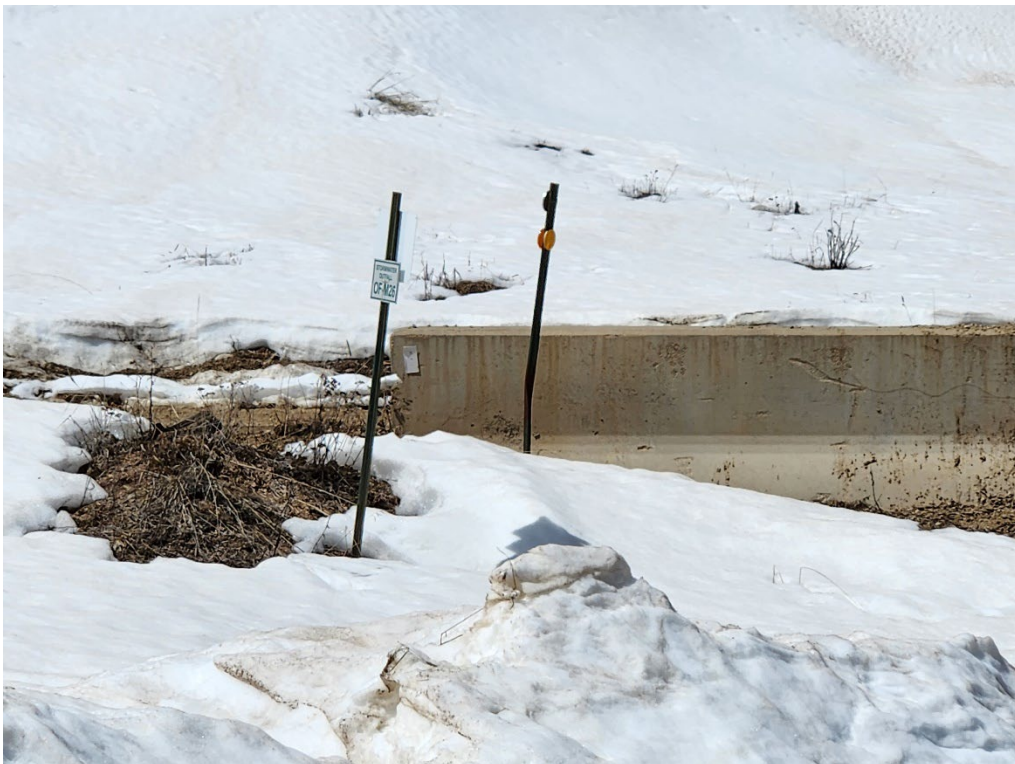
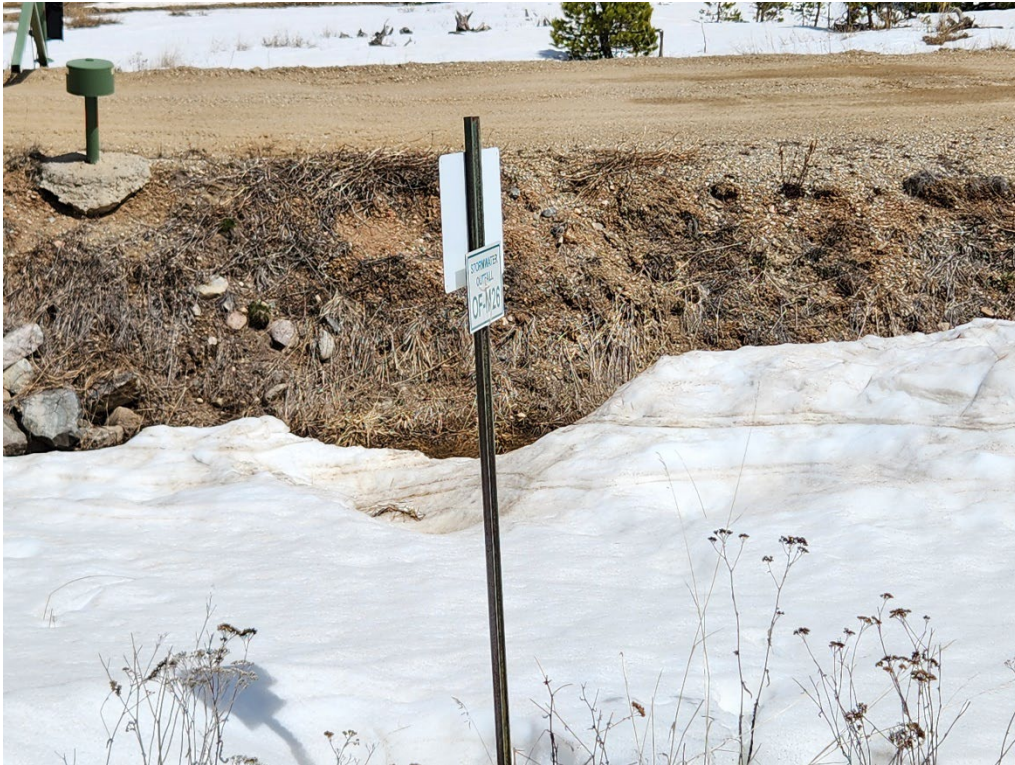
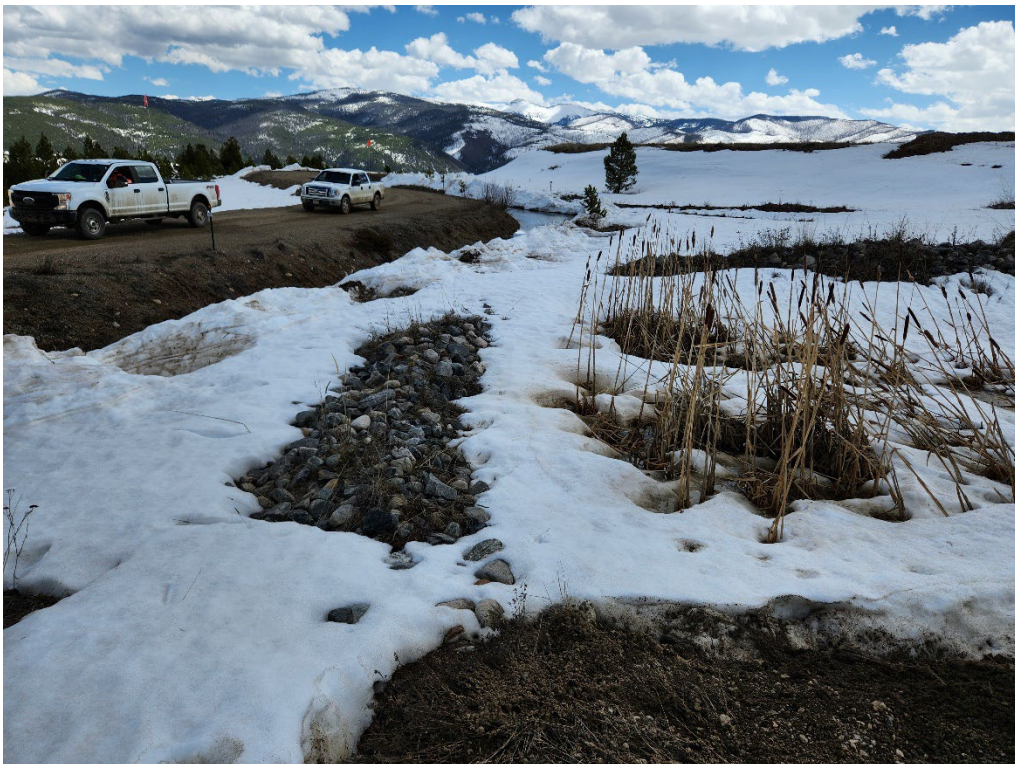
OF-M26: The BMP's of this outfall location consist of rip-rap, which was covered with snow at the time of inspection.
